SHAKING-TABLE TESTING OF SINGLE-STORY CLAY MASONRY VENEER WOOD-FRAME BUILDING

H. O. Okail¹, S. Jo², P. B. Shing³, R. E. Klingner⁴, W. M. McGinley⁵, and D.I. McLean⁶

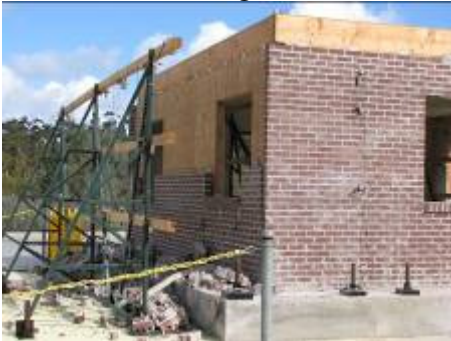
During ground shaking of Sylmar 80%, the veneer on the west wall peeled off the structure by the formation of a horizontal bed-joint crack above the 18th brick course (Figure 6). The collapse was characterized by complete nail extraction from the wood studs (Figure 7). Based on the observations of the tests conducted earlier on individual wall segments and the analytical studies conducted prior to the building tests, this mode of failure was not expected until higher levels of ground shaking. The rest of the structure, in contrast, showed no signs of distress under this level of shaking. During shaking at Sylmar 120 %, the rest of the veneer on the west wall detached from the backing wall by nail extraction from the wooden studs. The rest of the structure showed no signs of distress under this level of shaking.

Figure 6. Collapse of Veneer on West Wall

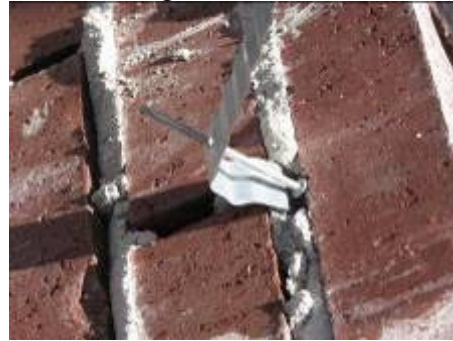
Figure 7. Typical Nail Extraction

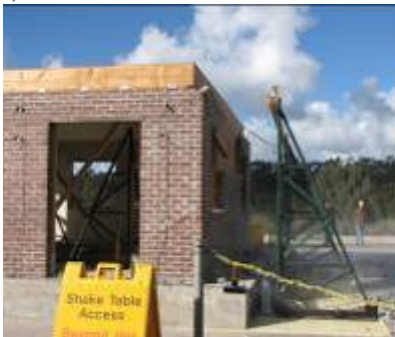
Figure 8. East Wall

No major additional damage was observed during the ground motion level of Sylmar 150%. The east wall responded in the out-of-plane direction with noticeable two-way bending, and no visible cracking. Relative motion between the rim joist and the double top plate was observed on the east wall, coupled with minor deformation of the metal plates connecting the outside of the rim joist and the top plate. During the first shaking at Sylmar 200%, the top portion of the veneer on the east wall collapsed (Figure 8). Failure was characterized by bed-joint cracking and pullout of most of the anchors from the mortar joints (Figure 9). A few anchors detached when screw heads pulled through deformed holes in the rigid ties. Diagonal cracking was also observed at the top and the bottom of the smaller veneer segments in the north and south walls, due to rocking of those segments. During the second application of Sylmar 200% shaking, more of the veneer on the east wall peeled off. Joint reinforcement in the top row of ties pulled out of the mortar joints and was not able to hold the dislodged pieces of veneer together.

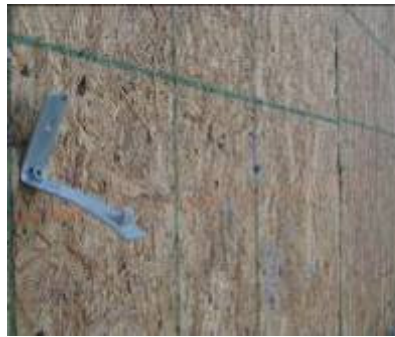
Figure 9. Anchor Pullout

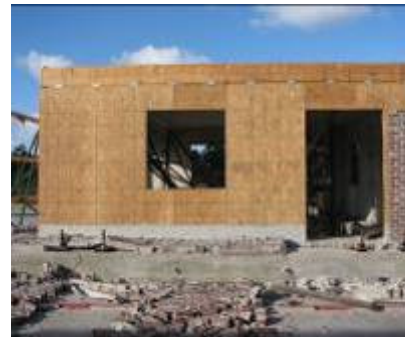
Figure 10. South Wall

The entire south wall pulled away from the backing frame and collapsed as shown in Figure 10. The collapse was initiated by the falling of the door lintel which was already diagonally cracked on both sides of the door during the previous test. After that, all the veneer anchors pulled out of the backing after experiencing severe cyclic shearing deformations (Figure 11). The north wall veneer was on the verge of collapse. It suffered excessive sliding and most of the anchors were pulled out of the backing wood-stud frame as shown in Figure 12. This pullout of veneer anchors was due to in-plane shearing deformations leading to the loss of any out-of-plane restraint as shown in Figure 13. The lintel beam over the door opening also suffered excessive diagonal cracking similar to that observed on the south wall. The joint reinforcement did not seem to help in arresting the propagated cracks (Figure 14). The roof of the structure, which had already suffered some minor differential movements between the rim joist and the double top plate, generally behaved well. During this level of excitation, the end nails at the blockings next to the east wall pulled out as shown in Figure 15. The magnitude of the pullout along the length of the east side suggests the bowing of the rim joist due to the two-way bending action of the entire east wall (veneer and backing). After the test, the gypsum board of the ceiling in this region was removed, and visual inspection showed a significant separation between the blockings and the rim joist as well as pullout of the braces connecting the rim joist to the first interior joist (Figure 16).

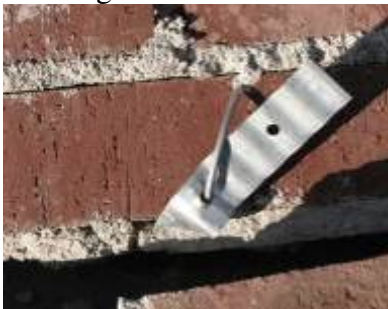
Figure 11. Deformed Anchor

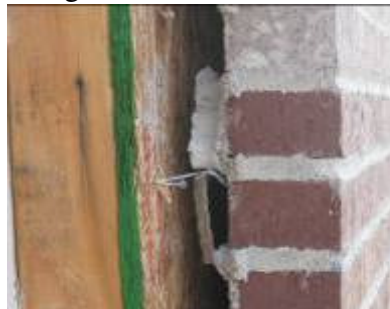
Figure 12. Anchor Extraction

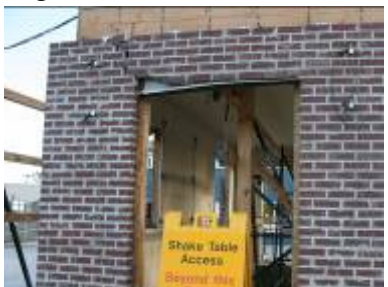
Figure 14. Cracked Lintel

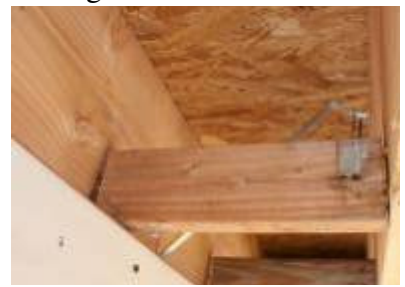
Figure 16. Brace Failure
