## THE EXPERIMENTAL STUDY OF THE CONSTRUCTION METHODS FOR STONE VENEERS IN TAIWAN

Fan-Ru Lin<sup>1</sup>, George C. Yao<sup>2</sup>, Shyh-Jiann Hwang<sup>3</sup>, Chien-Chuang Tseng<sup>4</sup>, Pu-Wen Weng<sup>5</sup>

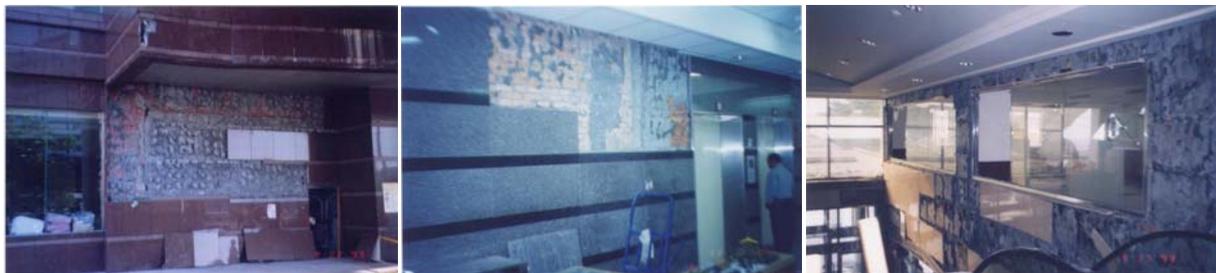
Veneers of stone materials are popular building decoration elements for both exterior and interior decoration components in Taiwan, and usually placed at entrances and lobbies in public buildings or modern apartment complex to create elegant appearance. However, stone veneers with inappropriate construction methods may become falling hazards and obstructions along escape egress during and after strong earthquakes, and thus cause unexpected severe casualties. In 1999 Chi-Chi earthquake, dislodged exterior and interior adhered stone veneers could be found in hospitals and residential buildings (Fig. 1).

Figure 1. Stone veneer damages at Taiwan Central Area in Chi-Chi Earthquake.

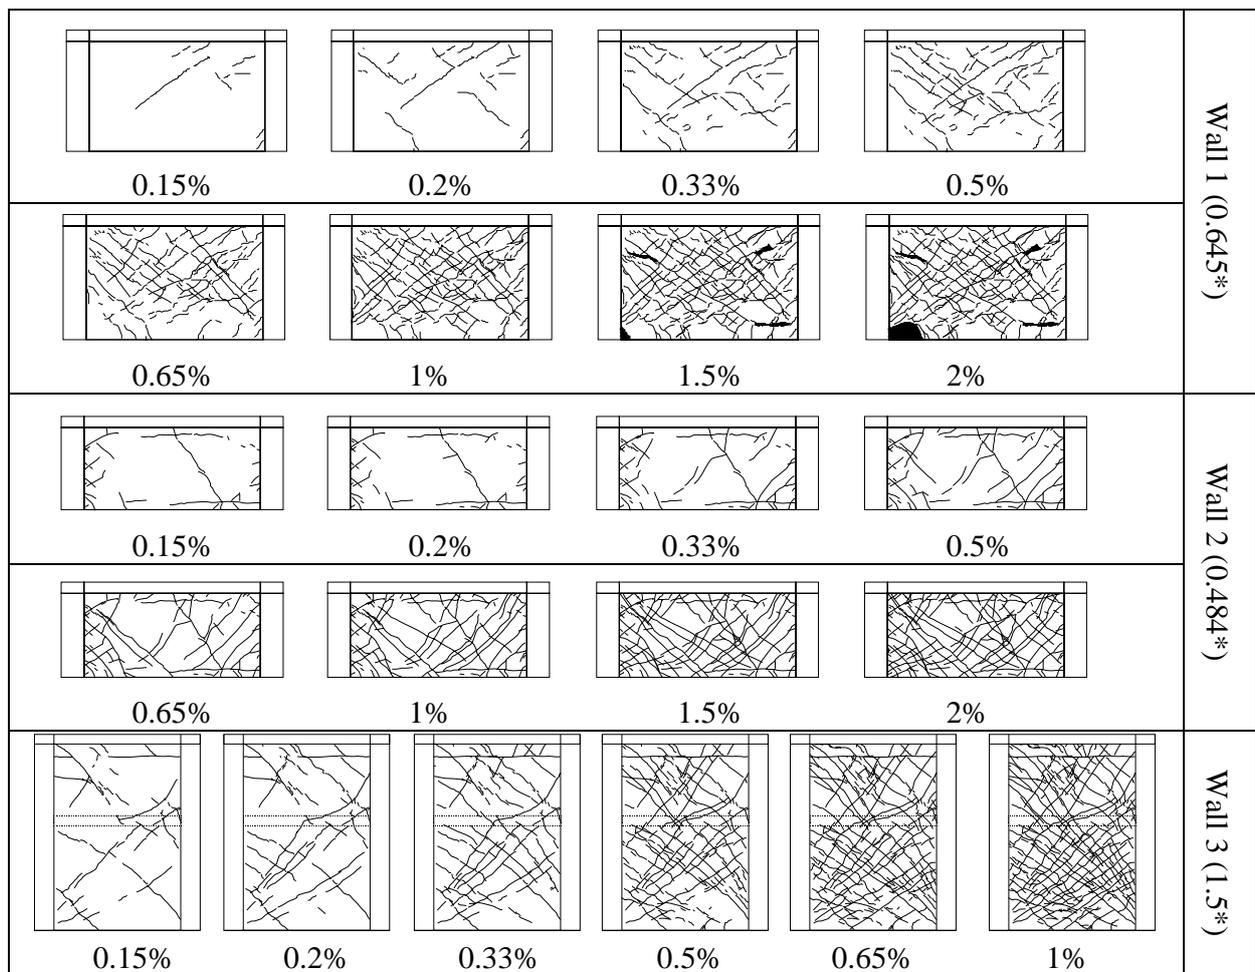
According to acceptable criteria in guidelines and standards, expected drift ratio values of cyclic loadings were decided in Table 3. Cyclic loading in X or Y direction were executed by turns, and each drift ratio was repeated 3 times to ensure the required drift ratio was achieved. The 2<sup>nd</sup> and 3<sup>rd</sup> floors were forced to the same drift ratio in X direction to give all interior veneer types the same deformation requirement. Two groups of maximum drift ratio values in each loading was shown in Table 3, which were measured from actuators connected to floors and from displacement transducers connected to wall specimens at diagonal points. Comparing achieved and expected drift ratio values, most drift ratio values of floors could conform to expected ones. However, drift ratios of wall specimens were much smaller due to the deformation of walls and the whole frame while expected drift ratio values were small than 1.0%, but they conformed while drift ratio exceeded 1.0 % in X direction while primary cracks ran through wall specimens (Fig. 7). Several cracks of three Wall Specimens exceeded 1.5mm when expected drift ratio is 1.0%, and partial area of concrete crushed and fell in Wall 1 when expected drift ratio is 2.0%.

Figure 7. Crack in Wall Specimens

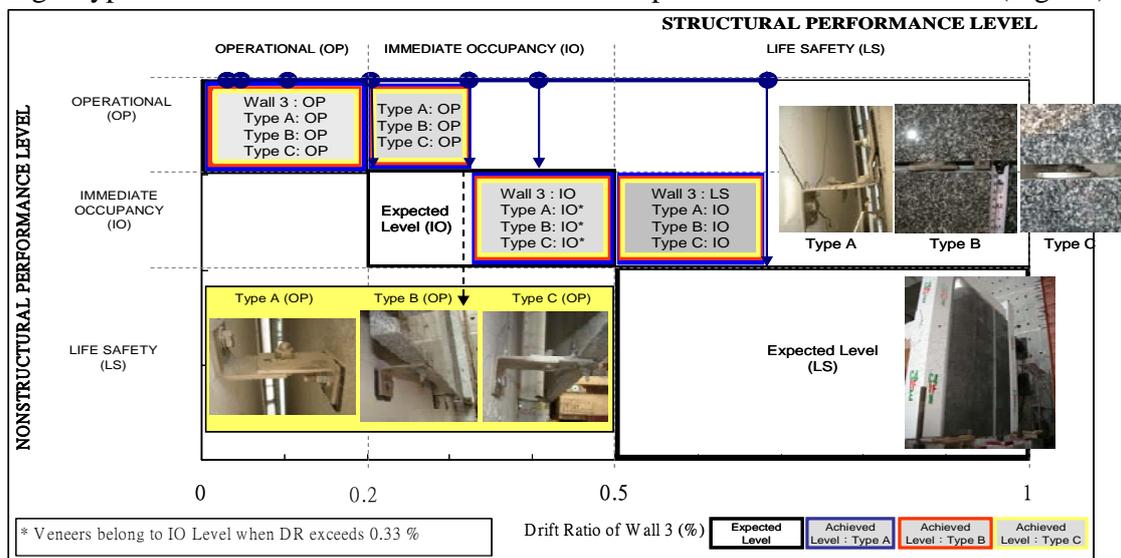
As shown in Fig. 8 to Fig. 10, damage states of veneers were classified to several performance levels according to FEMA 356 and test results. In this test, Nonstructural Performance Level was expected to be the same as the Structural Performance Level. As the result of tests, three exterior veneer types had high capacity, except the epoxy may split when drift ratio achieved 1.0% (0.685% of Wall 3). In addition, opening was obviously observed when drift ratio achieved 2.0% in out-of-plane axis. Considering poor capacity of adhered veneers, each type of interior veneers was arranged in a single row to avoid weight transfer effect. However, two types of interior veneers still failed during this test (Fig. 9). Type-E and Type-D separated from backup wall and were hung by stainless steel wires when expected drift ratio were 0.5% and 0.65% (0.432% and 0.582% of Wall 2), and fell when expected drift ratio was 1.0% (0.924% of Wall 2). In addition, two anchored interior veneers still remained in place although Type G devices had severe distortion while expected drift ratio was 2.0% (Fig. 10).

Figure 8. Achieved Performance Level of Exterior Veneers (Type A~C)

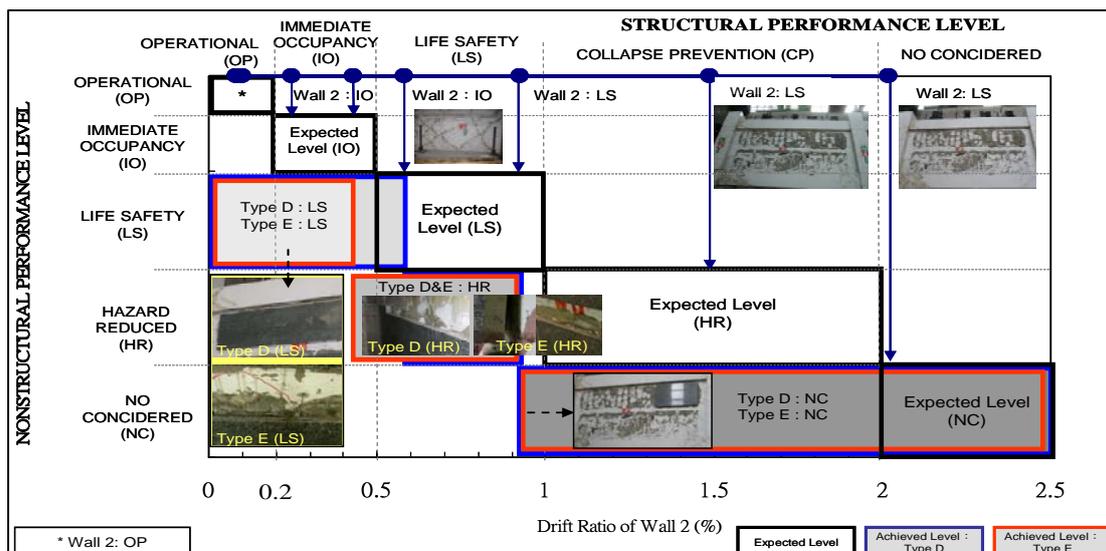
Figure 9. Achieved Performance Level of Interior Veneers (Type D~E)

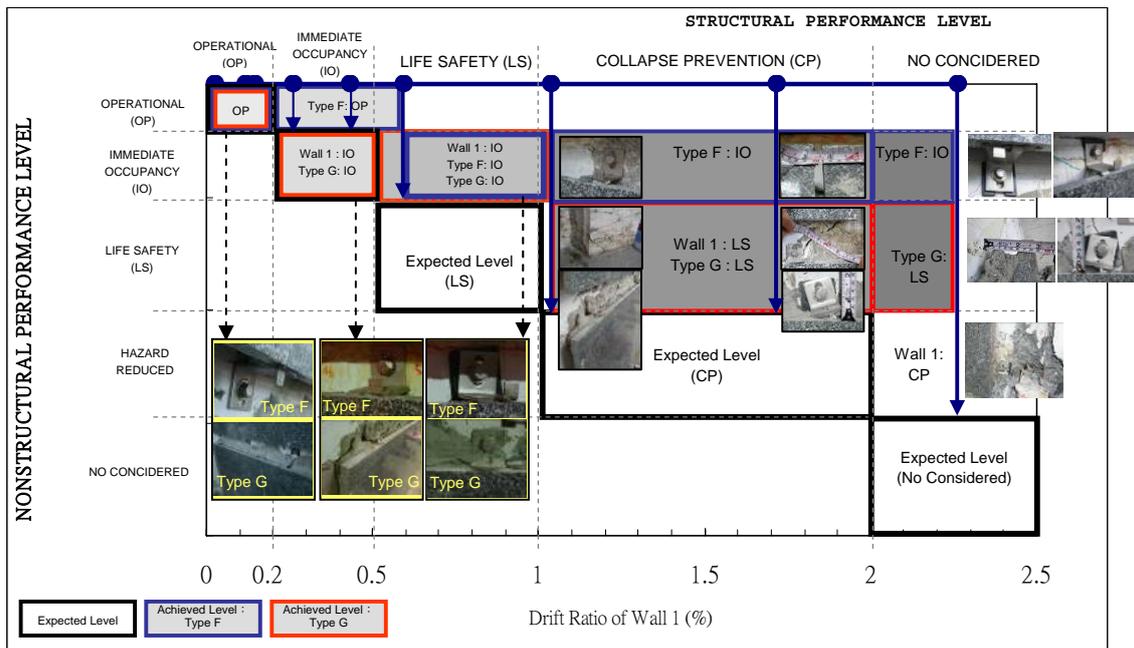
Figure 10. Achieved Performance Level of Interior Veneers (Type F~G)
