BUILDING DAMAGE DISTRIBUTION IN THE SOUTHERN PART OF BEICHUAN COUNTY BY THE 2008 WENCHUAN, CHINA, EARTHQUAKE DETECTED FROM SATELLITE OPTICAL IMAGES

H. Miura¹ and S. Midorikawa²

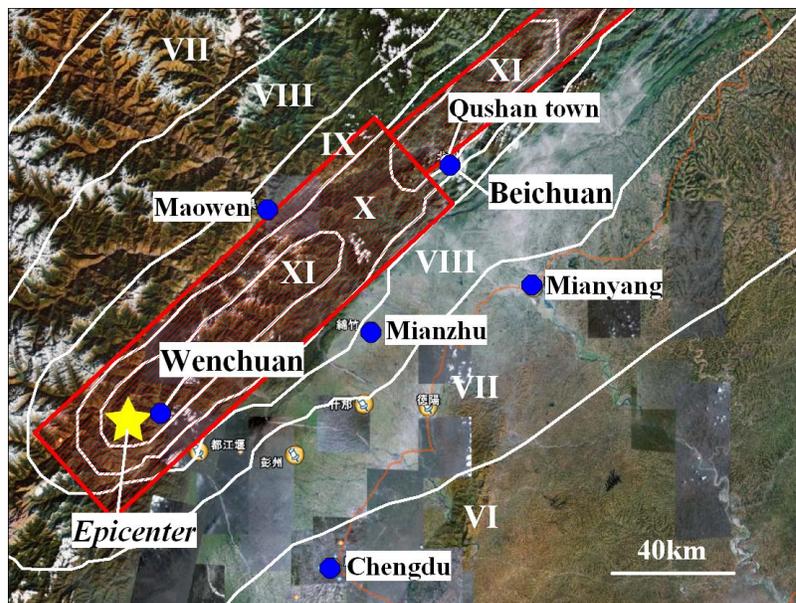
Figure 1 shows the isoseismal map of the 2008 Wenchuan earthquake (China Earthquake Administration 2008) with the locations of major cities in Sichuan province, China. The seismic intensity scale in China almost corresponds to the Modified Mercari intensity scale. The seismic intensity XI areas are distributed not only in Wenchuan county located near the epicenter but also in Beichuan county located about 130km northeast from the epicenter.

Figure 1 Isoseismal map of the 2008 Wenchuan, China, earthquake (China Earthquake Administration 2008) with surface projection of fault planes (Koketsu et al. 2008)

by solid rectangles in Fig. 1. The fault model was determined from distribution of the aftershocks, observed ground motion data, and the results of the field investigation of the surface ruptures (Hao et al. 2009). Two reverse faults dipping to northwest were estimated in the earthquake. The southern fault located beneath Wenchuan county has dip angle of 35 degree while the northern fault located beneath Beichuan county has dip angle of 65 degree. The lengths of the both faults are 140km.

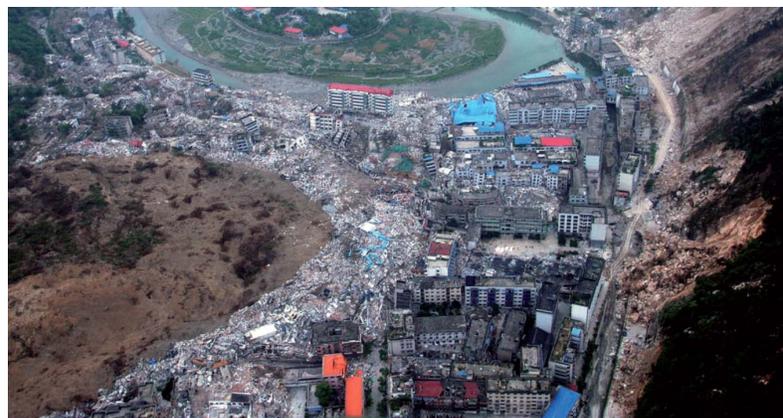
Figure 2 Photograph at southern part of Qushan town, Beichuan county (Munich Re Group 2008)

The target area of this study is the southeastern part of Beichuan county that was severely damaged in the earthquake. Especially, Qushan town, the capital of the county, was catastrophically damaged. Figure 2 shows the aerial photograph observed in Qushan town just after the earthquake (Munich Re Group 2008). The photo shows that numerous buildings are collapsed and buried in debris of a large landslide. Number of the residents in the town was about 22,000 before the earthquake. About 12,000 people that correspond to 55% of the residents were killed in the earthquake. Because of the heavy damage, the town was abandoned and all the survived residents were evacuated from the town.

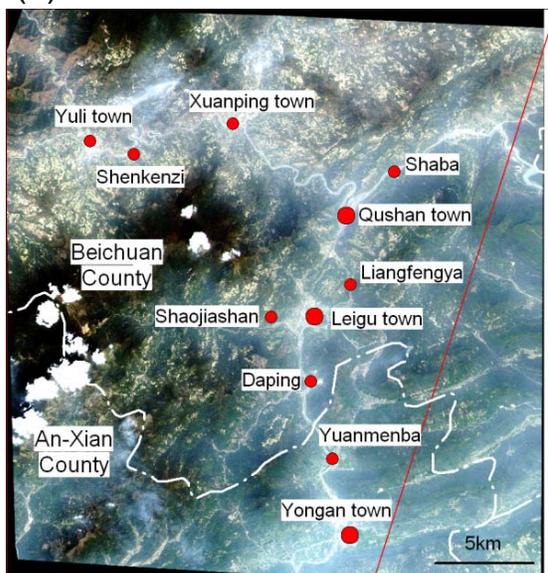
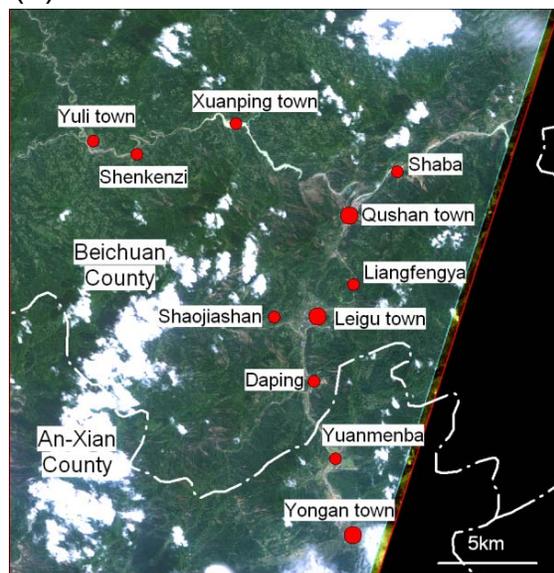
Figures 3 Pre- and post-event images in Beichuan county

resolution of the image is 2m. The pre-event FORMOSAT image, however, is not available because the target area is located outside of the regular observation range. The pre-event image observed from ALOS (PRISM/AVNIR2) with the spatial resolution of 3m is used in this study. The characteristics of the images are shown in Table 1. Figures 3 (a) and (b) show the pan-sharpened images of the target area. The images cover 11 towns and villages in the southeastern part of Beichuan county and the northern part of Anxian county, extending 28km by 28km in NS and EW directions.

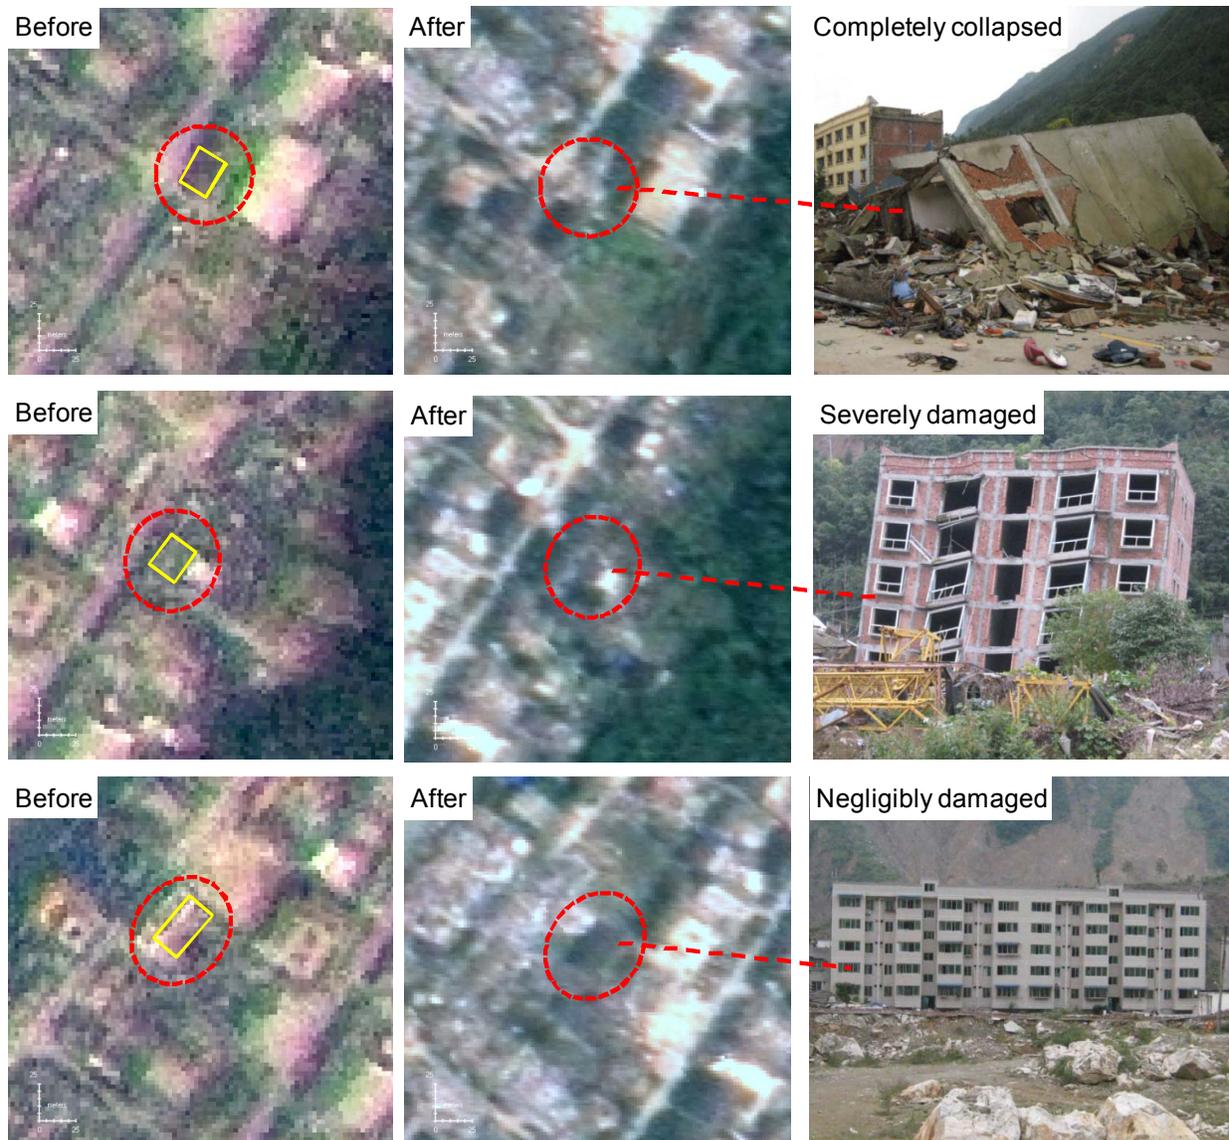
Figures 4 Pre- and post-event satellite images and ground photographs

Field survey was conducted in October 2008 in Qushan town, Beichuan county to confirm the building damage and the landslides. Figures 4 show the comparison of the pre- and post-event satellite images and the ground photographs in the survey. Rectangles in the pre-event image represent the outlines of the buildings. In the completely collapsed building, the roof and outline of the building cannot be identified from the post-event image and many rubbles are observed around the building. In the severely damaged building, although the roof and outline of the building can be identified, the rubbles are observed around the building in the post-event image. In the negligibly damaged building, the significant change cannot be identified between the images.

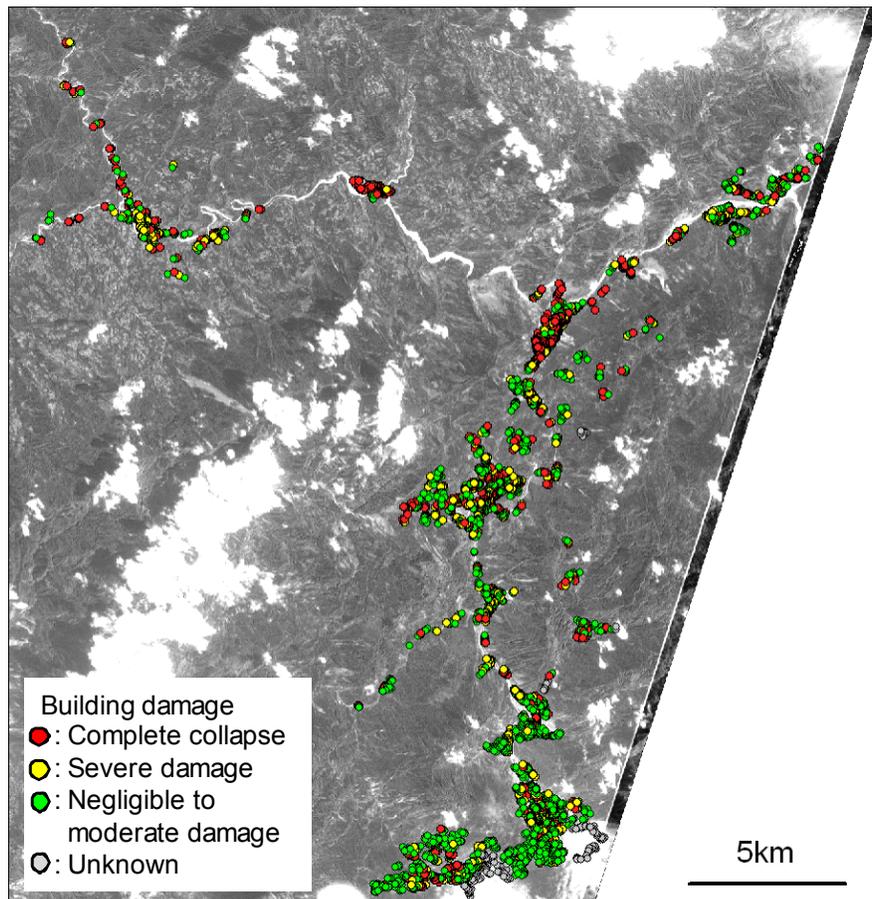
The result of the visual detection of the building damage is shown in Fig. 5. The number of the damaged buildings and their percentages are summarized in Table 4. The numbers of completely collapsed and severely damaged buildings are 1,222 and 988 that are about 25% and 20% of the total, respectively. The number of negligibly to moderately damaged buildings is 2,652 that is about 50% of the total. The result shows that approximately 45% of the buildings are classified into severe damage or complete collapse in the area.

Figure 5 Result of building damage detection

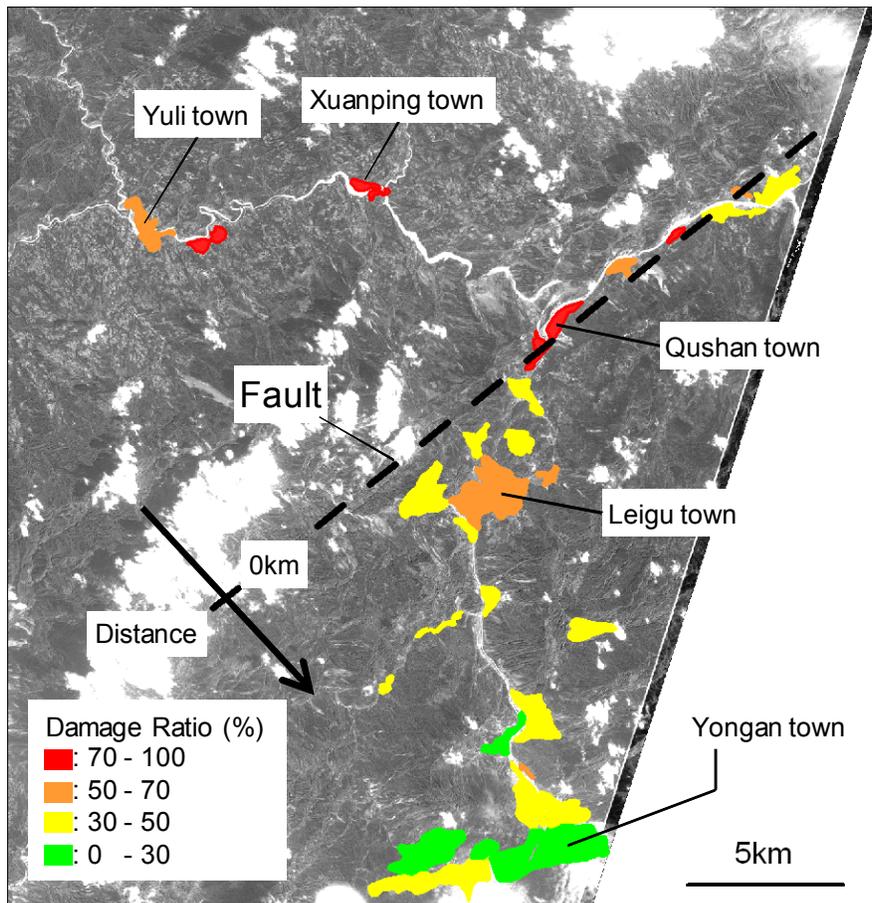
number of the completely collapsed buildings and the severely damaged buildings to the number of the identified buildings. The damage ratios are calculated for totally 34 towns and villages. Figure 6 shows the distribution of the damage ratios. The damage ratios in Qushan town and Xuanping town are more than 80%. The damage ratios in Yuli town and Leigu town are about 50-60%. The damage ratio in Yongan town is about 20%. The result shows that most of the damage ratios in the northern part of the area are higher than 50% while those in the southern part of the area are lower than 50%.

Figure 6 Distribution of damage ratios with fault line of the earthquake

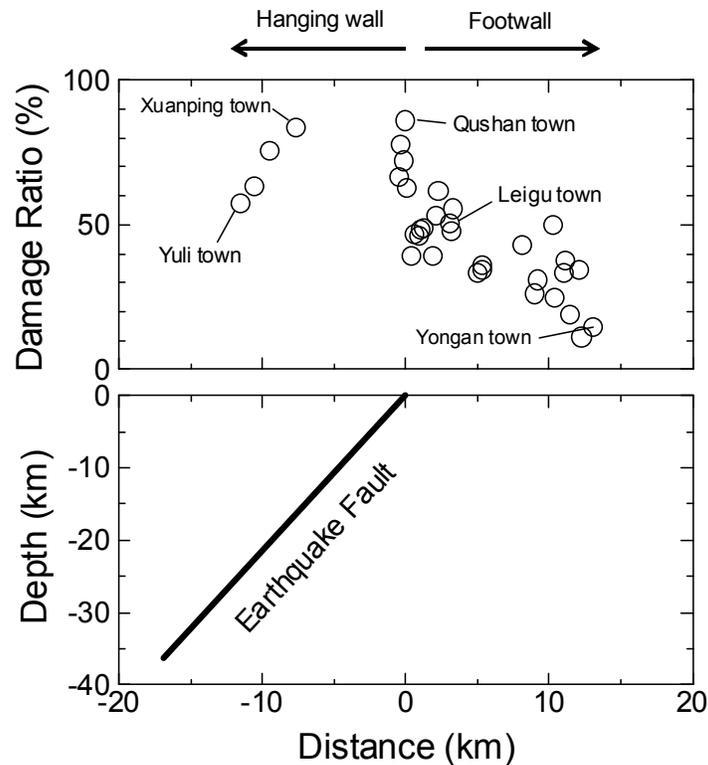
Figure 7 Cross section of damage ratios (upper) and fault (lower) for fault normal direction

direction as shown by an arrow in Fig. 6. Lower part of Fig. 7 shows the cross section of the fault. From the dip of the fault, the hanging wall side and the footwall side are classified as arrows in Fig. 7. The figure shows that the damage ratios on the hanging wall are higher than those on the footwall. In a dipping fault, sites located above the fault rupture on the hanging wall have larger ground motions than sites at the same rupture distance located on the footwall because the hanging wall sites are closer to the source area in total than the footwall sites. (Abrahamson and Somerville 1996). This effect would explain the higher damage ratios on the hanging wall area.
