EXPERIMENTAL SEISMIC FRAGILITY ASSESSMENT OF LIGHT GAUGE STEEL STUDDED GYPSUM PARTITION WALLS

Rodrigo Retamales¹, Ryan Davies², Gilberto Mosqueda³ and Andre Filiatrault⁴

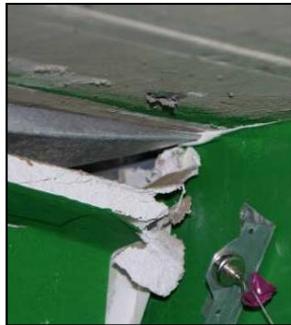
(a) Damage in transverse wall top track

| Config | Specimen ID | Main Damage/Failure Observed | Photo |
|---|---|--|---|
| 1 | 1, 2 & 3 | Damage concentrated in transverse walls top tracks: Tearing of track web, nails pulled out from concrete, and bending of track flanges. Damage was also observed in the transverse walls top gypsum panels. Longitudinal walls exhibited limited crushing at wall corners. | a |
| 2 | 4 | Crushing of gypsum boards around all screws connecting sheathing to top track, at a relatively low drift level (~0.4%). Then, a similar damage to specimens 1, 2 & 3 was observed. | a |

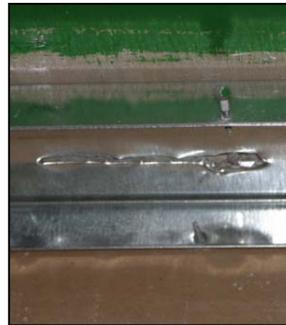
(c) Tearing along top track fastener

| Config | Specimen ID | Main Damage/Failure Observed | Photo |
|---|---|--|---|
| 3 | 5, 6 & 10 | Damage along steel cornerbeads. Crushing of gypsum boards at wall corners. Nails in connections of tracks to concrete passing thru the track webs. In specimen 10, tearing of the top track was observed. | b & c |
| 4 | 7, 8 & 9 | Specimen 7 & 9: Top and bottom tracks slipped after track tearing around all nailed connections. Specimen 8: Moment hinges were observed in all studs, approximately 1 ft under top end connection. | c & d |

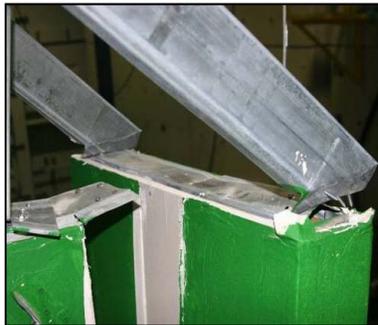
(f) Damage in brace connections

| Config | Specimen ID | Main Damage/Failure Observed | Photo |
|---|---|--|---|
| 7 | 17, 18 & 19 | Damage in seismic braces due to buckling. Failure in braces to top track connections. In specimen 18, the connection between the top tracks of longitudinal and transverse walls failed. Failure in some of the track to concrete connections were observed. | e & f |
| 22 | 48, 49 & 50 | Screws in connections of braces to walls' top tracks pulled out. Buckling of seismic braces. Buckling of top tracks around seismic brace connections. | e, f & s |

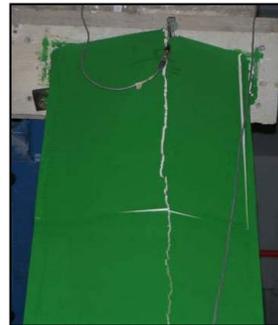
(g) Damage transverse walls

| Config | Specimen ID | Main Damage/Failure Observed | Photo |
|---|---|--|---|
| 8 | 20, 21 & 22 | Failure of bottom and top tracks of transverse walls. Severe damage of the studs in wall intersections. Severe damage of sheetrock in transverse wall due to out-of-plane bending. Bending of transverse wall top track flanges observed. Damage along vertical edges of sheathing of longitudinal wall. | g |
| 14 | 34 | Damage was observed for the first time at a drift level of 1.2%. Then joint paper tape detached from wall intersection (1.2-1.4% drift), vertical cracks in gypsum of transverse walls (1.6% drift), and failure of fasteners in transverse wall track connections (1.8% drift) were observed. | g |
| 16 | 36 | Joint paper tape detached from wall intersection (0.4-0.6% drift), failure of fasteners in transverse wall track connections (0.6% drift), and vertical cracks in gypsum of transverse walls (1.4% drift), were observed. | g |

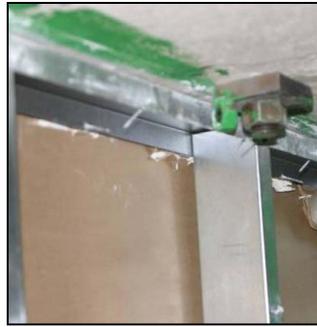
(j) Crushing and shearing of gypsum around screws in top track connection

| Config | Specimen ID | Main Damage/Failure Observed | Photo |
|---|---|--|---|
| 10 | 25, 27 & 28 | Crushing of gypsum around screws connecting to top track and plastic hinge forming on studs due to bending. | i & j |

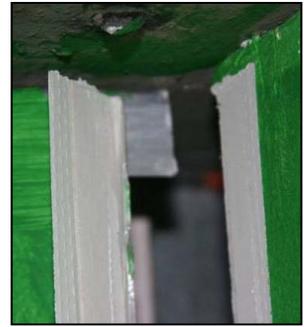
(l) Damage along sacrificial cornerbeads at wall intersection

| Config | Specimen ID | Main Damage/Failure Observed | Photo |
|---|---|--|---|
| 13 | 33 | Joint cornerbead detached from walls at drifts levels as low as 0.2-0.4%. Damage does not progresses in the specimen at larger drift levels. | l |

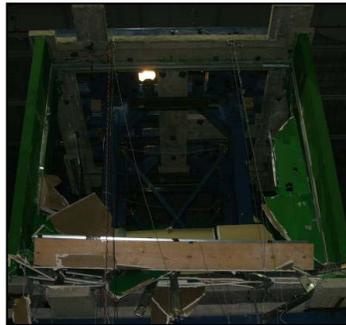
(o) Collapse of partition wall with returns

| Config | Specimen ID | Main Damage/Failure Observed | Photo |
|---|---|--|---|
| 19 | 39, 45 & 47 | Screws pulled out from gypsum to stud connections. Bookshelf connectors needed to be tighten after the test. Damage along top end of cornerbeads. Specimen 47 collapsed. | b & o |

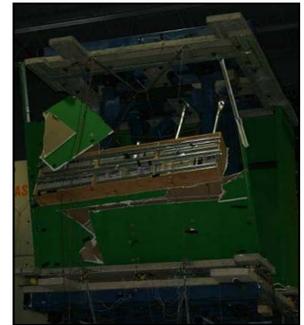
(p) Collapse of partition wall without returns

| Config | Specimen ID | Main Damage/Failure Observed | Photo |
|---|---|--|---|
| 20 | 40, 41 & 43 | Screws pulled out from gypsum to stud connections. Bookshelf connectors needed to be tighten after the test. Horizontal cracks along gypsumboard joints. Damage along top end of cornerbeads. Specimens 40 and 43b collapsed. | n, p & q |

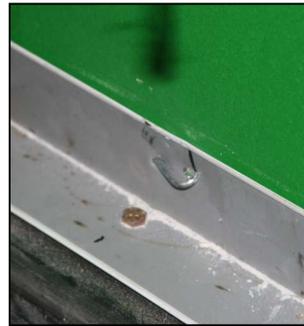
(r) Crushing of gypsum around fence staple connector

| Config | Specimen ID | Main Damage/Failure Observed | Photo |
|---|---|--|---|
| 21 | 42, 44 & 46 | Screws pulled out from gypsum to stud connections. Damage at the top and bottom ends of cornerbeads. In specimens 42 and 44, crushing of gypsumboards around fence staples connectors was observed. In specimens 44b and 46, the equivalent ceiling got completely detached from the partition wall. | b, n & r |
