Geoscience Aspect of September 19, 2017 Mexico Puebla-Morelos Earthquake

Robert C. Lo¹, Samuel Yniesta²

¹ Staff Consultant, Klohn Crippen Berger, Vancouver, British Columbia, Canada

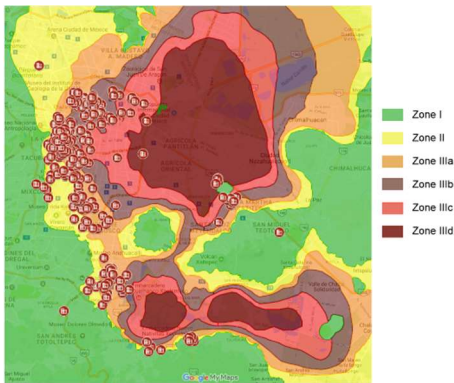
The Colegio de Ingenieros Civiles de México (CICM) website www.sismosmexico.org presents the geographical distribution of building damages in Mexico City, as shown in Figs. 2 and 3. The distribution of six geo-zonations is also shown on the figures. Damaged buildings shown by the red symbols in Fig. 2 are deemed unsafe for occupation following the September 19th earthquake, while those shown by the black symbols in Fig. 3 represent collapsed buildings. The majority of collapsed and damaged buildings are located in the western portions of the transition zone (zone II), and the two lake subzones with smaller

Figure 2. Map showing buildings deemed unsafe for occupation <https://www.sismosmexico.org/mapas>

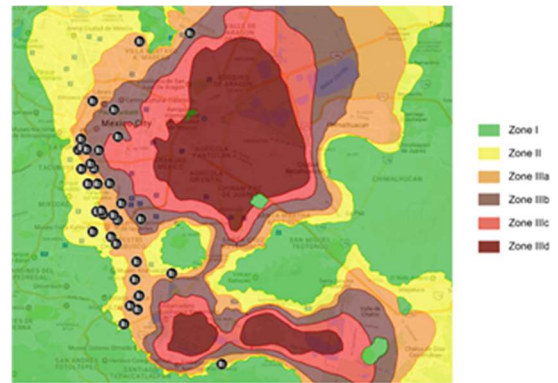
clay thickness (zone IIIa and IIIb). It is interesting to note that only a handful of buildings in zone IIIId, where the lacustrine clay thickness is greatest, were damaged and none of them collapsed.

Figure 3. Map showing collapsed buildings <https://www.sismosmexico.org/mapas>

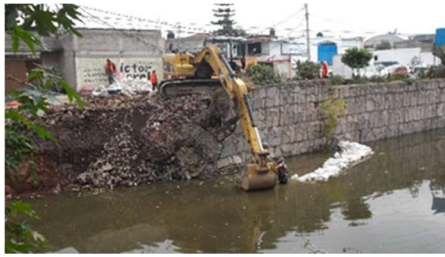
- Slumped canal masonry side wall (Fig. 10) – The masonry side wall, covered with a wire mesh, performed well in general except a local slumped segment. The wall segment repair was in progress. It appeared that a cofferdam was being built probably for dewatering purposes during replacement of the failed segment.

Figure 10. Slumped canal masonry side wall

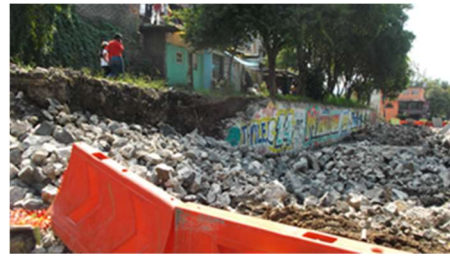
- Slumped low masonry retaining wall (Fig. 11) – The original hill slope of Xochimilco appeared to have been re-configured by cut- and-fill to fit in three-levels of roads: at the base, 1st and 2nd level along its perimeter. Masonry walls were used to retain soil on the uphill side of the roads. The hill slope was reported to undergo deformation during the 1985 earthquake, and continued to deform slowly prior to the recent seismic event which intensified the movements. Longitudinal cracks were formed along the 1st and 2nd level road; cracks at the 2nd level road were much shorter. The masonry wall shown in Fig. 11 was at the 1st level road; new masonry materials were stockpiled on the ground, and the distant end segment of the wall was shored up by timber struts. Drill rigs were observed at the base and 1st level road, indicating subsoil investigation was in progress. The ongoing operation of a water-well pump station at the base level with observed settlements, cracks and formation of voids in the vicinity is considered to be related to hill slope movement [2].

Figure 11. Slumped masonry retaining wall

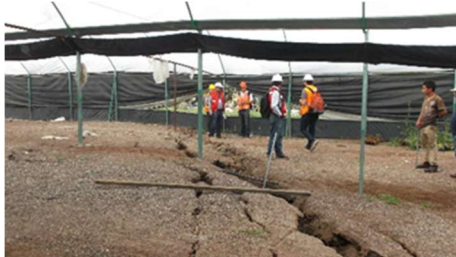
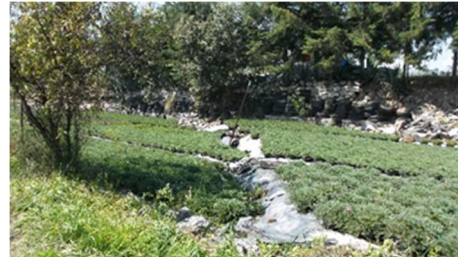
- Existing ground cracks were accelerated during the 2017 seismic events in Colonia Del Mar [2] and Cienega San Gregorio of Mexico City. Photos taken in Cienega San Gregorio are shown in Figs. 12 and 13. The area is an agricultural district with vegetable-flower fields and nurseries. Figure 12 shows an elongated crack passing through a covered nursery and open field all the way to the adjacent property. Figure 13 shows a slumped and repaired segment of a causeway. The slumped segment underwent lateral spreading failure involving soft lake deposits beneath the granular embankment fill. The repair was carried out by bulldozers and dump trucks using granular fills borrowed from nearby quarries.

(a) Ground cracks inside a nursery

(b) Cracks extended to open area outside

Figure 12. Ground cracks developed in a nursery extended all the way to neighbouring property

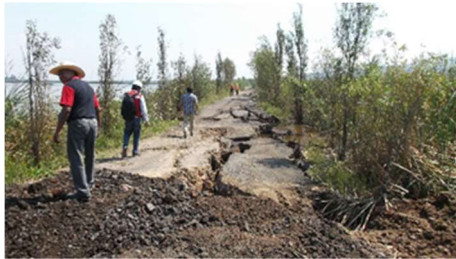
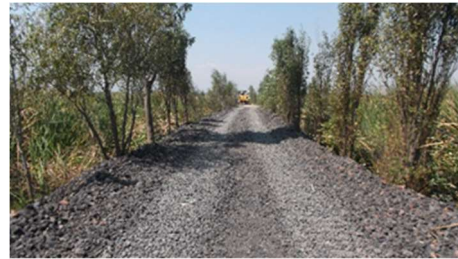
(a) Failed causeway segment

(b) Repaired causeway segment

Figure 13. Causeway embankment failed by lateral spreading
