Damage Assessment of a Sixteen Story Building Following the 2017 Central Mexico Earthquake

Yijun Liao¹, Richard L. Wood², M. Ebrahim Mohammadi³, Kanchan Devkota⁴, Christine E. Wittich⁵

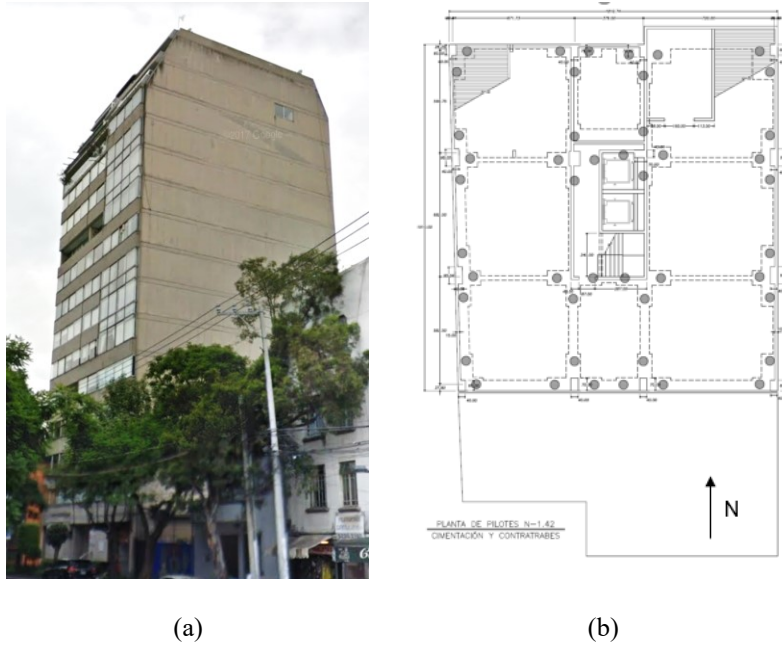
The sixteen-story residence building as showing in Figure 1a is a concrete structure with moment frames in the direction perpendicular to the roadway, and RC shear walls in the parallel direction to the roadway. The height of the structure is

approximately 42 meters, where typically two to four condos are located on each floor. As showing in Figure 1b, the structure had a footprint of 18 meters by 19 meters. Two elevators and a staircase are embedded at the center of each floor, from the basement to the top floor, which induces some potential torsional response in the structure. Exterior cracking was described by the building owner prior to the repair, while interior masonry severe damage was also witnessed by the research team. The basement columns were examined to have minor cracks, as well as on the ground floor.

Figure 1. (a) Sixteen-story residence building (courtesy of Google Map) and (b) floor plan drawing.

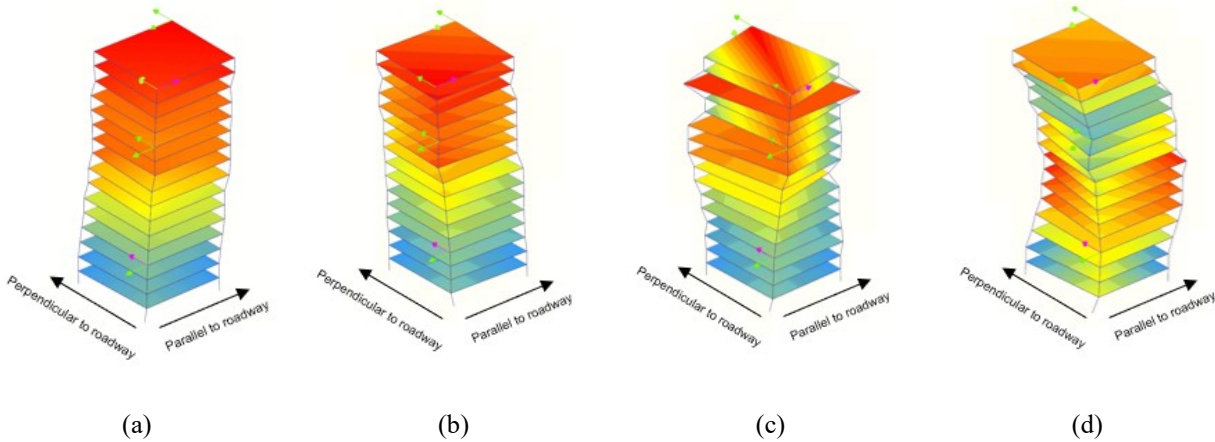
Specific to this study, the entire 60 minutes of recording were used for the preliminary assessment to estimate the natural frequencies and operational deflected shapes. Initially, the data was filtered and subdivided to minimize the uncertainties via spectral averaging. For each channel, the acceleration time histories was first downsampled to 256 Hz and filtered in the frequency range of 0.2 Hz to 4 Hz, matching the range of interest for this structure. The overall structural modal natural frequencies were identified initially by peak picking method. The natural frequencies were able estimated as 0.458 Hz, 0.773 Hz, 1.079 Hz, 1.673 Hz, 2.983 Hz, and 3.416 Hz. Out of all of these modes, only mode three demonstrates a torsional response while the other five modes are translational-dominated in nature.

Figure 4. Operational deflected shapes from ARTeMIS: (a) mode one, (b) mode two, (c) mode three, and (d) mode four.

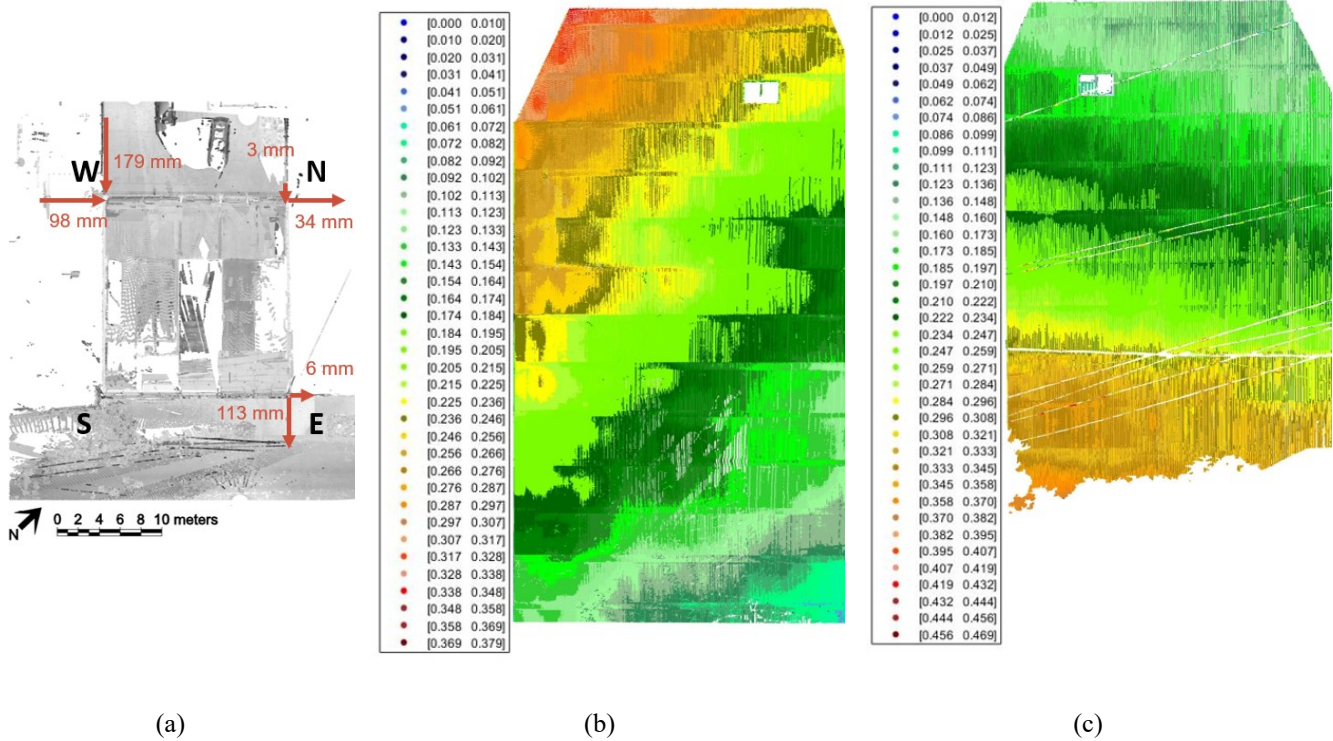
The lidar point cloud data was used to assess the residual deformation and quantify deformation profiles. To accomplish this task, initially, the depth maps for two side walls (perpendicular to the roadway) were developed, which were exterior RC shear walls. With the assumption that the vertical direction of the point cloud data is aligned with the direction of gravity. In this study, the lidar scanner has a vertical alignment accuracy of 19 arcseconds, which equates to a 3 mm measurement error at the full height of the structure at 42 meters. Measuring from the ground floor as 1st floor instead of the basement to the roof, the nomenclature and a depth map for each wall is created as shown in Figure 5. The depth map colorizes point cloud into 1 cm color bins according to the local deformation in the out-of-plane direction, which gives an overview of the salient residual deformation features. The depth maps results suggested that the structure is leaning in the northeast direction as elevation increases. This is up to a maximum value of 38 cm.

Figure 5. (a) Structure's top view and the nomenclatures with roof deformation values, (b) northeast wall depth-map in the out-of-plane direction, and (c) southwest wall depth map in the out-of-plane direction (white spaces near the roof are due to occlusion of windows).

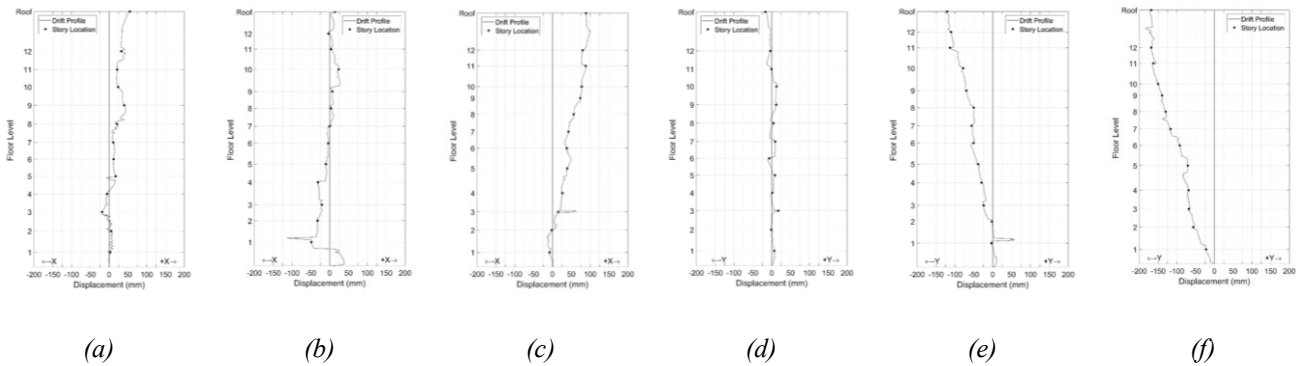
The deformation profiles of each building corner were created to further investigate the residual deformation. The deformation profile analysis was only carried out for three corners of the structure due to significant occlusion at the southwest corner. Significant tree cover occluded this area of the structure at the time of data collection. The residual deformation for each corner is measured for the three corners, as demonstrated in Figure 6 and summarized in Table 2. The deformation profiles of the west and east corners in the northwest direction suggested these two corners are leaning in the southeast direction. Deformation profiles of the north corner (in both directions) had values of 98 mm and 179 mm and the east corner deformation profile in the northeast direction of 6 mm demonstrate that the structure has relatively smaller deformations in comparison to the west corner. In addition, the upper level of structure is leaning towards northeast and southeast directions, which corresponds to depth maps findings. These deformations can be correlated to system identification results that third and fourth mode were potentially dominate, which is torsional and translational response along the northeast direction. In addition, the residual deformation is due to torsional dynamic behavior.

Figure 6. Deformation profiles: (a) north corner on northeast direction, (b) east corner on northeast direction, (c) west corner on northeast direction, (d) north corner on northwest direction, (e) east corner on northwest direction, and (f) west corner on northwest direction.
