### Structural damage due to the 1985 Mexican earthquake

D.Mitchell McGill University, Montreal, Quebec, Canada

ABSTRACT: Characteristics of the 1985 Mexican earthquake and the influence of the subsoil conditions on the strong ground motion in Mexico City are described. Some aspects of structural design practice and examples of structural damage are discussed along with the emergency changes to the building code.

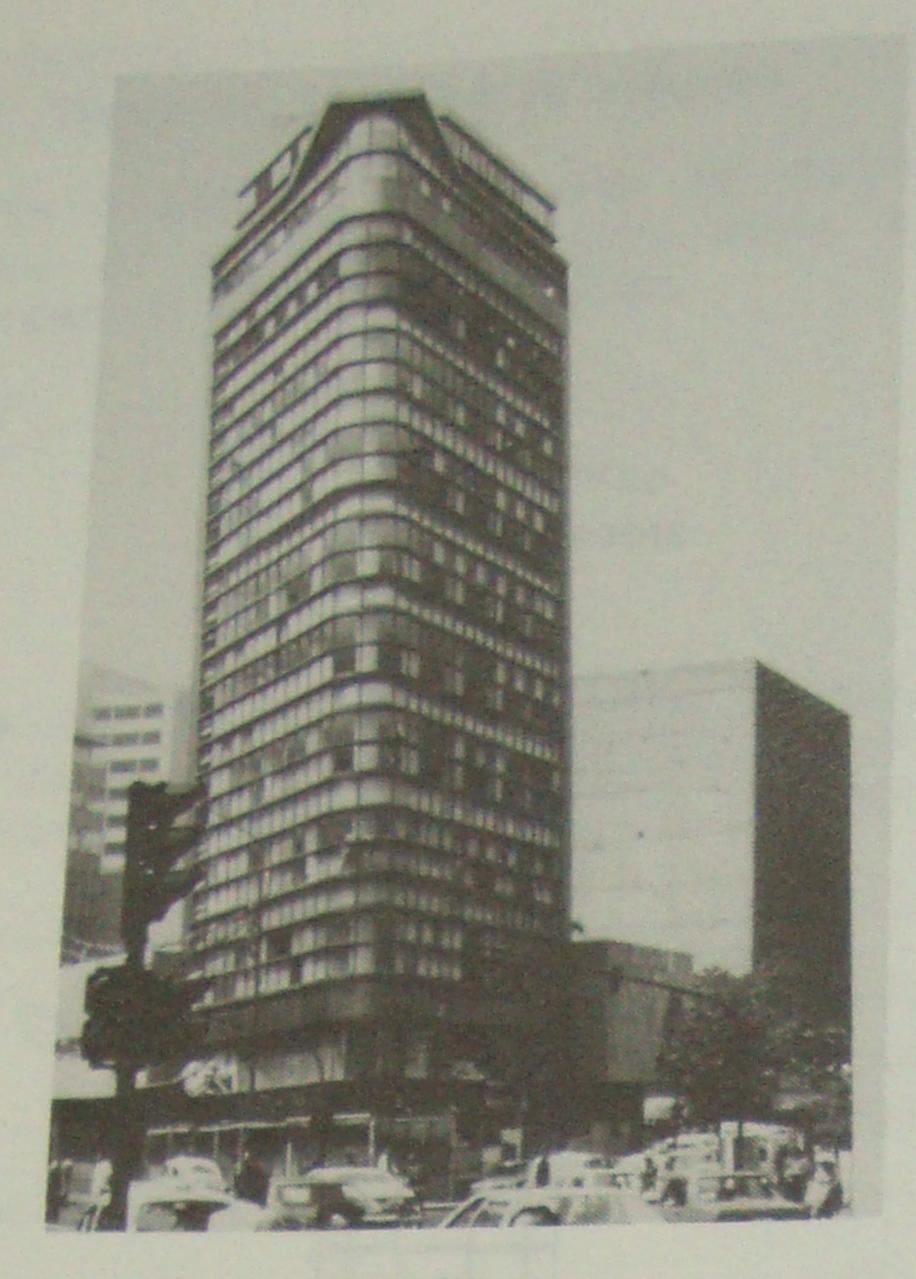
Fig. 19. Severely tilted building.

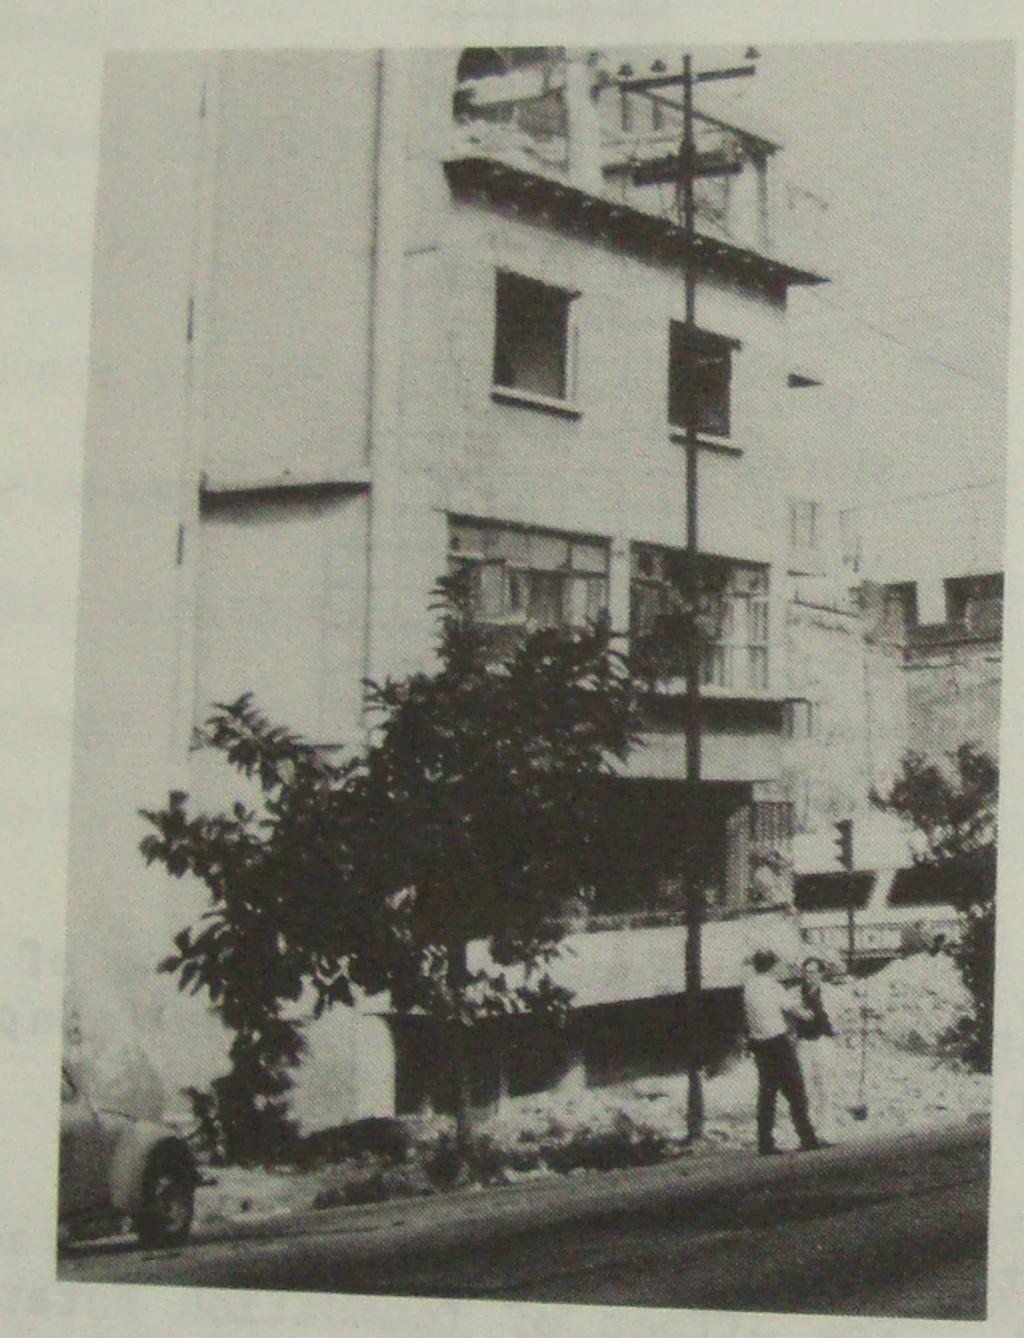
Fig. 20. Foundation settlement of about 1 m relative to road.

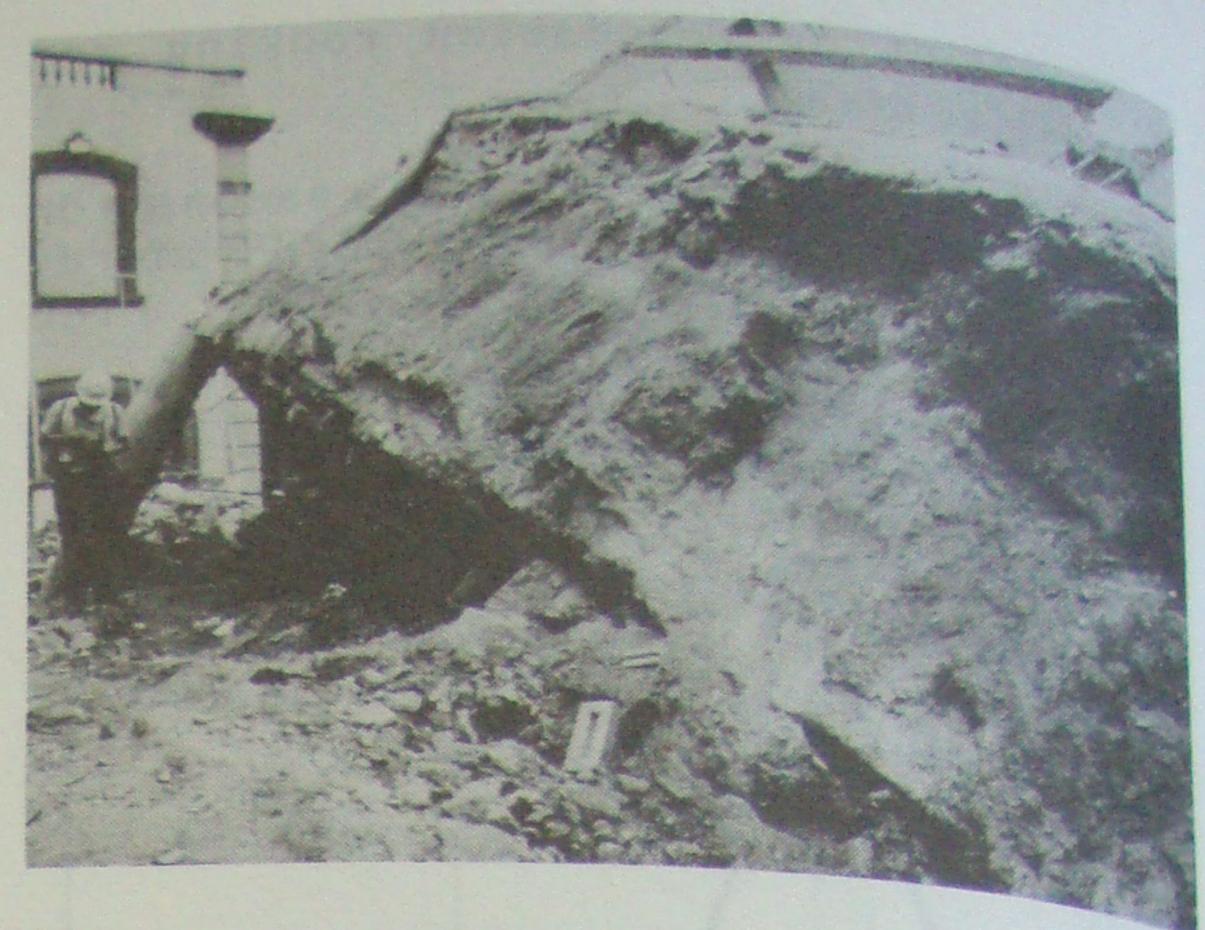
The main influence of the subsoil was to amplify the strong ground motion and to filter out the high frequencies causing severe damage and collapse of many structures. In addition there were many examples of foundation failures. Figures 19, 20 and 21 give examples of foundation overturning due to pullout of friction piles. A close-up of the pull-out of a friction pile is given in Fig. 22.

Fig. 21. Overturning of a 9 storey structure due to pull-out of friction piles (Mitchell et al. 1986a&b).

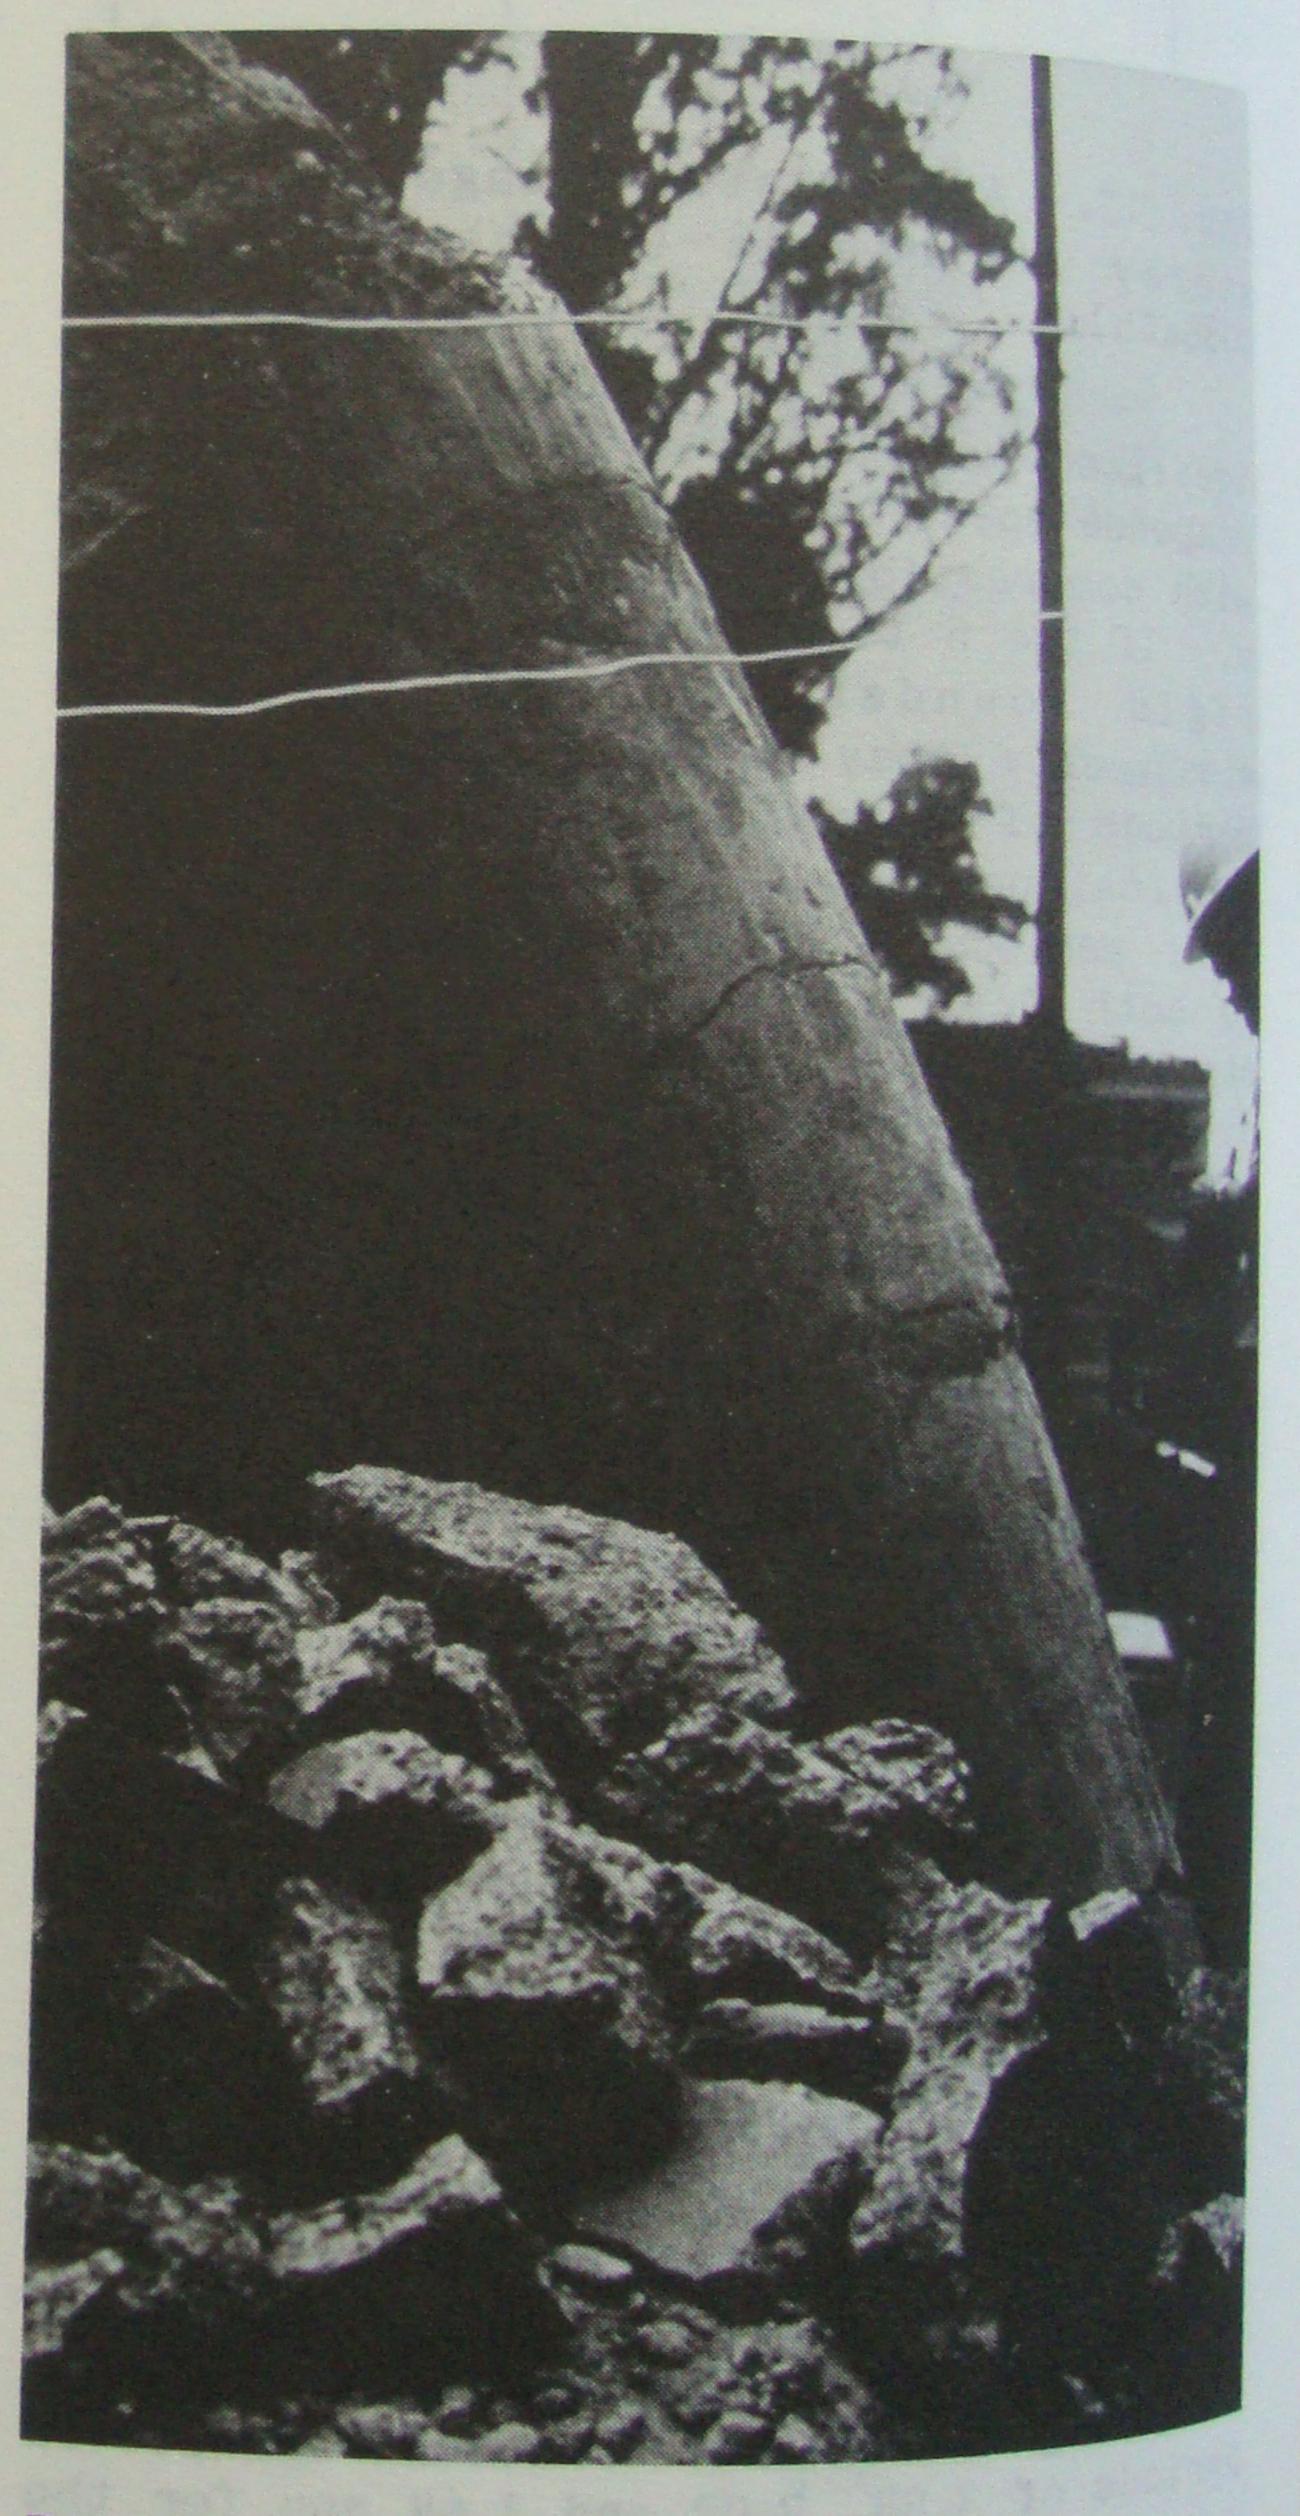
Fig. 22. Close-up of pile pull-out.

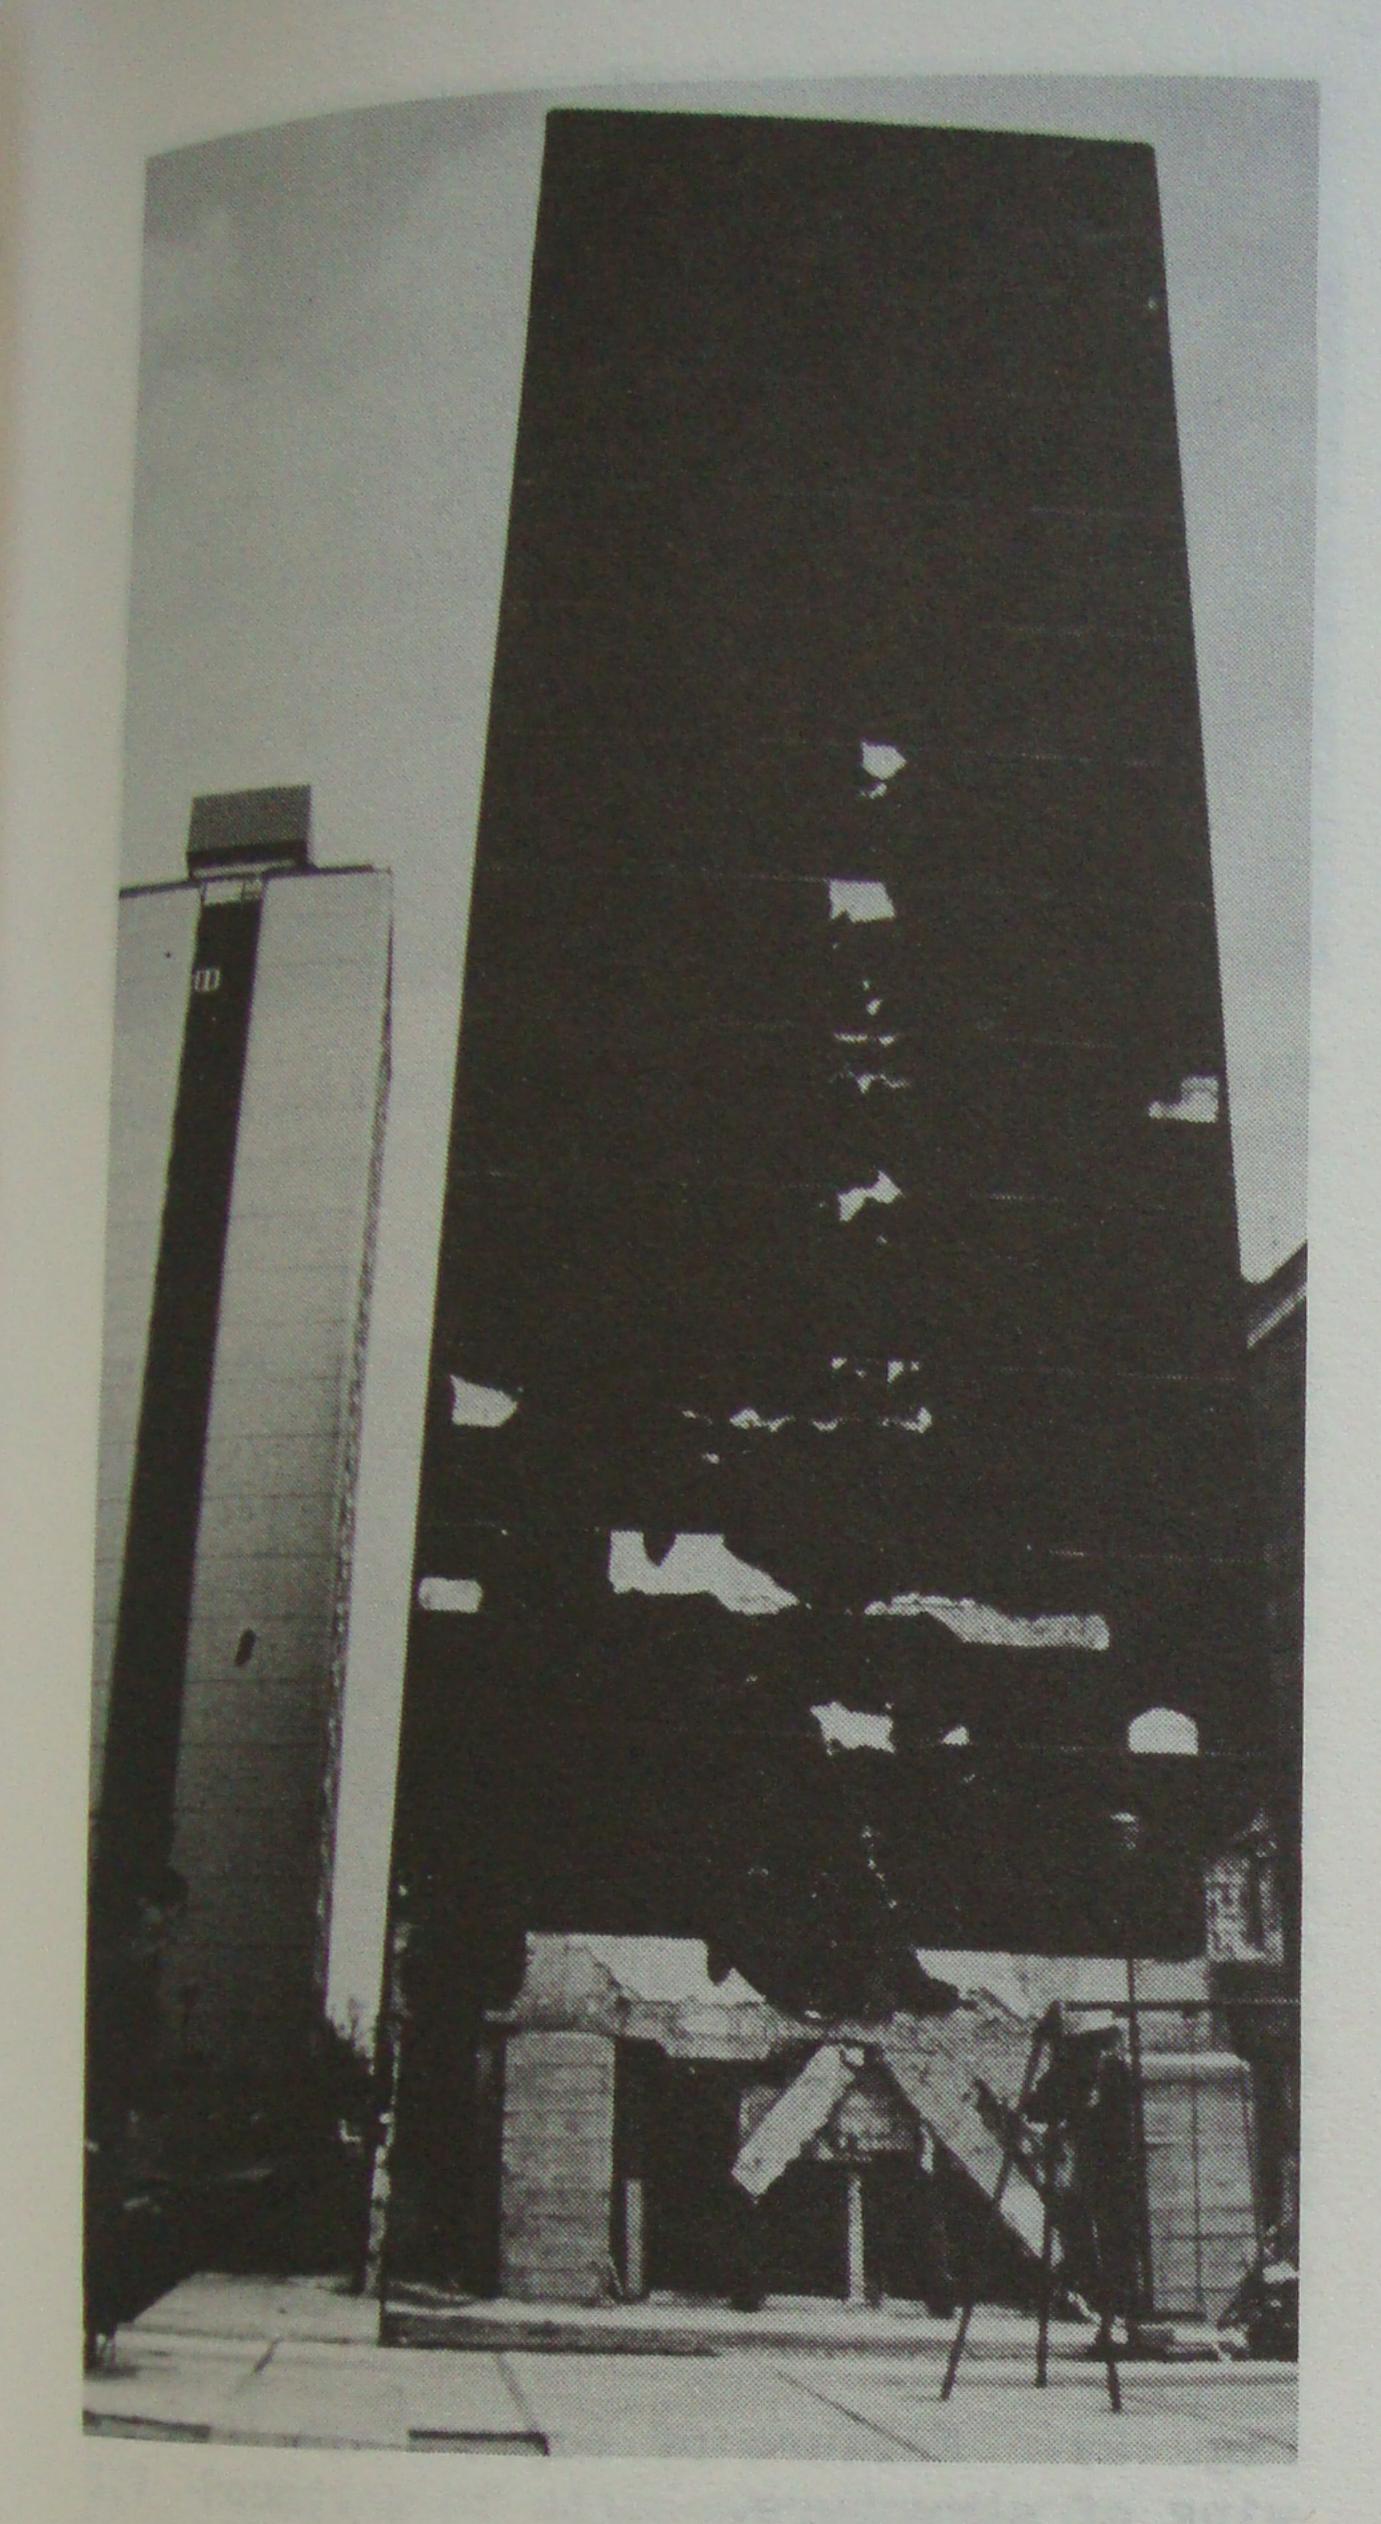
Fig. 23. Failure of reinforced concrete bracing and infilled masonry wall of 13 storey apartment structure.

Although structures with symmetrically placed masonry walls performed well during the earthquake many structures with eccentrically placed walls suffered severe damage. Figure 23 shows the damage to an end wall at the first storey level of a long, narrow apartment building. This figure also illustrates the use of memberced concrete diagonal bracing members with infilled masonry which is common in Mexico City. The bottom storey is shored with timber columns and two large concrete piers have been cast at the corners of the wall to facilitate evacuation of this structure. A close-up view of the diagonal bracing members is

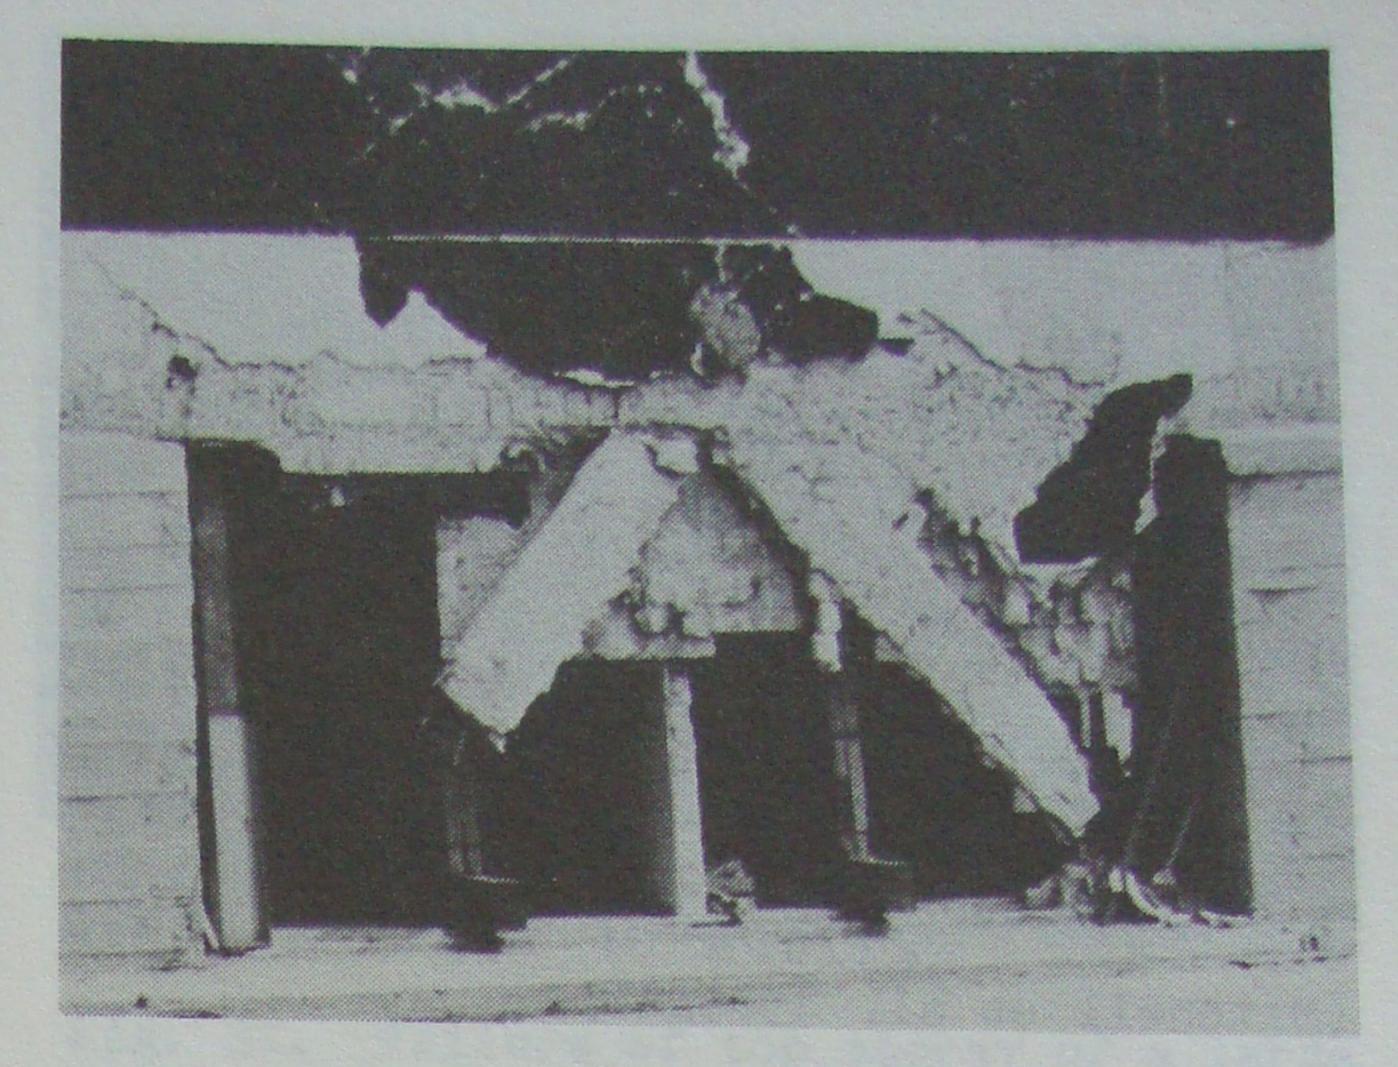
Fig. 24. Close-up of bracing failure.

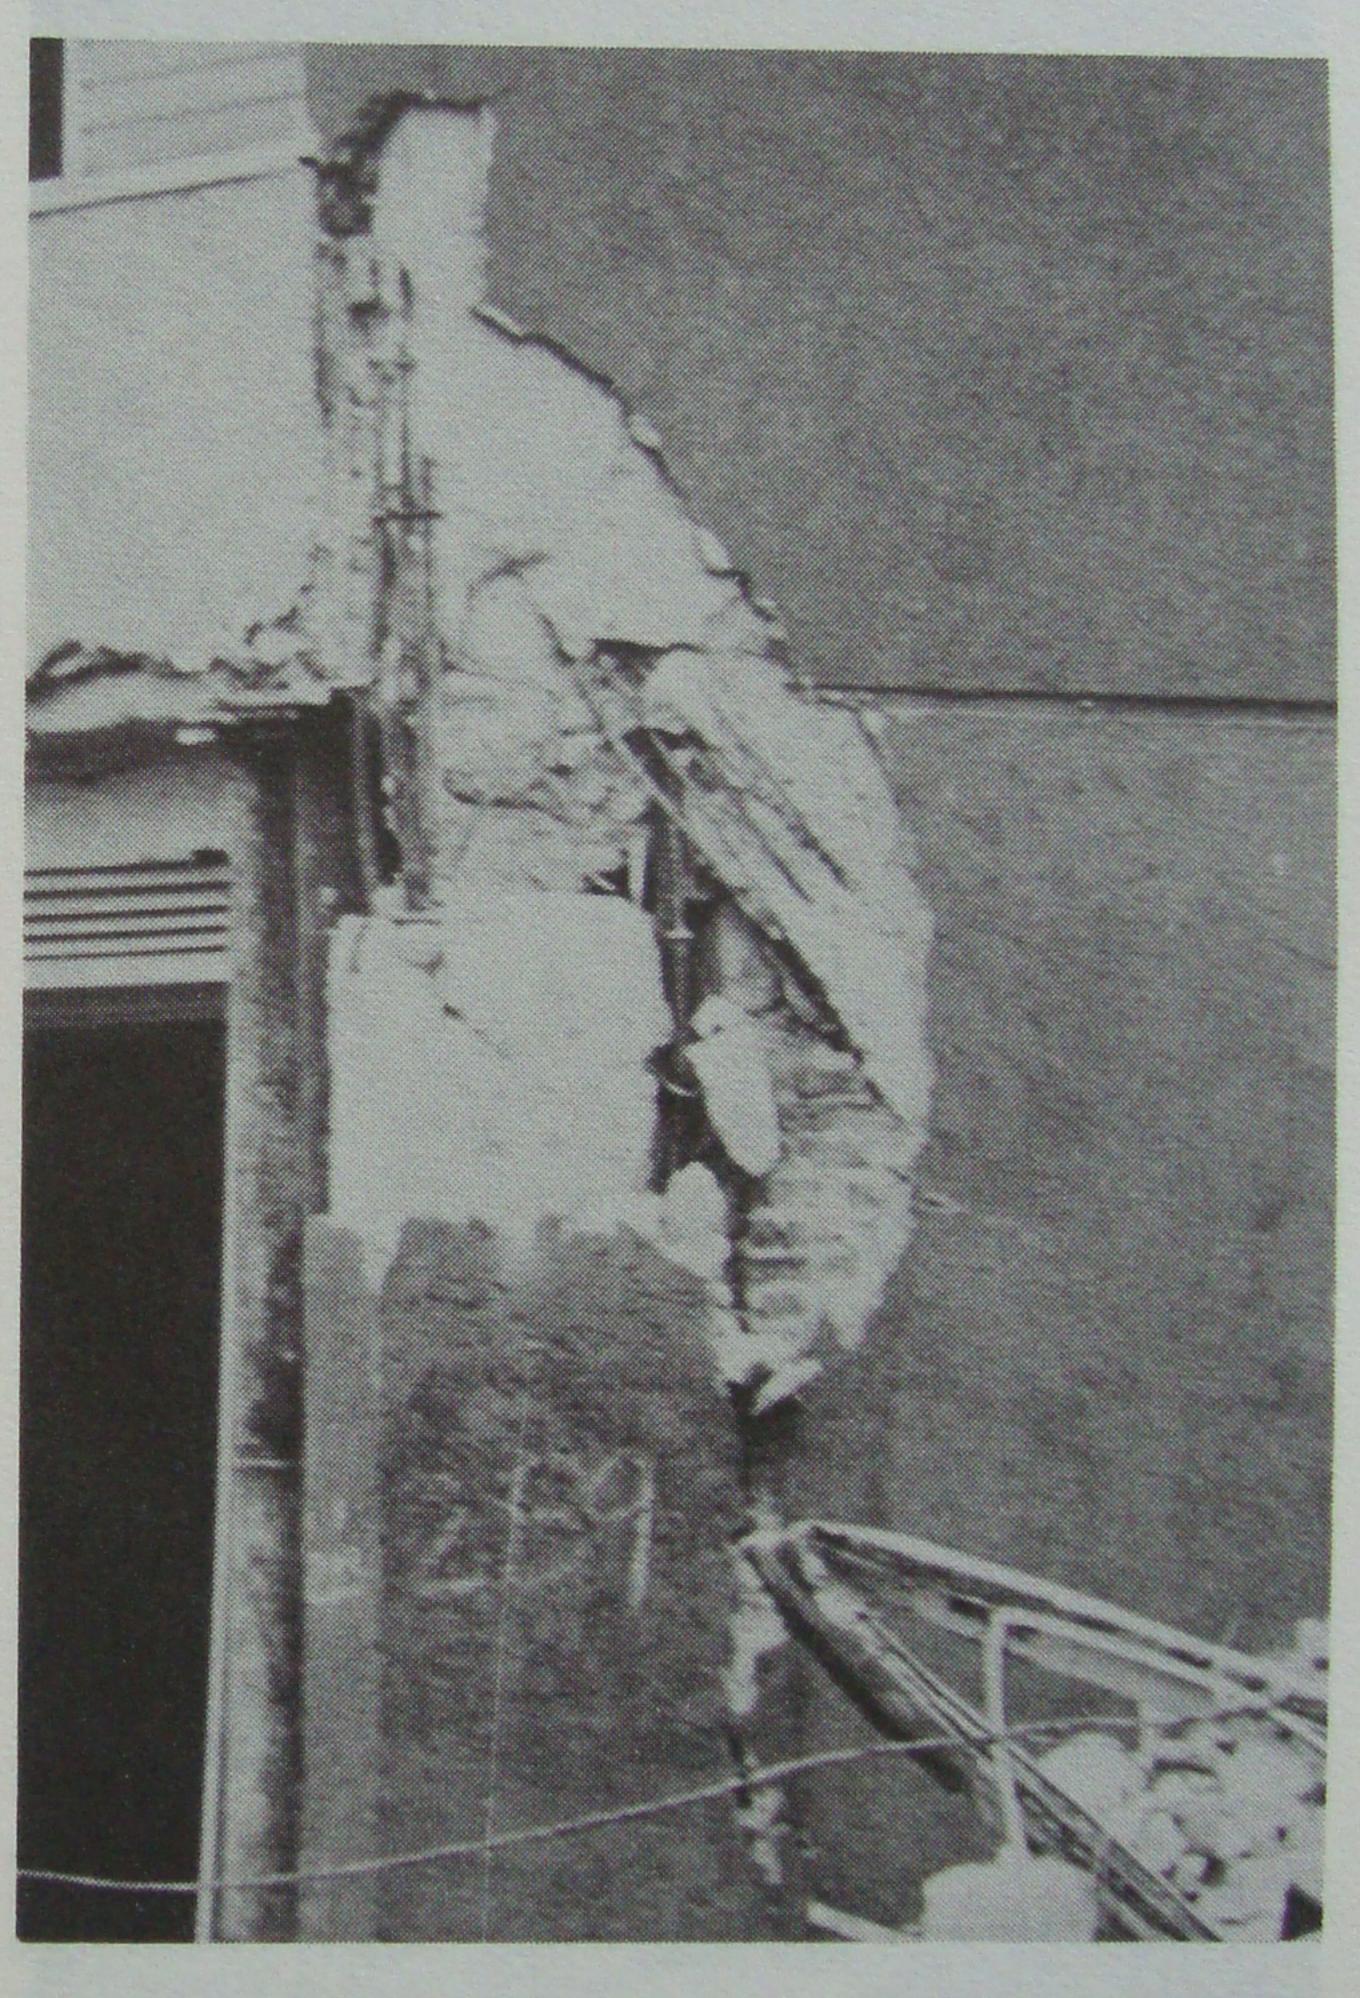
Fig. 25. Failure of joint of reinforced concrete braced structure with masonry wall infills.

given in Fig. 24. Figure 25 shows the failure of the joint region of a reinforced concrete structure with diagonal braces. This structure was triangular in plan and was subjected to large torsional loading due to the eccentrically located infilled masonry walls.

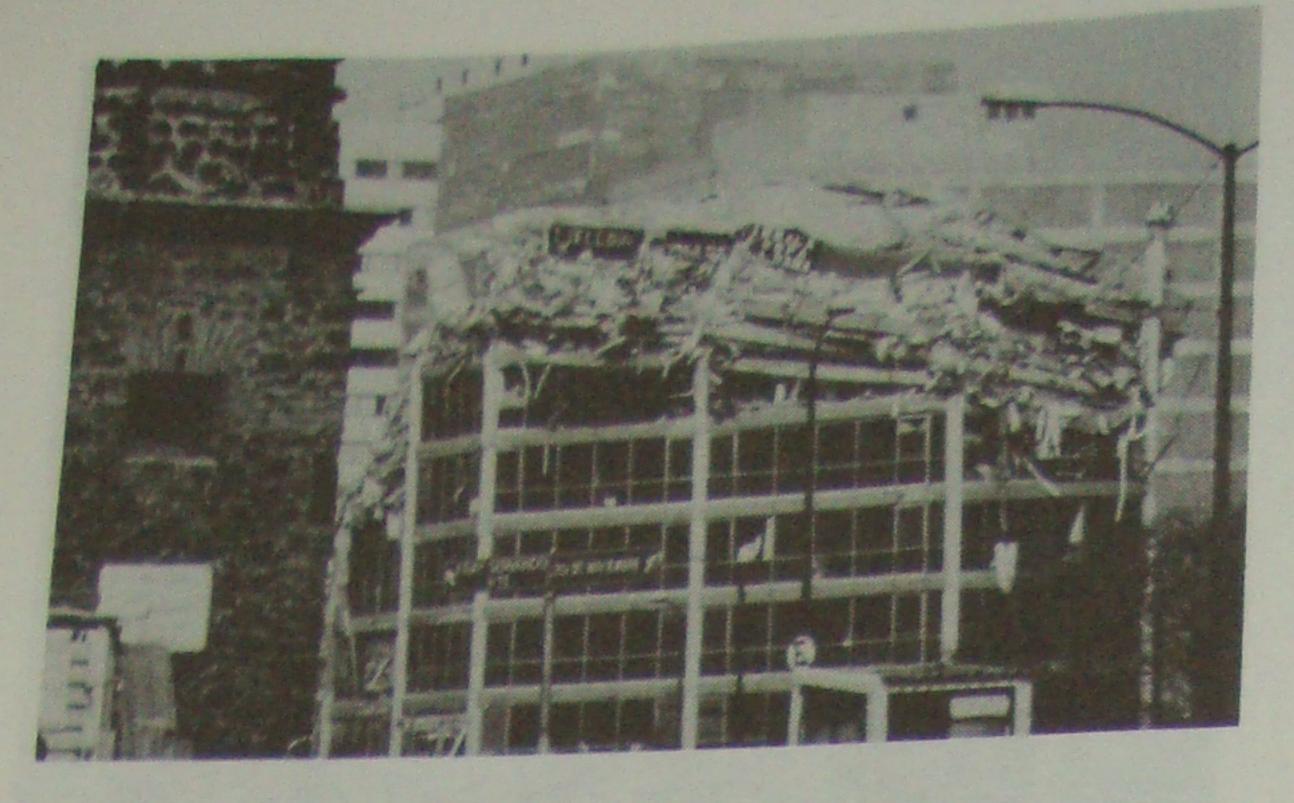
Fig. 26. Failure of upper storeys (Mitchell et al. 1986a&b).

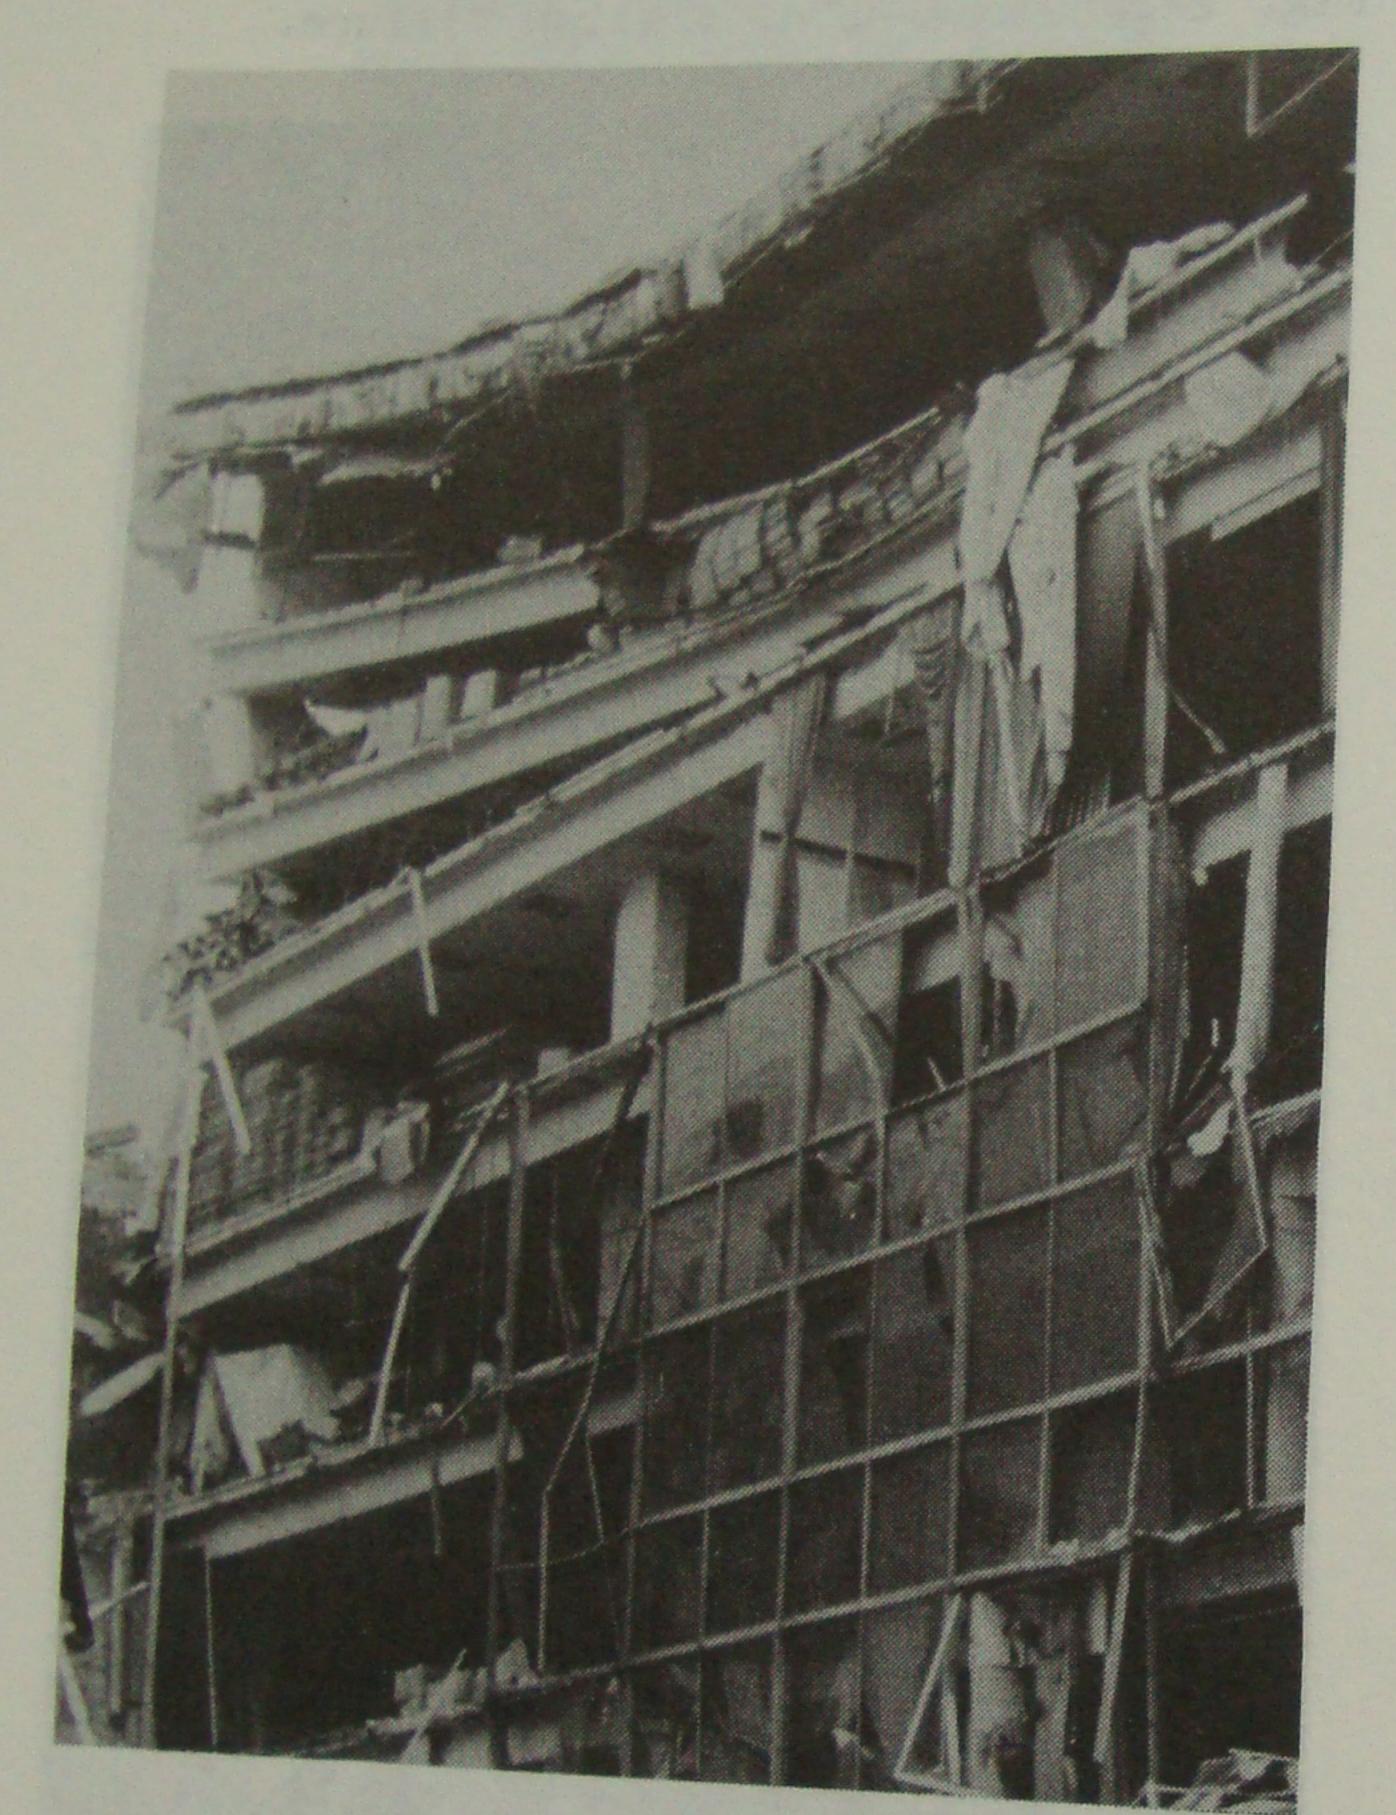
Fig. 27. Failure of upper storeys of government building with heavy storage loads.

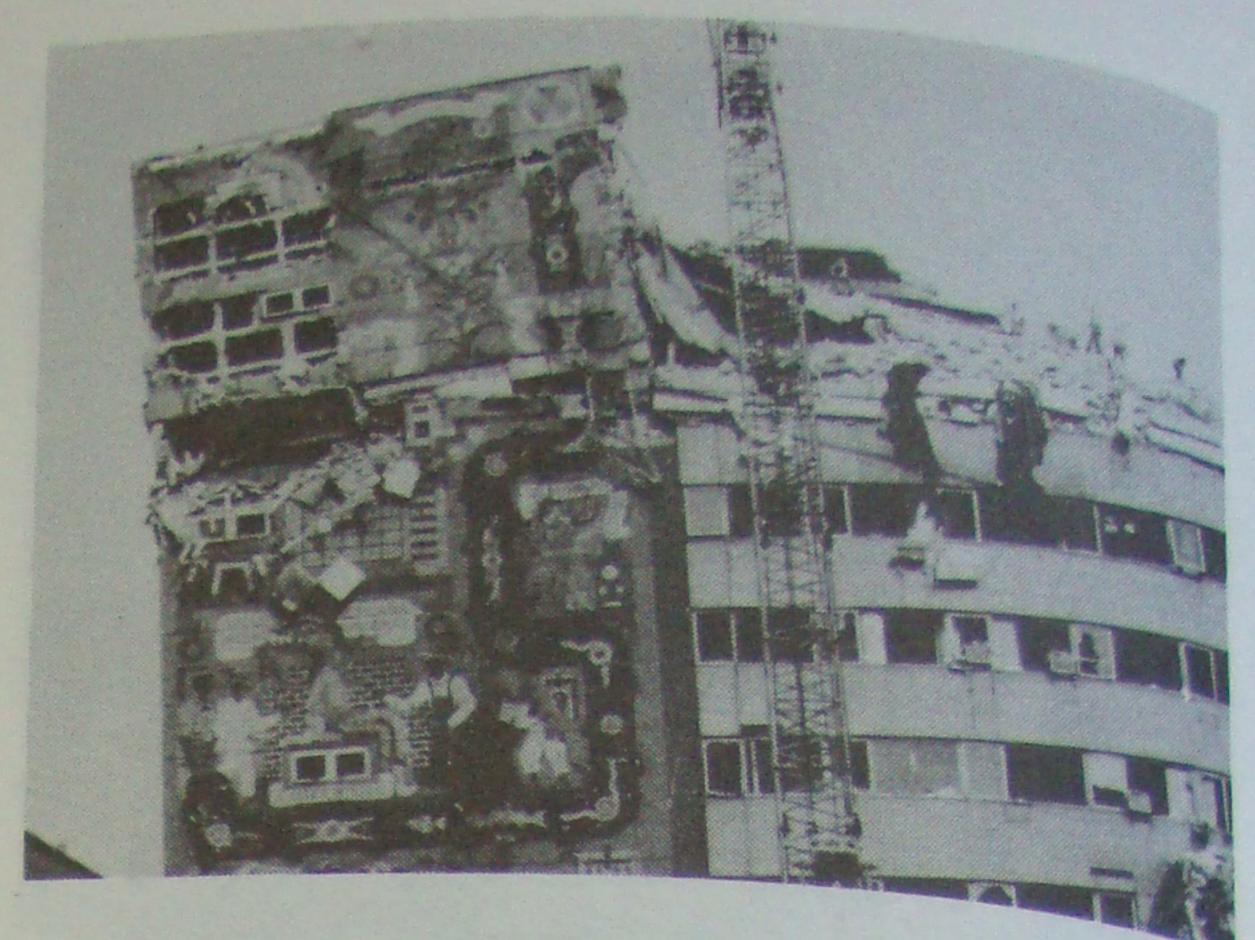
Fig. 28. Failure of top stories of SCT complex.

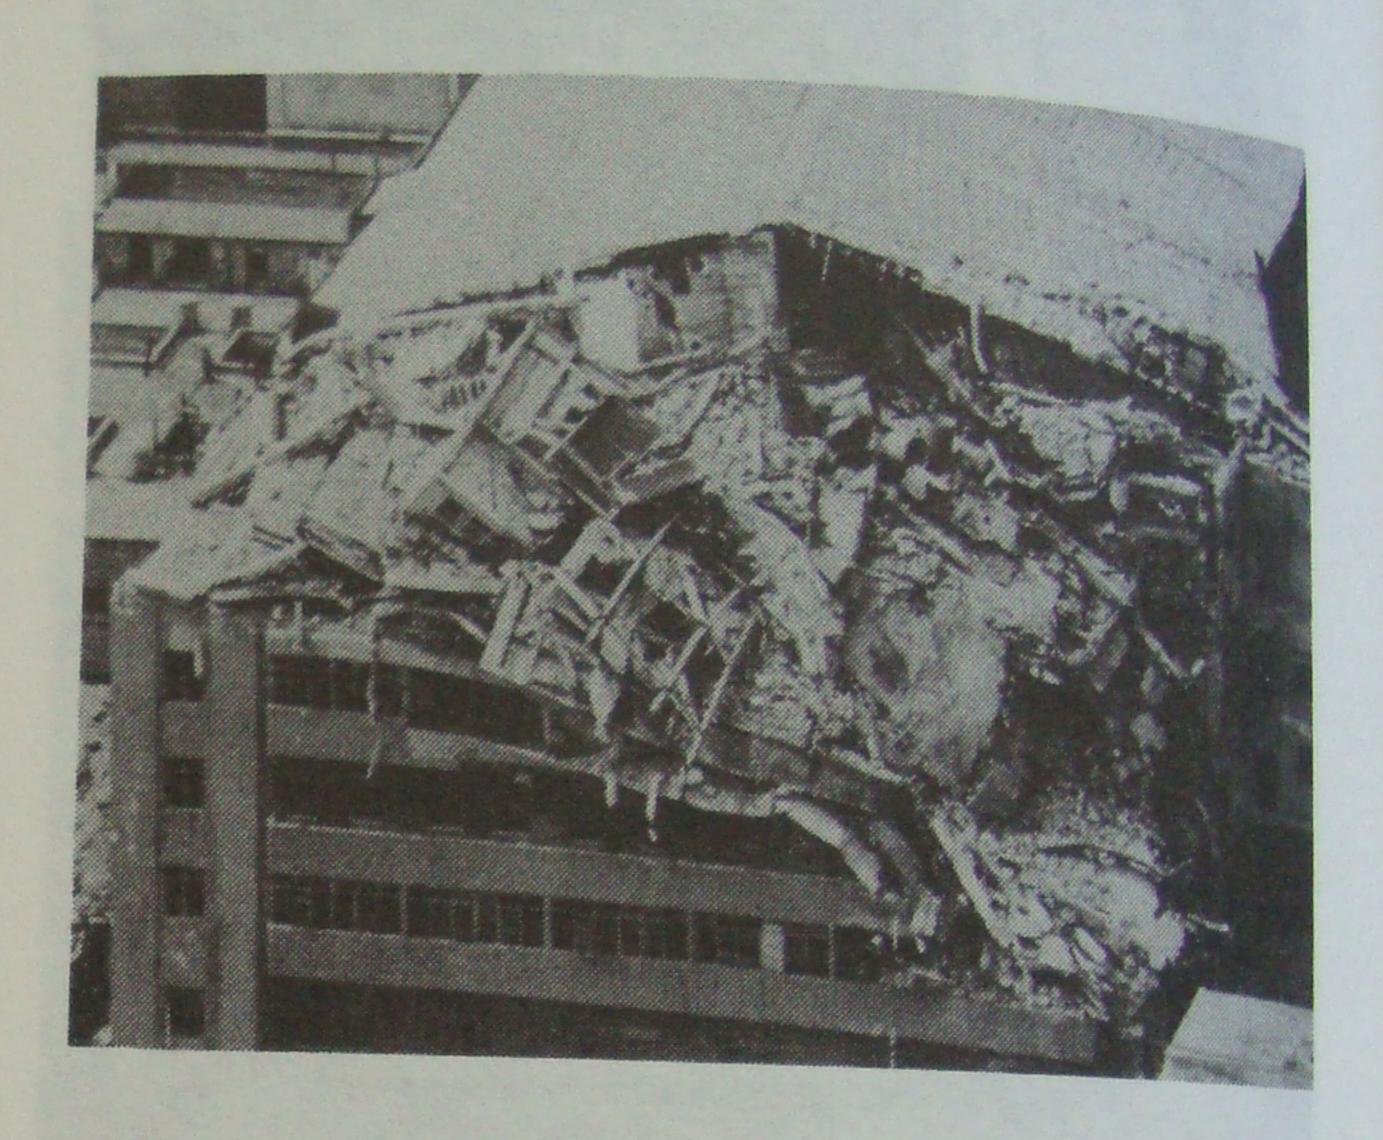
Fig. 29. Failure of top storeys in front wing of structure.

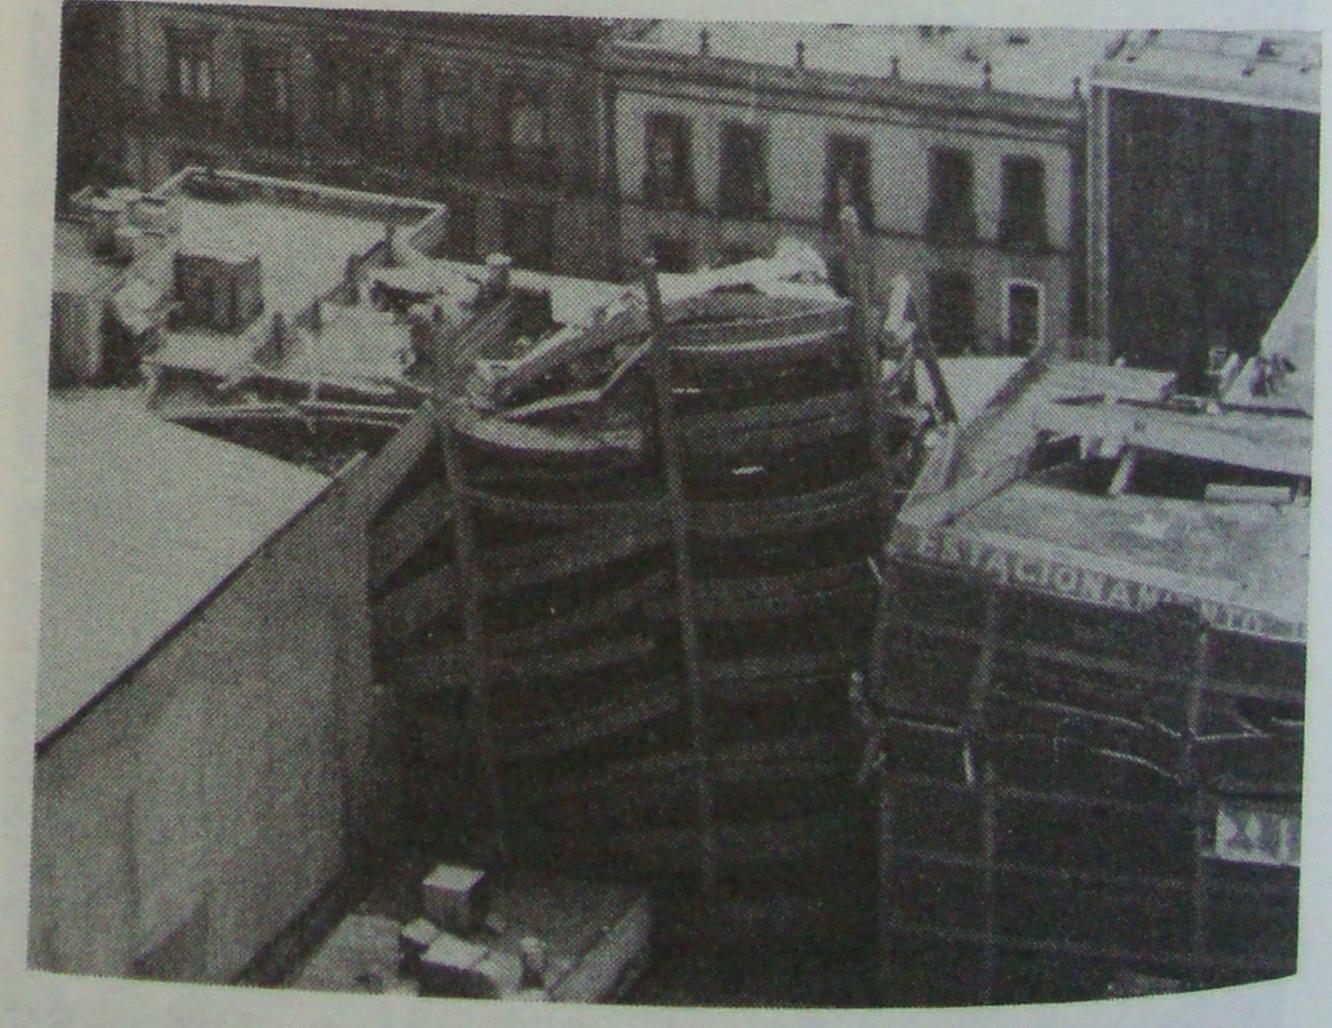
Fig. 30. Example of pounding failures in adjacent parking structures (Mitchell et al. 1986a&b).
