### Structural damage due to the 1985 Mexican earthquake

D.Mitchell McGill University, Montreal, Quebec, Canada

ABSTRACT: Characteristics of the 1985 Mexican earthquake and the influence of the subsoil conditions on the strong ground motion in Mexico City are described. Some aspects of structural design practice and examples of structural damage are discussed along with the emergency changes to the building code.

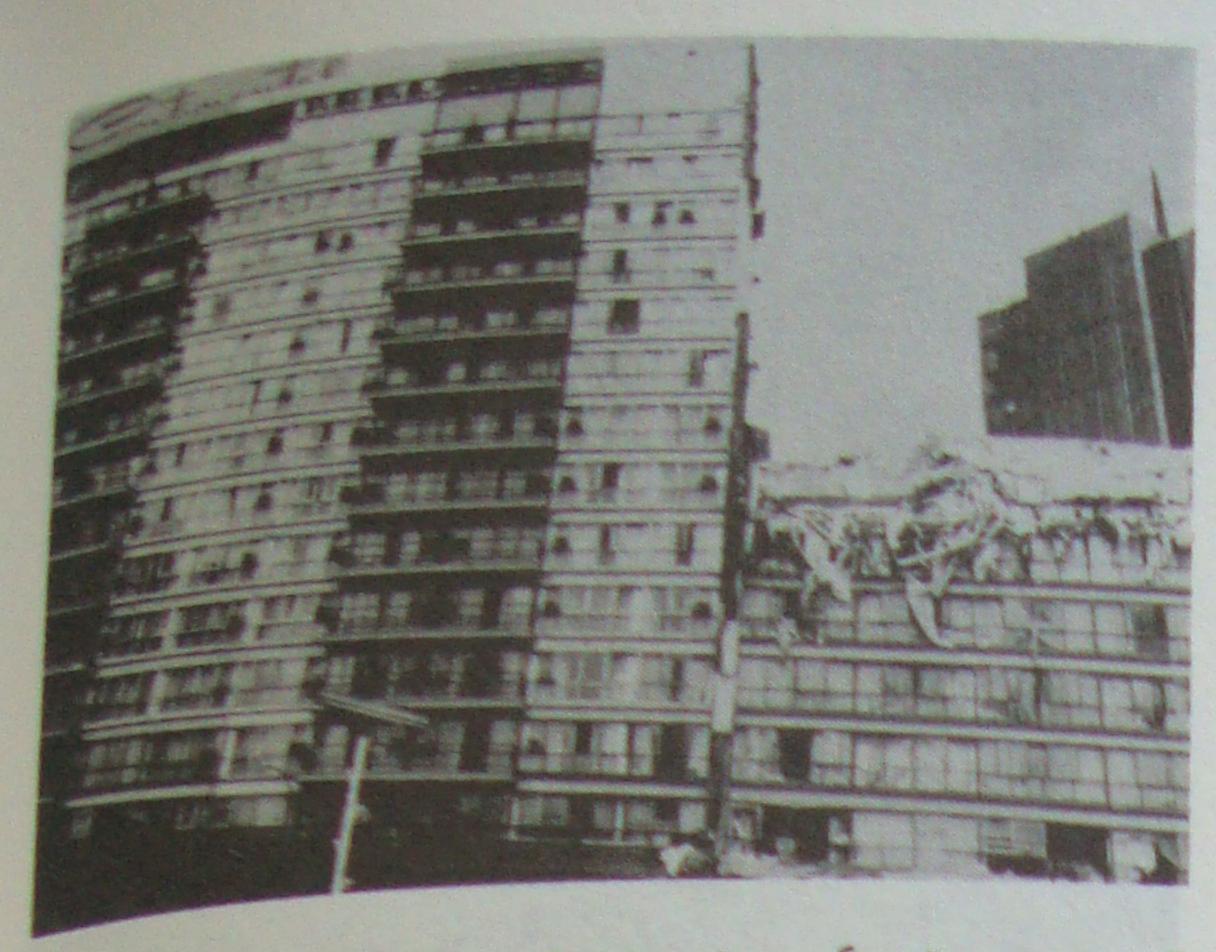
Fig. 31. Collapse of the top 6 storeys of the Continental Hotel (Mitchell et al. 1986a&b).

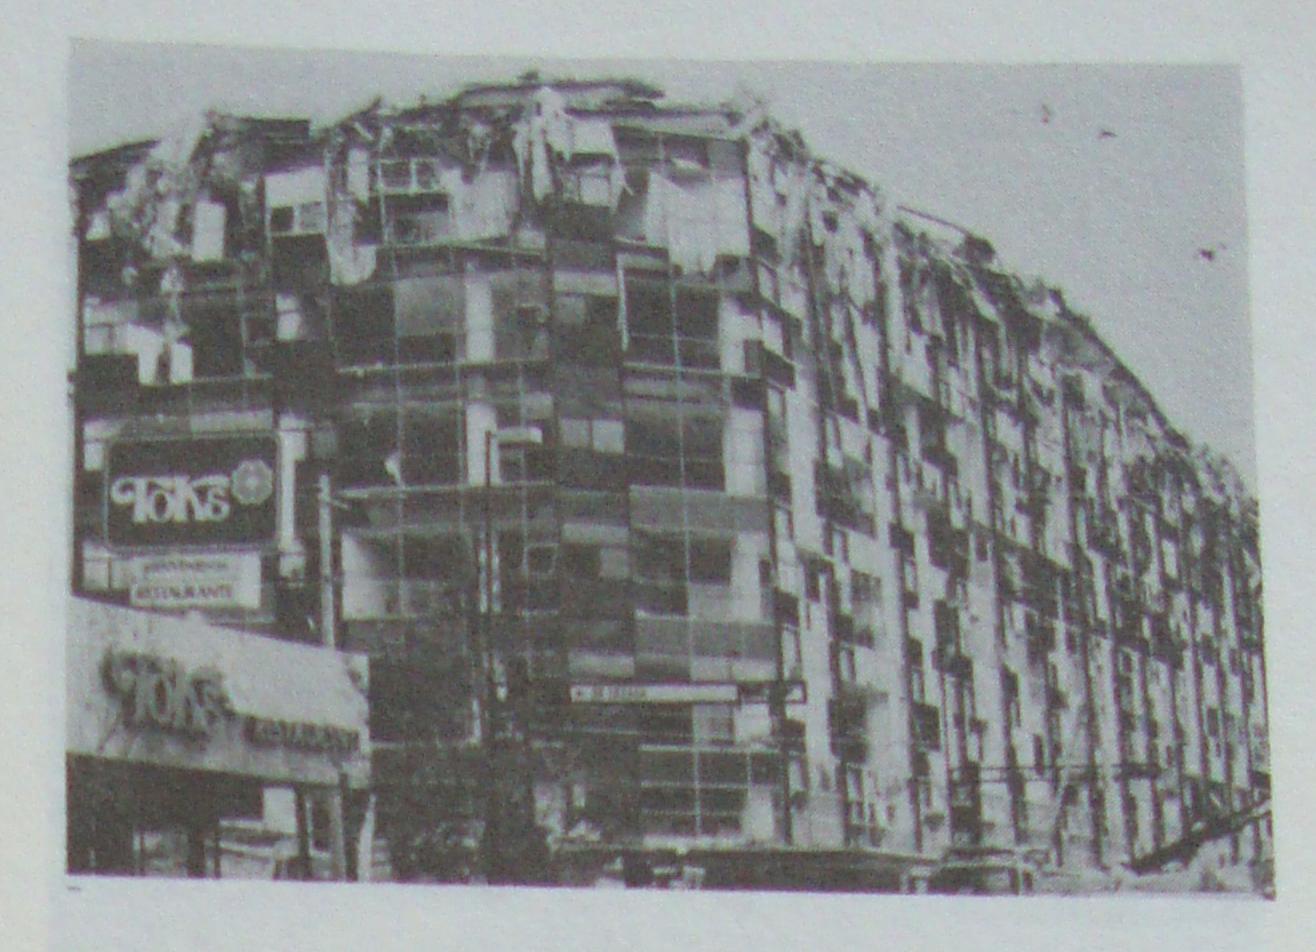
Fig. 32. Failure of top storey of a large structure due to pounding of adjacent wings.

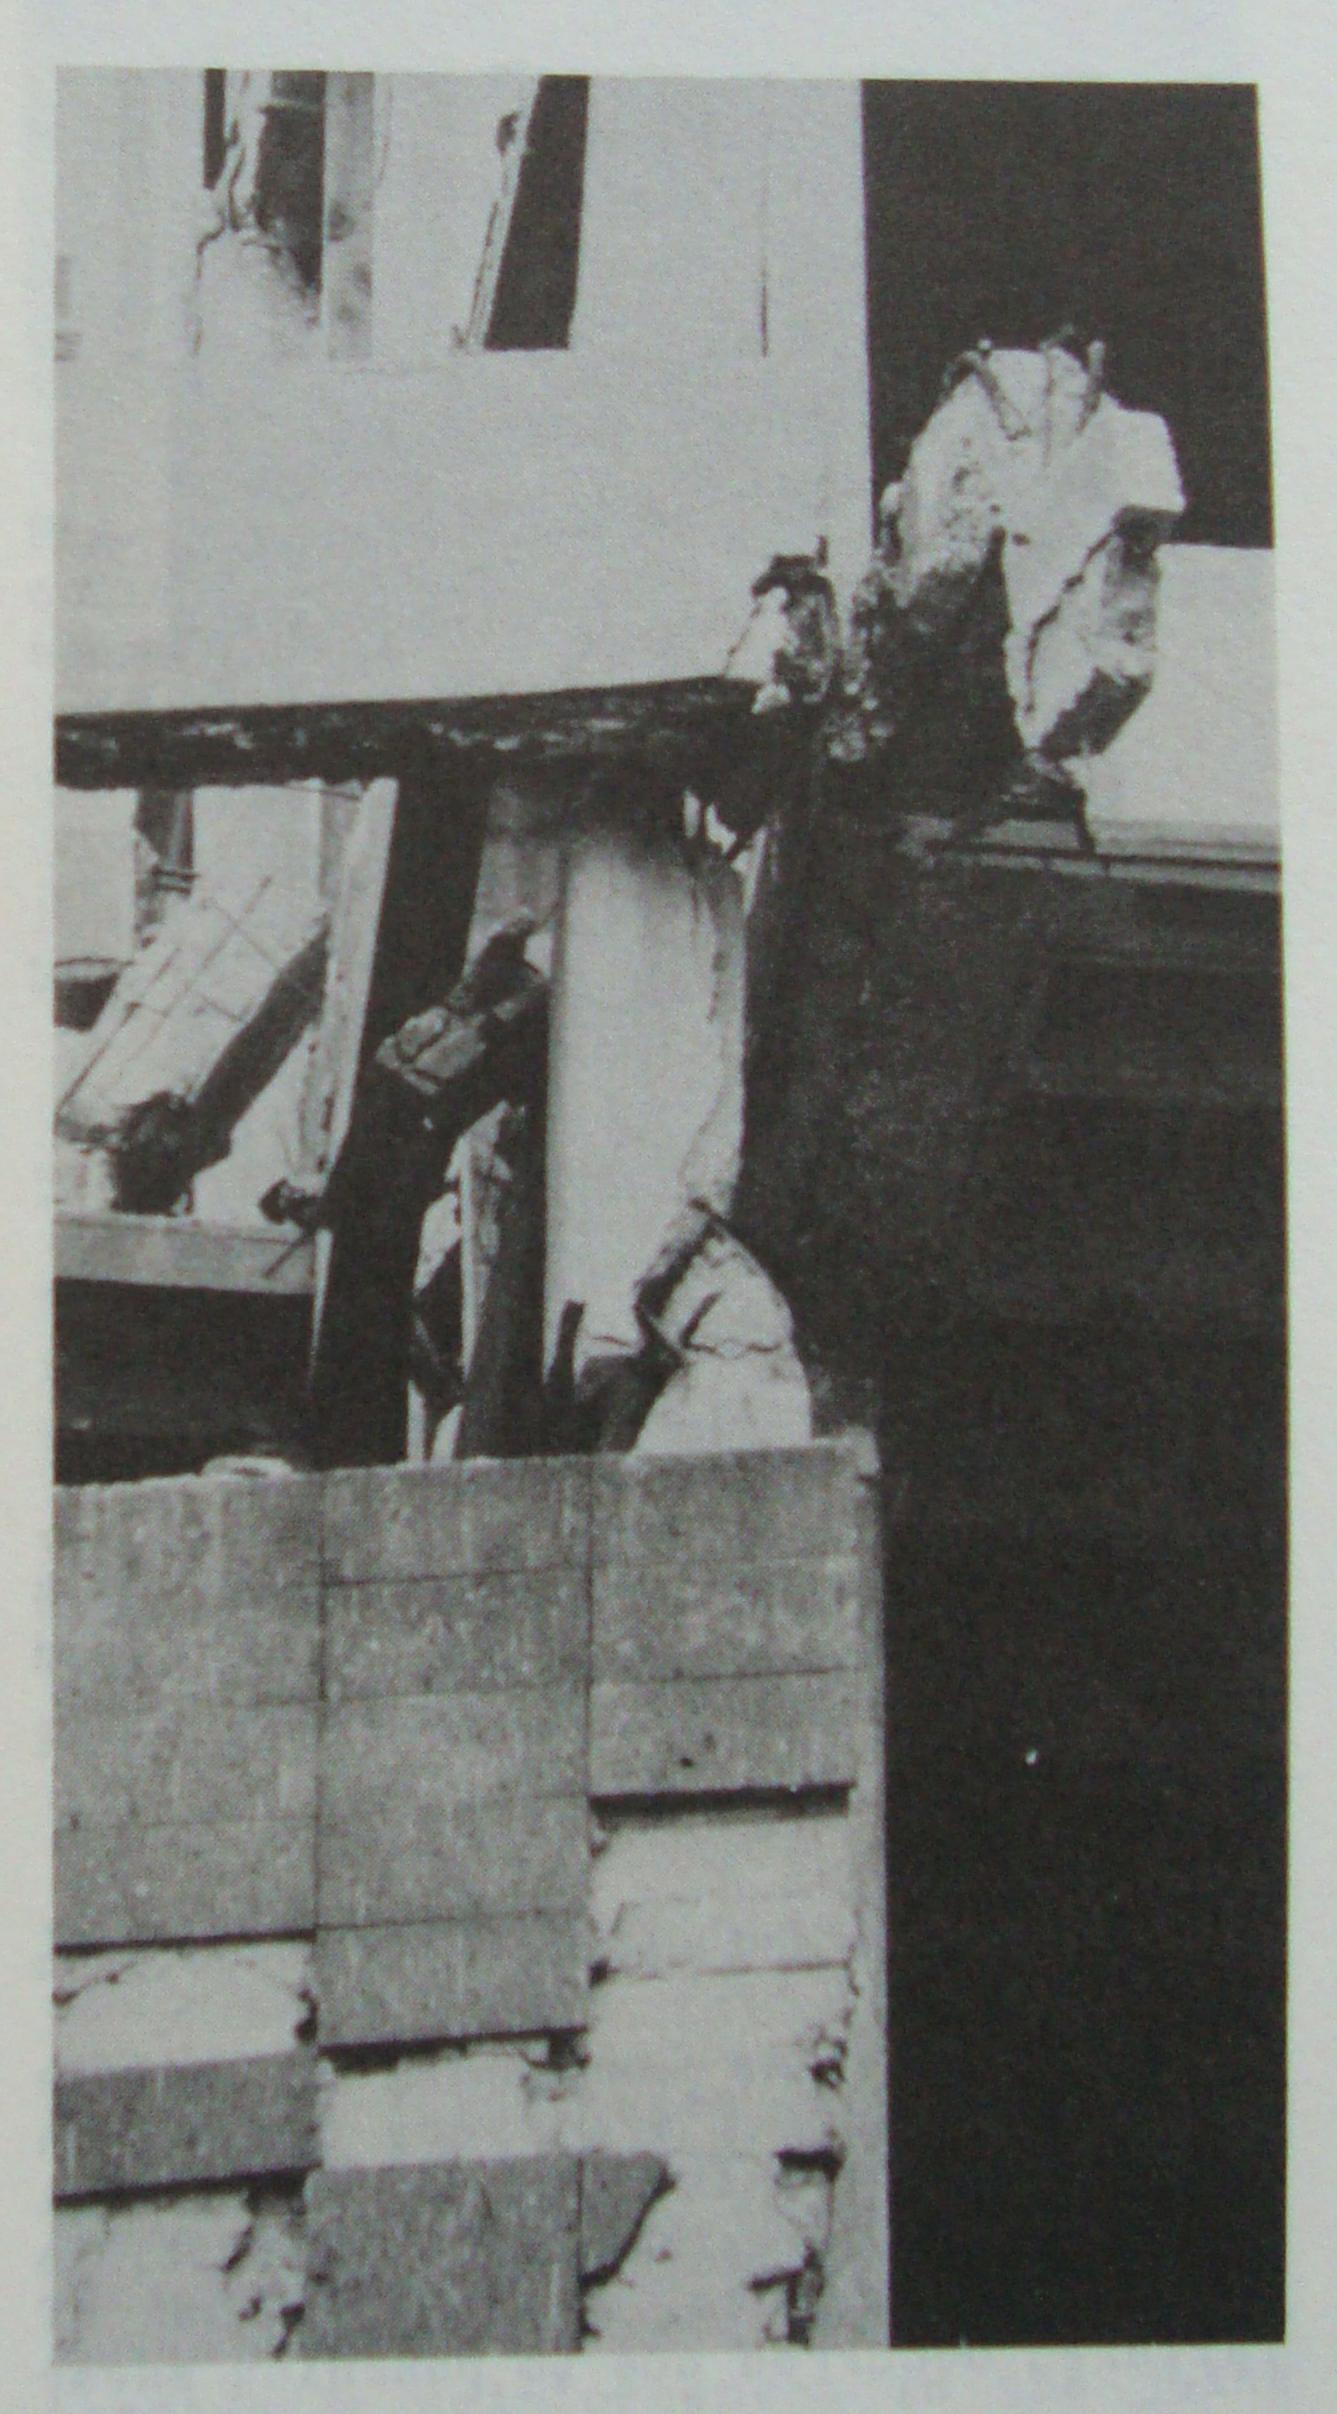
Due to inadequate separation between buildings and due to the flexibility of some structures there were many examples of collisions or pounding between adjacent structures. Figure 30 shows the failure due to pounding of two adjacent parking structures (a large span precast structure and a reinforced concrete frame structure with infilled masonry walls). The Continental Hotel suffered severe collapse of the top 6 storeys of a 12 storey wing as shown in Fig. 31. This 12 storey wing impacted against the 15 storey wing introducing large lateral forces at the top of the 12 storey structure. Figure 32 illustrates the top storey damage to a large waffle slab structure due to pounding of adjacent wings. There were several cases of pounding between adjacent structures whose floors were at different levels. This resulted in severe damage to the columns (see Fig. 33).

Fig 33. Shear failure of column due to pounding between adjacent structures.

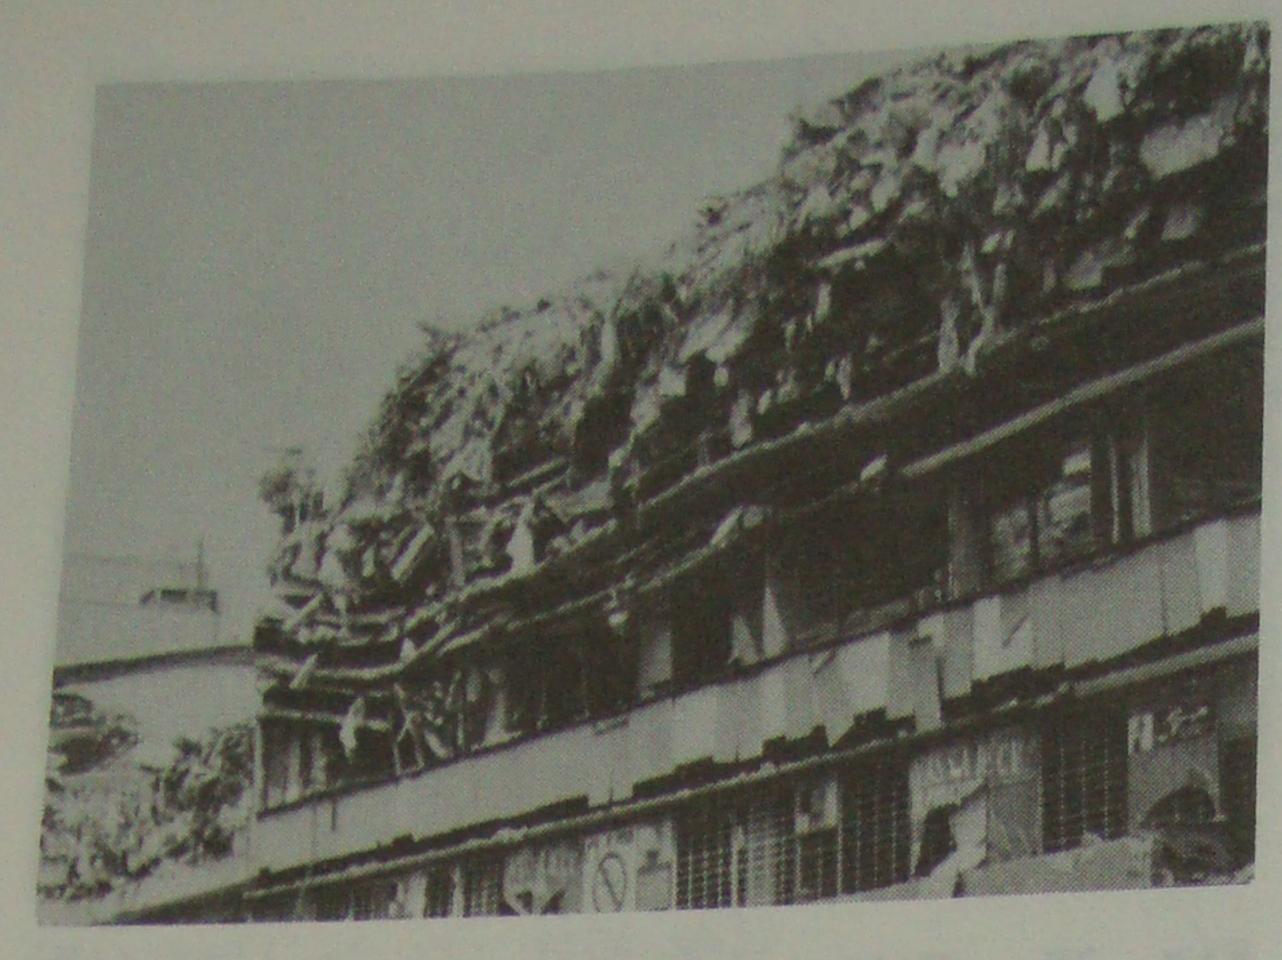
Fig. 34. Upper storey failures of flat plate structure.

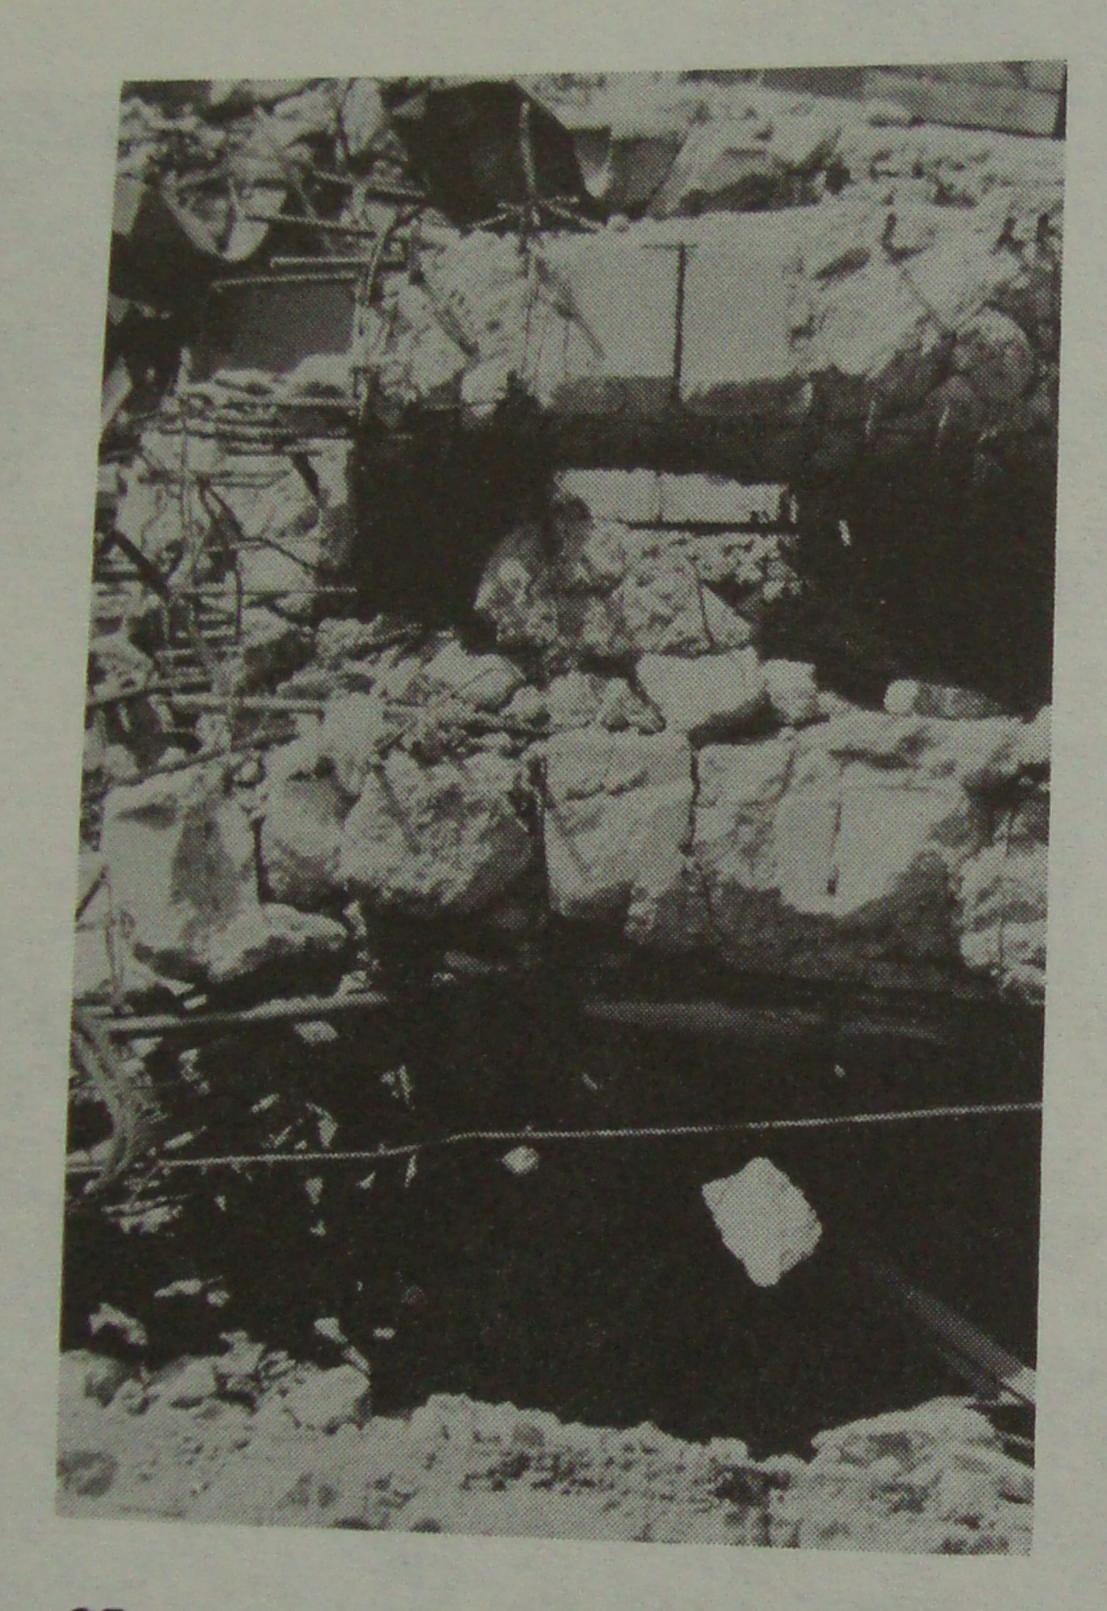
Fig. 35. Punching shear failures in 4 storey school structure with embedded hollow block masonry in floor slabs.

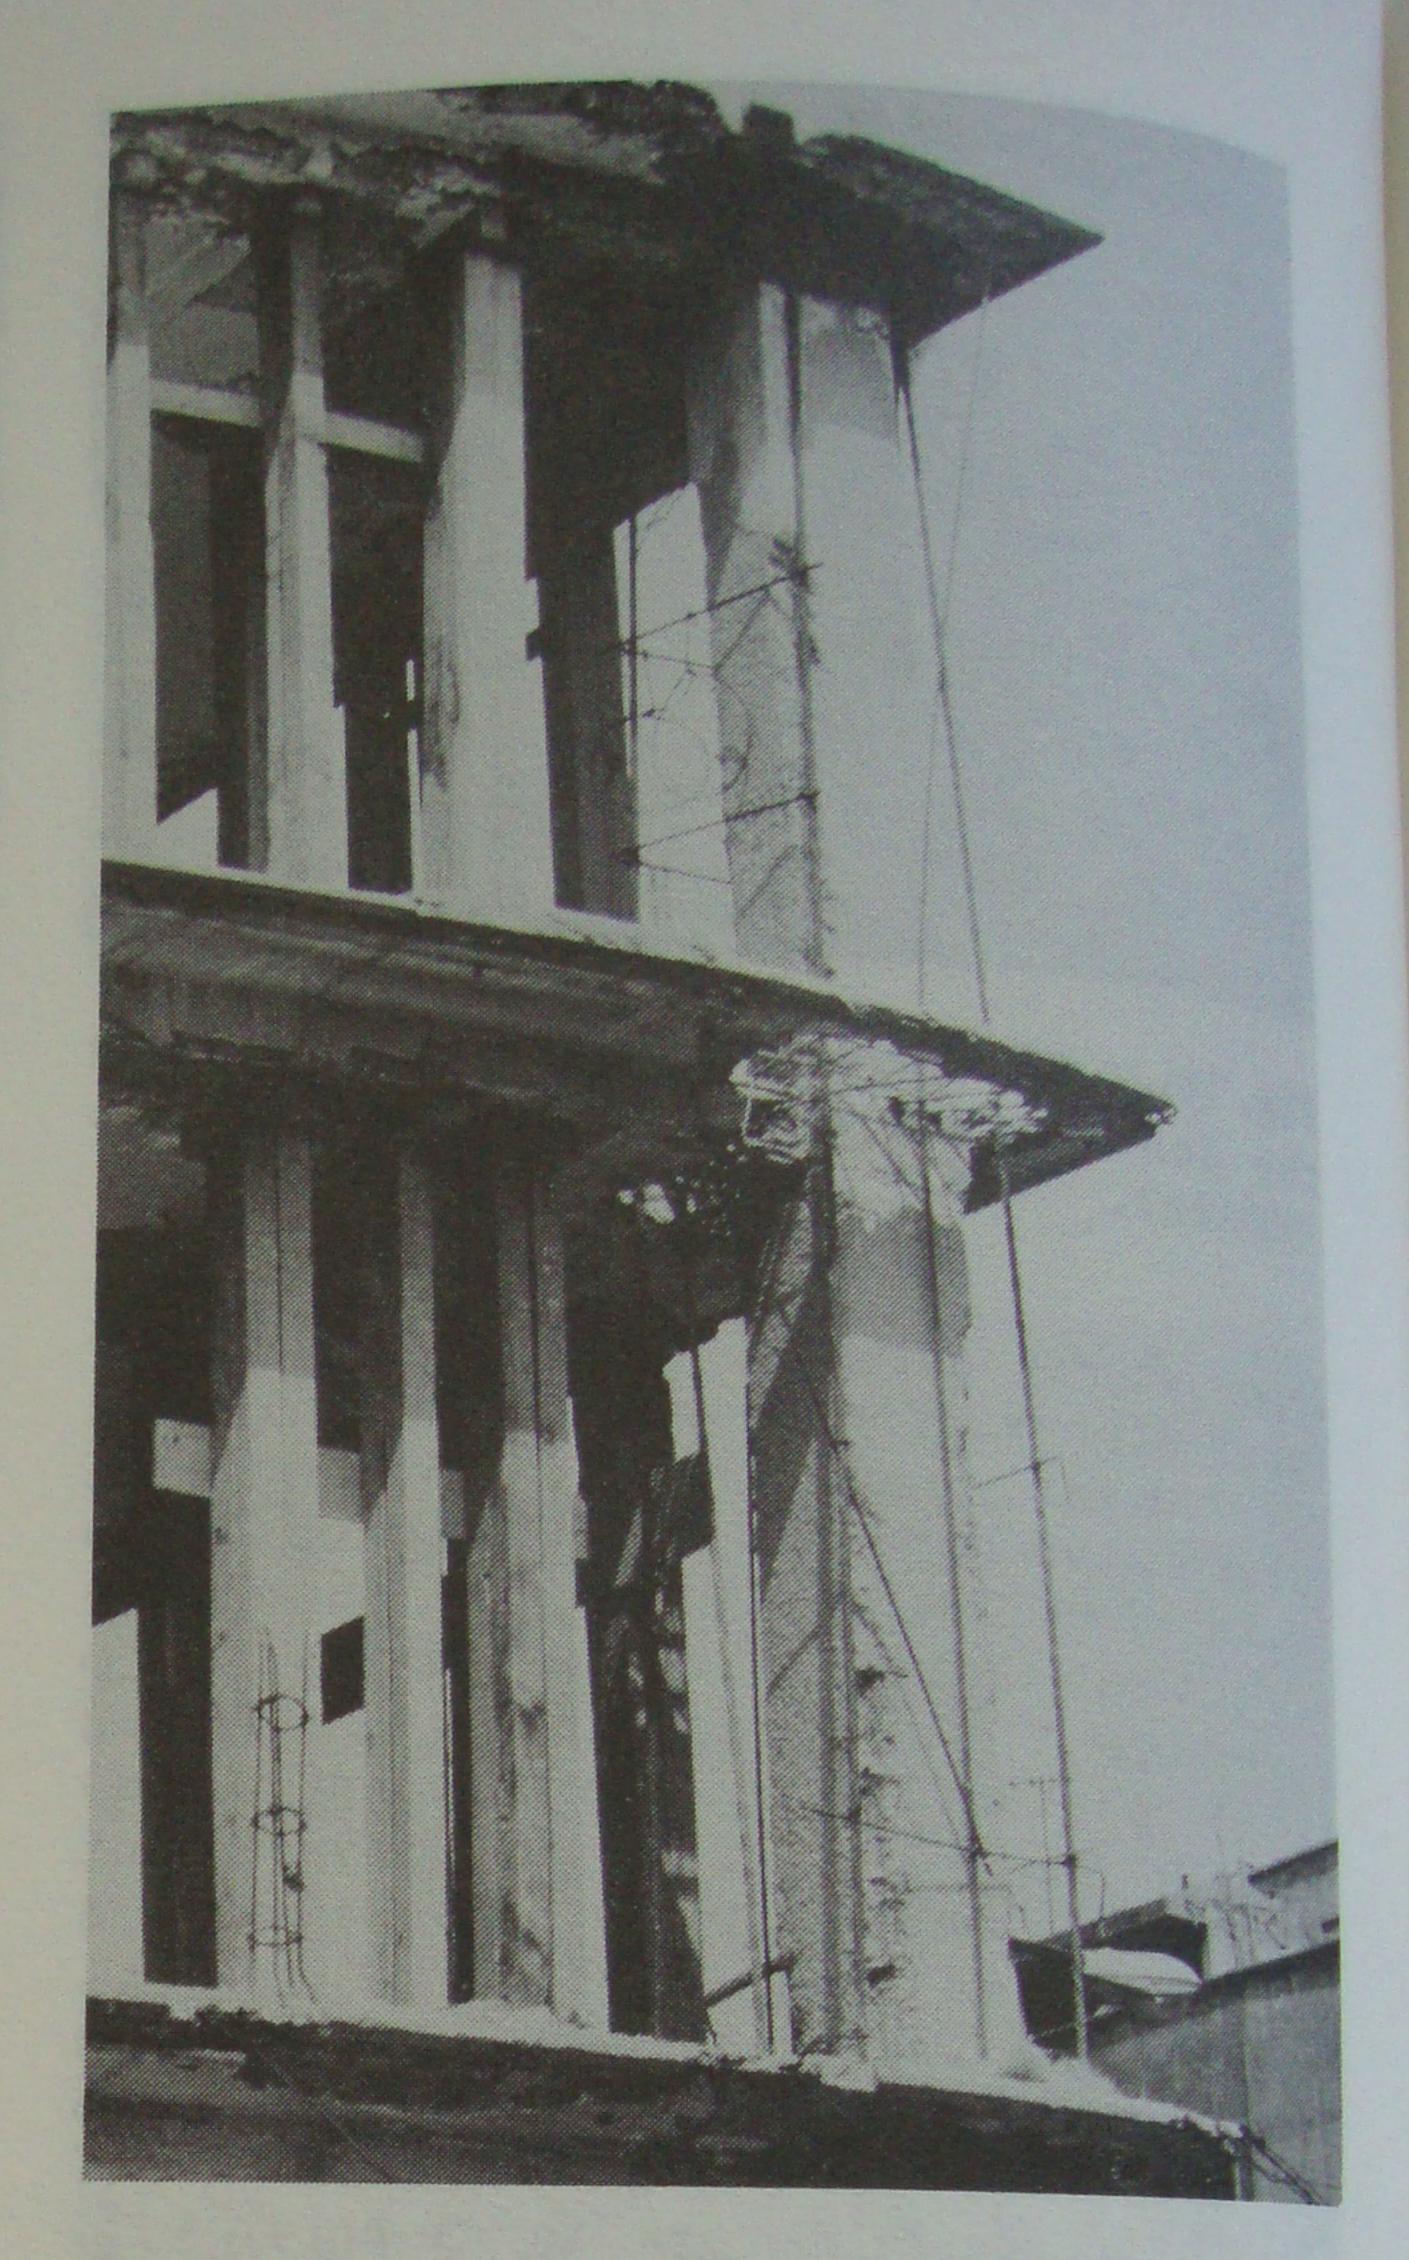
Fig. 36. Punching shear failure at corner column.

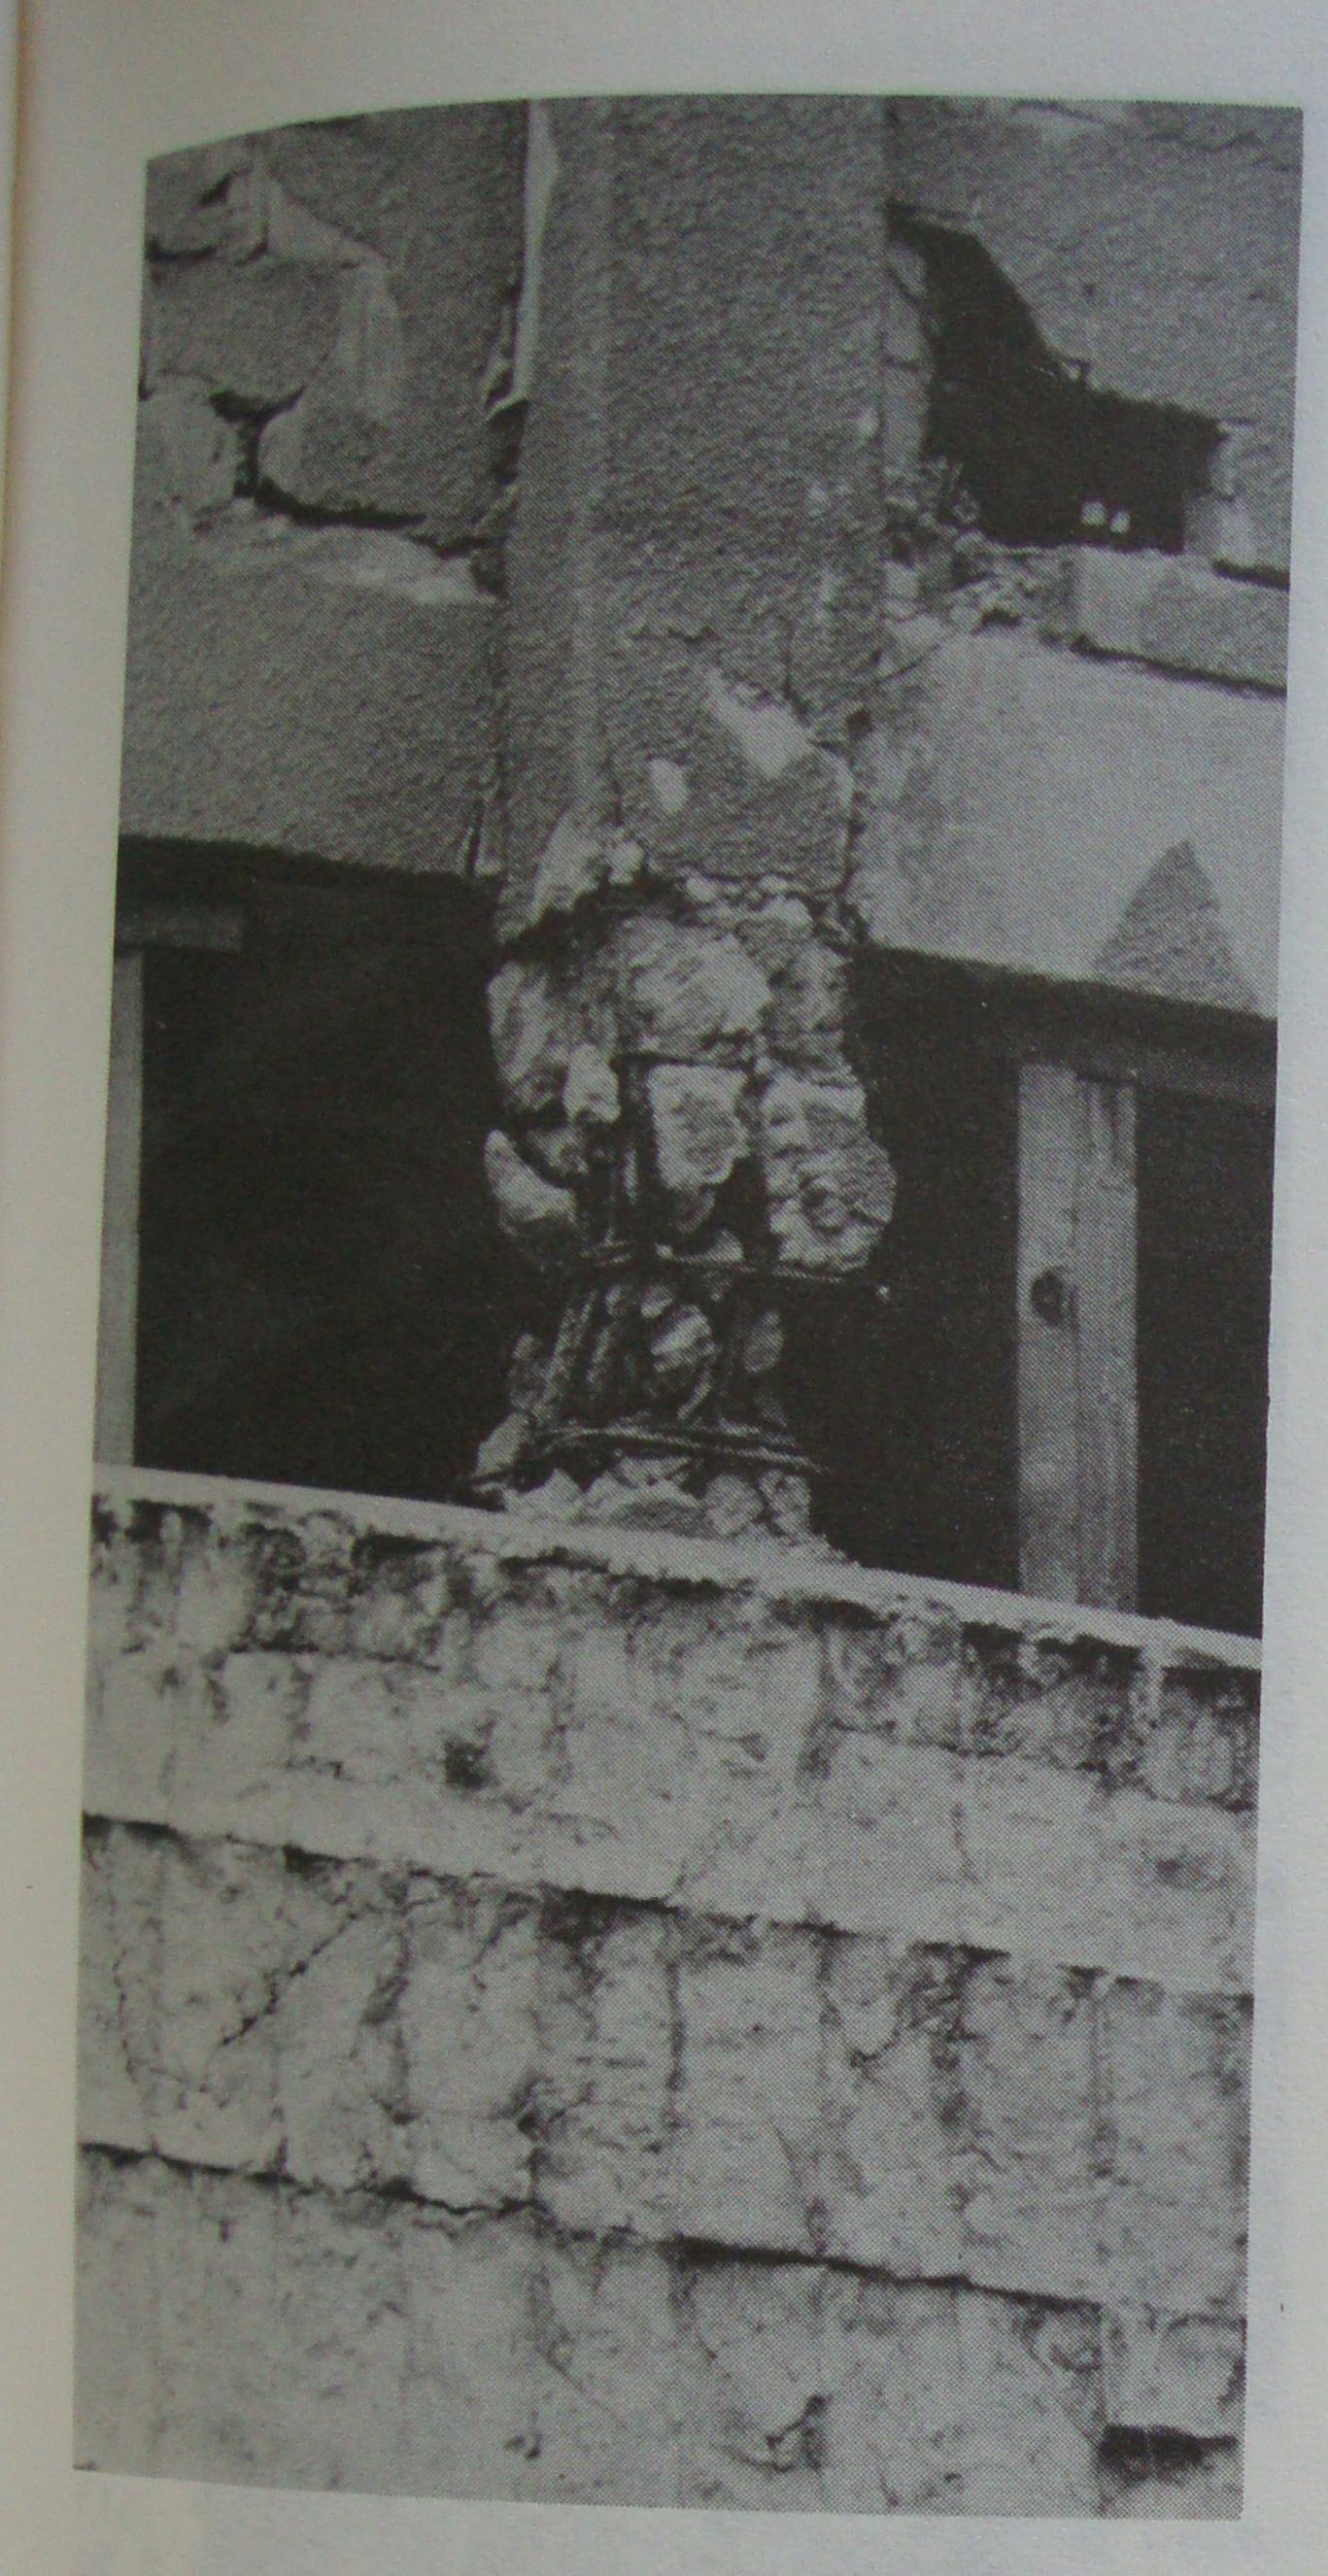
Fig. 37. Shear failure of short exposed column due to partially infilled masonry wall.

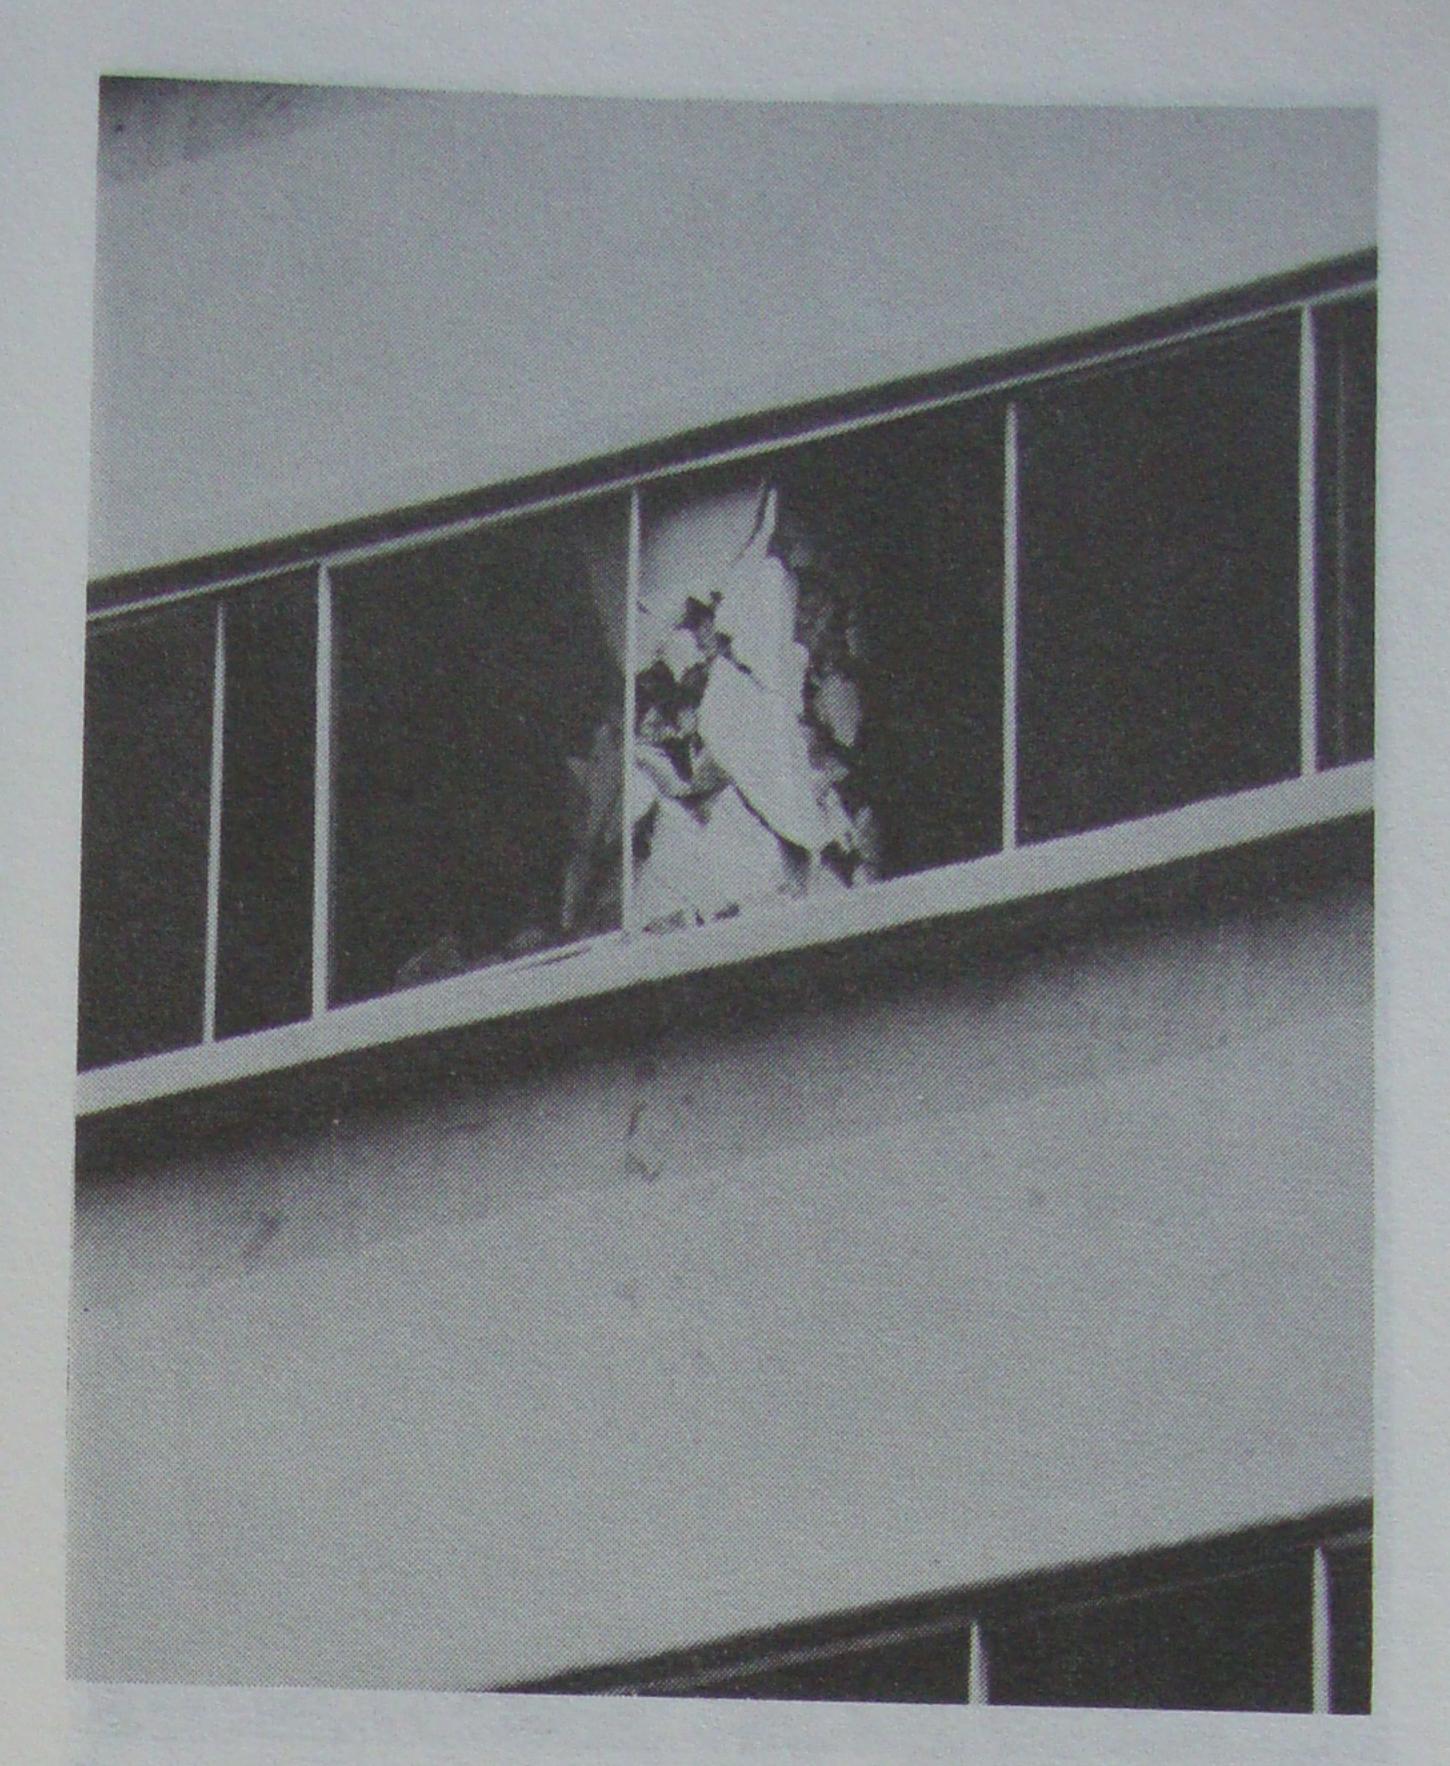
Fig. 38. Shear failure of short exposed column due to relatively deep spandrel beams.

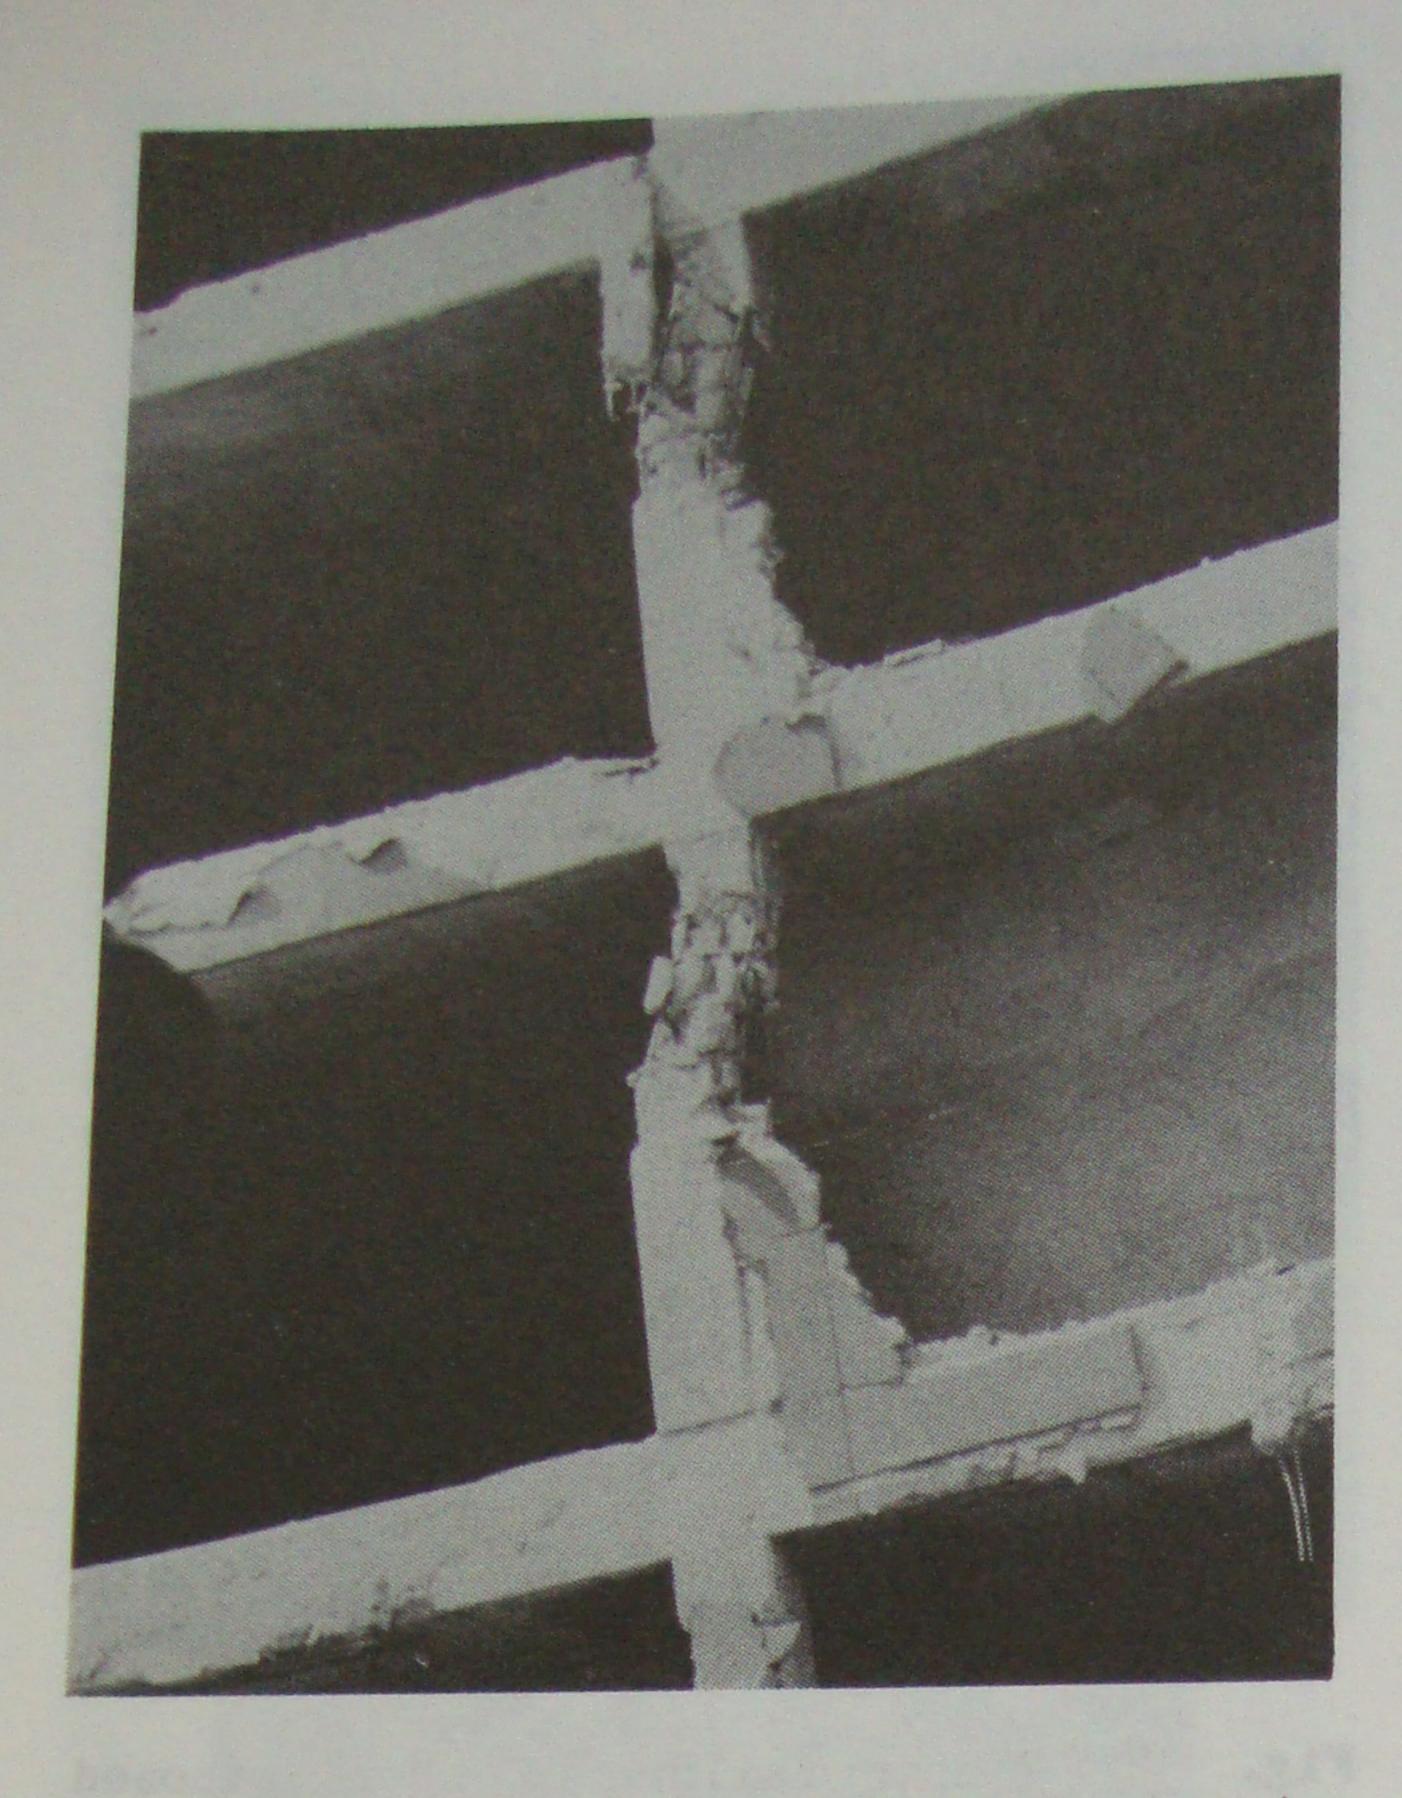
Fig. 39. Short column failure due to presence of partial storey height masonry wall (Mitchell et al. 1986a&b).
