### Structural damage due to the 1985 Mexican earthquake

D.Mitchell McGill University, Montreal, Quebec, Canada

ABSTRACT: Characteristics of the 1985 Mexican earthquake and the influence of the subsoil conditions on the strong ground motion in Mexico City are described. Some aspects of structural design practice and examples of structural damage are discussed along with the emergency changes to the building code.

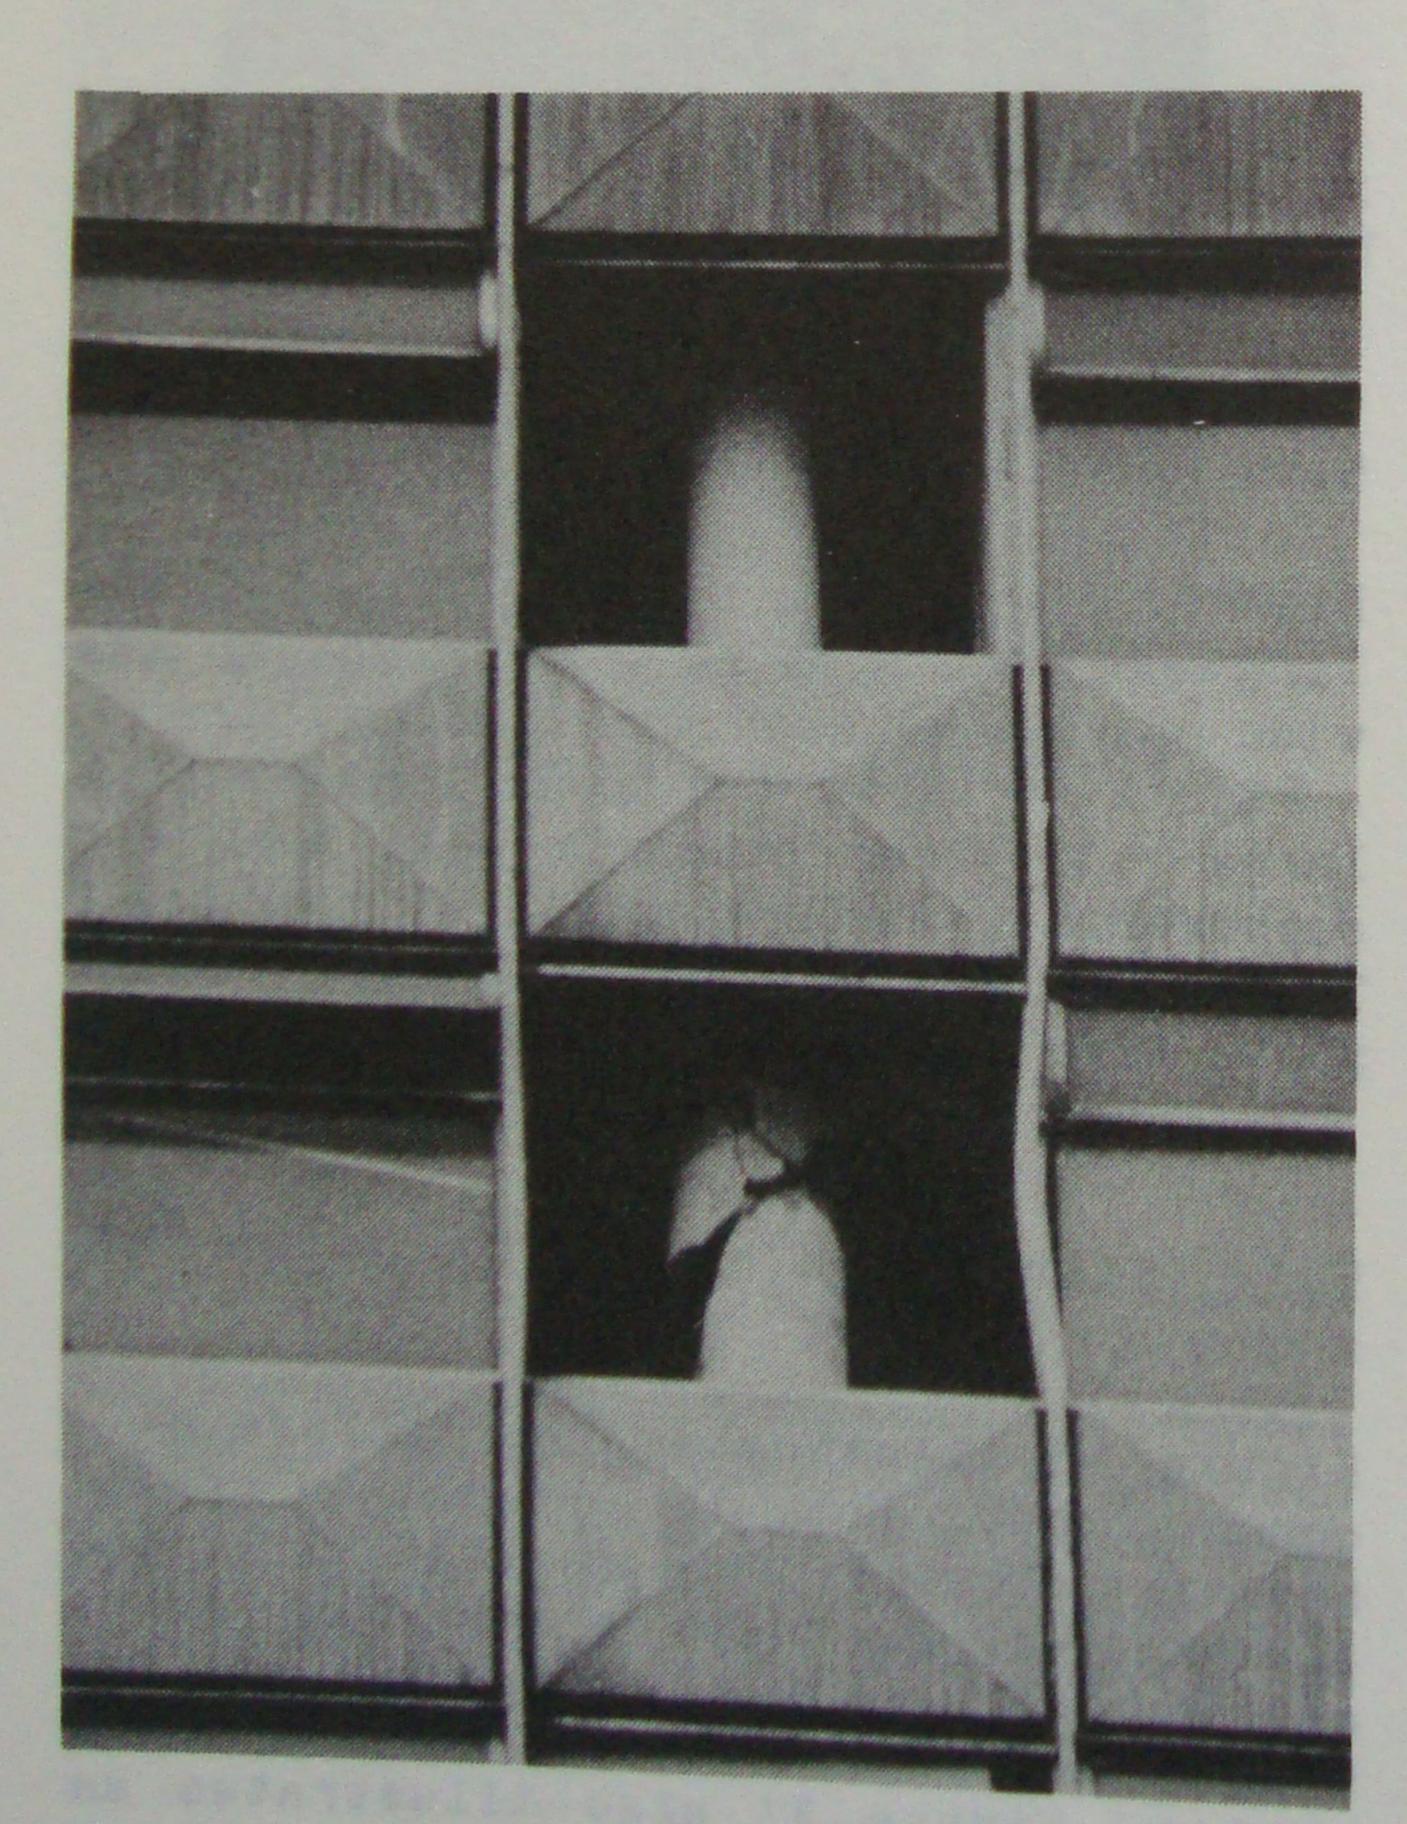
Figure 40 shows a shear failure in a reinforced concrete circular column. Examples of failures of columns due to inadequate confinement details are given failed had wide tie spacings, 90 degree spaces between the longitudinal bars. The ineffective after the concrete cover steel in the column shown in Fig. 41 had down" of the cross-section. This

Fig. 40. Shear failure of circular column.

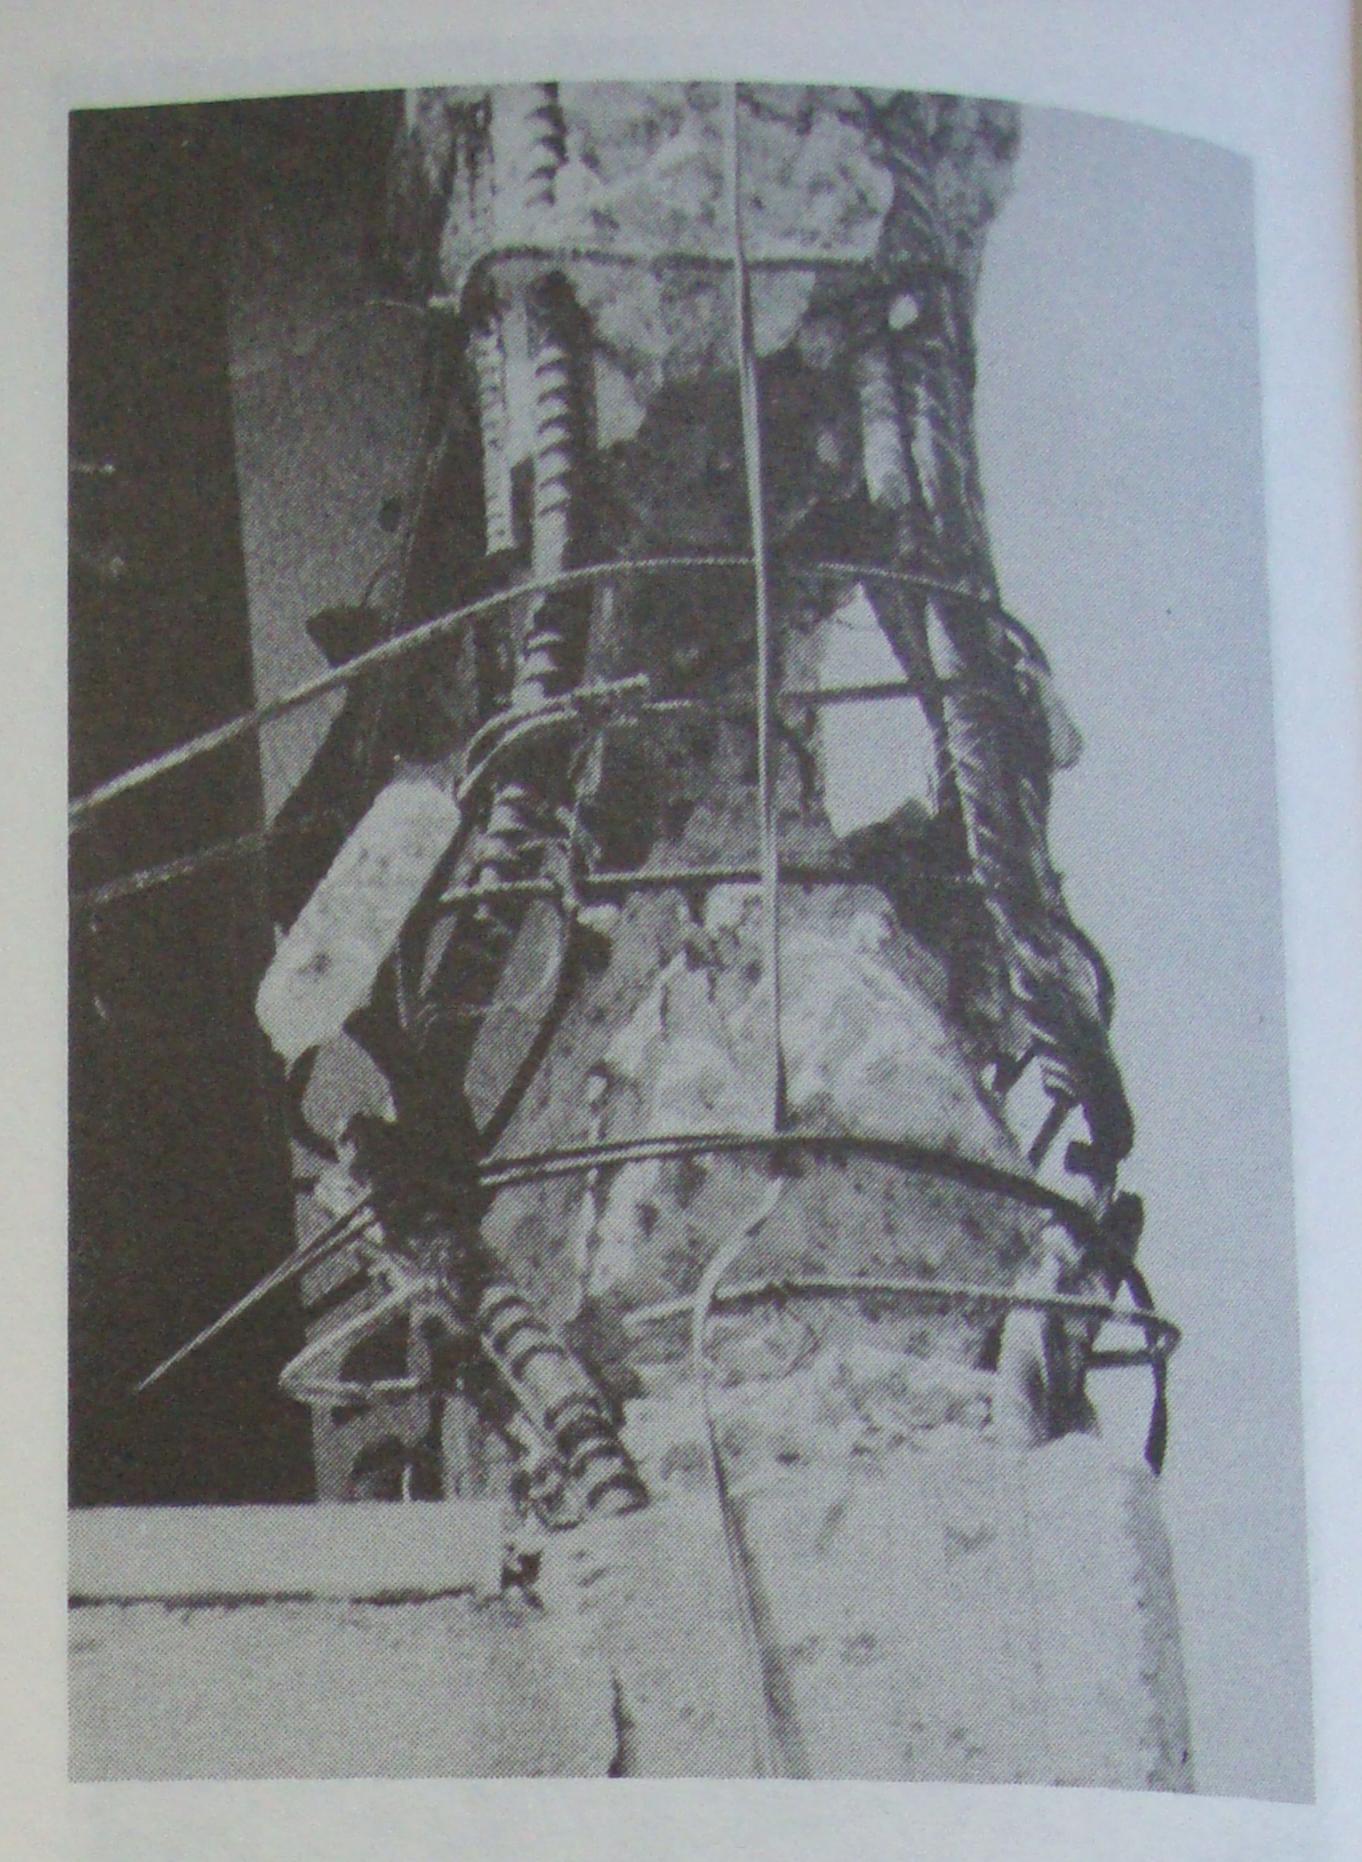
Fig. 41. Failure of column in second storey of 14 storey Nuevo León apartment building (Mitchell et al. 1986a&b).

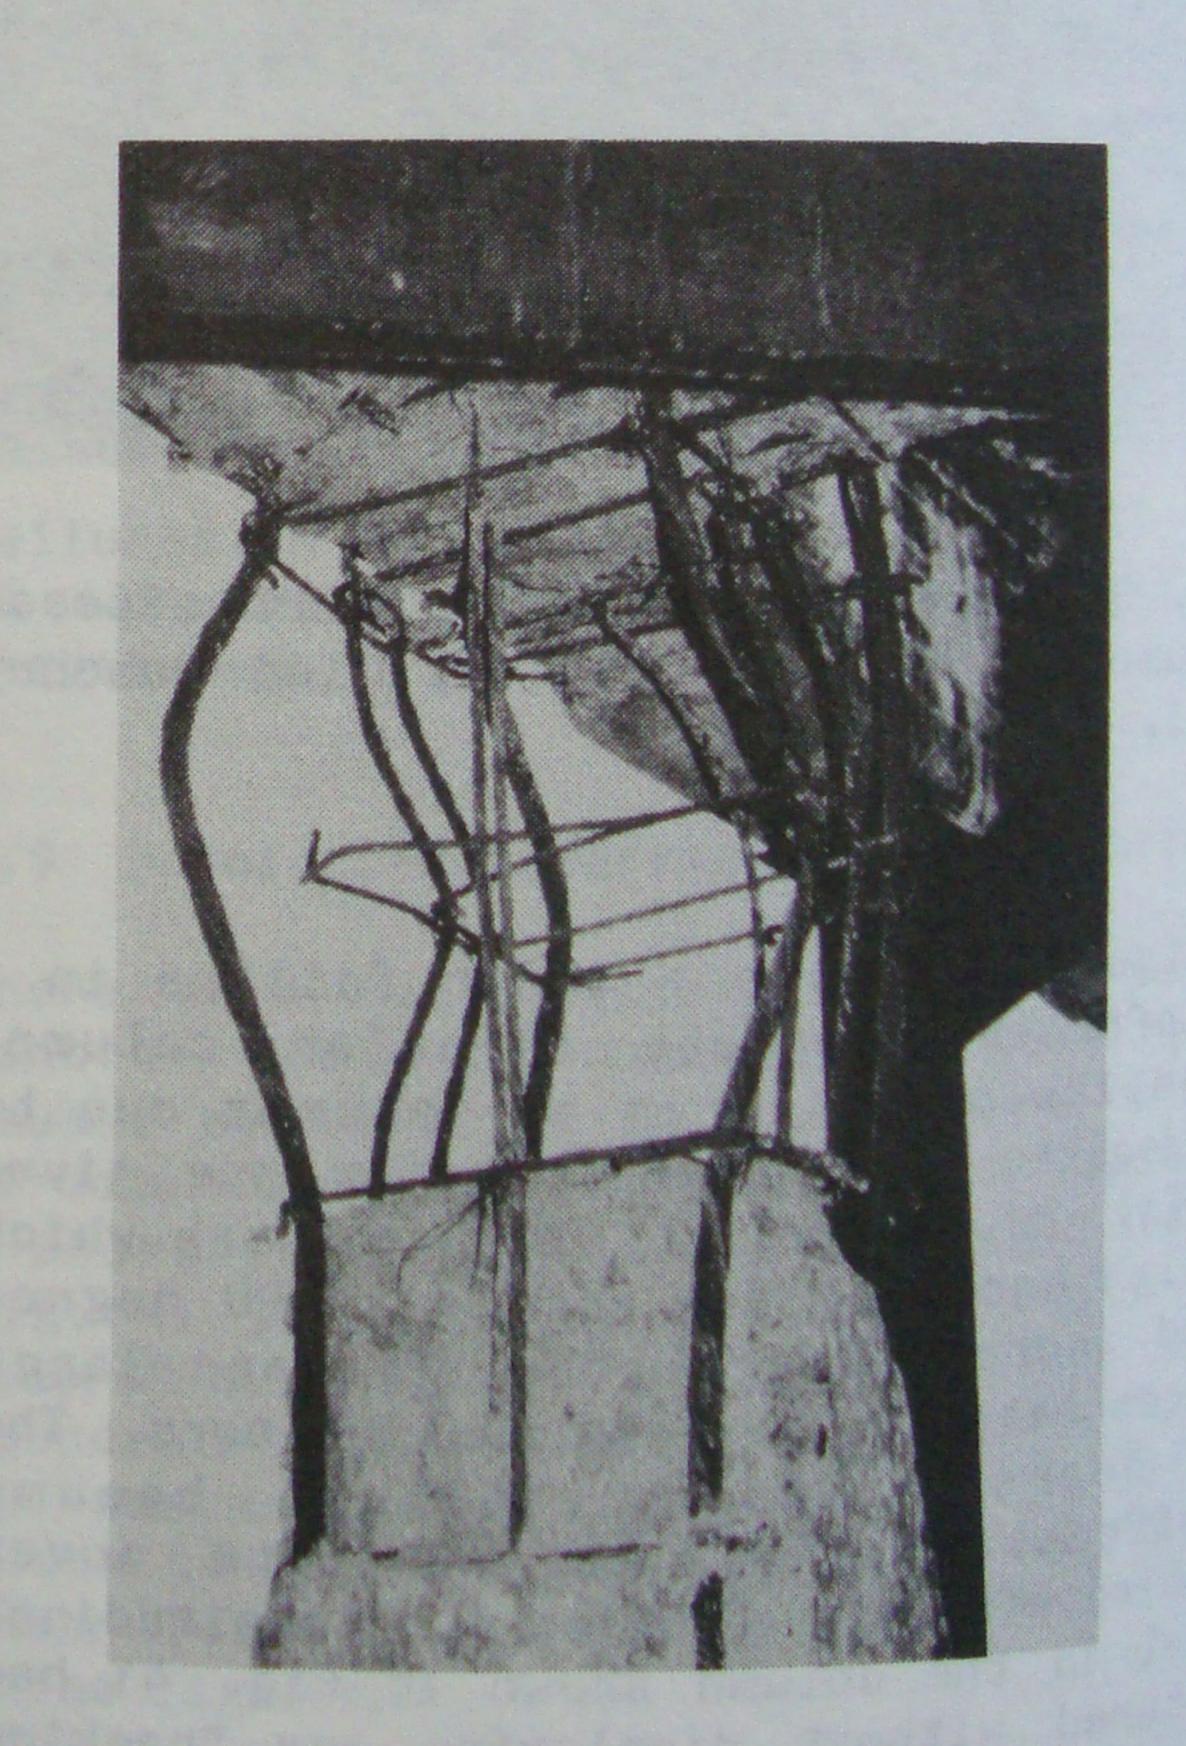
Fig. 42. Failure of upper storey column of 9 storey office building.

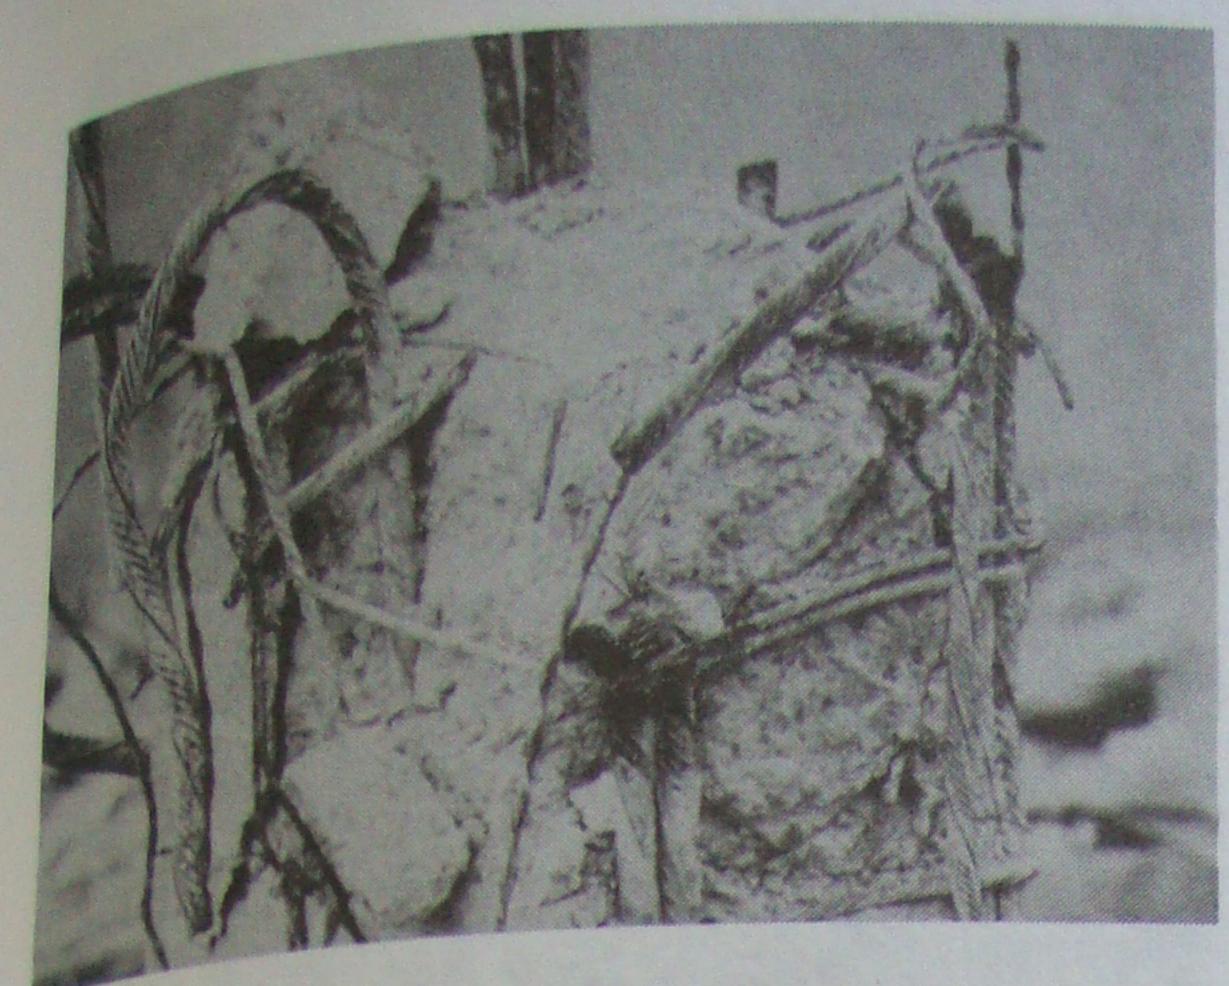
Fig. 43. Failure of ground storey column

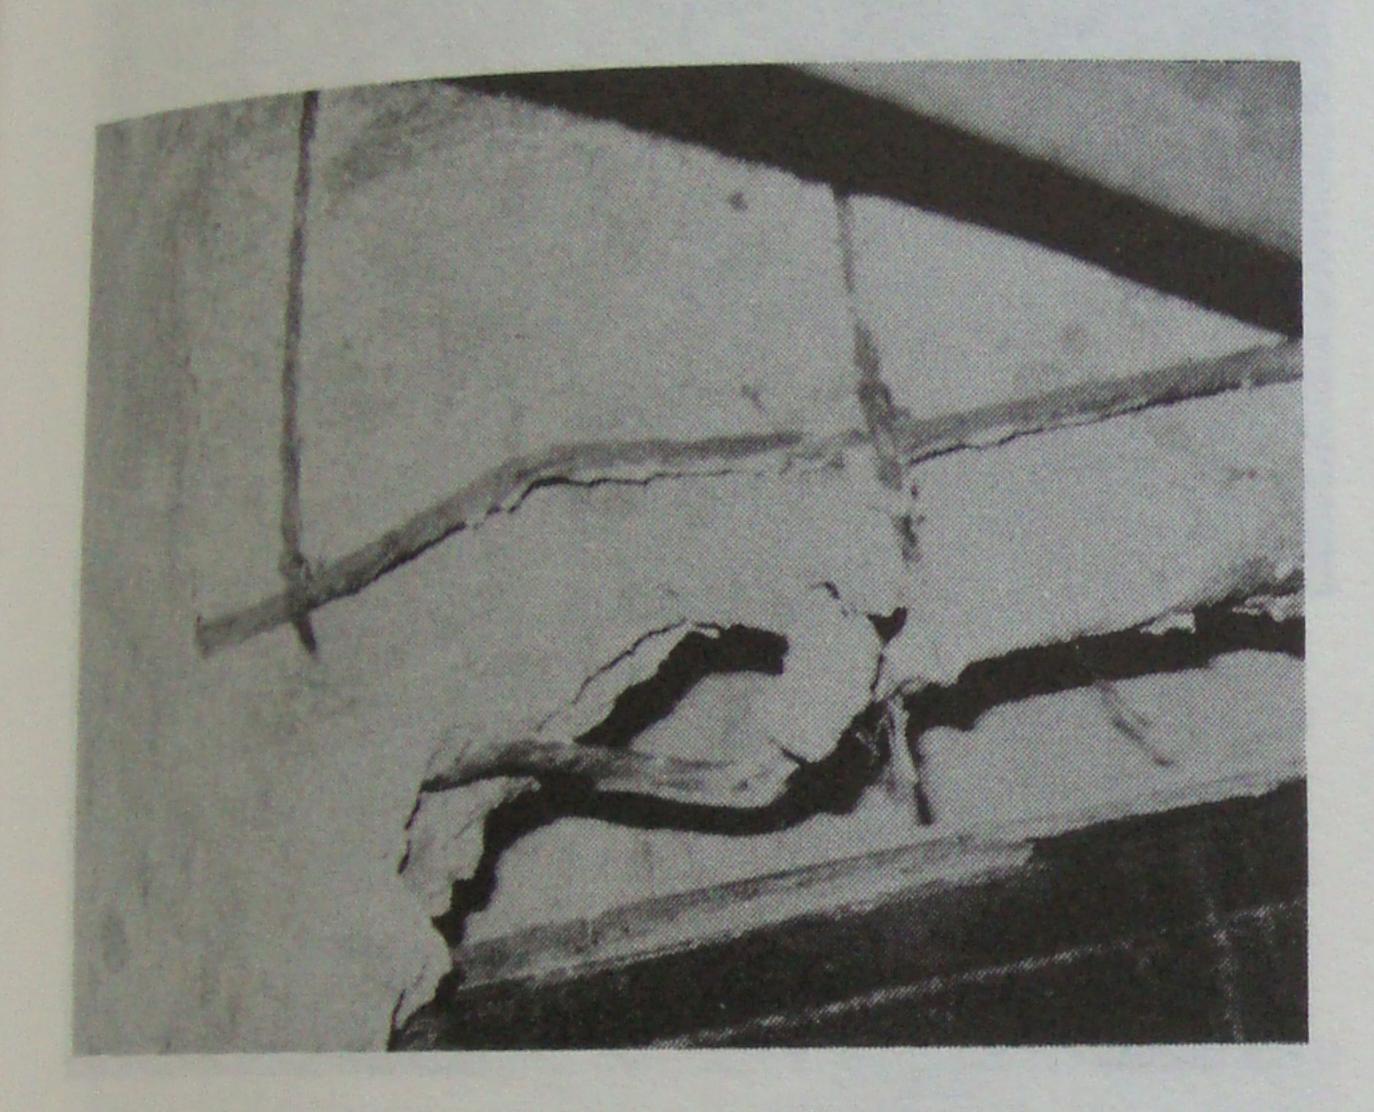
Fig. 44. Buckling of bottom bars in beam of 9 storey office building.

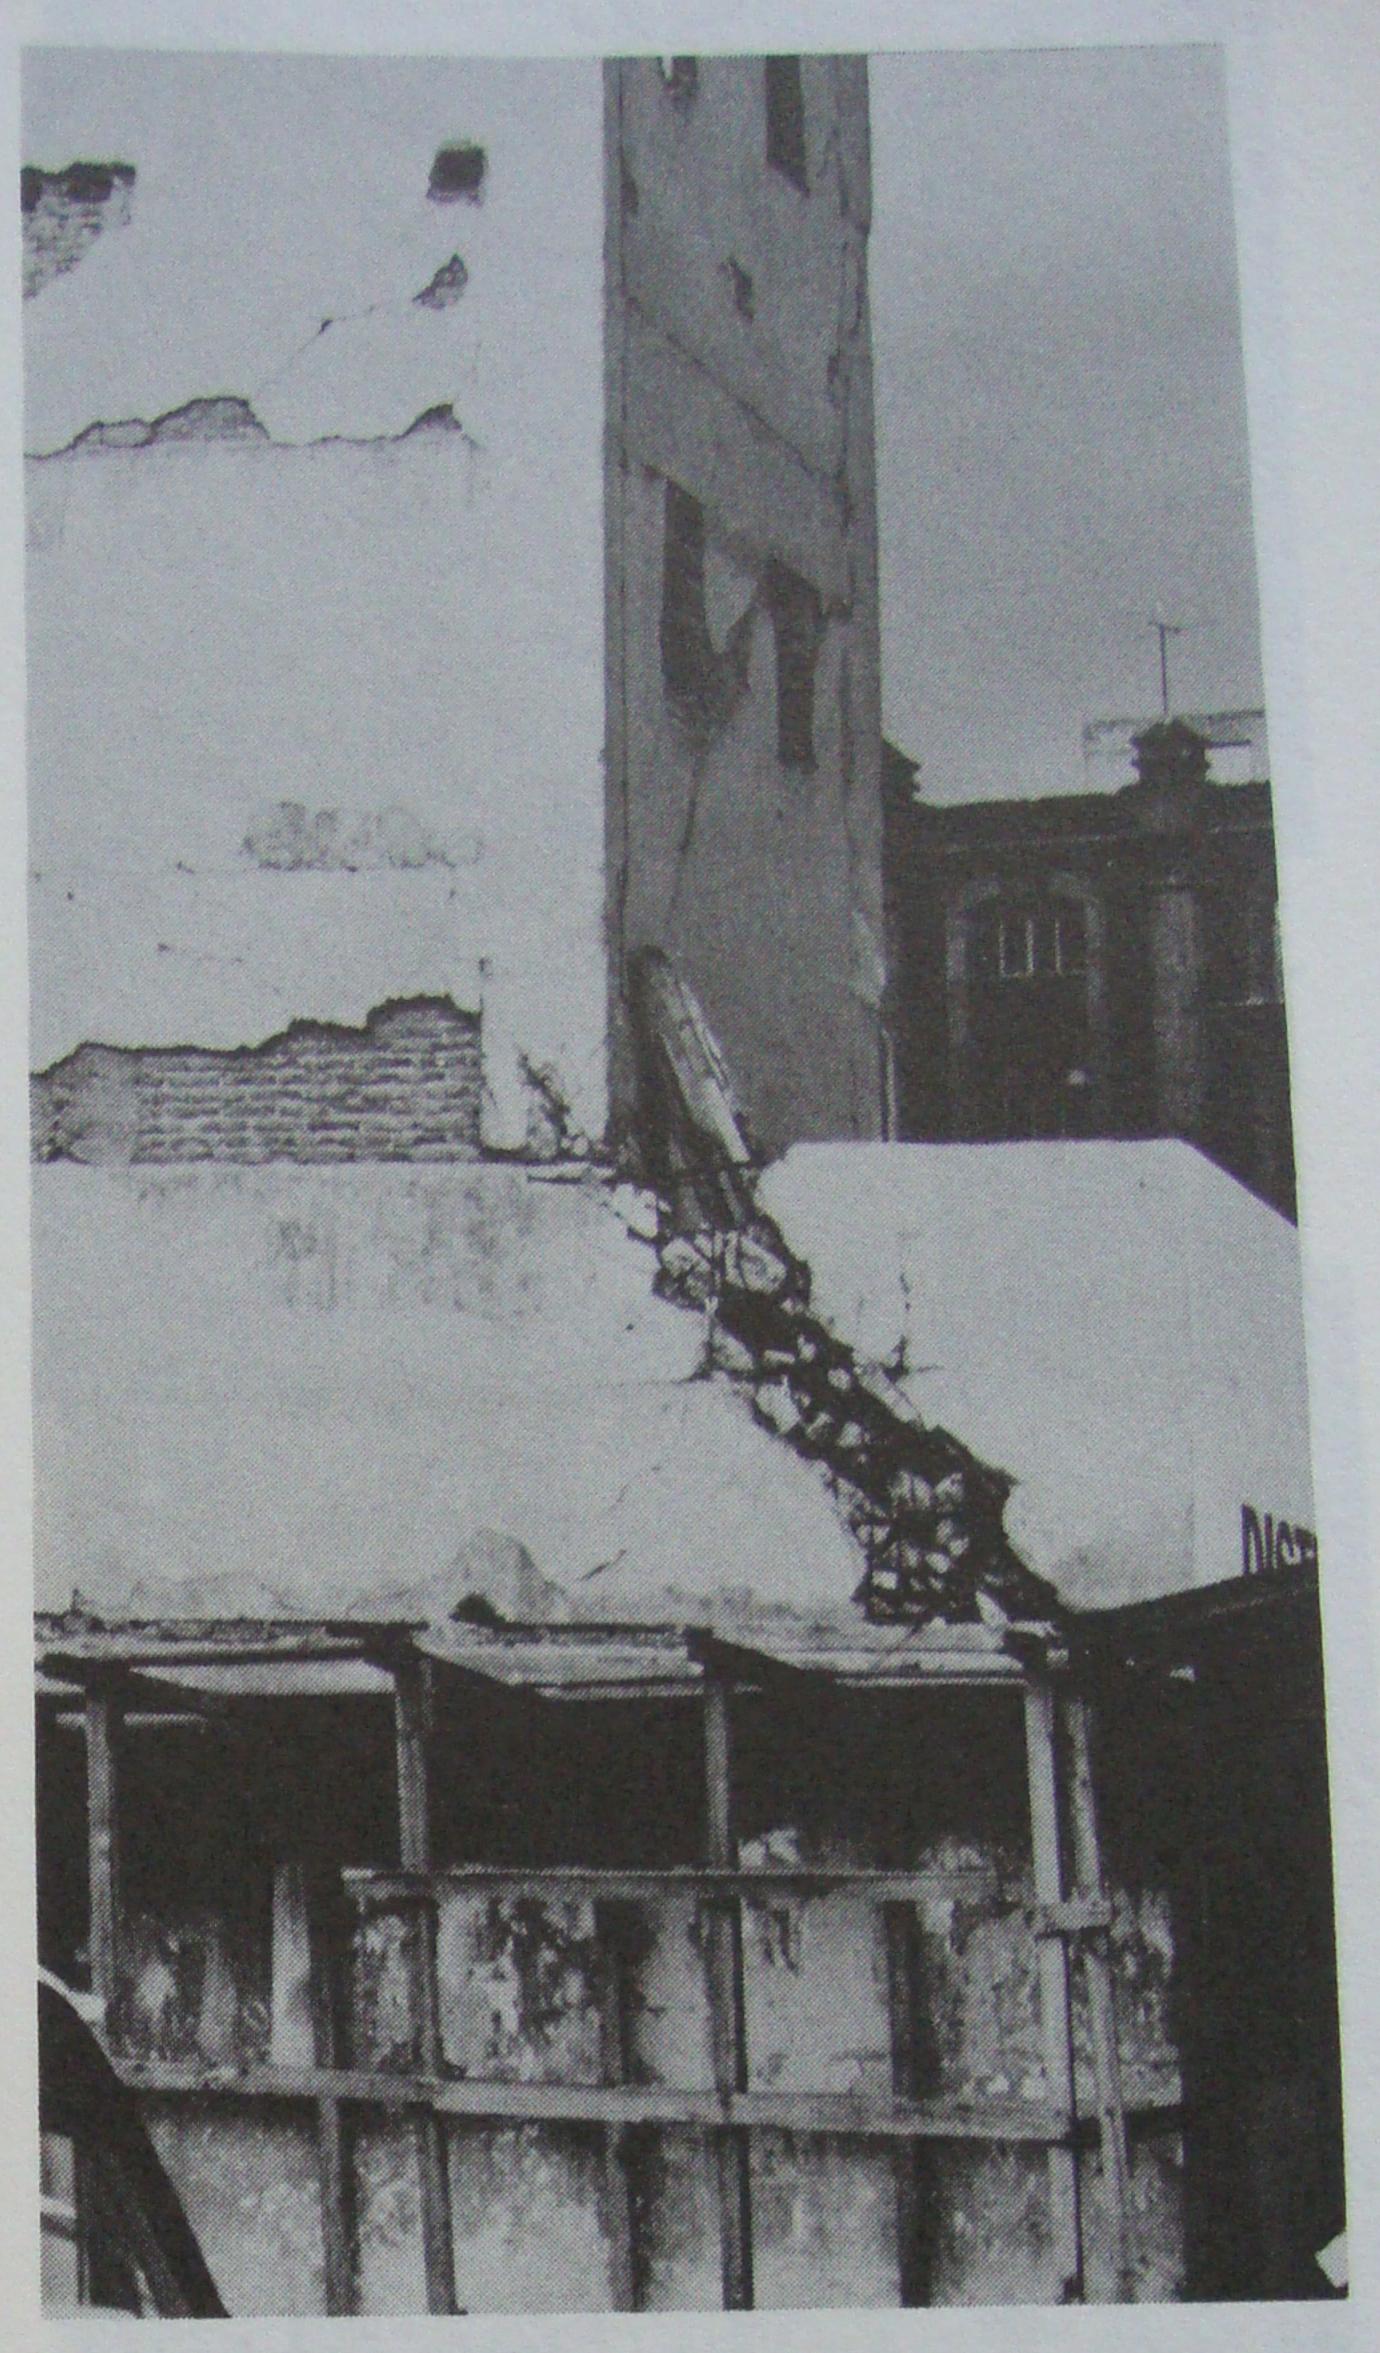
Figure 45 shows the shear failure of a large reinforced concrete beam that was supporting a masonry infilled frame-wall. The stirrups across the shear failure plane have ruptured.

Fig. 45. Shear failure of transfer girder in 13 storey structure.

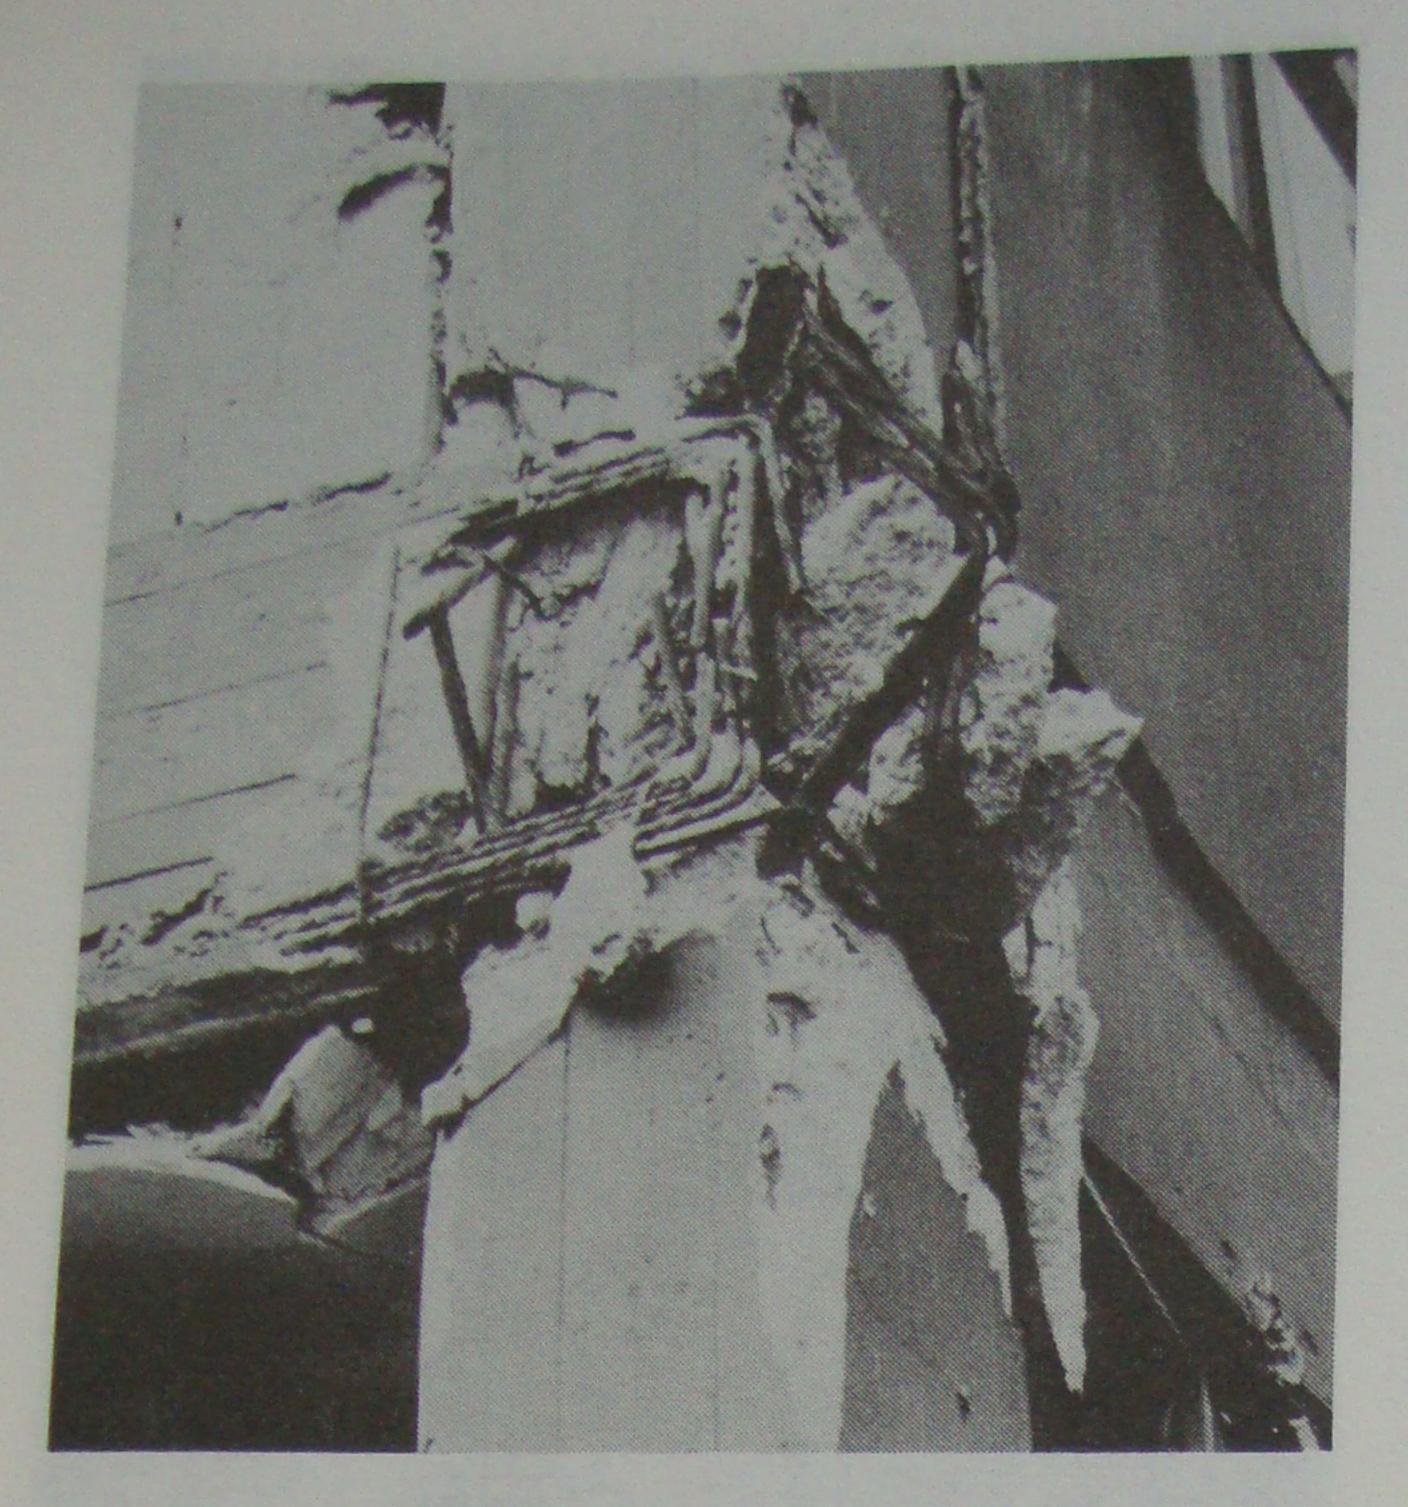
Figure 46 illustrates the failure of a corner joint. Note the congestion of the hooked anchorages for the beam bars, the placement of the beam bars outside of the column bars and the absence of any transverse reinforcement in the joint region. Figure 47 also illustrates an

Fig. 46. Failure of corner joint.

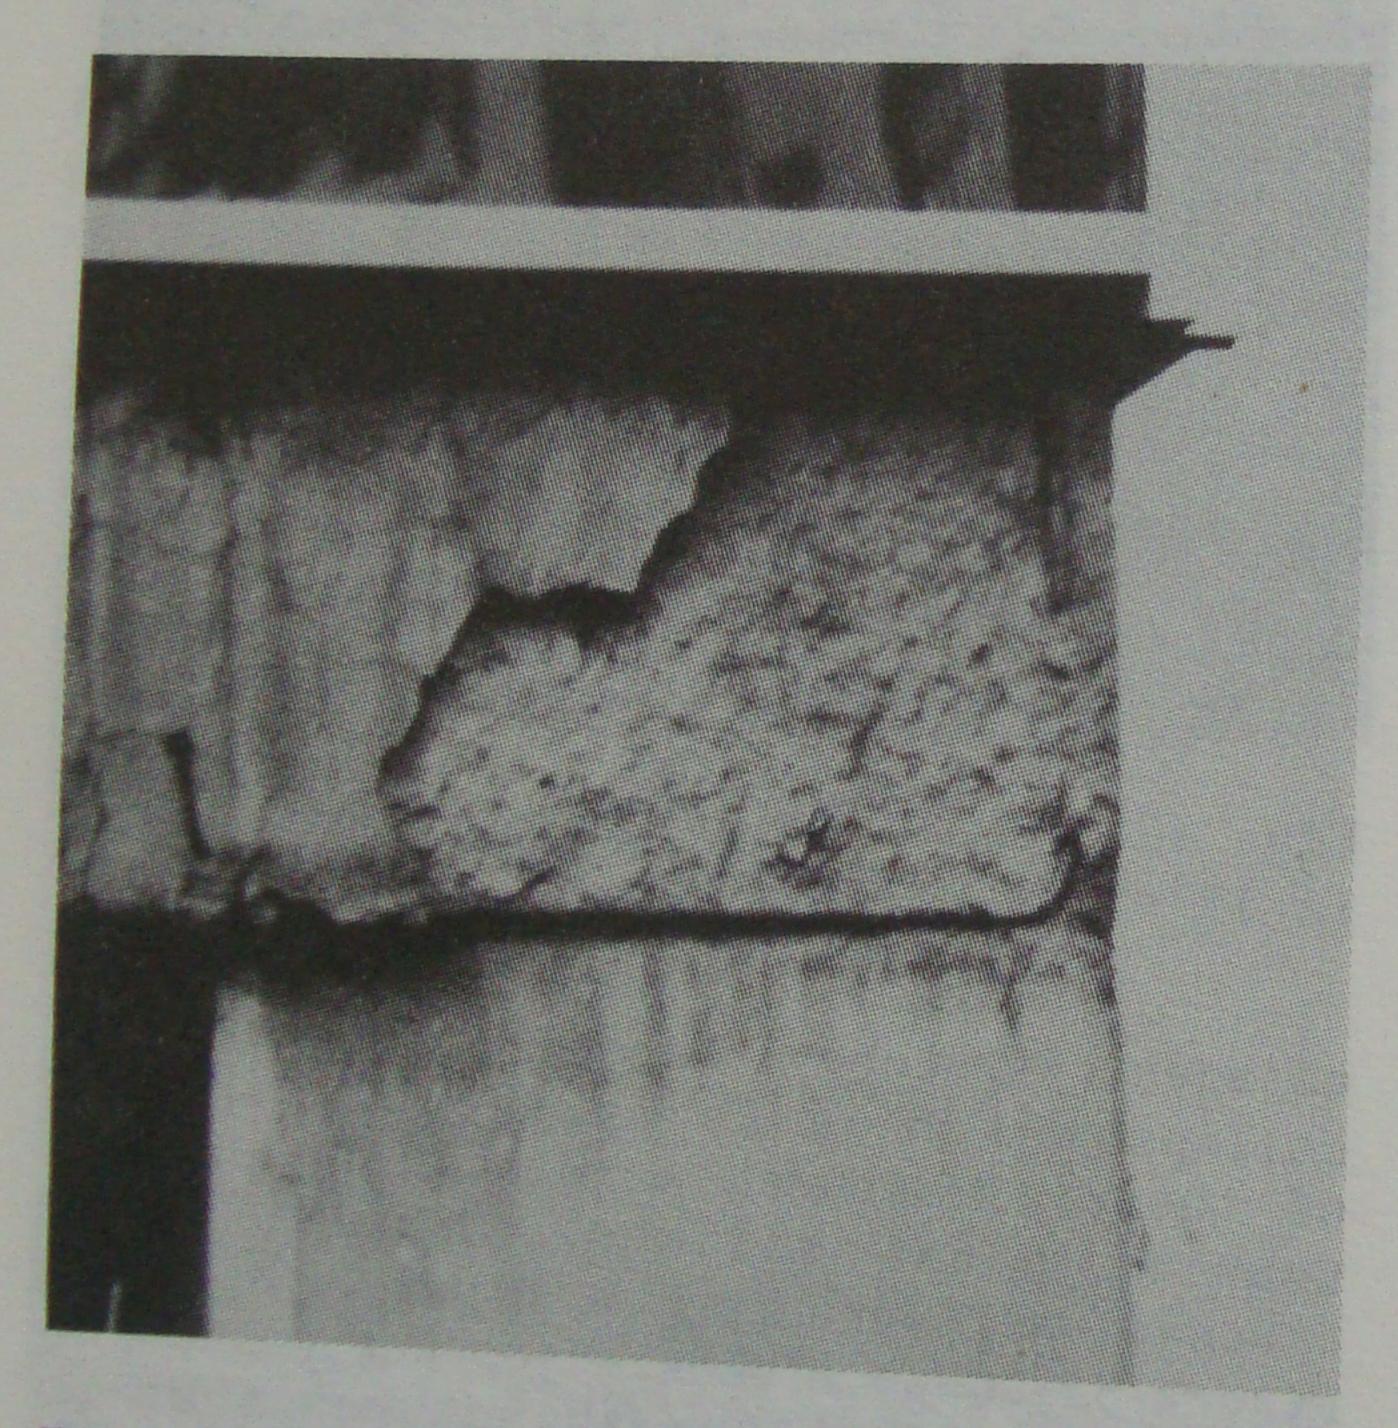
Fig. 47. Improper anchorage of beam steel in joint region.

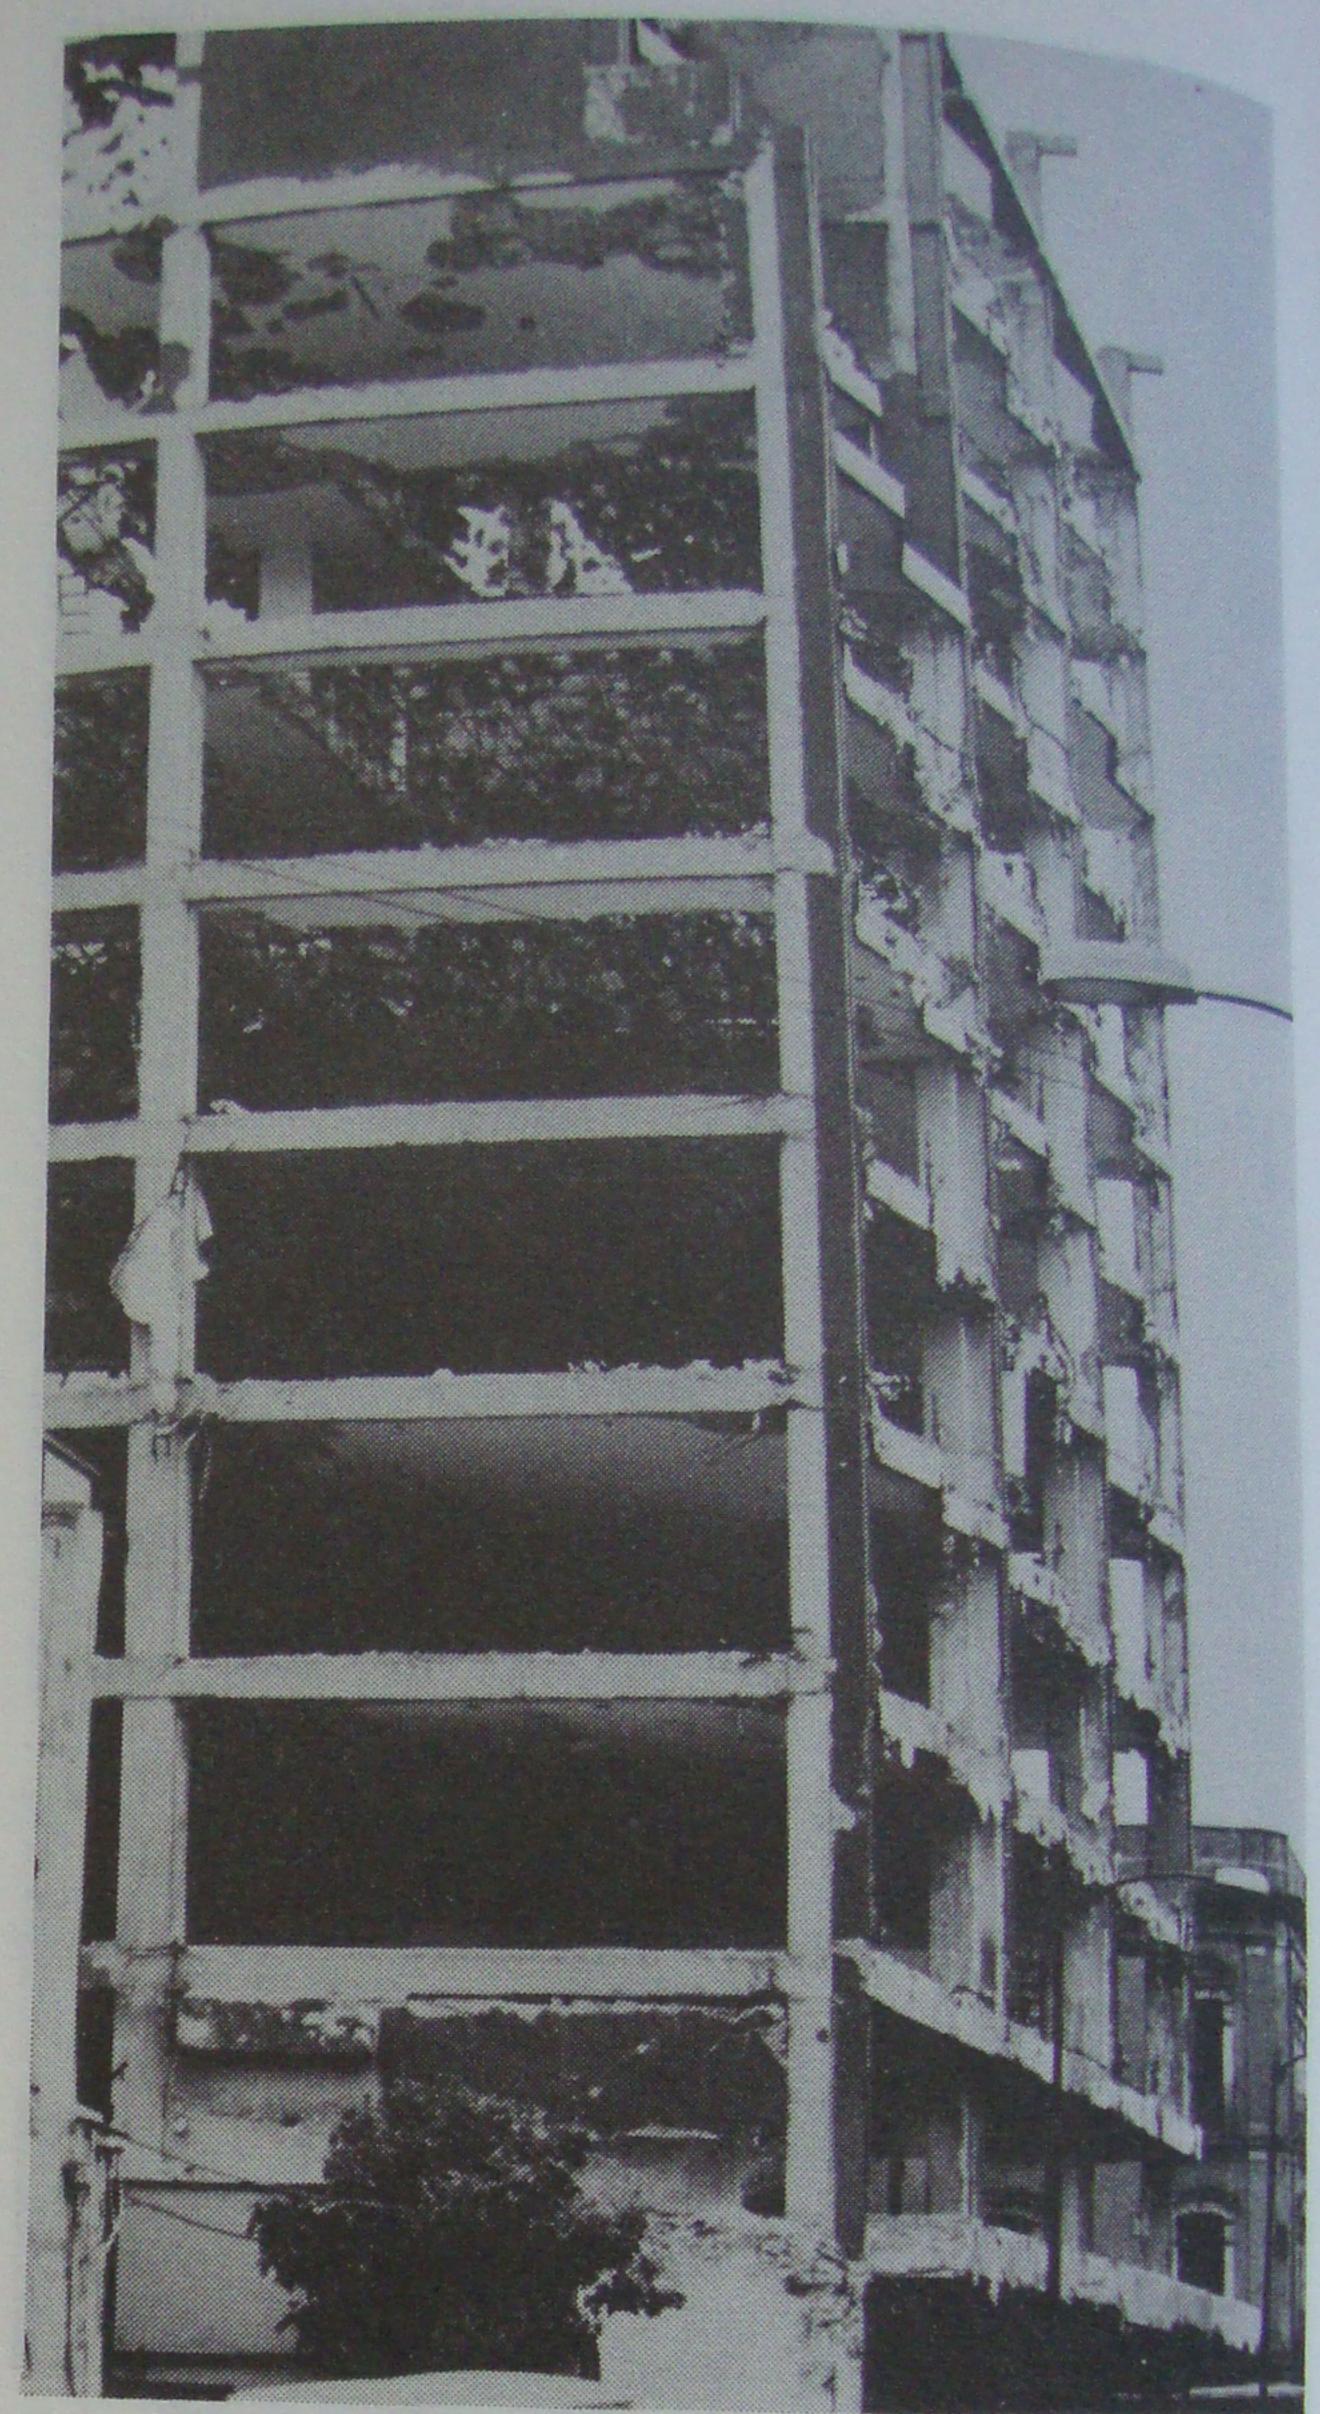
Fig. 48. Ten storey structure with large joint shear distortions.
