### Structural damage due to the 1985 Mexican earthquake

D.Mitchell McGill University, Montreal, Quebec, Canada

ABSTRACT: Characteristics of the 1985 Mexican earthquake and the influence of the subsoil conditions on the strong ground motion in Mexico City are described. Some aspects of structural design practice and examples of structural damage are discussed along with the emergency changes to the building code.

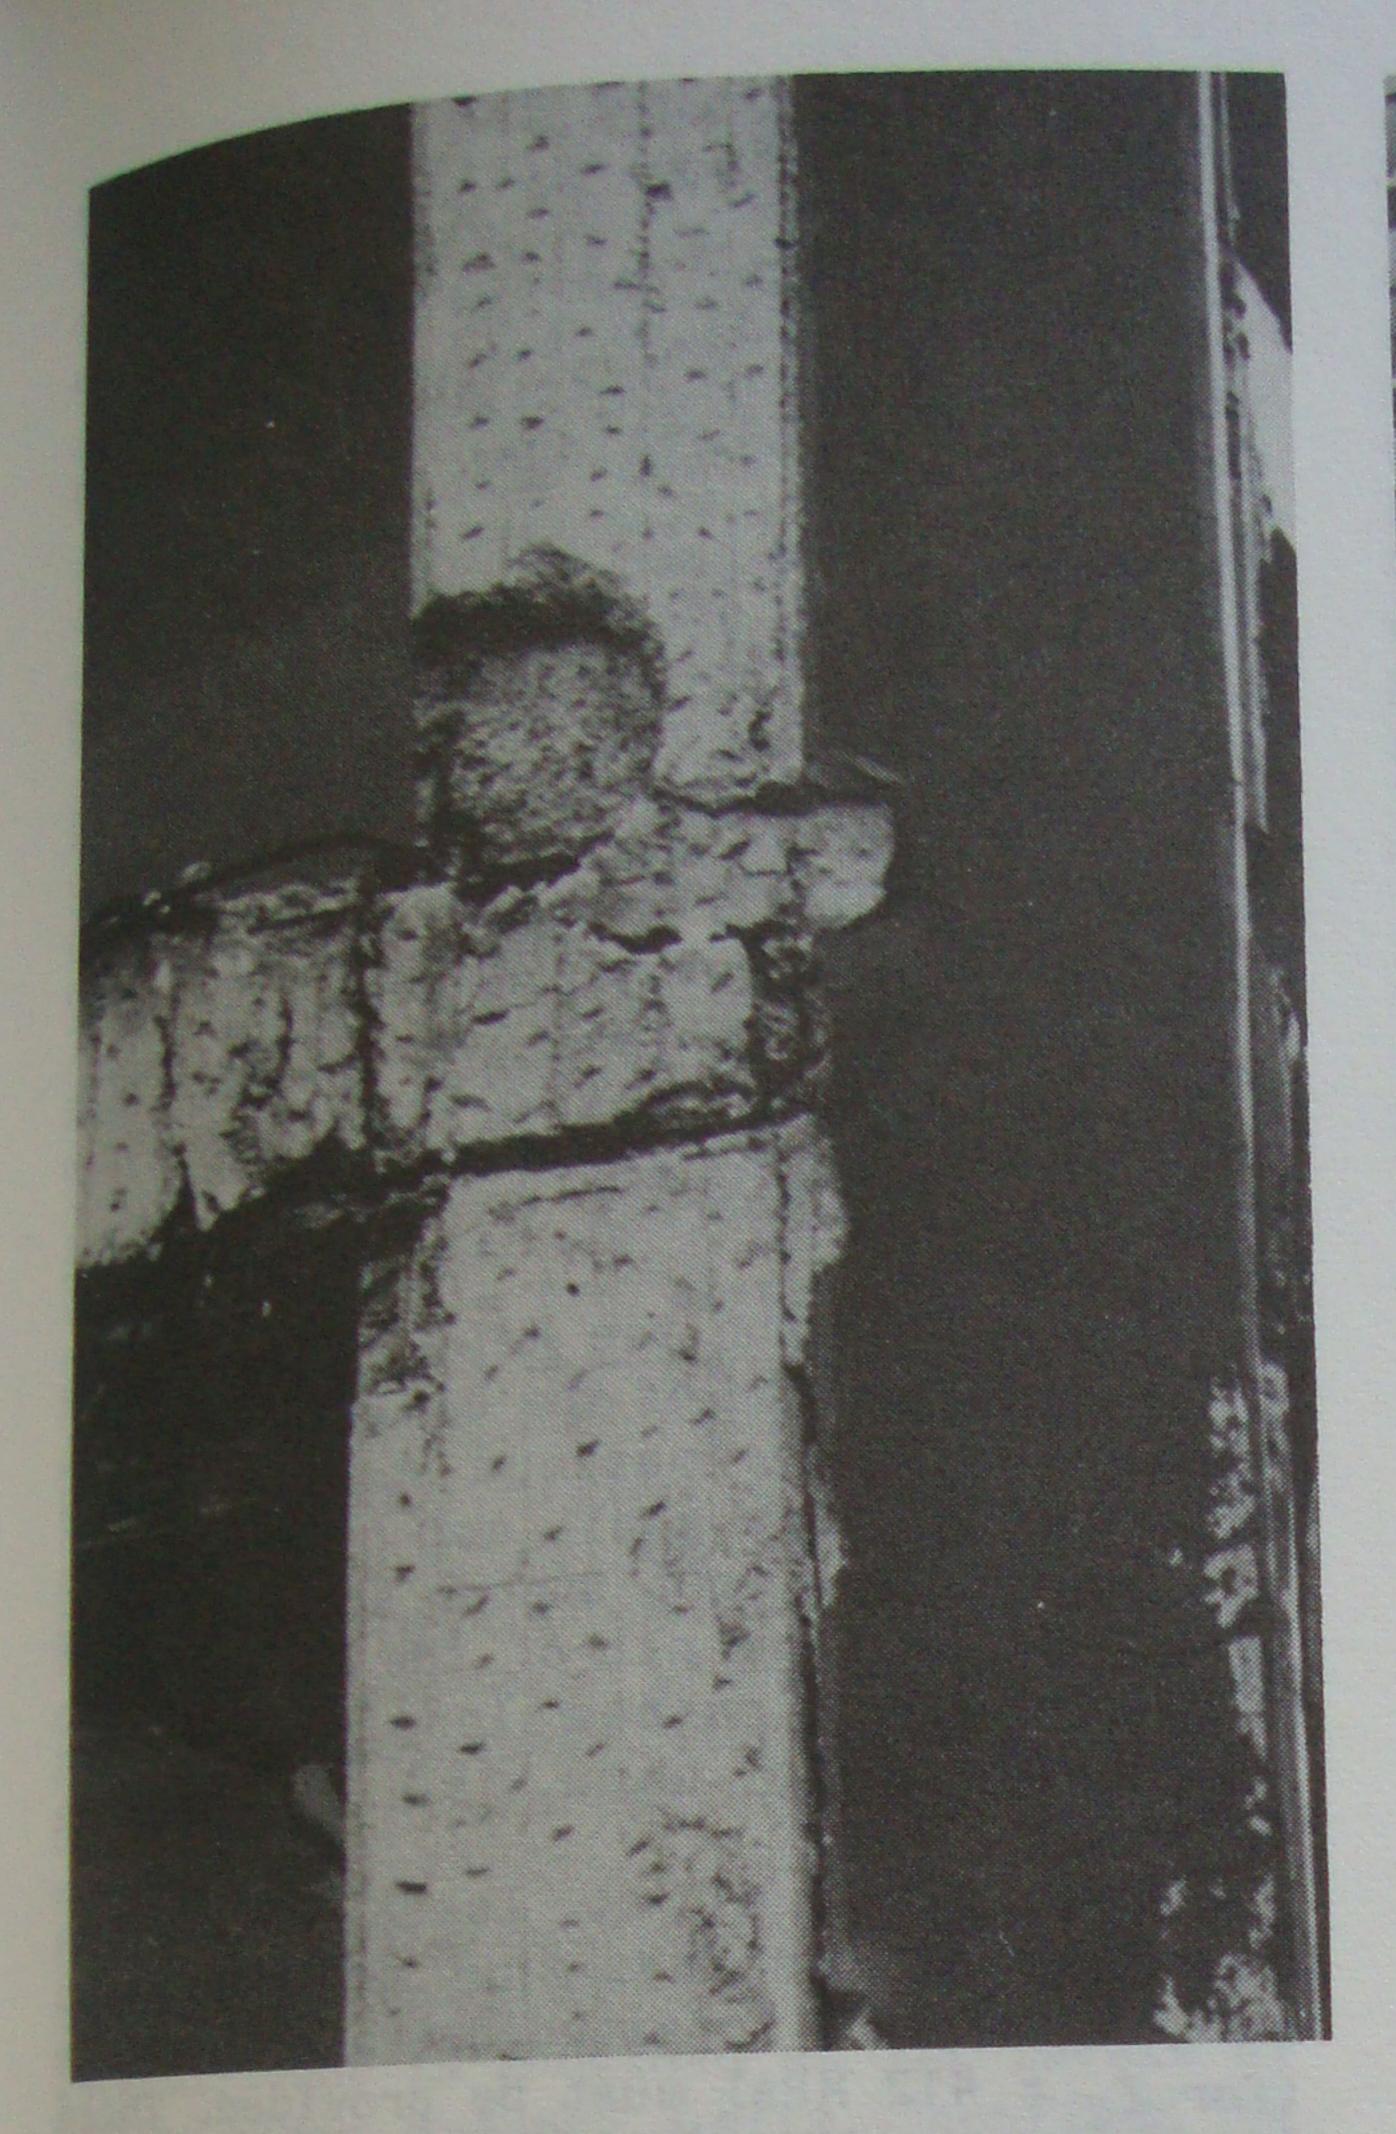
Fig. 49. Close-up of joint distress at corner column.

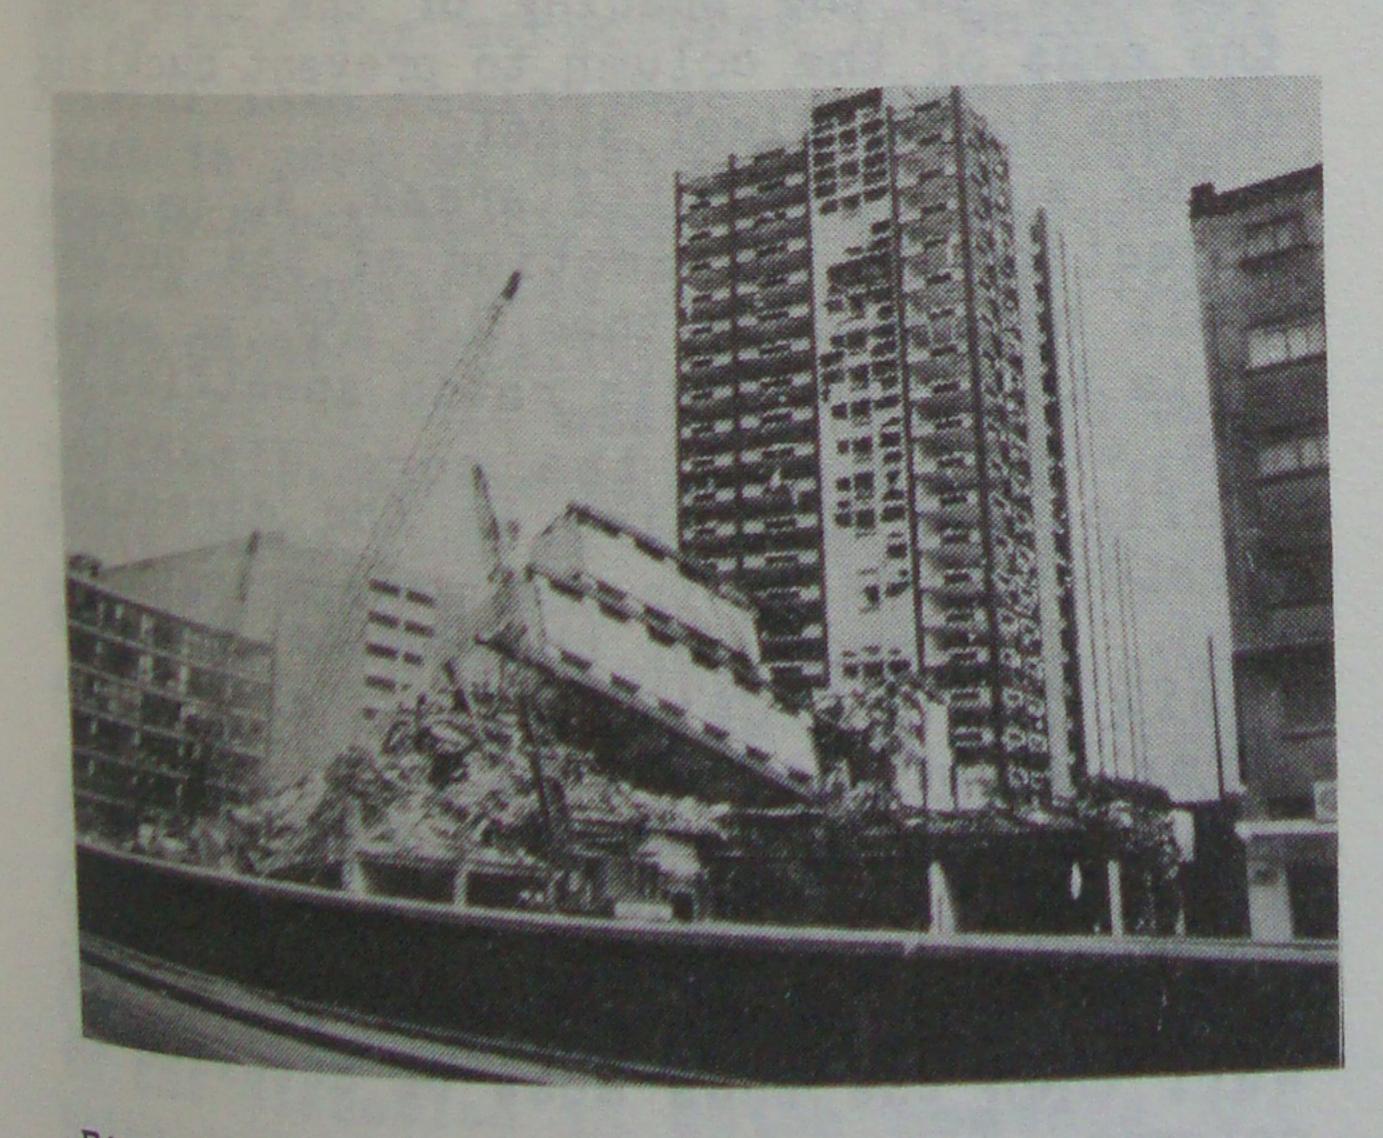
The Pino-Suarez government office complex contained three 21 storey structures and two 14 storey structures. One of the 21 storey office towers collapsed onto the

adjacent 14 storey structure causing it to collapse as shown in Fig. 50. The framing of these structures consists of built-up tubular steel columns, tubular steel trusses and K-bracing as shown in Fig. 51. Figure 52 shows a buckled corner column of one of the 21 storey structures that is still standing. The tubular columns were fabricated from 4-20 mm thick steel plates which had fillet welds at the corners to form a 400 mm x 600 mm box section. A close-up view of one of the buckled corner columns (see Fig. 53) reveals the local buckling of the plates and the failure of the welds. This structure was severely damaged with a permanent displacement at the top, in one direction, of 1200 mm. In addition permanent torsional deformations of the structure were evident.

Fig. 50. Collapse of the 21 storey Pino-Suarez steel structure (Mitchell et al. 1986a&b).

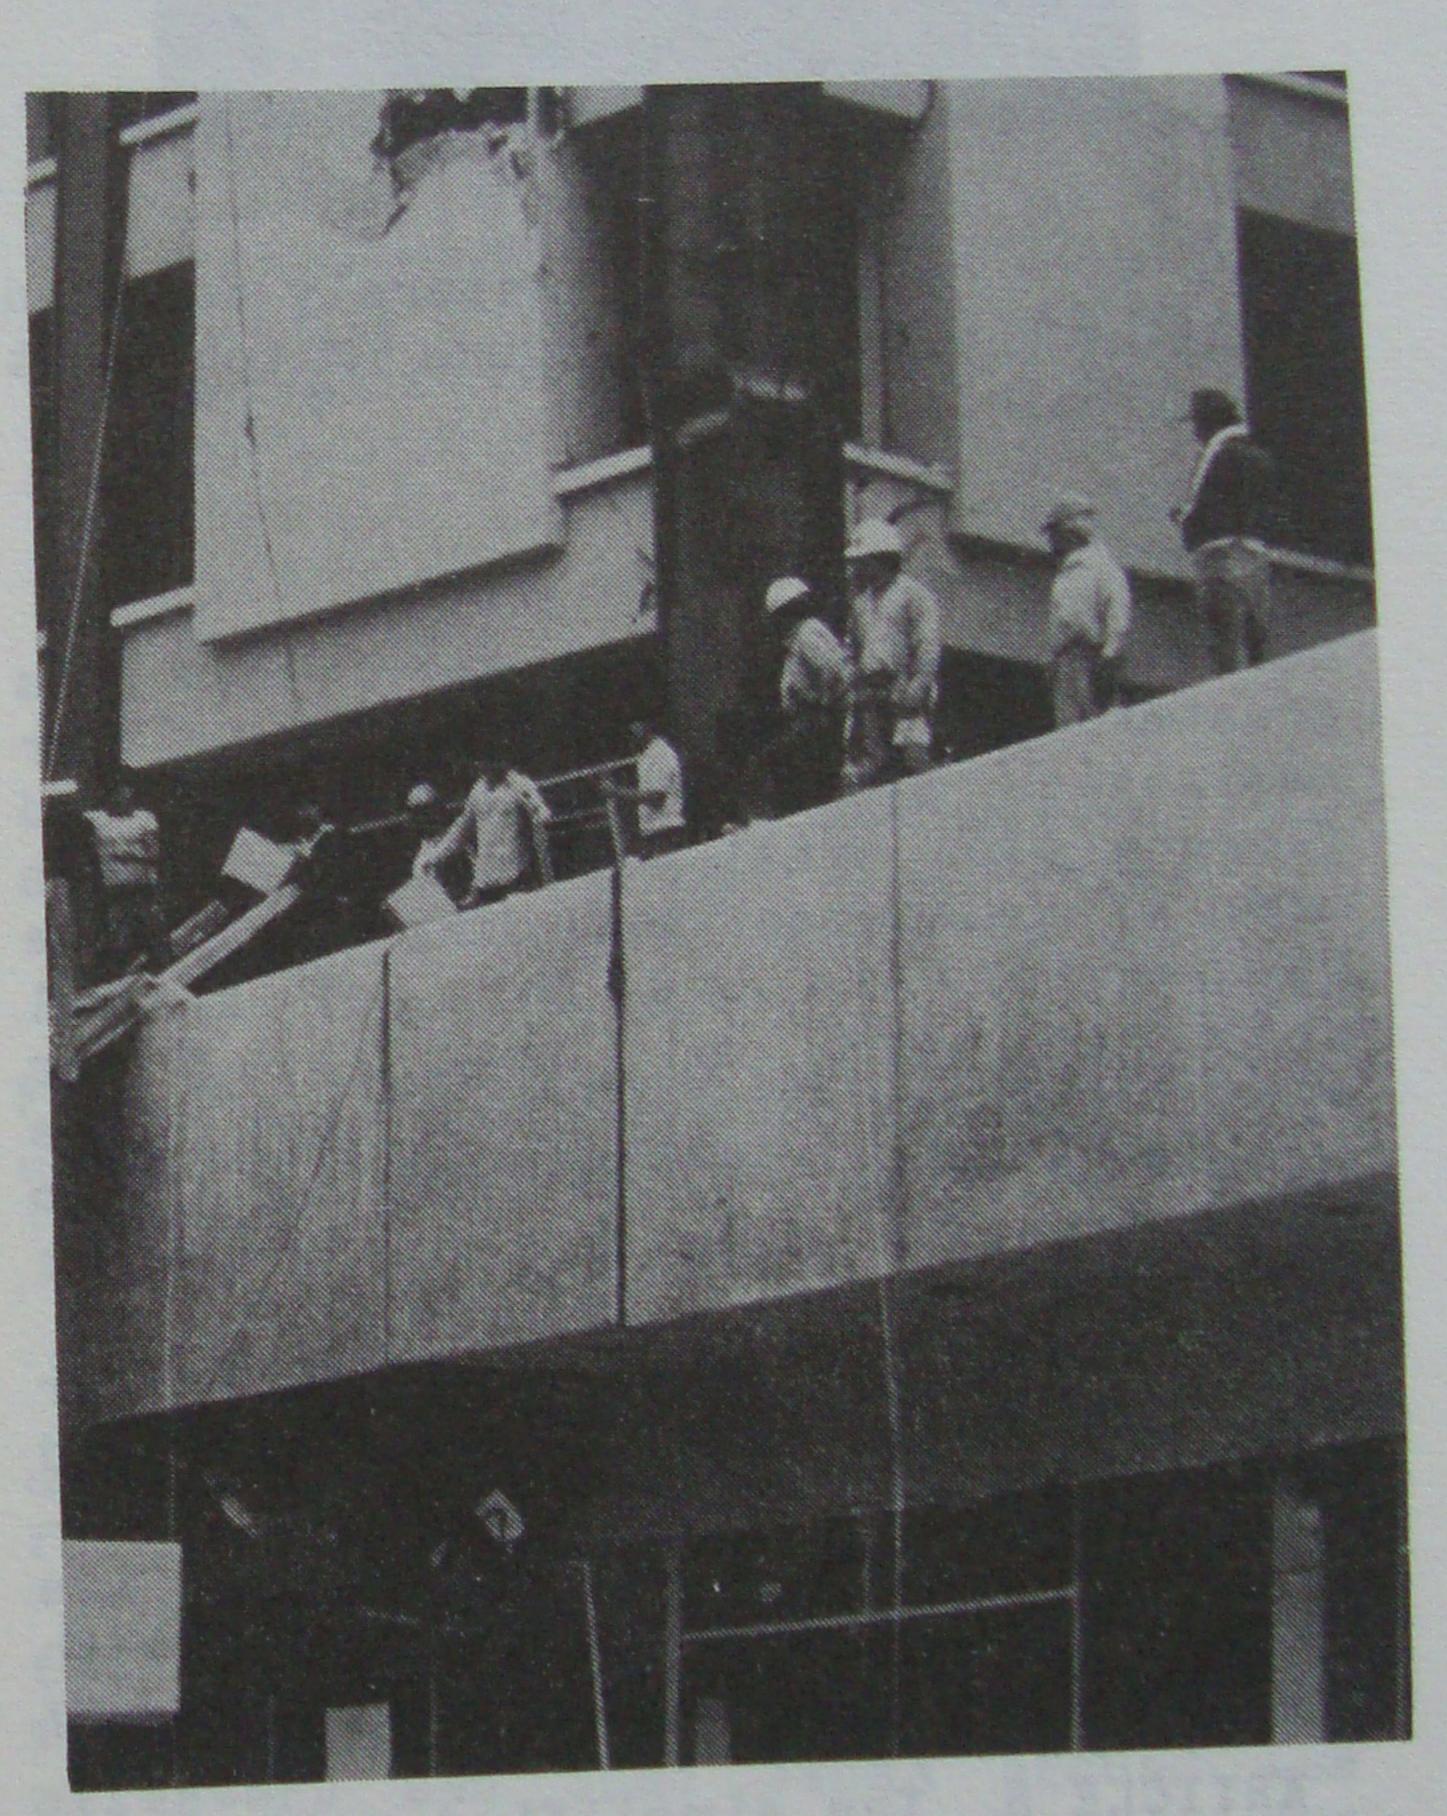
Fig. 52. Buckled column at second storey level of 21 storey structure.

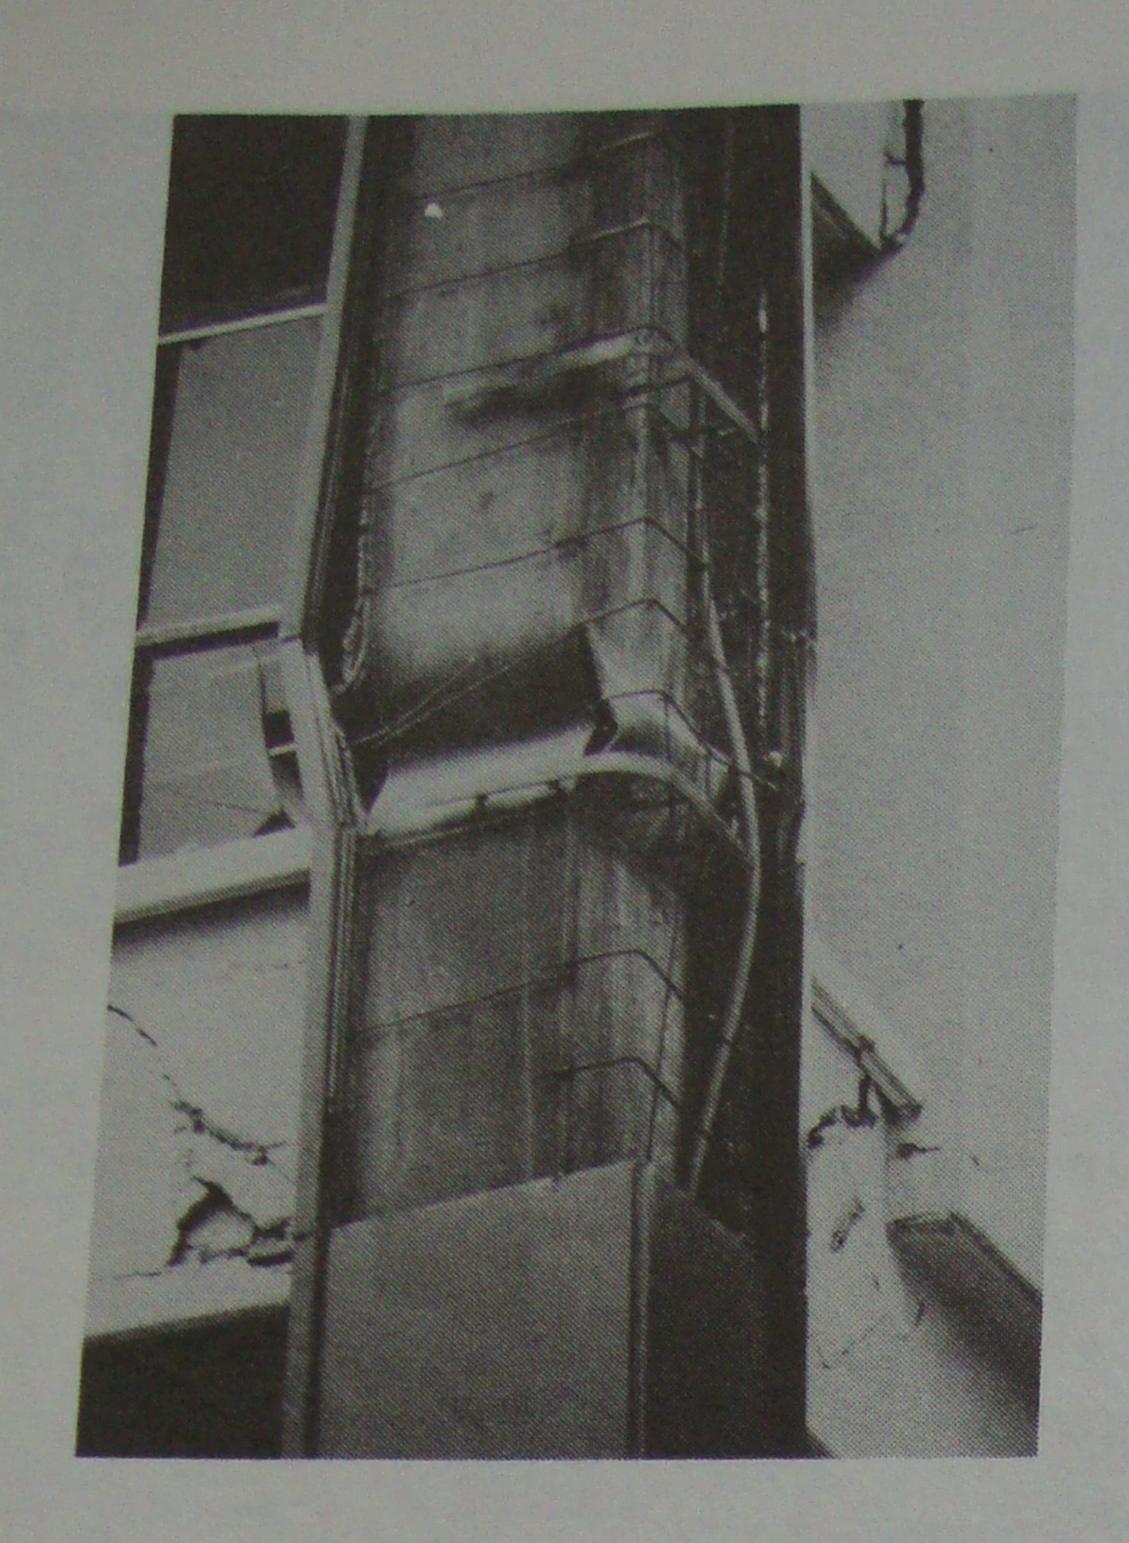
Fig. 53. Close-up of severely damaged built-up tubular steel column (Mitchell et al. 1986a&b).
