The Effect of Lateral Spreading on the Landing Road Bridge in the 1987 Edgecumbe, New Zealand Earthquake

J.B. Berrill¹ and S.A. Christensen²

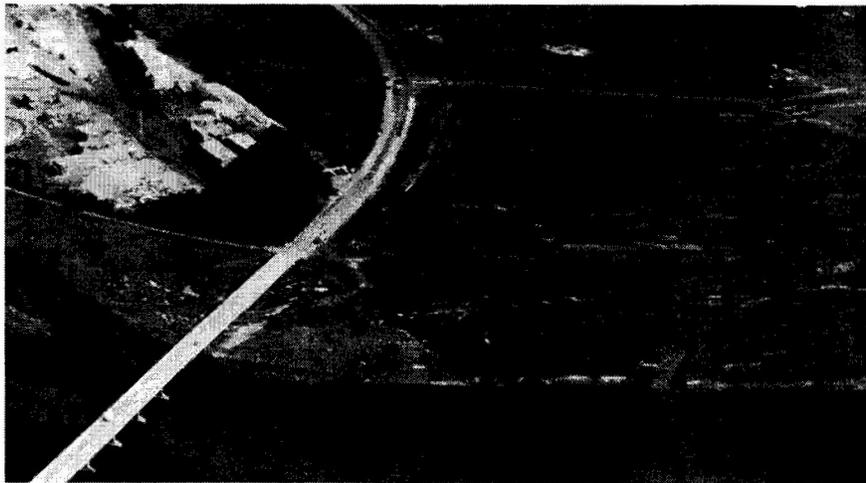
Extensive liquefaction, marked by lateral spreading and ejection of sand, occurred around the bridge and for a few hundred metres downstream on the northern (true left) bank of the river. Cracks associated with the lateral spreading show clearly in Figure 4. The cracks tended to be parallel to the river channel except immediately beside the bridge where they swung around to approximately 45° to the bridge centreline. Near the bridge, there were about five major crack sequences (Figure 5) which were in excess of 200 mm wide in a strip extending back about 300 m wide from the true left bank of the river. There was no observed evidence of liquefaction on the true right bank of the river. Particle size distributions of 13 samples of ejecta taken from upstream and downstream beside the bridge had D_{50} 's ranging from 0.2 to 0.5 mm. Some of the ejecta contained pumice particles, while others did not. The stopbank, seen in Figure 4 running through the bridge abutment, had longitudinal cracks which were in excess of 100 m in length in places. Intensive cracking and subsidence of the north-west road embankment ran from the bridge abutment to past the intersection of SH2 with Keepa Road. An eye witness states that this approach was passable immediately after the main earthquake, but one hour later it was no longer passable in a vehicle, suggesting that lateral spreading, here at least, took place under static conditions in persistently liquefied soil, after the shaking had stopped. Gaps between piers and soil of up to 600 mm appeared on the river side of the piers on the berm of the left bank of the river; on the landward side, soil piled up behind the piers.

Figure 4. Aerial view looking towards the north-west of the Landing Road Bridge site. The Landing Road Bridge can be seen in the left foreground. Ground cracking can be seen on the berm beside the bridge and in the fields beside State Highway 2.

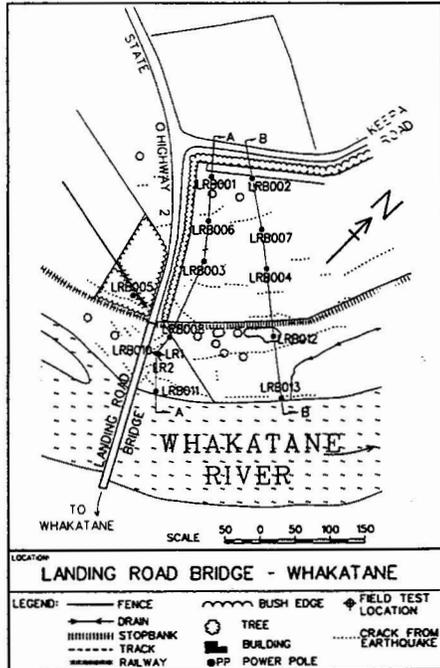
Figure 5. Map of the Landing Road Bridge site showing lateral spreading cracks and the location of *in situ* tests and cross section ties.

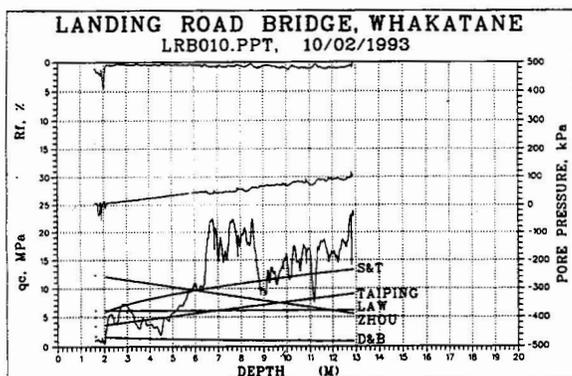
In 1993, five cone penetration tests (CPT) and eight piezocone (CPTU) probes and two rotary borings were carried out at the locations shown in Figure 5 at the Landing Road Bridge site. The log of piezocone probe LRB010 is shown in Figure 7 overlain with liquefaction criteria from several authors. Clearly these prediction procedures, which for the near-field condition of this site at least are highly inconsistent, are of little help in determining which layer liquefied. Another approach is to compare the particle size distribution (PSD) of ejected soil with that of samples recovered from the borings. However, here this method was not reliable since a precise record was not kept of exactly where samples were taken in 1987. In the event, the most useful evidence came from the comparison of grain sizes in a close up photograph of a three-layered sand boil taken in 1987 near pier C with samples retrieved from a rotary boring at the same location. This established that the loose clean sand strata shown shaded in Figure 8, with q_c up to about 8 MPa, liquefied in the earthquake.

Figure 7. LRB010.PPT graph for 2 March 1987 Edgecumbe Earthquake.

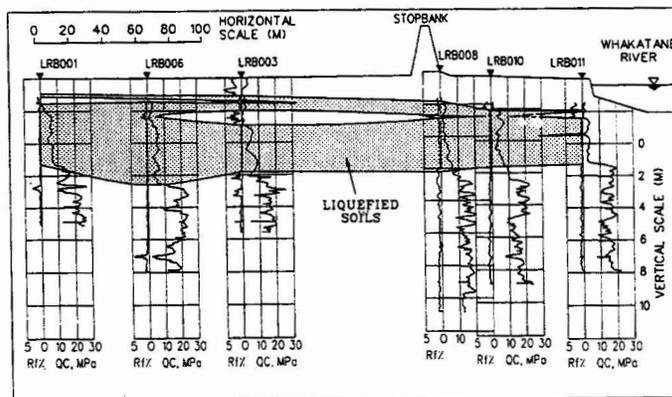
Figure 8. Cross Section AA at Landing Road Bridge showing the estimated liquefied strata. Cross Section BB is generally similar, with the loose sand layer slightly thicker.
