Starbucks Center Renovation

Lundeen, Terry R.¹

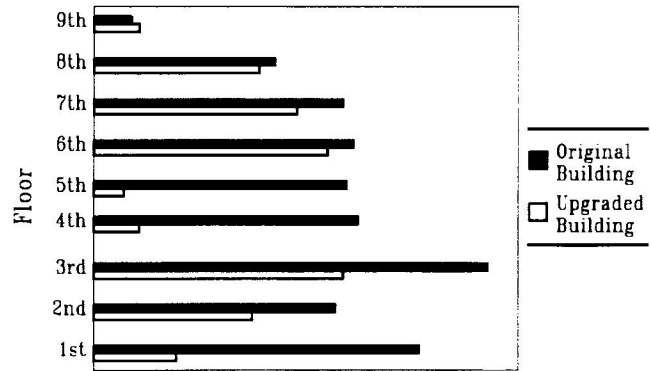
Figure 4: Column Shear

- The strength of the existing columns in the braced frames was checked for axial tension and compression. This check in the response spectrum analysis was somewhat academic because the ultimate capacity was later verified in the nonlinear, pushover analysis. The remaining columns were checked for flexure, and elastic demands were found to be 15% to 25% of capacity. Finally, ultimate shear demand was found to be less than 50% of the column's capacity in all cases. Shear stress in a typical column is shown in Figure 4.

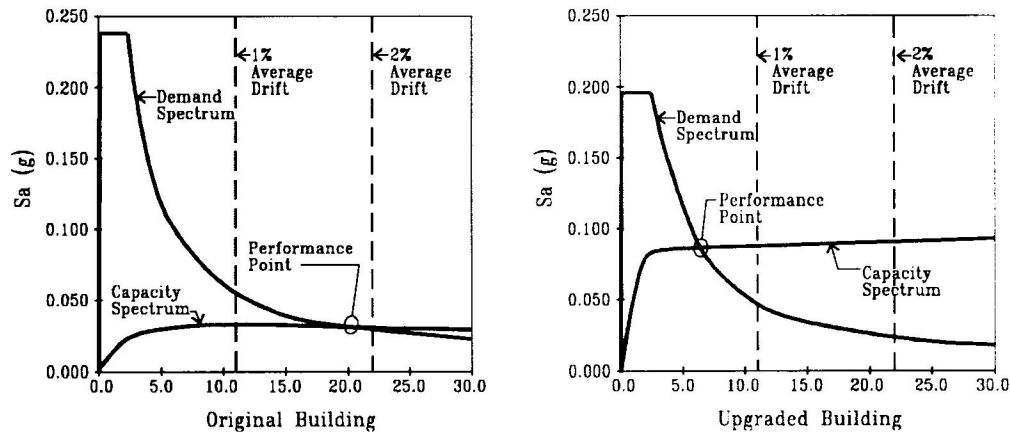
Figure 5: Pushover Results

The results of the analysis indicated that all of the objectives had been satisfied. The demand-capacity curves for the original and upgraded structures are provided in Figure 5. As can be seen, the upgrade increased the structure's strength by a factor of approximately 3.

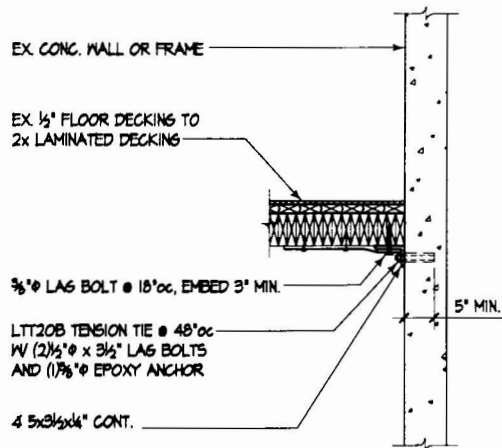
Figure 8: Floor-to-Wall Tie

The lateral force resisting system of this building consists of perimeter reinforced concrete wall frames and laminated timber floor diaphragms. Using a FEMA-178 approach with 500 year seismic ground motions, the main system (wall frames and floor diaphragms) had adequate capacity. The interconnection of the elements, however, was deficient both for in-plane shear transfer and for out-of-plane wall anchorage. Finally, there were life-safety concerns with interior clay tile partitions.

The seismic upgrade consisted of the addition of out-of-plane wall anchors from the floor and roof diaphragms to the exterior walls. Options were given for adding the wall anchors from either above or below the diaphragm level to the joists or to blocking perpendicular to the joists. Additionally, in-plane shear transfers consisting of 3x3x18ga angles were added (see Figure 8). The contractor chose to alternate the installations from above and below each floor as to minimize the number of floors and spaces in which work needed to be completed. Additionally, all interior clay tile partitions were removed.
