Seismic Upgrade Techniques For Concrete Reservoirs

John Sherstobitoff¹ and Svetlana Nikolic-Brzev²

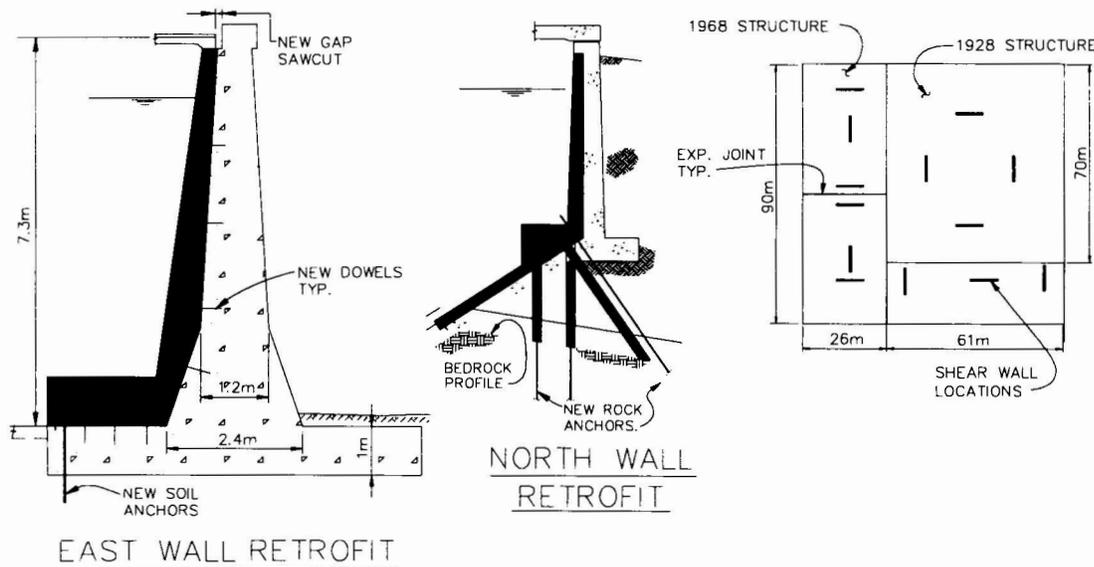
Figure 2. Vancouver Heights reservoir plan indicating new shear walls locations and retrofit of the existing walls.

The seismic evaluation of the 1928 portion indicated a number of critical structural deficiencies, such as: i) no bottom reinforcing in the roof slab at column locations, ii) roof slab connected only to the east wall, thus creating high torsional eccentricity, iii) columns of a limited flexural capacity and nominal ductility performance, iv) a deteriorated roof slab with limited shear capacity, v) a water retaining east wall grossly under reinforced, with potential for catastrophic failure at MCE loading, and vi) north wall with poor foundation conditions and inadequate flexural reinforcing. The 1968 portion was significantly better, with deficiencies similar to iii) above, and with short perimeter columns (high relative stiffness compared to the interior columns), attracting a significant load without adequate capacity or ductility.

The 1928 structure has no expansion joints within its plan area and was structurally connected to a full height water retaining cantilever east wall. The ground sloped steeply away from the buried north wall. The 1968 expansion increased the plan area with 3 new structurally

The pattern of shear walls is illustrated in Figure 2. The shear walls were designed as ductile structures with an R value of 3.5 (per NBCC 1995), with height/length aspect ratio in the range of 1.5. The walls were located to optimize the limited roof slab diaphragm capacity. To collect/distribute the shear to the roof slab, concrete “drag struts” were provided complete with adhesive anchors doweled to the underside of the slab. To achieve adequate sliding and overturning resistance in the foundations, 12 m long #18 soil anchors were used tensioned to 700 kN.

The east wall was retrofitted with a new heavily reinforced layer of concrete on the interior face, doweled to the existing concrete (see Fig. 2). The interior portion of the footing was thickened and 12 m long post-tensioned anchors similar to those used in the shear walls were provided to increase sliding resistance, reduce footing toe pressures, and enhance the overturning capacity. The north wall was retrofitted in a similar manner, using soil anchors as tension-compression piles founded on bedrock to provide complete vertical and lateral support (see Fig. 2).

Analysis of the upgraded roof structure indicated that deformations (including soil anchor flexibility, dynamic soil deformation, inelastic shear wall deformation) were reduced to a level to ensure elastic response of the existing roof structure during a design earthquake event. The damage for the OBE x 1.5 event is expected to be limited to local cracking/yielding at the shear wall bases and local slab damage around the shear wall drag struts, thus meeting criteria for an EQ-2 event. The damage state for the walls for the MCE is expected to be limited to extensive cracking and possibly local yielding at the base of the walls, thus meeting criteria for an EQ-3 event.

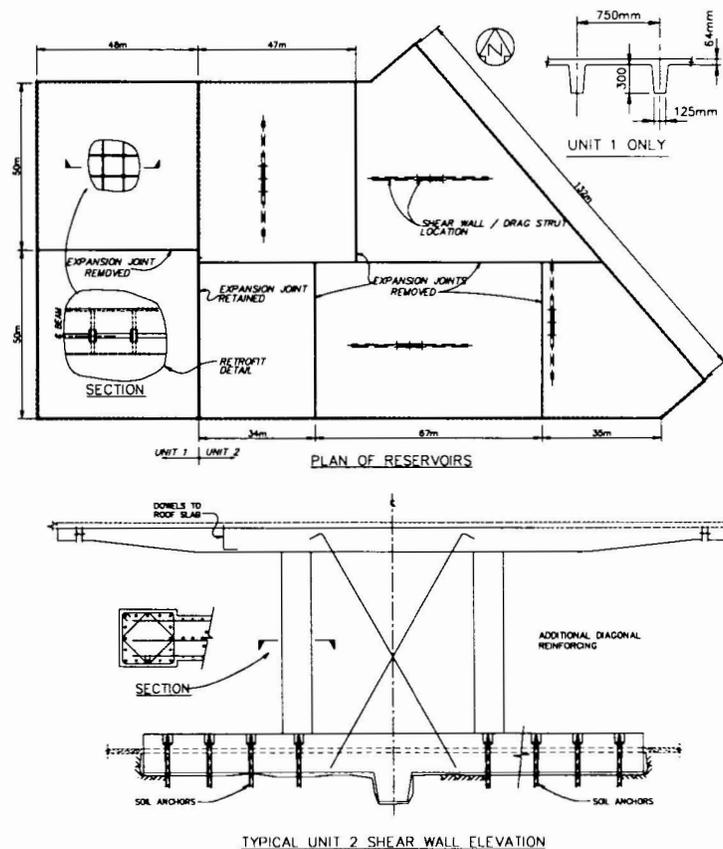
Figure 3. Kersland reservoir plan and shear wall elevation, including typical details.

The 1955 roof structure (Unit 1) consisted of a one-way slab system with one expansion joint within its plan area, as shown in Figure 3. The 1959 expansion (Unit 2) followed the typical flat slab construction practice and consisted of 5 structurally independent roof sections. The ground slopes away from the buried south walls, similar to the north wall of the Vancouver Heights Reservoir. In this case, however, housing is remote from the south walls and a sudden release of water from the south walls was not considered to be catastrophic and the criteria related to an EQ-3 event were not deemed appropriate in this case.

The seismic evaluation of the 1955 portion indicated the following deficiencies: i) roof joists and beams with inadequate flexural capacity to act as a moment frame, ii) columns with inadequate flexural capacity, iii) south wall with inadequate flexural reinforcing. In addition to the above listed deficiencies ii) and iii), the 1959 portion had no bottom reinforcing steel in the roof slab at the column locations.

The moment frame option was assessed for the 1959 roof structure but proved to be uneconomical. The selected shear wall option was essentially the same as used for the Vancouver Heights Reservoir but with the following differences: i) all 5 roof slab segments were connected together to create one large roof diaphragm; this was feasible due to the better condition of the slab, and significantly higher levels of in-plane reinforcing, ii) each of the four shear walls were

designed to sustain significantly higher loads with an aspect ratio of approximately 0.95; to ensure a flexural failure mode and to prevent shear failure, diagonal shear reinforcement was provided.

The walls in the 1955 section were adequate for an OBE ($I = 1.2$) level, similar to the capacity of the retrofitted roof structure, and as such no further reinforcing was added. A 2 m high section of the south wall in the 1959 portion, which was thickened to augment the deficient flexural capacity at mid height. The new vertical reinforcing was not connected to the existing footing, as this would have increased the overstrength moment capacity of the wall to a point where the footing capacity and bearing capacity would have been deficient.

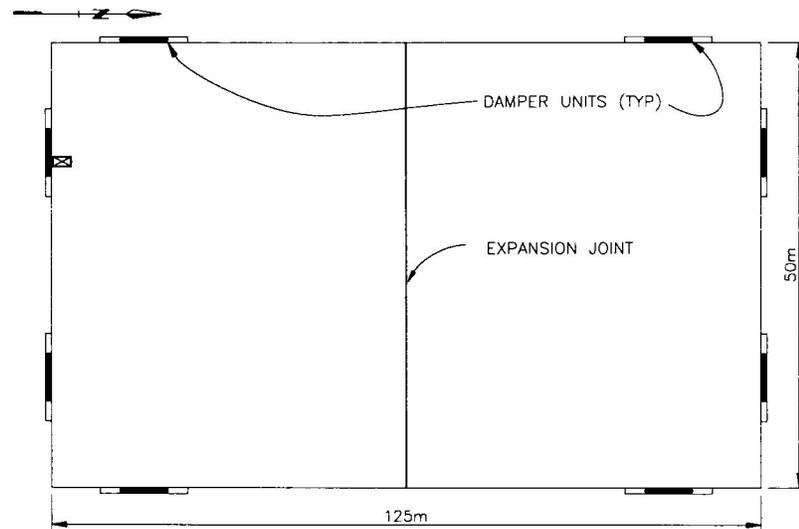
Figure 4. Central Park reservoir plan including damper locations

The roof structure has one expansion joint within its plan area, as illustrated in Figure 4. The critical deficiencies in the roof structure were as follows: i) discontinuous bottom slab reinforcement at the column locations, ii) lack of shear reinforcement at a critical slab perimeter around the columns, iii) inadequate lateral confinement of the column reinforcement, and iv) inadequate rebar development length at the column-to-slab connections.

Several seismic upgrade options were evaluated, similar to those outlined in the previous sections. An alternative, less conventional option - incorporating seismic dampers - was ultimately selected because of lower construction costs and a considerably reduced construction schedule as

compared to the other options. The damper option was estimated to be 12% less costly than the least cost shear wall option. Also, the majority of construction work can be carried out exterior of the reservoir, leaving the reservoir operational. Details of the damper retrofit scheme are discussed by Nikolic-Brzev and Sherstobitoff (1999).

The roof structure was retrofitted by connecting the two halves at the expansion joint to create one roof diaphragm, and connecting the perimeter of the slab via dampers to the perimeter walls. Four dampers on each side, in pairs of two, were aligned parallel to the walls. Both friction and viscous dampers were evaluated, and both were able to provide adequate damping and energy dissipation to limit the deformation of the existing roof structure to an acceptable level (approximately 30 mm to maintain elastic behaviour). Long steel plates with adhesive anchors distributed the damper loads to the roof slab, and a new concrete beam, doweled to the existing wall distribute loads to the walls.
