Seismic Response Analysis of Water Supply Pipe Network During the 1995 Hyogoken Nambu Earthquake

Miyajima, Masakatsu¹ and Kitaura, Masaru²

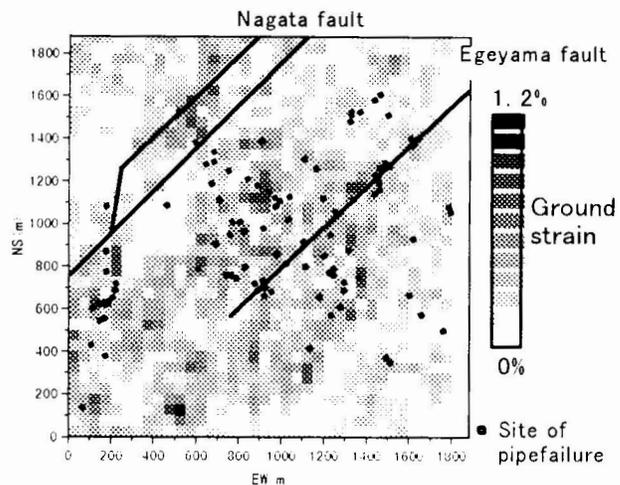
Fig. 4 Distribution of principal ground strain in Egeyama area.

The permanent ground displacement at fault topographical lands were estimated with the aid of aerial photographs before and after the earthquake at Egeyama area in Kobe city by Takada (1997). The principal ground strains were evaluated by using the permanent ground displacements in each 50m mesh. Fig. 4 shows the principal ground strains, location of active faults and sites of pipe failures. According to this figure, large ground strains appeared close to the active faults.

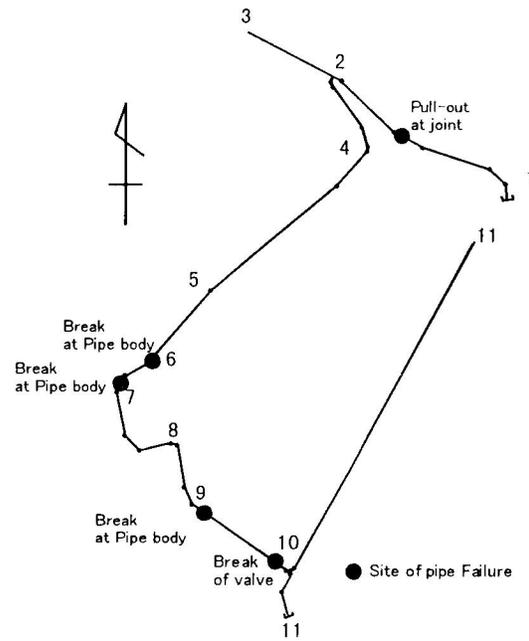
Fig. 5 Rough sketch of pipeline analyzed in Egeyama area.

A part of the water supply pipelines constructed in Egeyama area was analyzed employing the method presented above. A rough sketch of pipelines analyzed here is displayed in Fig. 5. The sites of pipe failure are also shown in this figure. The type of pipes was ductile cast iron and their diameters were 100 mm and 150 mm. The response of the pipelines corresponded to point 6 to point 10 shown in Fig. 5 was investigated in this chapter. The length of pipelines was about 234 m. Fig. 6 illustrates ground displacements along the pipelines. These were interpolated from the measured

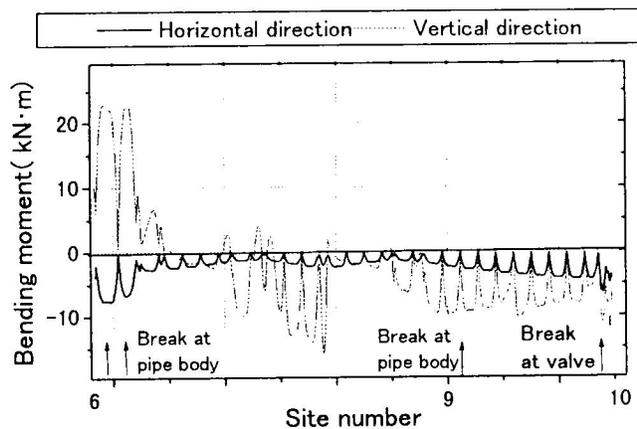
Fig. 7 Bending moment of pipeline in Egeyama area.

Fig. 7 illustrates the bending moment of the pipeline that corresponded to point 6 to point 10 in Fig. 5. This figure indicates that the bending moment decreased at each joint. The sites where pipe failures occurred are also illustrated in this figure. Three breaks at the pipe body and one break at the valve occurred. Although the bending moment in this section was under the allowable value, that is, 30 kN m, the bending moment near point 6 is large. The failure of pipe seems to be induced by large bending moment. Fig. 8 shows the joint displacement divided by the allowable value. According to this figure, the ratio of joint displacement to the allowable value is under 1.0. This coincides with no pull-out of pipe at joint. The results of analysis have agreement with the actual behavior of pipelines in this case.

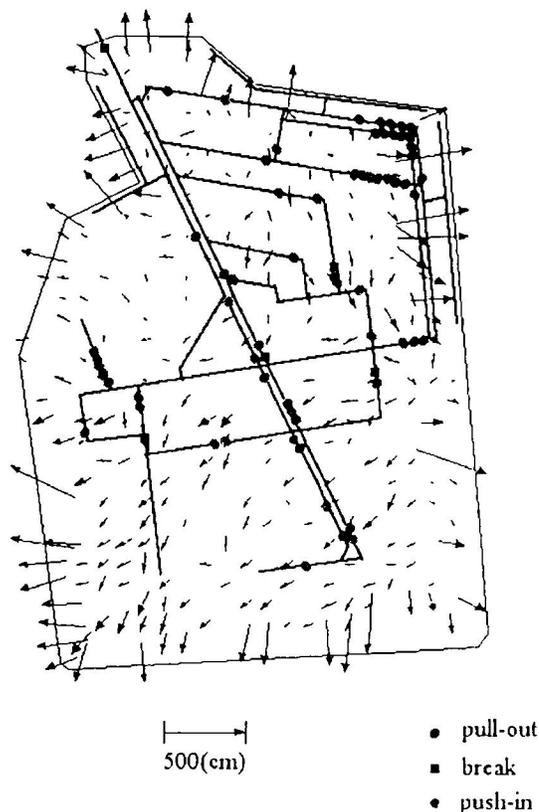
Fig. 9 Site of pipe failures and permanent ground displacement in Fukaehama.

The permanent ground displacement induced by liquefied ground flow were measured from aerial photographs before and after the earthquake in Kobe city by Hamada et al. (1995). Fig. 9 displayed the horizontal permanent ground displacement (Hamada et al. 1995) and damage to water supply pipelines (Japan Water Works Association 1996) plotted on the pipeline network in Fukaeahama. The length of arrows in this figure means the magnitude of permanent ground displacement and they were transformed from the actual measured data to cell data of 50 m x 50 m. Great permanent ground displacement occurred near the coastlines. The quay wall line moved toward the sea with a maximum magnitude of about 4 m, and also largely subsided. The principal ground strains were evaluated by using the permanent ground displacements in each 50m mesh. Fig. 10 shows the principal ground strains and sites of pipe failures. According to this figure, pipe failures were occurred at sites where the large ground strains appeared. The ground strains in Fukaeahama were less than those in Egeyama presented shown in Fig. 4.

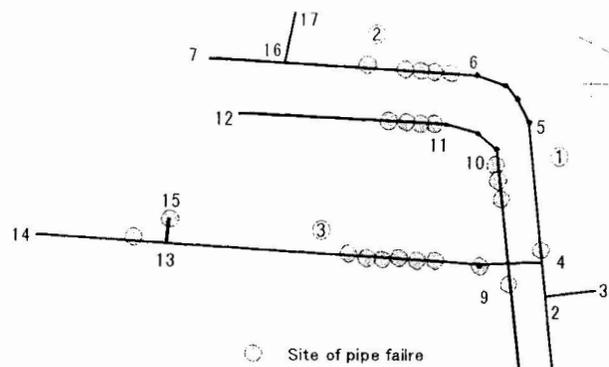
Fig. 11 Rough sketch of pipeline analyzed in Fukaehama.

A part of the water supply pipe network constructed in Fukaeahama, northeast area where the pipe failures were concentrated, was analyzed. A rough sketch of pipelines analyzed here is displayed in Fig. 11. The sites of pipe failure are also shown in this figure. The type of pipes was a ductile cast iron with mechanical joint and their diameters

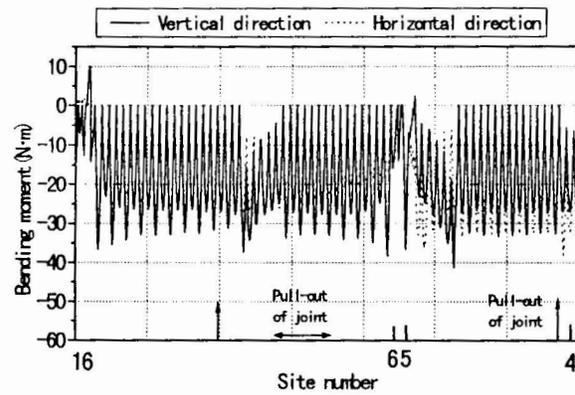
Fig. 13 Bending moment of pipeline in Fukaehama.

Fig. 13 illustrates the bending moment of the pipeline from point 4 to point 16 shown in Fig. 11. The bending moment was smaller than the allowable value. There was no failure of pipe body in these pipelines due to the earthquake according to Fig. 10. Fig. 14 illustrates the joint displacement divided by the allowable value. The sites where pull-out of pipe at joint occurred are also indicated on this figure. There was no damage at the bent part according to Fig. 11. This is because that the joints near the bent part have been strengthened before the earthquake. On the other hand, strengthening of joints at the bent part seems to affect the failure at straight part near the bent part. Fig. 14 suggests that there is a good agreement between the high value of ratio of joint displacement and sites of pull-out of pipe at joint.
