## September 19, 2017 Puebla-Morelos Earthquake in Mexico Reconnaissance Report

The Canadian  
Association  
for Earthquake  
Engineering

## **INTRODUCTION**

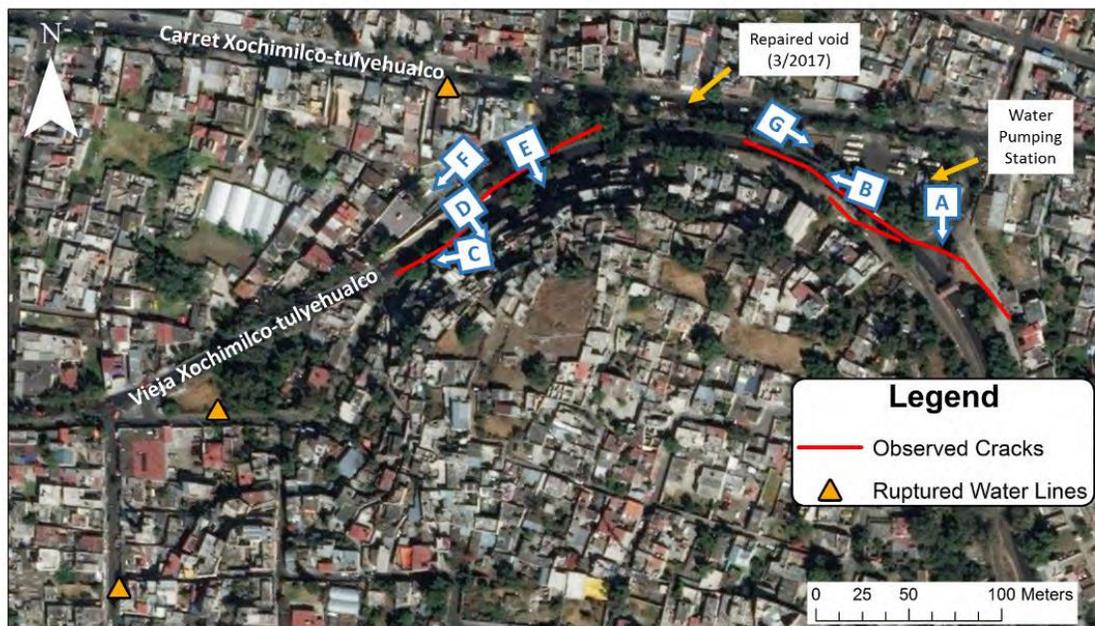
Slope instability was observed at Xochimilco in a residential area located on a hill slope. Anecdotal evidence indicated that the slope had deformed prior to the earthquake probably due to groundwater withdrawal by pumping, and the deformation became more substantial after the quake. Aerial view of the slope instability with marked cracks is shown in Fig. 17 (GEER 2018). The deformed hill slope consists of roads at three levels: the base, 1<sup>st</sup> and 2<sup>nd</sup> level; one drill rig was set at each of the two lower levels as shown in Figs. 18(a) and 18(b). The main crack was along the 1<sup>st</sup> level road, while a shorter crack was on the 2<sup>nd</sup> level road as can be seen in Figs. 19(a) and 20(a). The damaged masonry wall on the 1<sup>st</sup> level road was being repaired at the time of our visit, with new masonry materials transported in and stockpiled on the road, and a short distant end-segment of the deformed wall was shored up by timber struts. Houses on the hill slope above the 2<sup>nd</sup> level road appeared to be in good condition, with minor masonry debris on the road side.

Fig. 17 Aerial view of the Xochimilco slope instability with marked cracks and pipeline breaks  
(GEER 2018)

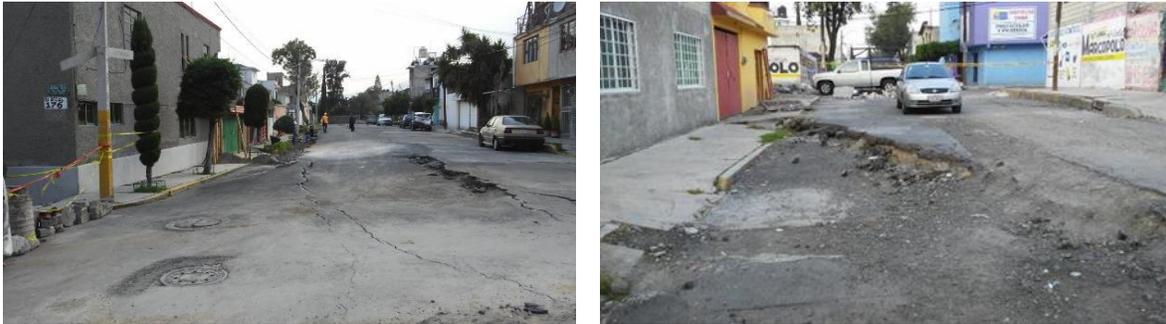
street involving both horizontal and vertical surface deformation. The alignments of settlements/cracks form some patterns on the scale of street-blocks. Buildings in the area showed varying degrees of distress as they accommodated the ongoing development of ground settlement and crack (see Fig. 27). The street level appears to have undergone significant change in front of the building with the Mexican flag. Pipeline and manhole repair and a street intersection are shown in Fig. 28.

Fig. 26 Ground settlements and cracks seemed to follow some patterns at street-block scale

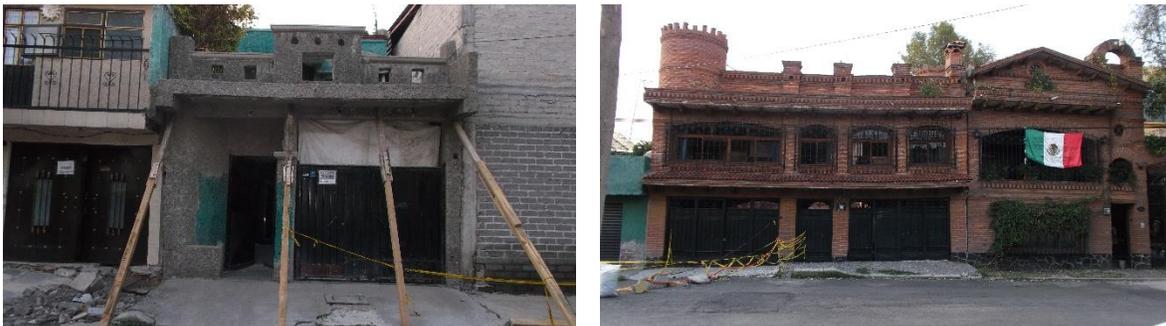
Fig. 27 Buildings showing varying degrees of distress imposed by ongoing ground settlement and crack

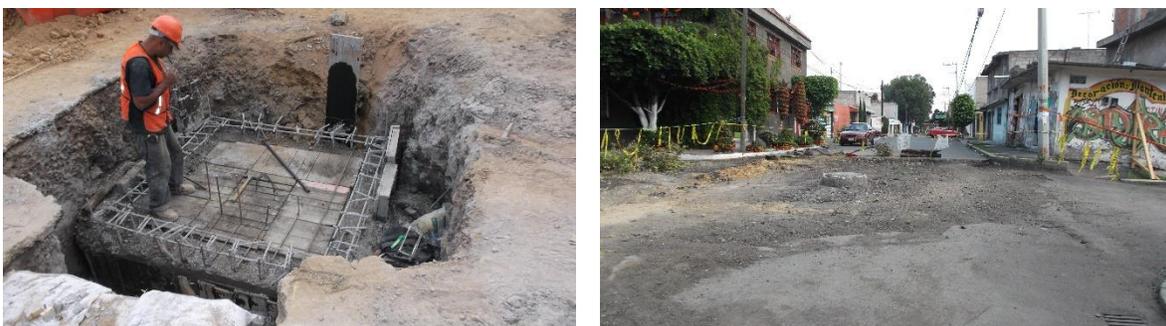
Fig. 28 Pipeline and manhole repair (left) and street scene at an intersection (right)

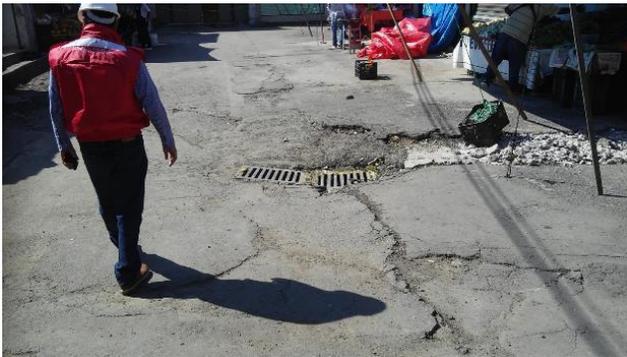
Fig. 30 Cracks in vicinity of a surface drain inlet

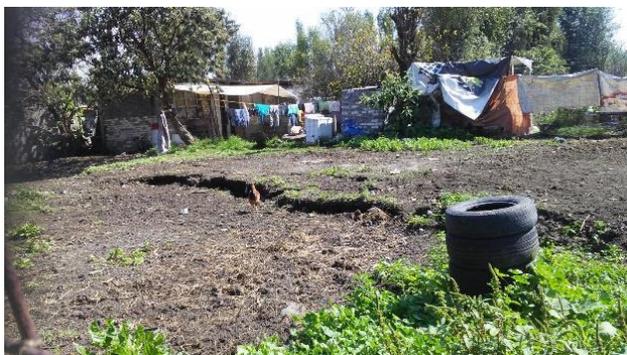
Fig. 31 Cracks through an open field

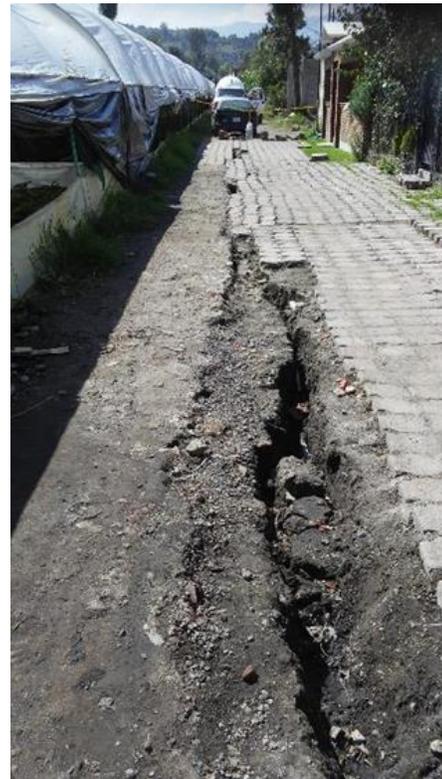
Fig. 32 Cracks through a driveway

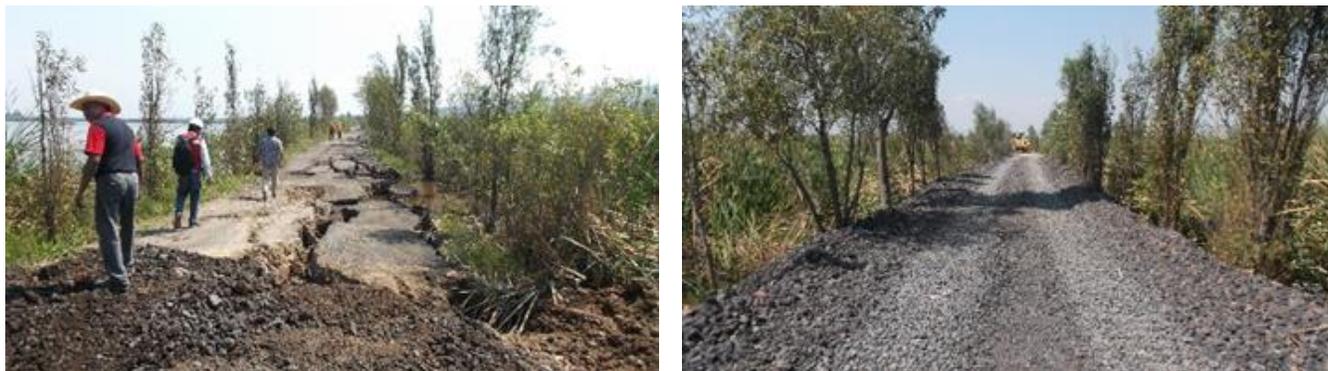
Figure 33 shows a slumped causeway being repaired. The slumped segment underwent lateral spreading failure involving soft lake deposits beneath the granular embankment fill. The repair was carried out by bulldozers and dump trucks using granular fills borrowed from nearby quarries.

(a) Lateral spreading of causeway towards both sides (b) Repair by placing additional embankment fill

Fig. 33 Causeway embankment failure due to lateral spreading

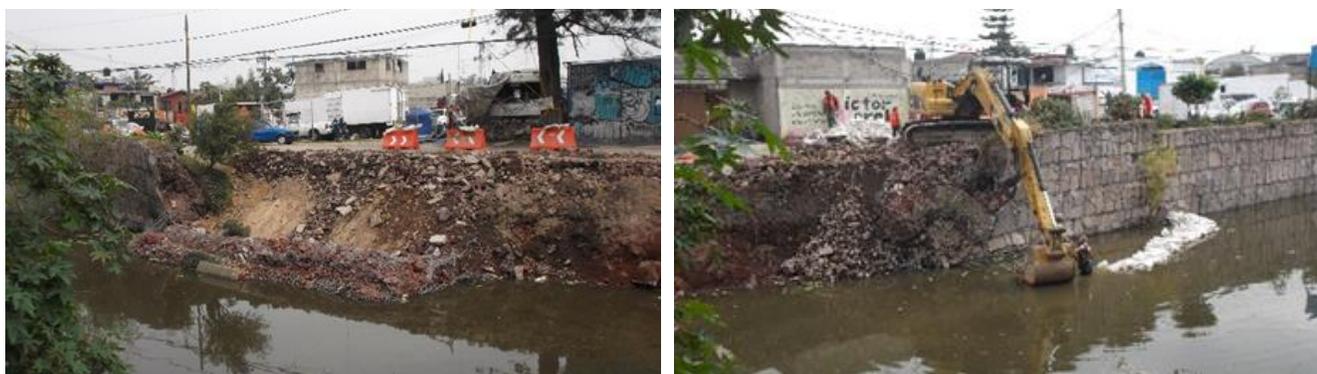
A masonry side wall, covered with a wire mesh, performed well in general with the exception of a local slumped segment shown in Fig. 34. The repair of the slumped segment was in progress. It appeared that a cofferdam (using white sand bags shown both above and below the side wall in the right photo) was being built with a backhoe, probably for purposes of later dewatering during construction of the replacement masonry wall.

(a) End segment of slumped side wall (b) Repair of beginning segment of slumped side wall

Fig. 34 Repair of a slumped masonry canal side wall

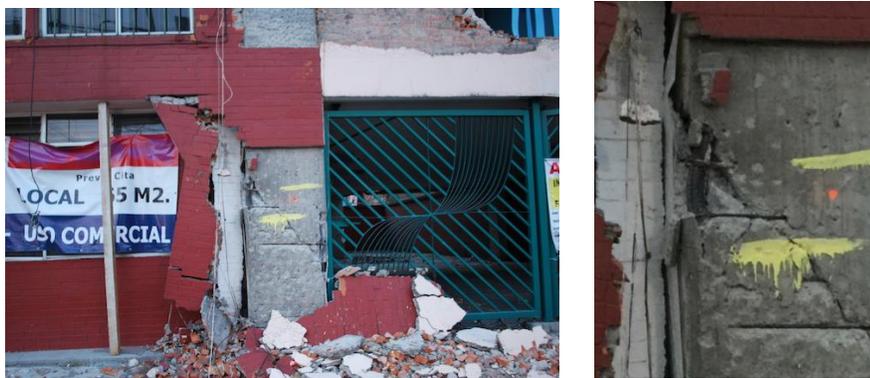
Lack of column transverse reinforcement was evident in older pre-1985 buildings. Figure 39 illustrates diagonal tension failure of one of the first storey columns of a multi-storey reinforced concrete frame building with masonry infill walls located in the Piedad Narvarte district of Mexico City. The figure also illustrates buckling of column longitudinal reinforcement near the previously opened wide diagonal cracks. Similar diagonal tension cracks were observed in other older residential construction. Figures 40(a) and (b) illustrate diagonal cracks in the first storey columns of a frame building with a soft storey. Figure 41(a) illustrates a rectangular column with diagonal shear cracks and Fig. 41(b) shows lack of concrete confinement due to insufficient transverse reinforcement in a residential building, hence resulting in the formation of a plastic hinge at the top. Lack of sufficient transverse column reinforcement could be seen in a number of different buildings as further illustrated in Fig. 42, which shows columns of an office building with insufficient buckling restraining ties and buckling of longitudinal bars in compression. All of these buildings were designed and built prior to the revisions of the seismic detailing requirements after the 1985 Mexico City Earthquake. However, one of the newer 5-storey reinforced concrete residential buildings, designed after 1985, also suffered column damage though the building in general performed well. One of the factors contributing to the column damage in this case was widely spaced column ties, as illustrated in Fig. 43, while the short column effect has also contributed to the increased seismic demand.

Fig. 39 Lack of sufficient column transverse reinforcement for diagonal tension

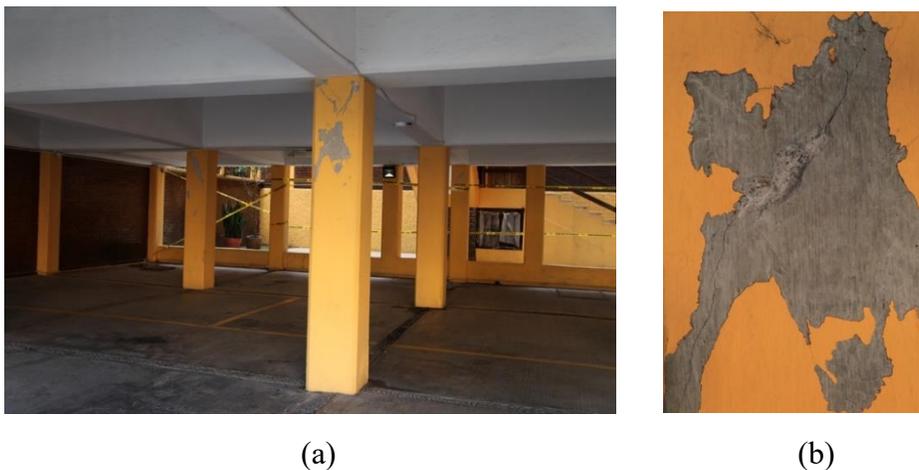
Fig. 40 Lack of transverse column reinforcement (a) diagonal tension cracking caused by increased shear demands in a soft-storey (b) close-up view

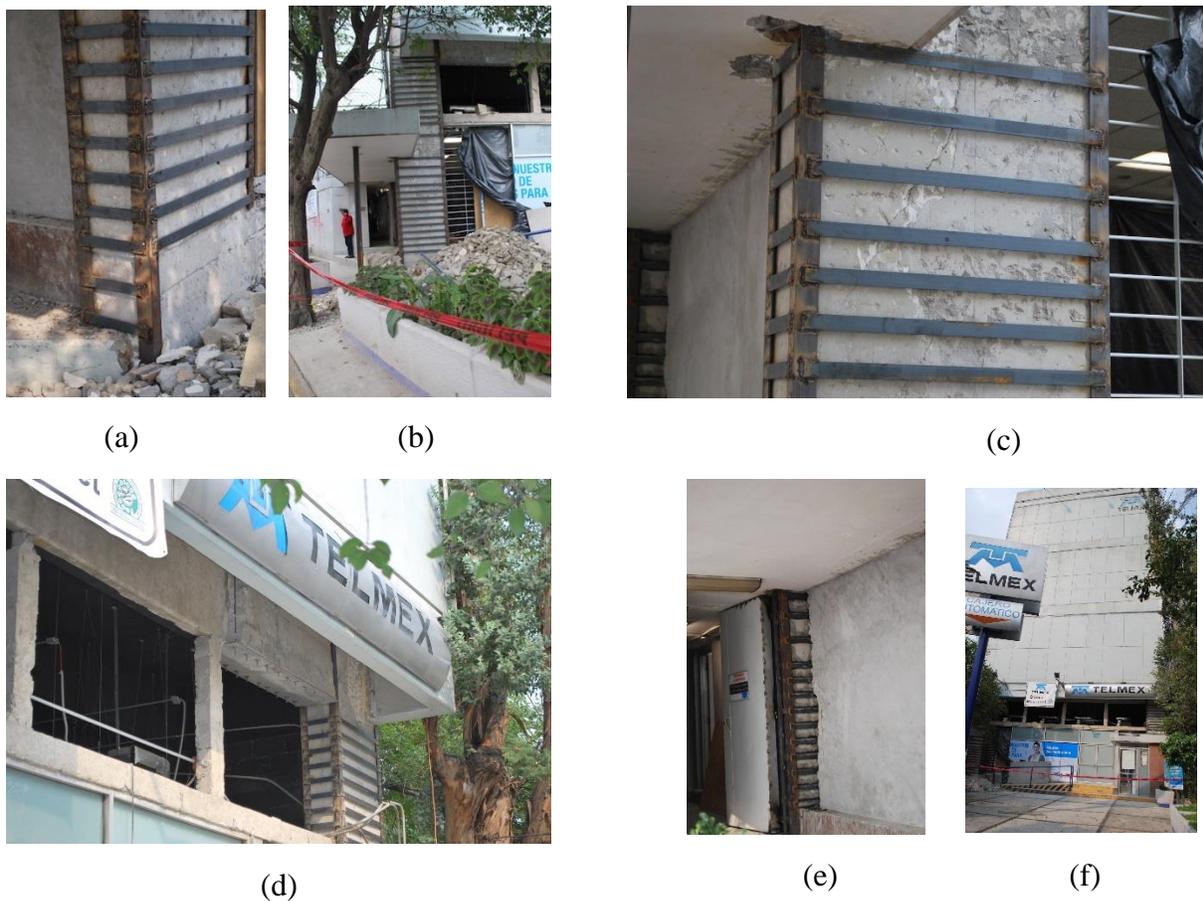
Figure 44 illustrates a typical column strengthening technique used in Mexico City. The figure illustrates retrofitting of Telmex Mexican Telecommunication Company building in Mexico City. The technique consists of steel angles placed longitudinally at each corner of a column, with steel strips welded to each angle in two transverse directions. The figure shows the application of the technique to a column that had already experienced some diagonal shear cracks during the September 19, 2017 Earthquake. It is interesting to note that the building had in-fill concrete panels in the short direction, as shown in Fig. 44(f), and the column shear cracks were associated with shear force reversals in the long direction. The same technique was used in an 8-storey reinforced concrete government building located near the San Antonio Abad subway station. The columns of the building were strengthened as shown in Fig. 45. However, this did not prevent the failure of columns and the collapse of the 4<sup>th</sup> floor in the corner, while many other columns in the building suffered varying degrees of damage. This retrofit technique was believed to have been used to increase shear reinforcement in the columns while also serving as buckling restraining ties. Indeed, the unretrofitted first-storey columns of the same building, shown in Fig. 42 indicate widely spaced small size perimeter and interior ties that were not able to prevent buckling of disproportionately larger longitudinal bars in compression. The same column retrofit technique was used for columns of a pre-1985 condominium in Calle Sonora Esquina Parque district, shown in Fig. 46, which suffered the collapse of a floor at the adjacent building roof level possibly due to the increased shear demands associated with pounding. The column retrofitting was not effective in preventing the collapse of the floor in the building.

Fig. 44 Telmex Telecommunication Company first storey column retrofit after the earthquake

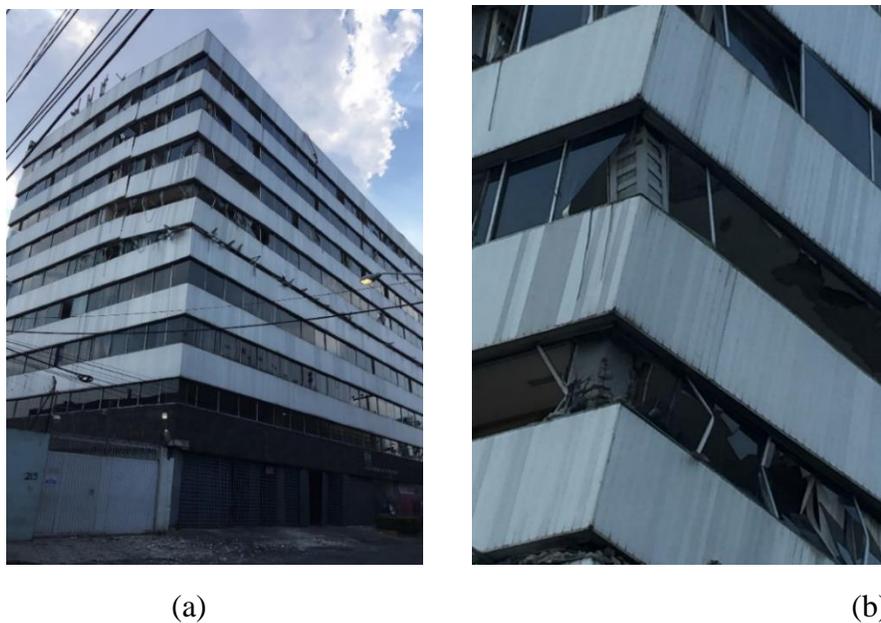
Fig. 45 Failure of the fourth floor of the office building near San Antonio Abad Subway Station in

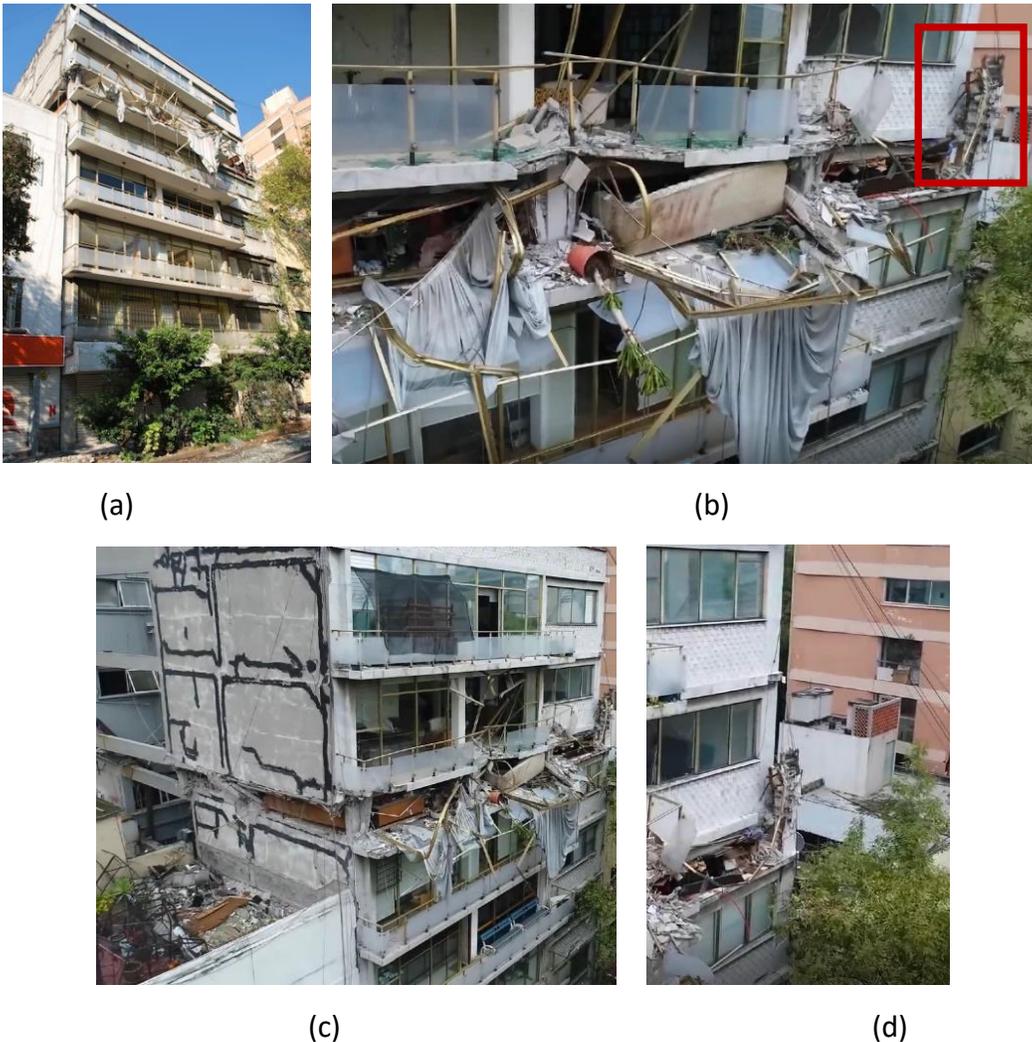
Fig. 46 Pre-1985 condominium in Calle Sonora Esquina Parque district with retrofitted columns that suffered the collapse of a floor at the adjacent building roof level possibly due to increased shear demand associated with pounding.

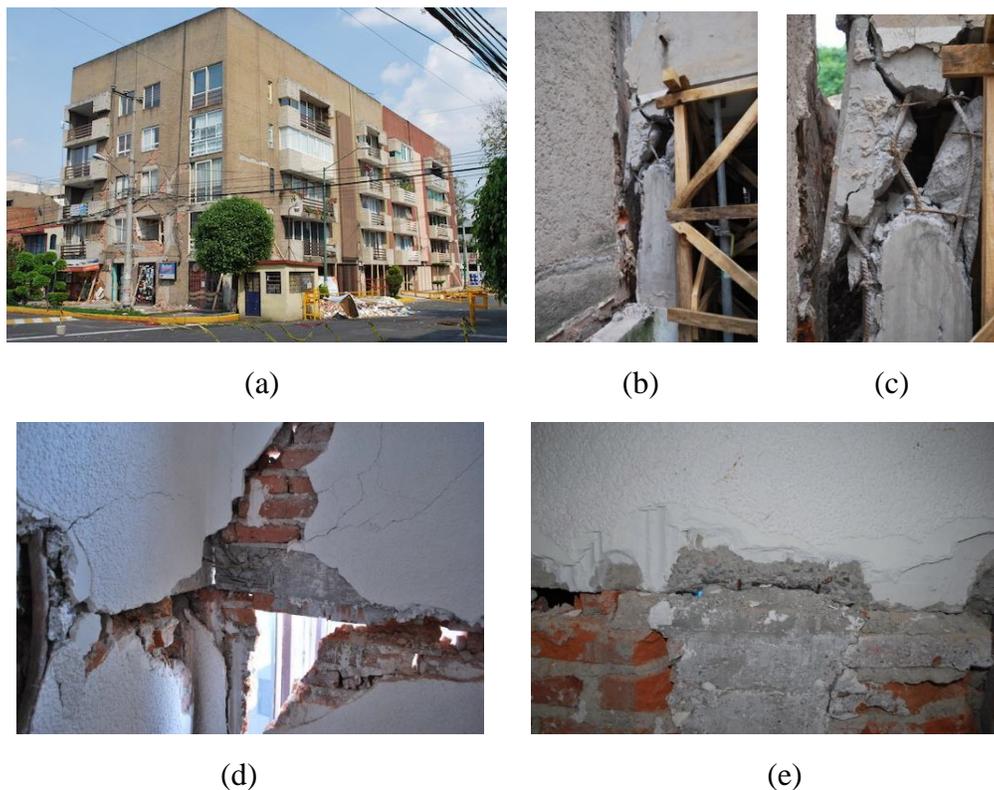
Fig. 52 Pre-1985 confined masonry 5-storey residential building with poor detailing

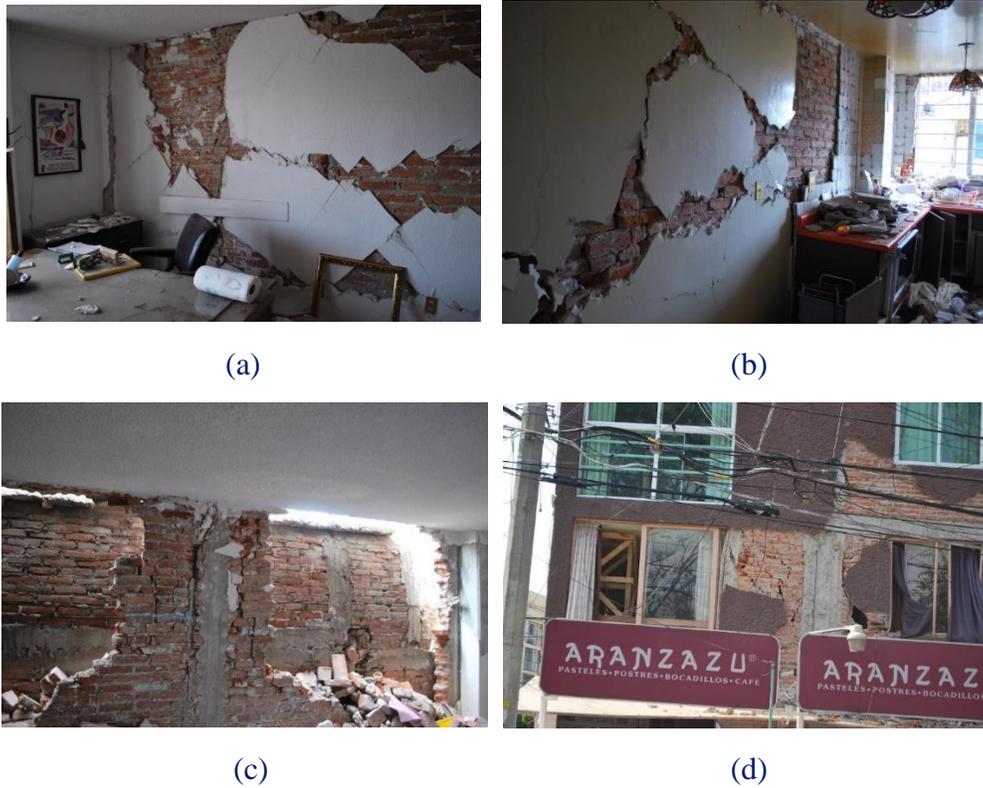
Fig. 53 Damage to brick masonry walls in confined masonry buildings

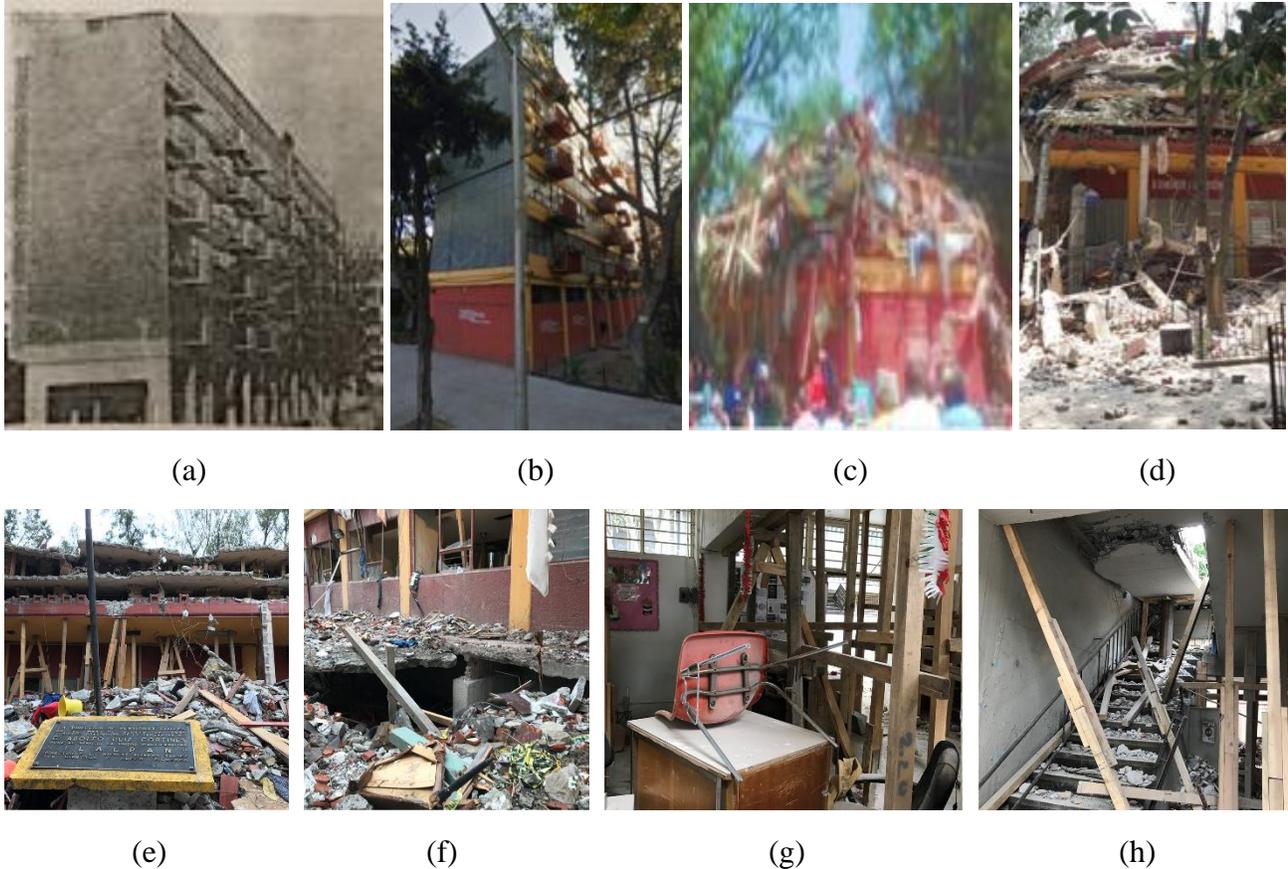
Fig. 55 6-Storey residential building in Tlalpan, Mexico City, (a) original configuration in 1957, (b) before the earthquake after the structural alterations, (c) few minutes after the collapse, (d) view of the longitudinal elevation after the earthquake.

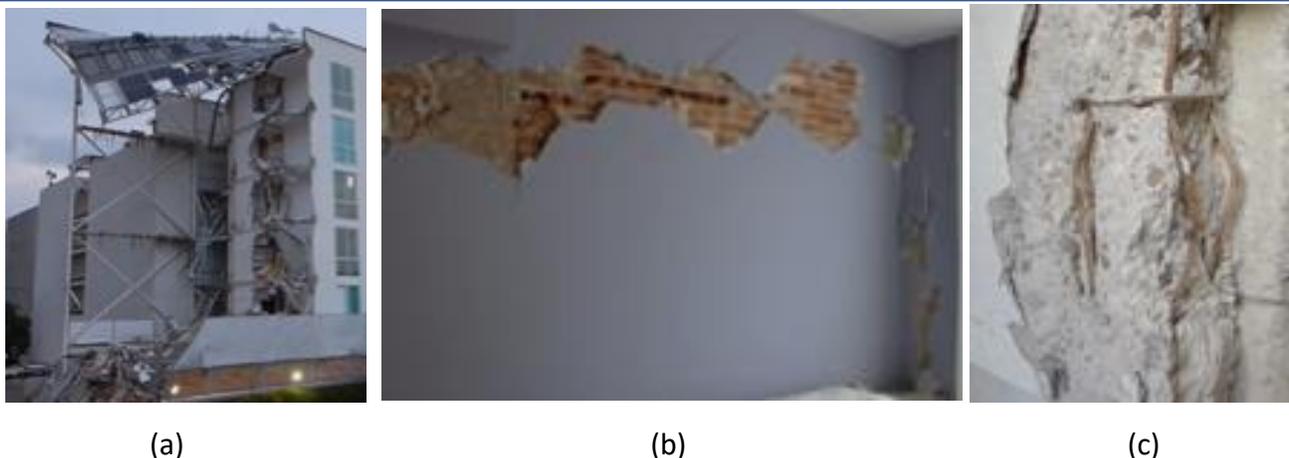
Fig. 56 Confined masonry apartment building built in 2016 (Zapata St., Coyoacan, Mexico City, (a) partial collapse of the building, (b) wide spacing of tie columns, (c) wide spacing of column ties and buckling of longitudinal reinforcement.

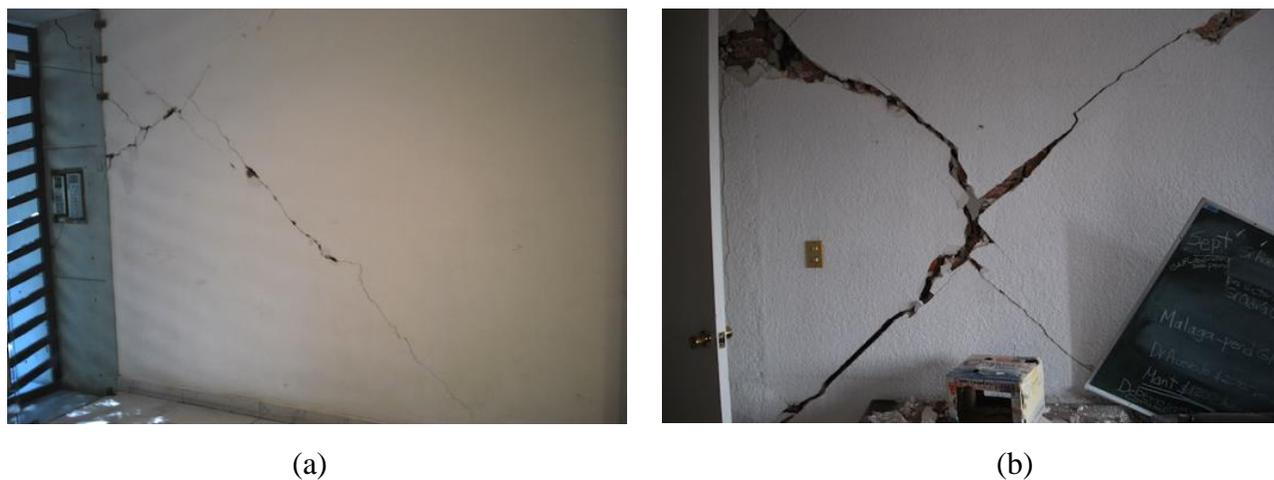
Fig. 58 Diagonal tension cracks in infill brick masonry walls of two reinforced concrete frame buildings in Cuauhtemoc, Mexico City, (a) wall in a post-1985 building, (b) wall in a pre-1985 building.

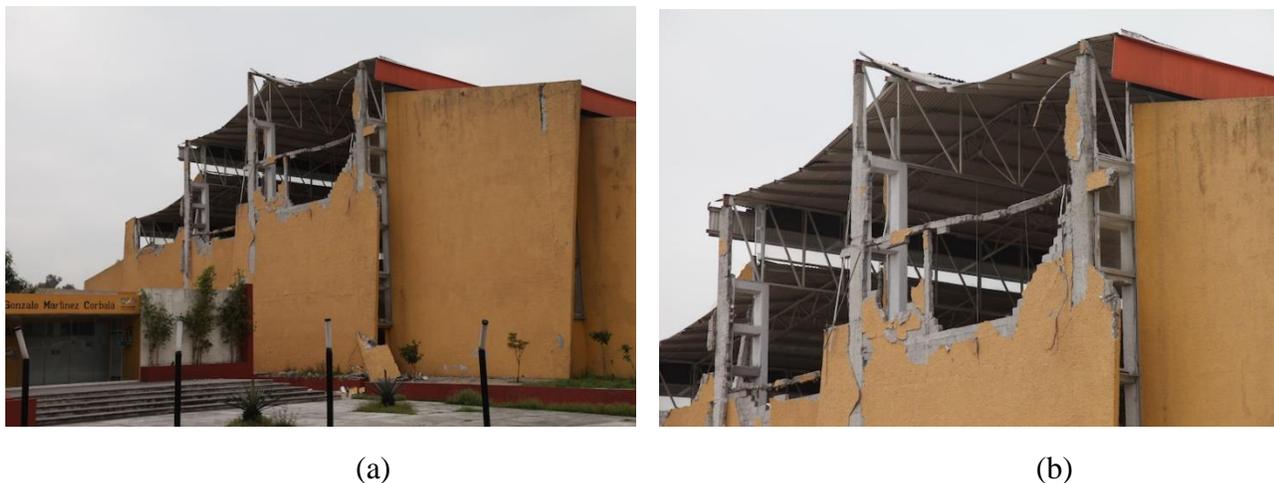
Fig. 59 Out of plane failure of concrete block masonry walls

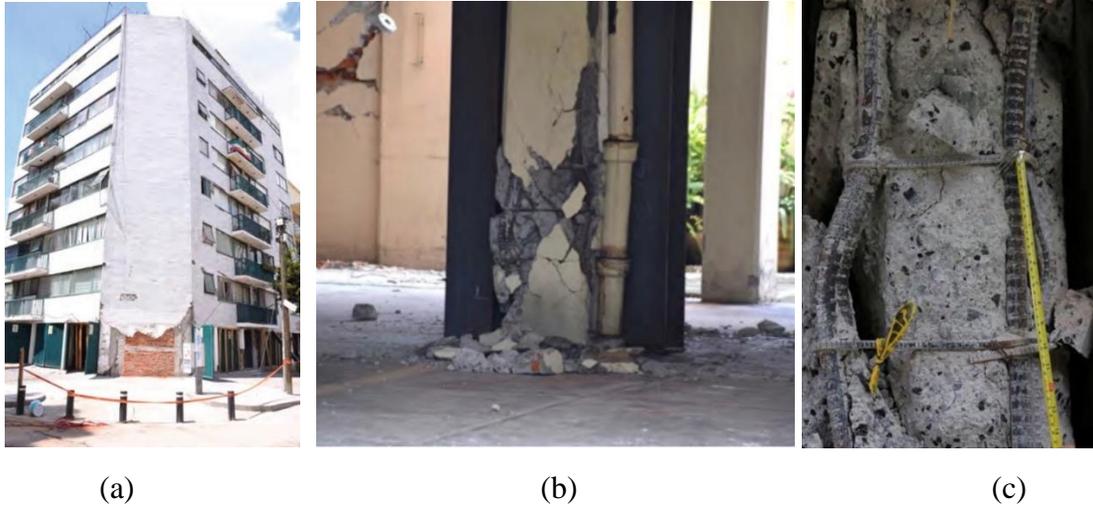
Fig. 67 Soft storey of a reinforced concrete frame building at 249 Enrique Rebsamen Street

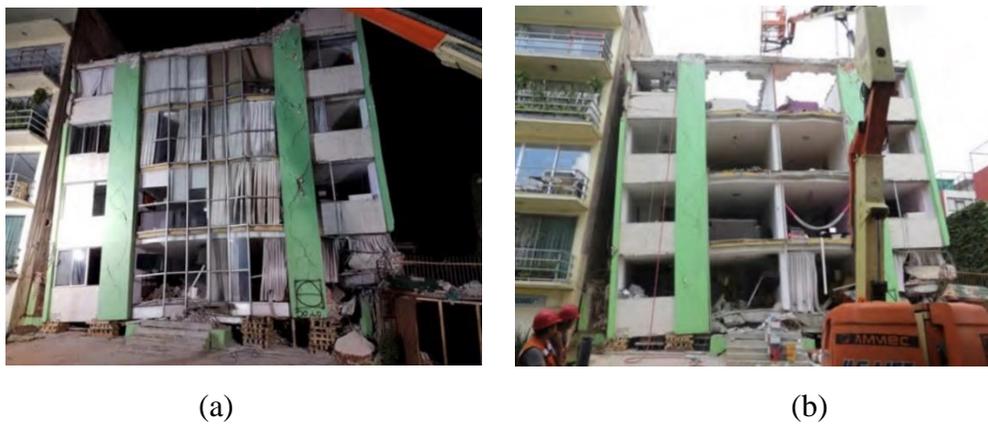
Fig. 68 Soft storey failure of a 5-storey reinforced concrete residential frame building at Enrique Rabasamen street (No: 241), (a) after the earthquake, and (b) during demolition

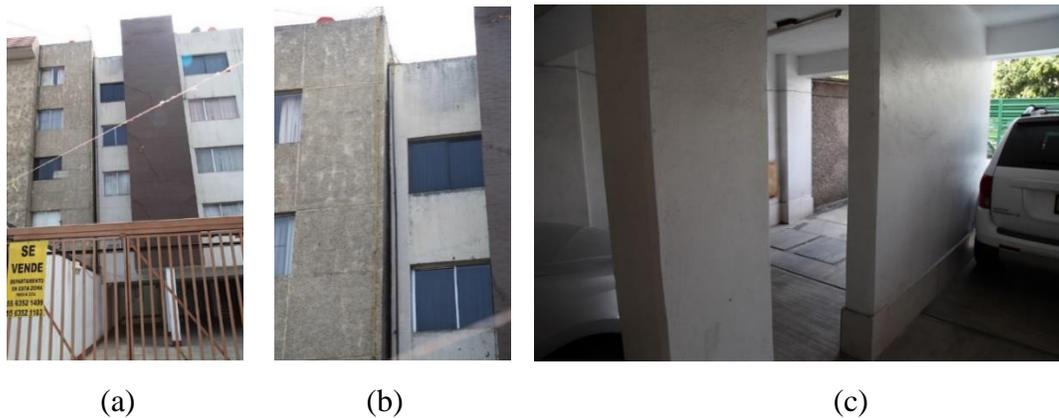
Fig. 69 (a) and (b) 5-storey residential building with reinforced concrete frames and a soft storey, leaning against the adjacent building, (c) a nearby reinforced concrete residential building first storey concrete shear walls preventing damage to soft storey

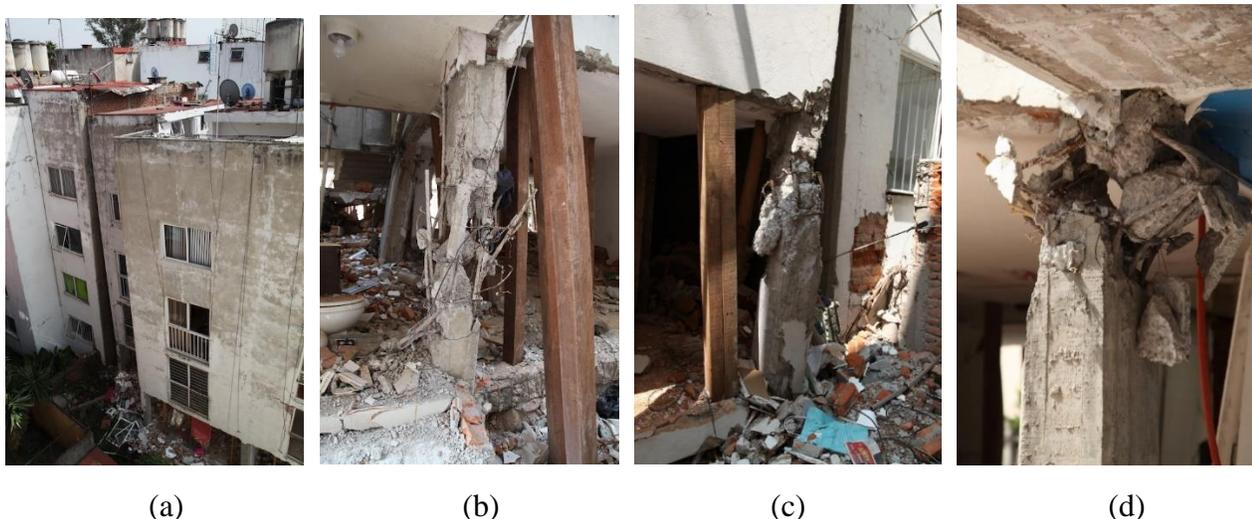
Fig. 70 (a) Building with a soft storey, leaning against the adjacent building, (b), (c), (d) damage to first-storey columns.

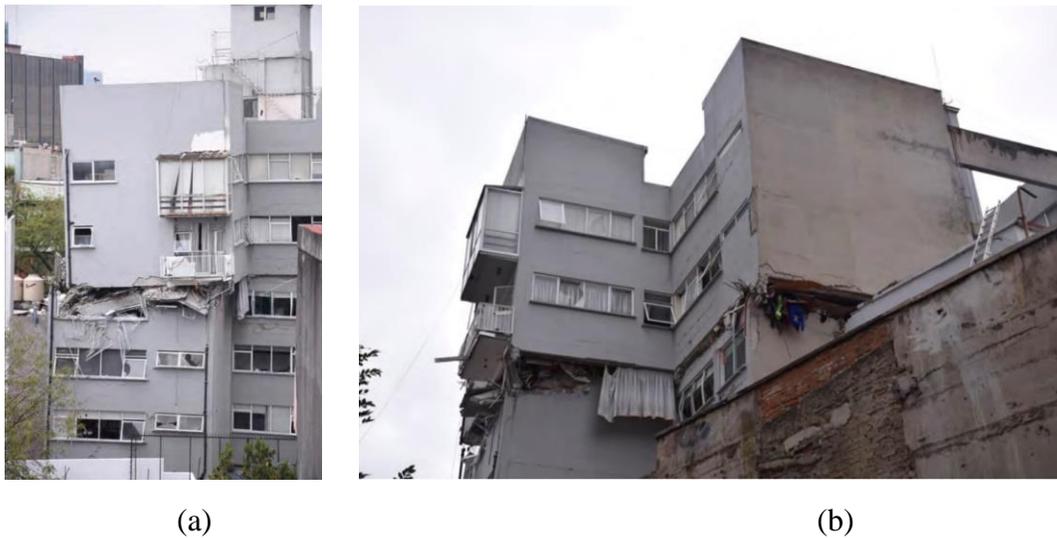
Fig. 73 8-Storey reinforced concrete building, with a collapsed intermediate floor due to pounding on the adjacent building (GEER Report 2017).

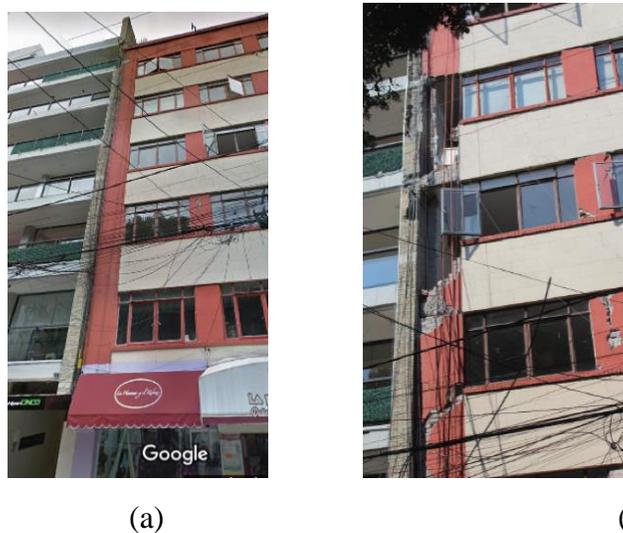
Fig. 74 Pounding of buildings (Chilpancingo St, Cuauhtemoc, Mexico City), (a) before the earthquake, separation not complying with the seismic code, b) local damage after the earthquake.

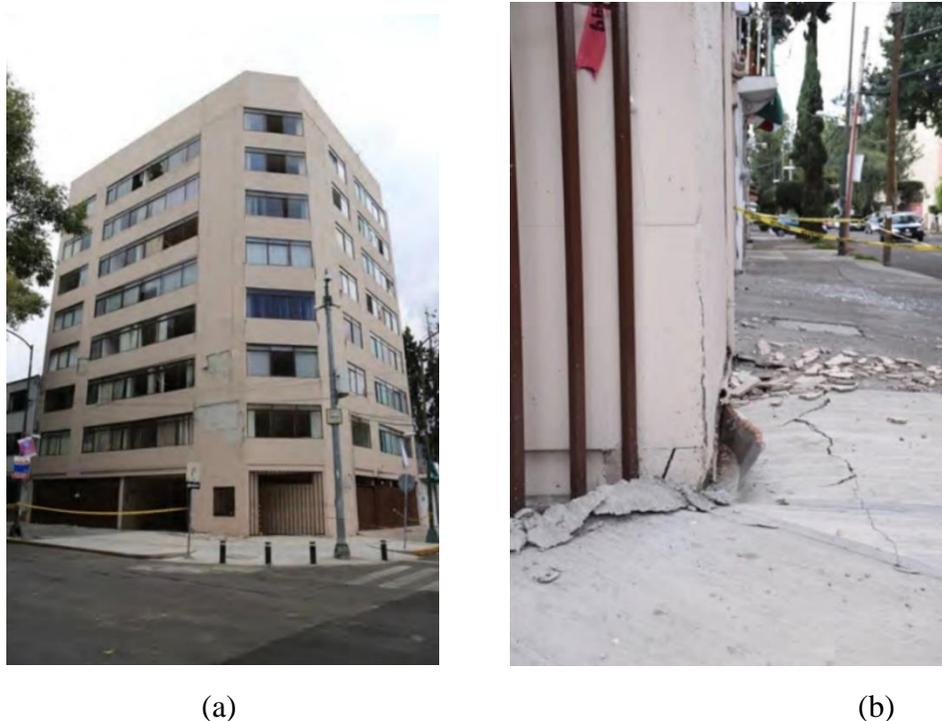
Fig. 75 8-Storey building on La Morena (716), foundation edge plunging into the ground (GEER 2017).

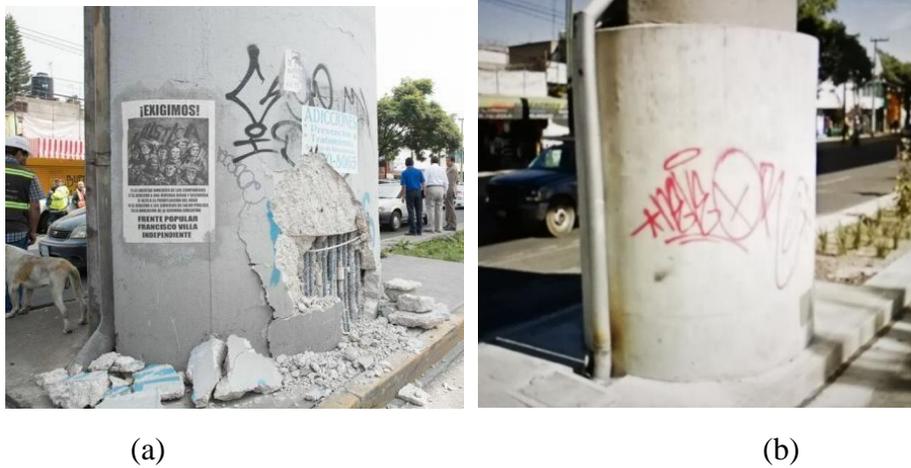
Fig. 80 (a) Damaged viaduct column (courtesy of C. Cruz-Noguez), (b) column after repair

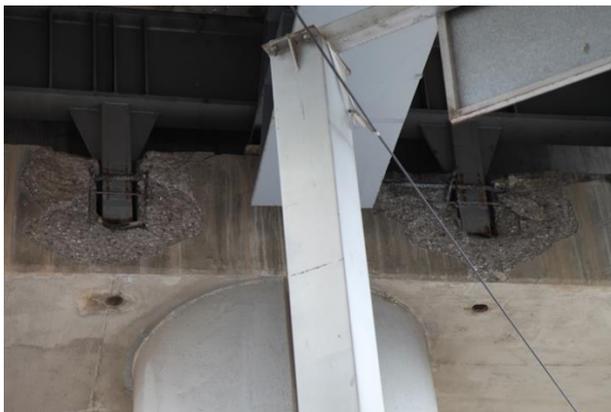
Fig. 85 Failure of concrete restraint at shear key of viaduct

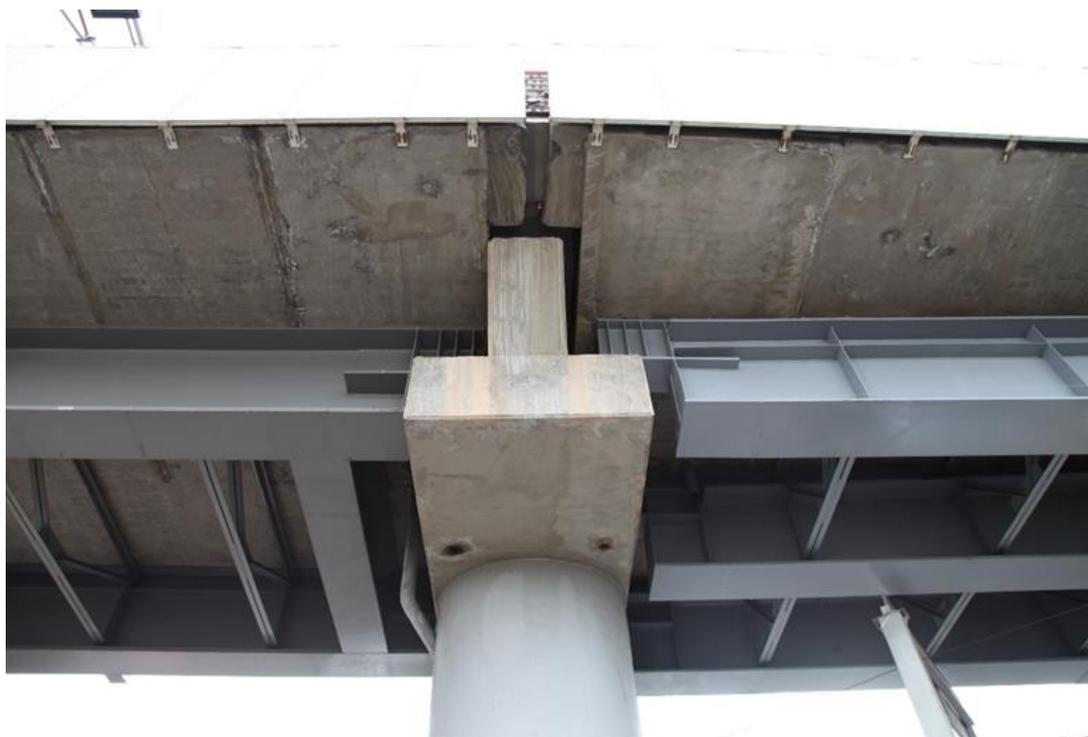
Fig. 87 Shift of viaduct girder

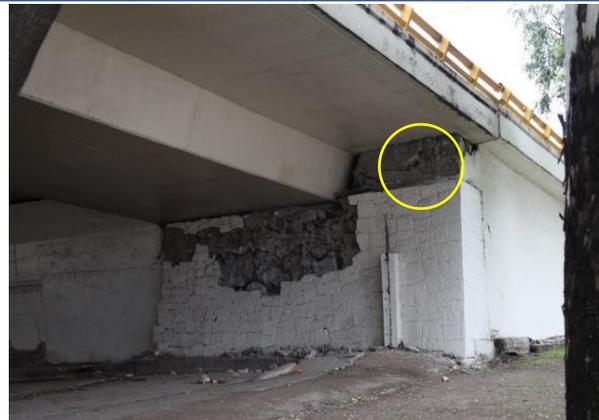
Fig. 91 Damaged URM abutment
