**Reconnaissance Report on
The December 26, 2004 Sumatra Earthquake
and Tsunami**

June 2005

Murat Saatcioglu¹, Ahmed Ghobarah² and Ioan Nistor³

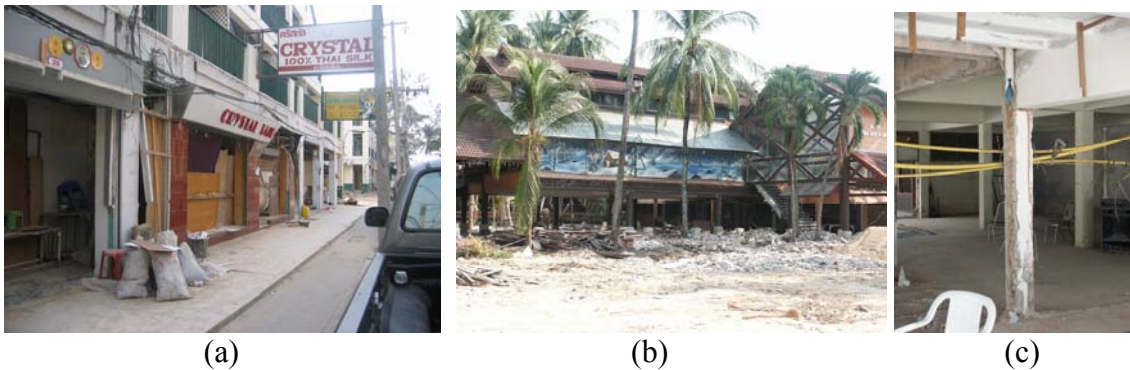
coast. The water height was measured to be approximately 6.0 m from the sea in Kata Beach, damaging low-rise buildings, including roof tiles, as illustrated in Fig. 5. The most populated beach town along the west coast of Phuket was Patong Beach, which suffered extensive damage to low-rise buildings. The water mark on buildings was measured to vary between 4.0 m to 6.0 m from the sea level. The building inventory in Patong Beach consisted of a large number of non-engineered one to two story reinforced concrete and timber frame shops and hotels. There were also a number of multistory engineered reinforced concrete hotels. Extensive damage to masonry infill walls was observed. Limited damage occurred in reinforced concrete structural elements, though significant damage was seen in timber structural elements. The entire shopping district of Patong Beach was destroyed within an area extending approximately two kilometers inland from the shore as illustrated in Fig. 6.

Fig. 6 Observed damage in Patong Beach

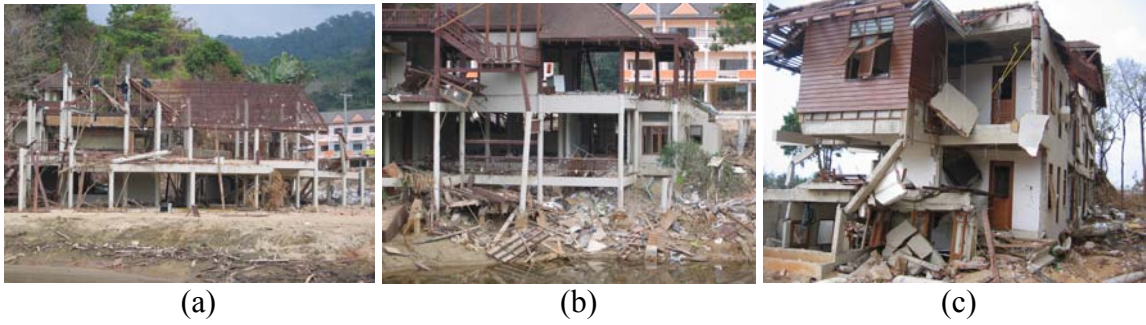
Nai Thon Beach, further north of Patong Beach on the island of Phuket, suffered extensive structural and non-structural damage to reinforced concrete frame buildings. The water height was in excess of 10 m, especially in areas between the shore and the nearby hilly terrains, which led to water run-ups. Figure 7 illustrates the extent of structural damage observed in this area.

Fig. 7 Structural damage in Nai Thon Beach due to tsunami waves

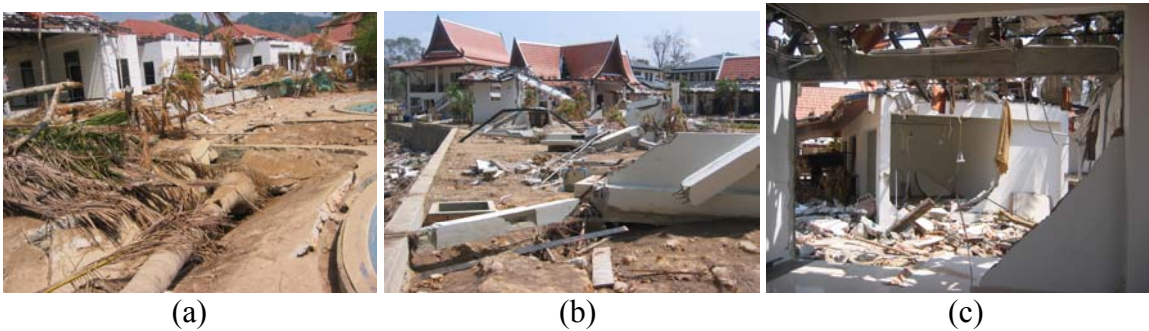
An area that was entirely devastated by the tsunami is Khao Lak Beach, about 100 km north of Phuket. The water height was measured to be in excess of 10 m, causing extensive structural damage. The failure of first-story masonry infill walls and structural collapse of low-rise reinforced concrete frame buildings are shown in Fig. 8. Many resort hotels were completely destroyed. Some multistory reinforced concrete hotels survived the tsunami pressure, with damage limited to the first-story infill walls.

Fig. 8 Structural and nonstructural damage in Khao Lak Beach

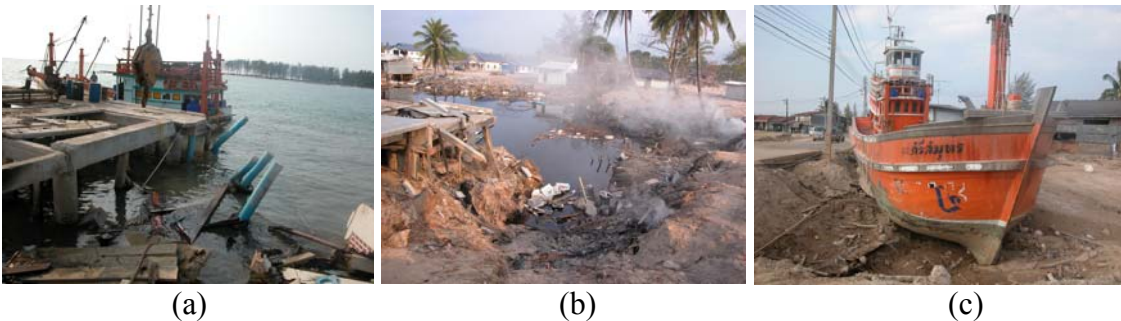
Further north of Khao Lak Beach is the harbor. This area was also hard hit by the tsunami, destroying the harbor and floating boats inland. The town near the harbor was devastated as shown in Fig. 9.

Fig. 9 Damage to Khao Lak harbor town

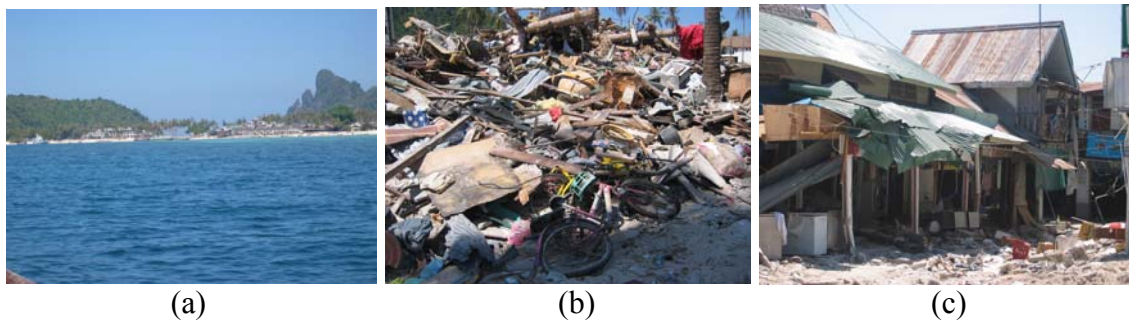
hills, with a low-lying area between the two, where most of the island's inhabitants live (Fig. 10a). This area is only a few meters above the sea level and was hit by the tsunami from both sides. Most structures on the island were destroyed, with the exception of a few well built reinforced concrete frame buildings, a steel frame building and some non-engineered construction. Many of the one and two story non-engineered reinforced concrete and timber frame buildings of the island collapsed entirely due to tsunami wave pressures. Figure 10 illustrates the extent of damage on the island.

Fig. 10 Phi Phi Island, Thailand

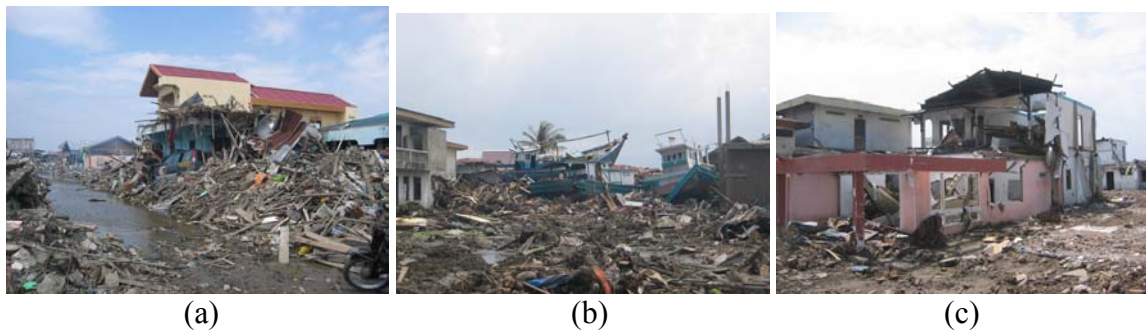
Banda Aceh, Indonesia is a city with a population of about 300,000 inhabitants before the tsunami. It was subjected to damaging forces of not only the tsunami but also the earthquake. The majority of casualties were in this city. Coastal areas were entirely swept away by tsunami waves, leaving piles of timber as the remains of building infrastructure. A large number of non-engineered reinforced concrete buildings suffered structural damage, especially in their first floor columns. Multi-story engineered reinforced concrete government buildings suffered seismic damage due to poor seismic design and detailing practices. A large number of mosques survived the disaster, though they also suffered damage to masonry walls. Figures 11 and 12 illustrate the extent of damage observed in Banda Aceh.

Fig. 11 Tsunami damage in Banda Aceh, Indonesia

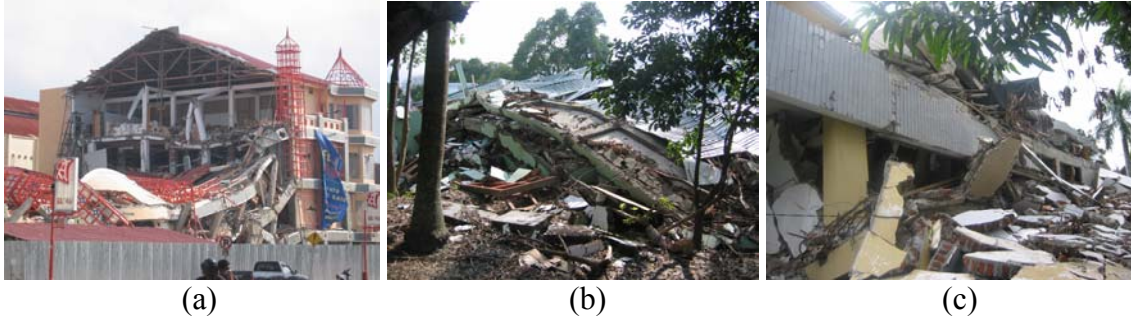
Fig. 12 Earthquake damage in Banda Aceh, Indonesia

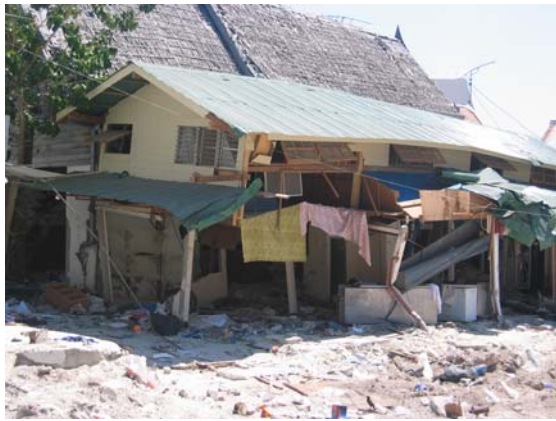
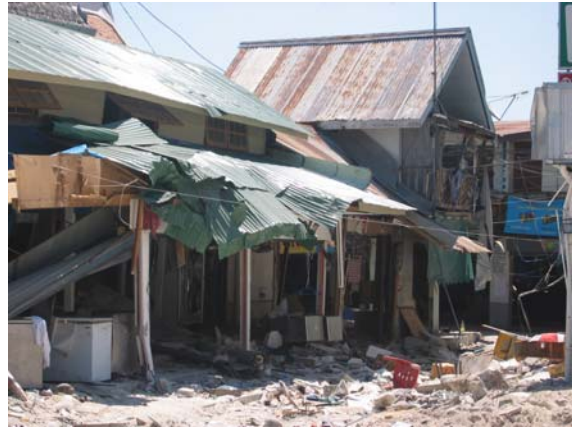
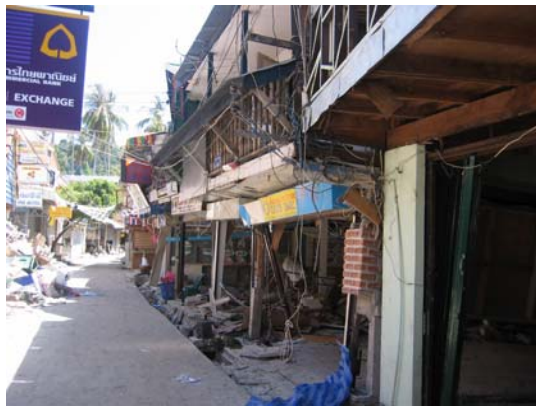
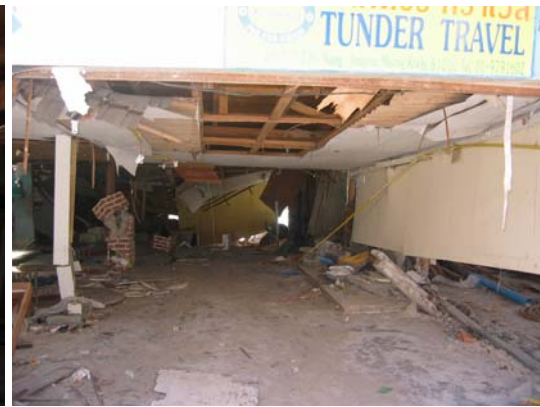
Both Thailand and Indonesia coastal towns had a large number of low-rise timber frame buildings. These buildings had timber columns and beams, supporting timber joist floor systems. The roofs either had light corrugated tin coverage or clay roofing tiles. Figure 14 illustrates the framing system used and the types of damage observed.

Fig. 14 Damage to timber frame buildings in Phi Phi Island, Thailand

- Light timber frame buildings are extremely vulnerable to tsunami wave pressures. Many residential districts with timber residential buildings in Banda Aceh were entirely wiped out by tsunami waves.

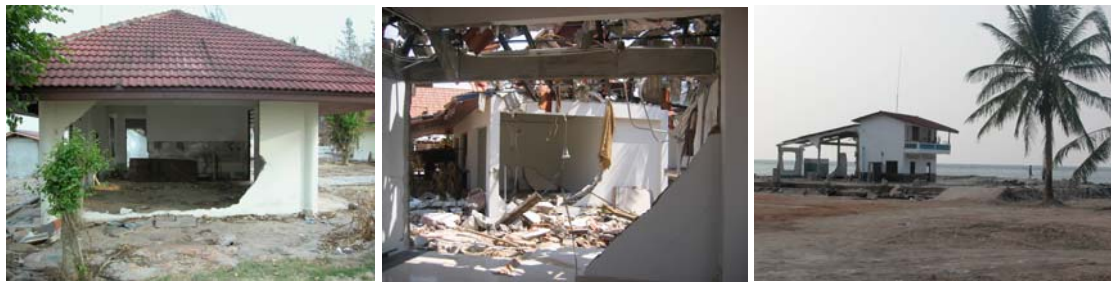
The majority of buildings in Thailand and Indonesia had frames infilled with unreinforced masonry walls. The masonry units used were consistently of the same type, with 50 mm thickness. Both hollow clay bricks and concrete masonry blocks of the same thickness were used, as illustrated in Fig. 15. These walls suffered punching shear failures due to the tsunami wave pressure, applied perpendicular to the wall plane. These resulted in large holes in walls, sometimes removing the masonry almost entirely. The remaining walls around the frames did not show any sign of diagonal tension cracks, contrary to expectations, unless the failure was caused by seismic excitations, which was limited to Banda Aceh only. Figure 16 shows the type of punching failures observed in masonry infill walls.

(a) Kamala Beach

(b) Khao Lak Beach

(c) Banda Aceh

Fig. 16 Punching failure of masonry infill walls caused by tsunami wave pressure

- Lateral forces generated by tsunami wave pressure can be significantly higher than typical design wind pressures, generating out of plane forces high enough to damage unreinforced masonry walls within the wave height. The observations indicated widespread failure of masonry infill walls within the first story level of most frame buildings. These failures were often in the form of large circular openings.

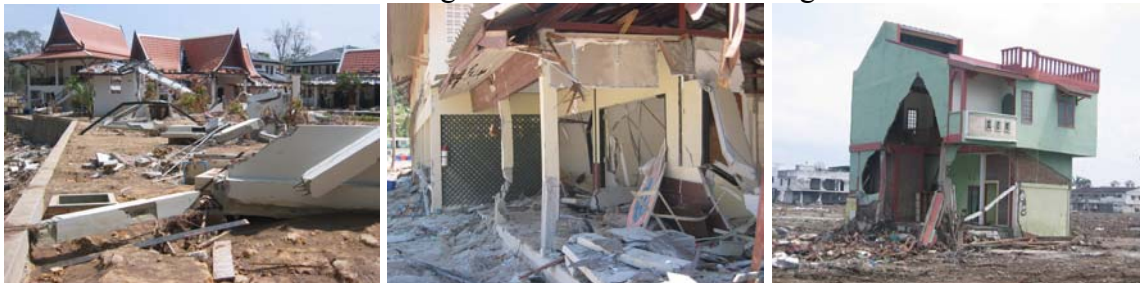
The majority of one to two story low-rise buildings were constructed using site-cast concrete, without much evidence of engineering design. The columns were of very small cross-section (about 200 mm square), containing 4 smooth or deformed corner bars with 8 mm diameter, resulting in approximately 0.5% reinforcement ratio. Their flexural capacity was computed to be significantly below the moments imposed by tsunami waves and slightly below the moments imposed by hydrostatic pressure. Figure 17 illustrates column failures in non-engineered reinforced concrete frame buildings due to the tsunami wave pressure.

Fig. 17 Column failures in non-engineered reinforced concrete construction

- Non-engineered low-rise reinforced concrete frame buildings, with small size structural elements, are vulnerable to partial or full collapse due to lateral tsunami pressures. Columns of such buildings are further vulnerable to impact forces generated by floating debris caused by tsunami, often leading to flexural failures of columns within their mid-heights.

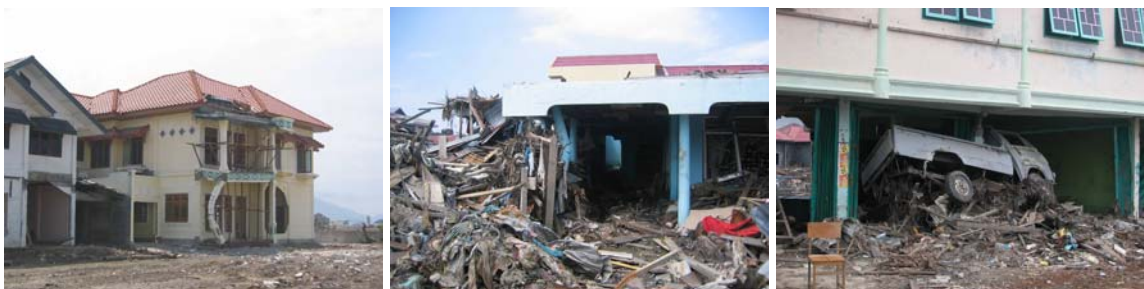
Observations on column behavior indicated that many failures occurred at mid-height, especially in Banda Aceh. This was attributed to the effects of debris impact, over and above the tsunami wave pressure. Indeed, floating building remains, as well as floating large objects like fishing boats and cars impacted on the columns, causing column failures near their mid-heights. This is illustrated in Fig. 18.

Fig. 18 Column failures due to debris impact in Banda Aceh

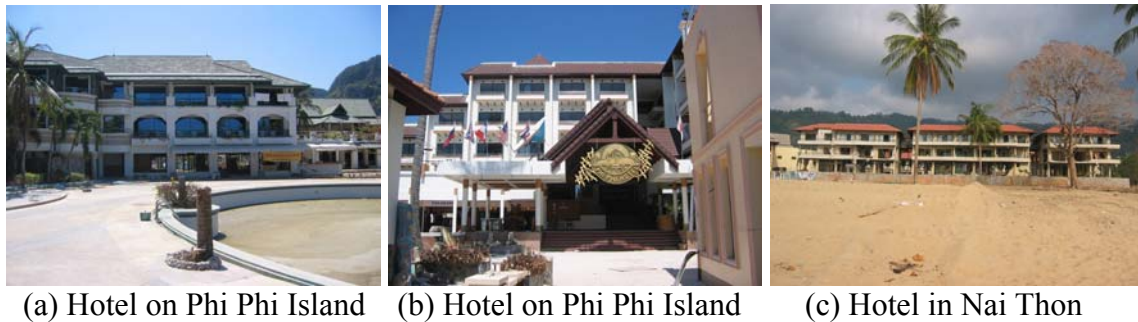
There were many low to mid-rise reinforced concrete frame building which appeared to have been engineered in the visited areas of Thailand and Indonesia. These frame buildings survived the tsunami pressure without structural damage, though they suffered damage to non-structural elements, especially the first story masonry walls. Figure 19 shows reinforced concrete hotel buildings in Thailand that survived the tsunami without any sign of structural damage, although nearby non-engineered buildings were either partially or fully collapsed. There were some exceptions to this observation in Nai Thon Beach, where water run-up affected slender reinforced concrete columns of a shopping centre, causing a partial collapse.

Fig. 19 Engineered concrete buildings survived tsunami forces without structural damage

- Engineered reinforced concrete frames appear to have sufficient strength against tsunami forces. There was very little damage observed in structural components of engineered concrete buildings. Often, nonstructural elements failed before the effects of tsunami pressure reached a critical level for structural components of such buildings, relieving pressure on structural elements. There was one steel frame building investigated, which survived the tsunami pressure without any sign of distress.

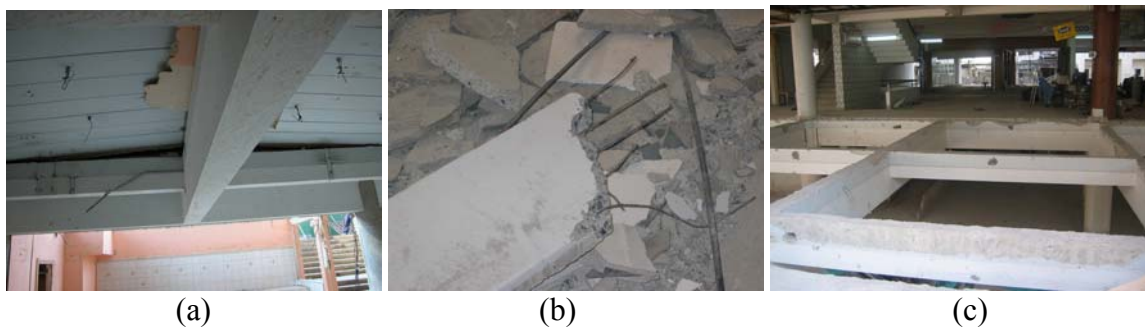
A common precast slab system that was used in Thailand consisted of prefabricated reinforced concrete strips, supported by cast-in-place beams. These strips had 50 mm thickness, 300 mm width and 2.0 m length, reinforced with 4-6 mm diameter smooth wires, equally spaced in the centre of the section. Figure 20 shows the specifics of the slab system. Because of lack of proper connection to the supporting beams, these strips lifted up due to water pressure, causing slab failures. One good example was a shopping centre in Patong Beach on Phuket Island, Thailand, where the lower level below grade was filled up with water, lifting and destroying the first floor slab panels, as illustrated in Fig. 20. A similar type of slab failure was also observed in the concrete dock of the Kao Lak Harbor, as shown in Fig. 21, though the strips used in the harbor dock was slightly thicker.

Fig. 20 Failure of precast slab strips in Patong Beach

- Prefabricated reinforced concrete slab strips, commonly used in the area, suffered from uplift forces caused by hydrostatic pressures. Lack of proper anchorage to the supporting beams was blamed for the failure of these slab systems.

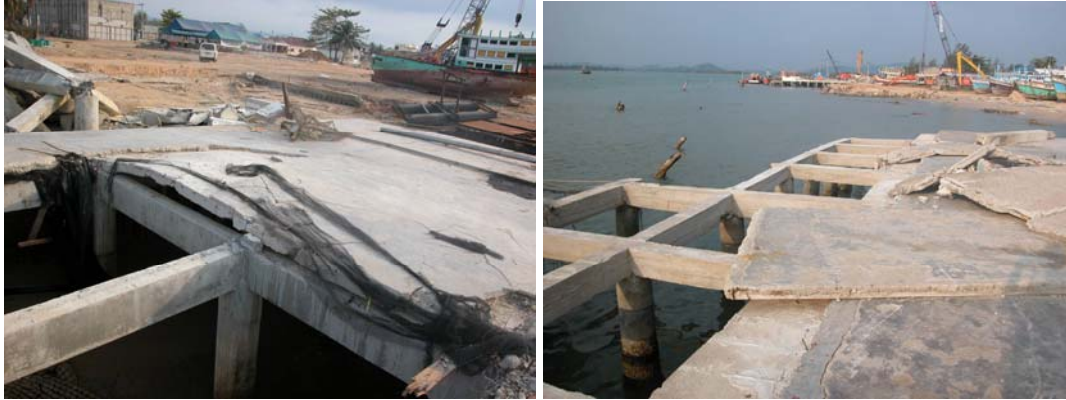
Fig. 21 Failure of Kao Lak Harbor dock

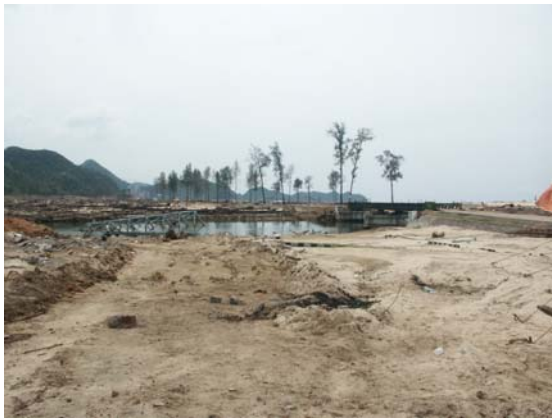
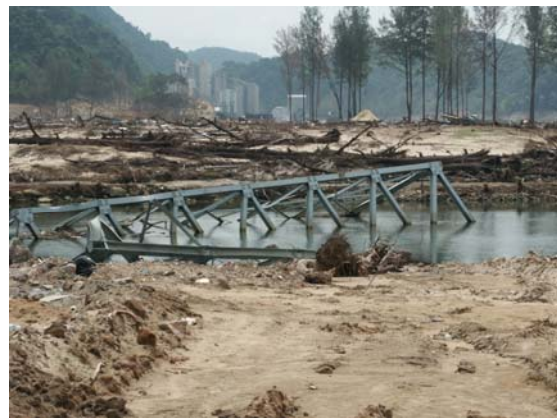
There was extensive damage to bridges in the Aceh province of Indonesia caused by tsunami wave forces, collapsing many and jeopardizing relief efforts. Figure 22 shows a two-span steel truss bridge in western Banda Aceh that failed and displaced approximately 50 m from its piers and abutments which were not damaged. The Indonesian army constructed a Bailey bridge on the same supports to maintain access to the nearby cement plant. Similarly, in eastern Banda Aceh a two-lane, multi-span reinforced concrete bridge was swept off its piers, as illustrated in Fig. 23(a). Two of the bridge piers were also destroyed while the others remained in place. Another multi-span, reinforced concrete bridge, over the same river further away from the ocean, survived the tsunami wave pressure as shown in Fig. 23(b). This bridge is likely to be of the same type as that collapsed (shown in Fig. 23(a)), judging by the spans and the piers, though this point could not be confirmed.

Fig. 22 The failure of steel truss bridge in eastern Banda Aceh

- Bridge infrastructure was devastated by tsunami forces. Many bridges were swept away from their supports, disabling the transportation network.

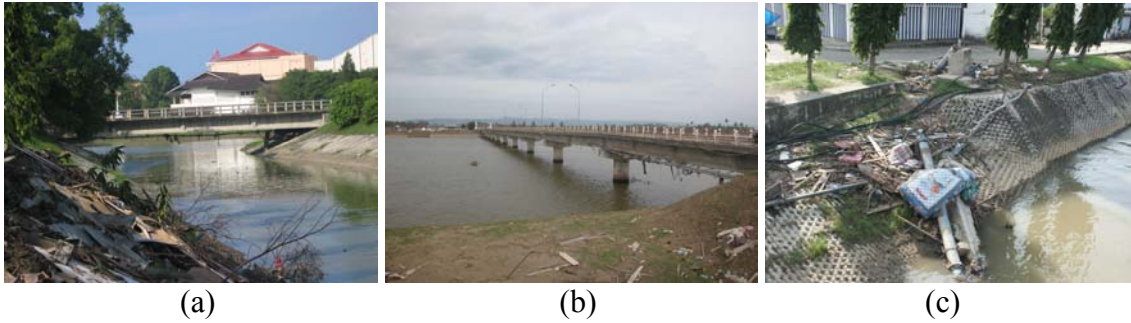
Fig. 25 Damage to pipeline attached to bridges in Banda Aceh

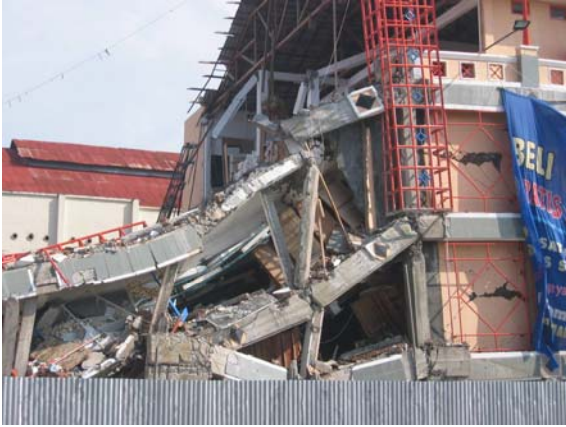
Most of the reinforced concrete frame buildings, which appeared to have been engineered, had strong and relatively deep beams supported by smaller size columns. Therefore, hinging of columns was widespread throughout the area while the majority of the beams remained elastic until the collapse of the structure, triggering overall stability failures of frames. Figure 26(a) shows an example of this type of failure of a shopping centre located in downtown Banda Aceh, although this building also suffered from an additional problem of lack of joint reinforcement. Hinging of weak columns relative to beams also resulted in the pancaking of slabs, as illustrated in Fig 26(b).

(a) Shopping centre in Banda Aceh

Fig. 26 Deep and strong beams supported by smaller size and weak columns

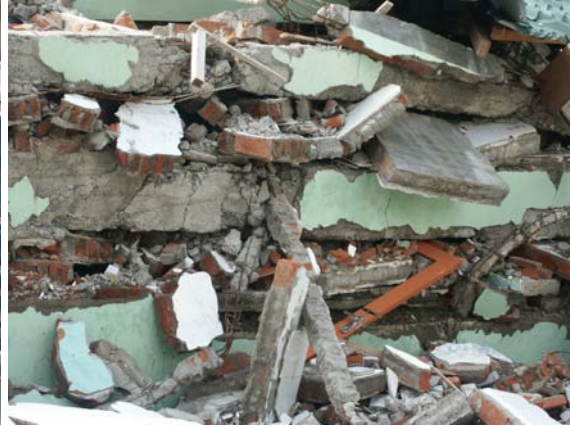
(b) Office building in Banda Aceh

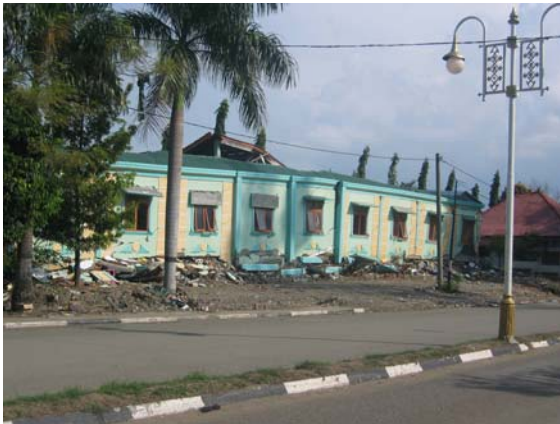
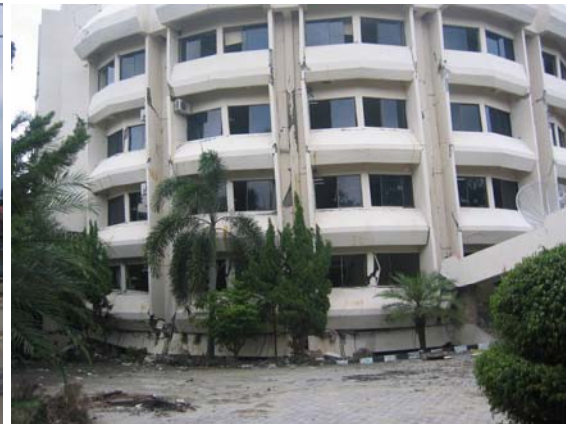
Open spaces at entrance levels resulted in soft stories in most commercial buildings. Increased deformation demands on the first story columns of these buildings, coupled with lack of confinement and column deformability, resulted in column failures. The failure of first story columns triggered the collapse of entire story. Older and newer buildings alike suffered from soft story failures as illustrated in Fig 27(a) and (b), respectively.

Fig. 27 Soft story failures in Banda Aceh

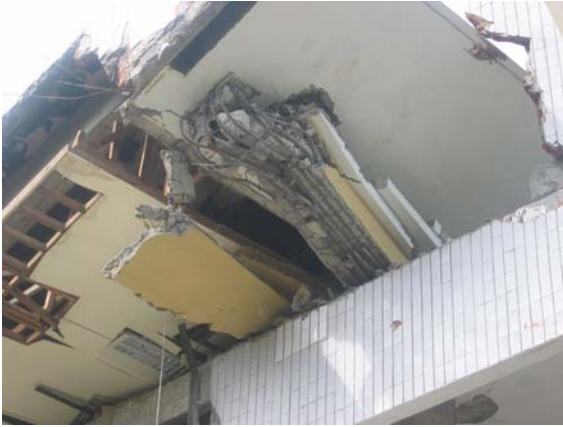
The investigation of damaged columns revealed lack of seismic design practices, including properly spaced and detailed hoops. This resulted in column flexural failures, especially in soft stories and where strong-column weak-beam design philosophy had not been implemented. While non-engineered building columns had definite lack of required volumetric ratio, as well as the spacing and detailing of column ties, engineered building columns did not contain sufficient transverse reinforcement either. Column failures and resulting building collapses associated with the lack of transverse reinforcement are illustrated in Fig. 28.

(a) Column failure in Tax Office

Fig. 28 Lack of concrete confinement and resulting failures in Banda Aceh

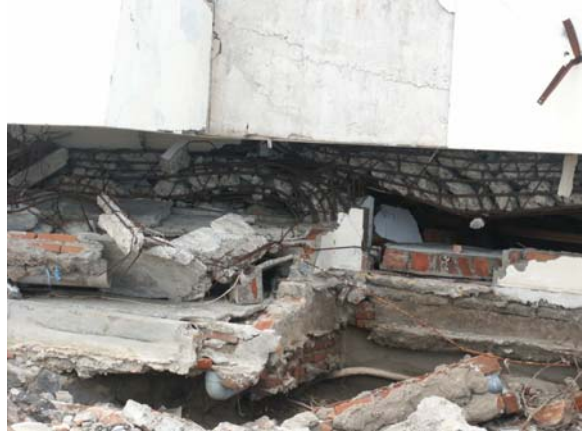
(b) Column failure in Customs Building

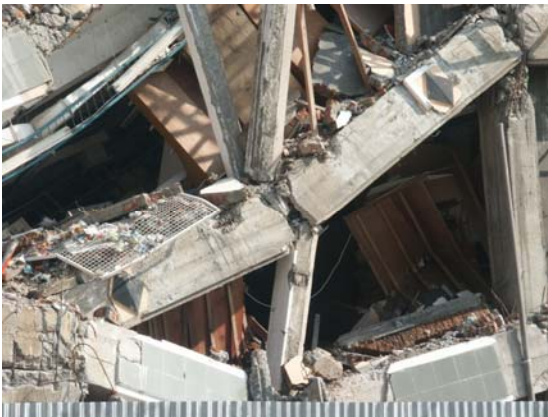
Many failures were attributed to lack of transverse reinforcement in beam-column connections. Furthermore, lack of transverse reinforcement in column splice regions, coupled with inadequate splice lengths resulted in additional column failures. Lack of shear reinforcement, aggravated by short column effects, resulted in column shear failures. Figure 29 and 30 show additional examples of column failures in Banda Aceh.

(a) Failure of beam-column connections

Fig. 29 Lack of confinement and resulting failures in Banda Aceh

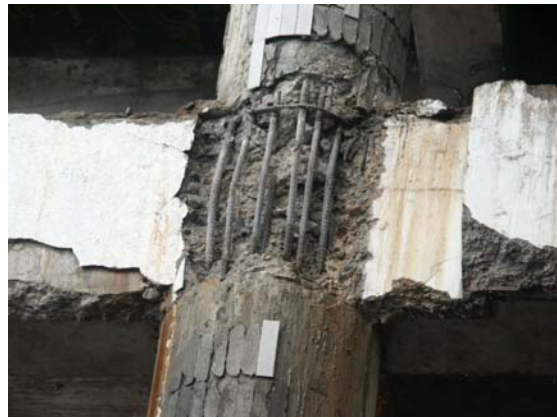
(b) Lack of joint reinforcement

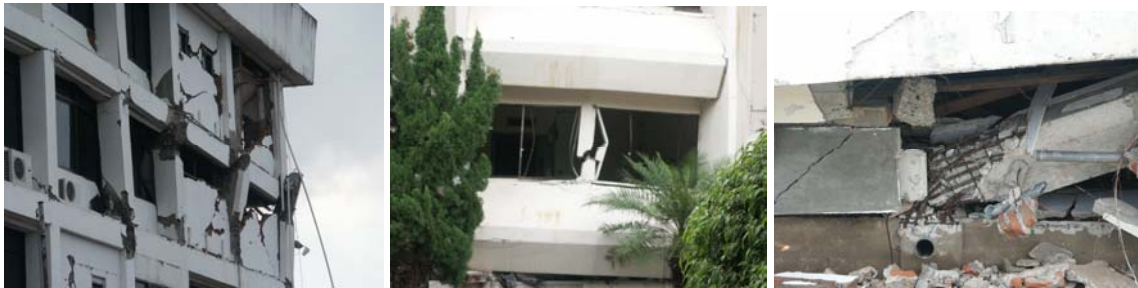
(a) Column shear failure (b) Column shear failure (c) Splice failure

Fig. 30 Column failures in Banda Aceh

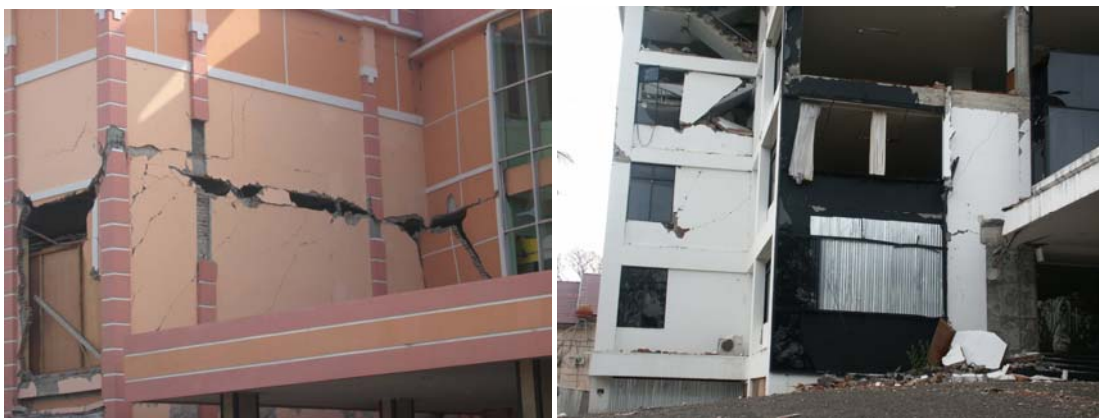
Unreinforced masonry walls were used extensively in all areas visited. Brick and block walls were used as exterior and interior infill walls, as well as partition walls. These walls increased the building mass and attracted seismic forces. They were able to brace buildings until their elastic limits were exceeded. When this happened, they developed either sliding shear failures or diagonal tension cracks followed by the crushing of diagonal compression struts. Figure 31 illustrates different types of damage inflicted on unreinforced masonry walls.

(a) Sliding shear failure (b) Diagonal tension failures

Fig. 31 Masonry damage in Banda Aceh

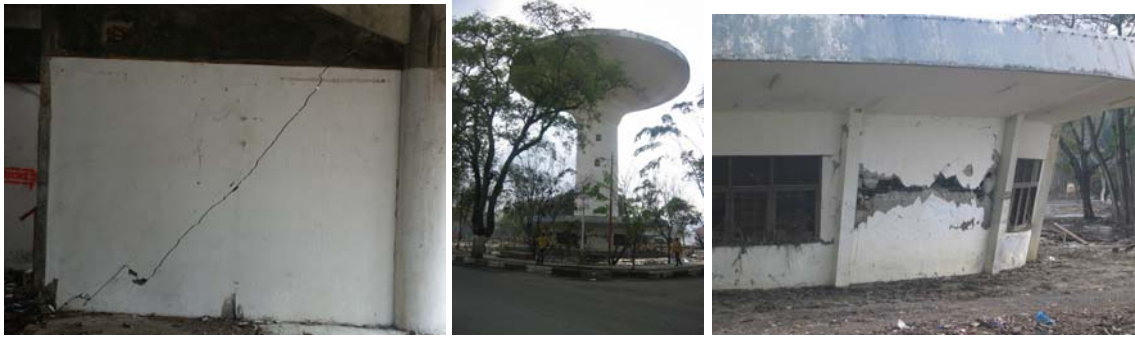
Very few structures had shear walls. A frame building, forming part of a shopping centre in Banda Aceh, had an inadequate shear wall which was not sufficient to provide lateral bracing, and developed a wide diagonal tension crack as shown in Fig. 32(a). Similarly inadequate reinforced concrete shear walls were used at the base of a concrete water tower in central Banda Aceh. The walls suffered from extensive diagonal cracking. They also developed sliding shear failure due to the window openings within the walls. This is illustrated in Fig. 32 (b) and (c). Some of the masonry walls behaved as shear walls in terms of providing lateral bracing. However, if and when their elastic limit was exceeded, they developed diagonal tension cracks and diagonal compression crushing.

(a) Diagonal crack in a shear wall (b) Water tower (c) Shear wall at the base of tower

Fig. 32 Performance of concrete shear walls in Banda Aceh
