Performance of buildings during the 2001 Bhuj earthquake

Jag Mohan Humar, David Lau, and Jean-Robert Pierre

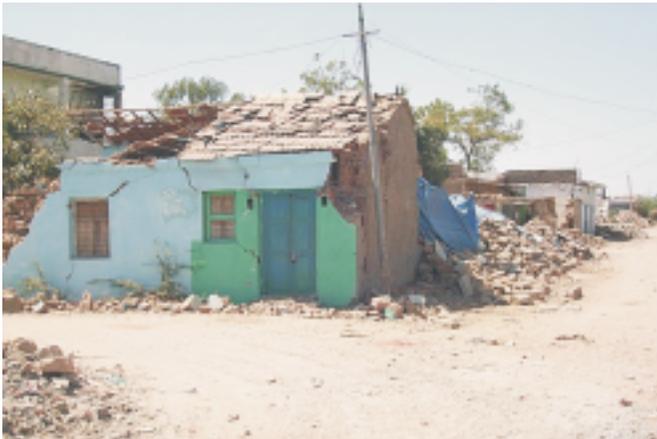
Fig. 5. A village house in Kachchh; stone masonry with Manglore tile roof.

many villages and towns not a single building was left standing. The worst-affected towns were Anjar, Bhachau, and Rapar. Figures 5–9 show examples of the destruction caused to load bearing masonry buildings. Figure 9 shows a masonry control building located at the Samkhiali electric substation. The damage to this building disrupted the functioning of control panels and batteries housed inside, leading to tripping of the power. A number of similar buildings in electric substations throughout Kachchh were either completely destroyed or severely damaged leading to a complete power blackout in the region.

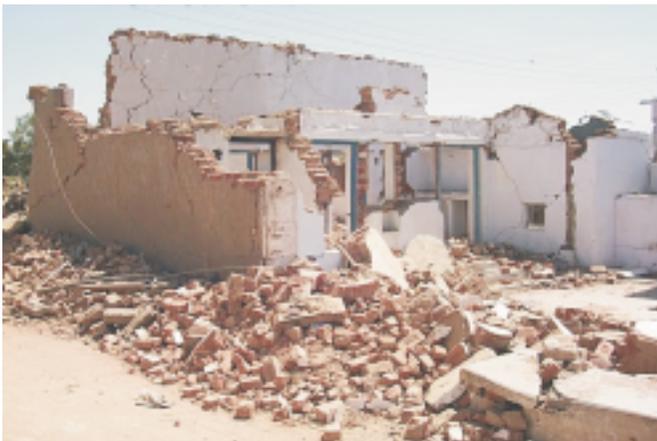
Fig. 6. Destruction of heavy stone masonry walls that had no reinforcement and were not tied to each other.

The performance of masonry buildings in the Kachchh region was very poor. No reinforcement had been provided in any of the buildings. The walls were not tied to each other or to the floors and roofs. Most buildings used large-size, heavy stone blocks, either undressed or rough dressed. The roof construction of wooden logs and Manglore tiles was very heavy. All of these factors made the buildings very vulnerable to damage during earthquake, leading to widespread destruction. As would be expected, the worst performance was that of random rubble construction in mud mortar. In

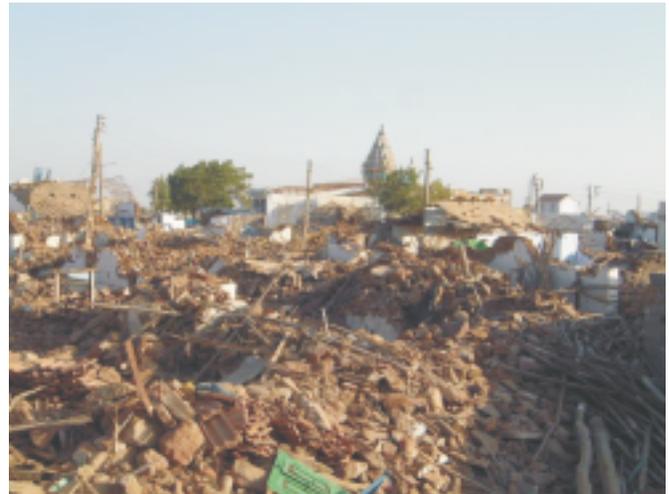
Fig. 7. Virtually complete destruction of masonry buildings in a village in Kachchh.

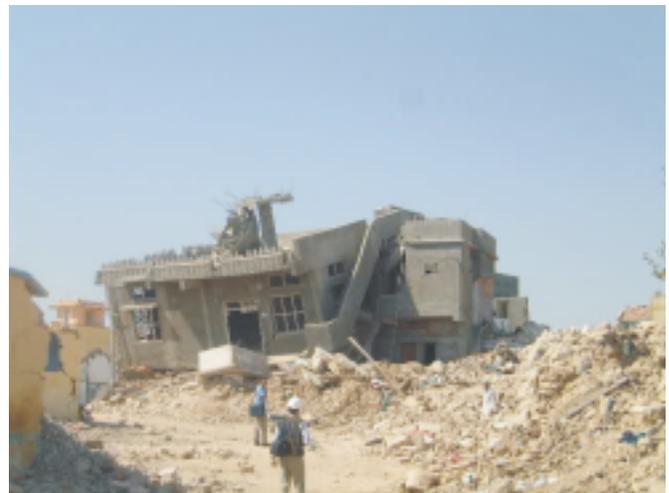
Fig. 8. A scene of destroyed load bearing masonry buildings in the town of Anjar.

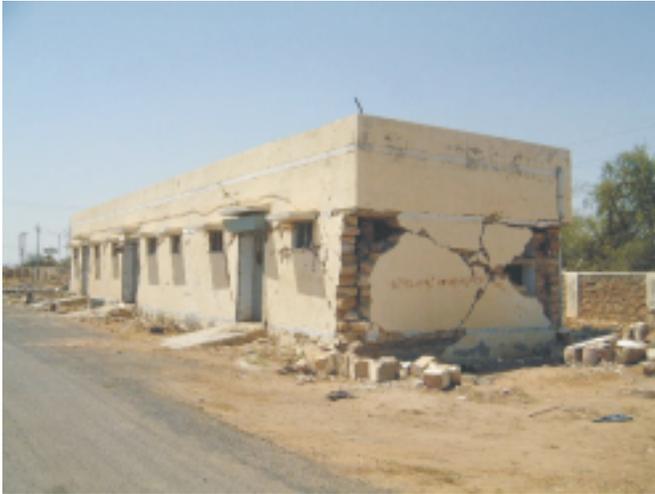
Fig. 9. Damaged control room building at the Samkhiali substation.

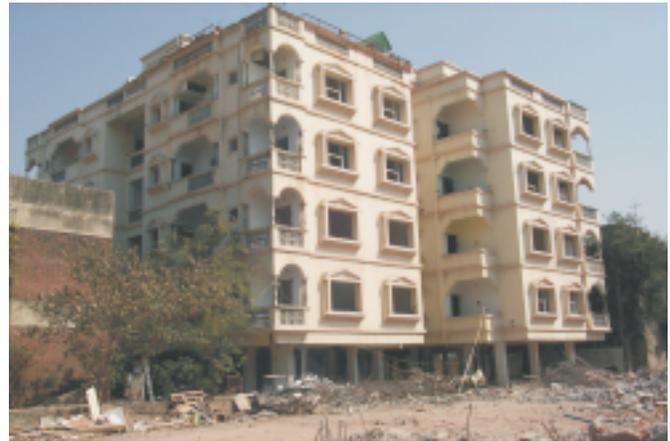
Almost all buildings with open first storey suffered some damage. In some cases the buildings collapsed, while in some others the damage was so severe that the buildings had to be written off. At the time of our visit, which is about 7 weeks after the earthquake, the rubble from the collapsed building had been cleared but the severely damaged buildings had not been pulled down. Repair work was in progress in some of the private buildings that had suffered repairable damage. A typical example of a framed building with open first storey is shown in Fig. 10, which shows what was once a complex of four identical five-storey blocks. Each block had a reinforced concrete frame construction with an open first storey and brick infill walls in upper storeys. Two of the four blocks, which were located in the foreground of the picture, completely collapsed killing several residents. The other two blocks that are seen standing in the picture suf-

Fig. 10. A block of damaged reinforced concrete frame buildings in Ahmedabad with open first storey and brick masonry infills.

fered severe damage. The owners have decided to pull them down. Temporary supports have been provided to the buildings in their lowest storey so that the useful contents of the buildings could be salvaged.

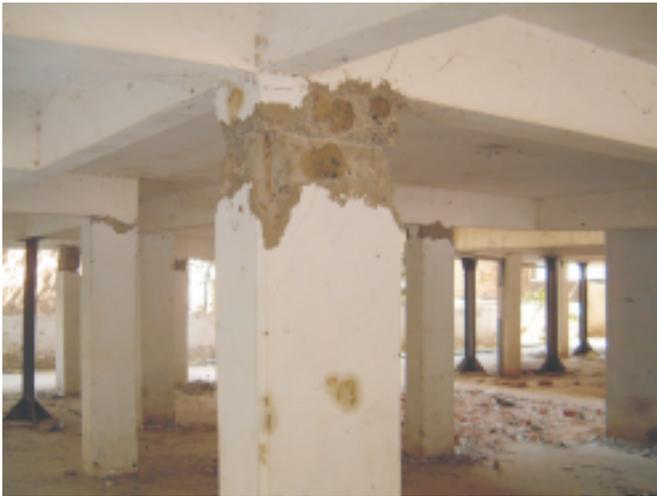
Figures 11 and 12 show details of the damage suffered by the first-storey columns. The columns are 225 mm by 375 mm in size. The longitudinal reinforcement consists of six 15 mm diameter torsteel bars. The hoops are of 6 mm plane bars spaced at 200 mm with 90° hooks. Given the local practice, it is unlikely that the confining reinforcement extends into the beam-column joint. The open first storey combined with the rather slender column size has caused hinging of most columns at their junction with the beams in the first floor above ground. The columns have a low ductility capacity because of inadequate confining reinforcement and absence of proper hooks. The situation is aggravated by the fact that according to the local practice concreting of the columns is stopped at about 200–250 mm below the soffit of the beam and a construction joint is provided at that level. The concrete in this region of 200–250 mm is poured along with the beam and usually has a poor bond with the rest of the column. This makes the hinge region even more vulnerable. The construction joint can be clearly seen in Figs. 11 and 12.

Fig. 11. Damage suffered by the open first storey columns in concrete frame building.

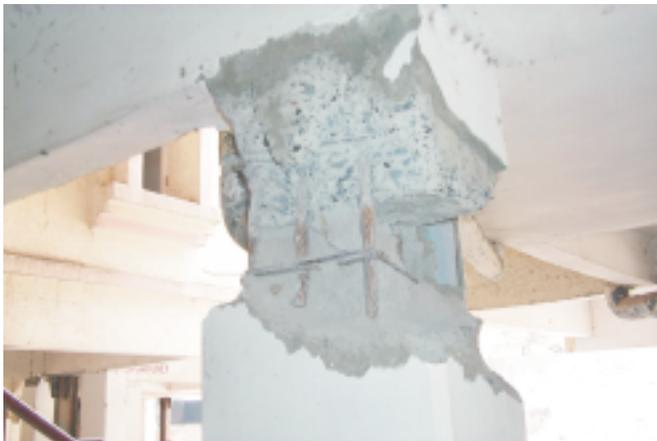
Fig. 12. The hinge in a first storey column showing the steel reinforcement.

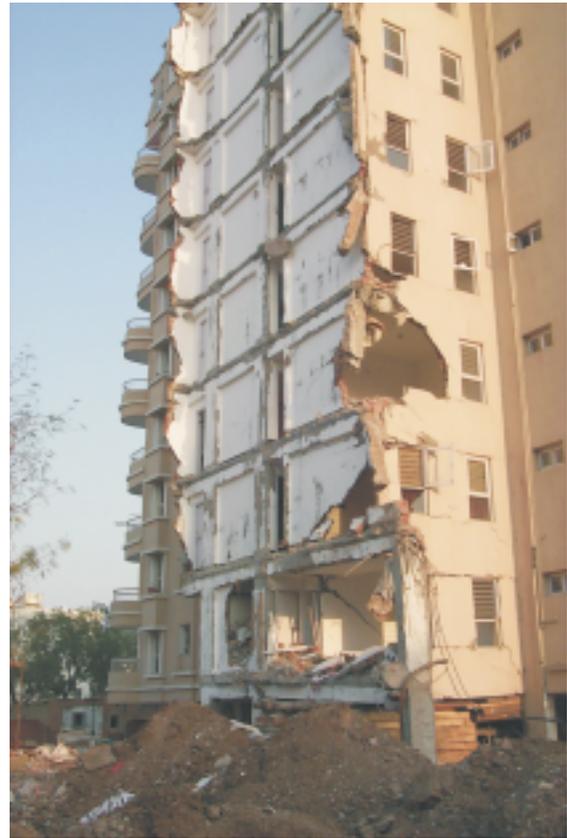
Any number of examples can be cited of the damage suffered by the open first storeys in multistorey reinforced concrete buildings in Ahmedabad. A particularly tragic case was of a ten-storey building known as Shikhara. The building was in the shape of an H. It had been completed only recently and was not fully occupied. One of the open arms of the H collapsed during the earthquake causing the death of 89 persons. Details of the building are shown in Figs. 13 and 14. The collapse was evidently caused by the failure of the columns in the open first storey. The first-storey columns in parts of the building that remain standing are severely damaged. Attempts have been made to repair these columns, as shown in Fig. 14, but the residents are unwilling to return to the building.

Fig. 13. One wing of the Shikhara building detached itself from the building and collapsed.

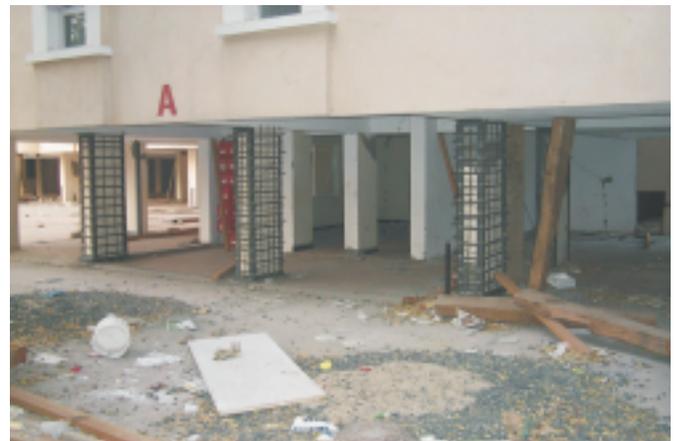
Fig. 14. Repairs to damaged columns in the first storey of the Shikhara building.

The technique used for repairs to the columns of the first storey can be observed from Fig. 14. The columns are being prepared for concrete jacketing. In the present case they have been encased in four vertical angle sections, one at each corner. The angles are tied together by welding hori-

zontal steel bars. Forms will be erected around this assembly and concrete will be poured from an open space at the top of the forms to complete the concrete jacket. We observed a similar technique being used for the repair of many damaged columns. For low-rise buildings and smaller columns, a reinforcing cage of longitudinal bars and hoops is placed around the column before concreting. However, in all cases the concrete jacket is not tied to the column foundation or to the beams above. It is evident that while the jacketing may restore the vertical load carrying capacity of the columns it does not improve the resistance to earthquake loads.

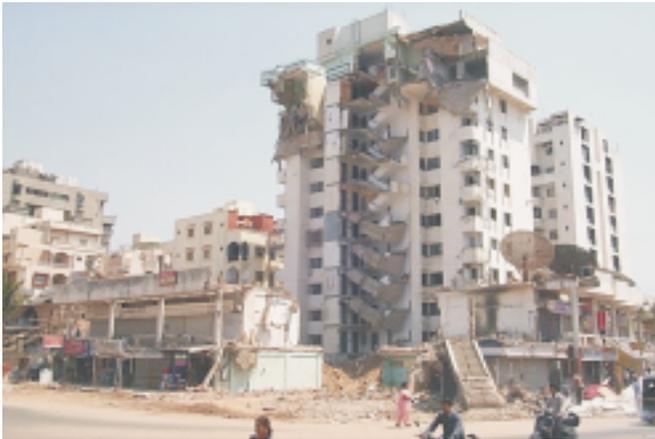
Another large reinforced concrete frame building whose failure attracted much publicity was the Mansi building located in downtown Ahmedabad. The building is 12 stories tall and consists of two identical but separate blocks. A part of one of the two blocks completely collapsed killing 22 people. The open first-storey columns of the parts that remain standing are heavily damaged. The building has been abandoned and its fate remains to be decided.

Figures 15 and 16 show some details of the damaged building. An observation of the remaining parts of this building indicates that the most likely cause of the collapse was

the soft first storey. The masonry infills in the upper stories of the building make the building stiff, attracting significantly higher earthquake forces. The high shears imposed on the first-storey columns have caused damage to the visible hinge regions at the top of the columns, as well as shear failure in some of the columns, as seen in Fig. 16.

Fig. 15. The portion of the Mansi building that collapsed detached itself from the block seen in the foreground; the other block in the background is still standing, but its first-storey columns are heavily damaged.

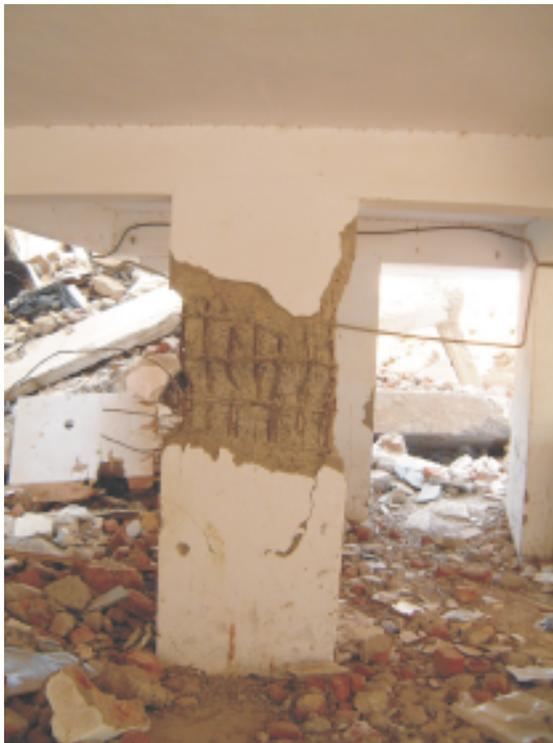
Fig. 16. Shear failure of a first-storey column in the Mansi building.

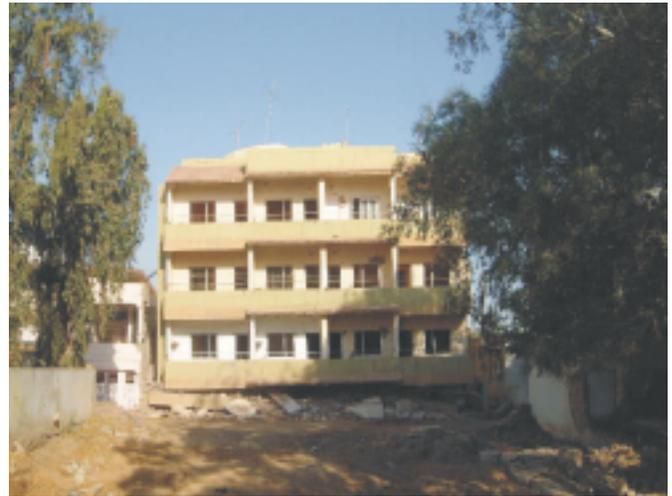
Figure 17 shows the collapsed open first storey of a four-storey concrete frame building in Bhuj in which the upper

Fig. 17. The open first storey of this building in Bhuj was crushed bringing the upper three storeys down.

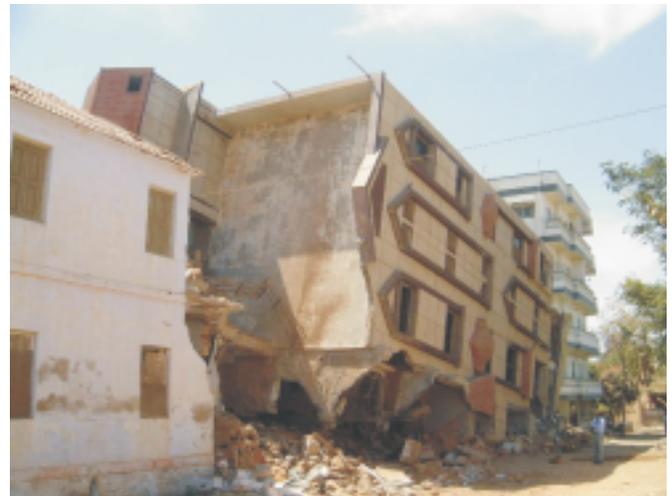
Fig. 18. The columns on one edge of the open first storey of this building in Bhuj collapsed bringing the building down on its side.

storeys have come down as a rigid body. Figure 18 shows a similar building also in Bhuj. In this case the columns on one side of the building failed and the building came down to rest on its side. Figure 19 shows some columns in the first storey of a building in Anjar. The loss of concrete cover and the lack of sufficient hoop reinforcement have caused the columns in the open storey to be severely damaged in the hinge region.

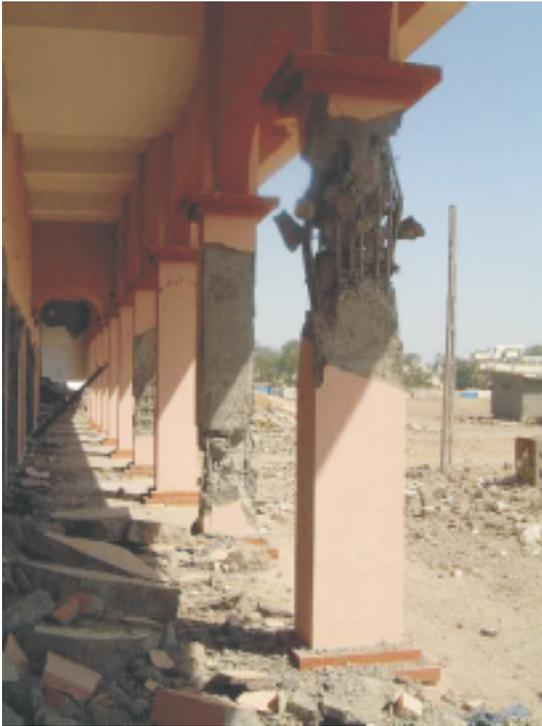
Fig 19. Failure of column through plastic hinging and buckling of longitudinal reinforcement due to loss of concrete cover and insufficient hoop reinforcement.

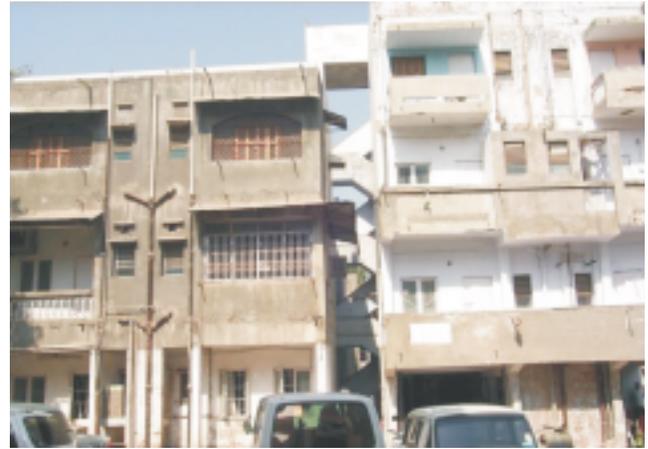
Figure 20 shows an interesting example of two buildings located in the Maninagar district of Ahmedabad. The buildings stood side-by-side and were connected by a staircase. The three-storey building on the left was of concrete frame with infill panels extending throughout the height in most of the column bays. It sustained the earthquake with minor damage. The four-storey building on the right had an open first storey, which suffered severe damage in the earthquake as seen in Fig. 21. Evidently the right-hand building leaned against the building on the left, which supported it and prevented it from collapse. The support was provided through the interconnecting staircase, which was damaged in the process as seen in Fig. 22.

Fig. 20. Two adjoining buildings in Maninagar; the interconnecting staircase allowed the building on the left to support the building on the right.

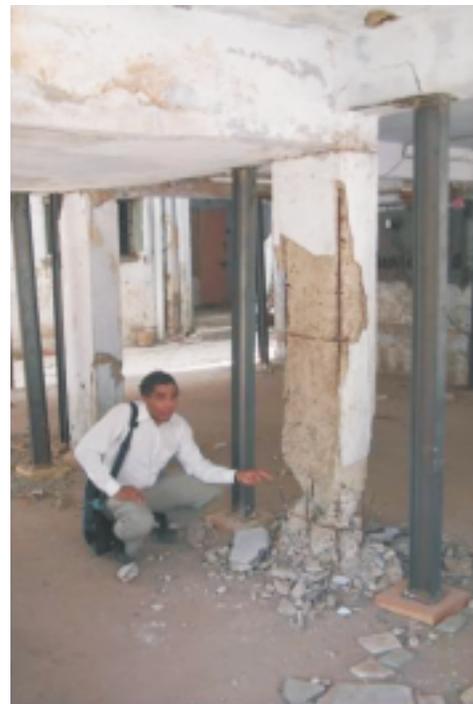
Fig. 21. The damaged first storey of the building on the right-hand side of Fig. 20.

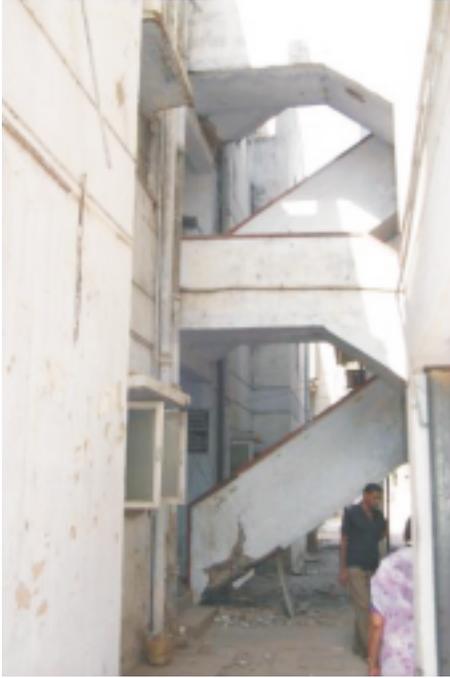
Fig. 22. The staircase interconnecting the two buildings in Fig. 20 allowed the building on the right to be supported by the building on the left.

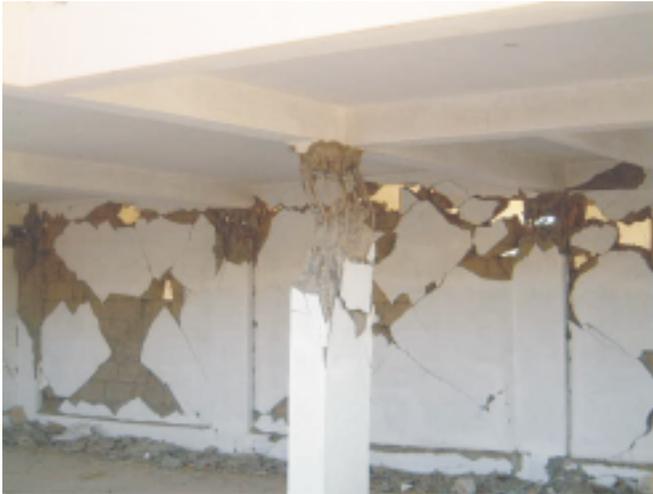
Figure 23 shows the first storey of a building in Anjar. The columns of this soft storey were heavily damaged in the hinge regions as seen from the figure. However, it appears that a few infill walls at this level protected the building against total collapse. Interaction between the columns and the walls damaged the latter quite severely as evidenced by

the large shear cracks in the wall panels. However, the panels did not fall out of their plane. It may be noted that the infill panels had no reinforcement, nor were they tied to the boundary elements.

Fig. 23. The hinge regions of the columns in the open first storey of this building in Anjar are heavily damaged; complete collapse of the building was prevented by the presence of a few infill walls, which although heavily damaged remained in their place.

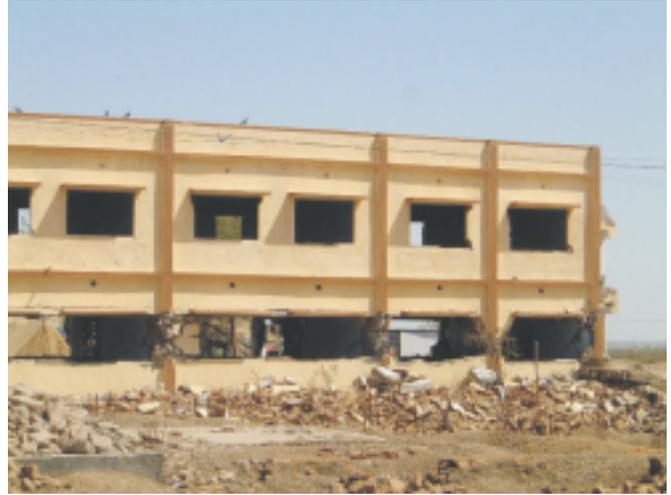
short column failures were evident following the Bhuj earthquake. Figures 24 and 25 show the failure of short columns in a school in Bhachau for sight-impaired children. The columns are restrained in one direction by partition walls built in stone blocks, but were unrestrained in the other direction. As will be noted from Fig. 25 the columns are quite slender and are reinforced by just four longitudinal Torsteel bars 15 mm in diameter and have widely spaced hoops of 6 mm plain steel bars.

Fig. 24. Failure of reinforced concrete short columns in a school in Bhachau.

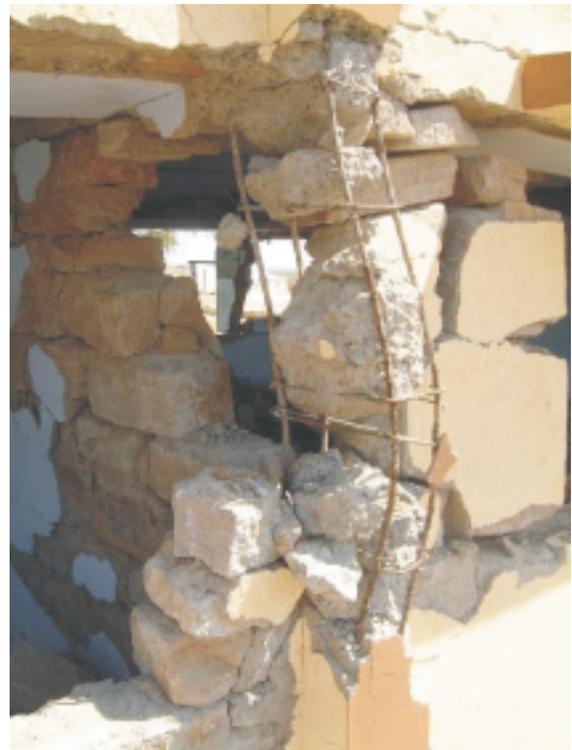
Fig. 25. Details of the short columns in the building shown in Fig. 24.

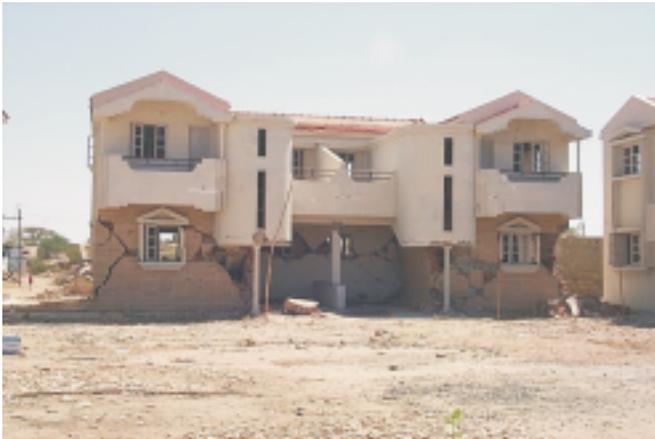
Figure 26 shows one of a row of newly built semi-detached houses in the town of Samkhiali near Bhachau. The developers had just finished constructing the bungalows, which were not yet occupied. As will be seen from Fig. 26, the fronts of the houses are open for a large portion of the first storey to provide space for parking. A very slender circular column (Fig. 27) supports the staircase leading to the floor above ground. A masonry perimeter wall at the back of the first storey provides considerable stiffness in its plane, creating a large torsional eccentricity. This eccentricity combined with an open floor and very slender supporting col-

Fig. 26. Row of semi-detached houses in Samkhiali; note the open spaces in the first storey, the masonry infill wall at the back, and the slender columns supporting the front of the building.

umns made the structure very vulnerable. All of the houses in the complex suffered extensive damage, and some actually crumbled.

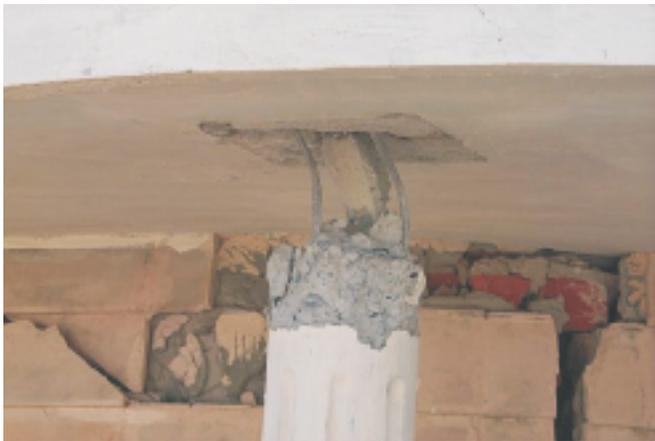
Fig. 27. Details of the column supporting the front of the building shown in Fig. 26.

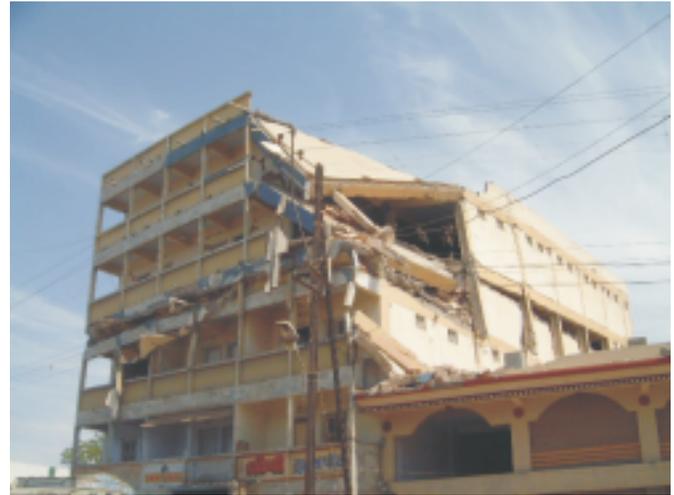
As another example refer to the six-storey reinforced concrete frame building shown in Fig. 28. The first three storeys of this building had been built earlier, the remaining three storeys being added subsequently. Evidently the connections between the structural columns of the two parts were not adequate and led to shear failure of columns at the junction.

Fig. 28. The fourth storey of this six-storey building in Bhuj collapsed bringing the topmost two storeys down and causing more extensive damage to one corner of the building.

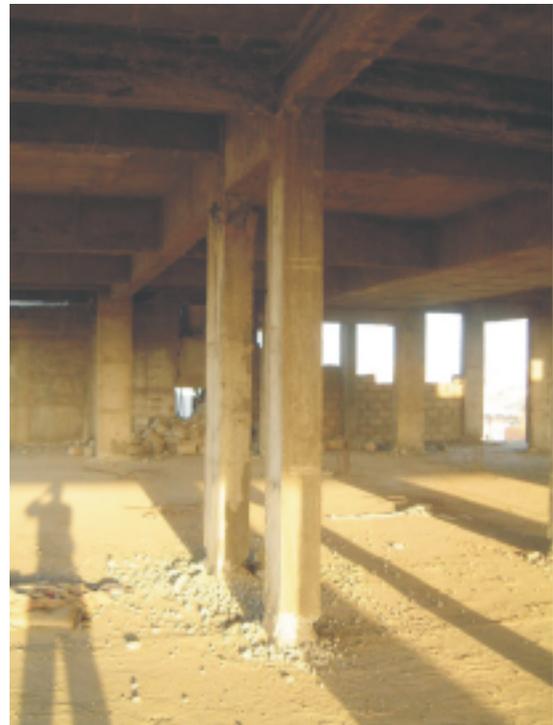
Previous observations have shown that a change in stiffness across the height of the building constitutes a location of weakness. An example of this is provided by the damage suffered by the building of Hotel Abha in Bhuj. At the time of the earthquake the first three storeys of the building had been completed, including the masonry infill walls. The concrete frame structure for the upper floors had been constructed, but the walls had not been built. During the earthquake the concrete columns at the transition between the completed portion and the bare concrete frame suffered damage as seen from Fig. 29. The columns, however, had

Fig. 29. Damage suffered by the columns in the partially completed upper floor of the Abha building in Bhuj.

sufficient ductility to sustain the displacement imposed by the earthquake.

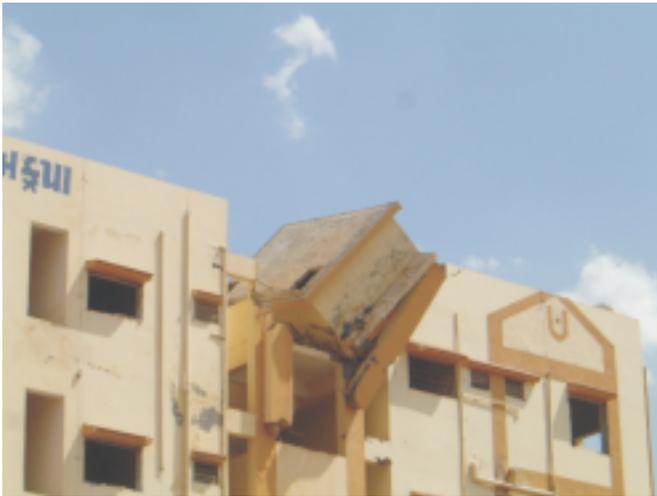
In the concrete frame residential buildings in Gujarat it is a common practice to place a water storage tanks at the top of the building. The tank is constructed in reinforced concrete and is usually supported by short concrete columns projecting above the roof level. The storage capacity of the tank depends on the size of the building but is of the order of 20 to 25 000 L. Many of these tanks were filled with water at the time of the earthquake. In many instances the sup-

Fig. 30. A water tank supported by four short columns projecting above the roof collapsed during the earthquake.

porting columns were unable to sustain the large seismic shear and failed. An example is presented in Fig. 30.
