The August 17, 1999, Kocaeli (Turkey) earthquake — damage to structures

Murat Saatcioglu, Denis Mitchell, René Tinawi, N. John Gardner, Anthony G. Gillies, Ahmed Ghojarah, Donald L. Anderson, and David Lau

Abstract: The 1975 Turkish code provisions are first reviewed to provide the background for design and detailing of structures prior to the earthquake. The performance of reinforced concrete and masonry structures is described indicating many of the deficiencies in design, detailing, and construction execution. The behaviour of precast concrete structures, steel structures, and industrial facilities is also presented. The provisions of the 1997 Turkish building code are summarized and a description of new construction provides evidence of both excellent and poor construction practice. Some examples of retrofitting of damaged structures soon after the earthquake are also presented.

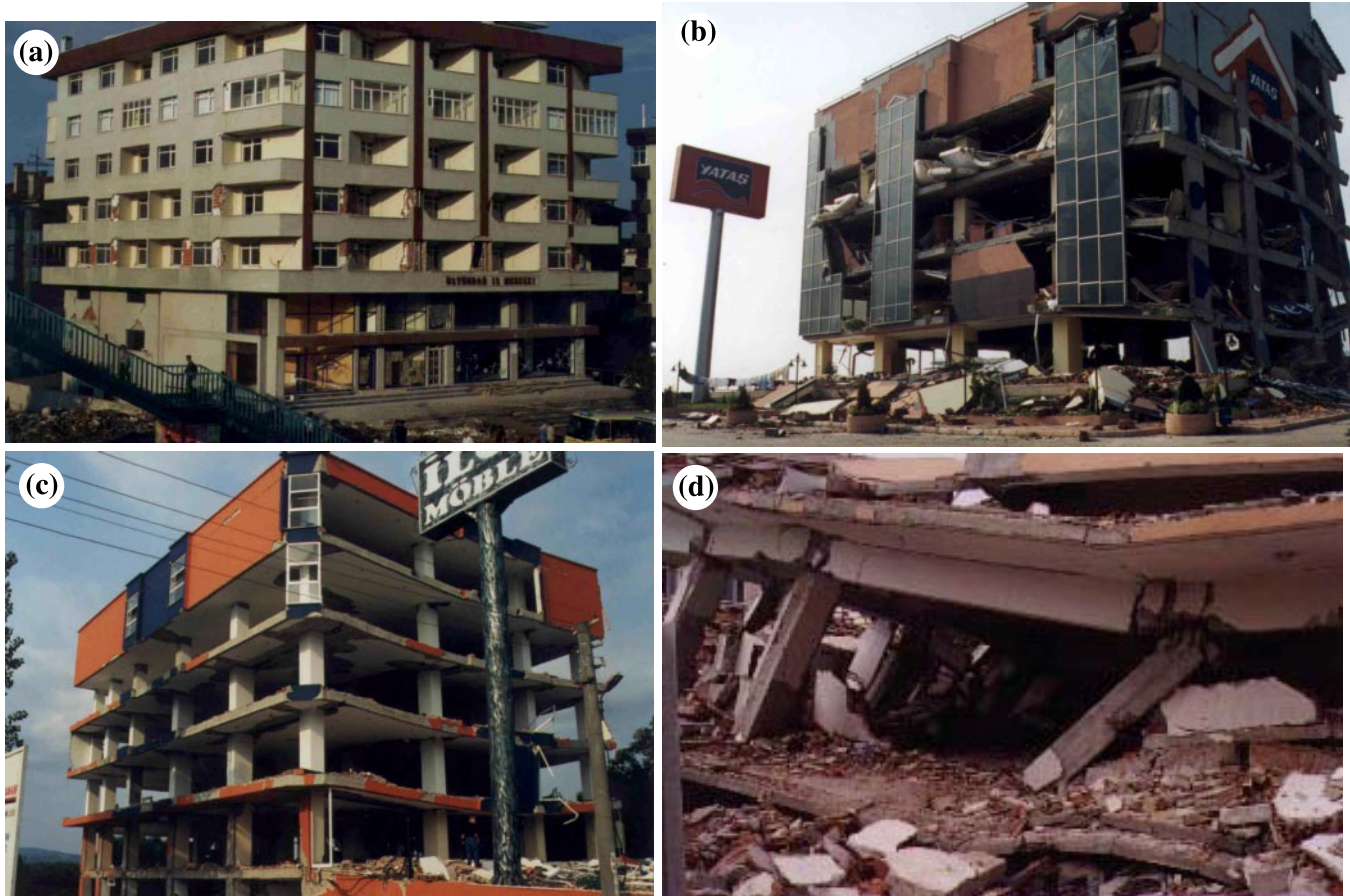
Fig. 2. Different levels of contribution of masonry infills to reinforced concrete frame responses: (a) limited masonry damage; (b) extensive damage to masonry, no apparent distress in frames; (c) total masonry damage with some distress in first-storey columns; (d) total damage to masonry and structural collapse.

Lateral bracing for reinforced concrete frame structures was provided by unreinforced brick and (or) concrete masonry walls. The brick masonry used was often in the form of unreinforced hollow architectural blocks. During the earthquake, these walls were able to participate in lateral load resistance to varying degrees and were often damaged prematurely, developing diagonal tension and compression failures or out-of-plane failures. The degree of lateral load resistance depended on the amount of masonry used and the framing system provided. In contrast to modern moment resisting frames of North American practice, the use of light partitions, such as dry walls, was not common in the earthquake-stricken areas. Instead, masonry was used extensively for interior partitioning, as well as exterior enclosure of buildings, increasing wall-to-floor area ratios. Therefore, in spite of lower strength and expected brittleness of this type of masonry walls, the frames did benefit somewhat from such extensive use of masonry until the threshold of elastic behaviour was exceeded. Beyond the failure of brittle masonry, there was no lateral load resisting system with sufficient stiffness to control lateral drift, thereby resulting in high drift demands on the frame members. Figure 2 illustrates different degrees of masonry failure, resulting in partial damage, severe damage, and collapse of the frame structure.

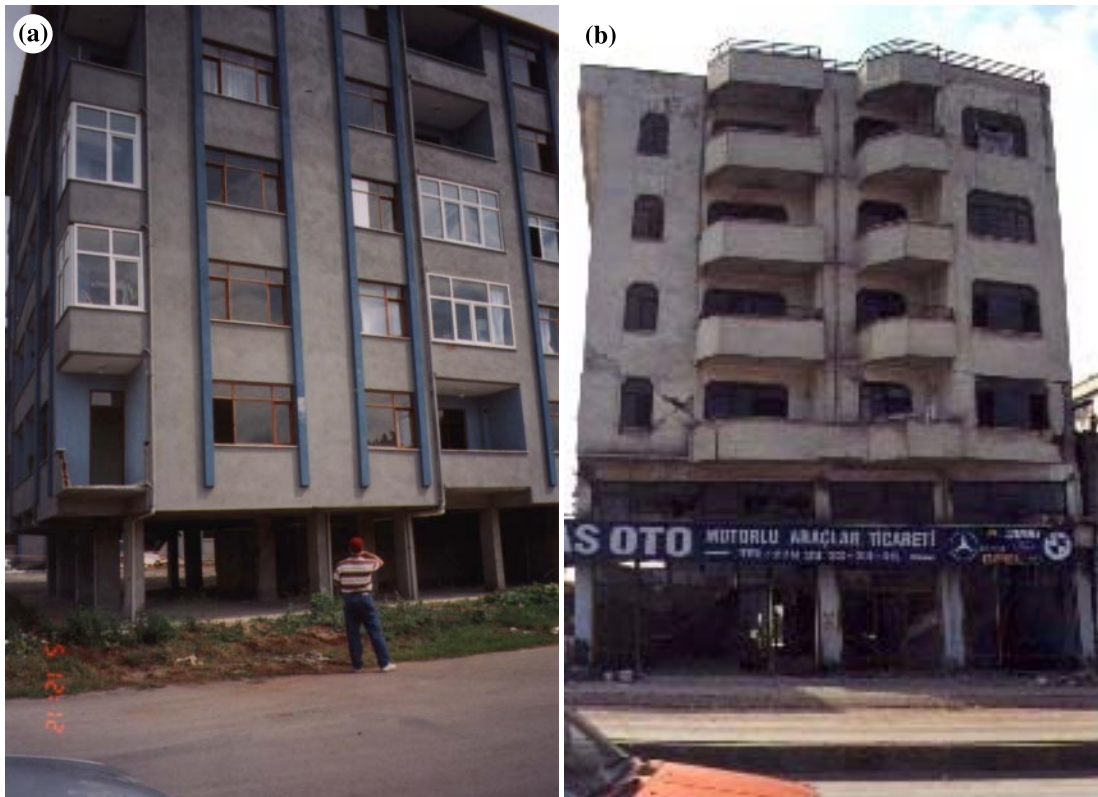
Fig. 3. Examples of soft storey reinforced concrete buildings.

Most buildings in Turkey are designed to have commercial space at the first-storey level, generally used for stores, as illustrated in Fig. 3. Furthermore, many buildings have a larger floor area above the ground-storey level. Both of these features result in soft storeys at the street level and added mass above the ground-storey level, placing excessive deformation demands on the highly critical first-storey columns.

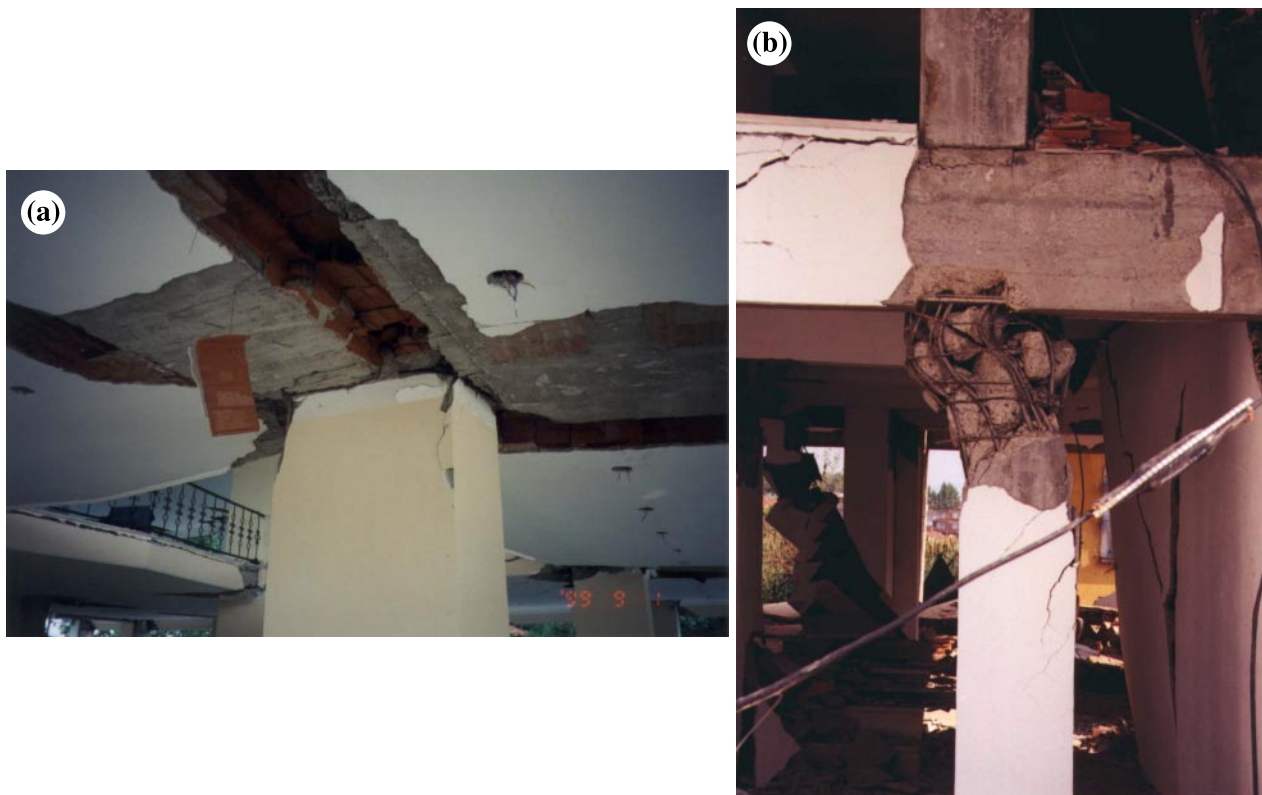
Fig. 4. Use of “Asmolen” one-way slab system and resulting strong beam and weak columns: (a) “Asmolen” concrete slab system and (b) strong-beam weak-column connection.

Another reason for increased seismic demands on structures was the common use of a structural slab system called *Asmolen*. This is a one-way slab system, consisting of concrete joists with masonry units placed in between the joists, forming a deep structural slab system, as illustrated in Fig. 4a. Columns used are usually smaller in size, resulting in flexible and weak vertical elements relative to the adjoining horizontal members at beam-column joints. This system, totally in violation of the strong-column weak-beam design philosophy, places heavy deformation demands on the columns, especially at the first-storey level, increasing storey drifts and forcing hinging to occur in the columns. Figure 4b shows column damage resulting from a strong-beam weak-column connection.

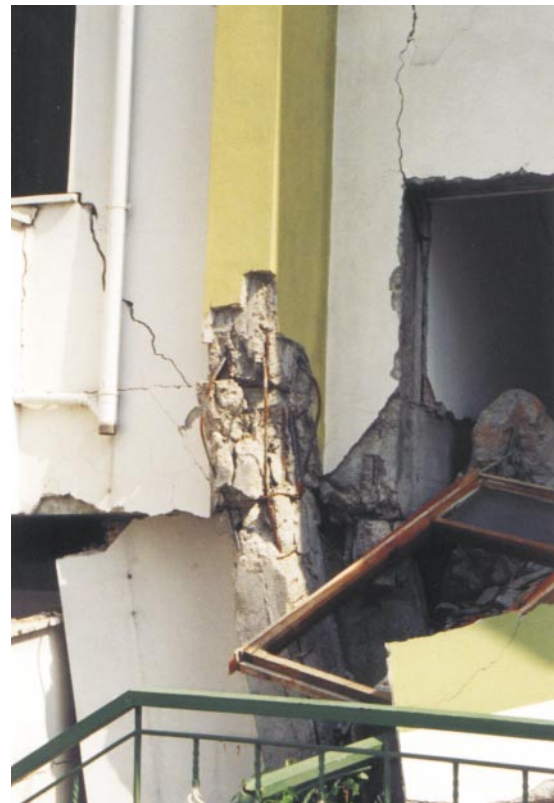
Fig. 5. Lack of transverse reinforcement in concrete columns.

multistorey buildings. The columns sustained heavy damage mostly because of lack of sufficient transverse reinforcement. The transverse reinforcement consisted of 8 mm diameter smooth reinforcement, generally placed at 300 mm or wider spacing. In some buildings some of the ties were left out as illustrated in Fig. 5. The ties did not appear to be sufficient either in terms of amount or detailing. This resulted in widespread column shear failures as illustrated in Fig. 6. In the majority of cases, the transverse reinforcement was limited to perimeter ties with 90° hooks. Columns that were subjected to heavy axial compression and flexural compression resulted in the crushing of concrete due to lack of confinement. Figure 7 shows additional examples of column damage caused by lack of sufficient transverse reinforcement, this time resulting in compression crushing rather than diagonal tension failures. First-storey column failures accounted for the majority of building collapses and hence a significant portion of the overall casualties.

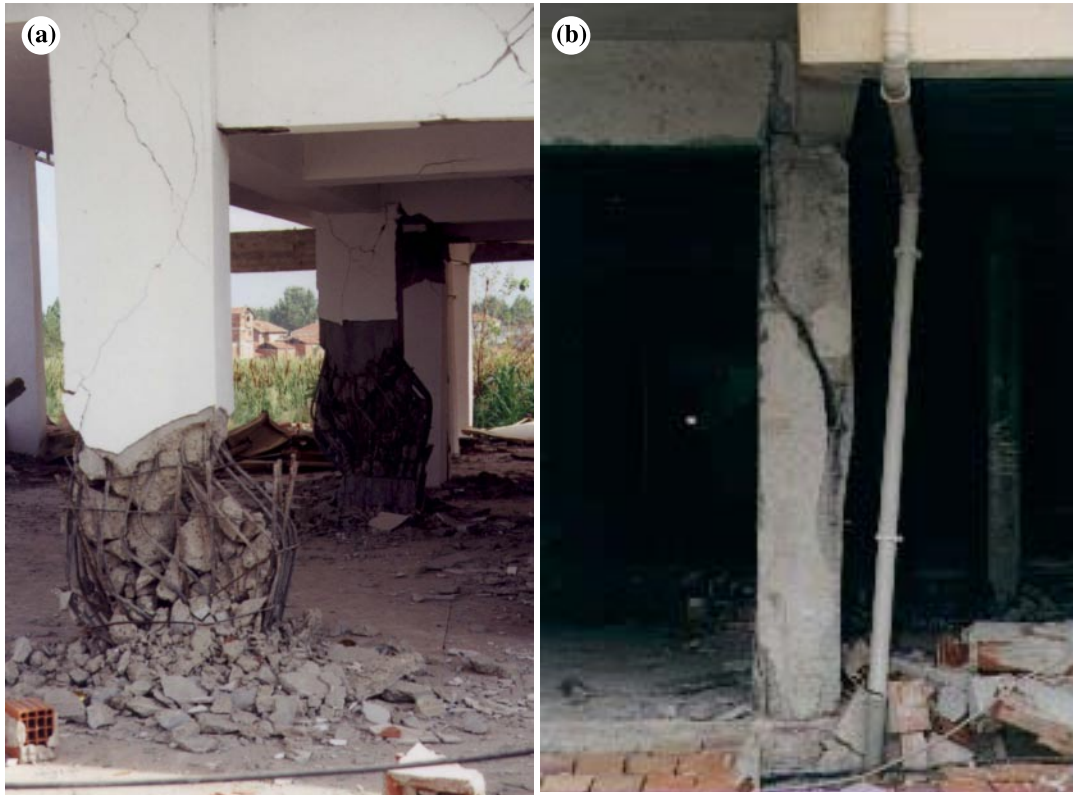
Fig. 6. Lack of transverse shear reinforcement and resulting diagonal tension failures.

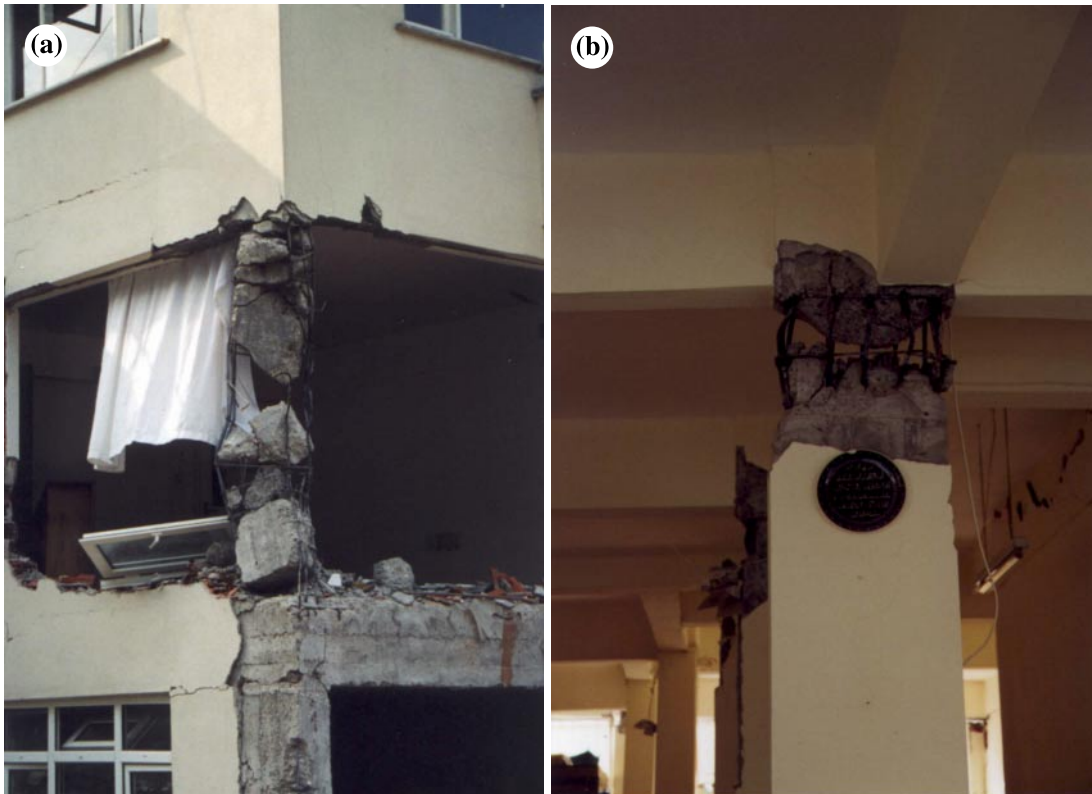
Fig. 7. Lack of column confinement reinforcement and resulting crushing.

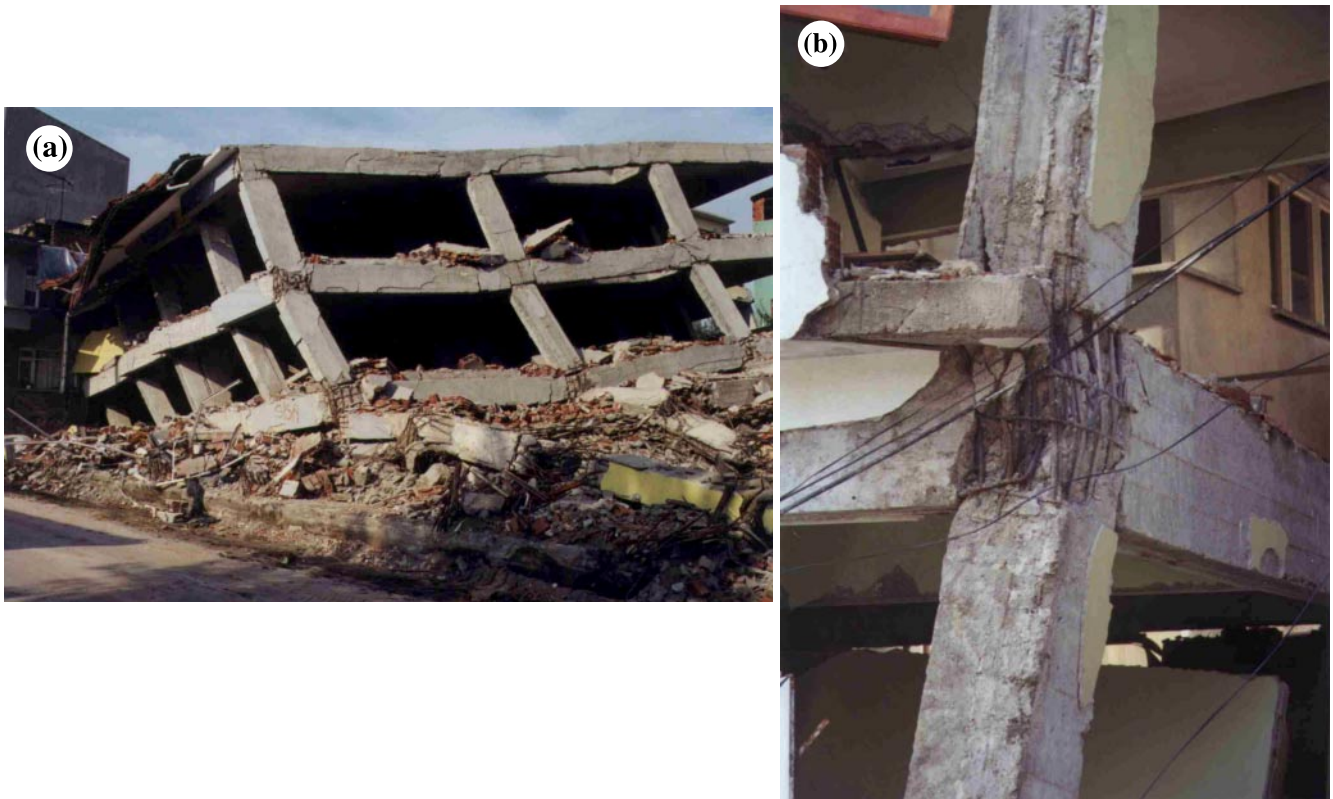
The lack of transverse reinforcement was also observed in monolithic beam-column connections. Beam-column connections in the majority of buildings did not contain any transverse reinforcement, suggesting that joint shear design was never a consideration in these buildings. Figure 8 illustrates damage to beam-column connections lacking joint reinforcement.

Fig. 8. Lack of joint reinforcement and resulting failures in beam–column connections.

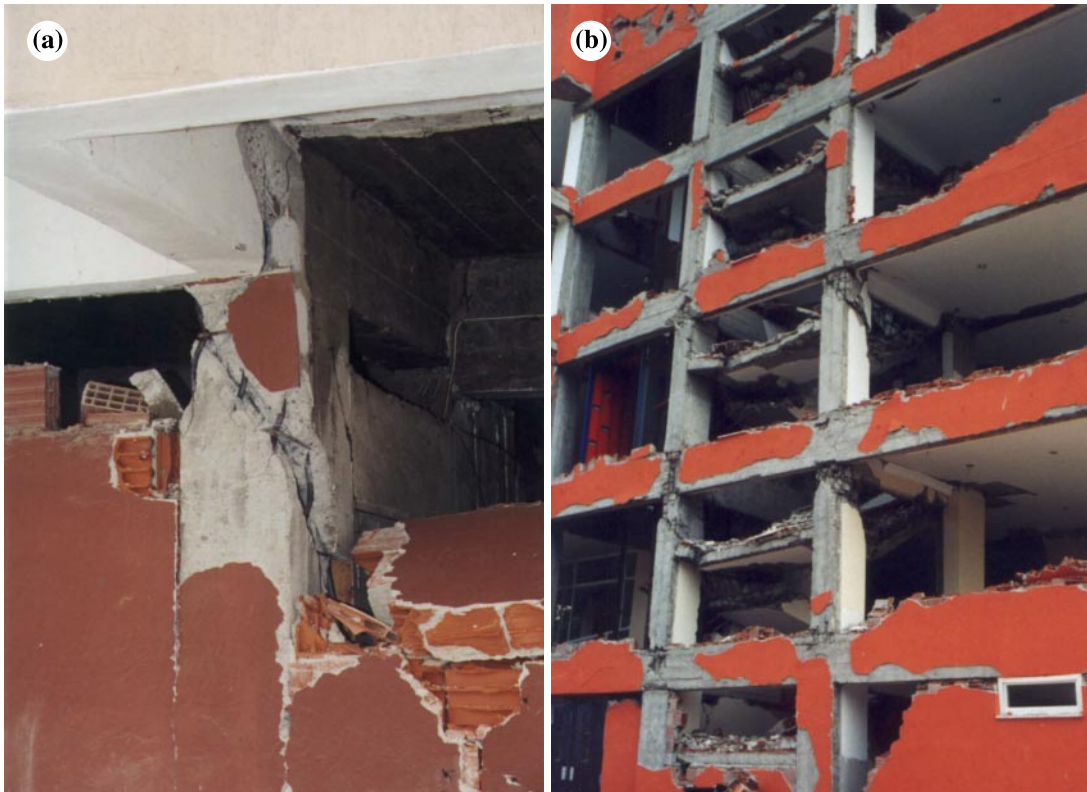
Fig. 9. Interference of non-structural elements with lateral load resisting system: (a) short column effect and (b) interference of stairway landing slabs.

sociated with reduced unsupported height suffered brittle shear failures as depicted in Fig. 9a. In some buildings, the landing slabs of staircases were connected to columns, and either applied unexpected lateral forces or caused short column effects as shown in Fig. 9b.

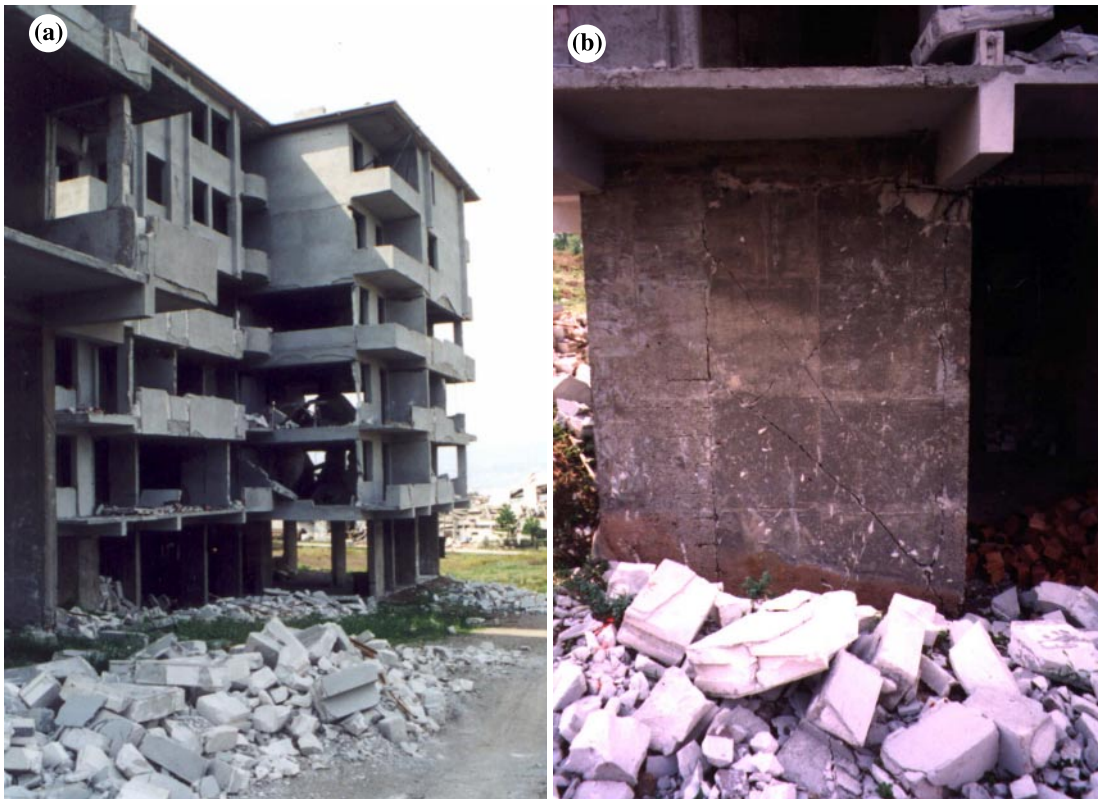
Fig. 10. Frame shear wall building with lightweight concrete masonry blocks: (a) apartment building with narrow shear walls and (b) diagonal tension cracks in shear wall.

Use of reinforced concrete shear walls is limited in Turkey, especially in older buildings. A number of buildings were found with walls having cross sections with relatively small aspect ratios, which in some cases resembled elongated rectangular columns. These buildings performed reasonably well. Figure 10 illustrates an apartment complex under construction with lightweight concrete masonry units and this type of walls. These buildings survived the earthquake with minor damage to the structural framing system, but major damage to the masonry. Figure 10b shows a shear wall in this complex that developed diagonal shear cracks wide enough to suggest some yielding of the reinforcement, survived the earthquake, and saved the structure. There were other shear wall buildings with older and significantly lower

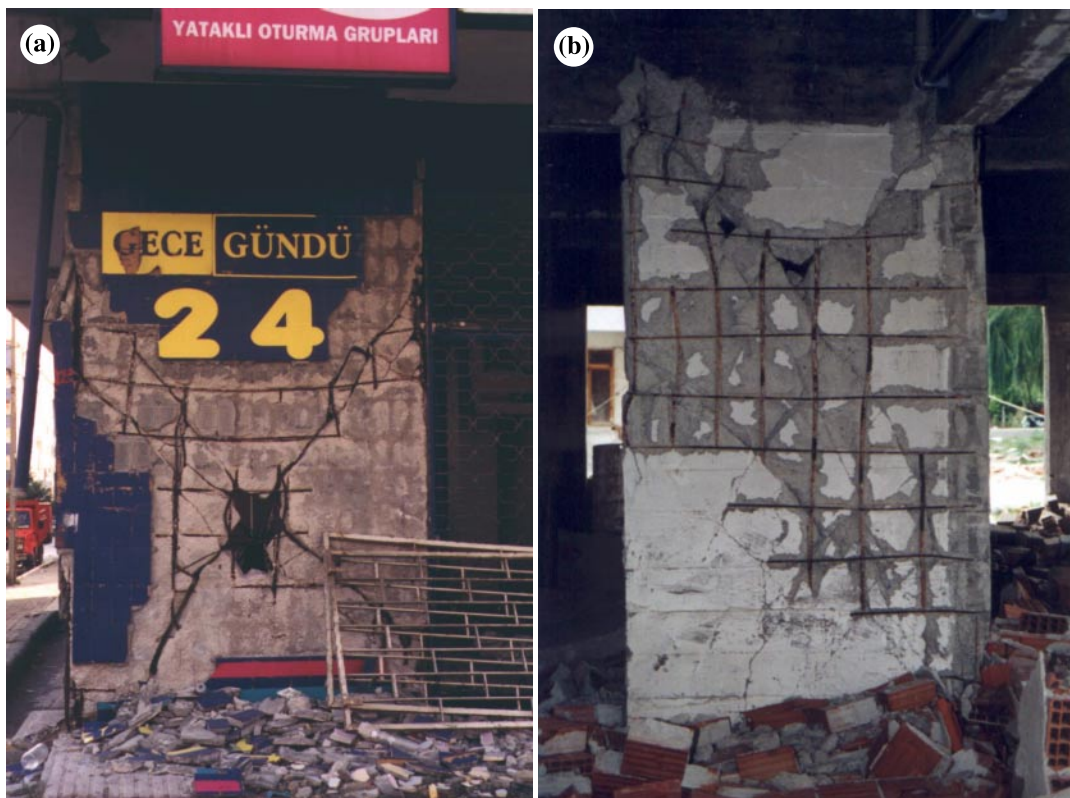
Fig. 11. Excessive damage caused by shear in older shear walls.

quality concrete. Although the concrete in these walls was damaged extensively, the shear walls did save the structures from collapsing. This is illustrated in Fig. 11.

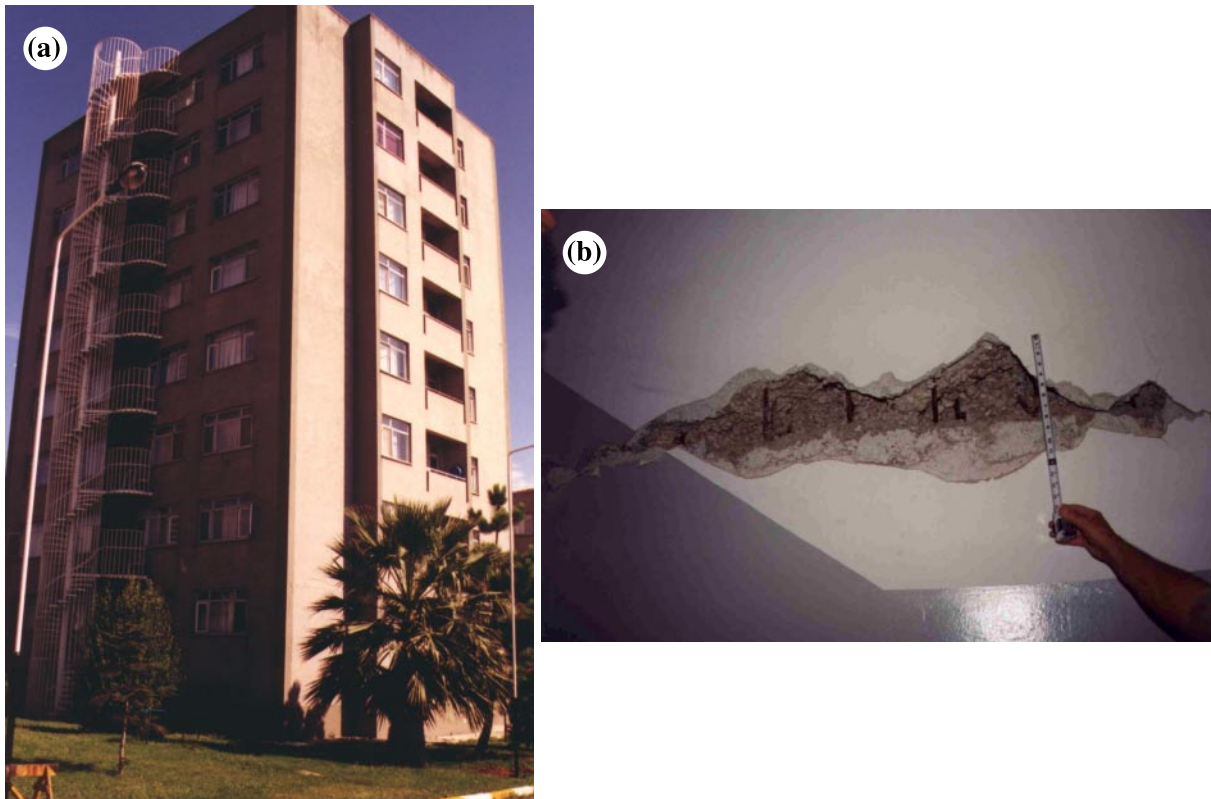
Fig. 12. Frame wall building in Izmit without significant damage: (a) exterior view and (b) structural wall with concrete placement problem.

Properly designed and detailed shear wall structures performed exceptionally well even in regions close to the fault. Figure 12a shows the overall view of an apartment building within the Tupras Oil Refinery in Izmit, which performed well except for minor damage at a cold joint in one of these walls due to poor concrete placement (see Fig. 12b).

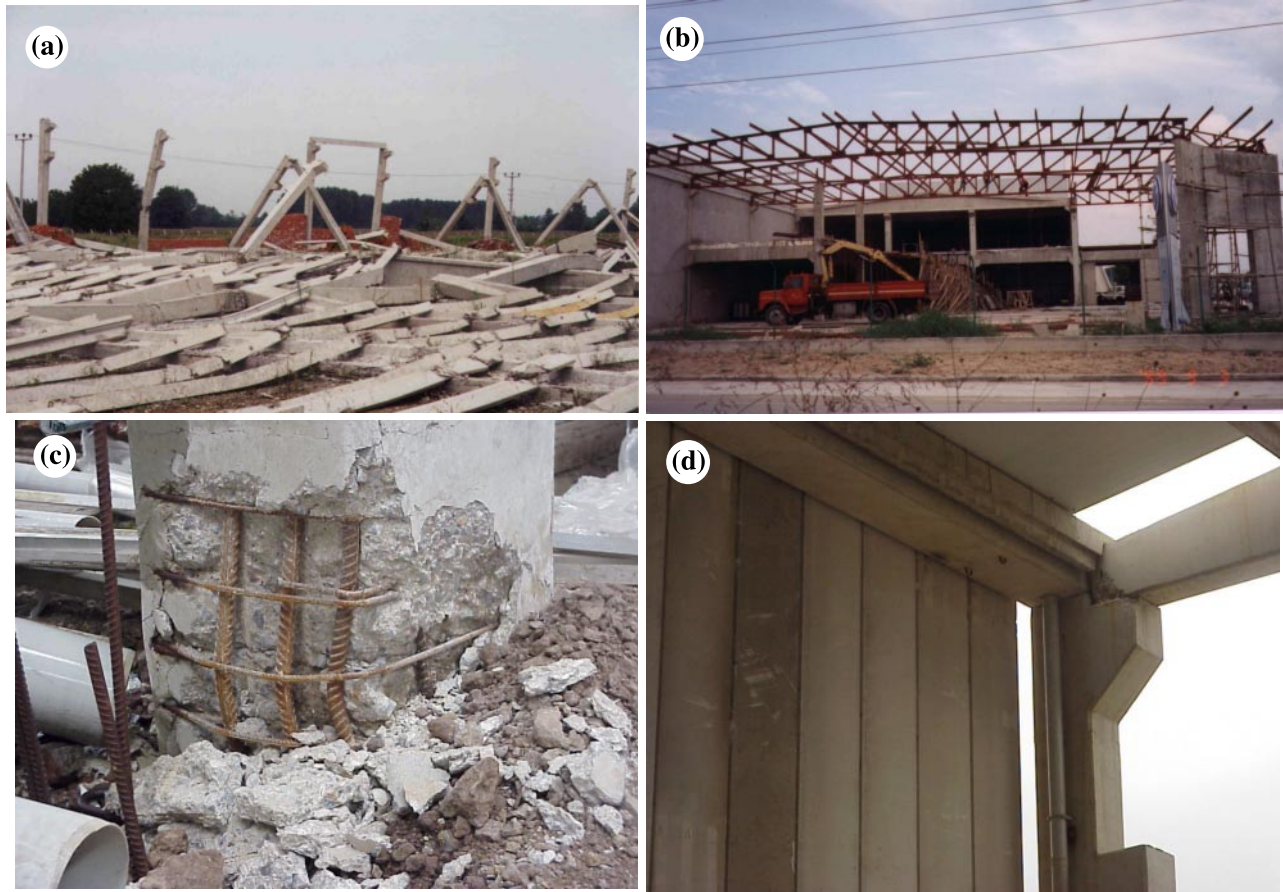
A significant number of precast concrete industrial structures are located in the epicentral area. In general, the precast structures did not fair well during this earthquake. Figure 13 provides an interesting contrast between two structures that totally collapsed and an adjacent structure that remained standing. These three structures are located in the industrial park region of Yeni Sanayi about 2 km from the fault. The two structures that collapsed were still under construction with only bare frames, without any roof diaphragms and without the side panels. These unfinished structures had inadequate connections between the columns and the beams and many of the columns failed at their bases as shown in Fig. 13c. The third structure was identical to the ones that collapsed, but the structural wall panels and roof diaphragms were completed. This structure underwent only slight hinging at some columns near their bases, with some evidence of connection distress at one beam–column joint (see Fig. 13d).

Fig. 13. Two precast concrete industrial buildings under different stages of construction: (a) incomplete building with frame elements only; (b) building with bracing walls in place; (c) shear distress at base of column; (d) distress at beam–column joint.

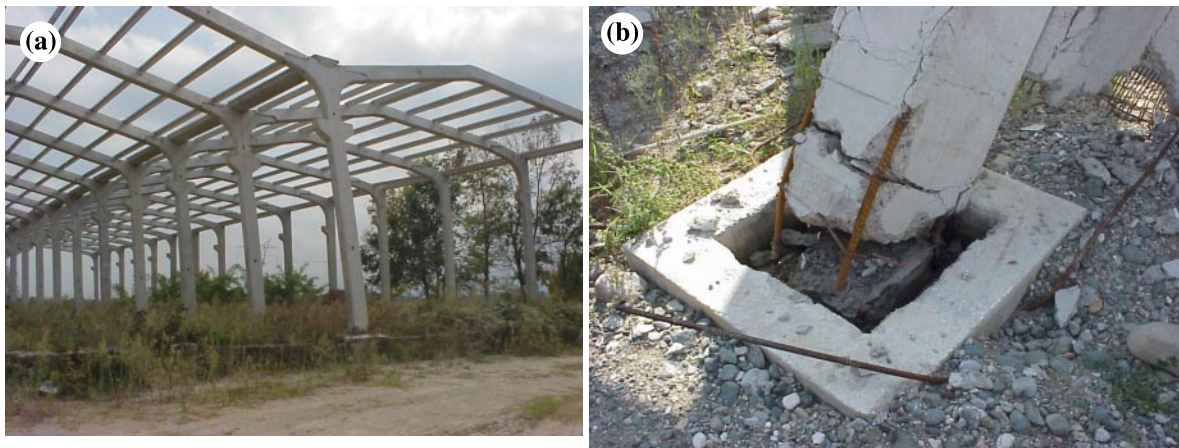
Fig. 14. Typical precast industrial building: (a) frame with short cantilevers supporting cranked beam and (b) column socket at base.

Figure 14a shows one form of construction for precast industrial buildings that was very common in Turkey. This construction consists of precast columns with short cantilevers, which support cranked beams and, in turn, support precast stringers. The precast columns are fixed at their bases, since they are grouted into sockets in the foundation perimeter wall footing as shown in Fig. 14b. The damage at the base of the central columns is partly due to the lack of diaphragm action in this unfinished structure. Figure 15a illus-

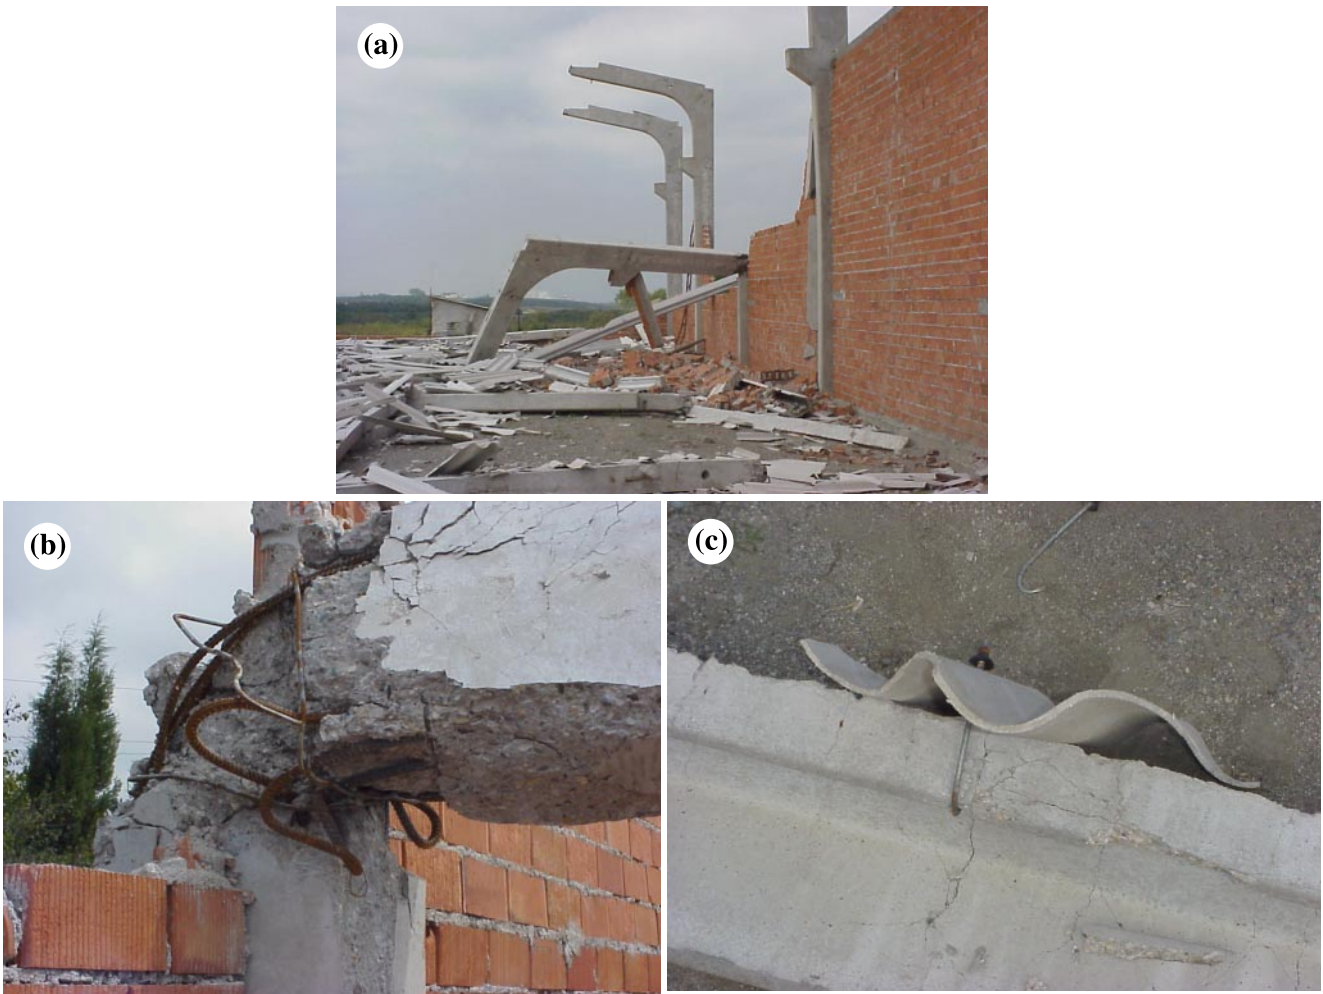
trates the complete collapse of a similar precast structure that was completed before the earthquake. The main reasons for the collapse are the following:

- (i) The presence of partial height masonry infills led to failure in some columns at the level of the top of the damaged infills where the columns contained splices of the vertical bars.
- (ii) The columns contained inadequate confinement (see Fig. 15b).

Fig. 15. Collapse of completed precast industrial building: (a) influence of partial height masonry infills; (b) inadequate confinement in columns; (c) thin corrugated fibre concrete diaphragm.

- (iii) The diaphragm consisted of very thin corrugated fibre-concrete panels with very flexible clip-on fasteners as shown in Fig. 15c.
- (iv) The following connection failures took place: cantilever-column, cantilever-beam, and beam-stringers connections.

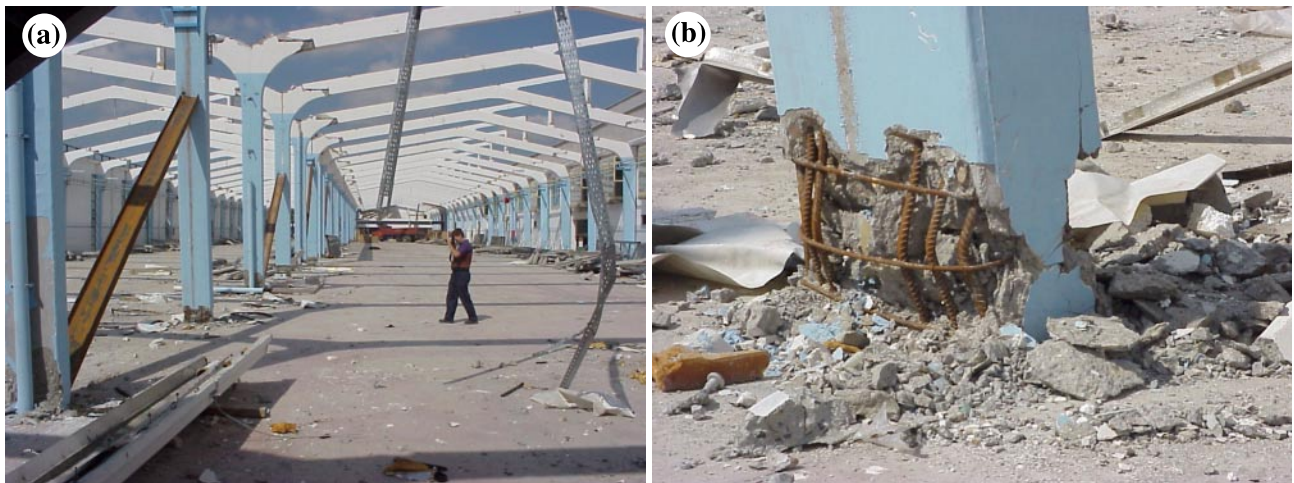
Fig. 16. Severe damage to frames of precast warehouse structure: (a) large deformation of columns and (b) flexural hinging at column base.

Figure 16a shows the severe damage to another industrial structure. Figure 16b shows the significant flexural hinging that occurred at the base of one of the interior 400×450 mm columns in an industrial precast building. The vertical reinforcement consisted of 4–20 mm diameter bars. The column ties consisted of 8 mm diameter deformed bars, spaced at 150 mm. The ties were anchored with 135° bends and had free end extensions of 60 mm. Other columns along the centre line were 260×510 mm, which suffered flexural hinging about their weak axis. Another deficiency of this type of construction is the connection between the double cantilever heads to the interior columns. Figure 17a shows a double cantilever head, in a building in the same industrial park, which has collapsed as a result of failure of the bolted connection to the column. Figure 17b shows the connection bolts for the double cantilever head after the failure. A different structural system in the same industrial park utilized pretensioned long-span tapered beams which fitted into slots formed at the top of the interior and exterior columns. Figure 18a shows the failure of a precast industrial building which experienced large lateral drift at the roof level. Figure 18b shows an interior column where loss of support for the beam has occurred due to the extremely large lateral drift at the top. Figure 18c shows the significant flexural hinging over a height of about 800 mm from the base of one of the interior columns. The 450×450 mm column had 2–20 mm diameter vertical bundled bars in each corner. The column ties consisted of 6 mm diameter plane bars at 100 mm spacing. The ties were anchored with 90° bends with 120 mm

free end extensions. Although the column behaved in a very ductile manner, the lack of proper diaphragm action and inadequate connections between the beams and the columns contributed to the collapse.

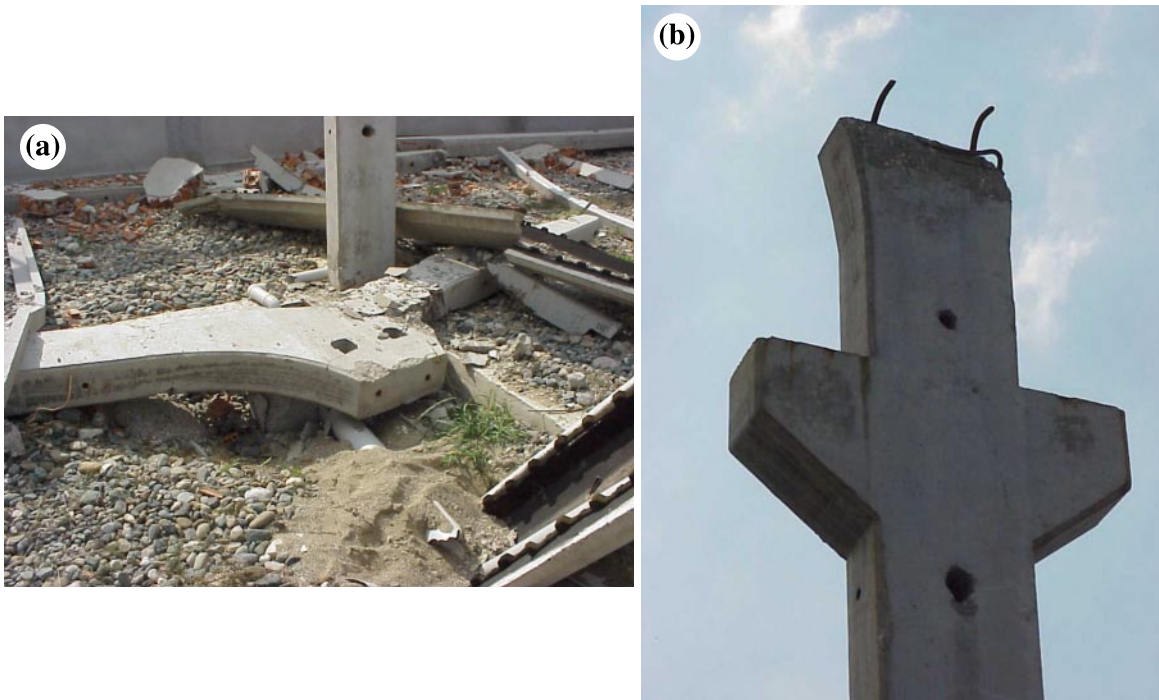
Fig. 17. Collapse of industrial building: (a) failure of double cantilever and (b) failure of connection.

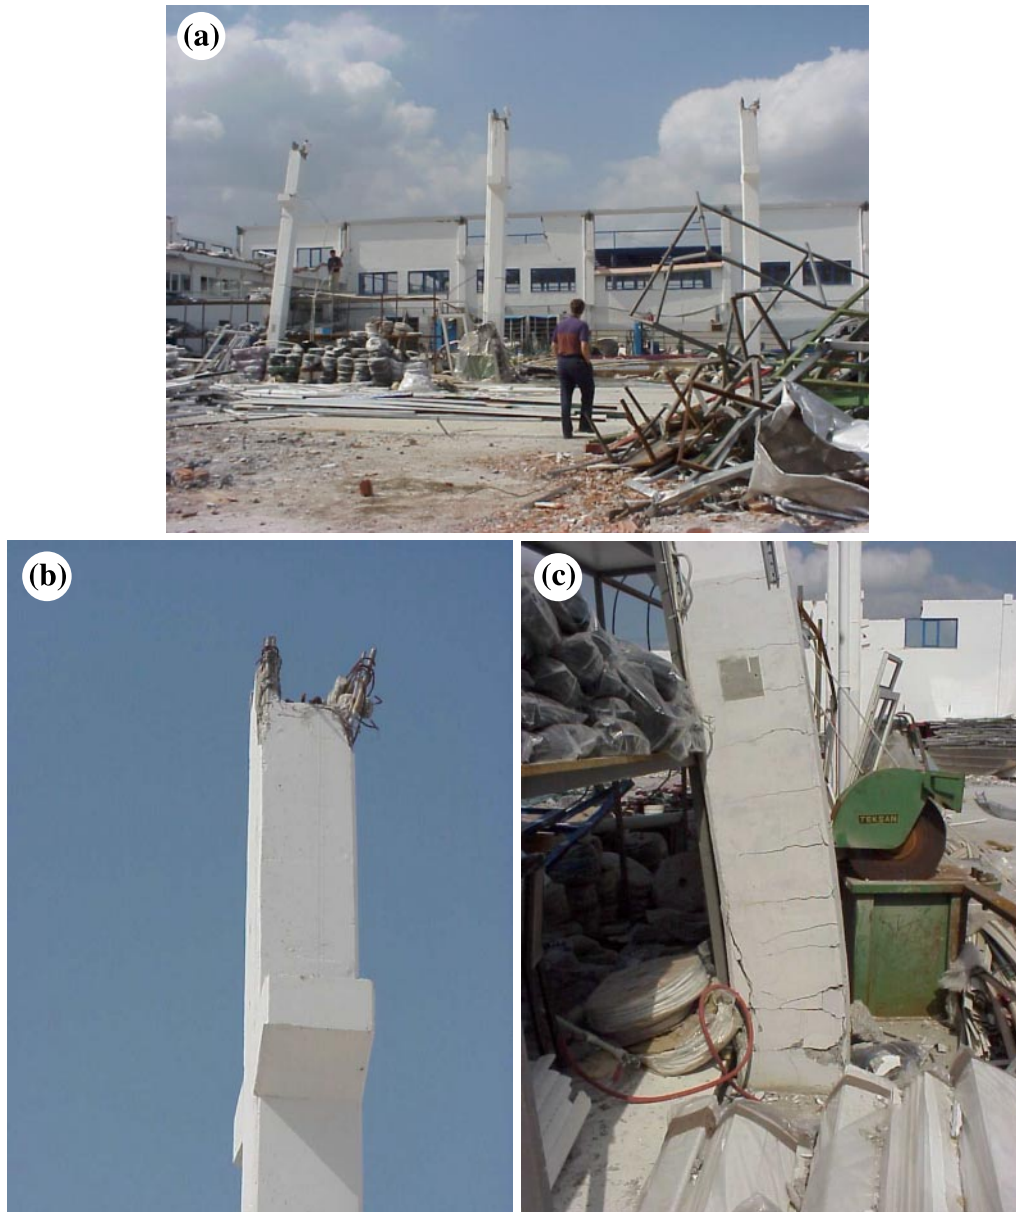
Fig. 18. Failure of industrial precast building: (a) evidence of large displacements at tops of columns; (b) loss of beam support in column slotted connection; (c) severe hinging at base of column.

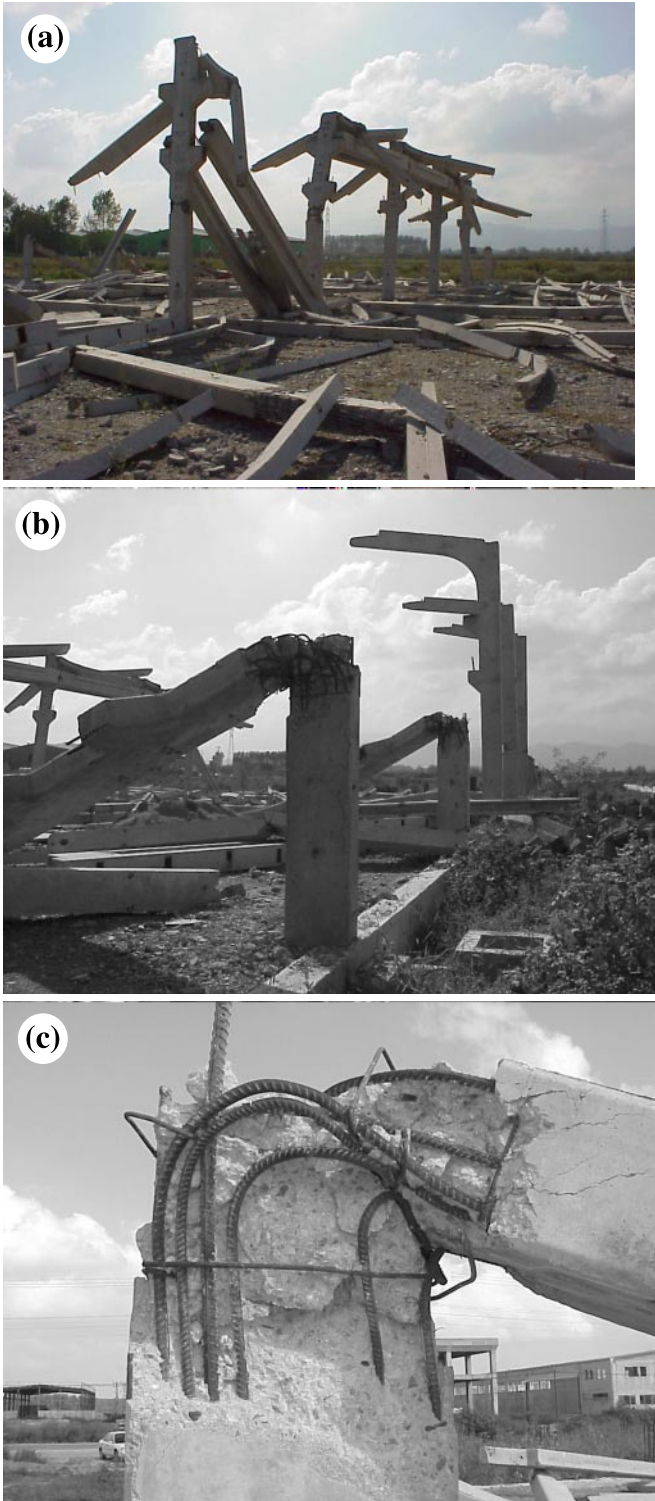
Figures 19a and 19b illustrate another type of failure that occurred in precast columns within the industrial area between Izmit and Adapazari. The complete failure of this unfinished structure was due to the absence of diaphragm action, failure of the double cantilever to column connections (see Fig. 19a) and mid-height column failures (see Fig. 19b). Figure 19c shows a mid-height failure. The vertical reinforcement of the 260×510 mm rectangular columns consisted of 12–15 mm diameter continuous bars and 4–20 mm diameter bars that were curtailed at the top of the failure zone. The transverse reinforcement consisted of 6 mm diameter plain ties at a spacing of 175 mm. The transverse hoops were anchored with 135° bends into the core.

Fig. 19. Complete collapse of unfinished precast structure:
 (a) failure of double cantilevers; (b) mid-height column failures;
 (c) close-up of column failure.

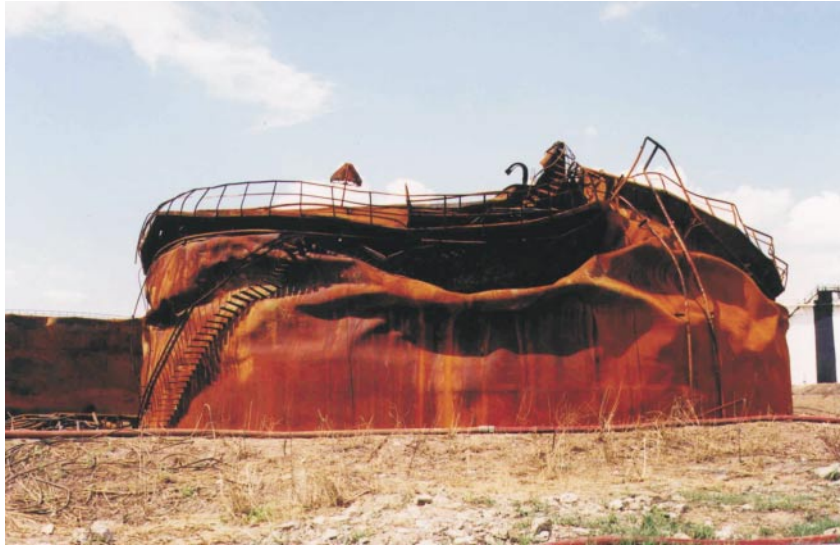
Fig. 22. Tank damage caused by fire.

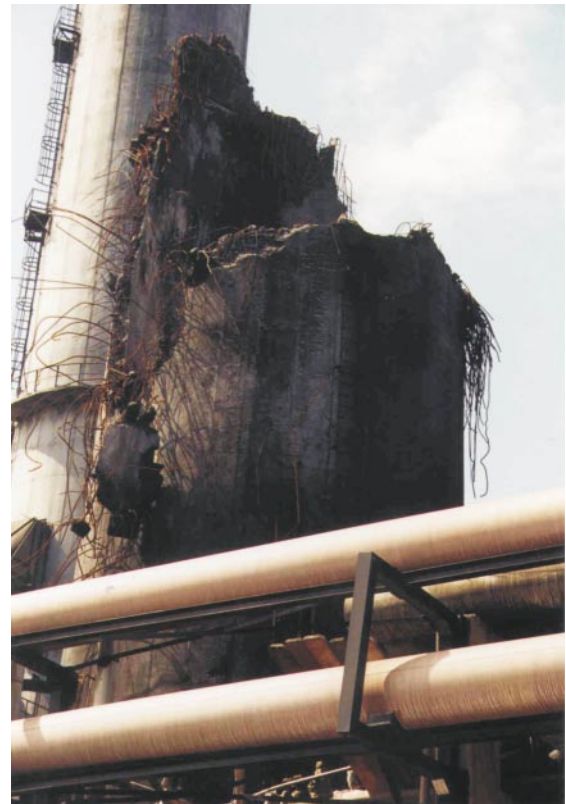
Many industrial facilities suffered damage and interruption of operations as a result of the earthquake. The most significant damage occurred at the Tüpras refinery (Izmit), which supplies 96% of the country's requirement of petroleum products. Three separate fires started due to the earthquake, one of which took several days to bring under control with substantial fire damage. Figure 22 illustrates the extent of tank damage in one of the four tanks, inflicted by the fire. The main fire was caused by a pipe rupture during the earthquake, exposing oil products at extreme temperatures to oxygen. One of the fires started because of the collapse of a 115 m high reinforced concrete chimney that ruptured pipes carrying hot H_2S gas which only needed oxygen to ignite, as illustrated in Figs. 23 and 24. The failure occurred at about one-third of the height from the base due to the additional

Fig. 23. Chimney failure at Tupras Oil Refinery.

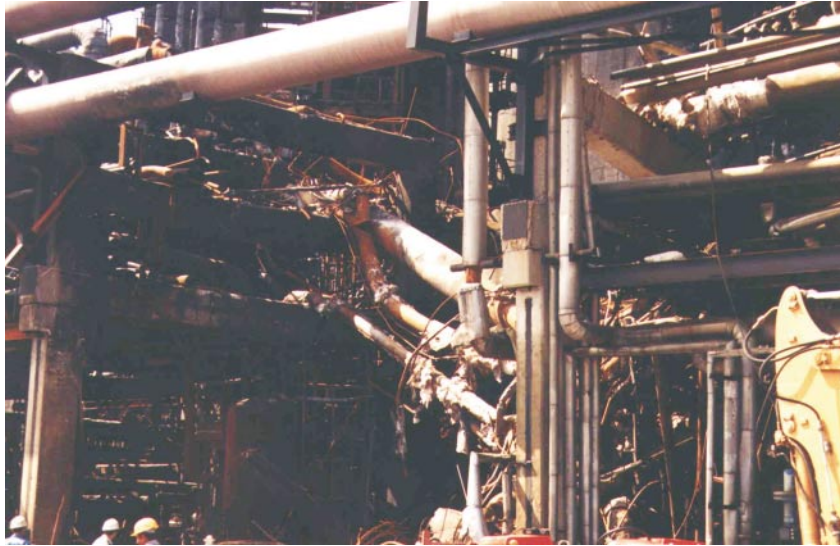
support provided by connecting pipes at this level. The refinery suffered ruptures of many pipes due to large displacements. Over 60 main pipeline systems were broken. Damage to the liquid storage tanks in the refinery was extensive. About 80% of the tanks suffered from various types of failure such as buckling of the supports of elevated tanks, buckling of the tank walls, and elephant foot buckling of the tank wall near the base, as depicted in Figs. 25–28. Many tanks suffered damage to the floating roof system with the consequence of liquid spillage with associated increased fire hazard. Several tanks were destroyed by the fire. An interesting mode of failure of several tanks is the bulging inwards and outwards of the roof causing internal suction resulting in inward deformation of the walls. One of the tanks that suffered roof damage had a diameter of 27.4 m and a height of 12.8 m and was filled to the 12 m level at the time of the earthquake. Other civil works in the refinery

Fig. 24. Pipe ruptures caused by chimney failure.

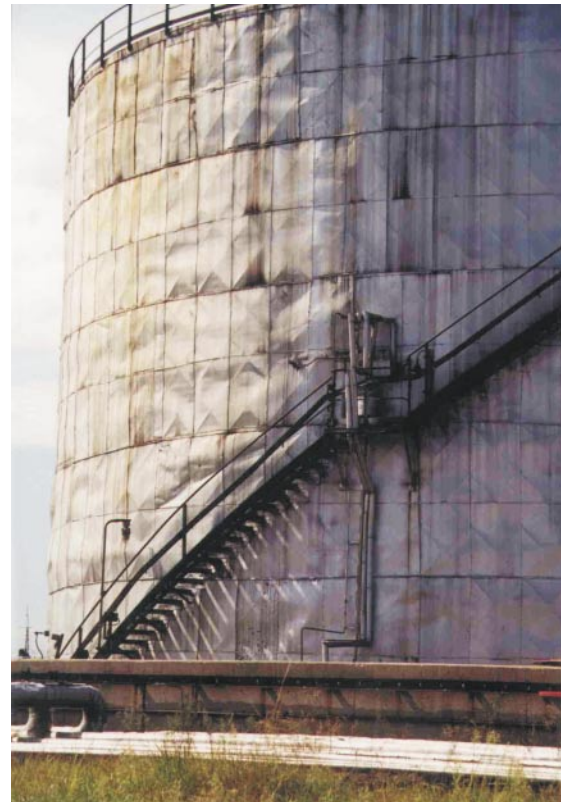
Fig. 25. Wrinkling of tank wall.
