The August 17, 1999, Kocaeli (Turkey) earthquake — damage to structures

Murat Saatcioglu, Denis Mitchell, René Tinawi, N. John Gardner, Anthony G. Gillies, Ahmed Ghojarah, Donald L. Anderson, and David Lau

Abstract: The 1975 Turkish code provisions are first reviewed to provide the background for design and detailing of structures prior to the earthquake. The performance of reinforced concrete and masonry structures is described indicating many of the deficiencies in design, detailing, and construction execution. The behaviour of precast concrete structures, steel structures, and industrial facilities is also presented. The provisions of the 1997 Turkish building code are summarized and a description of new construction provides evidence of both excellent and poor construction practice. Some examples of retrofitting of damaged structures soon after the earthquake are also presented.

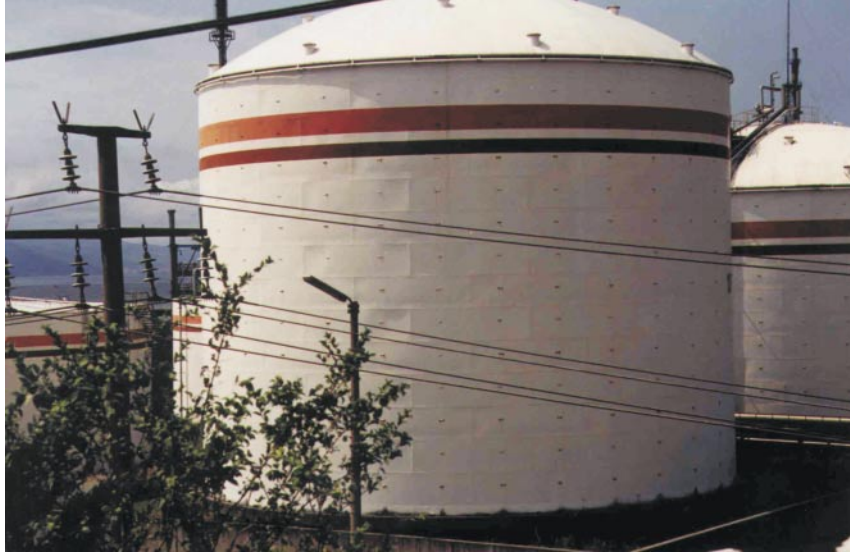
Fig. 26. Local buckling of steel tank wall.

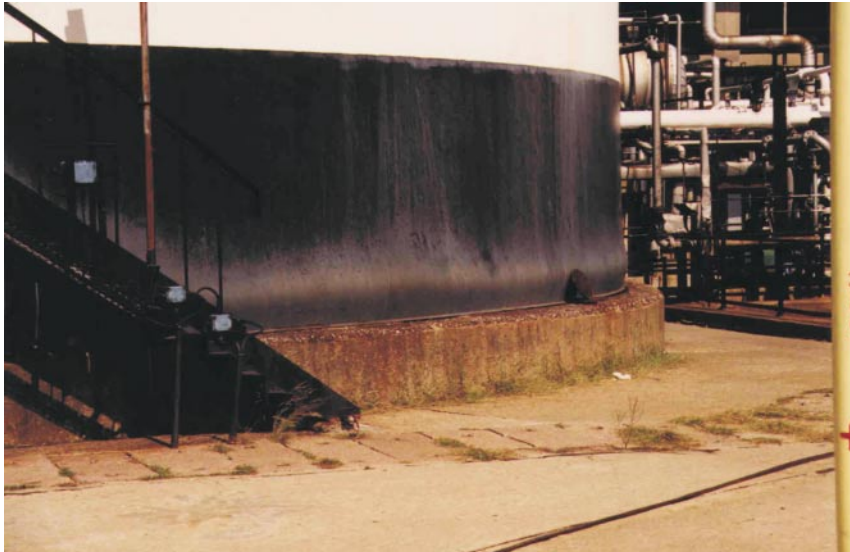
Fig. 27. Elephant foot buckling of a tank wall.

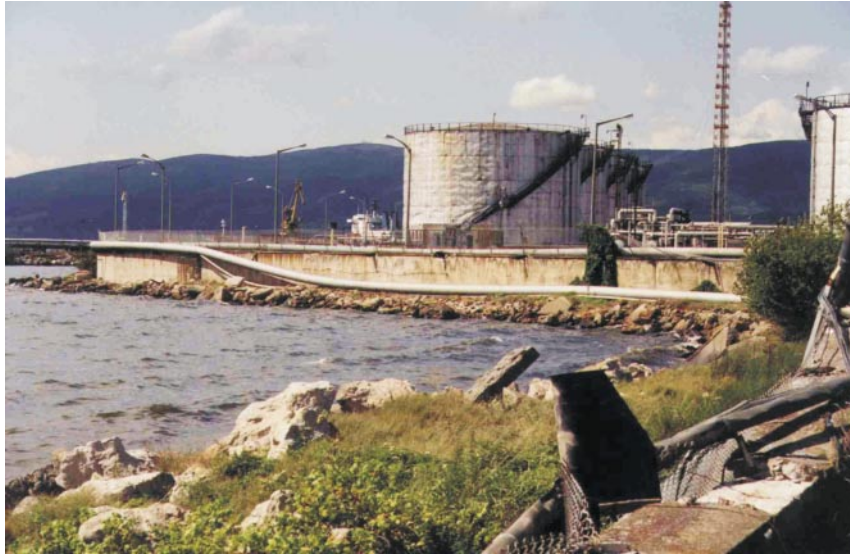
facility suffered severe damage, including the port facilities and pipe supports, as shown in Figs. 29 and 30, and the collapse of one of the administration buildings and the heavy damage of others. Other less spectacular damage to industrial facilities includes collapse of structures, partial roof collapse, failure of tanks, and large displacement of equipment. Another industrial facility that suffered minor damage was a fertilizer factory just west of Izmit. The factory survived the earthquake without significant damage, other than minor hairline cracks in some of the concrete walls and minor soil failure at its harbor. The operation had to be stopped, however, because a large kiln, which is shown in Fig. 31, was forced off its support.

Fig. 29. Dislocated pipes along the seashore.

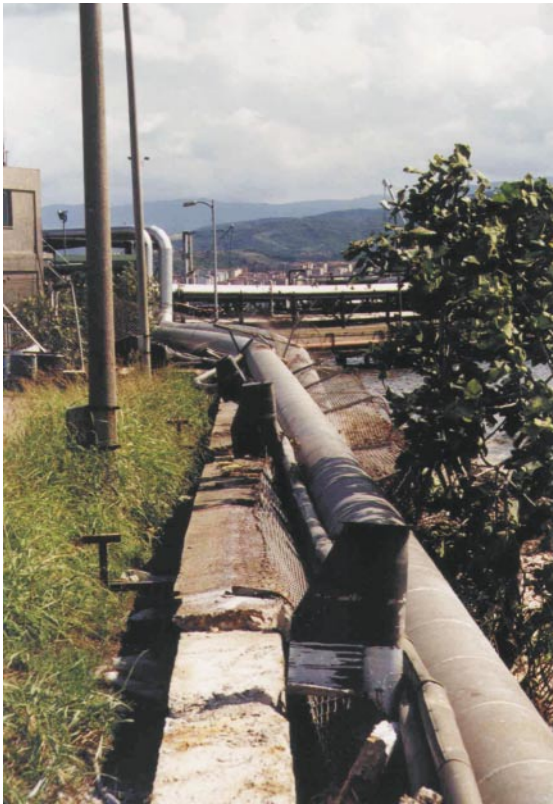
Fig. 30. Failure of pipe supports.

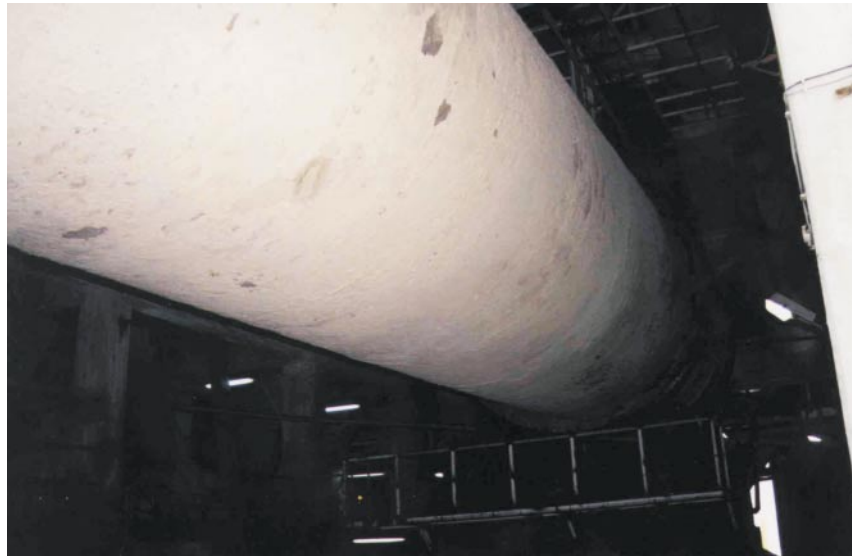
Fig. 31. Kiln of a fertilizer factory in Izmit, dislocated during the earthquake.

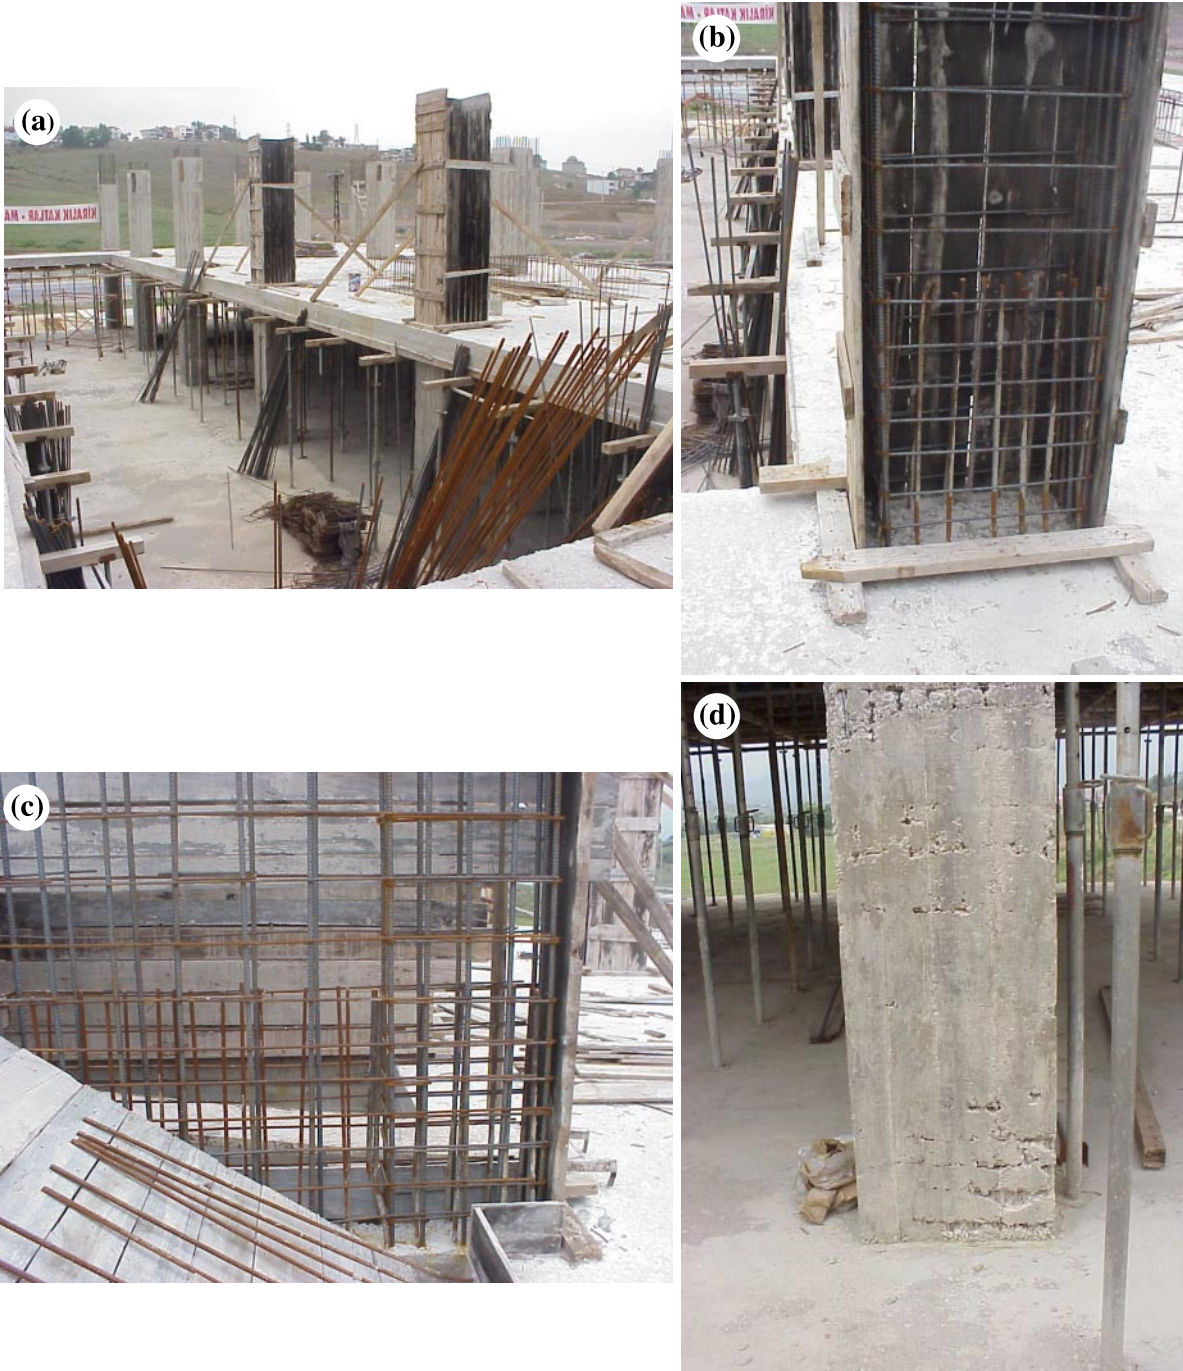
Figure 33a illustrates the details of a frame wall structure under construction, which had the following deficiencies:

The poor detailing in this structure represents numerous violations of the Turkish seismic code requirements.

Fig. 33. Frame wall structure under construction: (a) overall view; (b) column reinforcement details; (c) wall reinforcement details; (d) insufficient concrete cover.

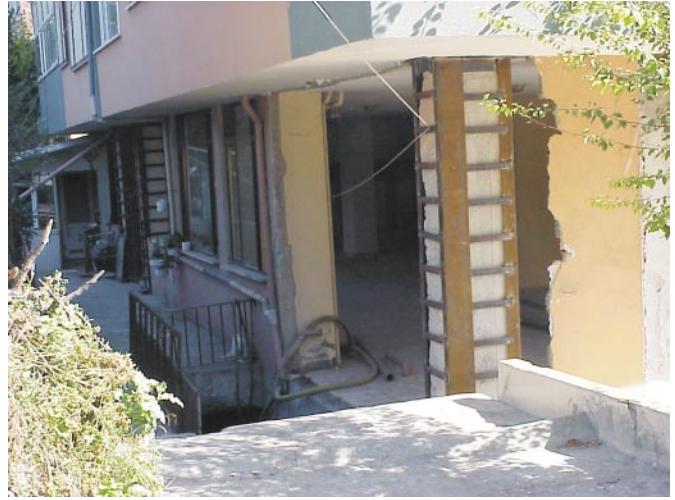
Fig. 36. Retrofit of corner column.

One month after the earthquake there were several examples of retrofitting of damaged structures. Figure 36 shows the retrofit of a corner column of an eight-storey reinforced concrete frame structure in Avcilar, west of the airport in Istanbul. Due to lack of symmetry in the wall system and the torsional eccentricities, the corner column was subjected to large displacements. This column was retrofitted at the ground-storey level with steel angles or channel sections at the corners of the column and with welded steel batten plates. This retrofit enhances the strength and stiffness of the column over its clear height but may lack proper continuity with the column above and the basement level.

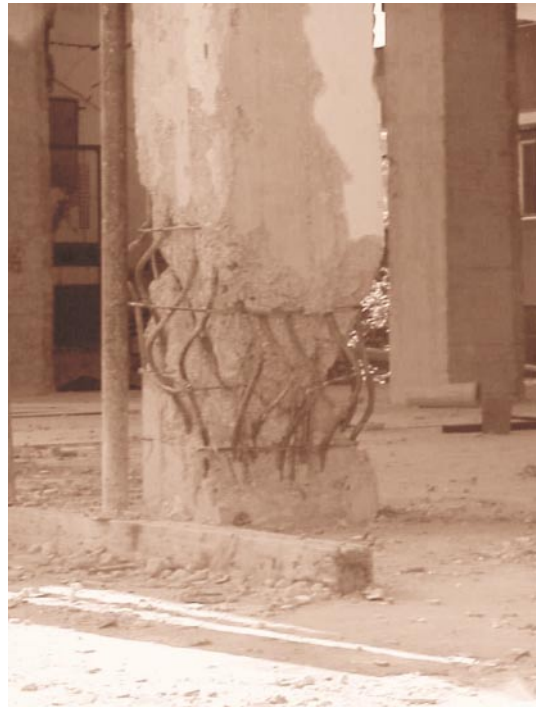
Figure 37 shows severe damage to the ground-storey column of a five-storey reinforced concrete frame structure on Darica Road in Gebze, between Istanbul and Izmit. Shear failure occurred at the base of the column just above the lap splice in the vertical reinforcing bars. The 400 by 520 mm column contained 16–25 mm diameter bars with 8 mm diameter ties at 200 mm spacing. The ties had 90° bend anchorages. A similar five-storey structure immediately across the street had similar damage to the ground-storey columns. Figure 38 shows the retrofitted ground-storey columns. The columns were retrofitted by encasing the existing columns with at least 200 mm of reinforced concrete on all sides. The resulting dimensions were 650 by 850 mm for the edge col-

**Fig. 37.** Shear failure of ground-storey column.
