The August 17, 1999, Kocaeli (Turkey) earthquake — lifelines and preparedness

Antony G. Gillies, Donald L. Anderson, Denis Mitchell, Rene Tinawi, Murat Saatcioglu, N. John Gardner, and Ahmed Ghoborah

Key words: Turkey earthquake, highway, hospital, railway, water, search and rescue, communications.

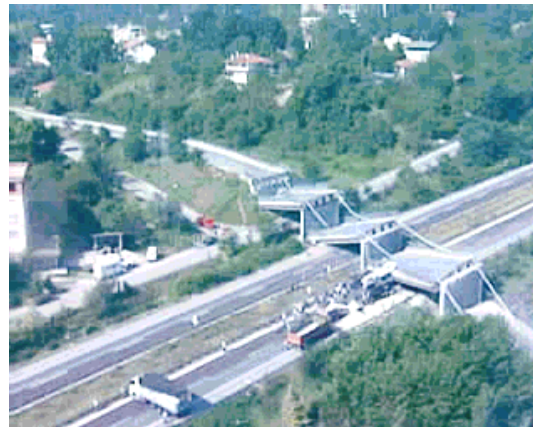
Fig. 2. Arifiye — Unseating of bridge spans at TEM overpass.

Only one bridge collapsed during the earthquake. Located at Arifiye, this was a reinforced concrete, two-lane, four simple-span overpass bridge, spanning the TEM east of Izmit. The failure was attributed to unseating of girders, as shown in Fig. 2. The failure was a consequence of fault slip effects; there was evidence that the fault rupture passed between the reinforced earth abutment on the north side and the first support pier, almost perpendicular to the span direction. About 50 m west of the bridge a culvert passed under the highway. The fault rupture was almost parallel to the highway at this point, having just crossed the expressway lanes approximately 0.5 km west of the bridge at a shallow skew angle. The team measured a lateral offset of 3.6 m between the culvert and its associated headwall in the ditch beside the roadway and a vertical offset in excess of 1 m (Fig. 3). Failure of the seating of the first span of the bridge triggered a domino-effect collapse failure for the remaining three spans. There was damage to the reinforced earth at the north bridge abutment (Fig. 4), but the abutment performed extremely well given that it was located right atop the fault trace. There was significant ground failure in the area, including soil settlement of large areas along the tollway and on adjacent collector roads in the vicinity of the bridge (Fig. 5).

The failure of the Arifiye overpass blocked the TEM for several days until work crews could remove the debris. While the site was being cleared, the buckling and settlement induced failures in the carriageway were repaired and temporarily resurfaced so that traffic was flowing within days. Three weeks after the earthquake all traces of the five-cell reinforced concrete trapezoidal box superstructure had disappeared, as had the three piers between the spans. As well, the reinforced concrete retaining wall face of the south abutment was totally demolished.

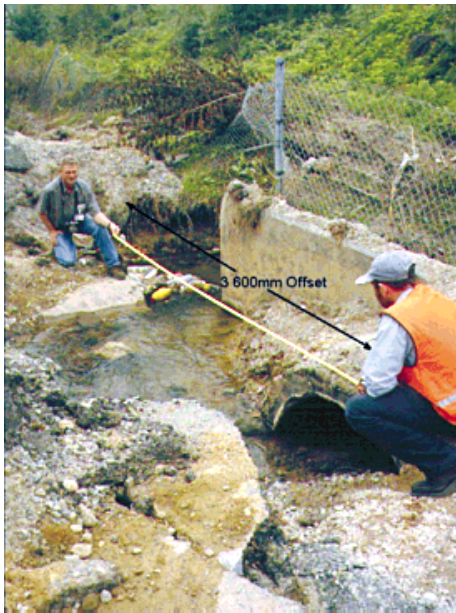
Fig. 3. Arifiye — Culvert headwall offset near overpass.

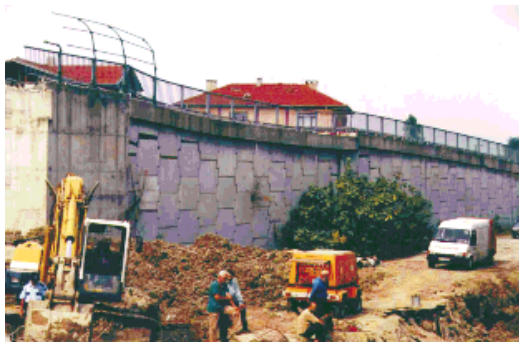
Fig. 4. Arifiye — Reinforced earth abutment at TEM overpass.

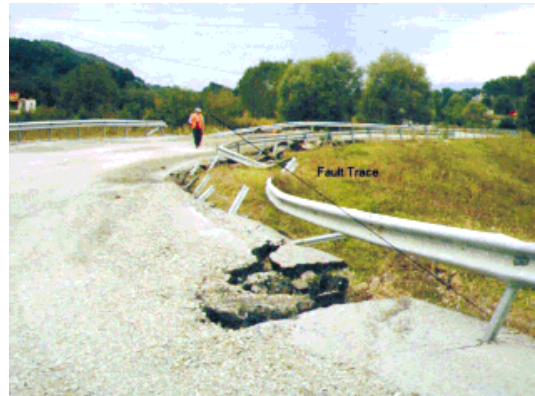
Fig. 5. Arifiye — Fault displacement effects on adjacent collectors.

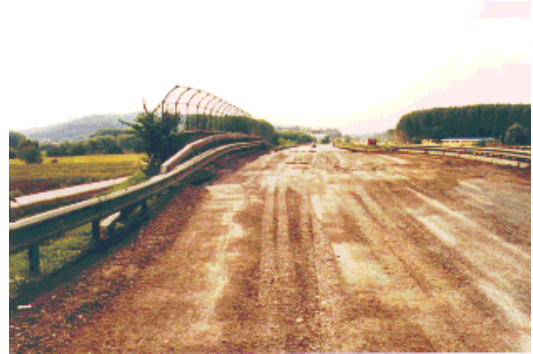
At several of the bridges there was significant settlement in the approach fills (Fig. 6), but this was able to be reinstated, at least temporarily, in the days immediately following the earthquake. Figure 7 shows the separation of an abutment wall of a bridge that was very close to a fault rupture. Other bridges in the Kocaeli–Sakarya regions, supporting and adjacent to the TEM, showed signs of damage between the support piers, their shear keys and bearings, and the supported superstructure. The shear keys had been fractured, and the beams partially unseated from their bearings. Despite the obvious damage, the bridges remained in service with no restrictions posted.

Fig. 6. Arifiye — Approach fill settlement.

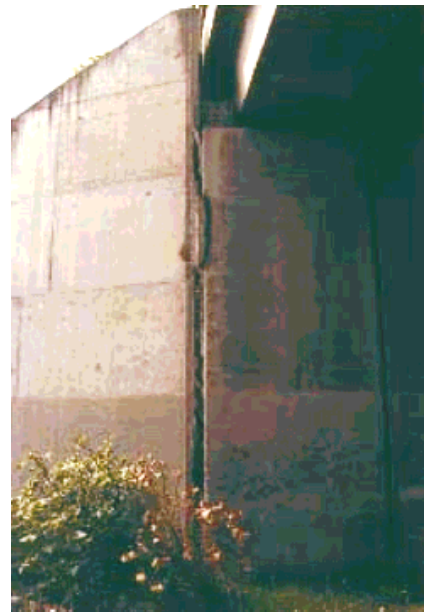
Fig. 7. Arifiye — Separation of abutment wall.

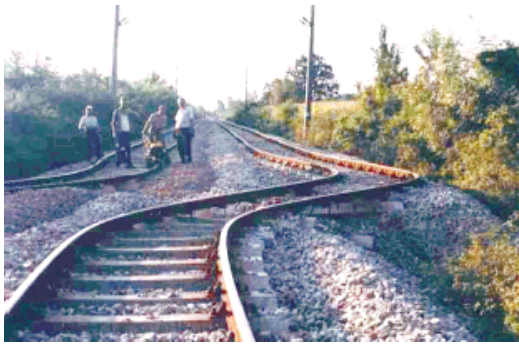
Fig. 8. Tepetarla — Temporary repair of railtrack after damage from fault offset.

An electrified railway track ran parallel to the TEM south of Sapanca Lake, and there was damage to the track between Izmit and Arifiye a distance of 35 km. The track was located in the area of observed surface faulting, and the faulting crossed the tracks in several locations, causing extreme distortions in the rails at these points. Figure 8 shows the repaired track near Tepetarla station where the fault crossed almost at right-angles to the rail. The offset could be measured in the abandoned damaged rails and was found to be

in excess of 2 m over a length of 6 m of rail. The railway did not operate for 3 days following the earthquake, but this was due to the lack of electrical power and controls. Three weeks after the earthquake, the track was open to traffic, but trains were running at reduced speed with flagmen controlling their progress at locations of concentrated damage.

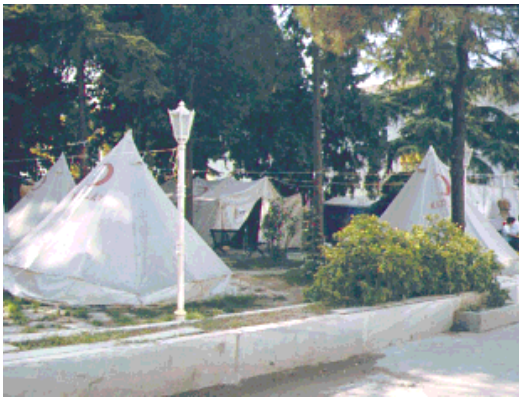
Fig. 9. Sakaraya — Tents outside maternity hospital.

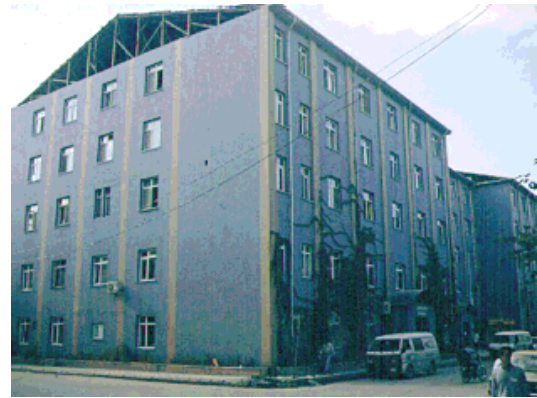
Fig. 10. Sakaraya — Maternity hospital gable-end.

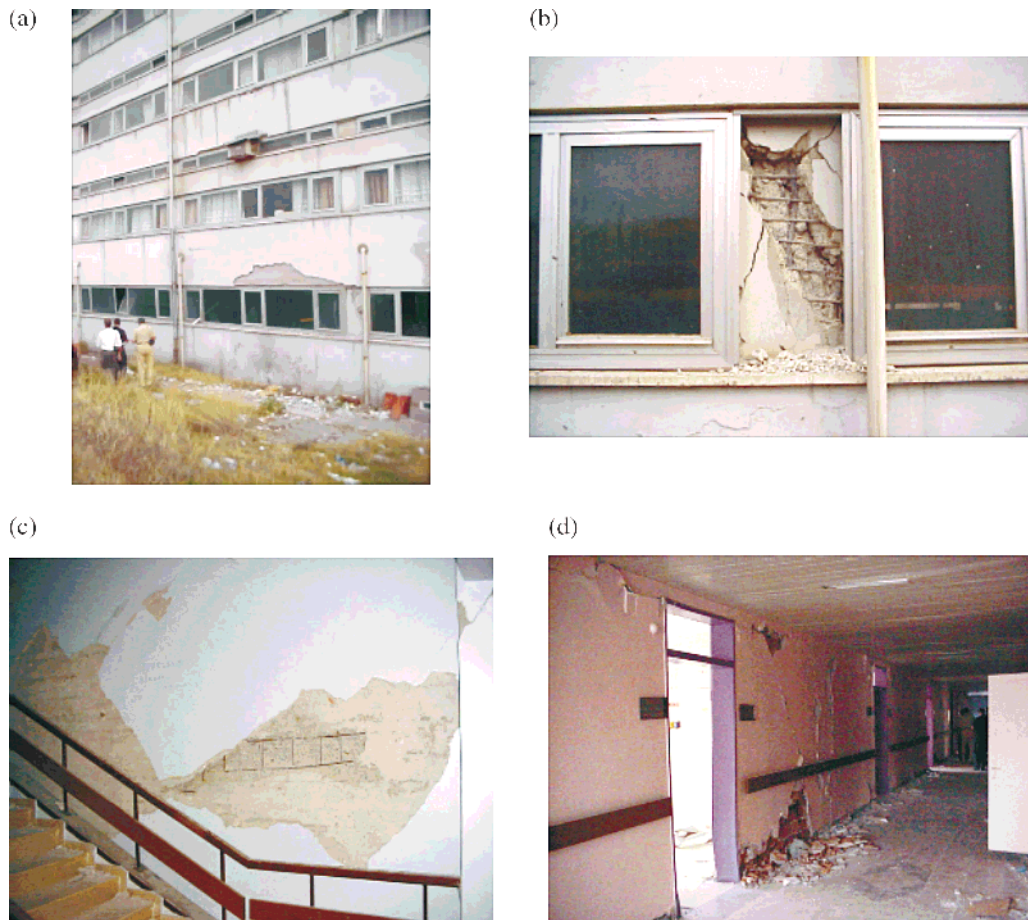
Fig. 11. Izmit — Kocaeli University Hospital: (a) elevation view of damaged nine-storey wing; (b) shear failure of 450×1350 mm “short columns”; (c) shear cracking of shear wall; (d) structural and non-structural damage to partition walls.

Figure 11 shows a severely damaged wing of the Kocaeli University Hospital in Izmit. This nine-storey wing is a reinforced concrete wall-frame structure. Figure 11a shows the elevation view of the damaged wing, and Fig. 11b shows the shear failure of one of the 450 by 1350 mm columns. The presence of the deep spandrel beams created “short columns,” with shear failure occurring through the 450-mm column width. The column was reinforced with deformed 25-mm-diameter vertical bars and 10-mm-diameter plain ties

at a spacing of 100 mm, anchored with 60-mm-long hooks with 90° bend. The shear failures occurred to two adjacent columns that were located in the region of a two-storey mechanical room, which created a vertical irregularity in this region of the wing. Figure 11c shows the shear cracking and spalling of the cover concrete in one of the interior shear walls around a staircase. This large wing of the hospital had to be closed after the earthquake due to severe structural and non-structural damage (Fig. 11d).

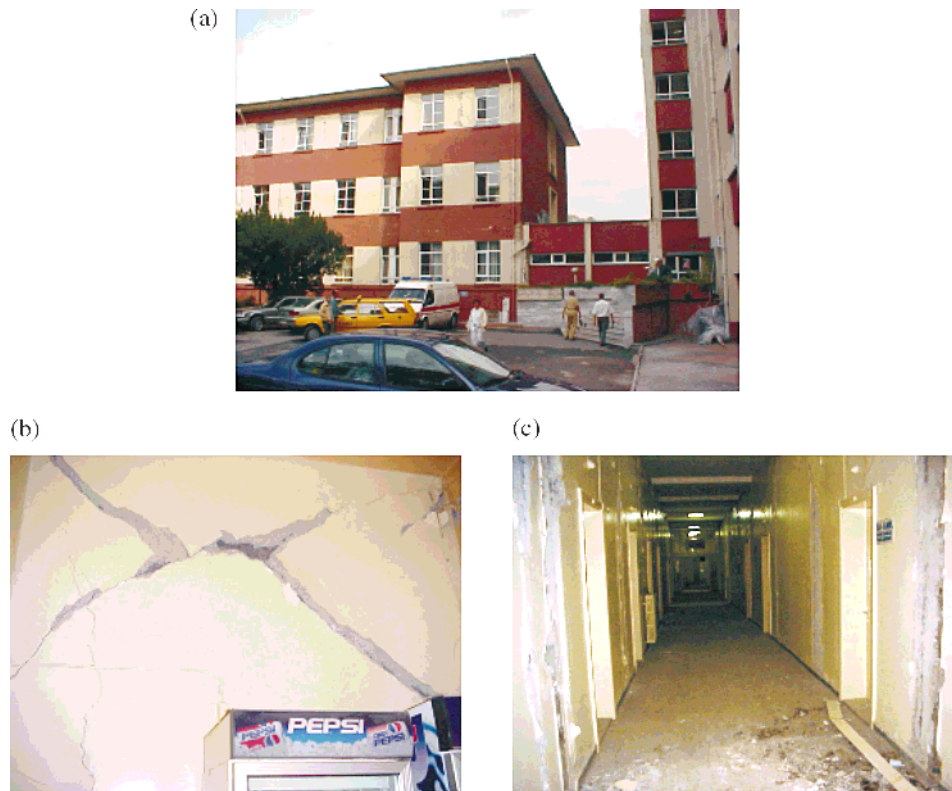
Figure 12a shows an overall view of the SSK Hospital in Izmit, which suffered severe damage to the three-storey older wing built in 1946. This wing is a frame-wall structure with masonry infills. Figure 12b shows the shear failure of a lightly reinforced concrete wall at the ground level. Due to severe structural and non-structural damage (see Fig. 12b) the hospital was closed. The large permanent drifts of the partition walls are evident in Fig. 12c. Although the newer seven-storey wing, built in 1976, was undamaged and remained fully operational, the single storey connecting structure (see Figs. 12a and 12b) suffered damage due to pounding between the connecting structure and the older wing. This pounding probably augmented the damage to the older wing.

Fig. 12. Izmit — SSK Hospital: (a) general view, 1946 wing (left) and 1976 wing (right); (b) shear failure of lightly reinforced concrete wall; (c) severe damage to partition walls.

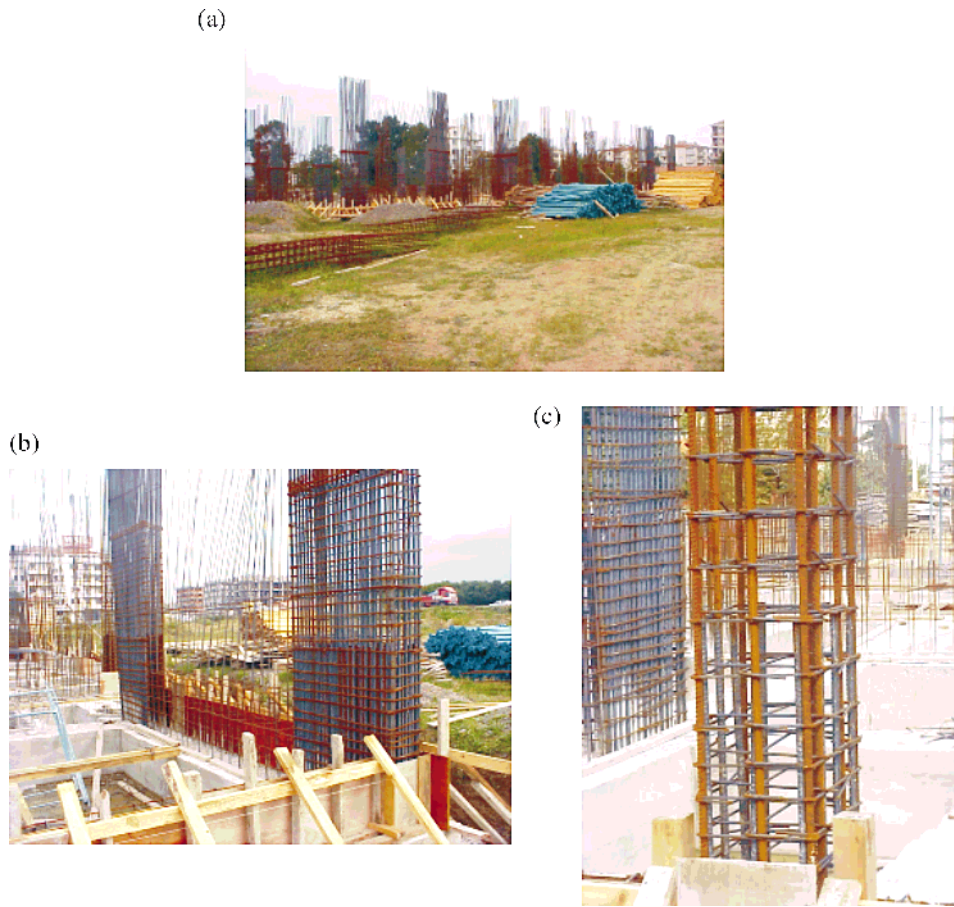
Figure 13a shows the construction of a six-storey hospital near Yalova. The reinforcement details for the frame-wall structure are shown in Figs. 13b and 13c. The shear walls

had very good details with closely spaced confinement reinforcement in the end regions of the walls where the vertical reinforcement was concentrated. The 600 by 600 mm columns were reinforced with 12–20-mm diameter vertical bars and were confined with 9-mm-diameter ties at a spacing of 100 mm. In terms of possible deficiencies of the detailing provided, it is noted that the ties had only 90° bend anchorages with free end extensions of 120 mm, and in both the columns and the walls all vertical reinforcement was spliced at the floor levels.

Fig. 13. Yalova — Six-storey hospital under construction: (a) overall view; (b) shear wall reinforcement; (c) confinement reinforcement at ends of walls.

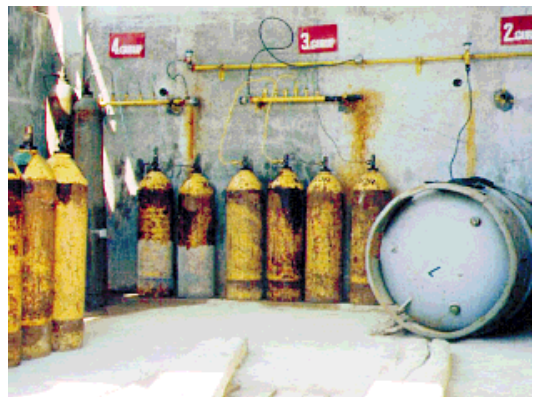
Fig. 15. Esentepe — Pumping station chlorination unit.

One of the two intake pipes in Lake Sapanca was still out of service at the time of the reconnaissance visit, 29 days after the earthquake. The Esentepe pumping station had no major mechanical failures. However, the restraining bar supporting the chlorine gas cylinders had failed and the cylinders had overturned, leading to a chlorine gas escape (Fig. 15). Prior to the earthquake, the only chlorination of the potable water was at the Esentepe station, and the dosage

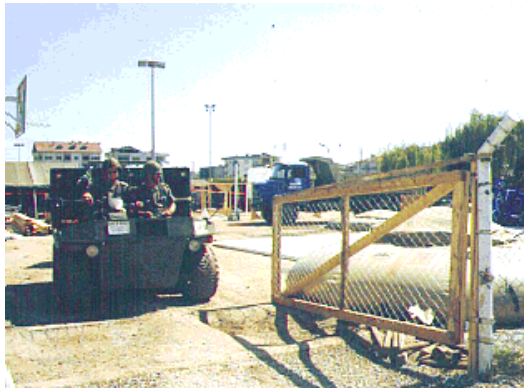
Fig. 16. Serdivan — 15 000-L rubber bladder temporary water reservoir.

To reinstate a temporary potable water supply immediately following the earthquake, the DART team commissioned three portable reverse osmosis filtration units, locating two by the lake and the third near the camp. Temporary rubber bladder style reservoirs, each 15 000-L capacity, were placed at key locations in Serdivan (Fig. 16). Water distribution to the reservoirs continued to be a problem. Local tanker trucks were not up to the sanitation standards for potable water distribution and other trucks were on temporary secondment from Istanbul or Ankara. Fortunately, the DART team had the facility to bag water in pouches (similar to the 1.3-L milk pouches used in some parts of Canada) and these could be stacked in the back of dump trucks or trailers for distribution.
