# February 6, 2023 Kahramanmaraş Earthquakes in Türkiye

## Reconnaissance Report

Canadian  
Association  
for Earthquake  
Engineering  
and Seismology

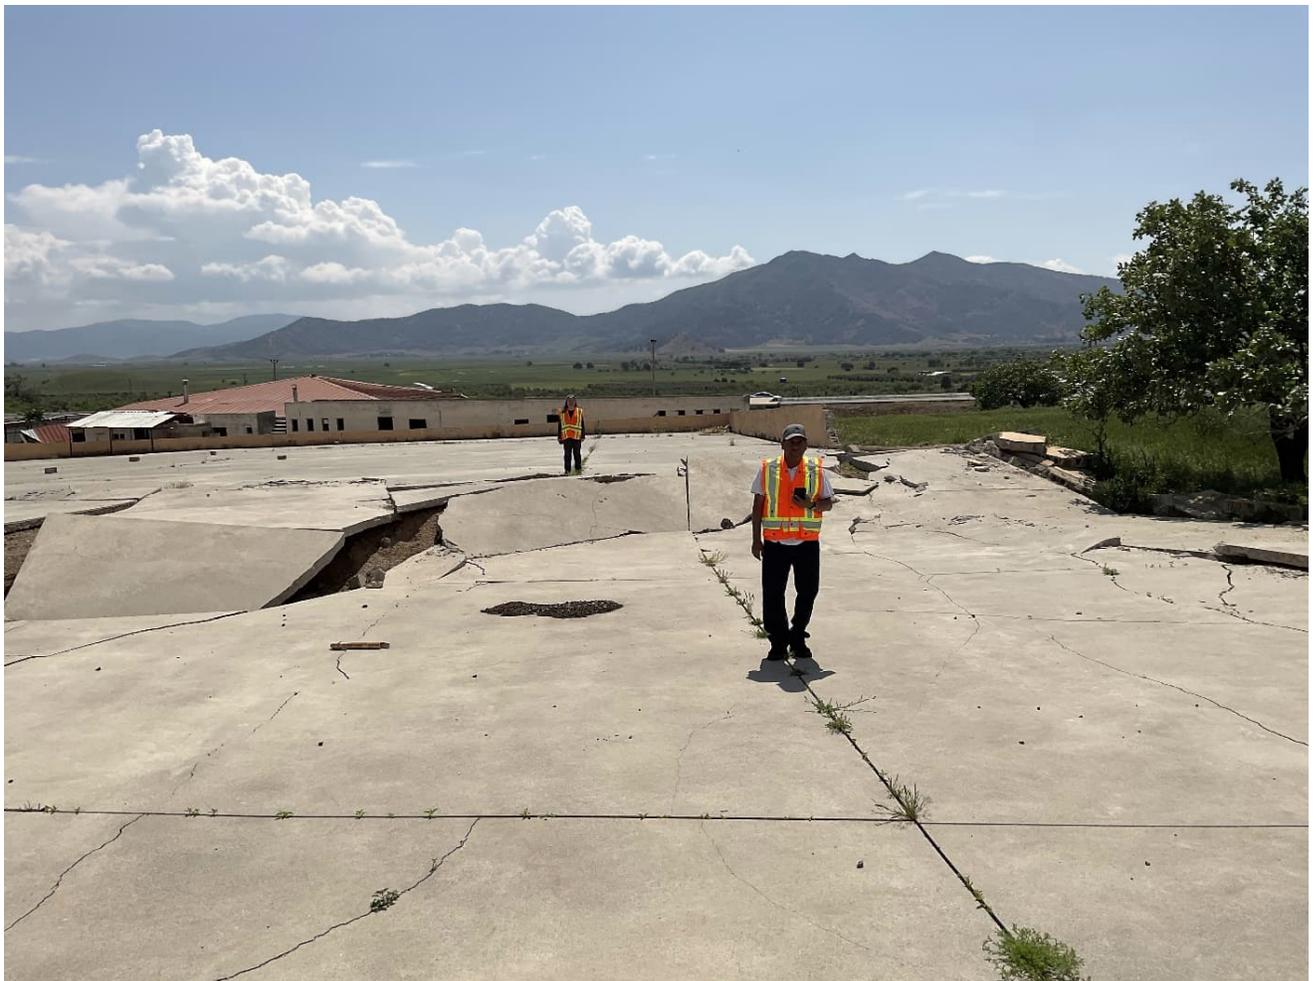
At Altınüzüm, a cast-in-place concrete pad and attached concrete-block wall were damaged and offset by surface faulting directly through them. Up to 1.65 m left-lateral and 0.35 m west-side-up displacement occurred (Figure 3.3). To the immediate north, the scarp changes from west-side-up through alluvial fan deposits to east-side-up where it crosses a west-facing, bedrock-cored slope (Figure 3.4 and Figure 3.5).

**Figure 3.3:** Facing east across concrete pad cut by surface faulting at Altınüzüm (36.9550 N, 36.5839 E). 1.4 m left-lateral and 0.4 m east-side-up vertical offset were measured. Photo: M. Zaleski.

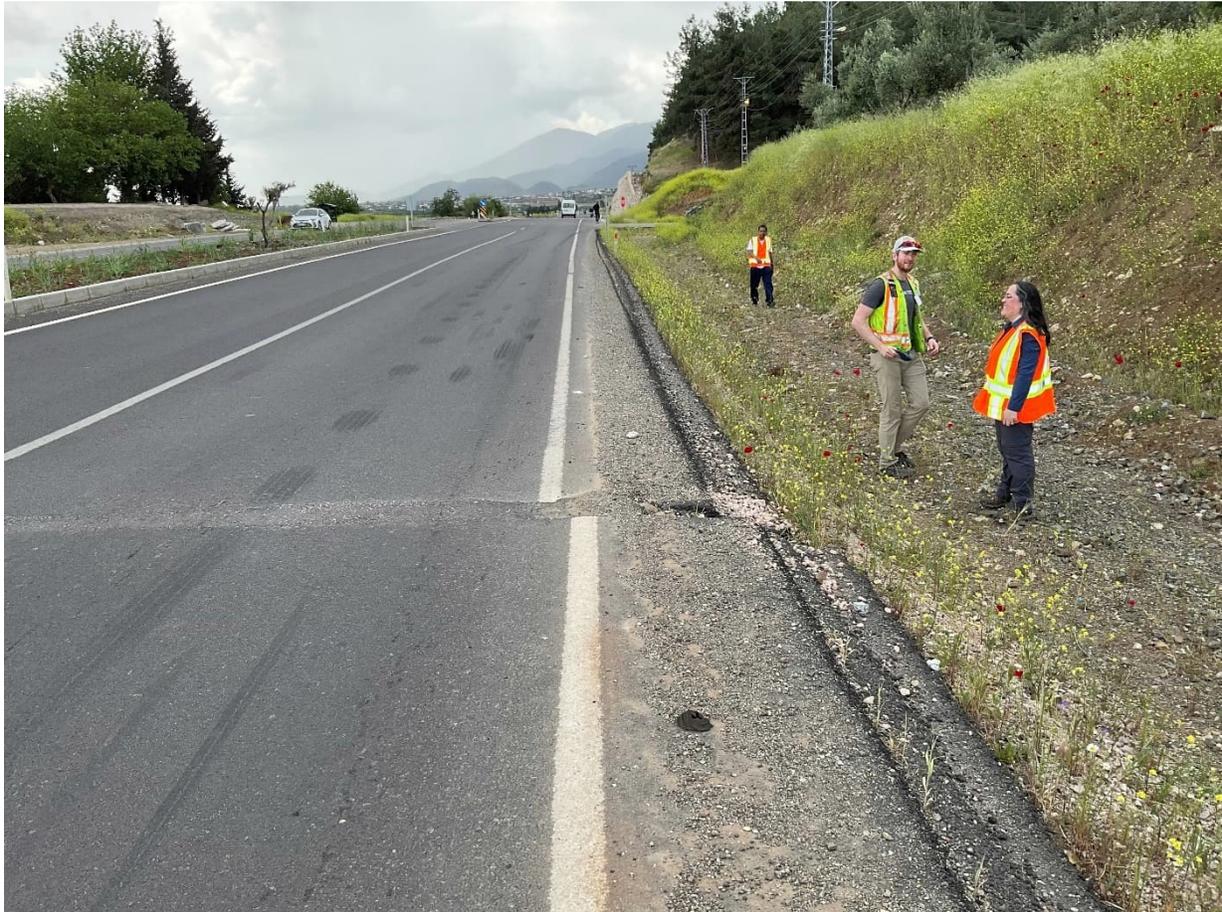
**Figure 3.6:** Facing southwest along Highway D825, near Ağabey (36.9700 N, 36.5991 E), showing 0.15 m left-lateral offset of pavement along a structure orthogonal to the main fault trace. Photo: M. Zaleski.

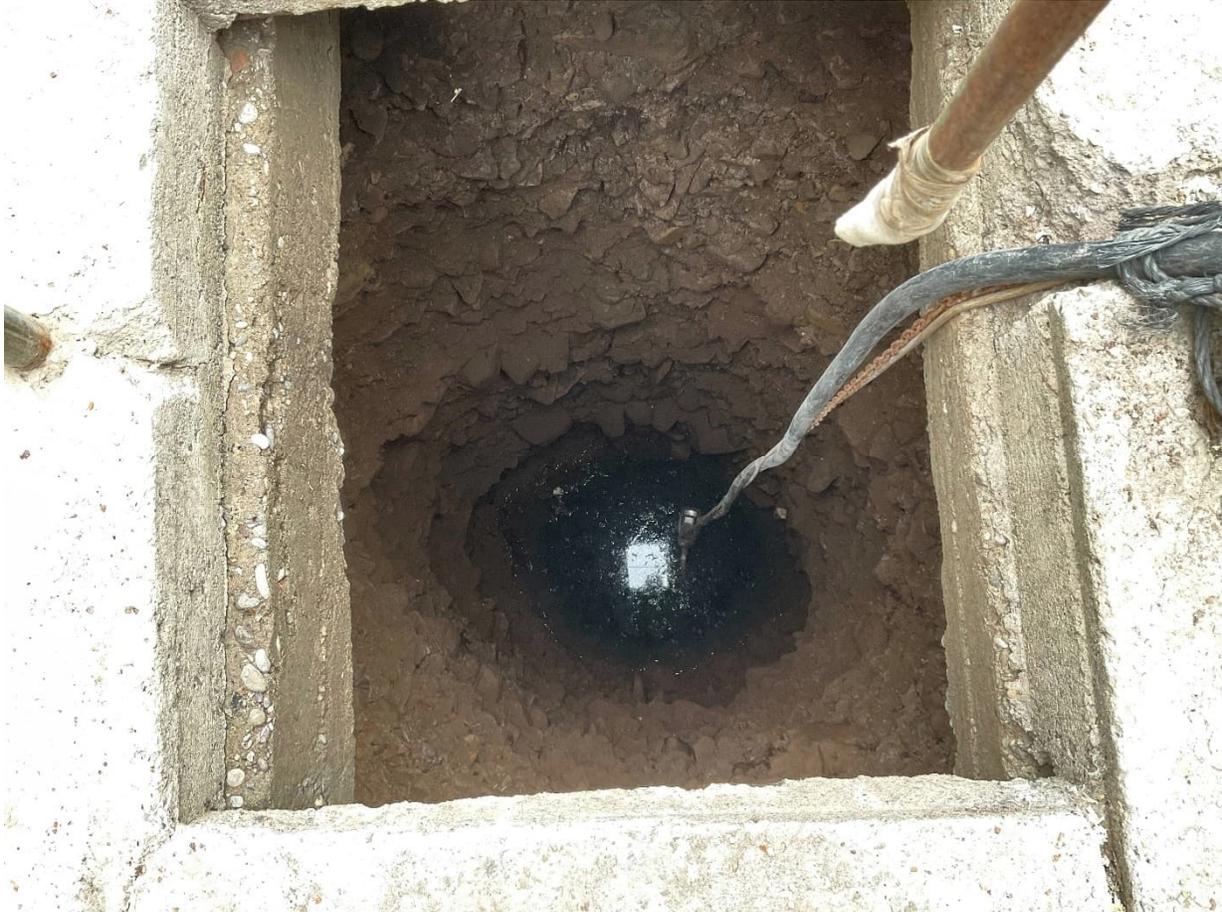
**Figure 3.9: Ovalized well located 5 m from the East Anatolian fault trace in 3.1.5 Şekeroba (37.2587 N, 36.7742 E). Photo: M. Zaleski.**

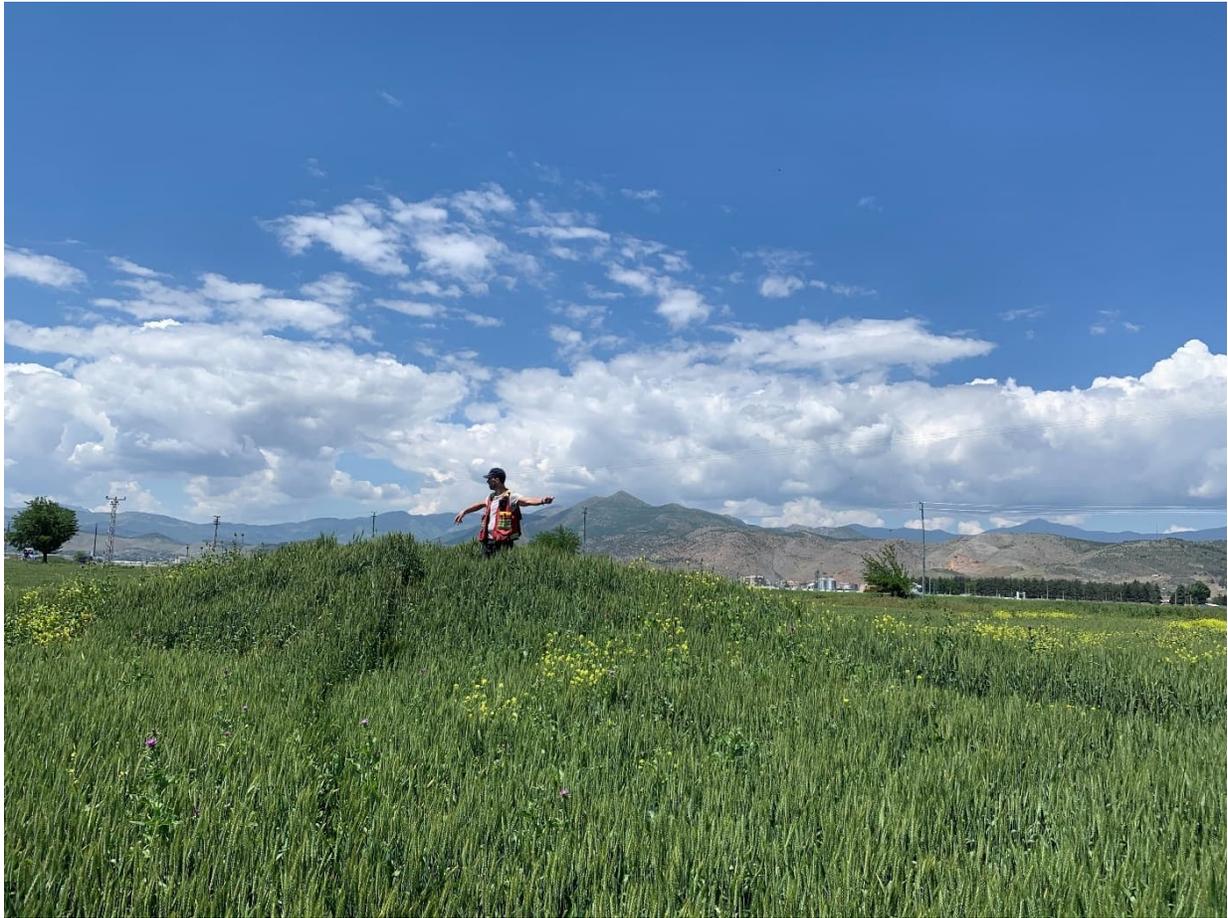
**Figure 3.12: Facing south toward push-up ridge along main fault trace near Türkoğlu (37.3716 N, 36.8703 E). Photo: T. Southam.**

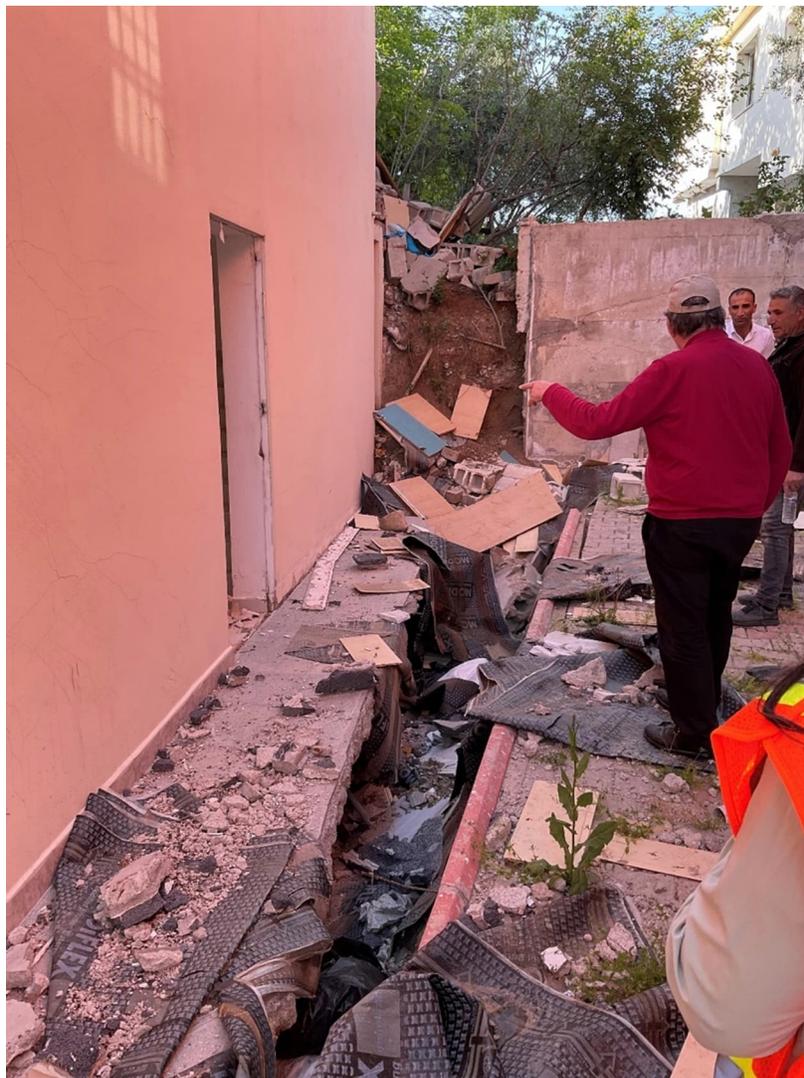
**Figure 3.17: Gap between house foundation and adjacent patio in Çiğli, indicating counterclockwise rotation during the earthquake (37.4937 N, 37.0730 E). Photo: M. Zaleski.**

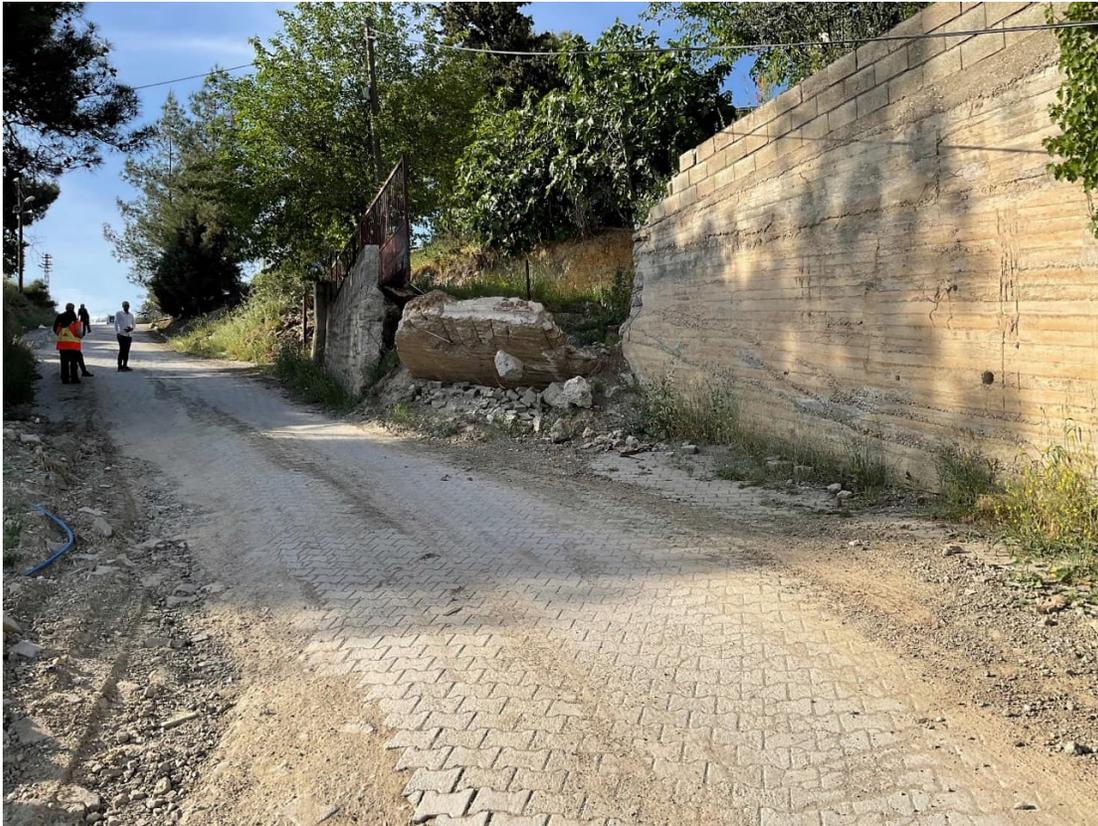
**Figure 3.18: 3.0 m left-lateral offset of a retaining wall in Çiğli (37.4936 N, 37.0278 E). Photo: M. Zaleski.**

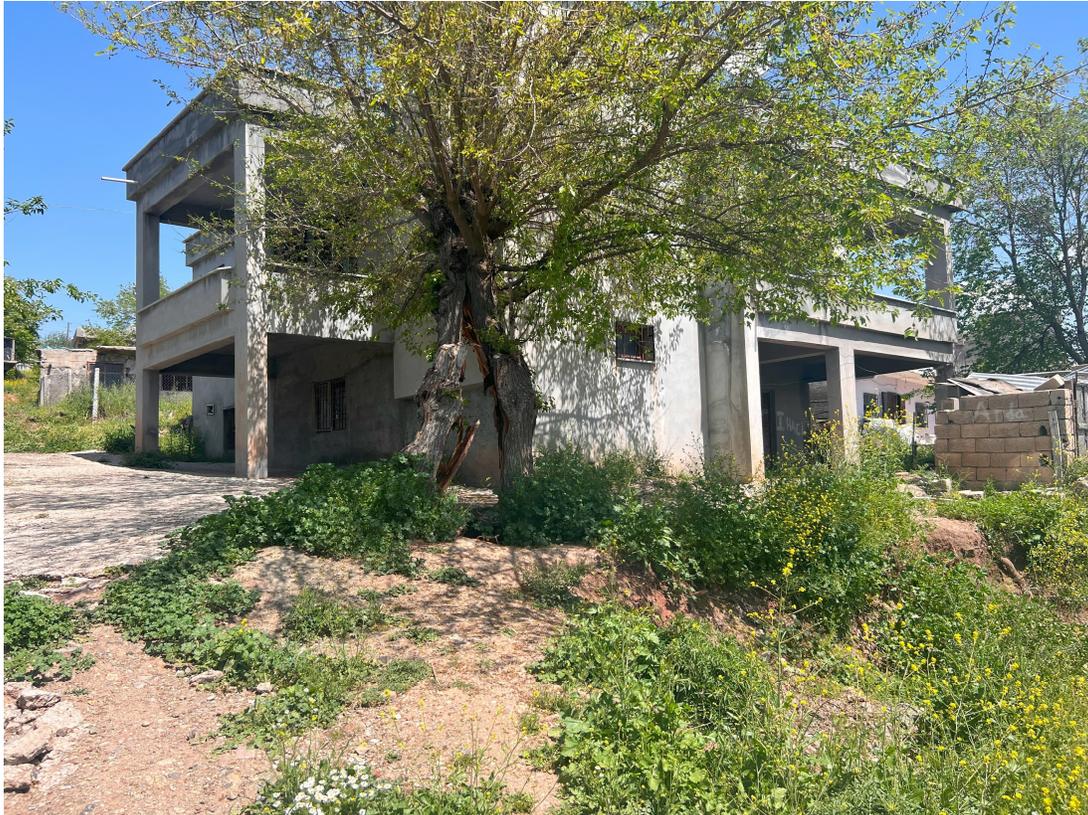
**Figure 3.24.** Facing north toward a tree split by surface faulting, on strike with a displaced corner column at the east (photo right) side of the home in the background, in Tetirlik (37.5368 N, 37.2733 E). Photo: M. Zaleski.

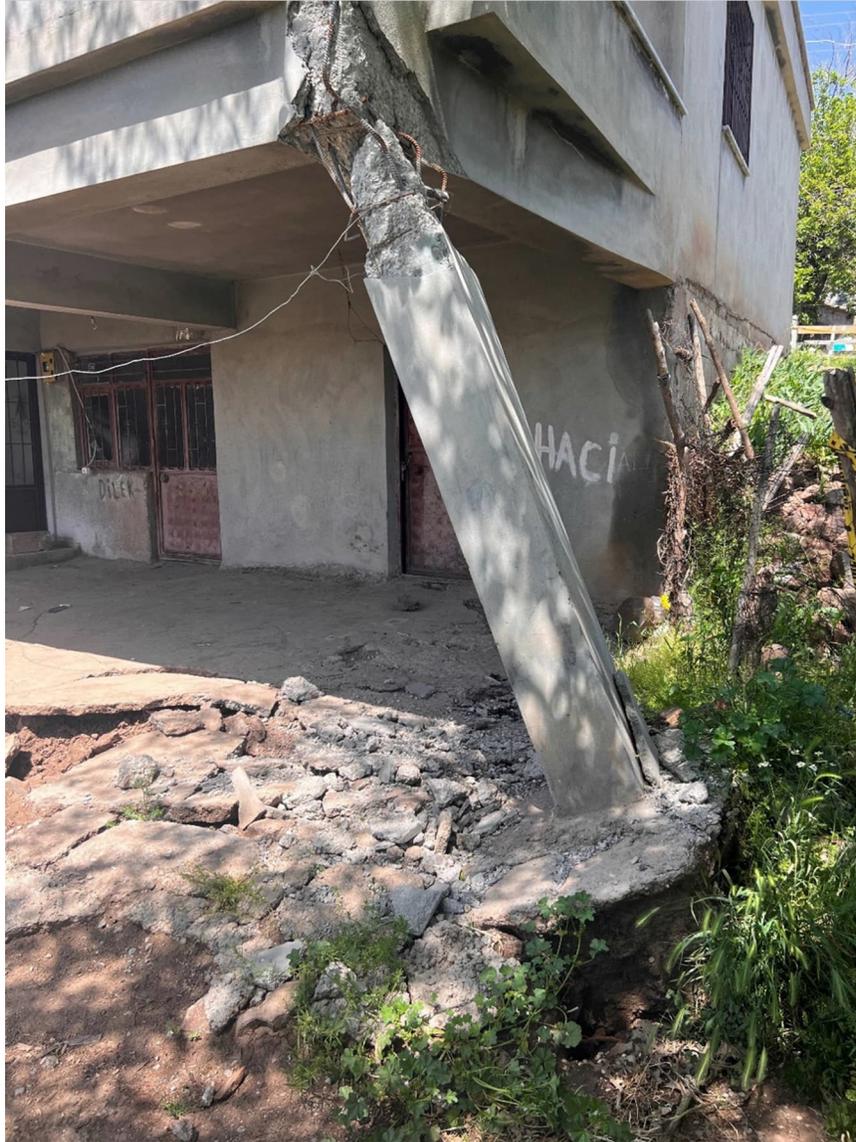
**Figure 3.25:** Column separated from remainder of house by left-lateral offset along the Narlı fault in Tetirlik (37.5368 N, 37.2733 E). Photo: M. Zaleski.

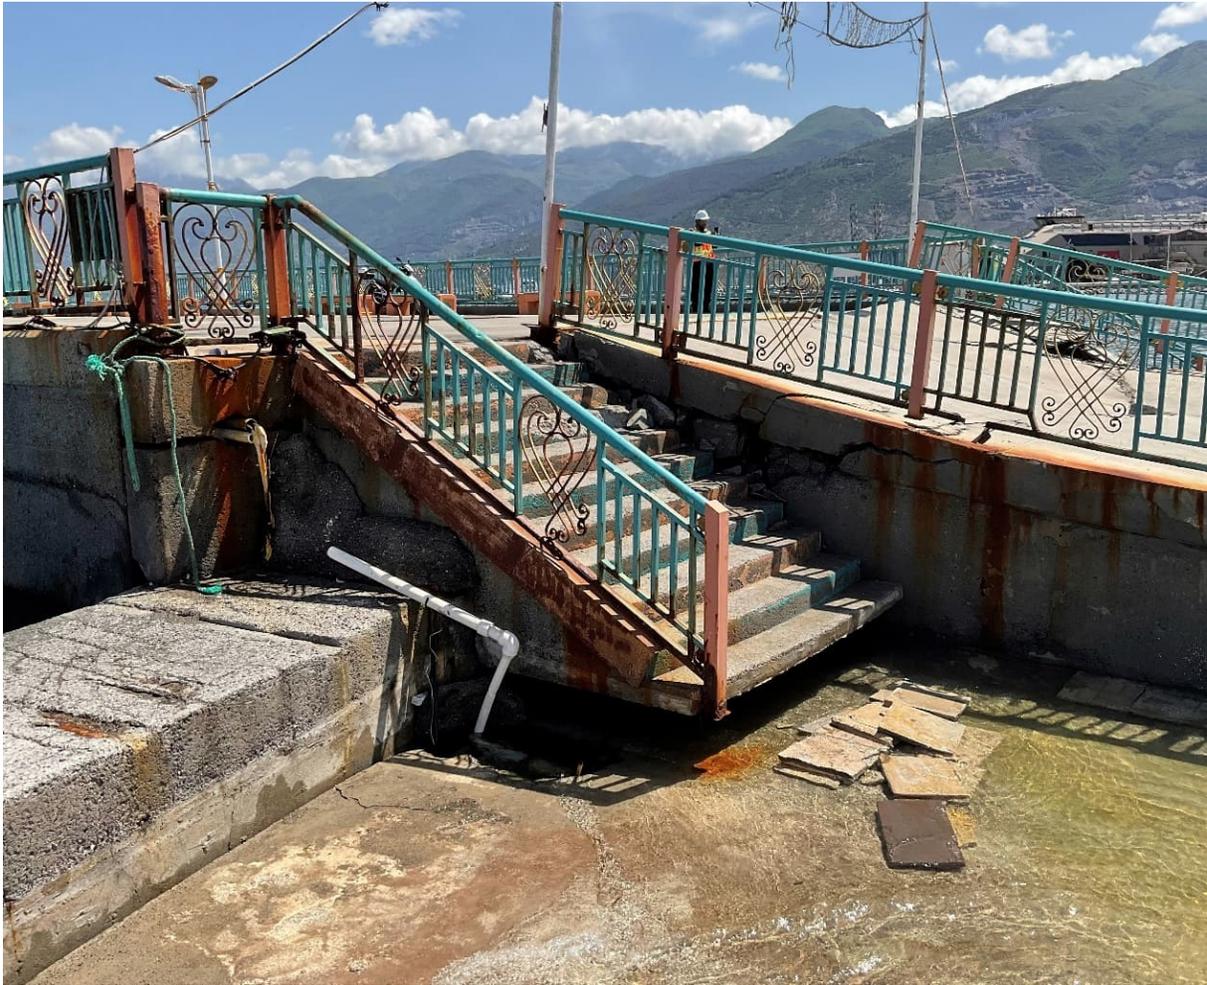
The pedestrian pier on the waterfront adject to the İskenderun monument square displayed settlement of the area surrounding the pier of about 35 to 40 cm relative to the surrounding ground as shown in Figure 5.1.

**Figure 5.1: İskenderun Pedestrian Pier Settlement (36.5927,36.1727)**

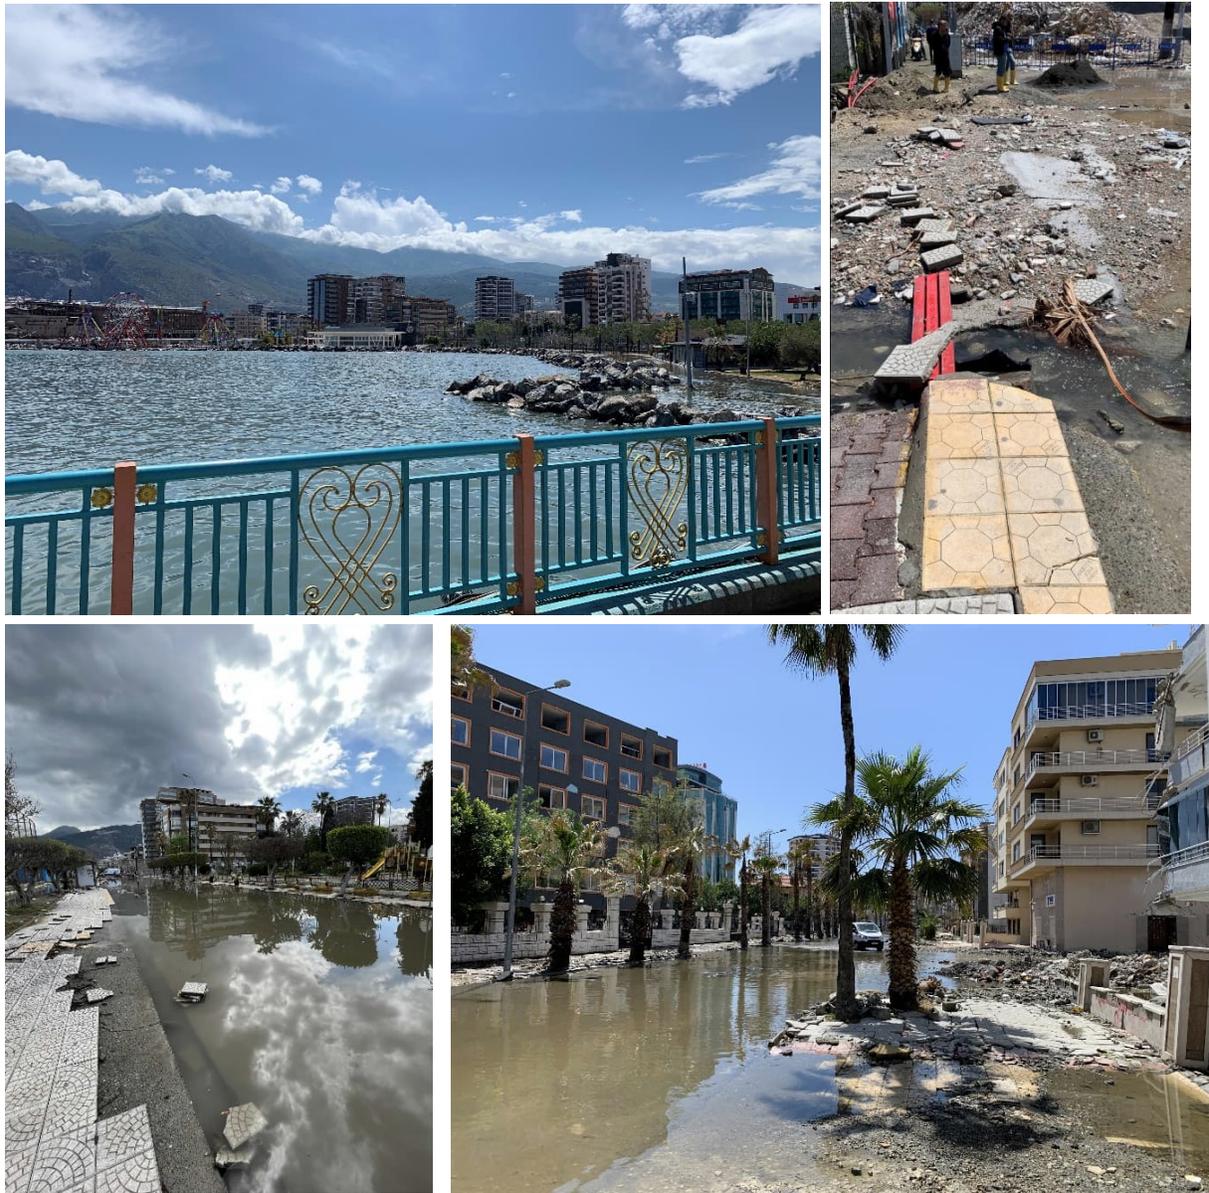
Along the waterfront, there was widespread flooding and ponding of water along Atatürk Blvd and Bahçeli Sahil Evler Cd. While undertaking the reconnaissance tidal waters were observed to be flowing towards the city. From conversations with local residents they believed the ground level of the area had settled approximately 70 cm which has resulted in the water inflow. Images collected during the reconnaissance in the area on May 7, 2023 are shown in Figure 5.2.

**Figure 5.2: Top Left - İskenderun Shoreline Water Level on May 7, 2023 (36.5927,36.1727). Top Right – Water flowing from shoreline towards Atatürk Blvd (36.5907, 36.1754). Bottom Left – Water ponding along Atatürk Blvd (36.5907, 36.1747) Bottom Right – Water ponding along Bahçeli Sahil Evler Cd (36.5906, 36.1797).**

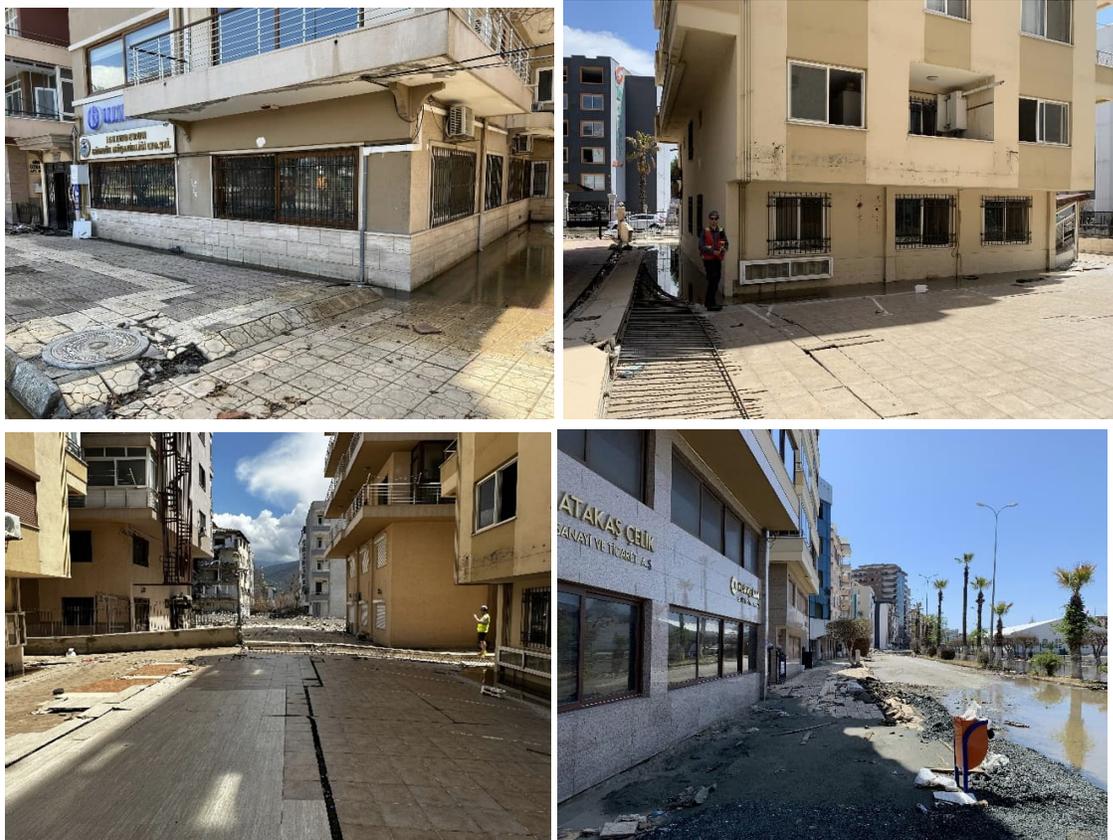
Typically the buildings located on Atatürk Blvd and Bahçeli Sahil Evler Cd experienced settlements up to about 70 cm. Limited differential settlements were observed in the structures, however due to the settlements positive drainage from the foundations was no longer present and in many cases ponding water was observed adjacent to the foundations as shown in Figure 5.3.

**Figure 5.3: Examples of Building Settlement and Water ponding typical along Atatürk Blvd and Bahçeli Sahil Evler Cd. Top Left 36.5908, 36.1782, Top Right 36.5907, 36.1789, Bottom Left 36.5907, 36.1789, Bottom Right 36.5911, 36.1795.**

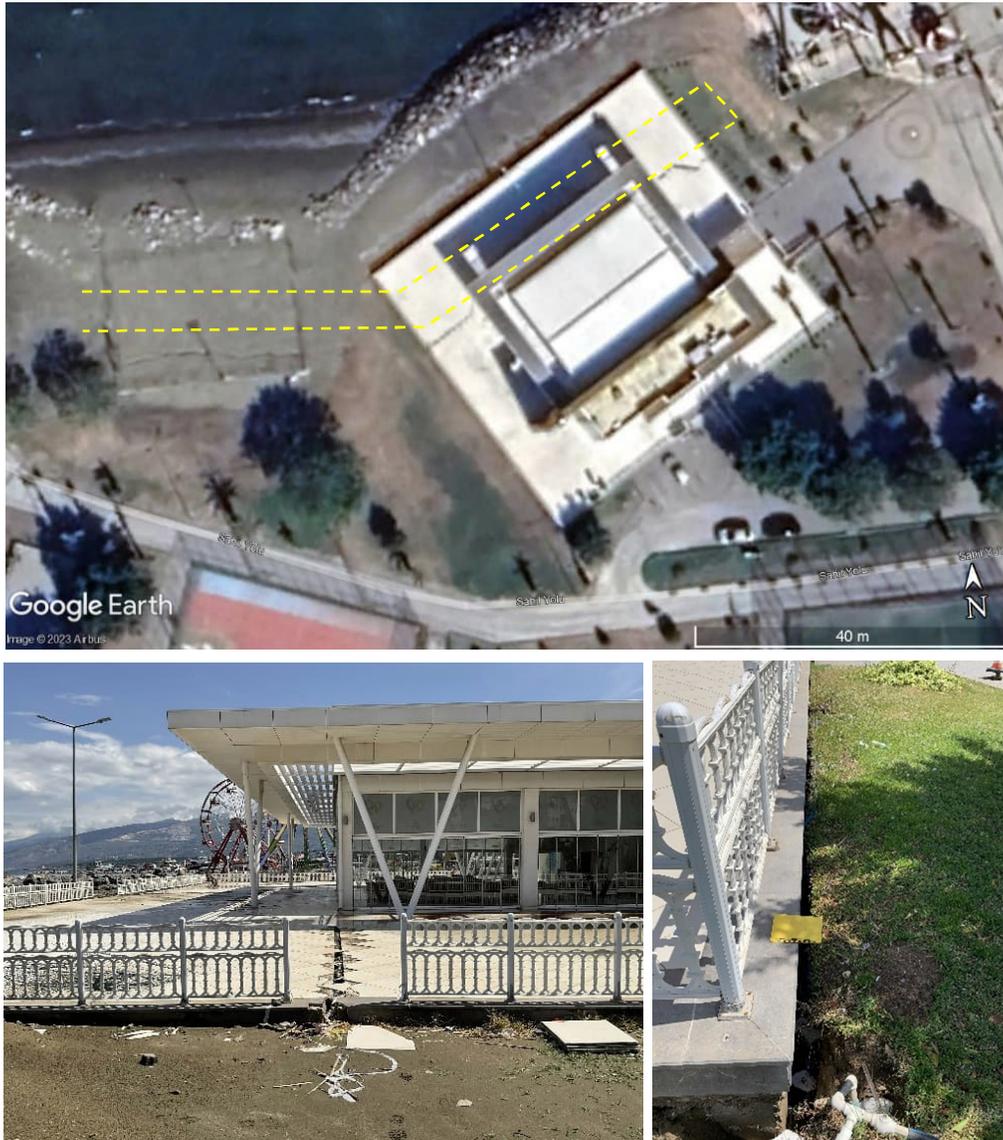
Along the waterfront of the Çay District there were comparatively minor observations of lateral spreading. At the Çay District Evlendirme Dairesi building, the structure generally appeared to have moved towards the shoreline. Several tension cracks were present surrounding the structure up to about 15 cm, indications of lateral spreading at the Evlendirme Dairesi building are shown in Figure 5.6.

**Figure 5.6: Lateral Spreading at Evlendirme Dairesi building (36.5915, 36.1743). Top Google Earth Aerial Imagery Dated Feb. 16, 2023 [7], Bottom left-right indications of movement.**

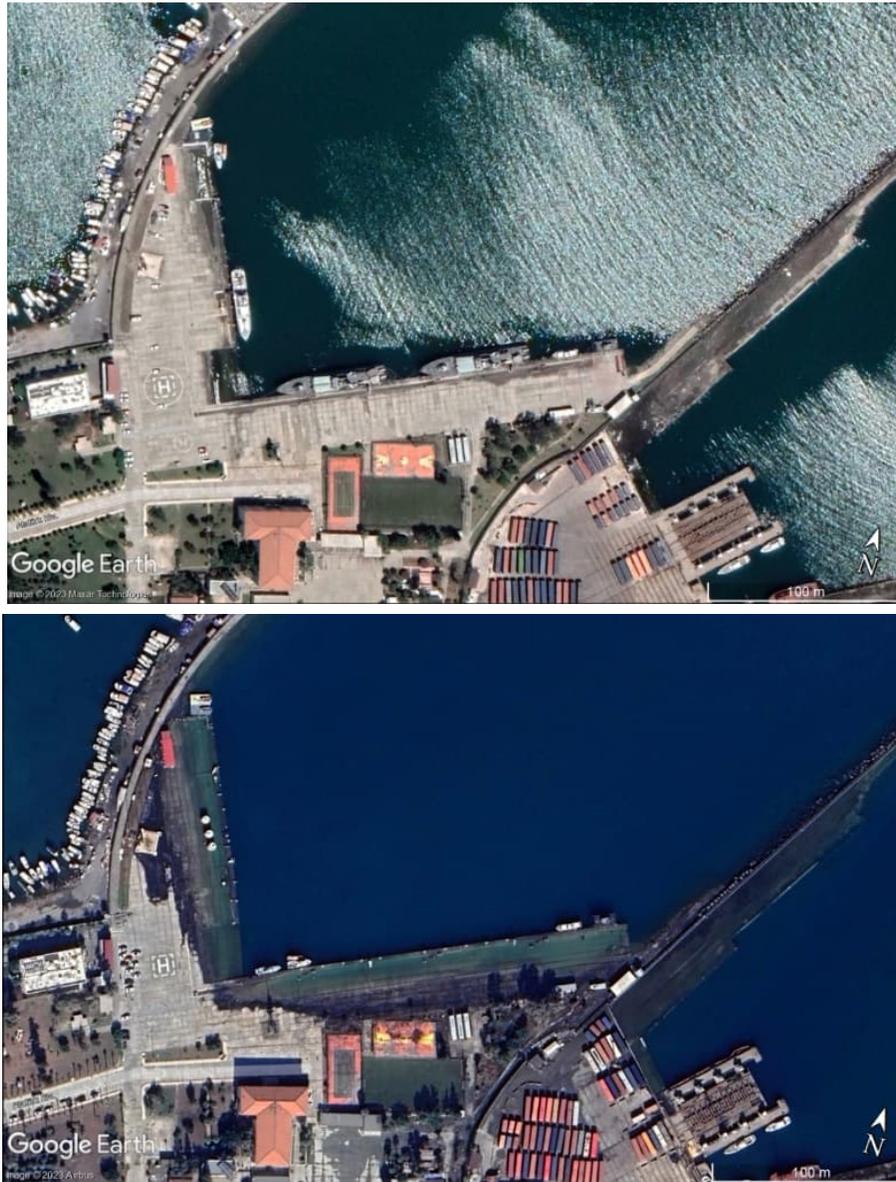
Other earlier reconnaissance observations noted more pronounced liquefaction induced lateral spreading within the port areas of İskenderun [5, 6]. These areas were not reviewed as part of the reconnaissance described herein. From conversations with security at the port facilities it was understood these areas had been repaired at the time of the reconnaissance. Examples of the lateral spreading from available aerial imagery are shown in Figure 5.7 below.

**Figure 5.7: Lateral Spreading within port area adjacent Atatürk Blvd (36.5928, 36.1806). Top Google Earth Aerial Imagery Dated Jul. 2022, Bottom Google Earth Aerial Imagery Dated Feb. 16, 2023. [7]**

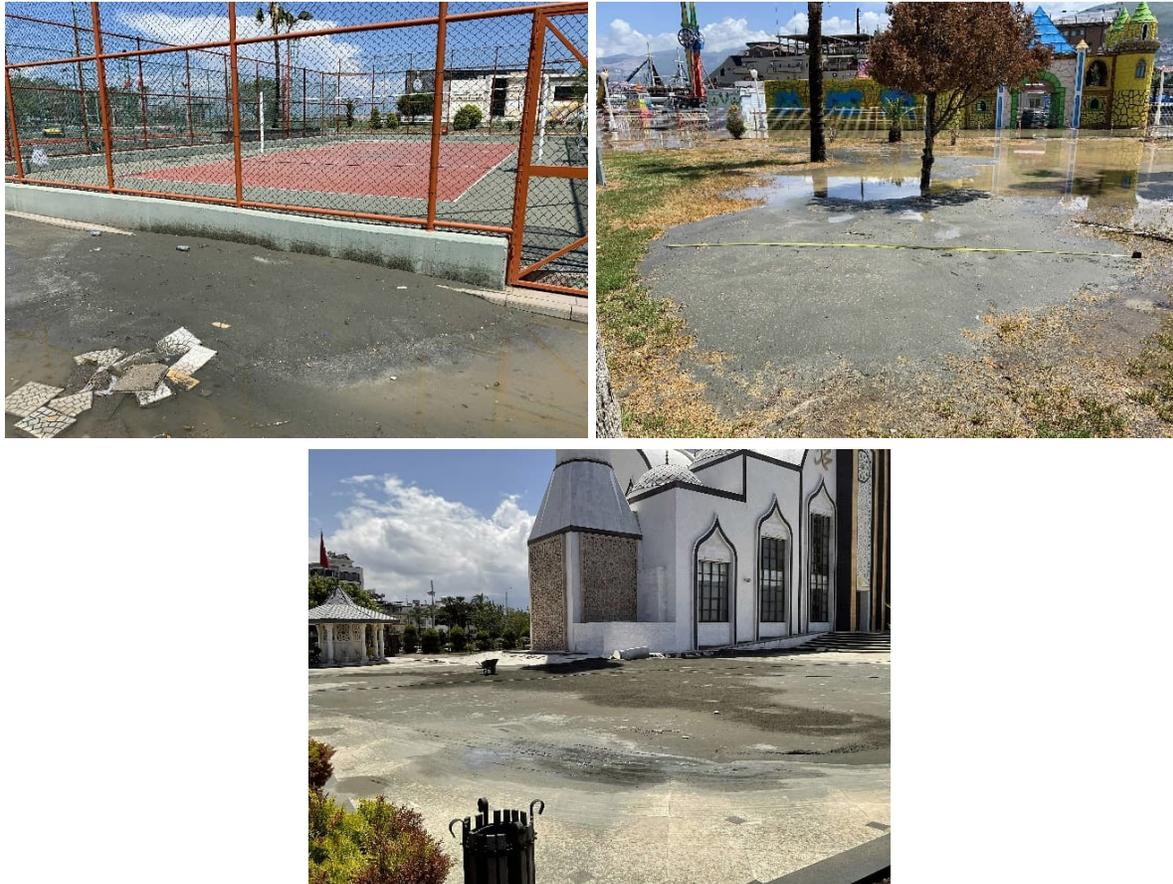
The remnants of liquefaction ejecta were observed throughout the waterfront of the Çay District. The ejecta generally appeared to be composed of grey fine sand with trace non-plastic fines (<10%), however subsequent laboratory testing will be required to substantiate field observations. Examples of the ejecta are shown in Figure 5.8.

**Figure 5.8: Liquefaction Ejecta. Top Left - 36.5907, 36.1748, Top Right - 36.5914, 36.175, Bottom 36.5927, 36.1572.**

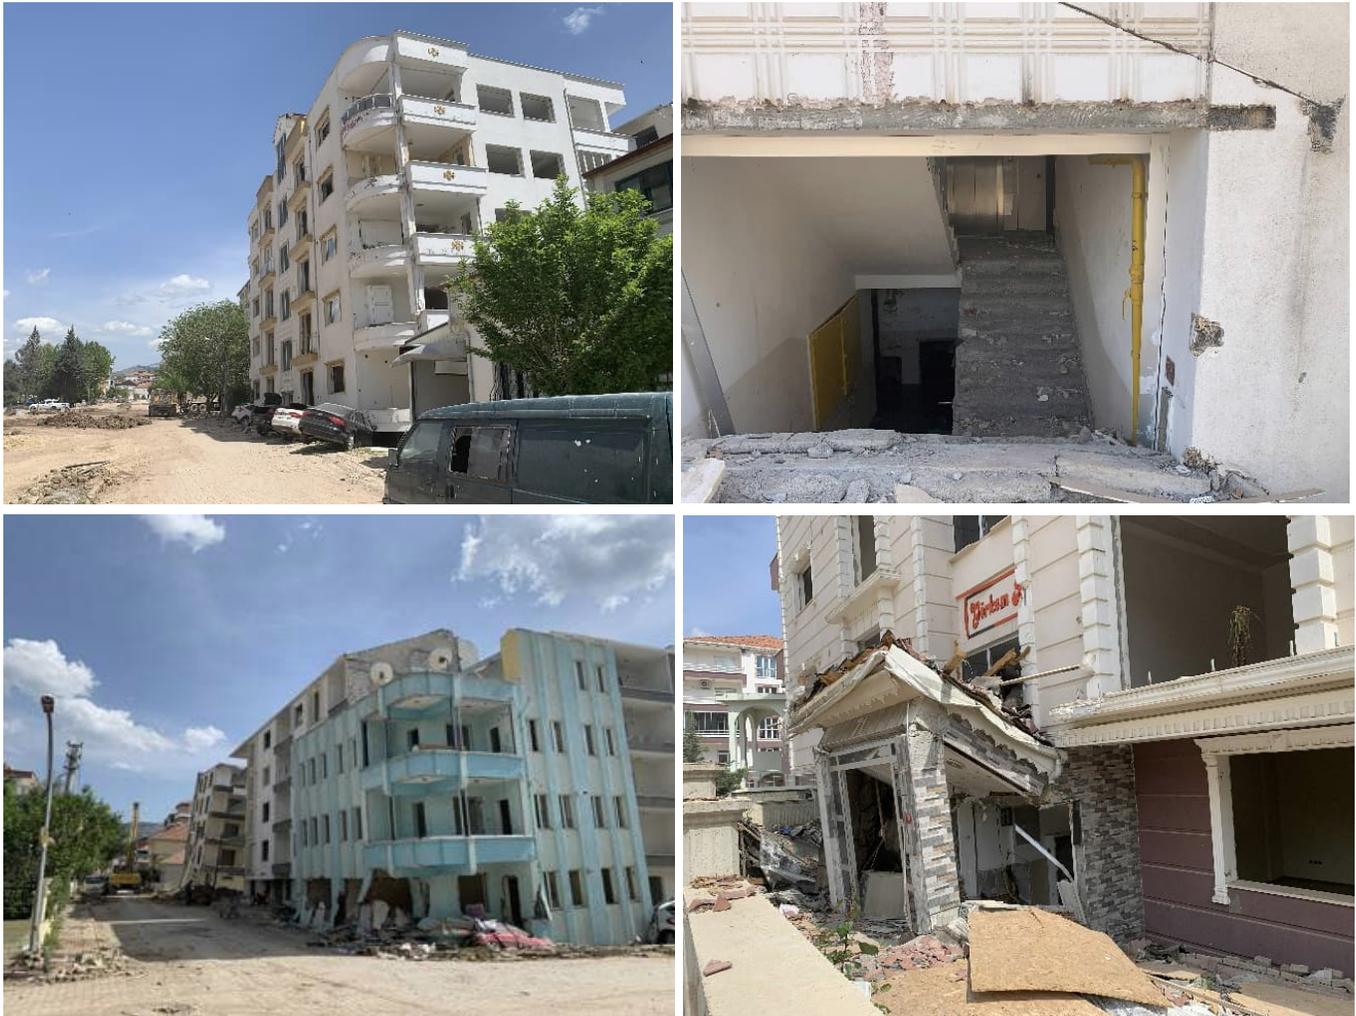
**Figure 5.12: Excessive building settlements. Top left and right - 37.7879, 37.6432, Bottom left - 37.7878,37.6427, Bottom right - 37.7887, 37.6453.**

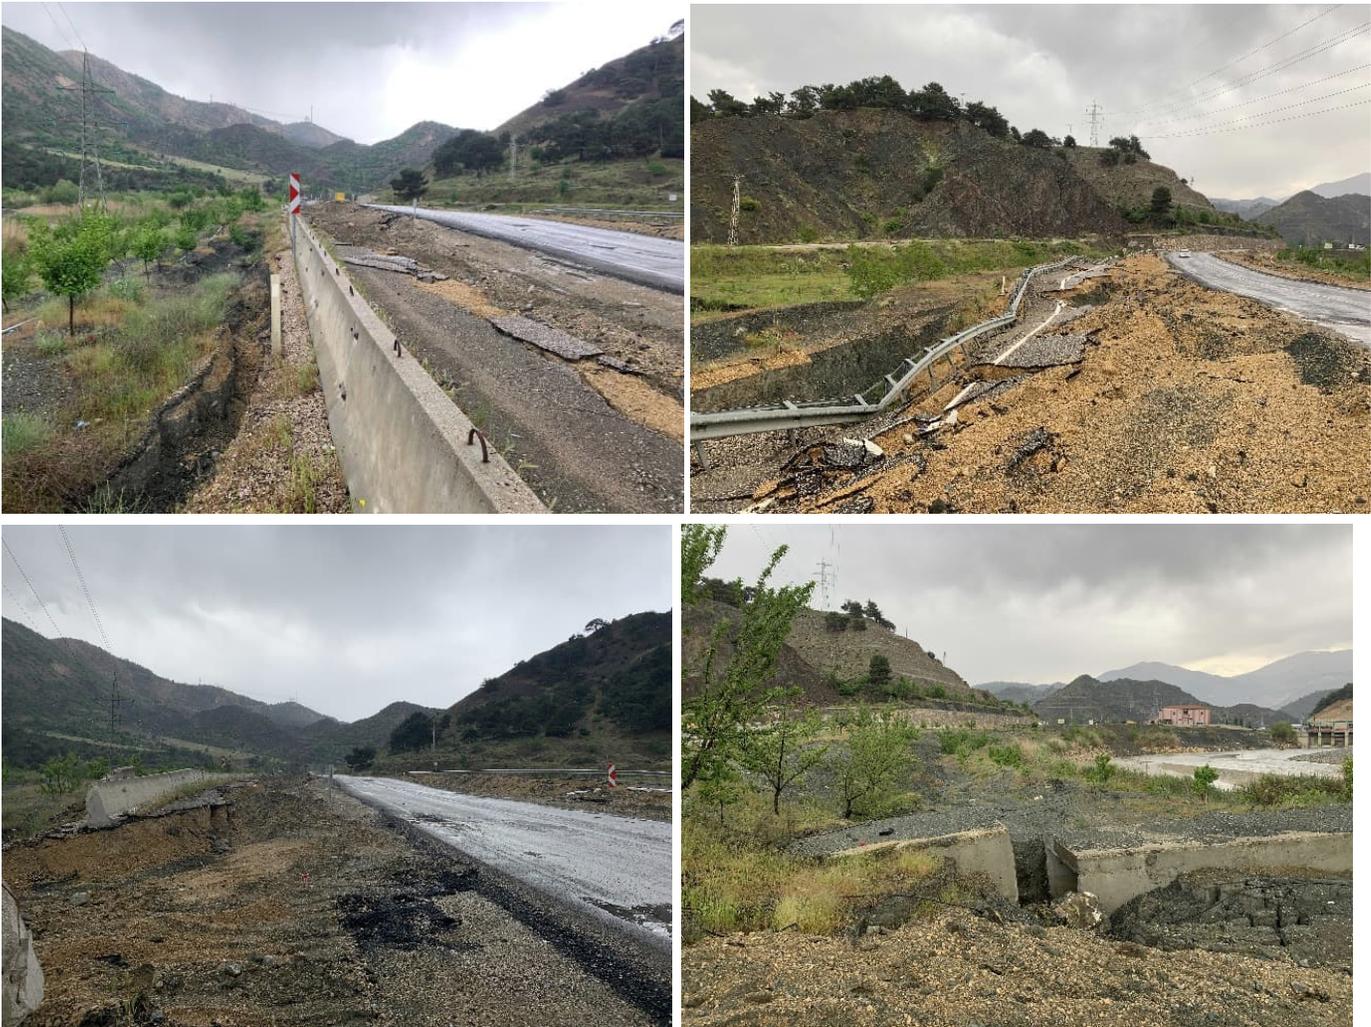
**Figure 5.18: Lateral Spreading Observations on Malatya-Kahramanmaraş Road -37.8645, 37.7698.**

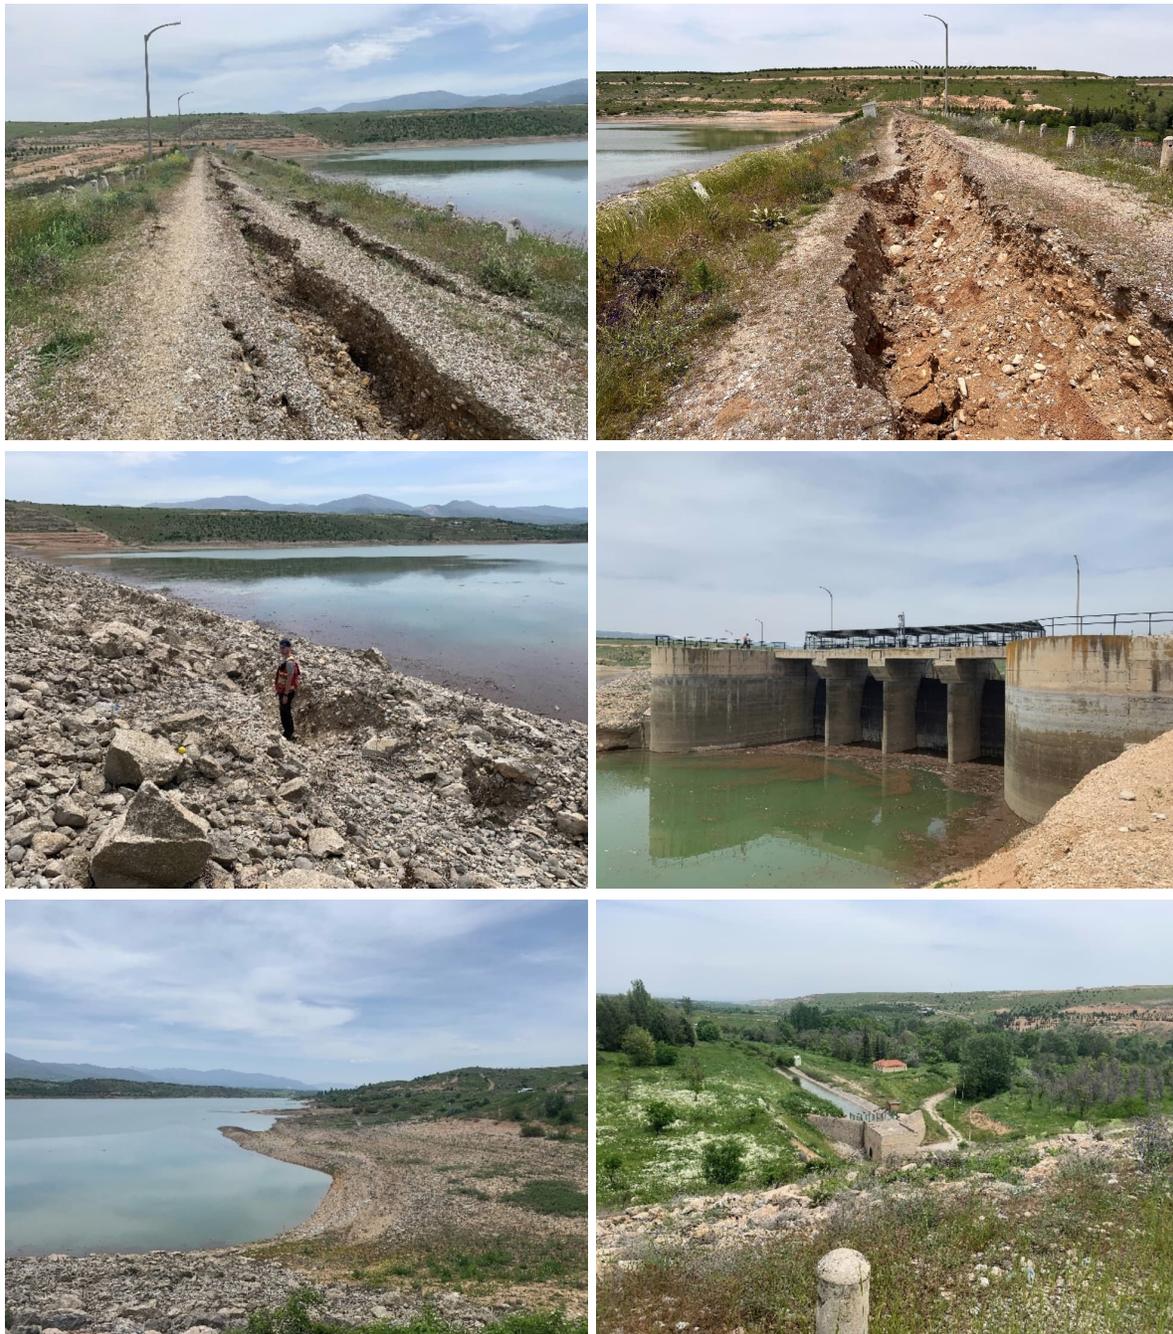
**Figure 5.25: Condition photographs of Sultansuyu Dam - 38.3186, 38.0525.**

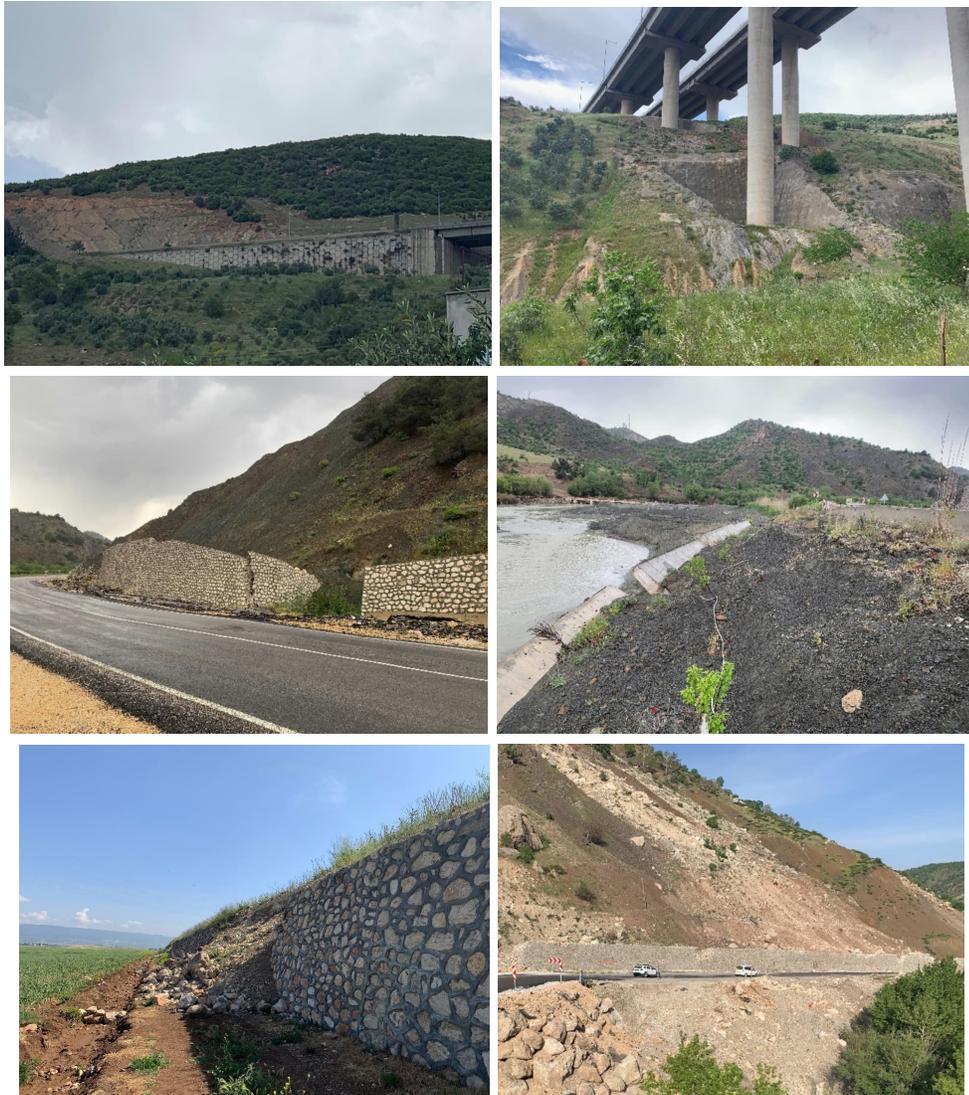
**Figure 5.26: Top left – Undamaged MSE wall along O-52 Adana Şanlıurfa Highway (37.1951, 36.7217). Top right – Undamaged anchored/soil nailed wall supporting O-52 Adana Şanlıurfa Highway Viaduct pier (37.1951, 36.7217). Middle left – Damaged stone gravity wall due to differential settlement (forefront) and surcharging from slide material (background) along Malatya-Kahramanmaraş Road (37.8634, 37.7669). Middle right – Failed gravity wall due to lateral spreading along Malatya-Kahramanmaraş Road (37.8634, 37.7681). Bottom left - Failed stone gravity wall inferred due to irregularities or construction defects (37.3909, 37.1533). Bottom-right Wall damage due to rockfall on Adiyaman Çelikhhan Road (37.9837, 38.2820).**
