# February 6, 2023 Kahramanmaraş Earthquakes in Türkiye

## Reconnaissance Report

Canadian  
Association  
for Earthquake  
Engineering  
and Seismology

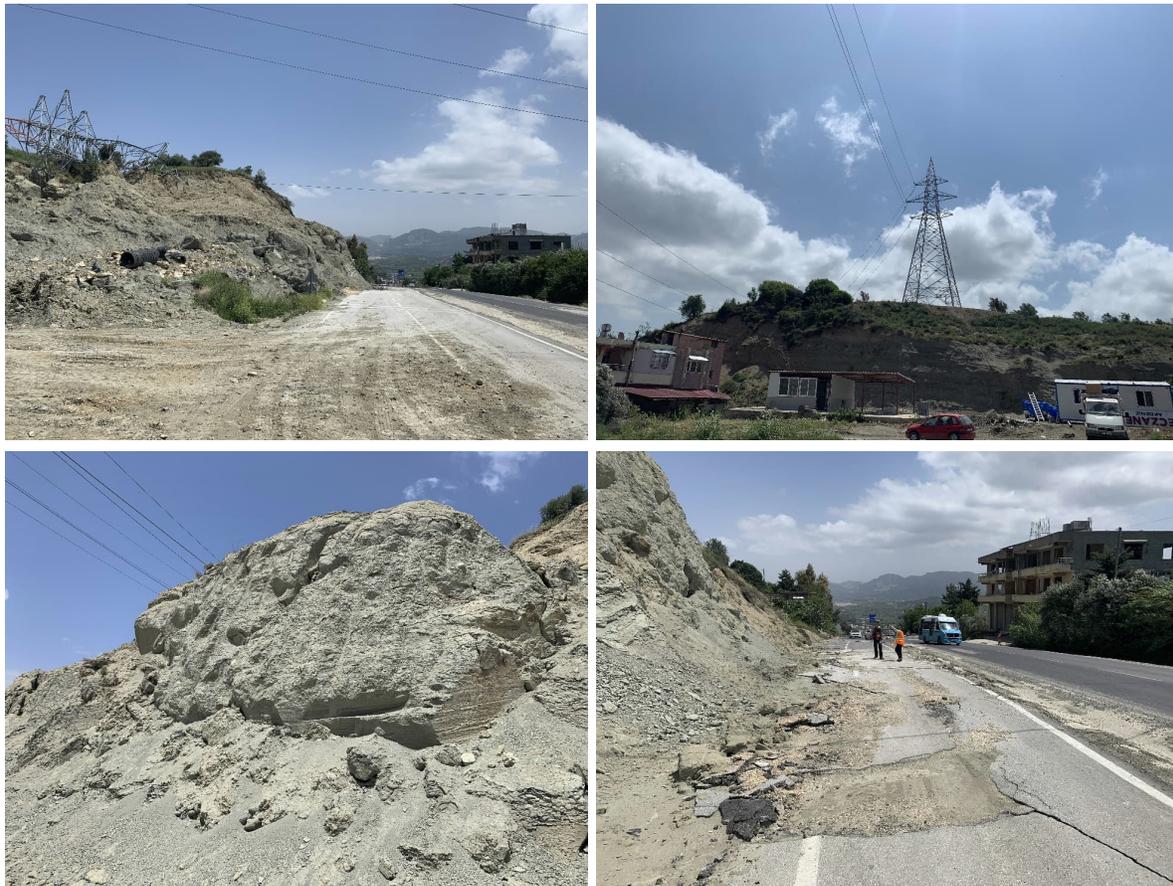
**Figure 5.27: D420 Transmission Tower Block Slide - 36.1483, 36.0832.**

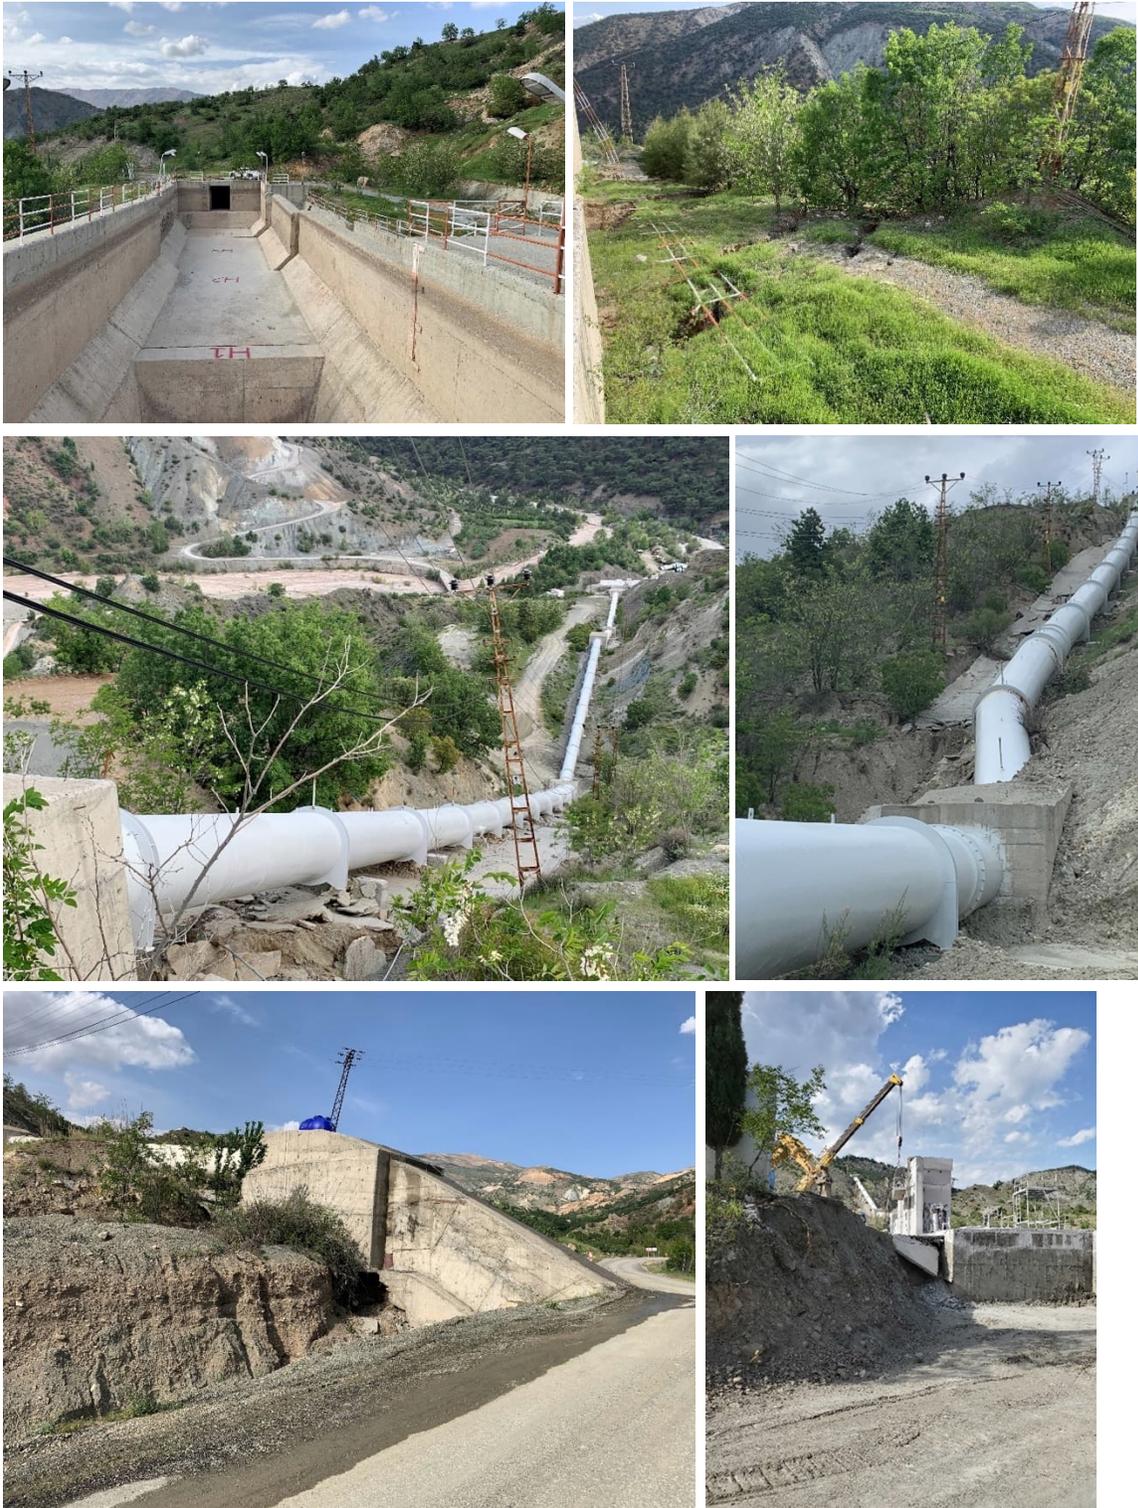
**Figure 5.31** Error! Reference source not found. : **Damage to the Tektuğ Erkenek hes H ydroelectric Facility - 37.8694, 37.8201**

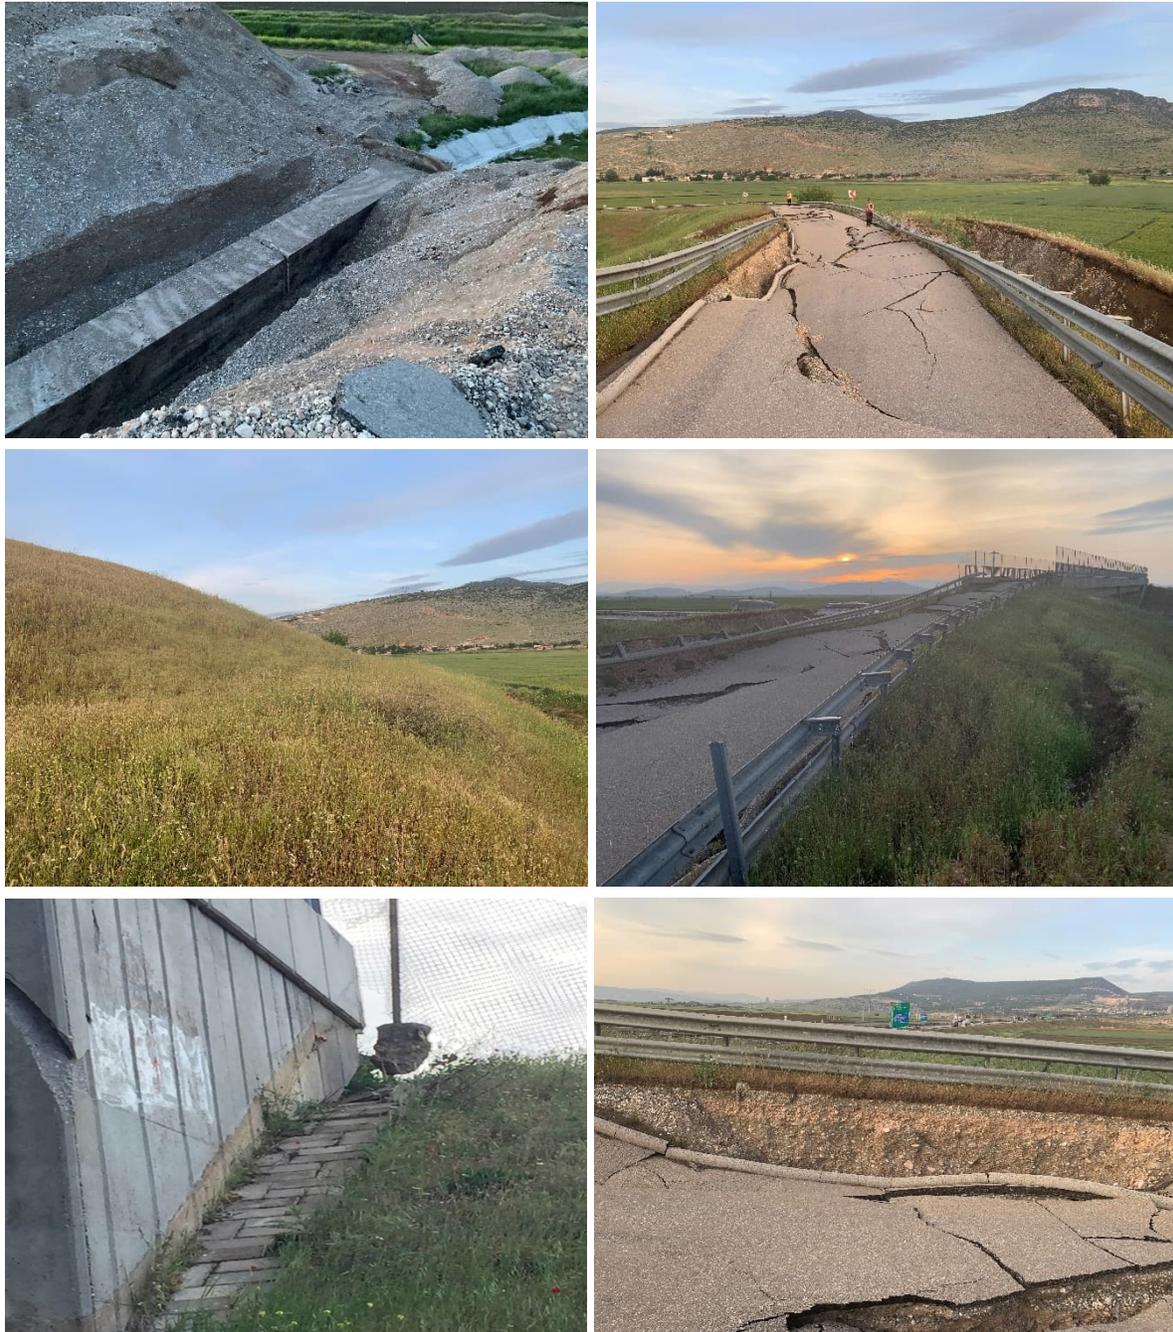
**Figure 5.32: O-52 Adana Şanlıurfa Highway Underpass Embankment Failure - 37.2824, 37.1158.**

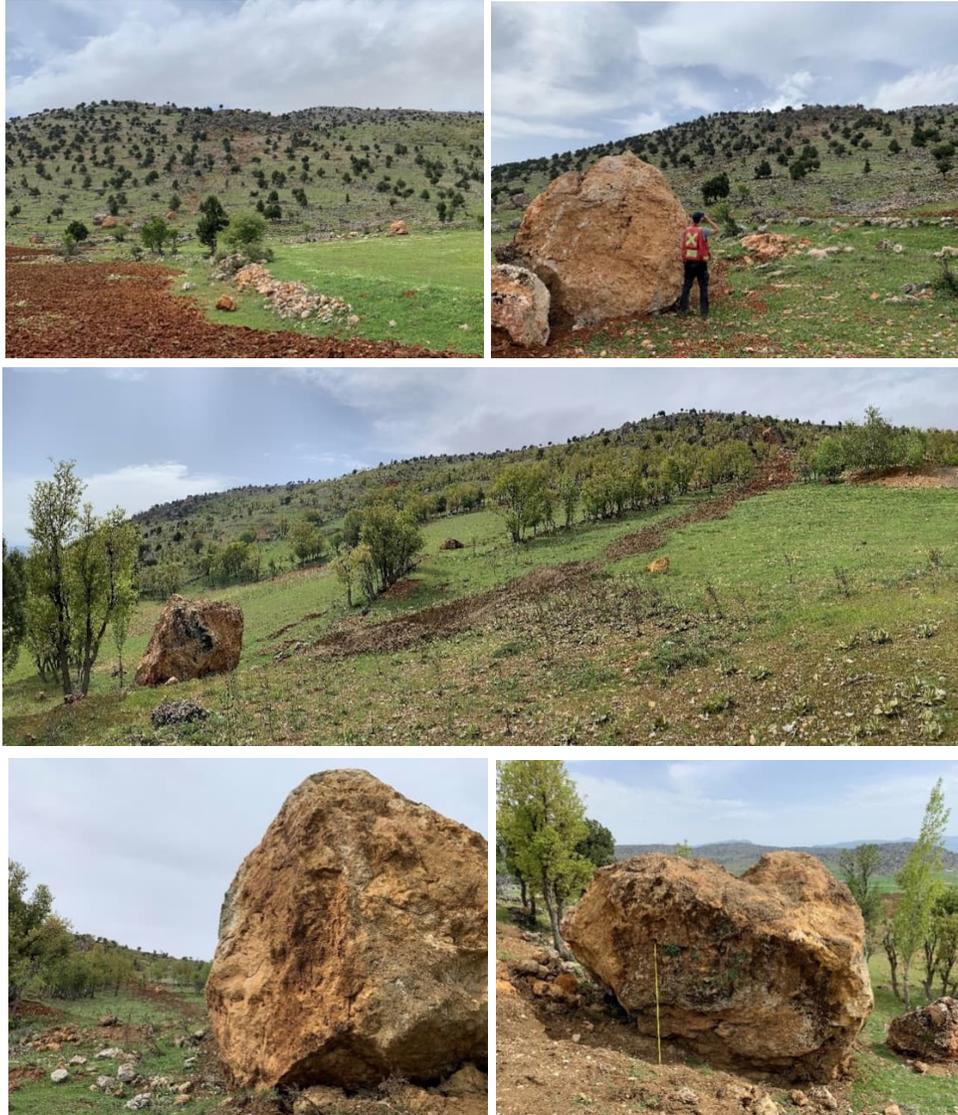
**Figure 5.33: Rockfall outside of Nurhak - 37.9744, 37.4862.**

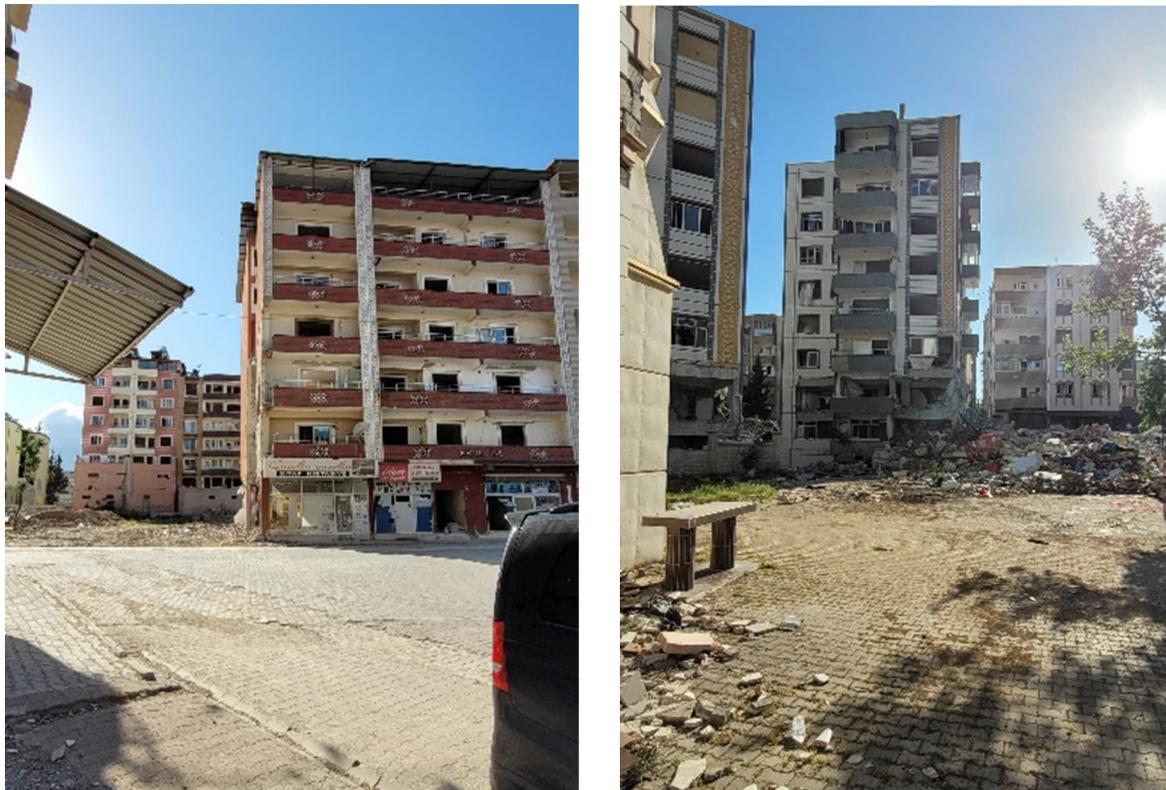
**Figure 6.14: Typical damage observed in Kırıkhan**

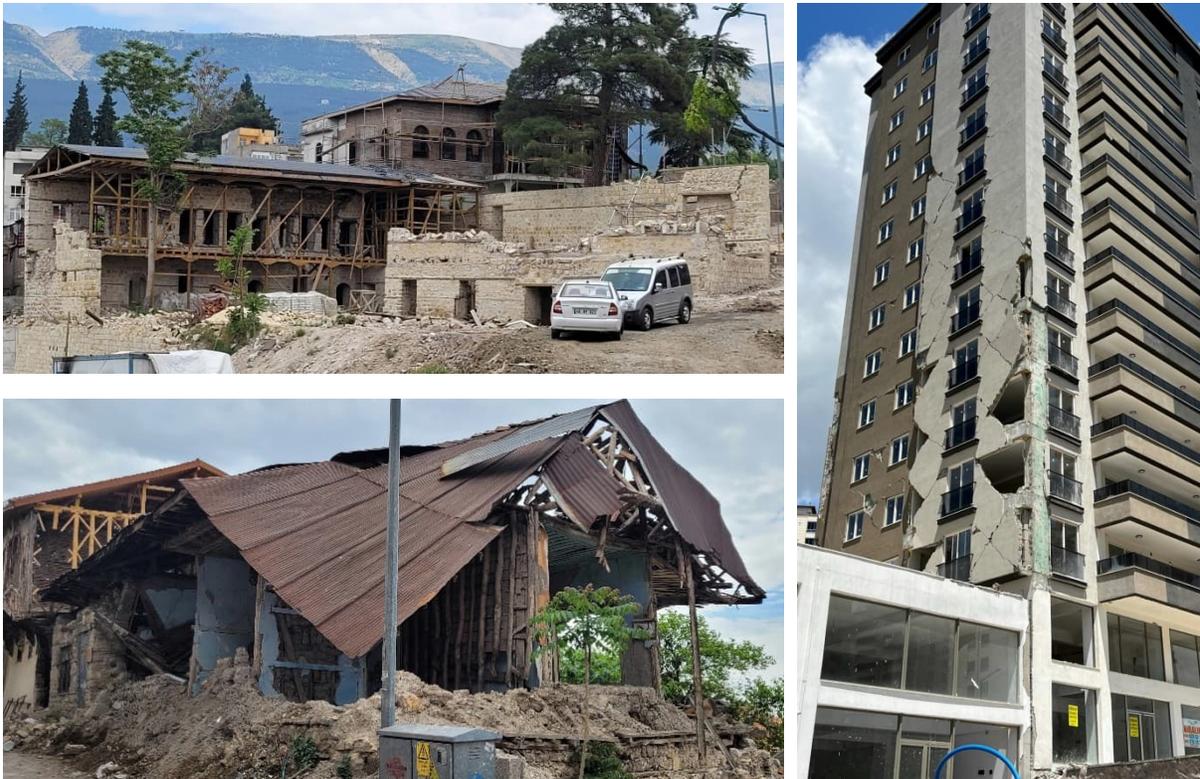
**Figure 6.15: Typical damage observed in Kahramanmaraş**

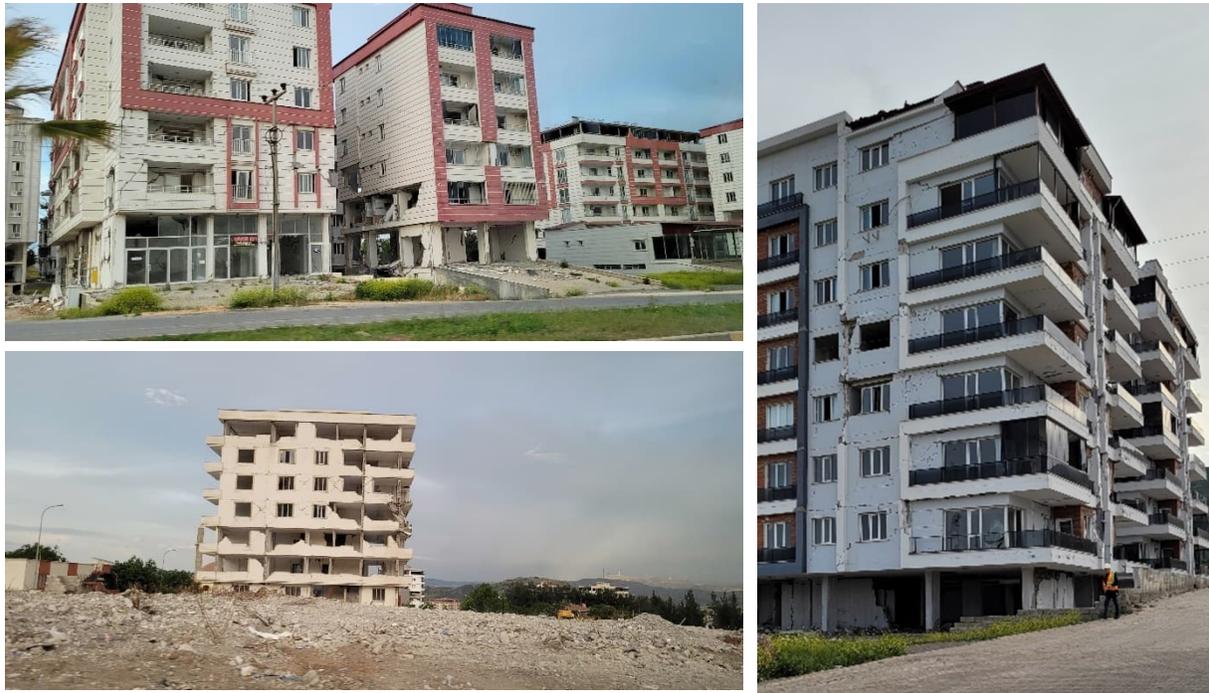
**Figure 6.16: Typical damage observed in Nurdağı**

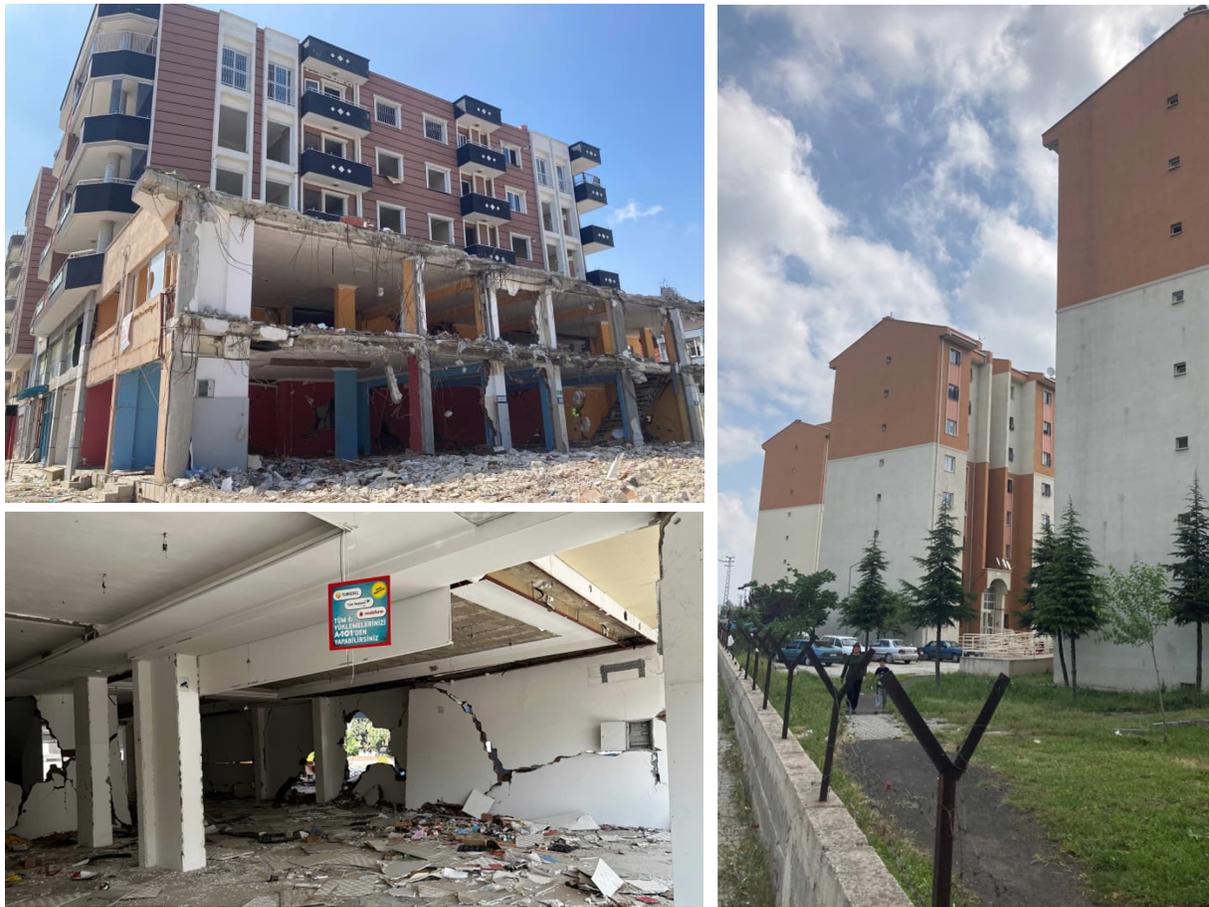
**Figure 6.17: Typical observed damage in Osmaniye. Tunnel form buildings in right photo.**

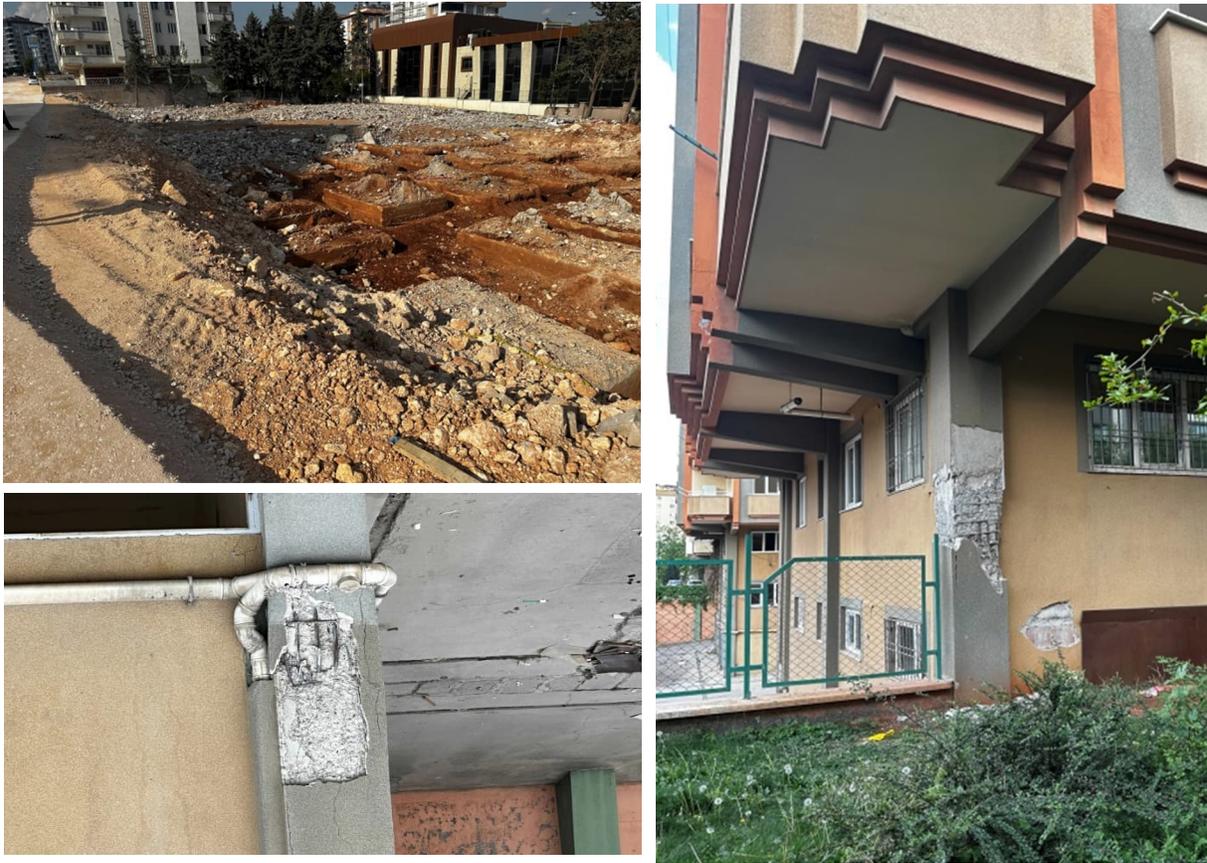
**Figure 6.18: Typical observed observations of damage in Gaziantep**

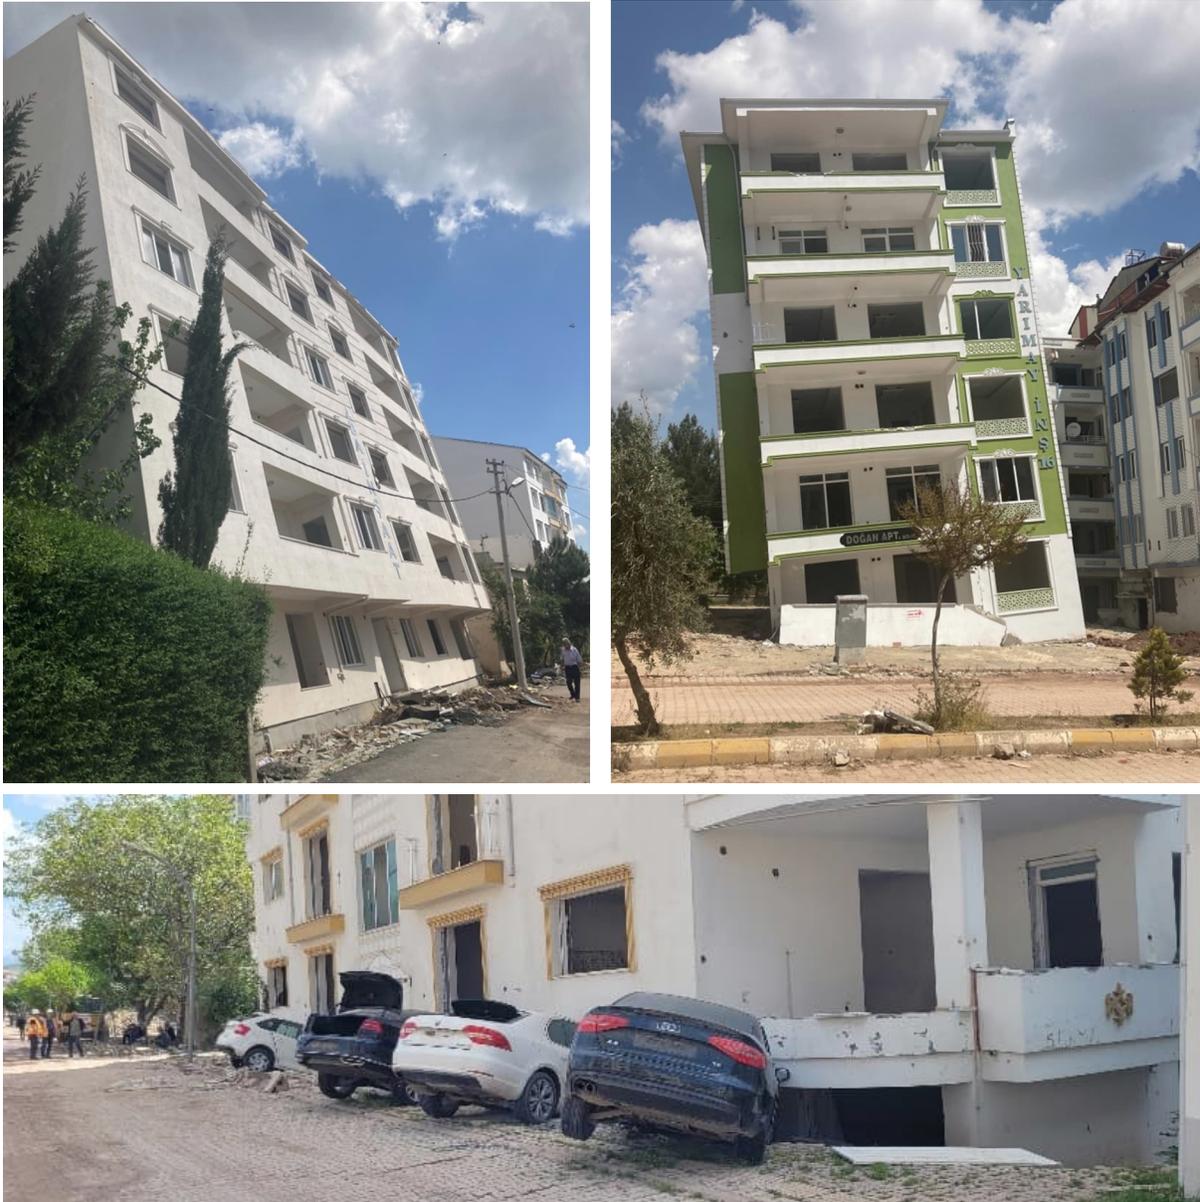
**Figure 6.19: Typical observed damage observed in Gölbaşı**

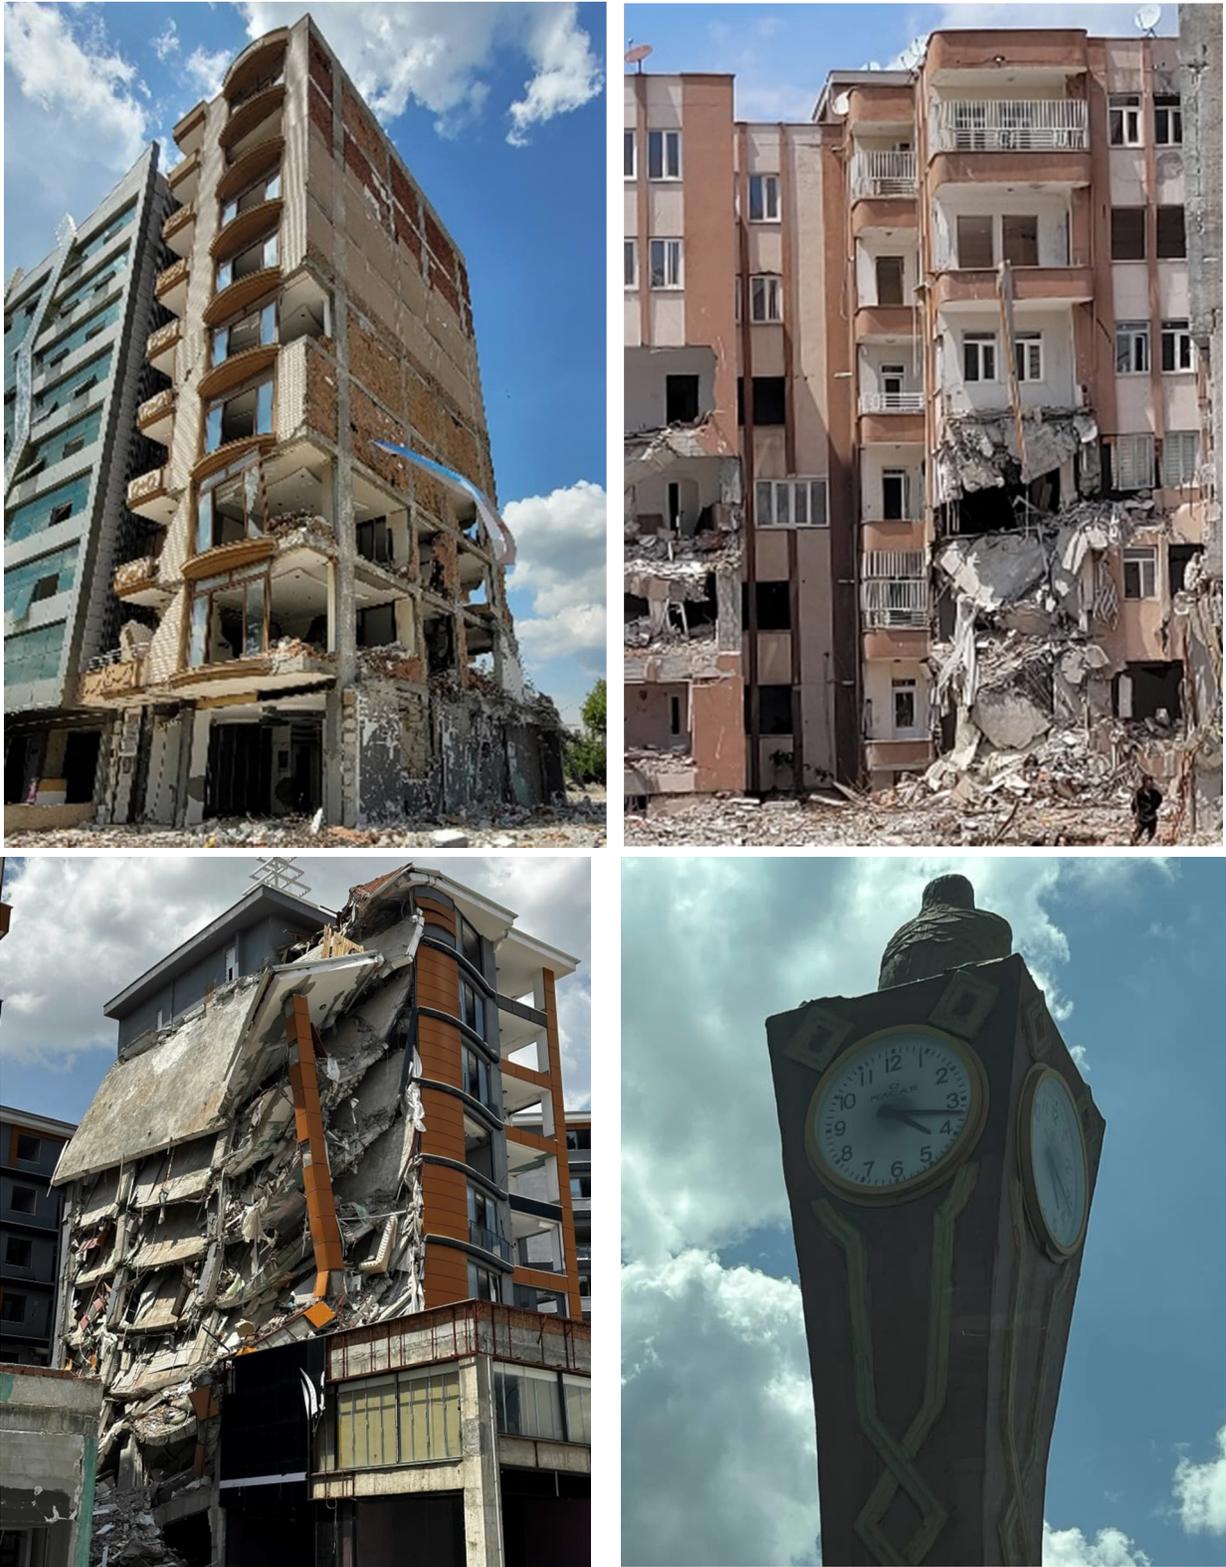
**Figure 6.20: Typical damage observed in Adiyaman**

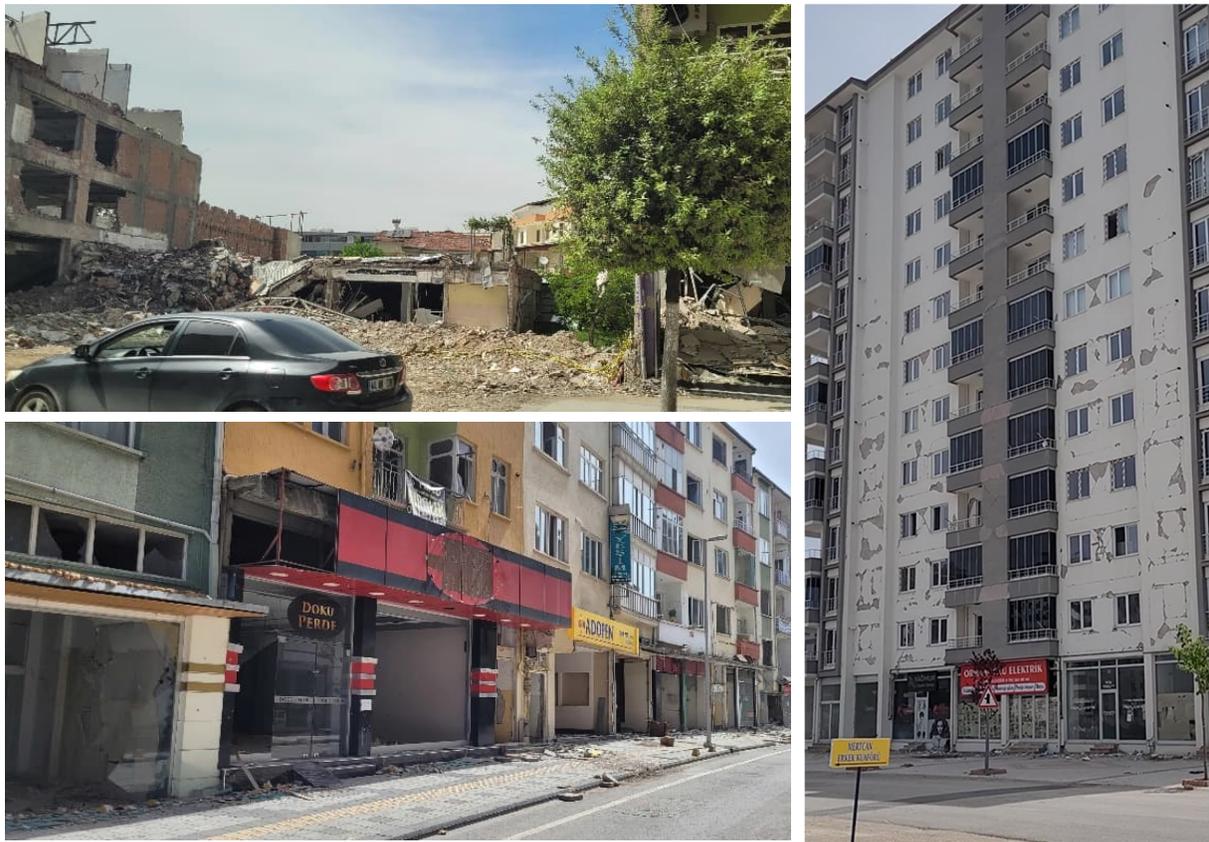
**Figure 6.21: Typical observed damage in Malatya**

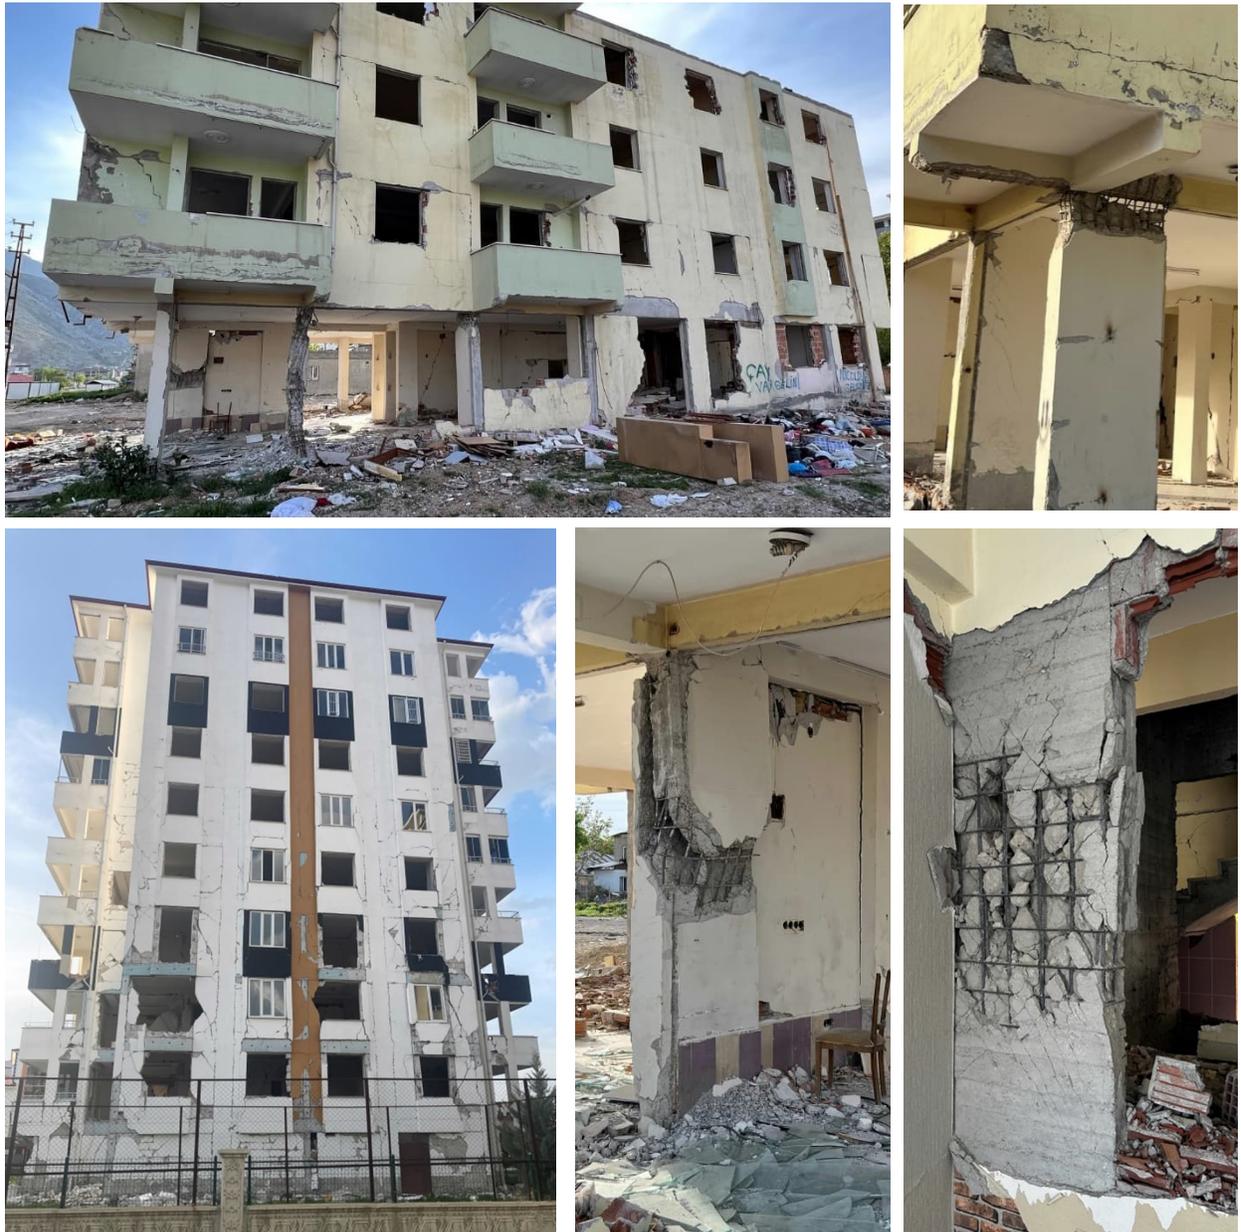
**Figure 6.22: Typical observed damage in Elbistan**

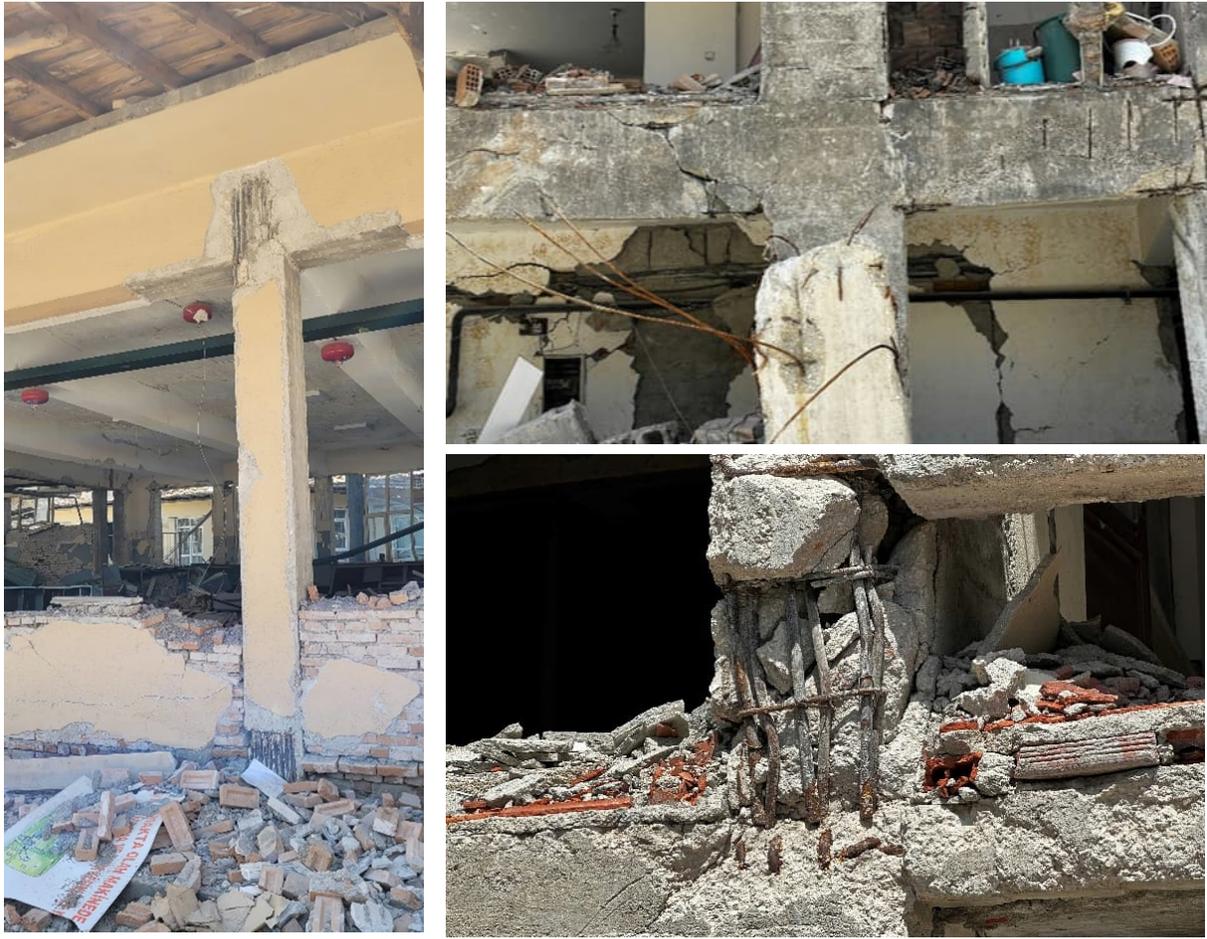
Figure 6.23: Damage observed in RC moment frame structures.

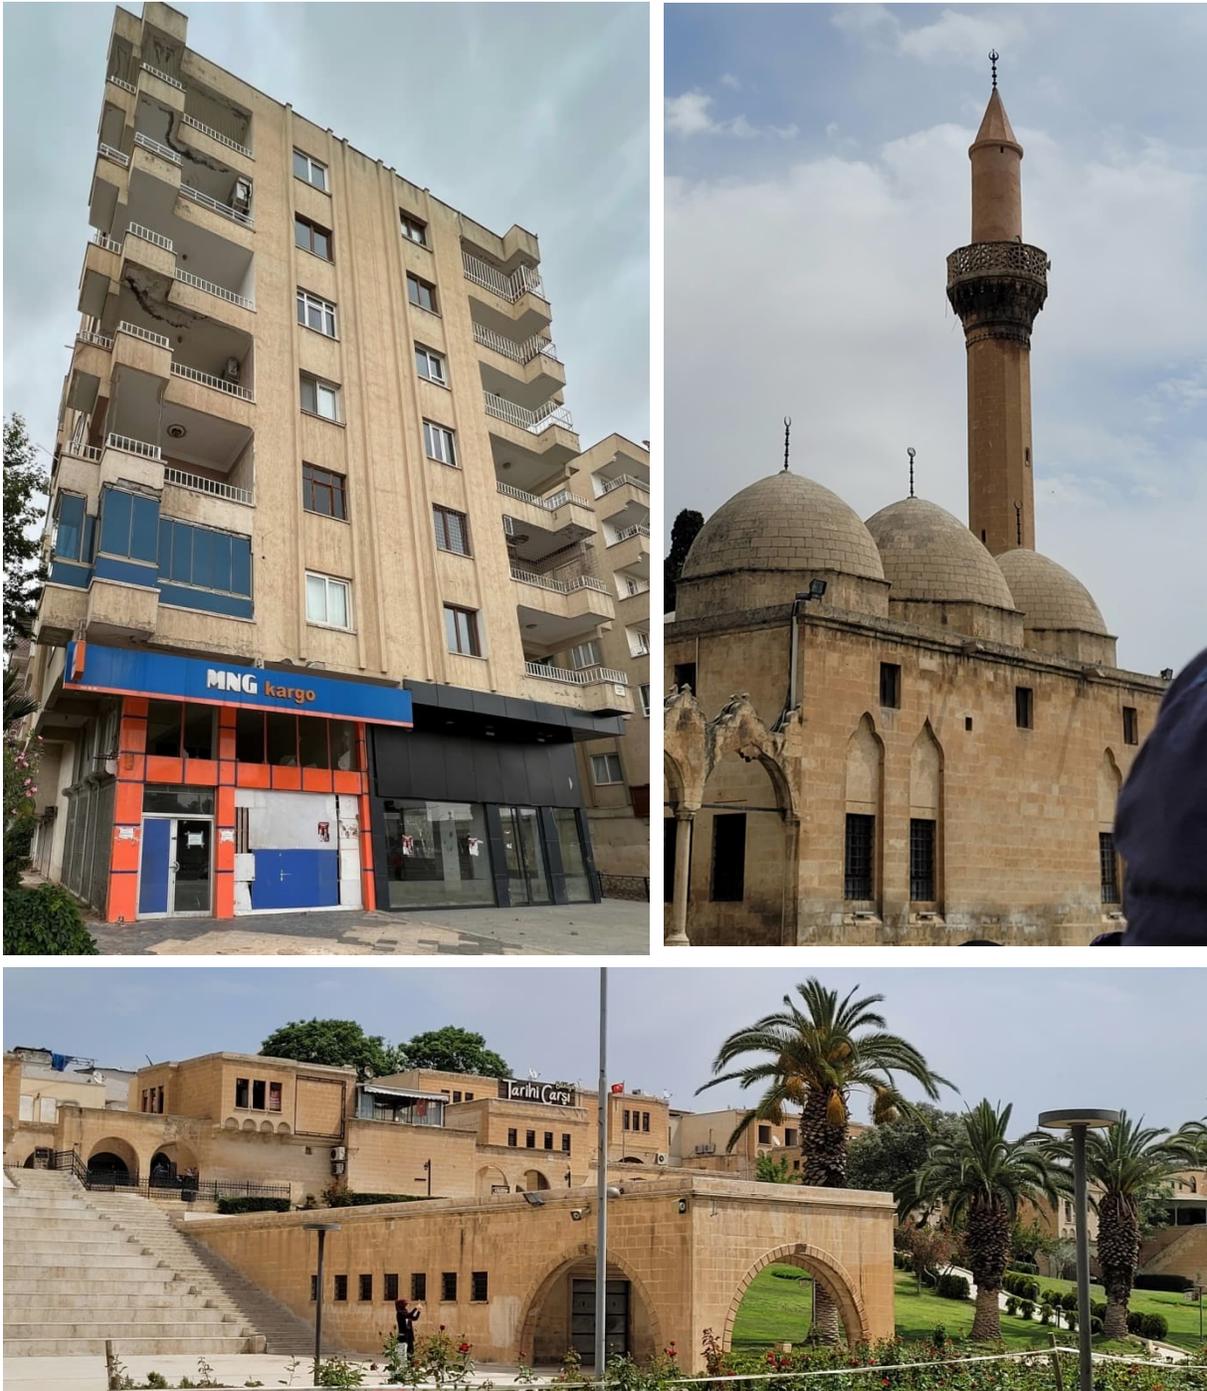
**Figure 6.24: Typical observed damage in Şanlıurfa**

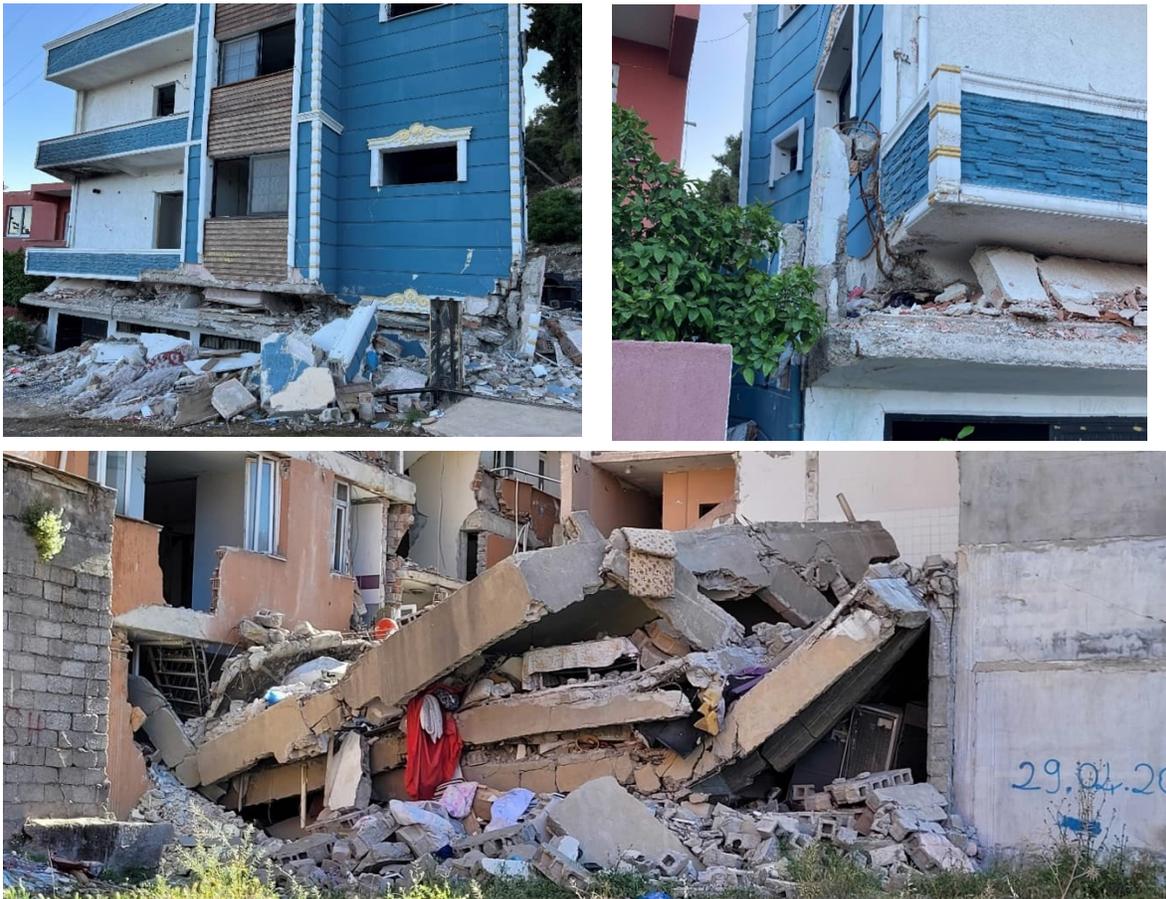
**Figure 6.30: Pancaked ground floor (top) and total building collapse (bottom), Kırıkhan.**

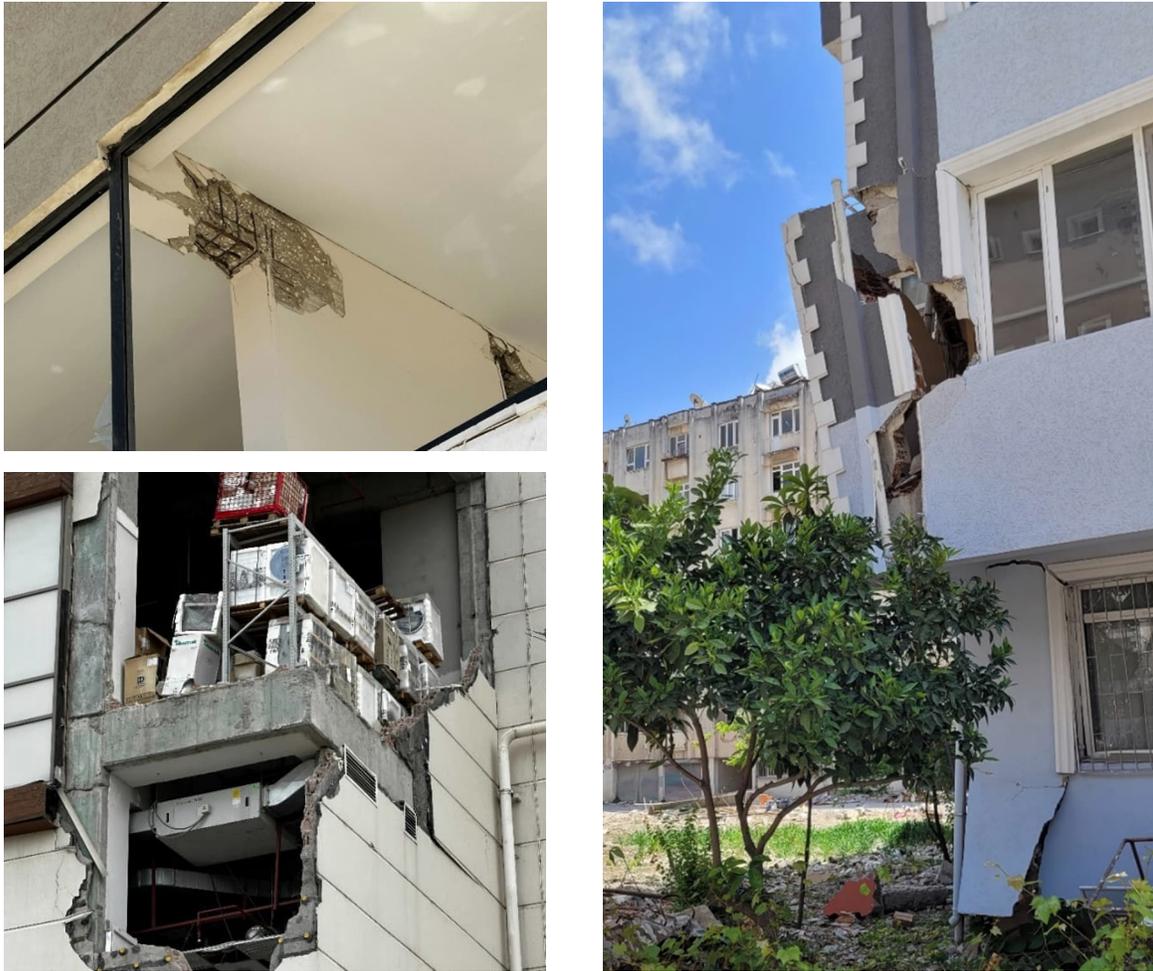
**Figure 6.32: Damage due to cantilevered floor beams**

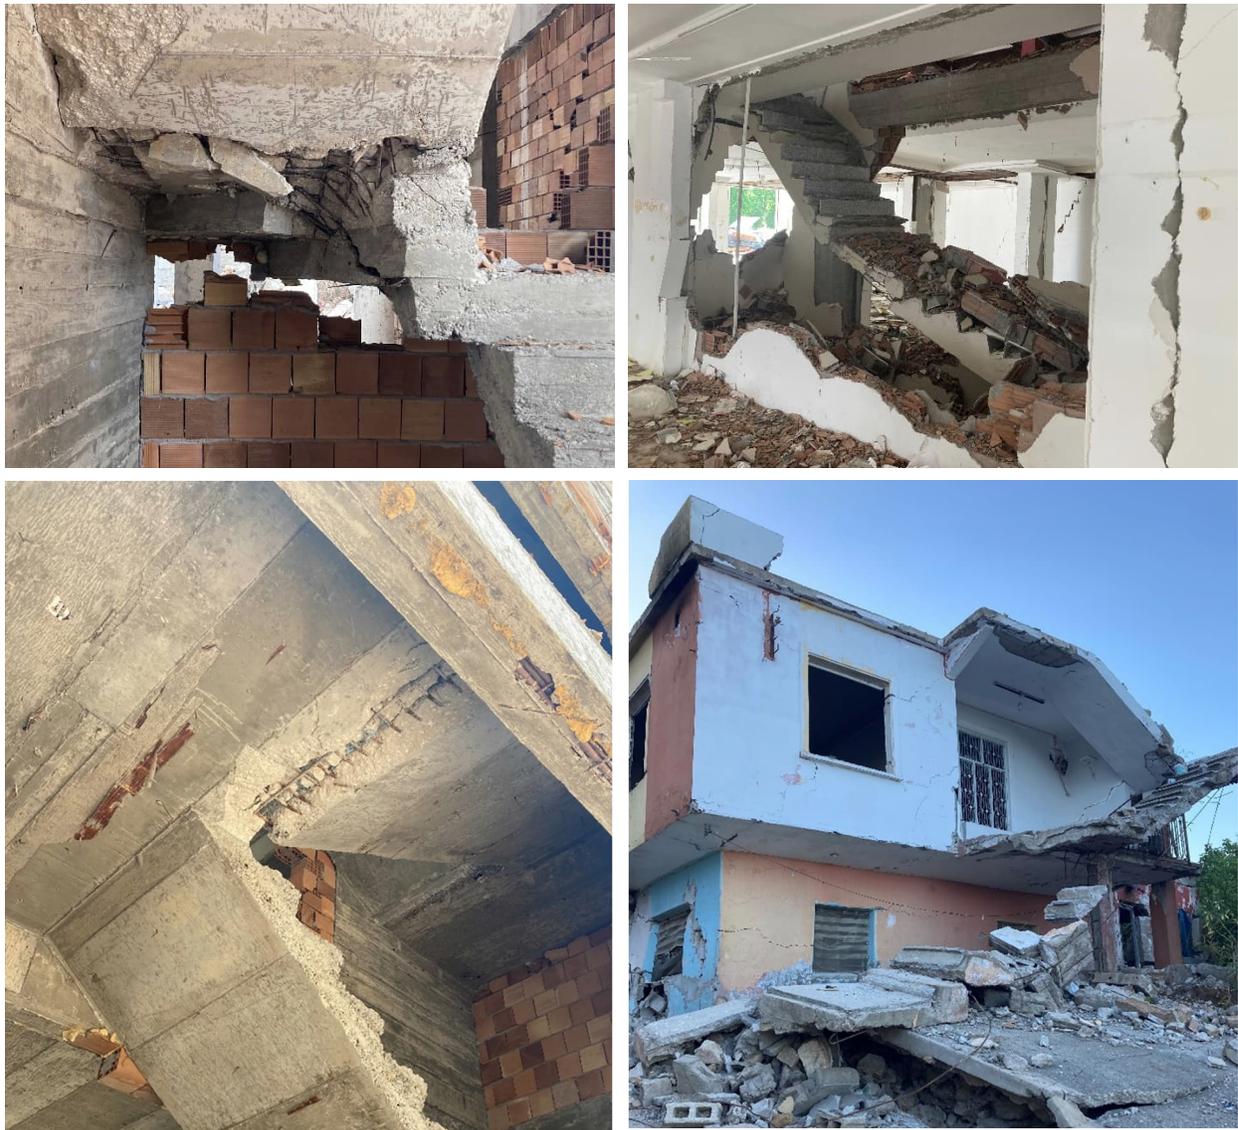
**Figure 6.33: Damage observed to exit stairs.**
