# February 6, 2023 Kahramanmaraş Earthquakes in Türkiye

## Reconnaissance Report

Canadian  
Association  
for Earthquake  
Engineering  
and Seismology

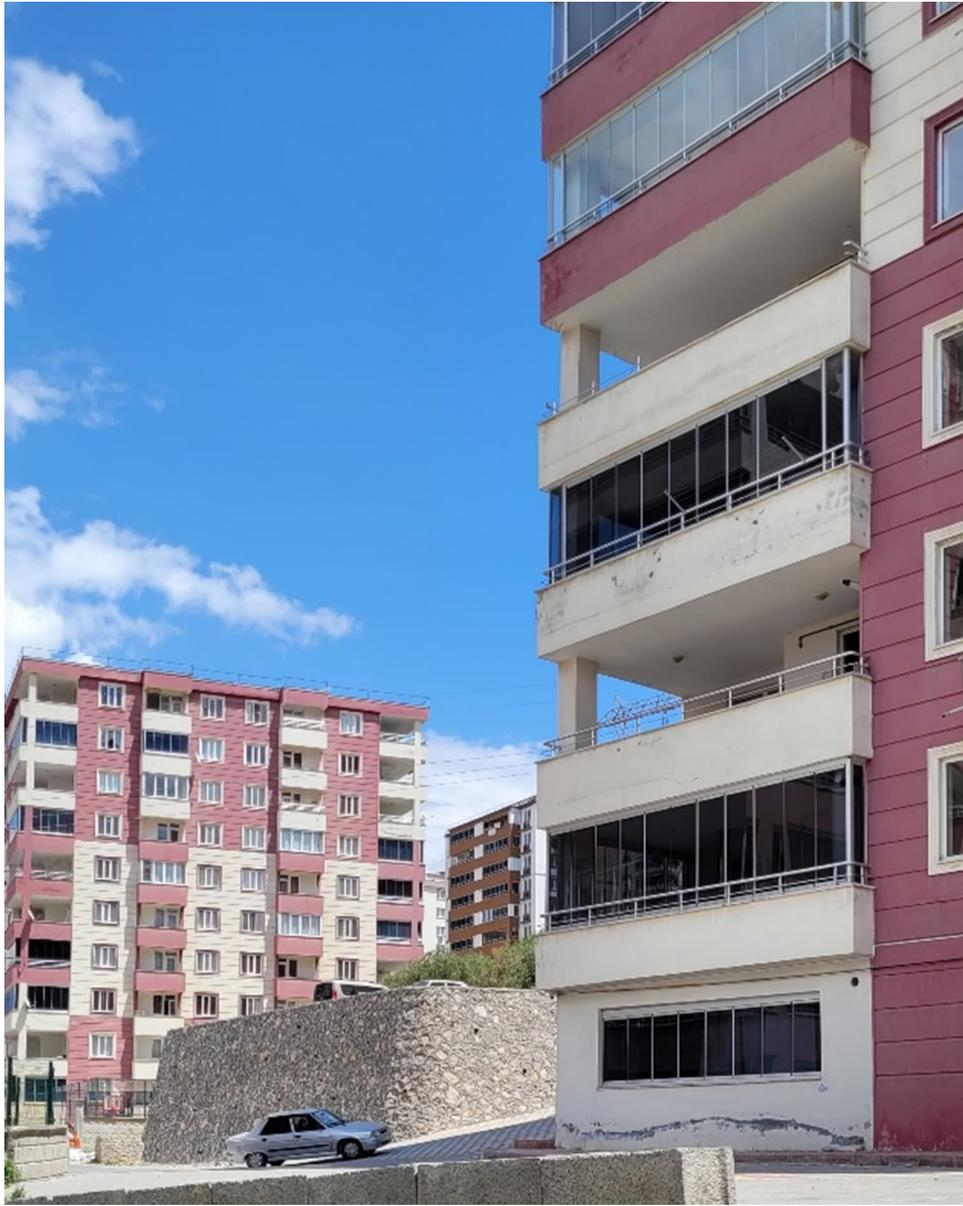
***Figure 6.35: Performance of regular concrete buildings next to tunnel form buildings in Kahramanmaraş [37.57628, 36.857665].***

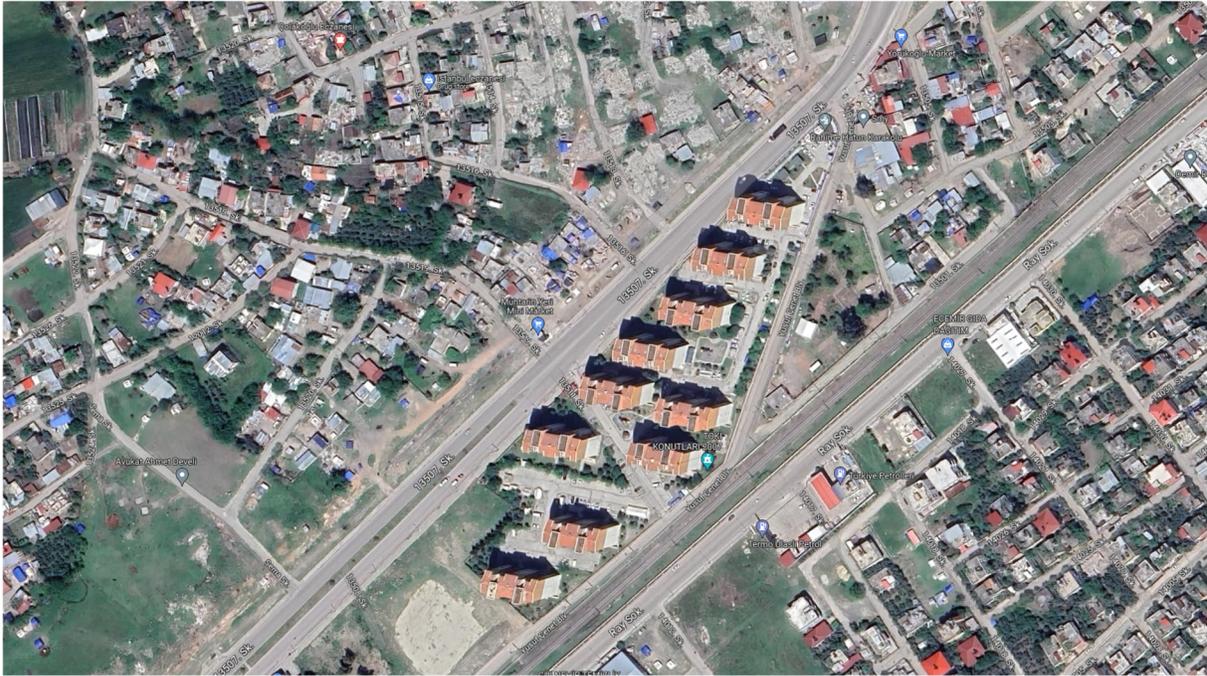
**Figure 6.37: Generalized damage around tunnel form buildings observed in Osmaniye, Google Maps (accessed on 2023.07.15).**

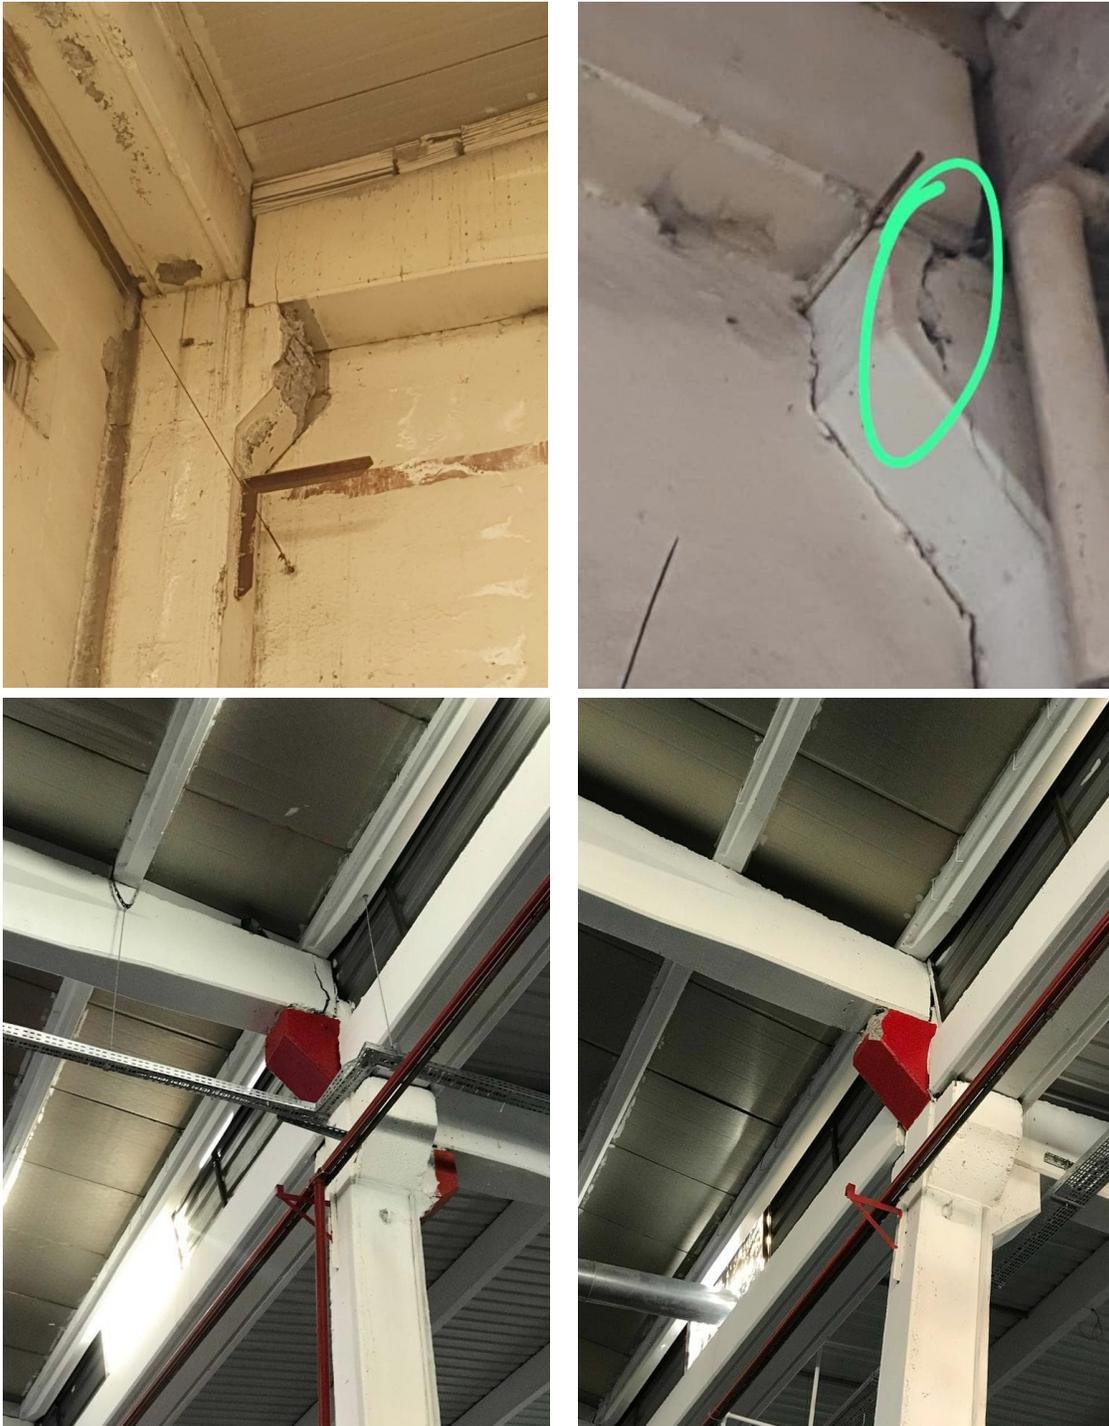
**Figure 6.41: Observed damage to connections of precast concrete frames, provided by the team's local engineering contact, Ali Kürşad Bozbaş.**

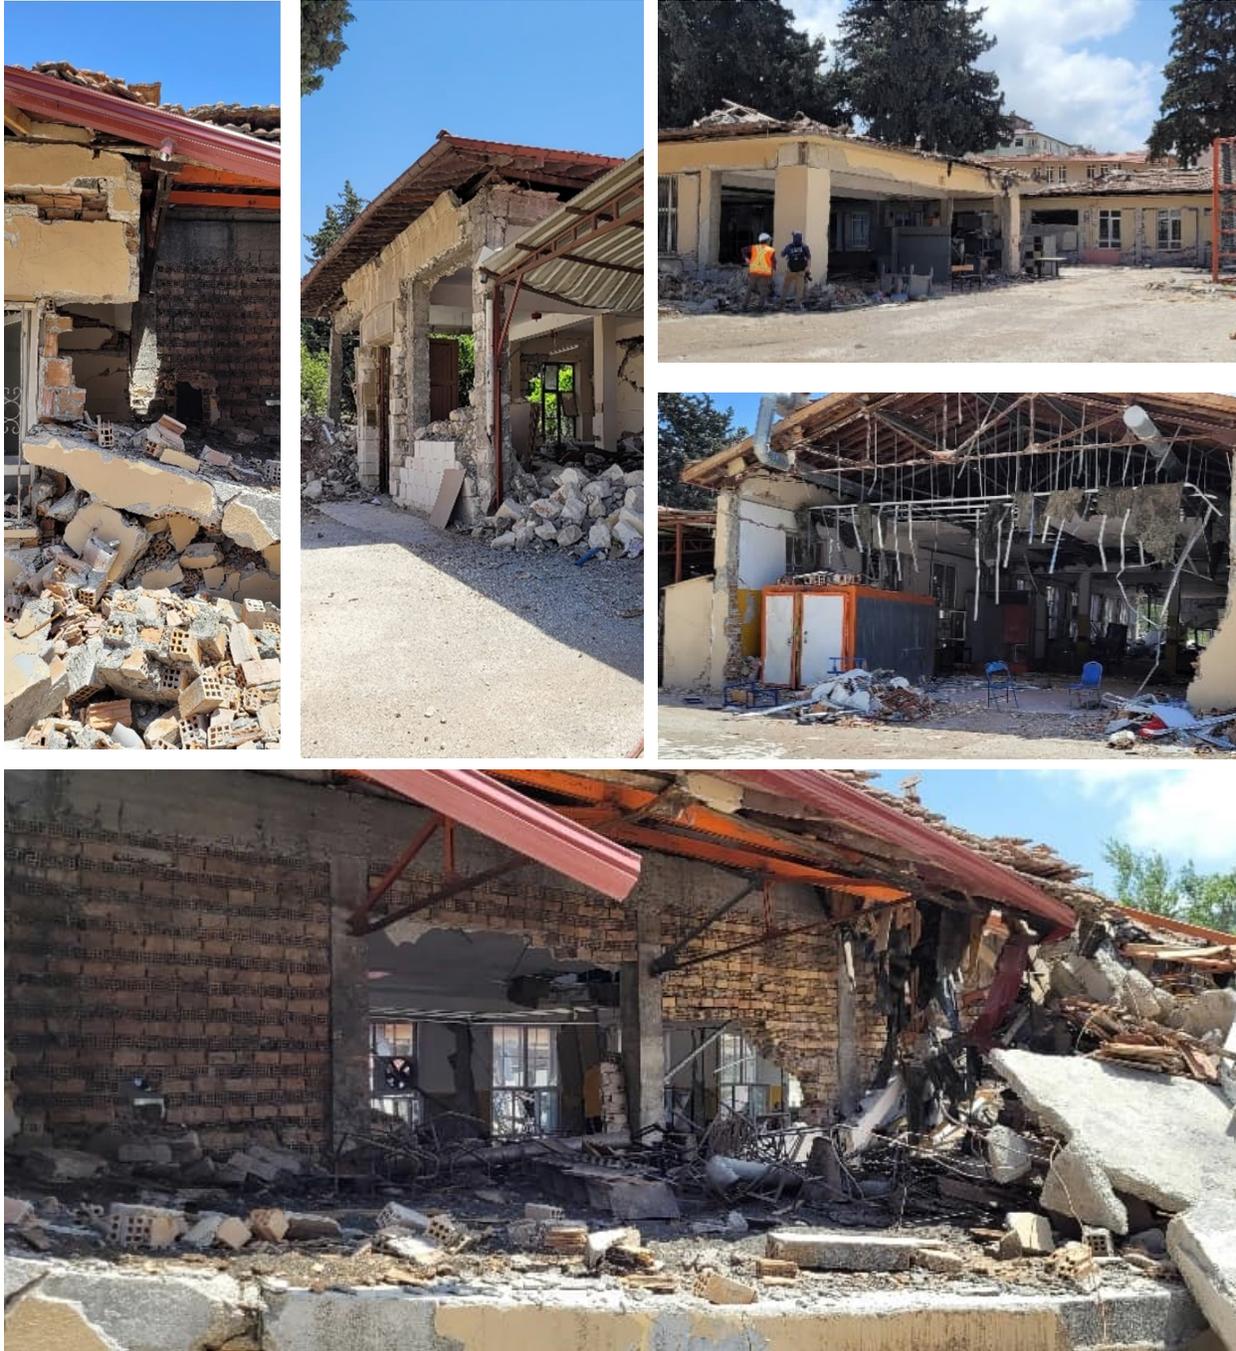
**Figure 6.53: Damage to various older buildings, school number 2 in Antakya [36.2022693, 36.15850883]**

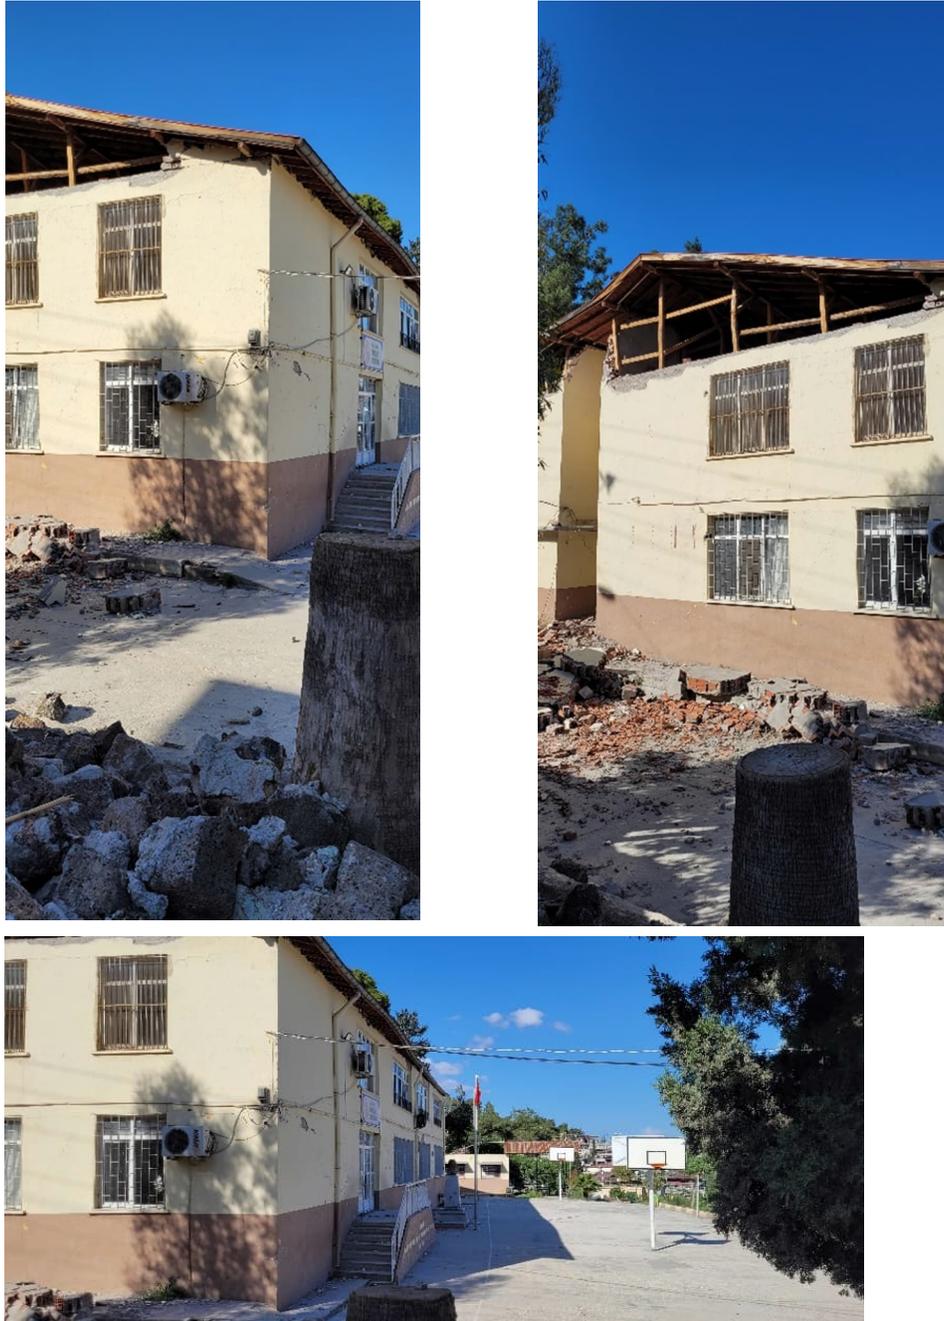
**Figure 6.54: Damage to school in Kirikhan [36.50216861, 36.35216615].**

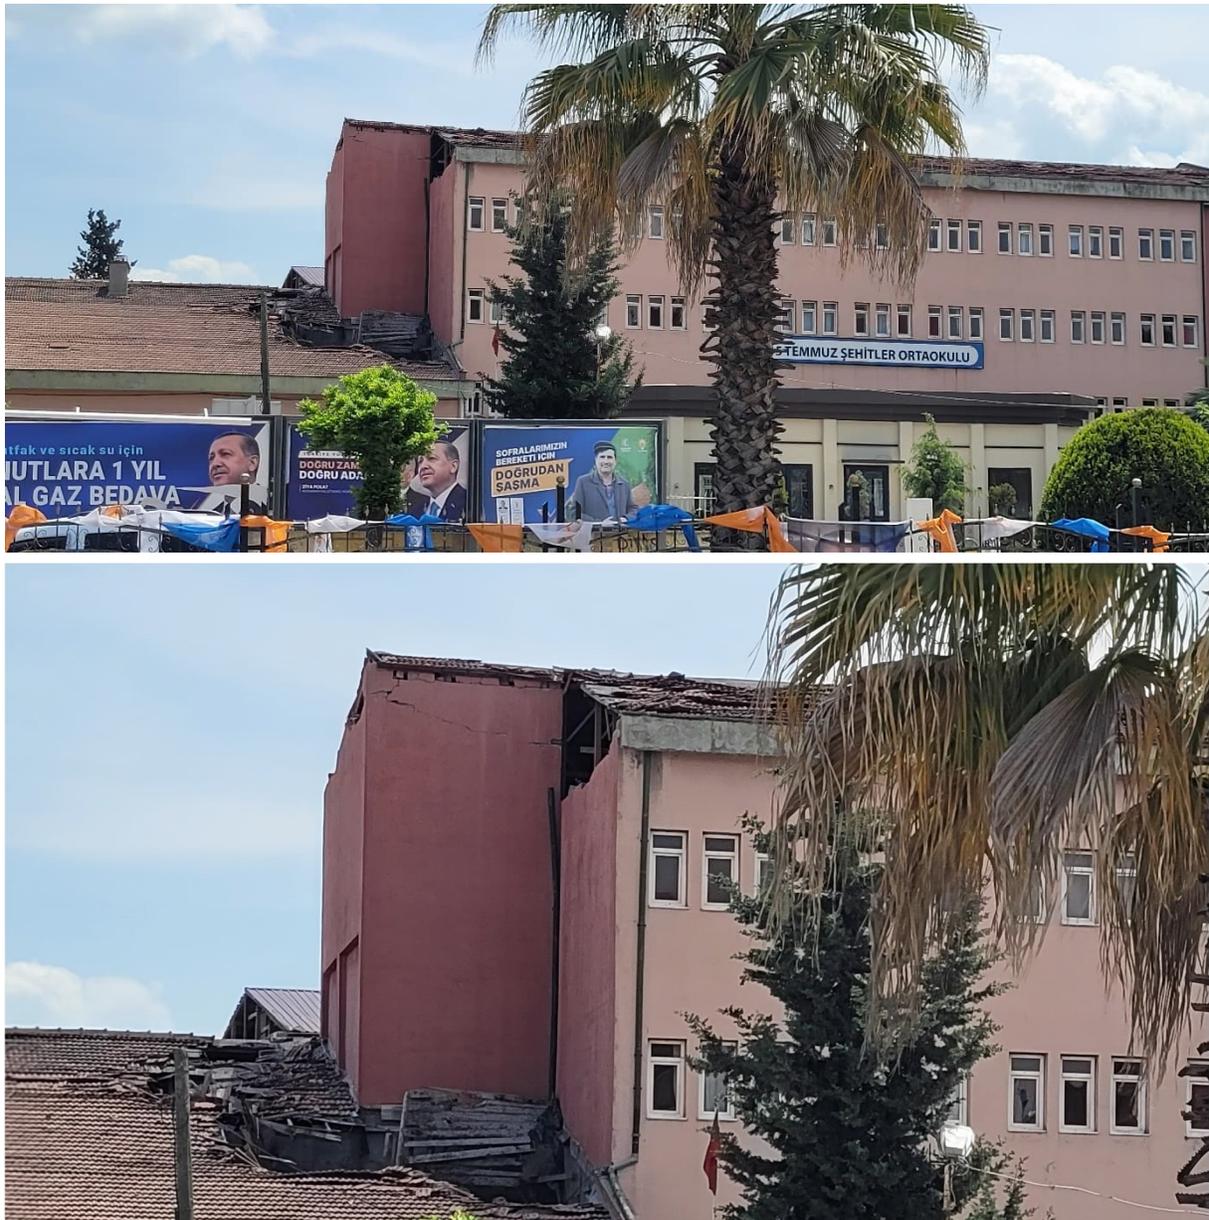
**Figure 6.56: Damage to school in Adiyaman [37.76252745, 38.26990334].**

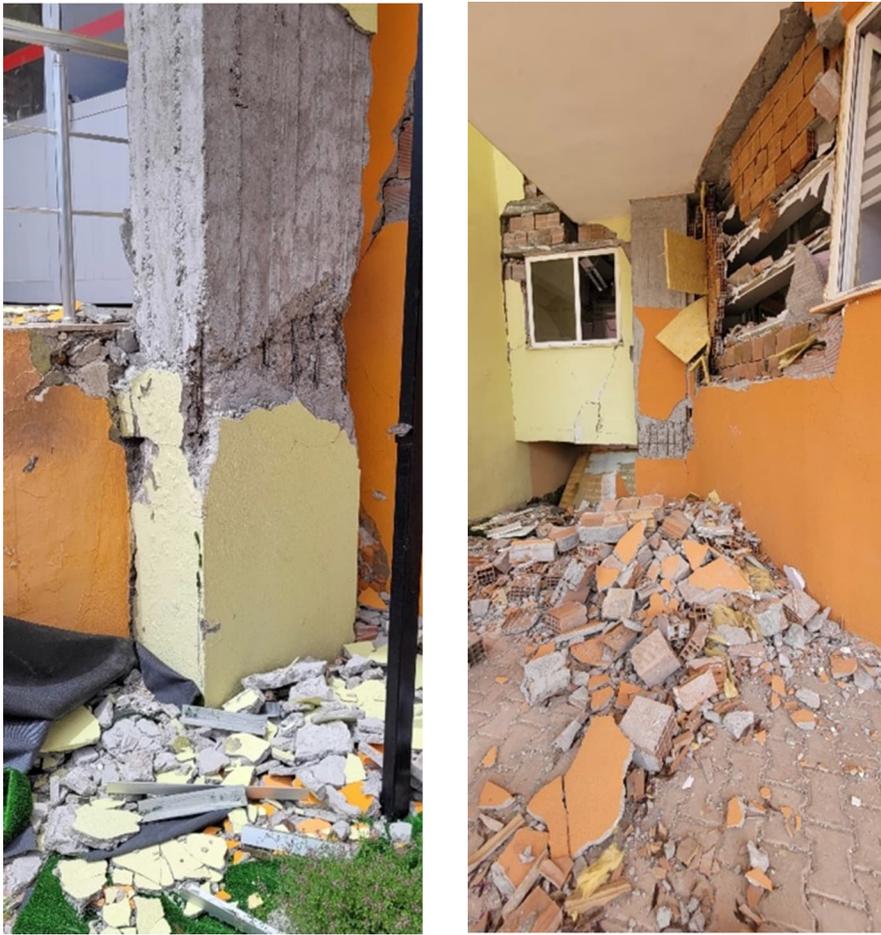
**Figure 6.59 (Cont'd): Damage to Building 1, school in Malatya**

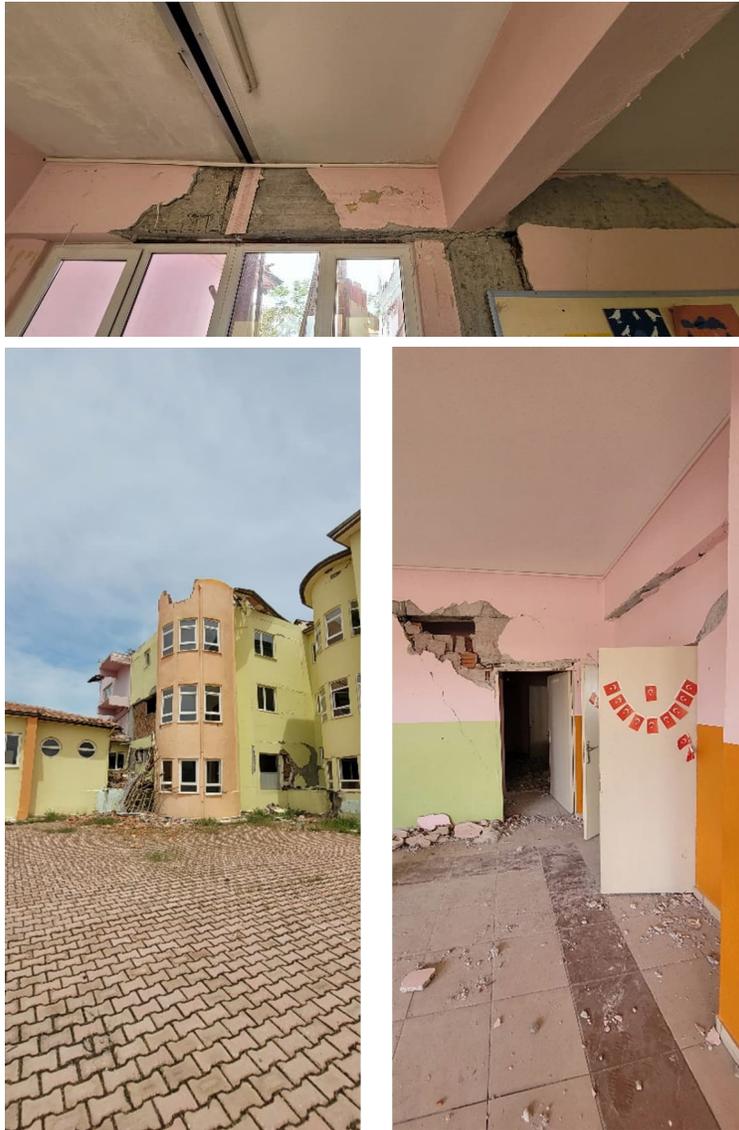
**Figure 6.60: Damage to Building 3, school in Malatya.**

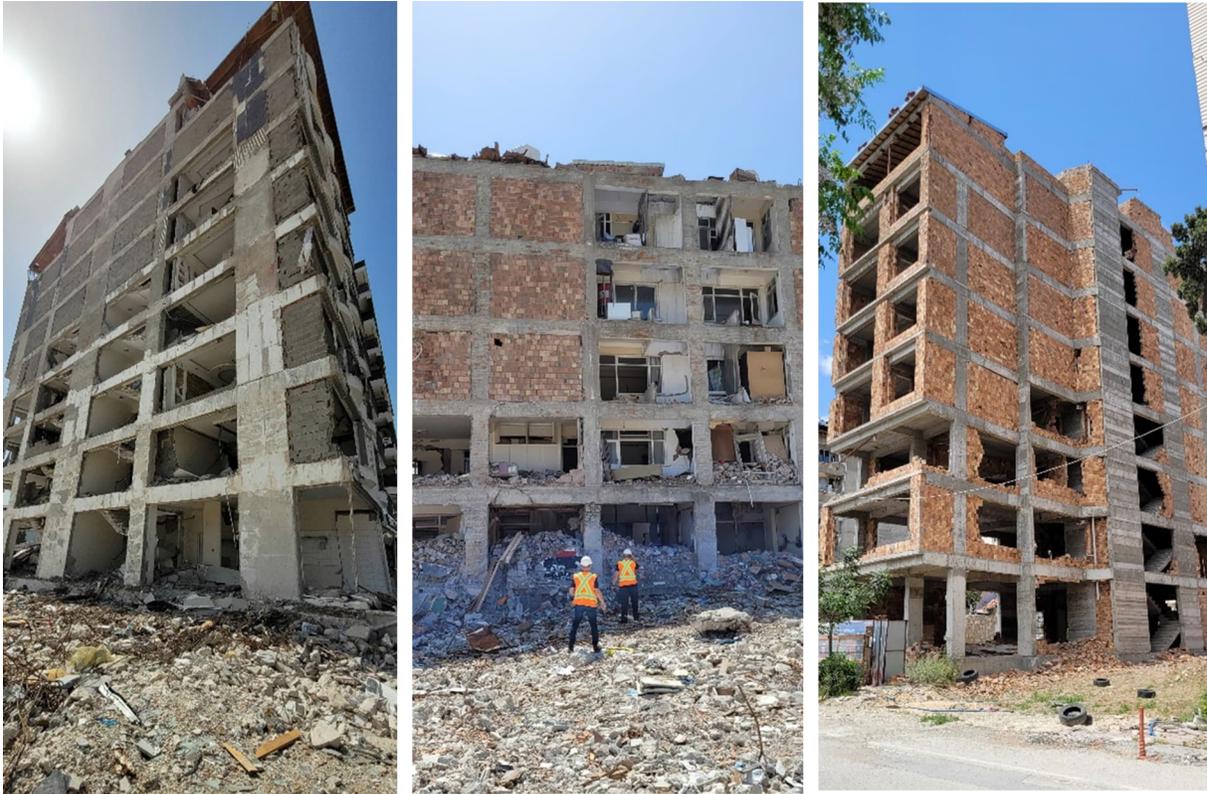
**Figure 6.63: Buildings with damage to unreinforced masonry infill walls.**

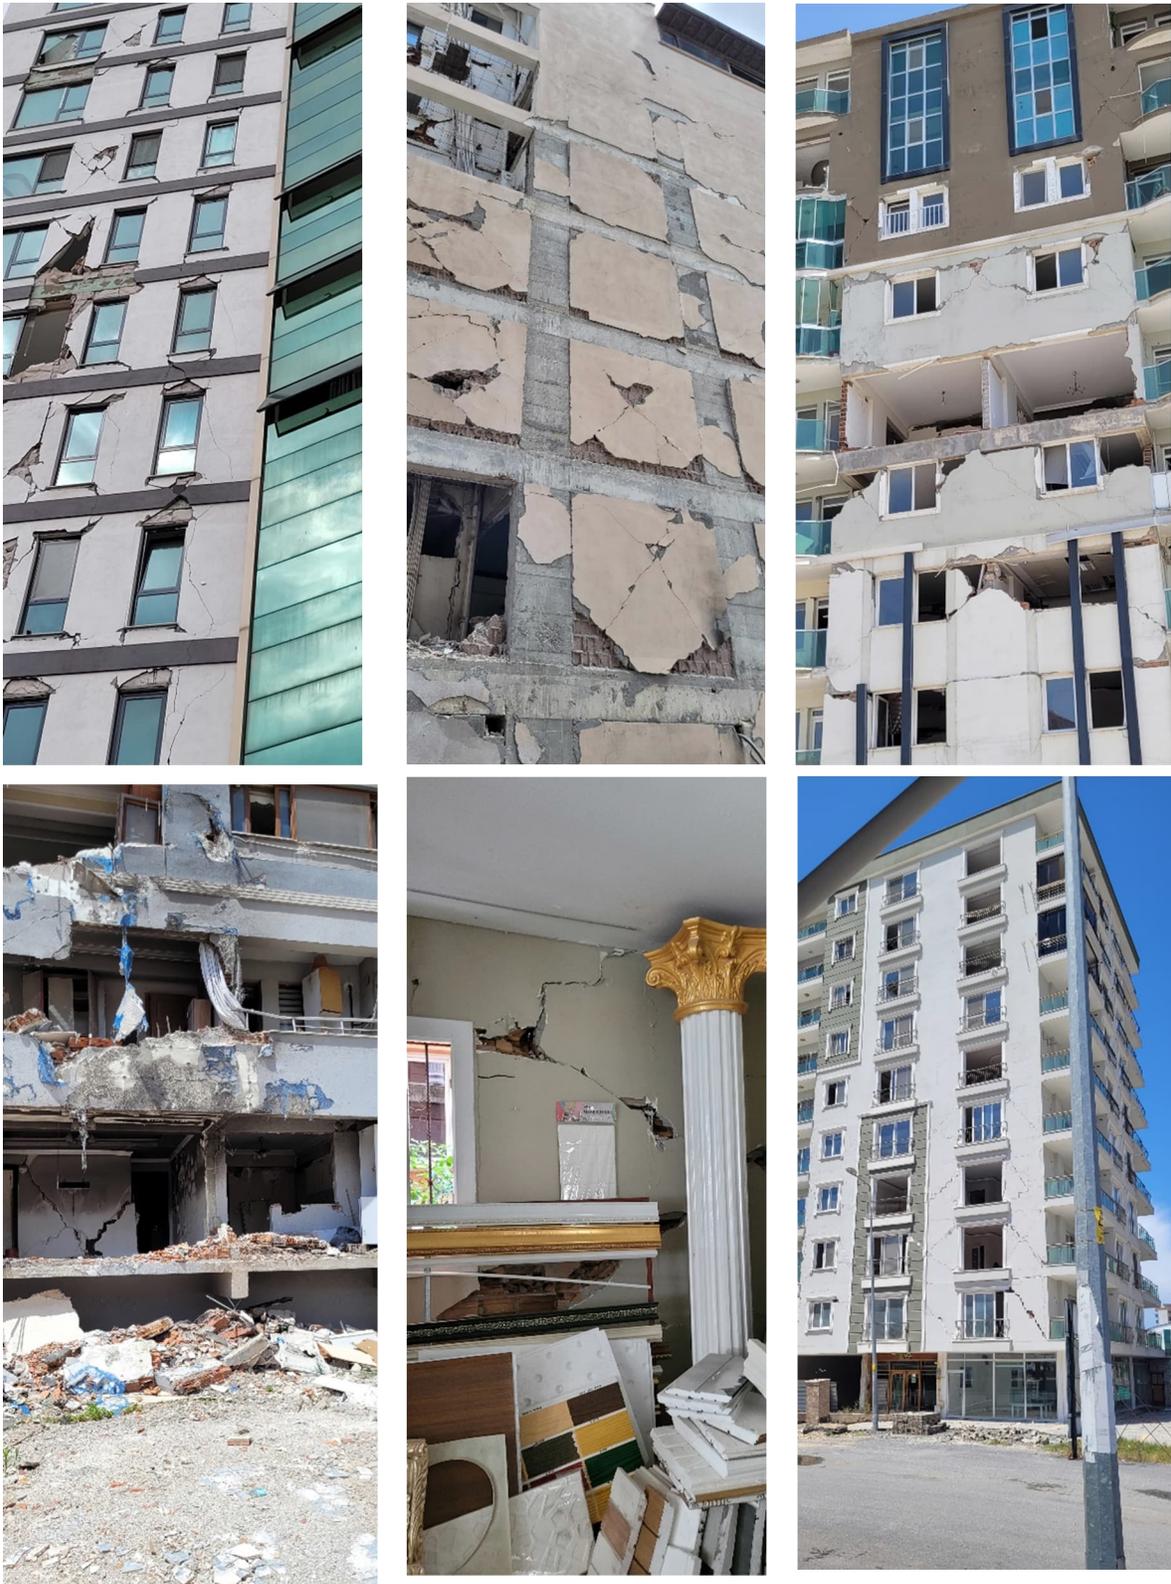
**Figure 6.65: In-plane diagonal cracking of masonry infill walls.**

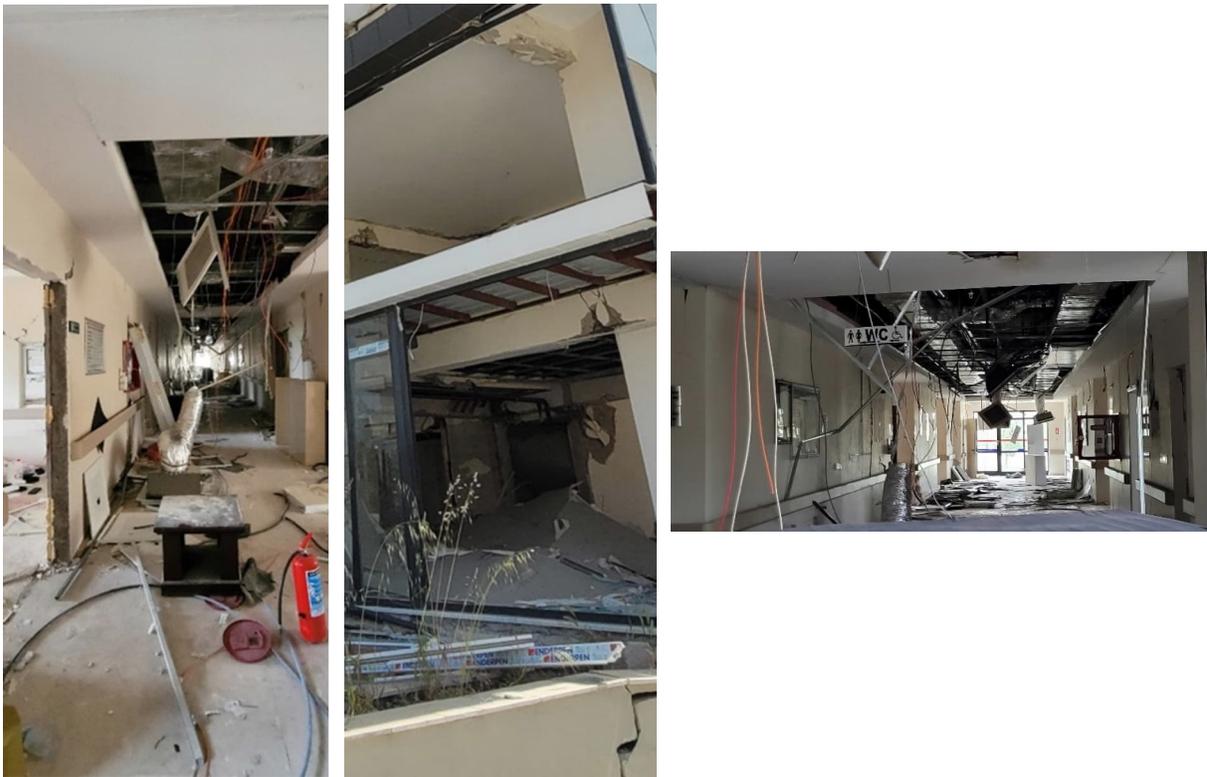
**Figure 6.67: Collapse of ceiling and mechanical, electrical, plumbing (MEP) fixtures.**

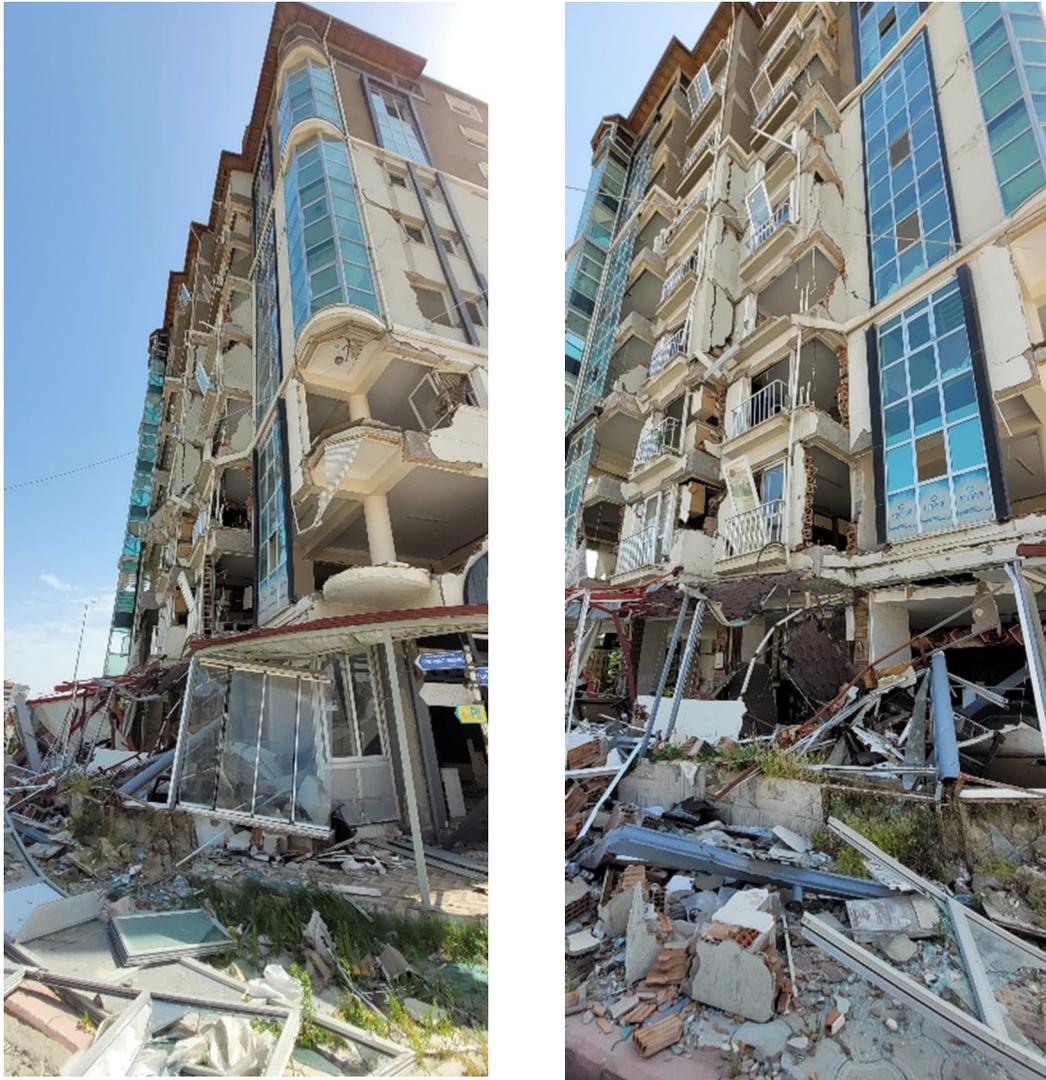
**Figure 6.68: Damage to entry canopy and windows.**

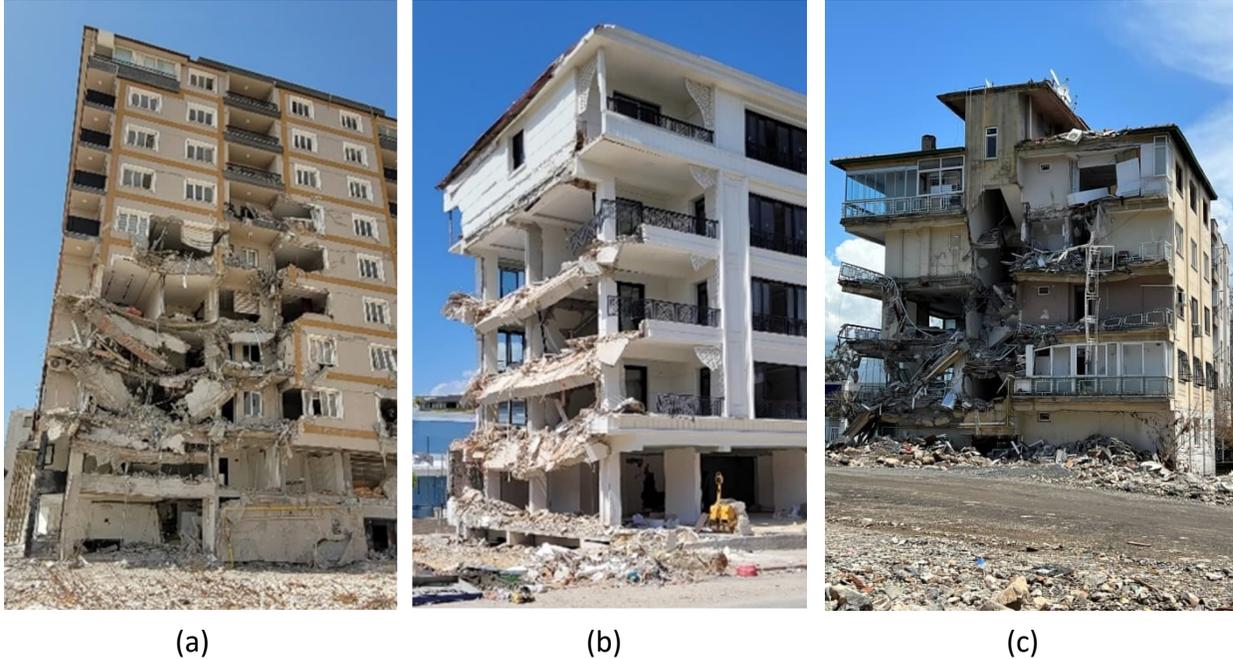
**Figure 6.71: Damage due to impact of adjacent building collapse in Antakya, (a) [36.22763627, 36.16370273] and (b) [36.22044677, 36.14869397] and (c) İskenderun [36.59072930, 36.17922080]**

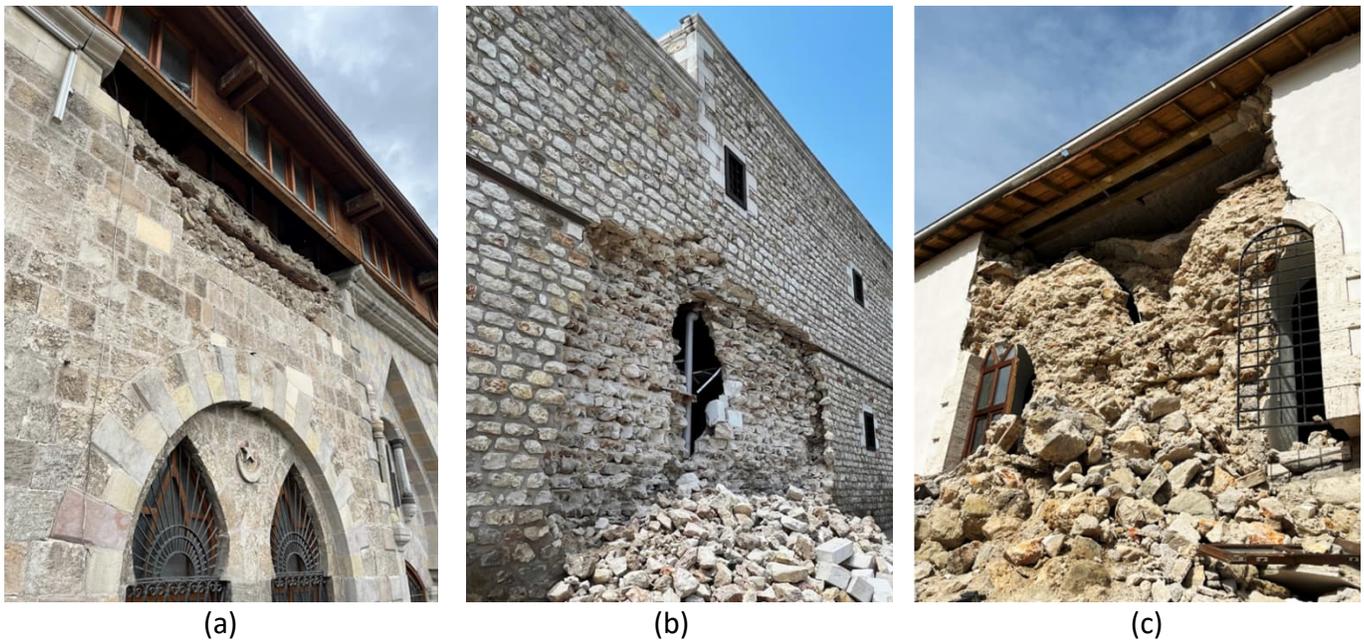
**Figure 7.3: Local failures due to wall disintegration: (a) Arasa Mosque (Kahramanmaraş), (b) stone masonry building (Adiyaman) and (c) Cami-i Kebir – Mosque (Malatya)**

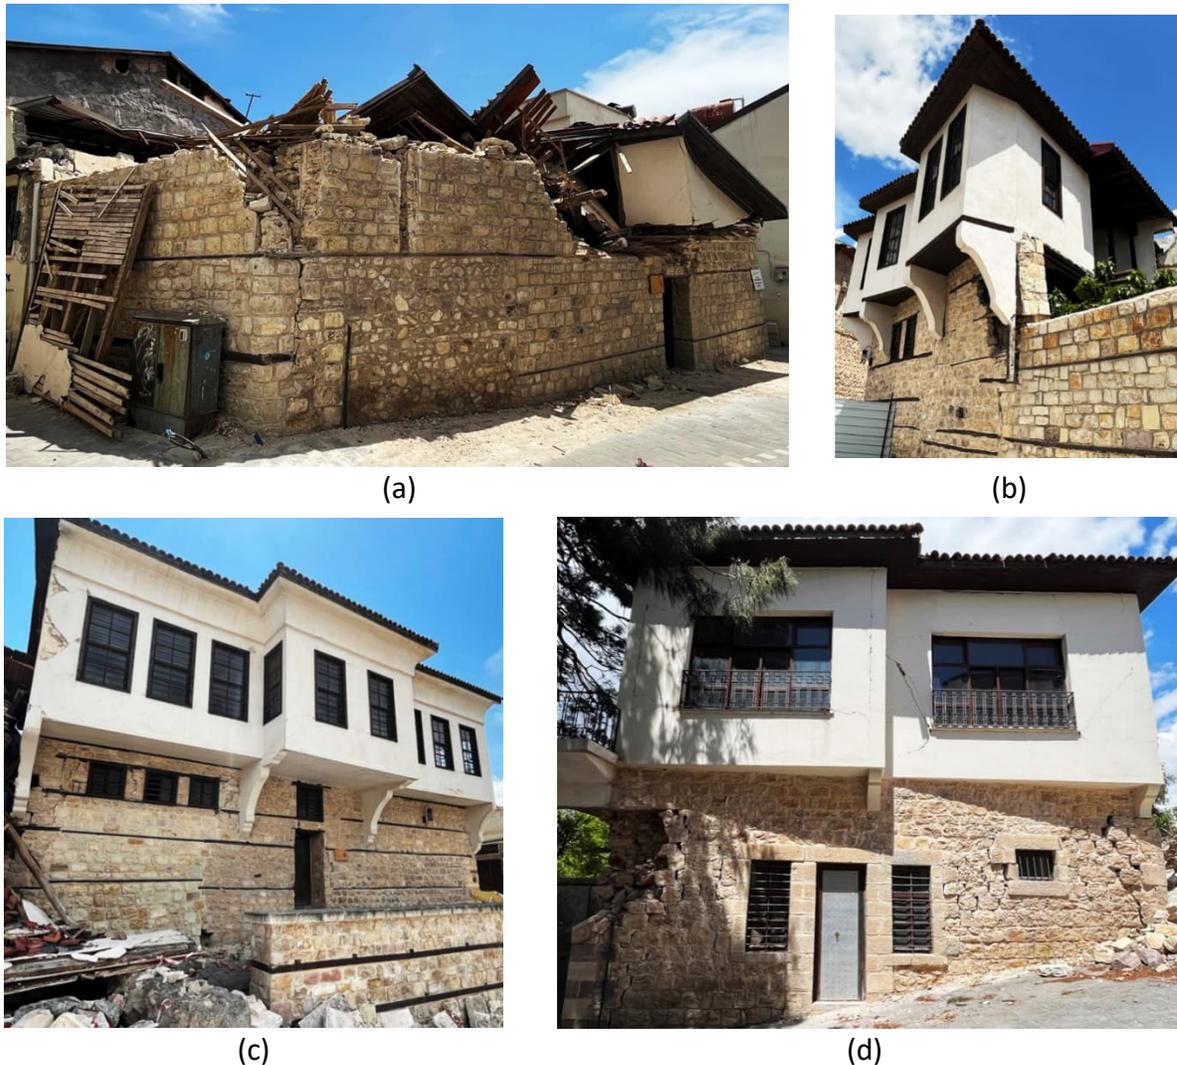
**Figure 7.7:** (a) Total collapse of a “Himis” house, (b) Detachment of the supporting timber column for the upper storey from the URM wall, (c-d) Illustration of the favourable effect of confinement led by timber lacing noted on similar building typologies (Kahramanmaraş)

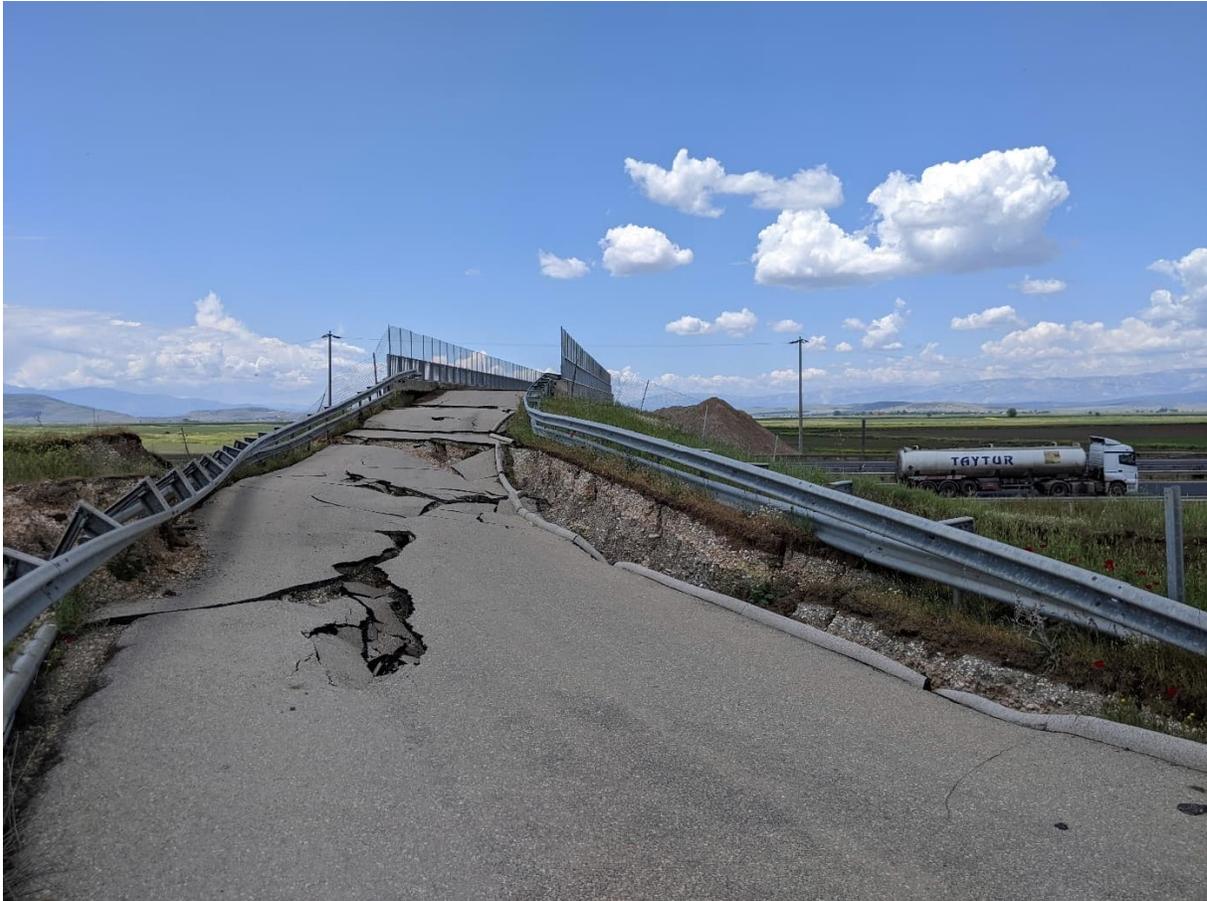
**Figure 8.4: Approach Embankment Failure at a Typical Highway Underpass in Gaziantep.**

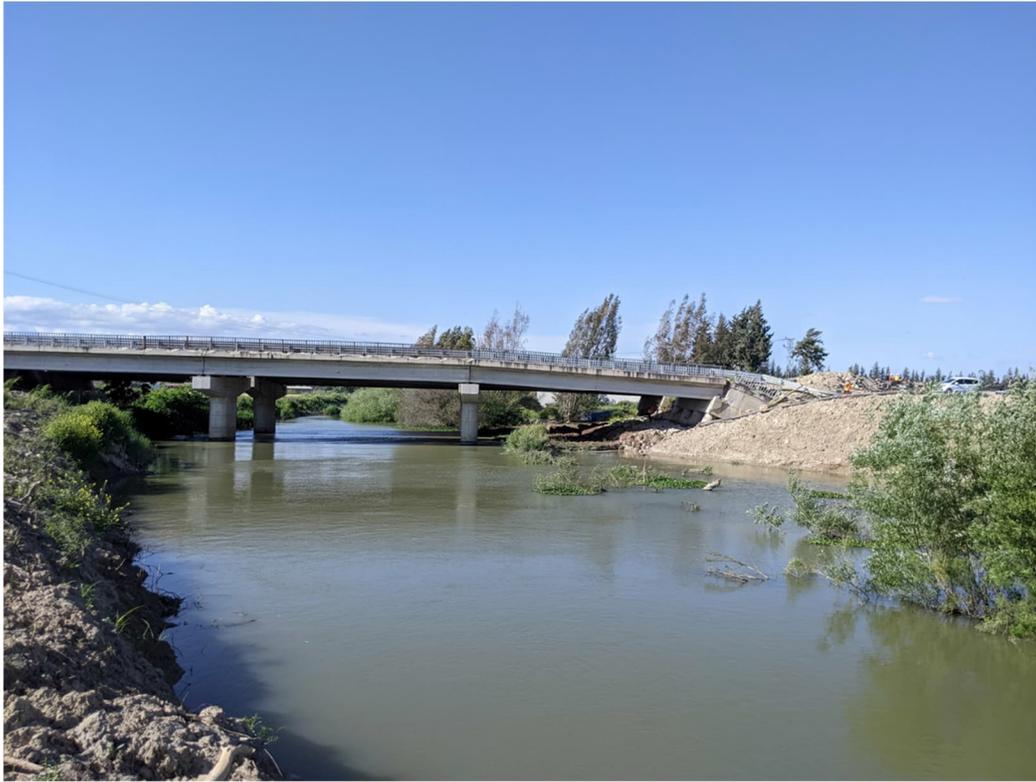
**Figure 8.10: Liquefaction damage at Demirköprü**
