CYCLIC LATERAL-LOAD TEST TO FAILURE OF A FULL-SCALE THREE-STORY FLAT-PLATE REINFORCED CONCRETE STRUCTURE

Damon R. Fick¹

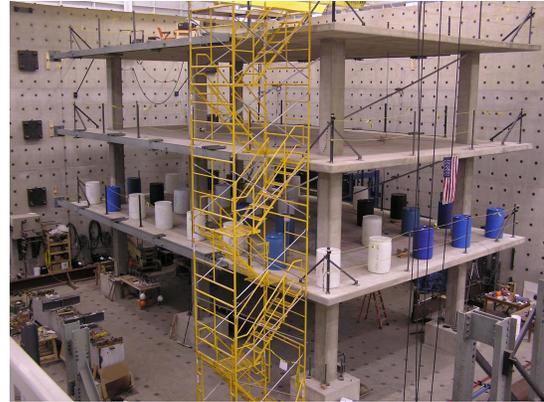
Figure 4. Completed specimen with load frames and water barrel loading.

A superimposed load was added to the structure by filling 55 gallon barrels with water. Each barrel weighed approximately 500 lbs. Forty barrels per floor resulted in a distributed load of 13.3 psf. Total weight of the building, including the superimposed loading was 509 kips. A photograph of the completed specimen, distributed loading, and steel load frame is shown in Fig. 4.

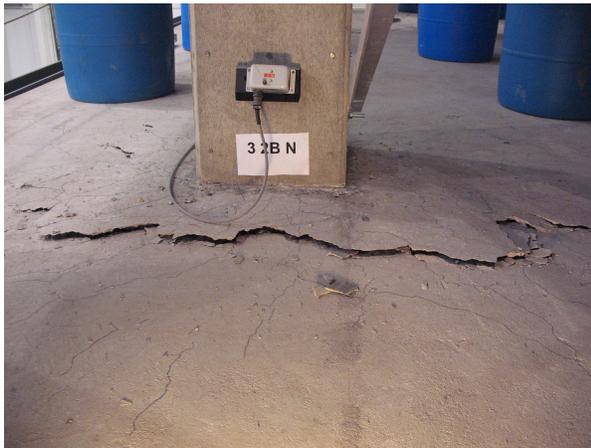
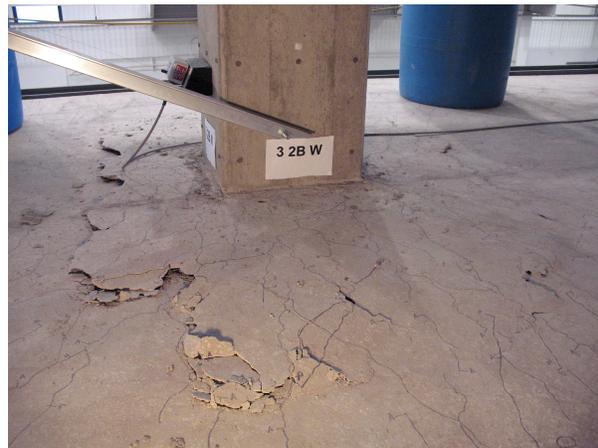
Figure 7. Slab column connection failure.

the failure are shown in Table 2. The roof displacement at failure was 10.5 in. (2.9% roof drift ratio). The peak base shear was 154 kips (base shear coefficient, $C_b = 0.30$). The failure occurred suddenly without any forewarning in the load-displacement curve. On its occurrence, the measured base shear dropped 18 kips to 136 kips ($C_b = 0.27$). Loading in the south direction was resumed 4 minutes later until the roof displacement was 10.8 in (3.0% roof drift ratio). The corresponding base shear was 140 kips ($C_b = 0.28$). Photographs of the failure are shown in Fig. 7.

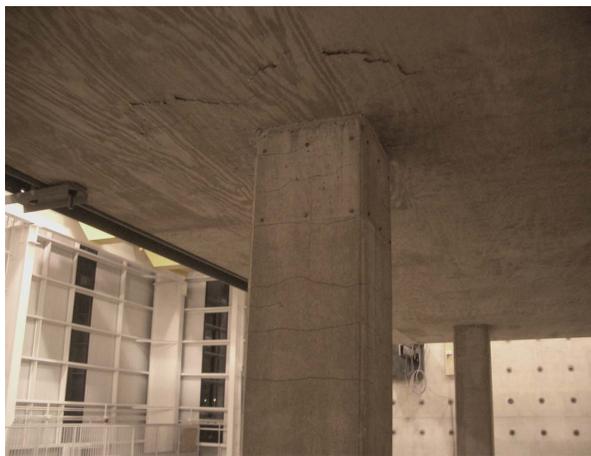
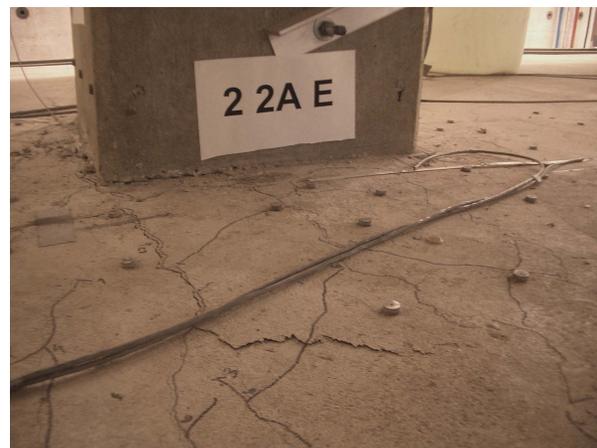
Figure 10. Vertical slab separations before limiting drift condition.

Vertical slab separations were also observed near the columns at the target displacement in the south direction (after failure). Slab separations near the columns ranged from 1/16 to 1/2-in. and are shown in Fig. 9. Representative photographs of the observed vertical slab separations are shown in Fig. 10.
