## Shake table tests on typical stone masonry buildings used in the Himalayan Belt

### ABSTRACT

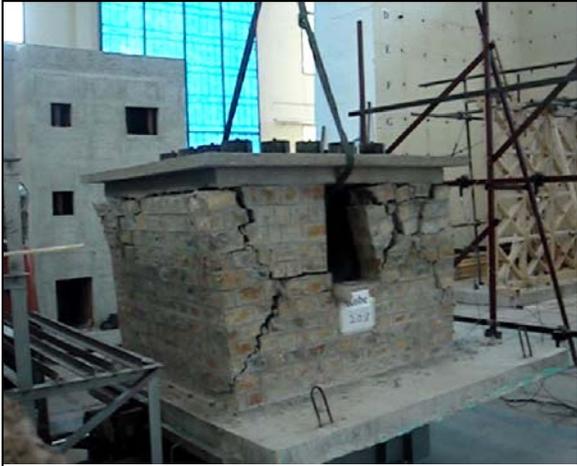
Figure 6: Damages to the front and back walls of model SM1 (PGA = 0.19 g)

Reinforced concrete roof and the RC roof band in the model SM1 helped initially in maintaining the integrity of the walls by engaging all the walls to act like a box structure. A crack was observed nearly at a PGA value of 0.1g at the contact surface between the walls and RC roof band along the full perimeter. This ceased the functioning of box like structure of the model and made the walls more susceptible to damage by further shaking. The cracks initiated around the openings and at the corners and kept on widening with increased shaking. The propagation and widening of the cracks around the openings detached the walls, fig 6. Consequently out of plane walls started vibrating like a cantilever wall resulting in their collapse followed by collapse of in-plane walls and ultimately resulting in a rapid collapse of the overall structure. Figure 9 also shows that post crack behavior of the model SM1 is essentially of brittle nature. Various damage levels at different intensities of ground shaking along with base shear coefficient and story rotation are given in table 2.

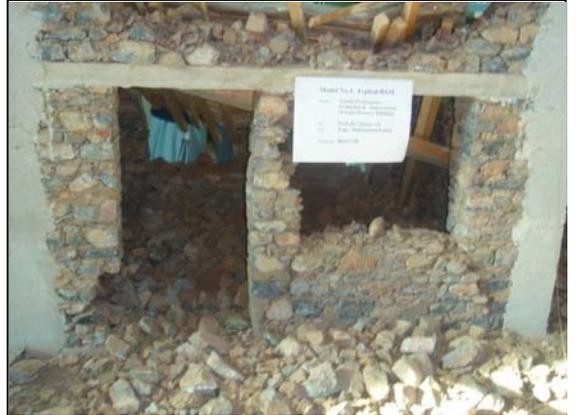
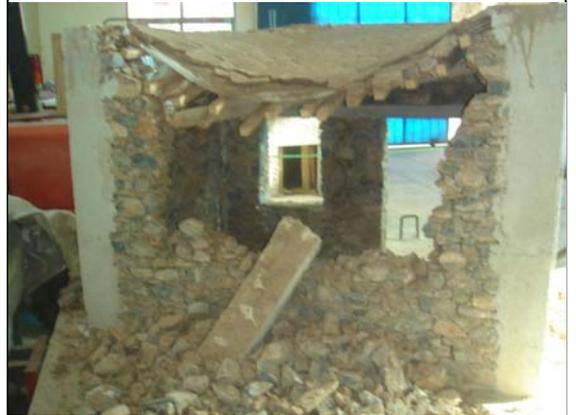
Figure 7: Damages to the front and back wall of the model SM2 (PGA = 0.16g)

Model SM2 showed slightly better behavior than model SM1. Presence of vertical columns at the corners increased the strength as well as the displacement capacity of the structure, fig 9. However the absence of horizontal bands in the model resulted in the termination of box like behavior of the model. Consequently the upper portion of the back wall collapsed nearly at a PGA value of 0.16g because lintel in the back wall was not continuously provided over the entire length of the wall but was provided only above the window opening as shown in figure 7. The collapse of this wall caused a rapid reduction in the capacity of the structure. Additionally, other walls also experienced damage in the upper quarter part essentially due to out of plane shaking, which caused further reduction in the overall capacity of the model. It is worth mentioning that the continuous lintel provided over the door and window in the front wall helped in maintaining the integrity of the wall, figure 7. The corner columns did not experience any damage even at high seismic demand. It was observed that providing columns alone without enough horizontal bands might not significantly improve the seismic capacity of the structure. Figure 9 and table 2 also demonstrate that there is not much difference between the overall seismic performance of the two models, SM1 and SM2, even though there is no vertical and/or horizontal bands except roof band in the model SM1.

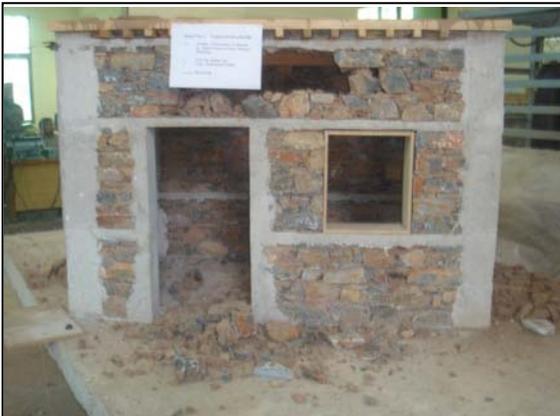
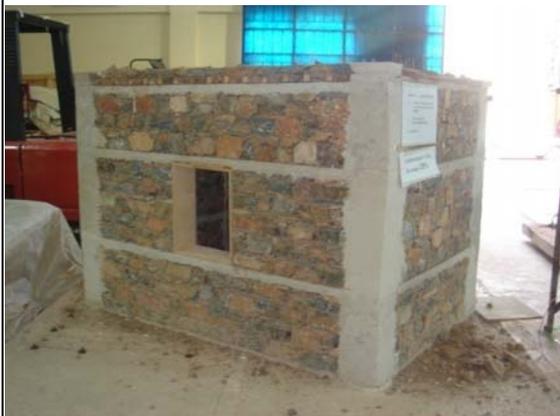
Figure 8: Damages to the front and back wall of the model SM3 (PGA = 0.27g)

The model SM3 showed considerably good performance in comparison to other two models, fig 9. The incorporation of vertical RC elements and horizontal RC bands helped to improve the structural response. In addition to introducing the box like structural behavior in the model, these elements divided the wall into small portions. The smaller these wall portions were the lesser was the damage caused, fig 8. Since the vertical elements at the door side in the front wall were curtailed at the lintel level and were not extended up to the roof of the model, the wall above the lintel level suffered moderate damage at a PGA of 0.27g, fig 8. Structural damage to the model SM3 at different levels of ground shaking intensity are given in table 2.
