PERFORMANCE OF TEMPLATE SCHOOL BUILDINGS IN TURKEY AND PERU DURING EARTHQUAKES

Ayhan Irfanoglu¹

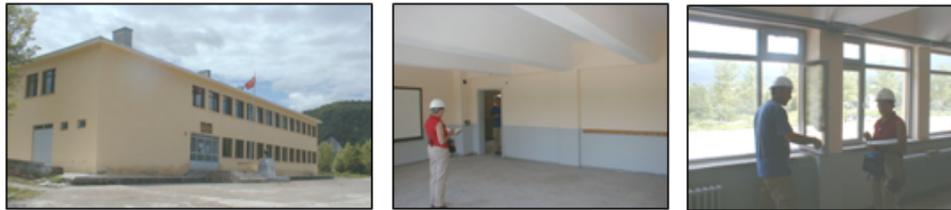
Fig. 5 shows a two-story RC dual system template school building built per the 1975 Turkish code. Despite its proximity to the fault, this dual system building sustained no damage during the two earthquakes in 1999. In Fig. 6, another dual system school building is shown. This four-story building, located in Düzce, sustained no damage in its shear walls. However, the structure suffered heavy damage at its perimeter columns at the basement level. Infill masonry walls restrained these to deform over a very short length that resulted in formation of a captive column condition. As such, the captive columns failed in shear-critical, non-ductile manner (so-called “shear failure”) before they could develop their flexural capacity fully.

Figure 5. A two-story template RC dual system school building in Kaynasli near Düzce. No structural or non-structural damage during 8/17/1999 and 11/12/1999 earthquakes.

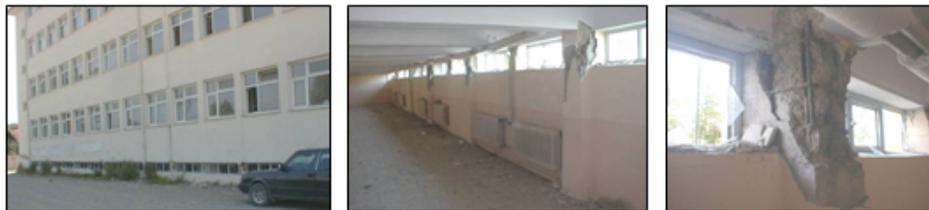
Figure 6. View of a dual system RC template school building in Düzce after the 12 November 1999 Düzce earthquake. The captive exterior columns in the basement failed.

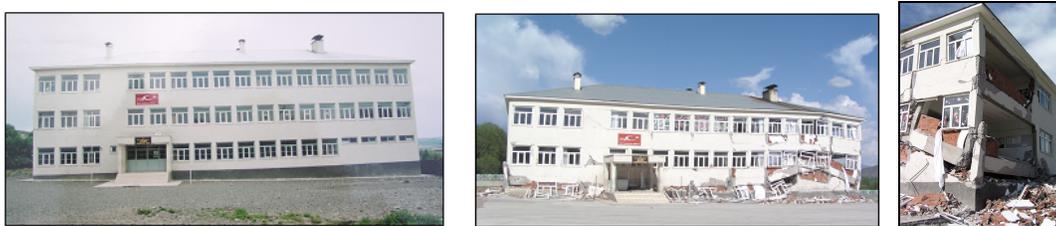
Performance of template school buildings in which RC moment-resisting frames form the lateral load resisting system were documented after the 2003 Bingöl earthquake (Gur et al. 2009). Fig. 7 shows a three-story school building in Bingöl after it was built in 1999 and after the 2003 Bingöl earthquake. During the earthquake, the first-story columns failed. It is difficult to reconstruct what might have initiated the collapse. However, a nearby school with identical floor plan and structural system provided clues. Figs. 8 and 9 show the state of that nearby school after the earthquake. It sustained significant damage in many columns, both interior and exterior, and infill walls, at the first story. Cracks in captive columns near a corner of the structure indicated the onset of brittle failure. Fig. 9 illustrates that failure in full-bay full-story high infill walls could cause concentration of deformations in the mid-height region of columns and make columns that originally appear to be integrated into infill walls to fail in a non-ductile manner.

Figure 7. A three-story RC moment-frame template school building with captive columns in Bingöl before and after the 5/1/2003 Bingöl earthquake.

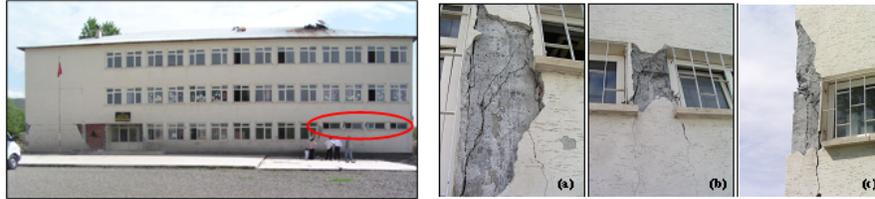
Figure 8. A three-story RC moment-frame template school in Bingöl after 5/1/2003 earthquake.

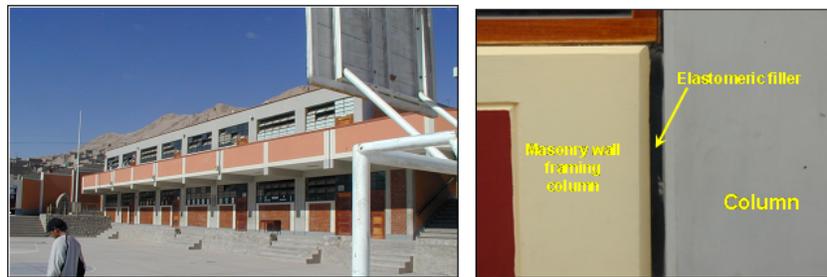
building from outside climate (see Fig. 12).

Figure 12. A school building in Peru built according to the template plan per the 1997 seismic code. Separation between the structural column and non-structural perimeter wall. (Photo credit: Eduardo A. Fierro - BFP Engineers, Inc.-Bertero-Fierro-Perry.)

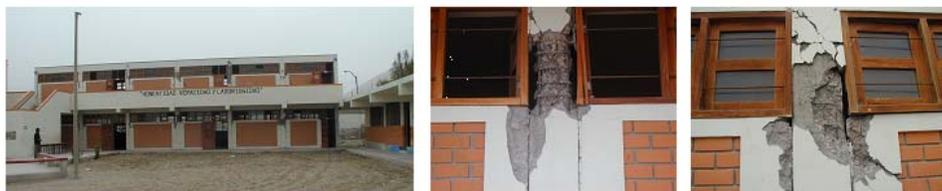
Fig. 14 depicts a two-story RC template school building in the coastal area of Arequipa region. This building was designed per the 1977 Peruvian seismic code. The infill walls were not separated from the columns sufficiently. The architectural infill wall assemblies restrained the columns inappropriately and caused them to fail due to the resulting captive column condition. In contrast, the 1997 code based RC template school buildings in the region shaken strongly during the 2001 Atico earthquake sustained no structural or nonstructural damage. Fig. 15 shows one those schools buildings, in the Arequipa region. A view of the elastomeric material filled 2.5 cm gap region from this school building has already been given in Fig. 12. It sustained no structural or nonstructural damage during the earthquake. In fact, none of the template school buildings designed and constructed per the 1997-code sustained any structural or nonstructural damage during the 2001 Atico earthquake³.

Figure 14. A template school building in Arequipa designed per the 1977 code after the 2001 Atico earthquake. center: a ground story column; right: a second story column. (Photo credit: Eduardo A. Fierro -BFP Engineers, Inc.-Bertero-Fierro-Perry.)

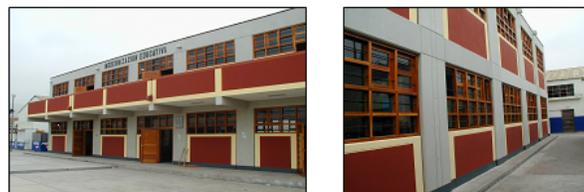
Figure 15. Views of a RC template school in Arequipa built per the 1997 Peruvian seismic code, seen after the 6/23/2001 Atico earthquake. No structural or nonstructural damage. (Photo credit: Eduardo A. Fierro - BFP Engineers, Inc.-Bertero-Fierro-Perry.)
