Structural characterization of residential buildings in Montreal with mixed structural systems for seismic risk studies.

Antoine. Gendron¹, Marie-José Nollet², Hadrien Ravary-Berger¹, Luc Chouinard³

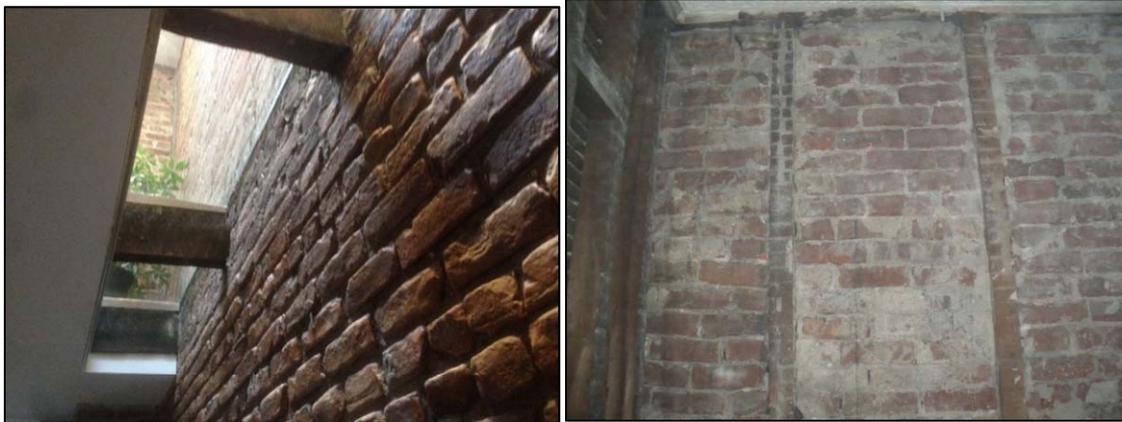
Figure 3: Features URM-B1 houses:(a) floor joists embedded in URM firewall, (b) half-timber encased in URM firewall.

The bearings walls are composed of two to three rows of bricks, with thickness decreasing at higher floor levels. Foundation is made of stones and are 24 inches thick. In older buildings, the main beam element supporting the first floor is made of a tree trunk, 10'' in diameter, embedded at its extremities in the URM walls on a bearing length of 4'' to 6''. The width of the house has an influence on the spanning direction of the floor joists. Houses with a width between 5 and 6 meters have joists spanning parallel to the street, supported by the URM firewalls. This is more common for older houses built before 1880. Houses with a width between 6 and 15 meters have their joists spanning perpendicular to the street and are supported by the façade and rear URM walls. All joists are embedded in the URM walls on a bearing length of approximately 3 inches, see Figure 3 (a). One interesting feature of these buildings is the use of half-timber work, a method in which URM firewalls are constructed f timber

frames and the spaces between the structural members are filled brick. This French-style construction technique [17] is illustrated in Figure 3 (b).

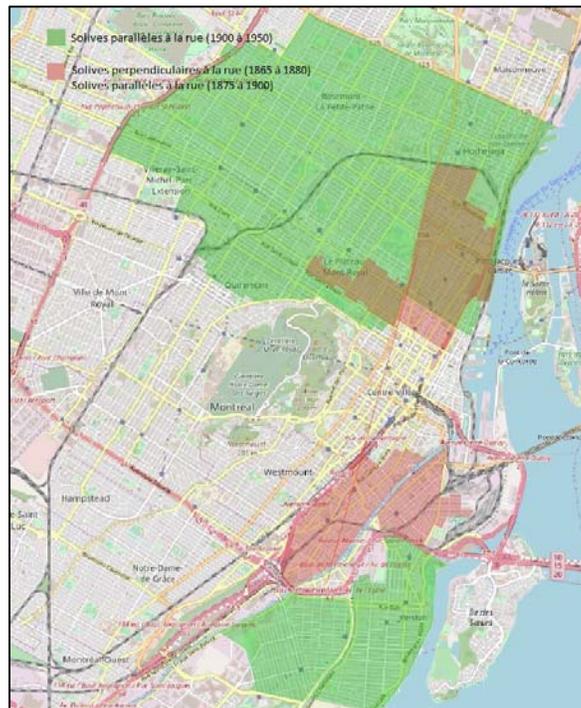
Figure 4: Location of URM-B2 buildings

Buildings with timber plank walls were the most popular type of construction due to their lowest cost. URM-B2 buildings are therefore common in more neighbourhoods than URM-B1 buildings. As shown in Figure 4, it is possible to find them in many districts developed before 1950 in Montreal. The colours on the map indicate the direction of the floor framing system. Between 1865 and 1880, joists were perpendicular to the street and were supported by the timber planks façade and rear walls (in red on the map). Buildings with joists parallel to the street and supported by the common firewalls were built in two different periods, between 1875 and 1900 (in red on the map) and after 1900 (in red on the map).

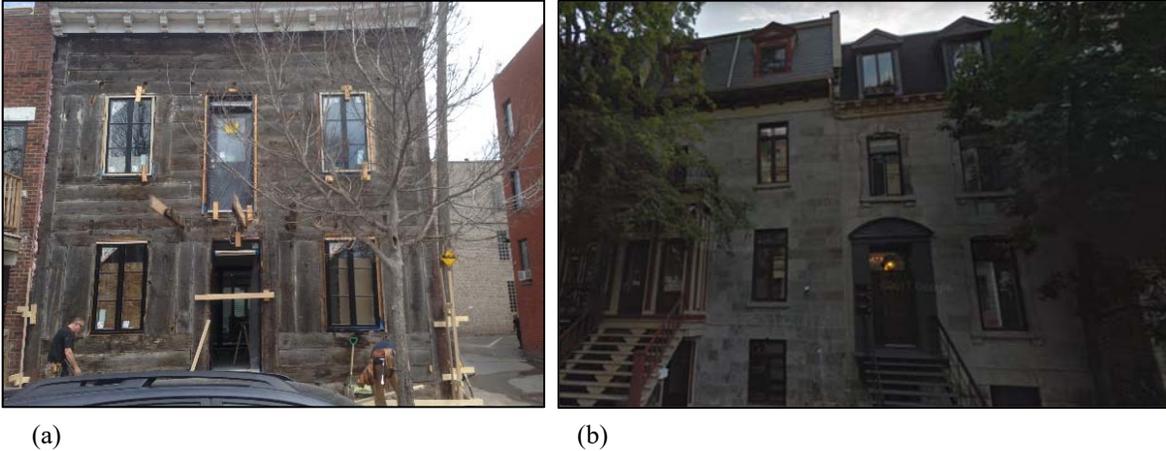
Figure 5: Typical URM-B2 houses: (a) timber plank wall, (b) 1865-1880 with floor system supported on the timber plank wall.

Timber plank walls are typically made of stacked white pine planks with a cross-section of three by eleven inches covered by one layer of brick veneer. Figure 5 (a) shows a typical timber plank wall where the brick veneer that was traditionally anchored by four inches nails is being replaced and fixed with new corrugated masonry anchors. House in Figure 5 (b) is typical of URM-B2 built between 1865 and 1880, with typical width between 6.5 to 8.5 metres. In these buildings, the 3'' x 11'' joists are encased in the full thickness of the timber plank walls, i.e 3''. Other structural details for the foundation, roof and floor system are similar to those of URM-B1 houses.

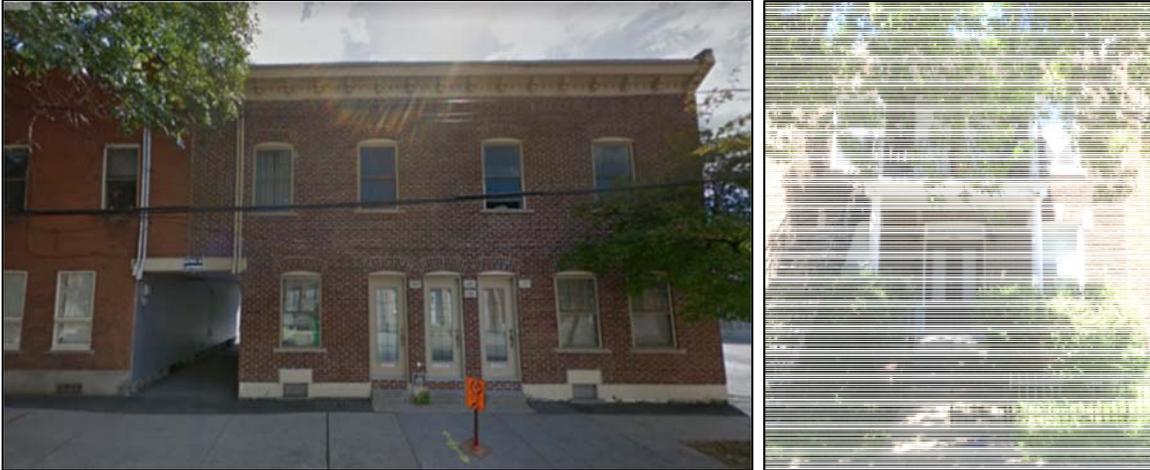
Figure 6 : Typical URM-B2 houses with spanning direction of the floor parallel to the street: (a) with carriage entrance located in South-West of Montreal, (b) with front staircase in Rosemont Petite-Patrie.

The oldest version of URM-B2 with spans parallel to the street (1875 to 1900) has a carriage entrance that provides access to the backyard. This element introduces a structural weakness to the building since the common brick firewall is located at mid span of this entrance (Figure 6 (a)). Between 1900 and 1950, the most common URM-B2 declination is a two to three storeys apartment building. The exterior staircase in front of the house is the main architectural distinctive element as shown in Figure 6 (b).
