# SOIL AND FOUNDATION BEHAVIOUR DURING EARTHQUAKES

H. Bolton Seed\*

## I. Earthquake Effects on Soils and Foundations

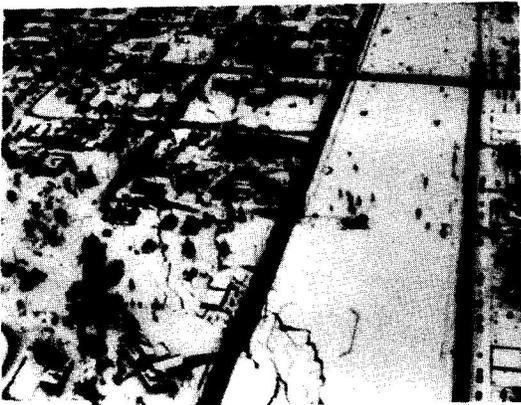
Fig. 8 shows an aerial view of the L-Street slide area in Anchorage.<sup>5</sup> The graben can readily be discerned, winding its way across the landscape. In this slide, the land mass moved about 15 feet, resulting in the formation of a graben about 10 feet deep and 100 feet wide.

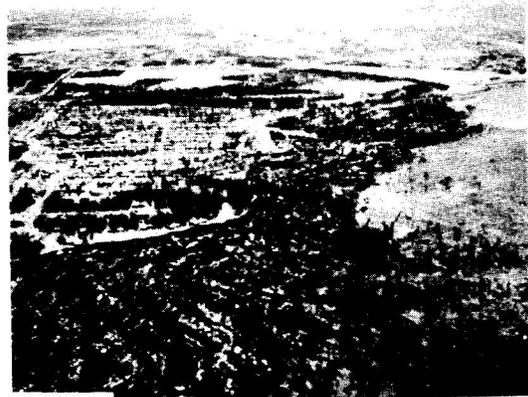
Fig. 11

Major damage can also result from failure of clay soils. Such a slide occurred in the soft clay soils underlying the Turnagain area of Anchorage during the Alaskan earthquake.<sup>5</sup> The slide area (see Fig. 11) was about 2 miles in length along the coast line and extended inland an average of 900 feet.
