FRP REINFORCED CONCRETE BEAMS AND COLUMNS UNDER REVERSED CYCLIC LOADING

ABSTRACT: The use of fibre reinforced polymer (FRP) reinforcement in new concrete elements offers advantages because of non-corrosive characteristics and electromagnetic neutrality of FRP reinforcement. However, the uncertainties associated with using FRP bars in compression as longitudinal reinforcement, especially under reversed cyclic loading, as well as the brittle nature of FRPs pose challenges for their use in earthquake resistant construction. A comprehensive experimental investigation was carried out at the Structures Laboratory of the University of Ottawa to assess the performance of FRP reinforced concrete columns and beams under reversed cyclic loading. Full-scale columns, representing part of a first-storey building column between the footing and the point of inflection, and beam specimens representing beam segments between the columns and the points of inflection were tested under reversed cyclic loading. All the elements had carbon FRP (CFRP) bars as longitudinal reinforcement and CFRP grids as transverse shear/confinement reinforcement. The test parameters included the arrangement of FRP longitu

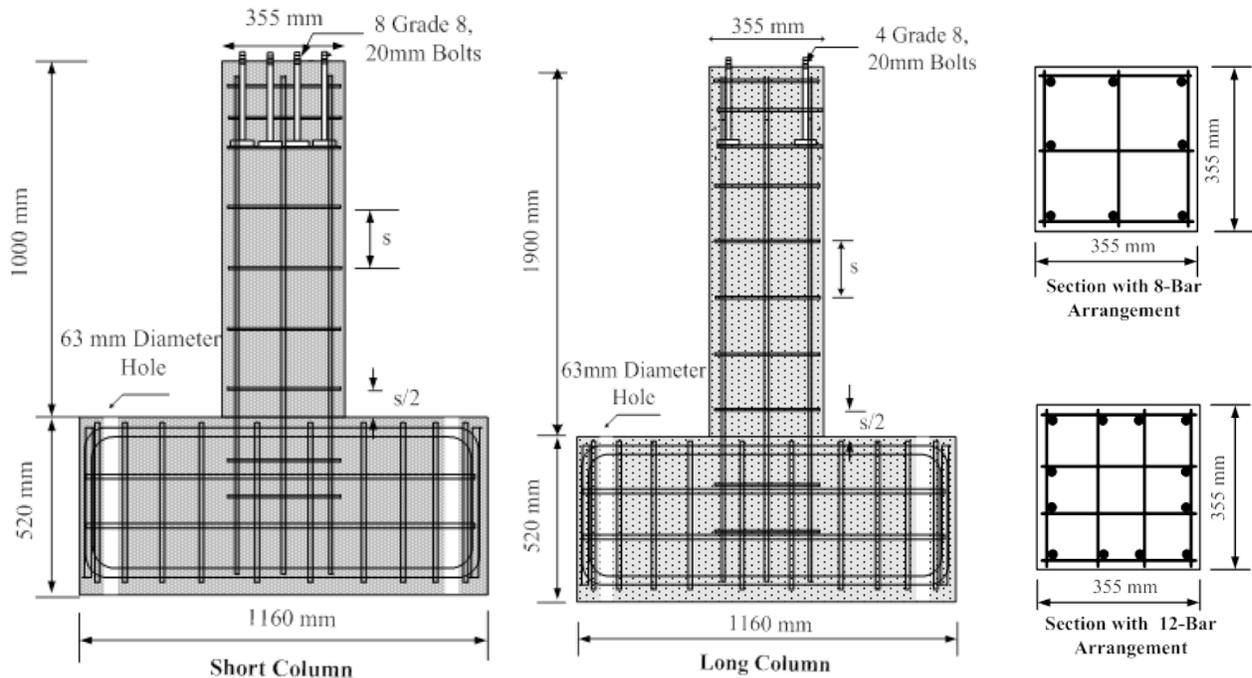
Ten cantilever columns, representing the portion of a first-storey column between the footing and the point of inflection were prepared for testing. The columns had a 355 mm square cross-section with either a 1000 mm or a 1900 mm height, which resulted in 1280 mm, or 2180 mm shear spans, respectively, up to the point of application of lateral force, after accounting for the presence of a top-loading beam. The two heights selected were used to represent shear-dominant and flexure-dominant columns. Figure 1 illustrates the geometric details of columns.

Fig. 1 – Geometric Properties of Test Columns

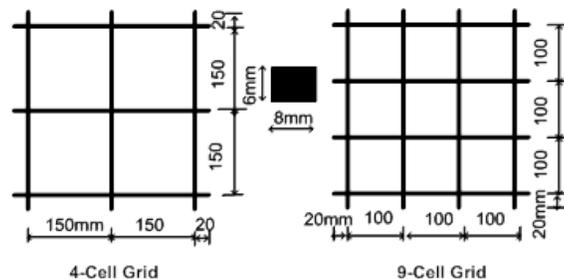
The longitudinal column reinforcement consisted of 9.5 mm diameter Pultrall CFRP bars. Two reinforcement ratios were used; 0.45% for the eight-bar arrangement and 0.67% for the twelve-bar arrangement. The longitudinal bars extended into the footing, which had a depth of 520 mm. The length of FRP bars inside the footing was 470 mm. Clear concrete cover was 20 mm in all cases measured from the face of the column section to the outer surface of the transverse reinforcement (NEFMAC grids). Grid spacing was either 88 mm or 175 mm. Four-cell grids were used with 8 longitudinal bars, and 9-cell grids were used with 12 longitudinal bars. Figure 2 shows the geometric properties of the two types of NEFMAC grids used as column ties.

Fig. 2 – Geometric Properties of NEFMAC Grids

NEFMAC grids, used as CFRP transverse reinforcement, were manufactured from carbon fibres by impregnating the fibres in vinyl ester resin. Two types of grids were used as transverse tie reinforcement; i) 6 x 8 mm rectangular bars forming four equal-size square openings, and ii) 6 x 8 mm rectangular bars forming nine equal-size square openings. They had a square configuration with 300 mm out-to-out dimension. Figure 2 and 3 illustrate the schematic view and test photographs of CFRP grids. Coupon tests were performed to establish the stress-strain relationship. The results indicated a linear relationship up to an average tensile strength of 1230 MPa, corresponding to a rupturing strain of 1.62%, with an elastic modulus of 76335 MPa.

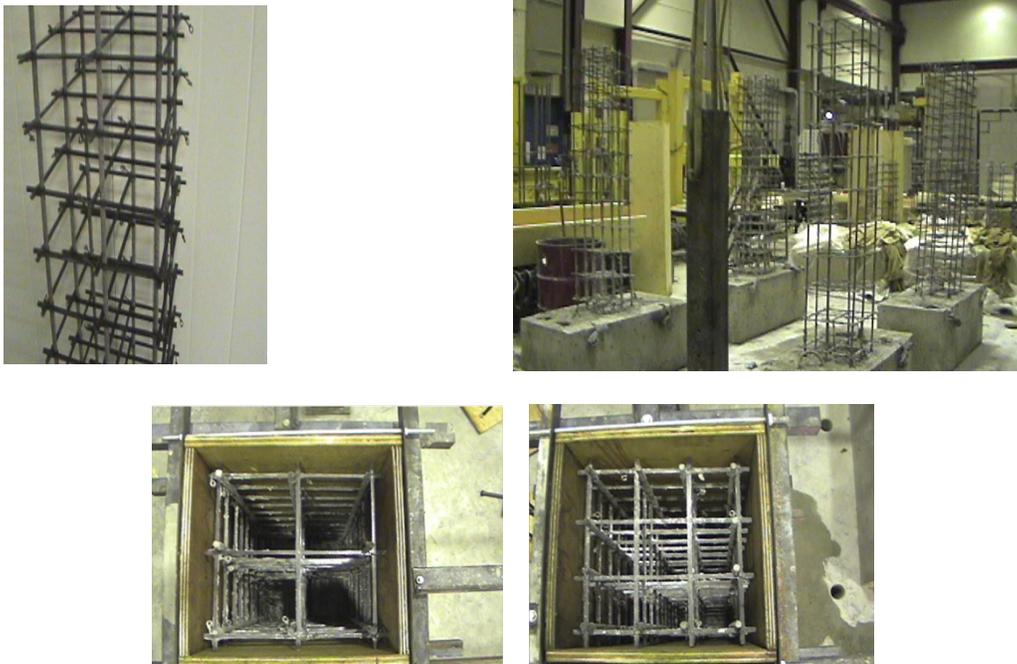
Reinforcement cages were assembled first by tying the Pultrall bars and NEFMAC grids together. The footing for each specimen was heavily reinforced with steel reinforcement to prevent premature failure in the footings. Ready-mix concrete was used to cast the footings first. The footing-column interface (construction joint) was intentionally left rough. The columns were cast vertically to simulate the actual construction practice. They were cast a few weeks later. The column cages and stages of casting are shown in Fig. 3.

Fig. 3 – Column Cages and Stages of Concrete Casting

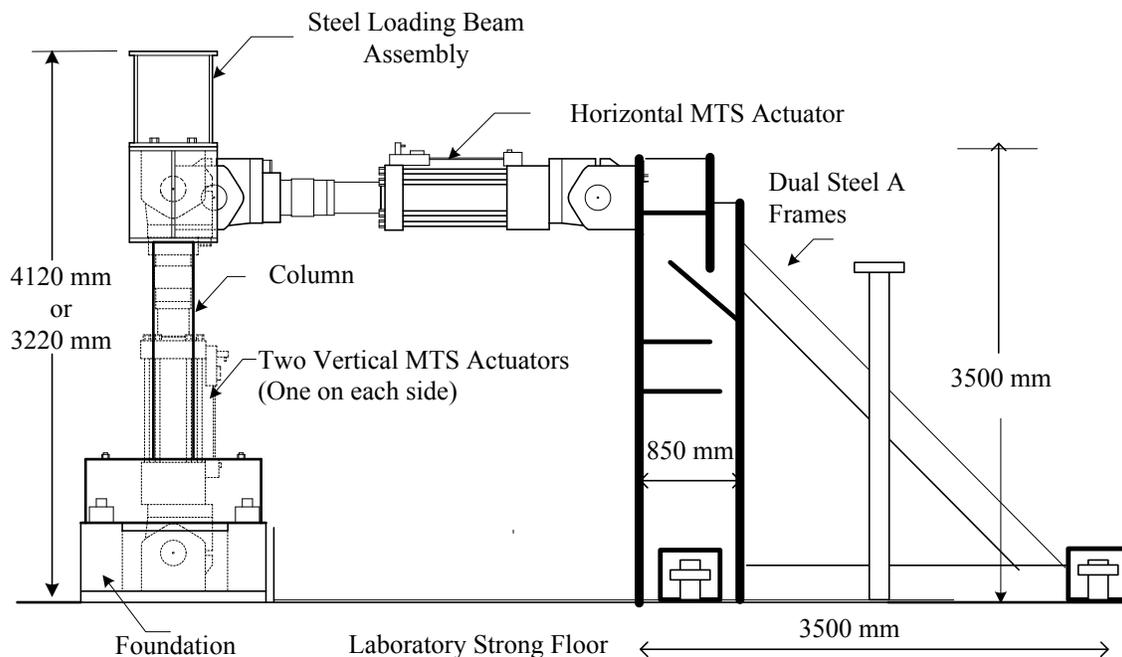
Figure 4 provides a schematic view of the test setup. A steel loading beam assembly was placed on the columns before they were connected to actuators. The specimens were instrumented with Linear Variable Differential Transducers (LVDTs), for displacement and rotation measurements. An LVDT was placed horizontally at the point of application of horizontal load to measure the column top displacement. A light aluminum frame was built around the column to attach the LVDT so that the measured displacements would be relative to the column footing. Four additional LVDTs were placed vertically near the critical section of columns to measure the rotations of hinging regions, as well as those caused by anchorage slip (extension of longitudinal reinforcement within the footing). Electric resistance strain gauges were placed on FRP bars and grids to measure strains in longitudinal and transverse reinforcement. Three 1000 kN capacity servo-controlled MTS actuators were used to apply the loads. Two of the actuators were positioned vertically to apply constant axial compression during testing. They were connected to a rigid base that had been fixed on the laboratory strong floor at one end, and to a steel-loading beam at the other end. The third actuator was positioned horizontally between the steel loading beam and the lateral support system. The maximum stroke of the horizontal actuator was 500 mm, which allowed horizontal displacement of up to ± 250 mm relative to the neutral position. The actual stroke and load during testing were monitored and recorded by two independent data acquisition systems.

Fig. 4 – Test Set-up

The axial load was applied first and was maintained at a constant level throughout the test. The horizontal load was applied in the deformation control mode. Lateral deformation reversals were applied starting with three elastic cycles at 0.5% lateral drift, which approximately corresponded to the displacement at first flexural cracking, followed by three cycles at 1% drift. The subsequent stages of loading included three cycles at 2%, 3%, 4% etc. lateral drift until a significant drop in lateral load resistance was observed.

A total of six full-scale cantilever beams with a 305 mm wide 405 mm deep cross-section were tested as representatives of beam segments between the framing columns and the beam inflection points. The beams had two different lengths; either, 1000 mm or 1900 mm, corresponding to shear spans of 870 mm or 1780 mm respectively, measured to the point of application of shear force. The longer shear span was intended to promote flexural behaviour while the shorter span would promote shear behaviour. Four specimens were tested under reversed cyclic loading and two were tested under monotonically increasing lateral loads using the column test setup shown in Fig. 4 in vertical position without any axial load. Geometric details of specimens are shown in Figure 8.

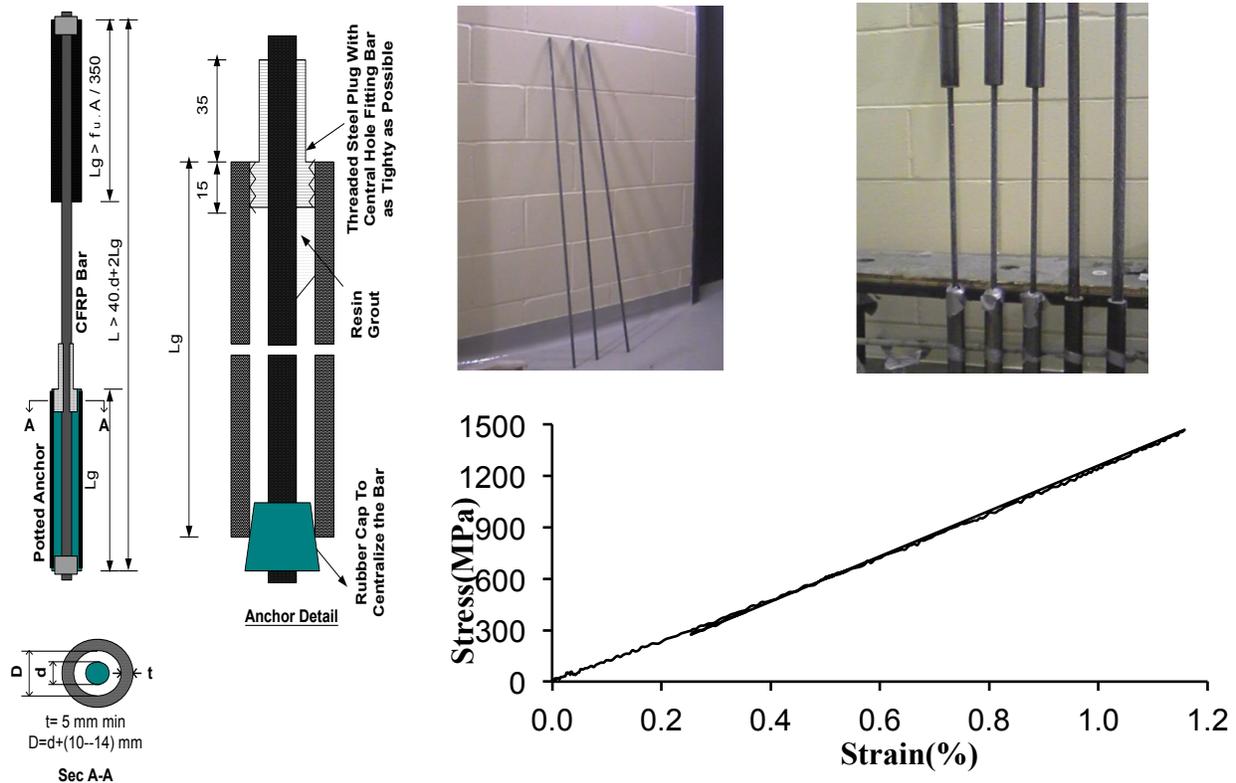
Tensile properties of Pultrall bars were established through laboratory testing. The procedure specified in CSA Standard S806 (2012), was used as shown in Fig. 5. The coupons were 1200 mm long, with a 400 mm segment at each end placed in a steel tube to be able to grip on the coupons by the jaws of the machine during testing. The tubes had 25.5 mm inner diameter and a 3.3 mm steel thickness.

Fig. 5 – Coupon Tests of 9.5 mm Diameter Pultrall CFRP Bars

The coupon tests indicated an average tensile rupturing strength of 1470 MPa and an elastic modulus of 125,000 MPa. These values are in close agreement with coupon tests reported by the University of Sherbrooke earlier during the development of the bars.

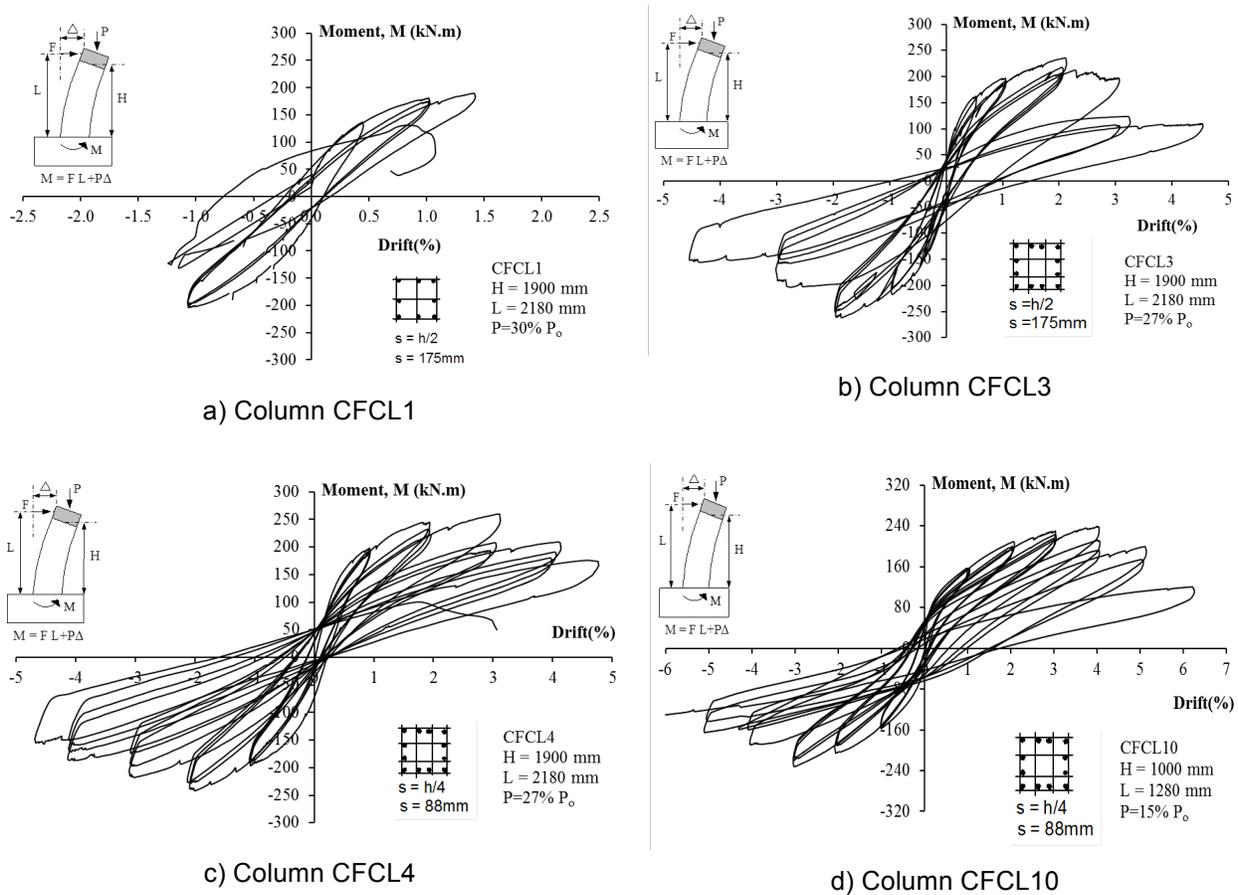
Base moment lateral drift hysteretic relationships for four columns are shown in Fig. 6. Column CFCL1 was reinforced with 8 - 9.5 mm diameter Pultrall CFRP longitudinal bars. The bars were tied with 4-cell CFRP grids with a spacing of 175 mm, which was approximately equal to twice the maximum spacing required by CSA S806-12. The column was tested under a constant compressive force of 30% of its concentric capacity. The hysteresis loops, shown in Fig 6(a) indicate stable behaviour up to 1.0% drift ratio, followed by significant and sudden strength decay due to the crushing of concrete and the stability failure of compression bars. This was expected because of wider spacing of grids, which resulted in poor concrete confinement and inadequate support for compression reinforcement. Strain gauge readings indicated that FRP bars experienced a maximum of 0.65% tensile strain and 0.50% compressive strain at the end of test, whereas the FRP grids experienced a maximum of 0.3% tensile strain.

The hysteretic relationship for unconfined column CFCL3 with 12 longitudinal reinforcement and CFRP grids with $h/2 = 175$ mm spacing is shown in Fig. 6(b). This column could sustain three cycles at 2% lateral drift, and showed significant strength degradation during the subsequent cycles at 3% drift, while also exhibiting severe concrete crushing. The longitudinal bars remained intact at this deformation level, but failed due to compression buckling at about 4% lateral drift. Strain gauge readings indicated that FRP bars experienced a maximum of 0.76% and 0.5% strains in tension and compression, respectively. The FRP grids experienced a maximum of 0.31% tensile strain.

Companion column CFCL4 with 12 longitudinal bars and closely spaced ties at a spacing of $h/4 = 88$ mm showed improved behaviour. Confinement of the core concrete resulted in improved ductility and the column was able to sustain 3% lateral drift without any strength decay, but developed significant strength decay during the subsequent cycles at 4% lateral drift. It failed when forced to resist the first cycle at 5% drift ratio due to the crushing of concrete, followed by the buckling of all compression bars. Strain gauge readings indicated that FRP bars experienced a maximum of 0.93% and 0.55% strains in tension and compression at the end of testing, respectively. The FRP grids experienced a maximum of 0.5% tensile strain. Figure 6(c) illustrates the moment-displacement hysteretic relationship for Column CFCL4.

The above columns were tested under approximately 30% of column concentric capacity. Additional tests were conducted under a lower level of axial load, corresponding to 15% of column concentric capacity. Figure 6(d) shows the hysteretic relationship of CFCL10 which was tested under a lower level of axial compression. This column was a well-confined column with a 12-bar arrangement and closely spaced

transverse reinforcement. It developed 4% lateral drift in push and 3% drift in pull prior to gradual strength decay. Some of the extreme compression bars failed at 4% drift ratio due to the instability of fibres. This resulted in significant strength degradation. During the last cycle at 4% drift, the cover concrete spalled off, exposing grids and broken compression bars. All of the extreme layer of FRP bars failed in compression on both sides when the column was cycles at 5% drift ratio, leaving only the middle layer of reinforcement to provide resistance. The test was stopped at this stage of loading. Strain gauge readings indicated that FRP bars experienced a maximum of 1.25% tensile strain and 0.64% compressive strain at the end of test, whereas the FRP grids experienced a maximum of 0.53% tensile strain. Though some longitudinal bars failed in tension before the end of test, the final failure of the column was triggered by the buckling of bars in compression.

Fig. 6 – Hysteretic Moment-Lateral Drift Relationships for Columns

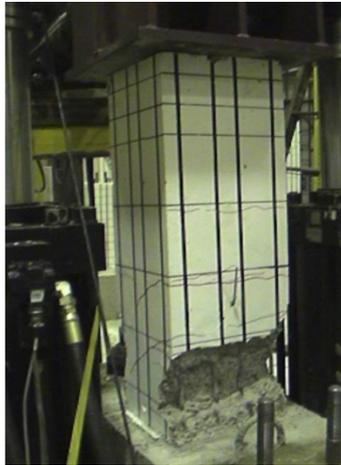
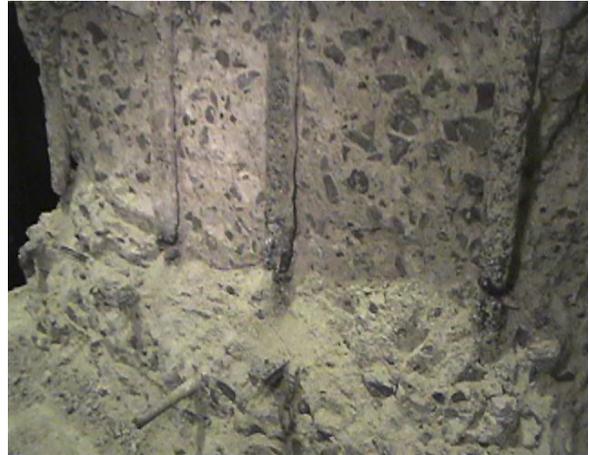
The majority of column failure was triggered by the crushing of concrete, followed by bar buckling in compression. Figure 7 illustrates typical column failure and the buckling of FRP bars in compression in the form of fibre buckling at the same location as if the bar was cut at that location while it remained straight, unlike the deformed shape typically observed in buckling steel bars.

a) Concrete crushing

b) Buckling of FRP bars in compression

Fig. 7 – Compression Crushing of Concrete and FRP Bar Buckling in Column CFCL8

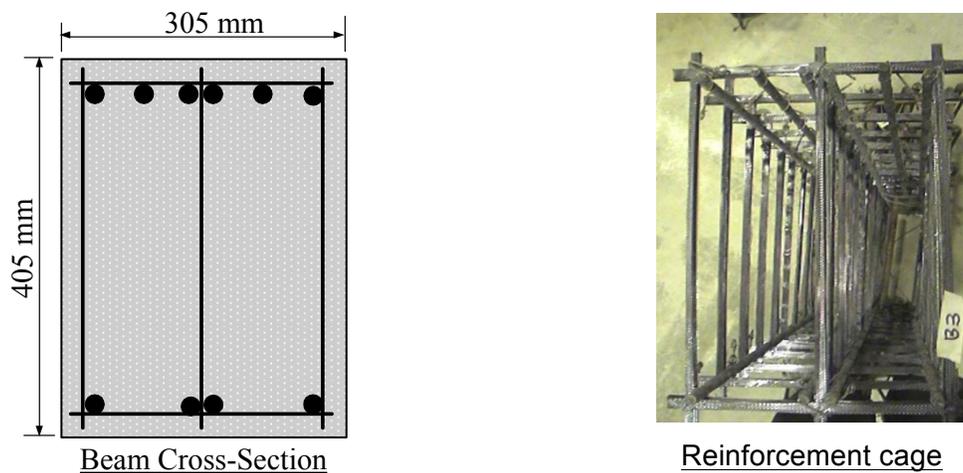
Only one longitudinal reinforcement ratio was used in all beams. A total of 6 - 9.5 mm diameter Pultrall CFRP bars were used as top (negative) beam reinforcement and 4 same size and type bars were used as bottom (positive) reinforcement. This resulted in 0.39% top and 0.26% bottom reinforcement ratios. The longitudinal bars extended 470 mm into the footing (simulating attached column), which had a total depth of 520 mm. The clear concrete cover in all beams was 15 mm, measured from the face of the beam to the outer surface of the grid reinforcement, which was used as transverse stirrups. The grids were placed either at 180 mm spacing (corresponding to $d/2$) or 90 mm spacing (corresponding to $d/4$). They were the same as those used in columns with a rectangular configuration, having 250 x 350 mm out-to-out dimensions. Two types of grids were employed; i) 6 x 8 mm rectangular cross-section FRP reinforcement forming two equal-size rectangular openings, and ii) 8 x 10 mm rectangular cross-section FRP reinforcement forming two equal-size rectangular openings. Figure 8 illustrates the beam reinforcement and Table 2 provides a summary of beam properties and test parameters.

Fig. 8 – Beam Cross-sectional Geometry and Reinforcement Details

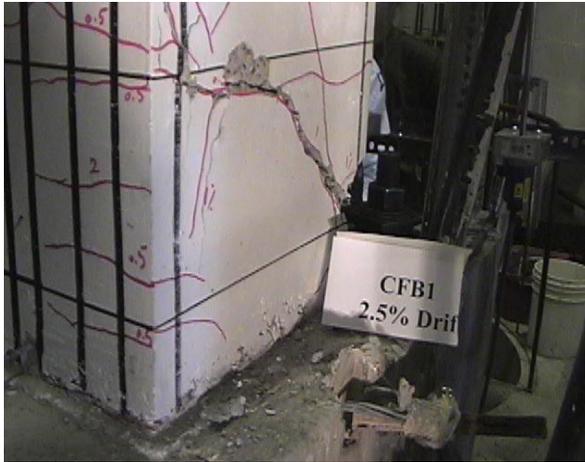
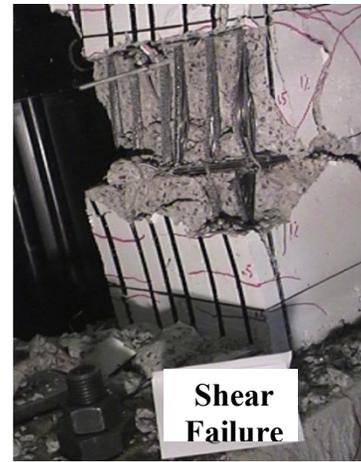
The hysteretic moment-lateral drift relationship for beams showed essentially elastic behavior until beam failure, with some dissipation of energy when the behaviour was dominated by flexure and the concrete was confined by closely spaced CFRP grids. However, the effectiveness of transverse grid reinforcement as confinement reinforcement was limited, and less than that for columns because of the reduced compression area due to the absence of axial load. Column CFB1 with a grid spacing of $d/2 = 225$ mm suffered from diagonal tension failure immediately after 2.0% drift in the strong direction. A diagonal crack

occurred during the push cycles at 1% drift, which became wider during 2% drift cycles. As the diagonal cracks widened due to the insufficient transverse reinforcement the compression bars crossing the diagonal crack were subjected to dowel action. These bars eventually failed under combined flexural compression and dowel forces caused by shear. This is shown in Fig. 9. Once the longitudinal reinforcement in the compression zone was lost, the column capacity in the weak direction was lost completely as there was no tension reinforcement left in that direction. The companion column with a closer spacing of transverse grids (Column CFB2 with $s = d/4 = 88 \text{ mm}$) sustained higher lateral forces and showed flexural behaviour. The column sustained drift cycles at 3% in the strong direction, and 2.3% in the weak direction before the CFRP longitudinal bars ruptured in tension, resulting in severe strength degradation. Beam CFB3 with the same properties as CFB2, but tested under monotonic loading showed a similar behavior, exhibiting a force deformation curve similar to the envelope of the hysteretic relationship under cyclic loading. Beams with longer shear spans showed flexural response with 3.0% to 3.5% lateral drift capacities until the longitudinal bars ruptured in flexure. Figure 10 shows typical moment-lateral drift hysteretic relationships for flexure dominant beams, either with a short shear span but sufficient transverse reinforcement or with long shear span.

a) Immediately after shear failure

b) At the end of test

Fig. 9 – Diagonal tension failure in Beam CFB1

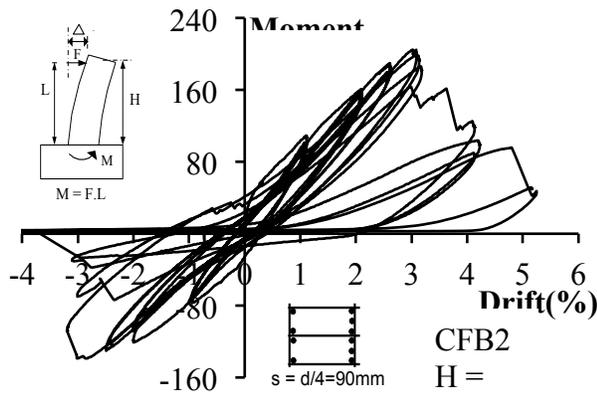
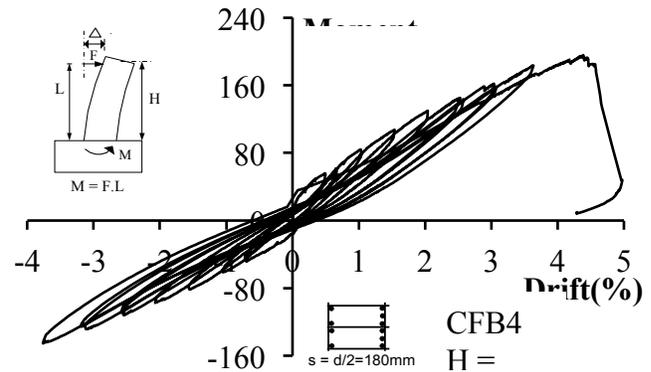
a) Beam CFB2

b) Beam CFB4

Fig. 10 – Typical Hysteretic Relationships for Flexure-dominant Beams
