## ENGINEERING SIGNIFICANCE AND LESSONS OF THE MARCH 11, 2011 TOHOKU TSUNAMI - TSUNAMI IMPACTS ON STRUCTURES

**Ioan Nistor**

Associate Professor, University of Ottawa, Canada  
*inistor@uottawa.ca*

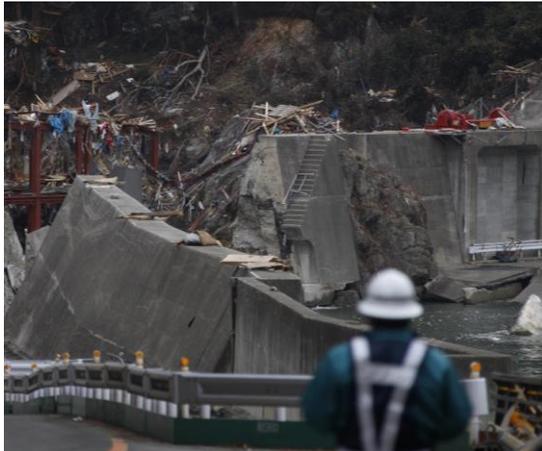
(a)

**Figure 4. Effects of 2011 Japan tsunami on structures (Nistor, 2012): a) breaching and overtopping of concrete sea walls in Taro; b) impact loading from large vessel in Otsuchi; c) overturning of reinforced concrete apartment building in Onagawa; and d) punching failure of reinforced concrete walls in Onagawa**

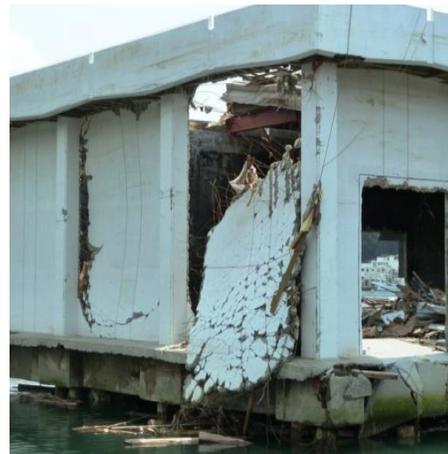
(d)

The destruction caused by this tsunami was extensive and somehow surprising given that Japan is a most equipped and trained country when it comes to protection against tsunami. However, tsunami waves displaced, overtopped and destroyed large structures, including seawalls, which were initially constructed to mitigate the impact of tsunami waves on local communities. The designs of these structures were based on historical tsunamis and were not necessarily sufficient considering probabilistic-based tsunami events. Figure 1 illustrates the effects of the 2011 Tohoku Tsunami, including breaching and overtopping of large concrete sea walls, displacement of floating vessels, overturning of a concrete building, and punching failure of a reinforced concrete wall panel.

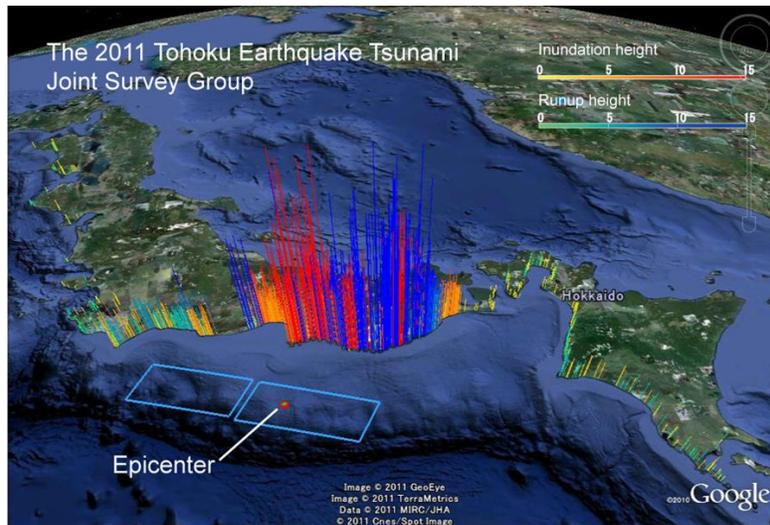
An example of the data collected by the JSCE survey groups is presented below in Fig. 2.

**Fig. 2 - Example of the tsunami runup and inundation field data prepared by the 2011 Tohoku Earthquake Tsunami Joint Survey Group of JSCE**

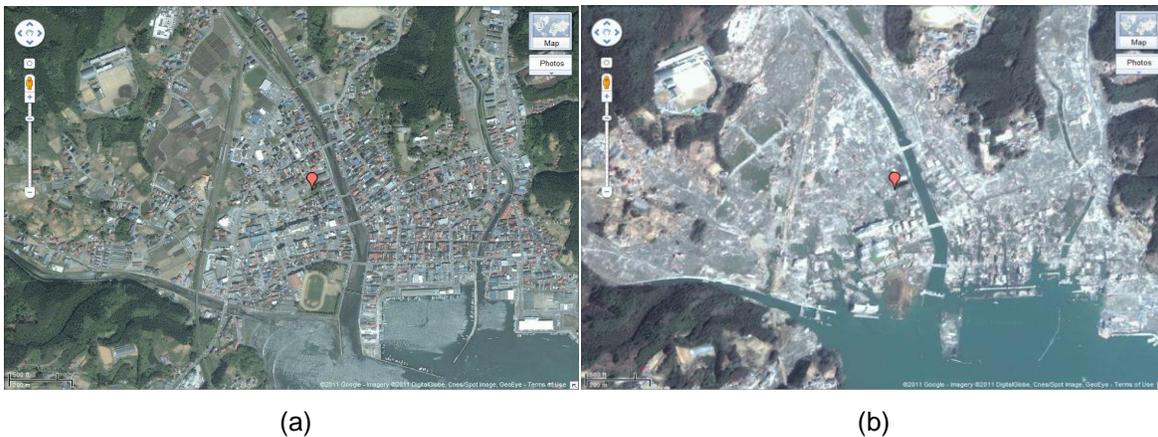
**Fig. 3 – GoogleMap satellite image of the Town of Minamisariiku (a) before and (b) after the 2011 Tohoku Tsunami (GoogleMap, 2011)**

One of the major sources of information was provided by the Japan Meteorological Agency website which featured tsunami warning documentation and initial offshore tsunami information. Aerial photography provided by JSCE as well as satellite images posted on the Google Earth Crisis Response (Fig. 3), and by Digital Globe, as well as status maps prepared by the Joint Research Centre of the European Commission were very helpful in verifying areas of interest for structural evaluations.

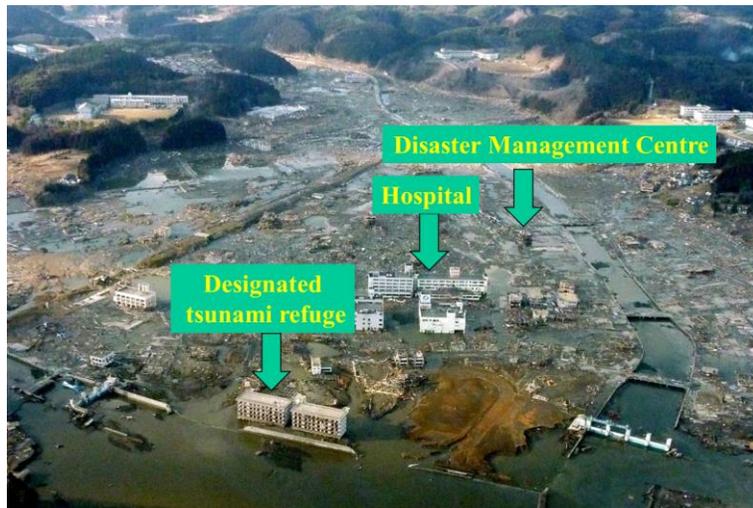
Asia Air Survey performed aerial surveillance with high-resolution cameras shortly after the tsunami as shown in Fig. 4 for the Town of Minamisanriku. On these maps, the members of the ASCE-SEI survey teams were able to identify structures, which they further surveyed during the tsunami forensic field survey.

**Fig. 4 – Aerial photograph of the Town of Minamisanriku after the 2011 Tohoku Tsunami (Asia Air Survey Co., Ltd.)**

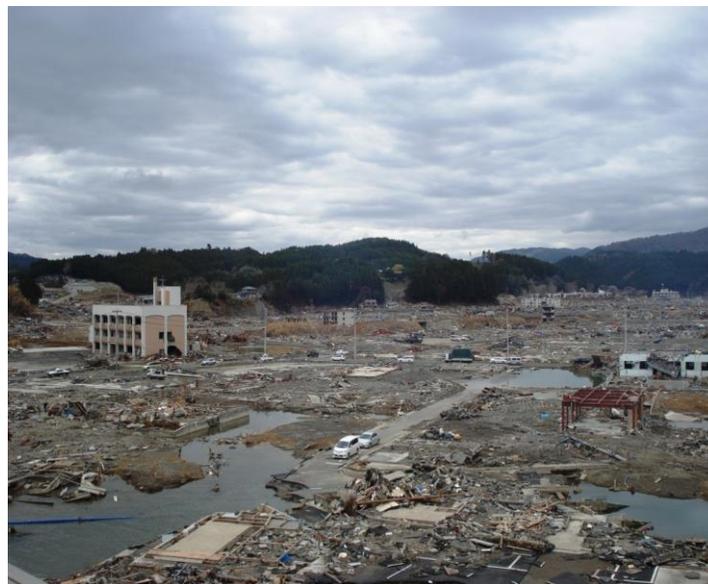
Tsunami inundation height was in the range of 5 to + 30 meters along the Tohoku coastline. Most of light-frame residential construction subject to about a story height or more of inundation collapsed. Therefore, complete collapse of residential light-frame construction occurred in nearly 100% of all affected areas up to the edge of the inundation limit. In commercial and industrial areas, low-rise building collapses occurred in the approximate range of 75% towards 95%, with the higher collapse rate occurring as tsunami height reached the upper range (Fig. 6).

**Fig. 6 – Infrastructure damage due to tsunami inundation in Minamisanriku**

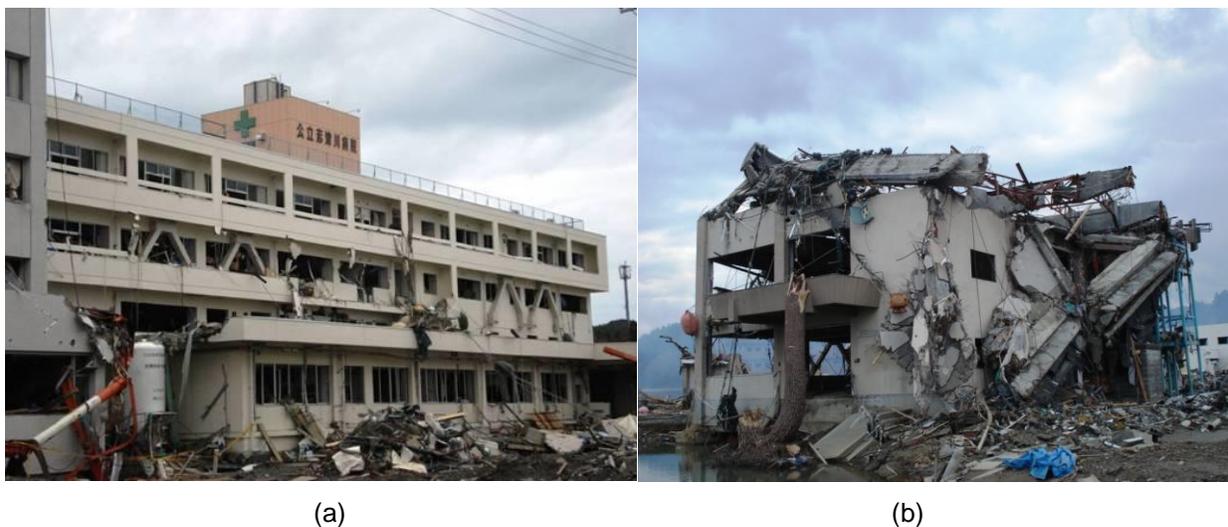
Generally, modern, mid-rise reinforced concrete (RC) buildings with deep pile foundations resisted the tsunami hydrodynamic and debris loading. It should be also noted that these RC structures surveyed during this forensic engineering survey were properly designed to withstand seismic loading. Figure 7 exemplifies cases of building performance for buildings surveyed in Minamisanriku.

**Fig. 7 – (a) Minamisanriku Hospital – RC building withstood tsunami loading (Chock et al., 2012); (b) RC building with collapsed steel trusses top floor**

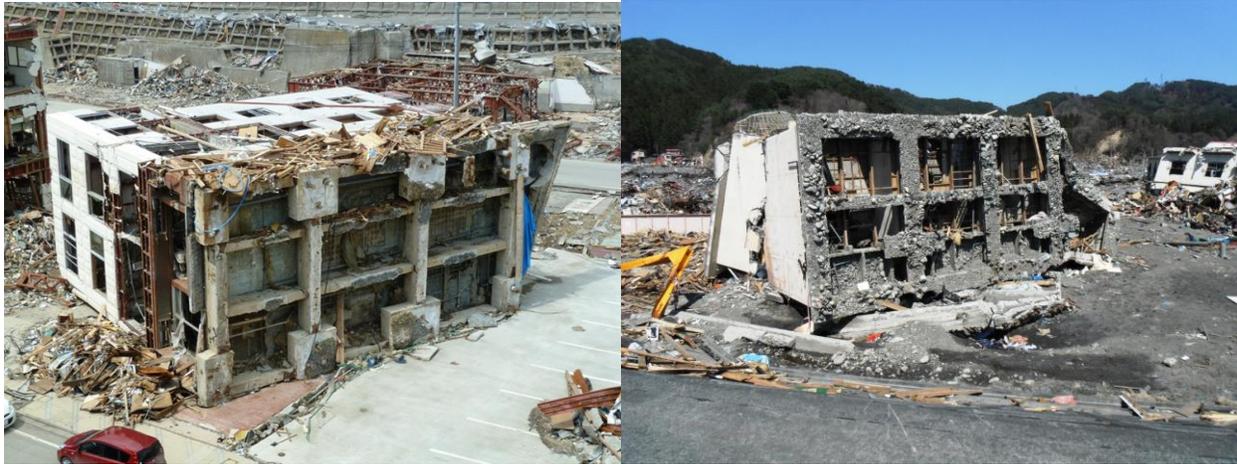
Several buildings were overturned and displaced on their side, while remaining nearly structurally complete from foundation to roof. These buildings either floated due to the hydrostatic forces and then were carried away by the lateral hydrodynamic loading, or they were simply overturned by hydrodynamic forces of the tsunami inflow or outflow, or a combination of both (Fig. 8). The contribution of these effects to the failures depended on the degree of openness of the building structures.

**Fig. 8 – (a) Overturned RC building in Onagawa with pile foundation; (b) Overturned masonry bearing wall apartment building in Otsuchi with shallow foundation**

- Structures of all construction and material types can be subject to general and progressive collapse during tsunami.
- Overturning should be considered as a tsunami design condition for the foundation and the superstructure.

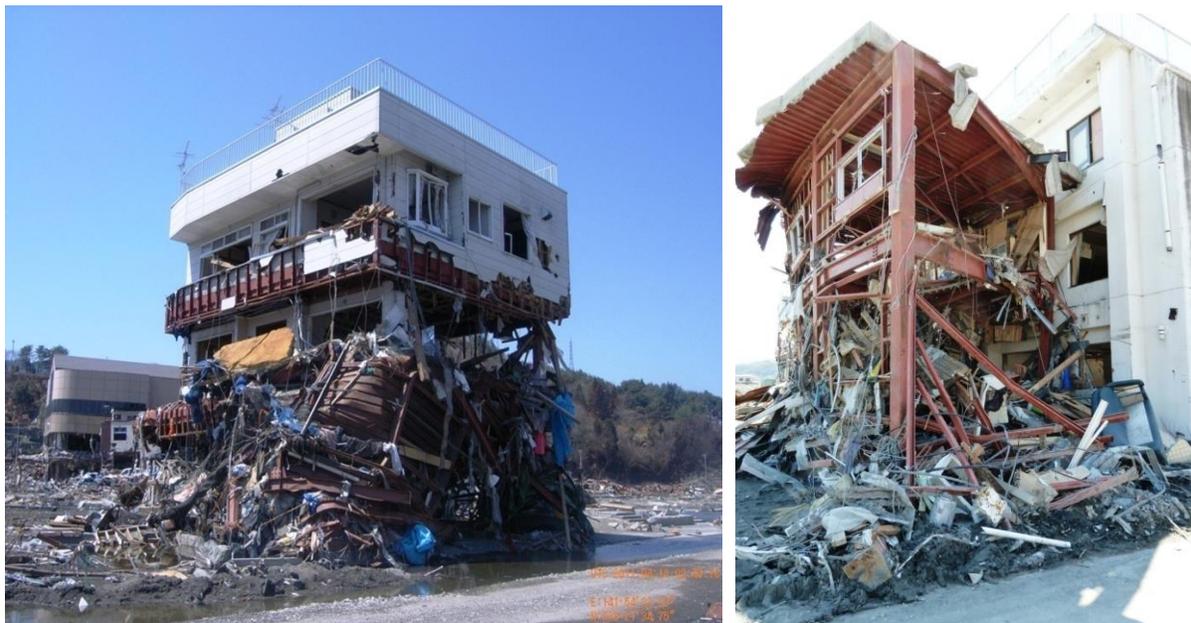
Tsunami flooding generates massive debris from failed building components, street infrastructure, and natural material stripping. Moreover, this debris load increases with each passing cycle of inflow and outflow (Fig. 9). Debris are not carried away but are hence recycled in the debris flow. Additionally, buildings always have contents that act as internal debris loading elements subject to hydrodynamic forces when tsunamis flow enters the structure; such debris then transmits additional hydrodynamic load to the structure even when the exterior envelope has opened to allow water to flow through.

**Fig. 9 – (a) Three stories steel moment-resisting building in Otsuchi with debris damming; (b) Overturned masonry bearing wall apartment building in Otsuchi with shallow foundation**

- Debris accumulation in tsunami inflow occurs rapidly. Loads on structures must consider debris damming and blockage.
- Buildings should have sufficient openings to alleviate buoyancy. The advantages of breakaway cladding may be more beneficial to prevent buoyancy rather than to drastically reduce hydrodynamic forces (due to debris accumulation).

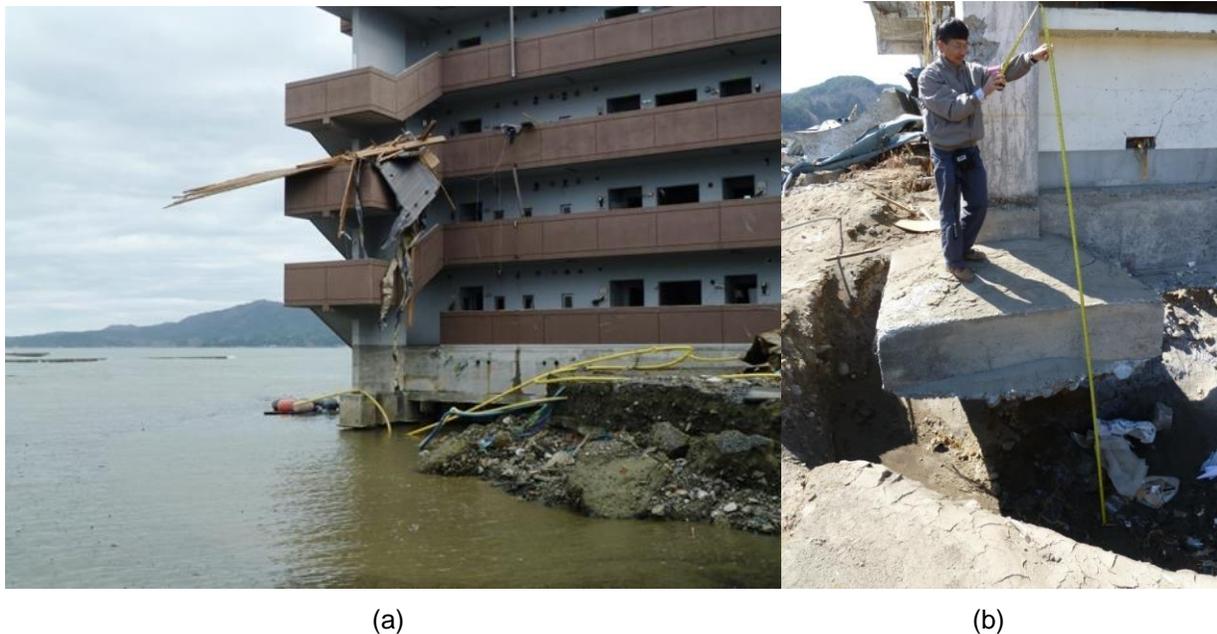
Building foundations are often also affected and subsequently undermined by erosion due to the overland tsunami-induced flow. This was observed to typically occur at the corners of building as flow accelerating around or between or over any bluff body obstructions generated scouring of the soil. Typical examples of scouring around building are shown in Fig. 10.

**Fig. 9 – (a) Scour due to return flow around apartment building in Minamisanriku; (b) Foundation scour at the corner of reinforced concrete building in Taro (Chock et al., 2012)**

- Flow diversion and acceleration around large buildings significantly focus flow on downstream buildings.
- Foundation systems should consider uplift and scour effects, particularly at corners.
