SHAKING-TABLE TESTING OF SINGLE-STORY CLAY MASONRY VENEER WOOD-FRAME BUILDING

H. O. Okail¹, S. Jo², P. B. Shing³, R. E. Klingner⁴, W. M. McGinley⁵, and D.I. McLean⁶

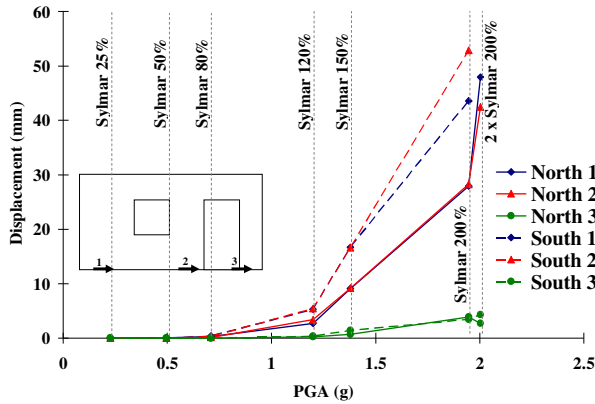
Figure 17. In-Plane Veneer Sliding vs. PGA

Figure 17 presents a plot of the sliding displacement at the base of the veneer in the north and south walls versus peak ground acceleration (PGA). The figure shows no sliding until a PGA corresponding to the ground motion level of Sylmar 120%. The figure also shows that the north and south veneer walls behaved similarly under in-plane shaking. Both walls showed less sliding at the smaller segments due to the flange effect provided by their connection to the east wall, and also due to their tendency to rock.

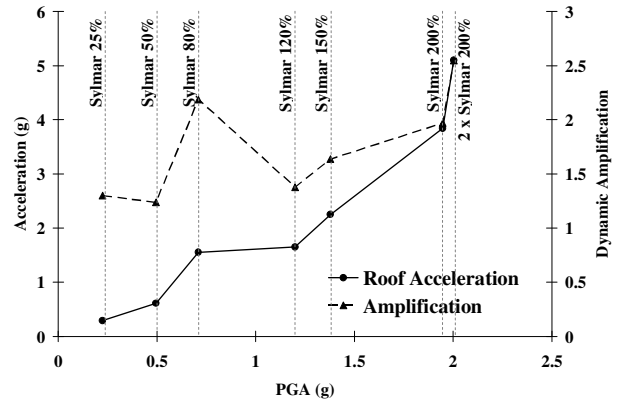
Figure 18. Roof Acceleration and Dynamic Amplification vs. PGA

Figure 18 presents the plots of the average peak roof acceleration and the average dynamic amplification (ratio of the peak average roof acceleration to the peak base acceleration) versus the PGA. The latter plot shows that the structure experienced an overall average dynamic amplification of 1.75 to 2.00 with the exception of the ground motion level that corresponds to Sylmar 80%, during which a dynamic amplification of 2.19 was recorded. This was the level at which the west wall veneer collapsed out-of-plane. Figures 19 and 20 present the peak out-of-plane accelerations at the top of the veneer and the backing versus the PGA for the west and east walls, respectively. The figures show that the west wall veneer experienced a peak acceleration of 2.07g, about twice that experienced by the east wall having the rigid ties under Sylmar 50%. This high acceleration corresponds to a local dynamic amplification of about 4.22 on the west wall veneer. This can be attributed to the straightening of the corrugated ties, eliminating the initial slack, on the west wall, which induced a shock to the veneer. The discontinuous corners at the edges of the west wall provided no restraint for the wall motion. Prior to the next shaking (Sylmar 80%), visual inspection of the top row of ties in the west wall revealed partial extraction of the nails from the wood-stud backing. The figures show that the east wall experienced more than twice the peak acceleration recorded on the west wall before failure. This can be attributed to 1) the rigid ties used on this wall, which had no initial slack; 2) the use of screws, which had significantly higher extraction capacities than nails; and 3) the bonded corners, which restrained the wall segments adjacent to the window from out-of-plane motion.

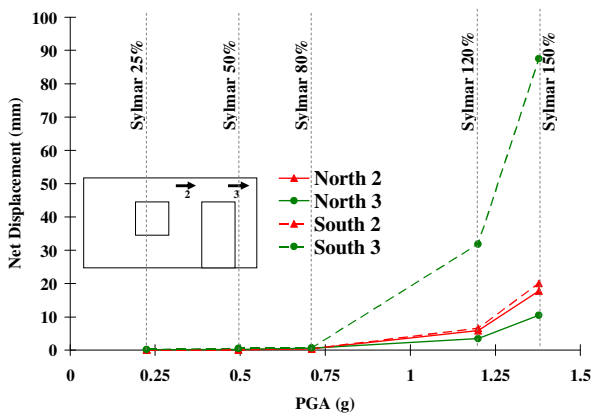
Figure 21. Net In-Plane Veneer Displacement vs. PGA

Figure 21 shows the net in-plane veneer displacement, defined as the difference between the top displacement and the base sliding, plotted against the PGA. This net displacement reflects the rocking of the veneer. The plots show no major motion till the MCE level. The small wall segment on the south side exhibited much more significant rocking than the other segments.

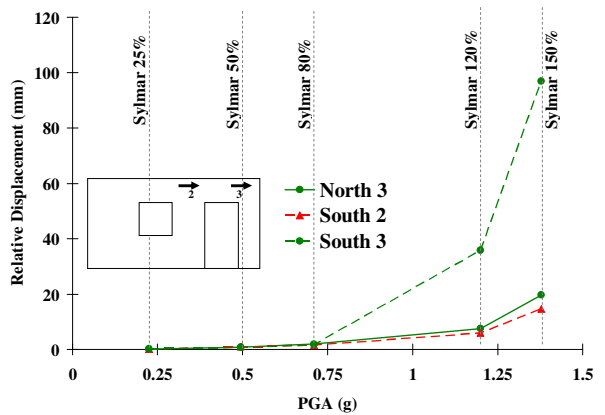
Figure 22. Relative In-Plane Top Displacement between the Veneer and the Wood Backing

Figure 22 shows the relative top displacement between the veneer and the backing. Once again, the plots show no major relative displacement till the MCE level with the small wall segment on the south side exhibited the most severe relative displacement.
