Geoscience Aspect of September 19, 2017 Mexico Puebla-Morelos Earthquake

Robert C. Lo¹, Samuel Yniesta²

¹ Staff Consultant, Klohn Crippen Berger, Vancouver, British Columbia, Canada

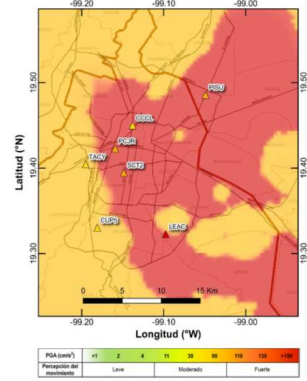
Figure 5. Map of PGA (cm/s^2) during the Sep. 19, 2017 earthquake (from II.UNAM 2017)

Raw earthquake recordings were provided by the Centro de Instrumentacion y Registro Sismico (CIRES, cires.org.mx). A total of 61 records were retrieved from the recording stations located in six seismic zones in Mexico City (see Fig. 4). Figure 5 shows the map of peak ground acceleration (PGA) in (cm/s^2). Table 2 presents the average properties of these stations in each seismic zone. These raw recordings were filtered in order to calculate acceleration, velocity and displacement response spectra for all three components of ground motion. The following section presents results of detailed analysis by Yniesta [14].

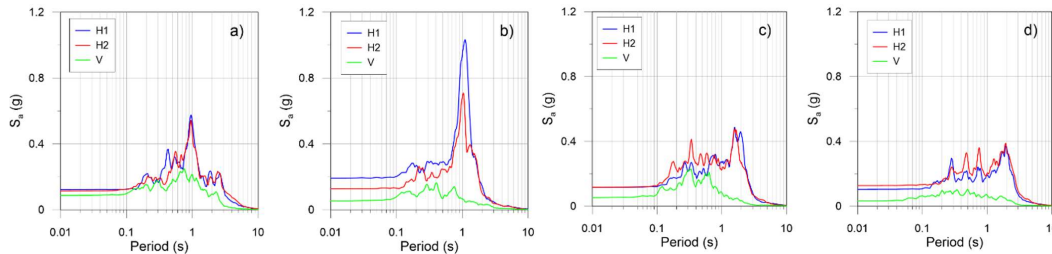
Figure 6. Acceleration response spectra (5% damped) at recording station: a) MY19 (Hill zone), b) DX37 (Transition zone (II)), c) CI05 (lake zone (IIIa)) and d) PE10 (Lake zone (III d))

Figure 6 presents selected response spectra for each zone. The selected spectra are representative of the average spectra observed over a given zone, with the exception of Fig. 6a for the hill zone (I). The spectra in Fig. 6a is larger than the average spectra in the hill zone. One of the takeaways from Fig. 6 is that the frequency content of the motion spectrum changes when going through zones of increasing softness. The larger spectral response is observed at greater periods in the softer zone, which is to be expected. However, the spectral acceleration for these zones is relatively low.

The shift in frequency content at all sites is consistent with the response spectra presented in Fig. 6. The frequency content of the response spectra is of interest because it defines the motion transmitted to the buildings located on the subsoil. Most of the buildings that collapsed were 7-10 storey high, and were associated with a fundamental period of about 1.0 sec. The motions in zones II and IIIa had predominant spectral period of about 1.0 sec, and had the highest spectral acceleration, which would affect specifically this type of buildings.

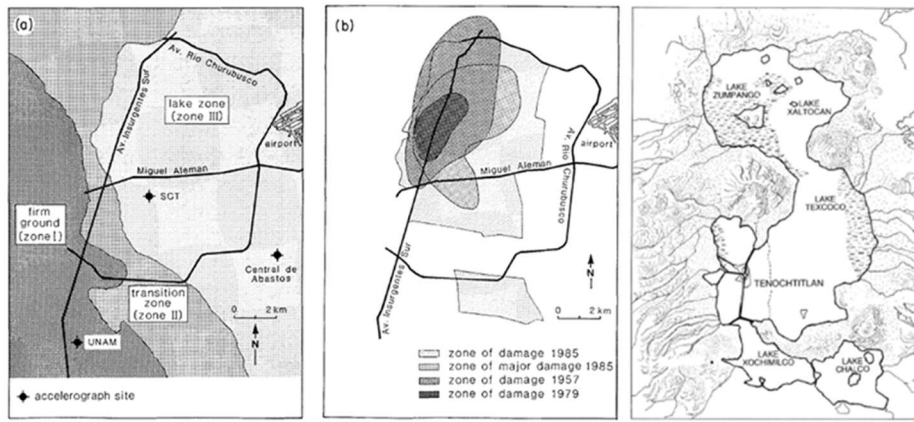
Figure 7. (a) Subsoil zones of Mexico City, (b) damage zones in the 1957, 1979, and 1985 earthquakes and (c) City of Tenochtitlan (modified from Mitchell et al. 1986 and Sabloff 1997)

Mexico City is located in the Valley of Mexico, which before the completion of the Nochistongo drainage cut in 1789 was a closed basin containing numerous lakes. These had been partially filled by alluvium and clay derived from weathered volcanic rocks. The original city was built on the location of the old Aztec capital Tenochtitlan [16] (see Fig. 7c), which was established on an island in Lake Texcoco with three causeways connected to adjacent lands. As Mexico City grew, it expanded from the old island, across the former lakebed, and onto the surrounding hills. To cope with the vast differences in subsoil conditions, it was necessary to divide the city into three zones for seismic design purposes: the foothills or firm ground zone, the transition zone, and the lake or soft soil zone (see Fig. 7a). Subsoil in the foothills zone is lava or very competent soils, while subsoil in the lake zone includes the upper and lower clay layers having water contents of about 300% and 200%, respectively. Geotechnical problems associated with Mexico City clay are regional subsidence (up to 9 m) due to groundwater withdrawal, building settlements, subsoil disturbance due to adjacent foundation construction, and severe earthquake shaking. Earthquake damage zones in the 1957, 1979, and 1985 earthquakes are shown in Fig. 7b.

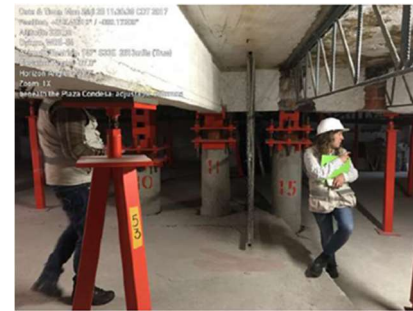
Figure 9. End-bearing control piles supporting the La Plaza Condesa building (Fig. 4.27 of GEER 2018)

Figure 9 shows the photo of such an installation, which would require periodical adjustments of the control elements to harmonize settlement of the structure with that of the surrounding ground. The famous Latin American Tower (La Torre Latinoamericana) has both end-bearing piles and a "compensating" foundation, designed by Zeevaert [17, 18]. The tower performed very well during both the 1985 M_w 8.0 and the 2017 M_w 7.1 earthquake. Many buildings in Mexico City become tilted due to differential settlement caused by static or seismic loading. Valenzuela-Beltrán et al. [19] looked into additional strength requirement for asymmetric yielding of this type of buildings, and recommended code-related provisions for their seismic design.

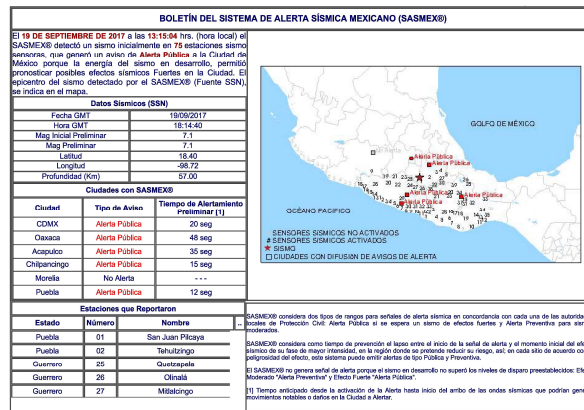
Figure 14. Screenshot of the CIRES website summarizing the alerts sent on September 19th, 2017

The intraplate M_w 7.1 earthquake was first picked up by recording stations situated in the Puebla state. For this earthquake, all major population centres, except Morelia, were warned (see Fig. 14). Given the short distance to the epicenter, Mexico City was only given 20 seconds of warning before strong shaking occurred. The fact that only a few recording stations were located in the epicentral area contributed to relatively short warning time. Unfortunately, when the alarm went off in Mexico City, the low amplitude P-wave had already been felt. The warning siren also tends to be masked somewhat by the cacophony of urban noise. However, the successful execution of the early-warning system attests the due diligence of the agency in charge as well as the opportunities of frequent seismic events available to root out system shortcomings.
