Damage Assessment of a Sixteen Story Building Following the 2017 Central Mexico Earthquake

Yijun Liao¹, Richard L. Wood², M. Ebrahim Mohammadi³, Kanchan Devkota⁴, Christine E. Wittich⁵

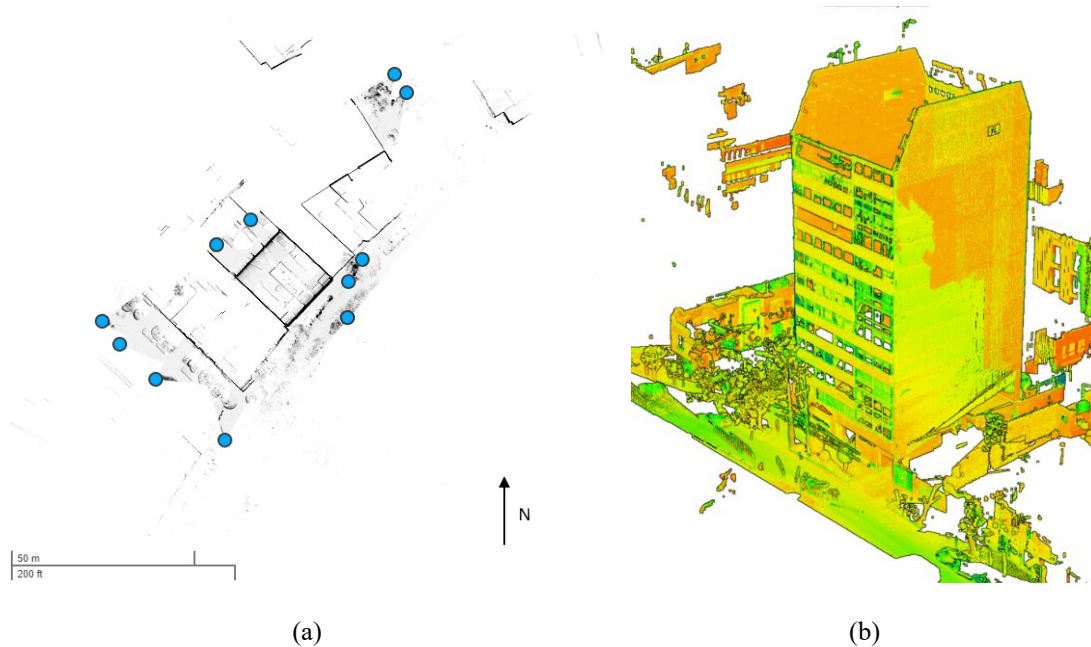
Figure 2. (a) Lidar scan locations, (b) Isometric view of registered point cloud colored by intensity.

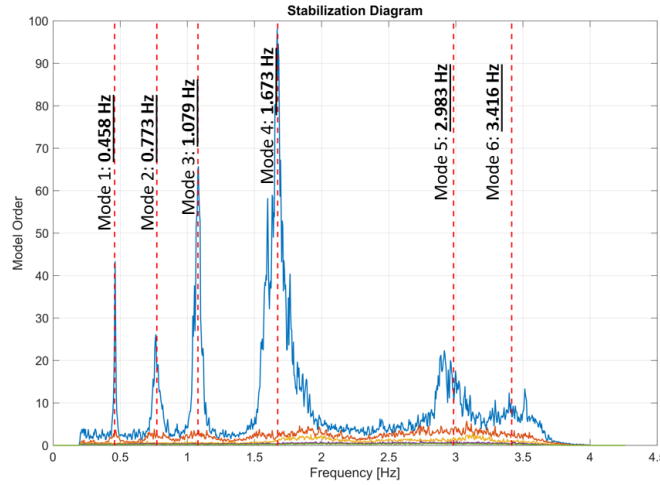
Due to the complexity of loading conditions, ARTEMIS software is used to perform the system identification process. ARTEMIS software is a commonly utilized software for system identification processing [13], which incorporates the stochastic subspace identification (SSI) method. The first six modes are identified and shown in the stability diagram in Figure 3. Table 1 and Figure 4 summarize the identification process, including the operational deflected shapes which are commonly akin to mode shapes. Note while the values are damping are reported in Table 1, these values may not represent the observed of damping present during the moderate level accelerations. Comparing the deflected shapes in Figure 4, it can be summarized that mode three and mode four have higher amounts of energy in the stabilization diagram.

Figure 3. Modal natural frequencies estimation.
