### Structural damage due to the 1985 Mexican earthquake

D.Mitchell McGill University, Montreal, Quebec, Canada

ABSTRACT: Characteristics of the 1985 Mexican earthquake and the influence of the subsoil conditions on the strong ground motion in Mexico City are described. Some aspects of structural design practice and examples of structural damage are discussed along with the emergency changes to the building code.

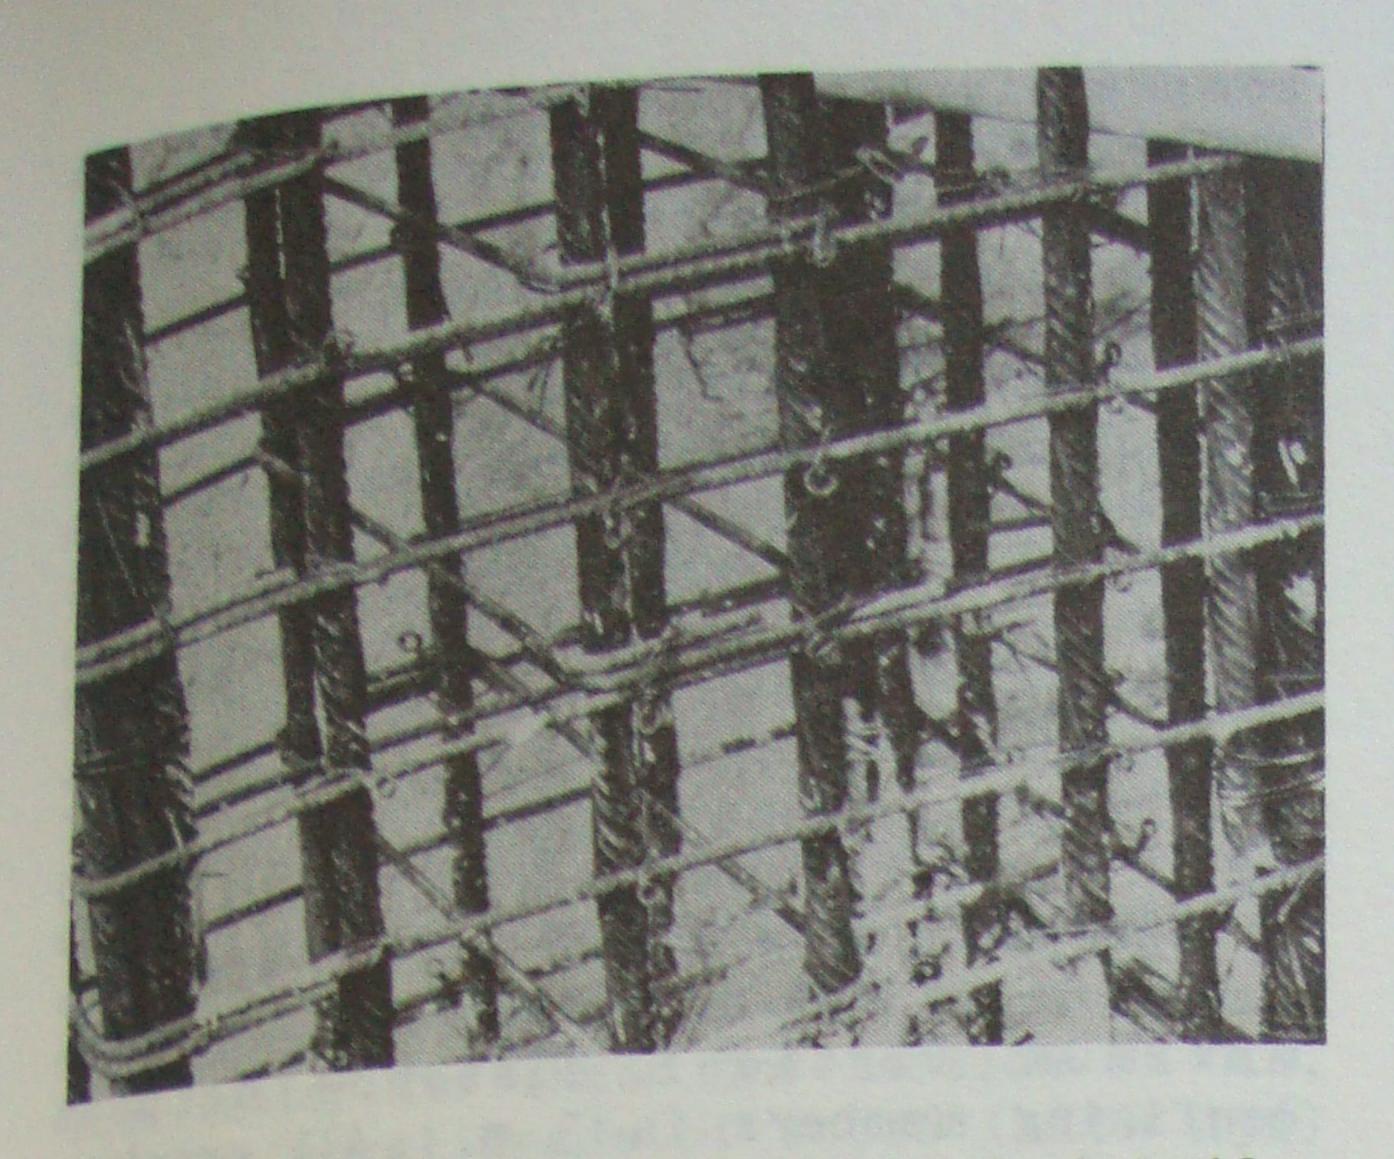
Fig. 11. Column reinforcement details with bundled bars (Mitchell et al. 1986a&b).

Figure 11 shows the reinforcement details at the end of a column under construction in Mexico City in October 1985, just after the earthquake. This column has a good the earthquake. This column has a good the perimeter of longitudinal bars around every alternate longitudinal bar is tied with closely spaced ties. Figure 11 also longitudinal bars in the corners of columns and the use of only 90 degree bend

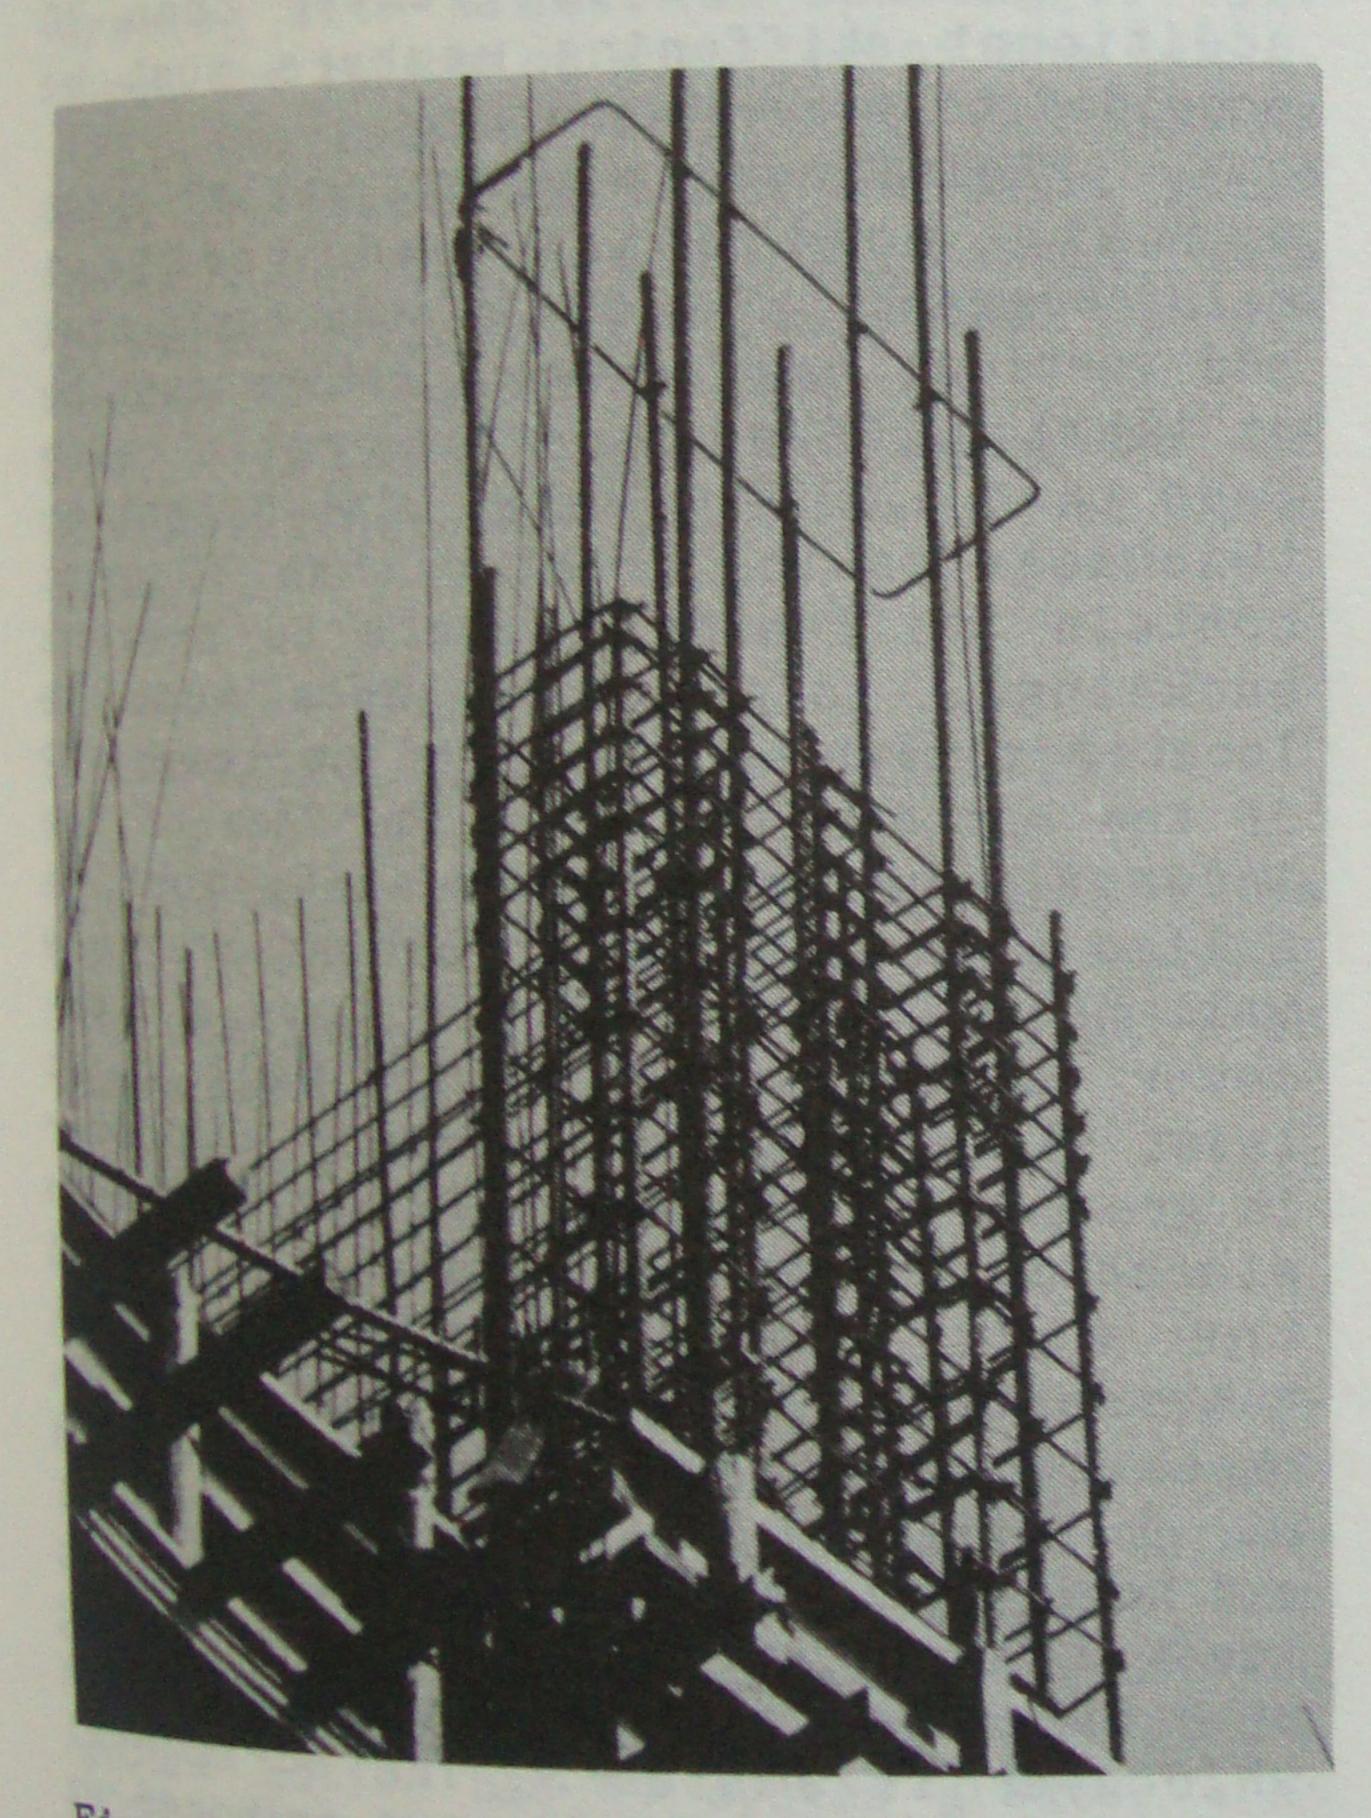
Fig. 12. Column reinforcement details.

anchorages for the column ties. Figure 12 illustrates the column tie reinforcement details for a large hotel structure under construction just after the earthquake. This column has well distributed longitudinal column bars (no bundled bars) with each longitudinal bar laterally supported by ties. The ties are anchored with free end extensions of 20 bar diameters with only 90 degree bends.

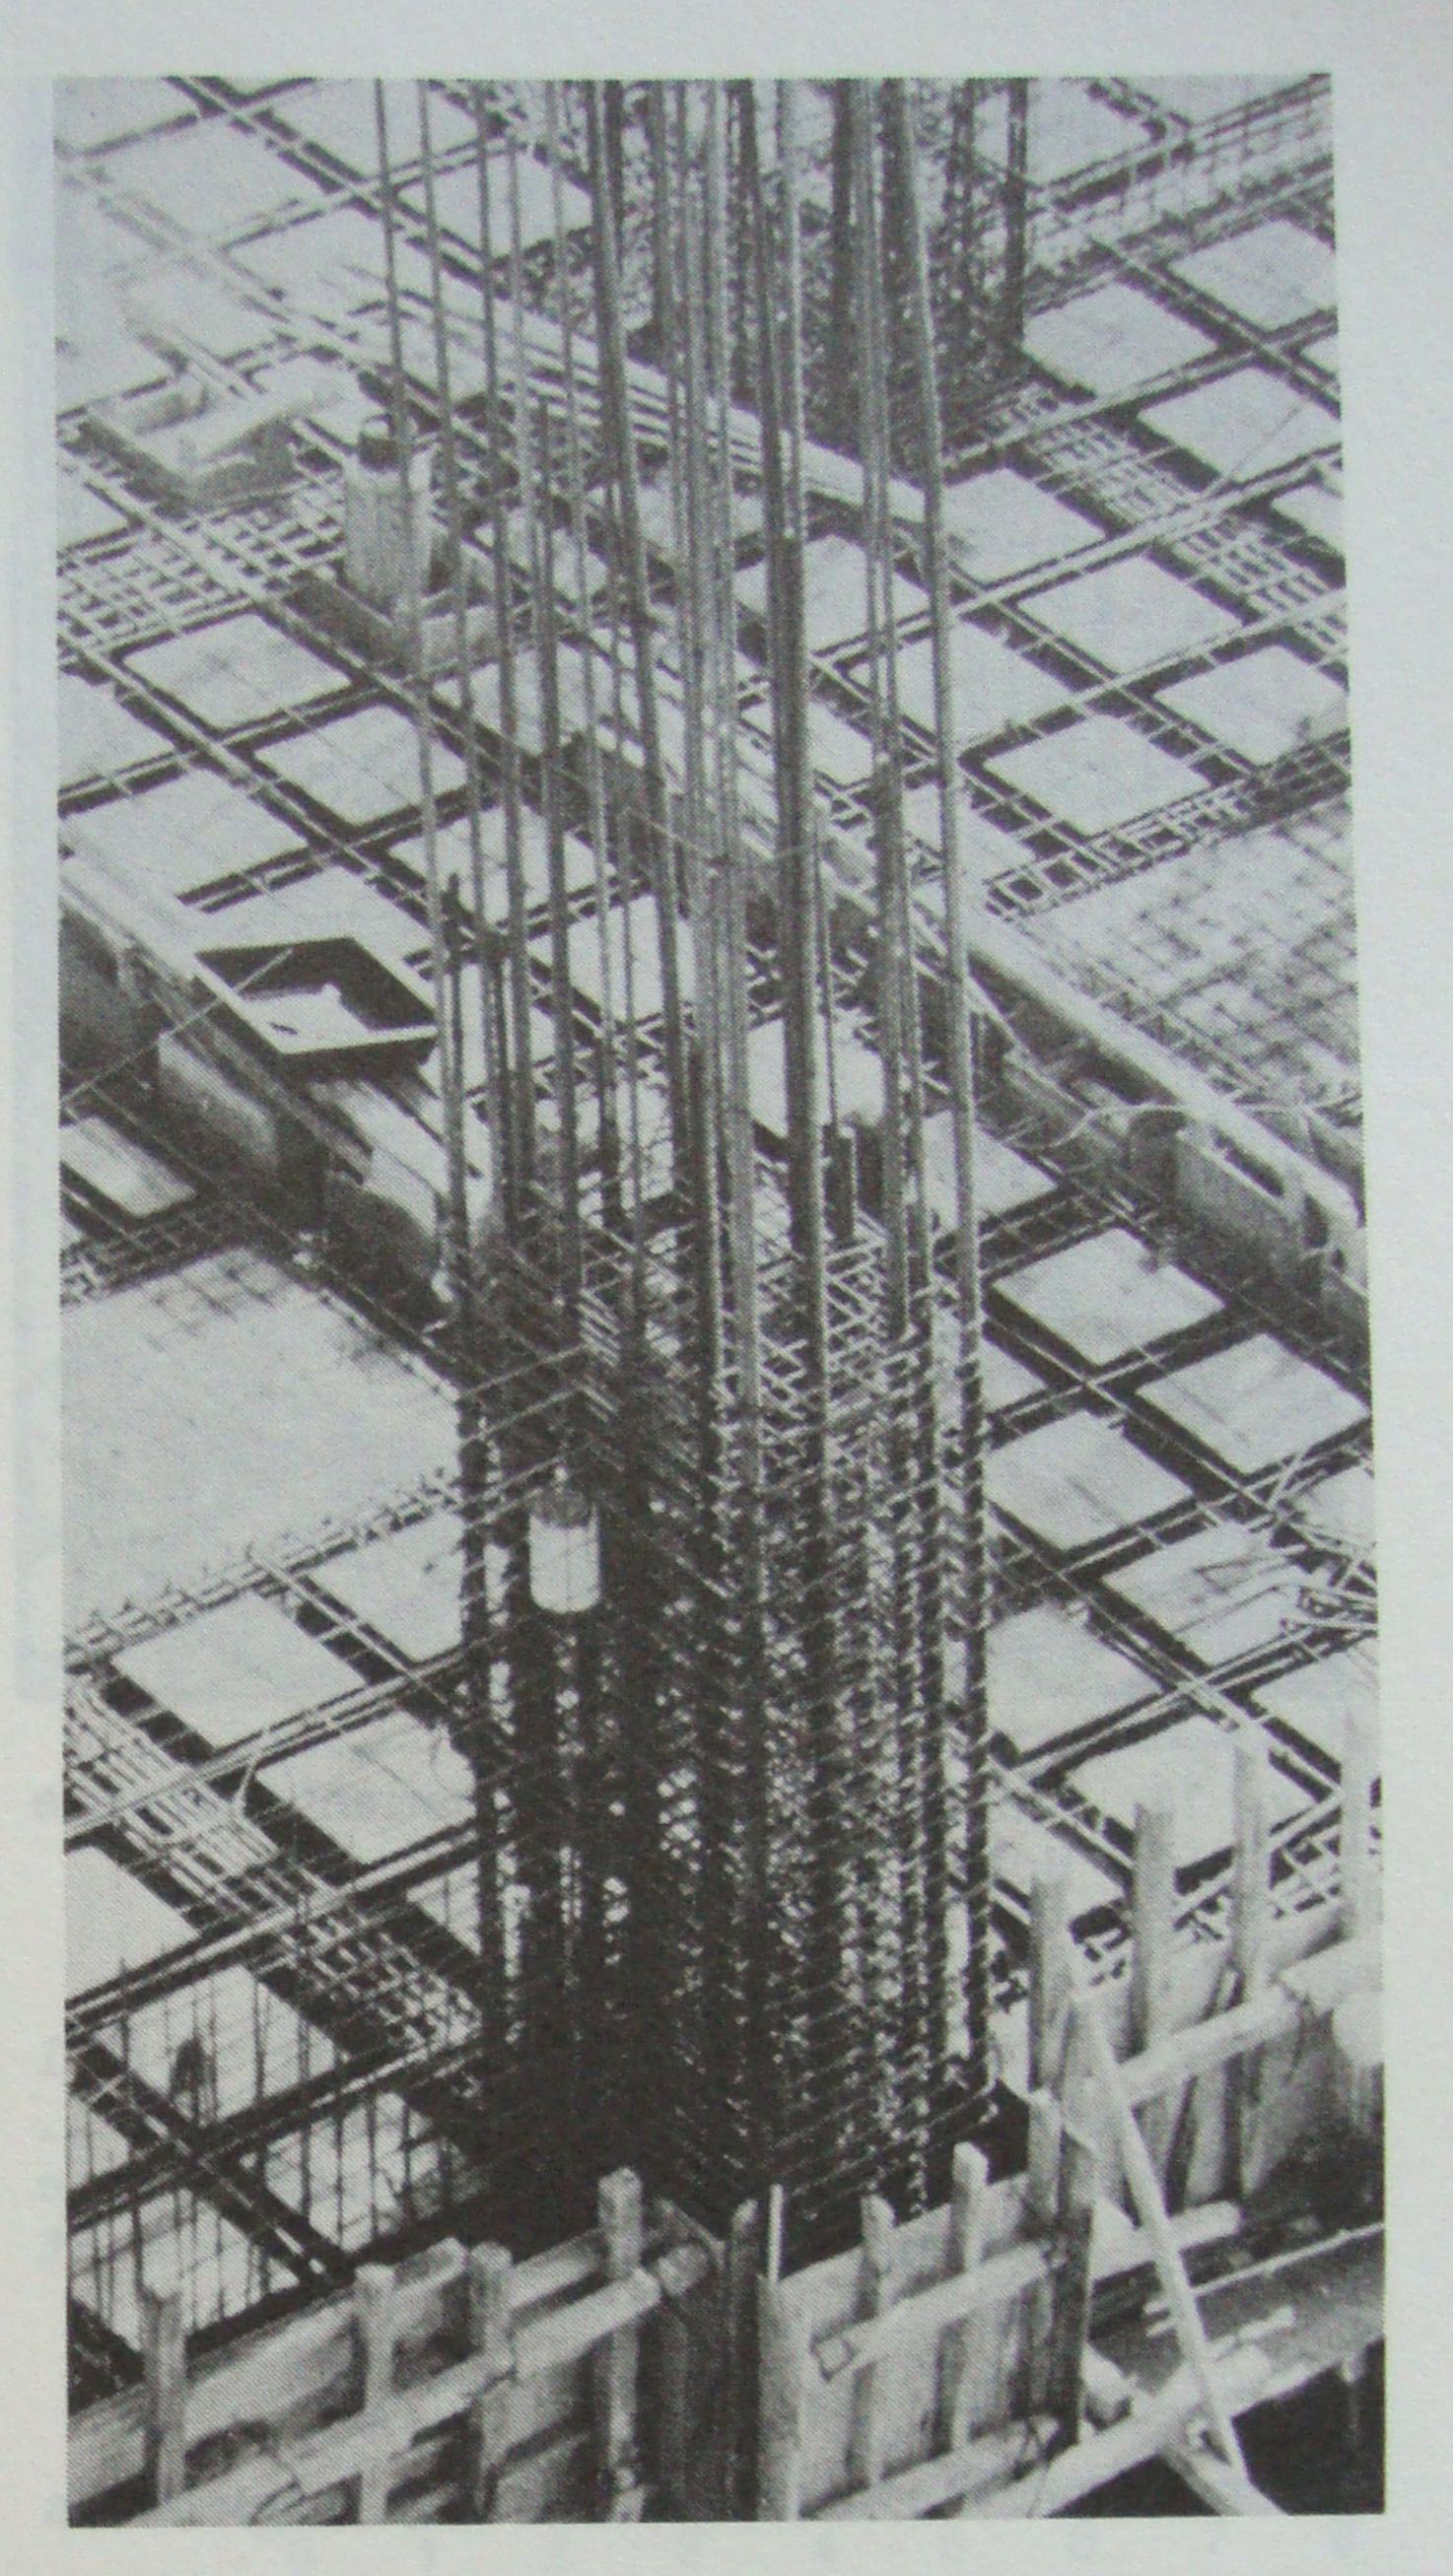
Fig. 13. Waffle slab construction in Nikko Hotel.

Figure 13 illustrates the reinforcement details in the Nikko Hotel which was under construction at the time of the 1985 earthquake. Waffle slabs are very common in Mexico City and are constructed either by reusable waffle pans (Fig. 13) or by embedding hollow masonry blocks in the slab. Note the presence of reinforced beams between the columns and walls.

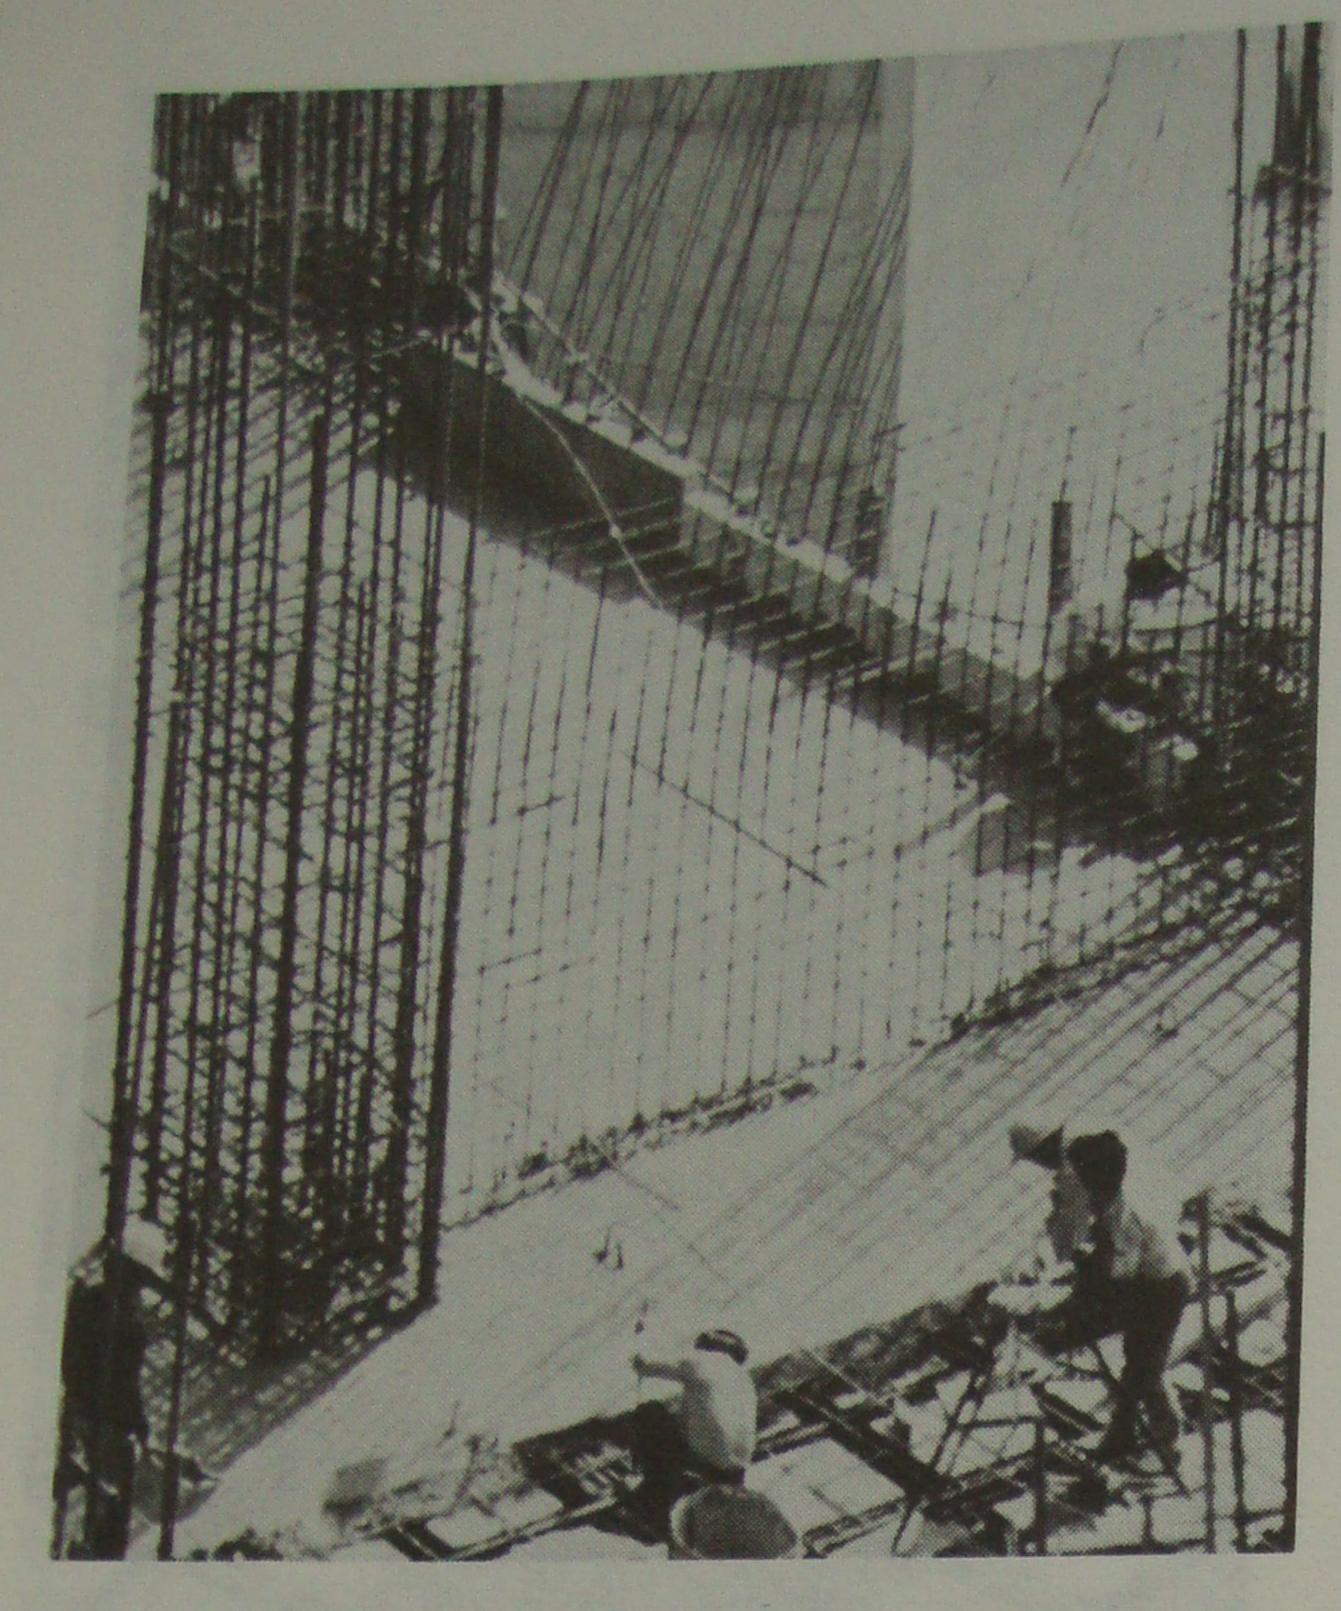
Fig. 14. Shear wall reinforcement details in Nikko Hotel.

Figure 14 shows the shear wall reinforcement details for the Nikko Hotel. These walls have boundary elements in the form of columns containing confinement reinforcement.

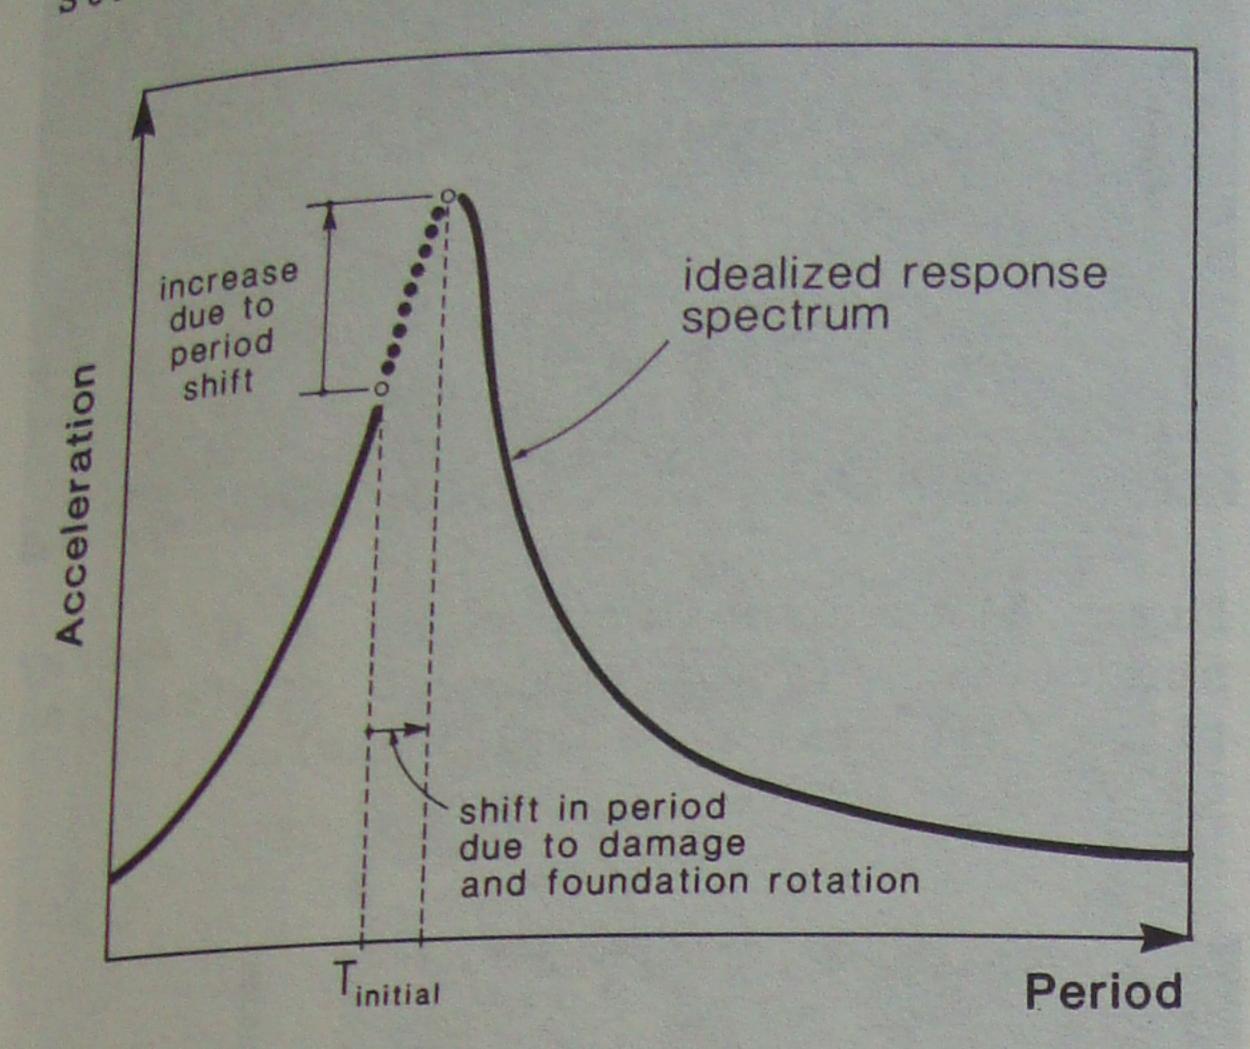
Figure 17 illustrates the reasons for the susceptibility of the 6 to 15 storey the susceptibility to severe damage. The

Fig. 17. Accumulated damage of 6 to 15 storey structures (Mitchell et al. 1986a&b).

idealized response spectrum represents the response spectrum for the lake zone region with compressible soil depths of about 30 m. If the 6 to 15 storey structures had rigid foundations and responded elastically they would have fundamental periods of vibration below the 2 sec critical period. These structures had their periods of vibration lengthened due to both foundation rocking and due to structural damage. With each successive cycle of strong ground motion the structures suffered cumulative damage, the period of vibration increased and as a result the structure attracted greater inertial forces! This resulted in severe damage or collapse in many cases.

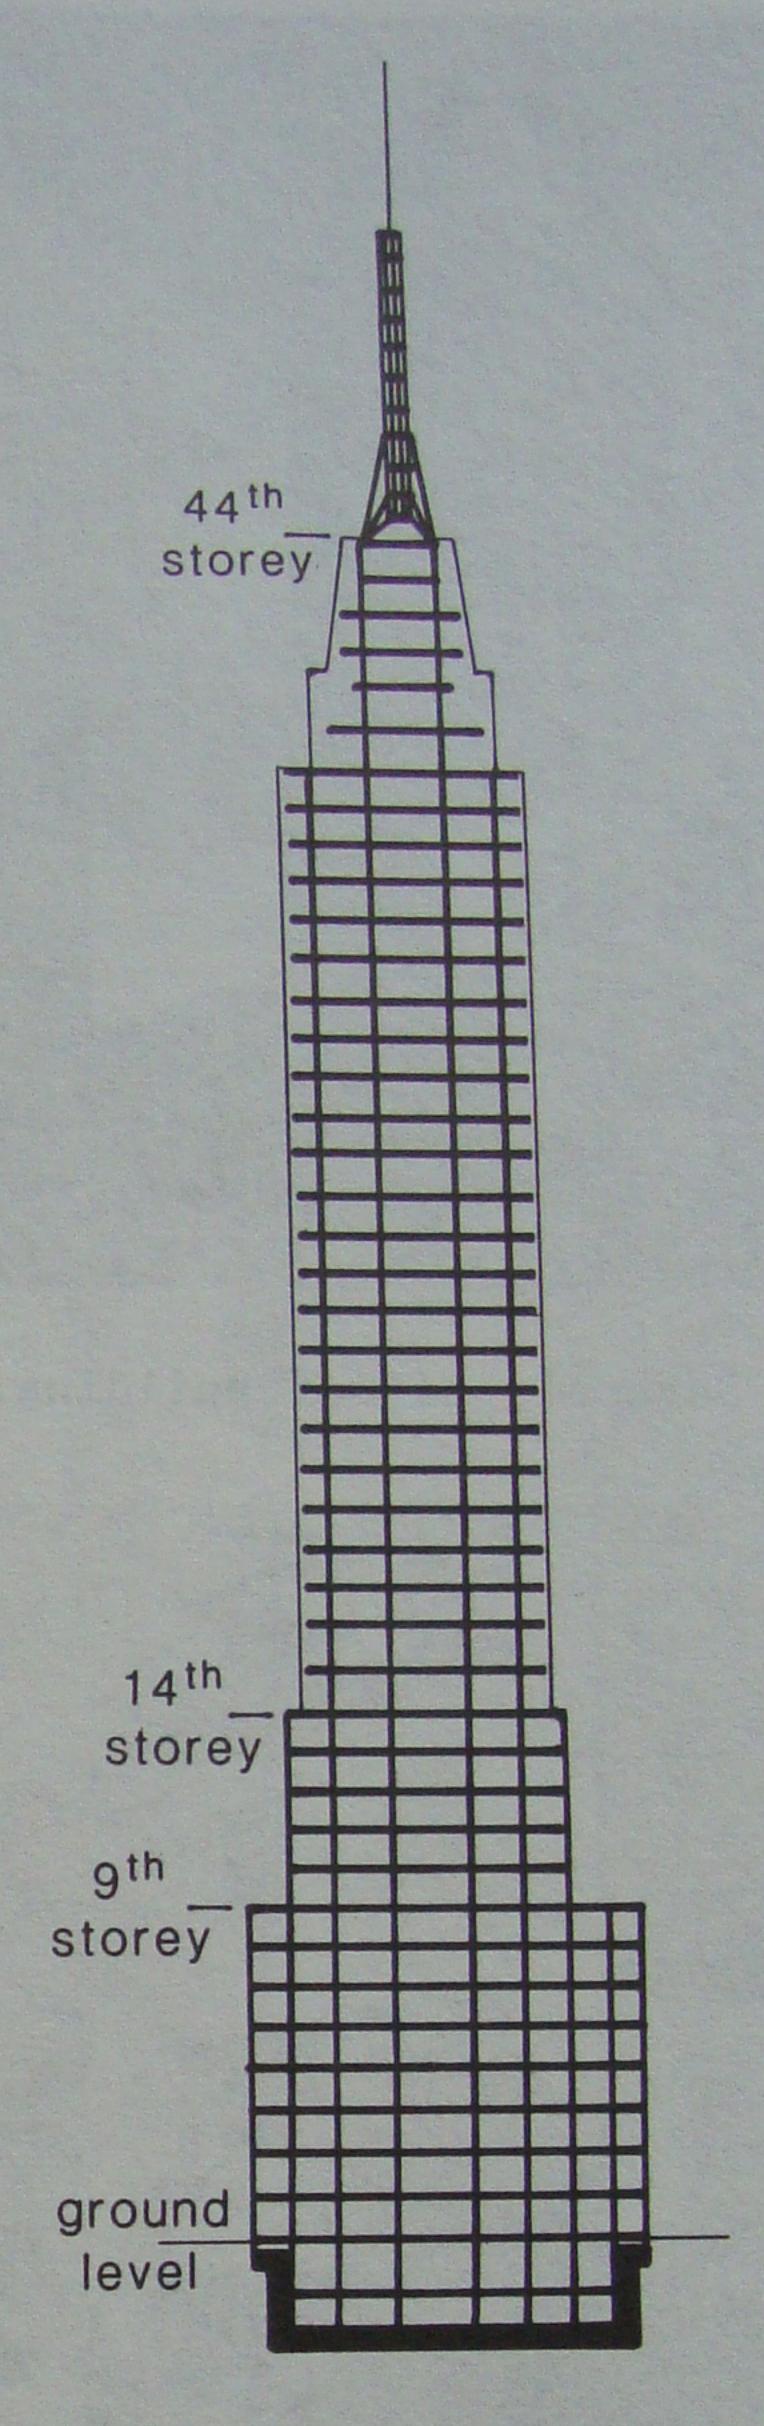
It is interesting to note that a taller structure (greater than about 20 storeys) would attract smaller inertial forces as its period lengthens due to foundation rocking and due to inelastic response. For example the steel-framed 44 storey Latin American Tower (see Fig. 18) has calculated periods of vibration of 3.66, 1.54 and 0.98 sec for the first, second and third modes (Zeevaert and Newmark 1956). This moment resisting frame structure is founded on end bearing piles and is situated in the compressible soil region of Mexico City. The period of rotation of the foundation is 1.31 sec resulting in combined structure-foundation periods of 3.88, 2.02 and 1.64 sec for the

Fig. 18. Structural steel framing of the 44 storey Latin American Tower (adapted from Zeevaert and Cuevas 1983).

first, second and third modes (Zeevaert 1972). The effect of foundation rotation is to increase the periods of vibration, particularly the higher modes of vibration. The increase in the periods of higher modes of vibration results in a greater participation of these higher modes resulting in greater overall inertial forces and in particular larger inertial forces in the upper storeys. This phenomenon was an important factor in the damage to the upper storeys of many structures.

The Latin American Tower which was completed in 1956 has been subjected to three major earthquakes (1957, 1979 and 1985) without experiencing structural damage.

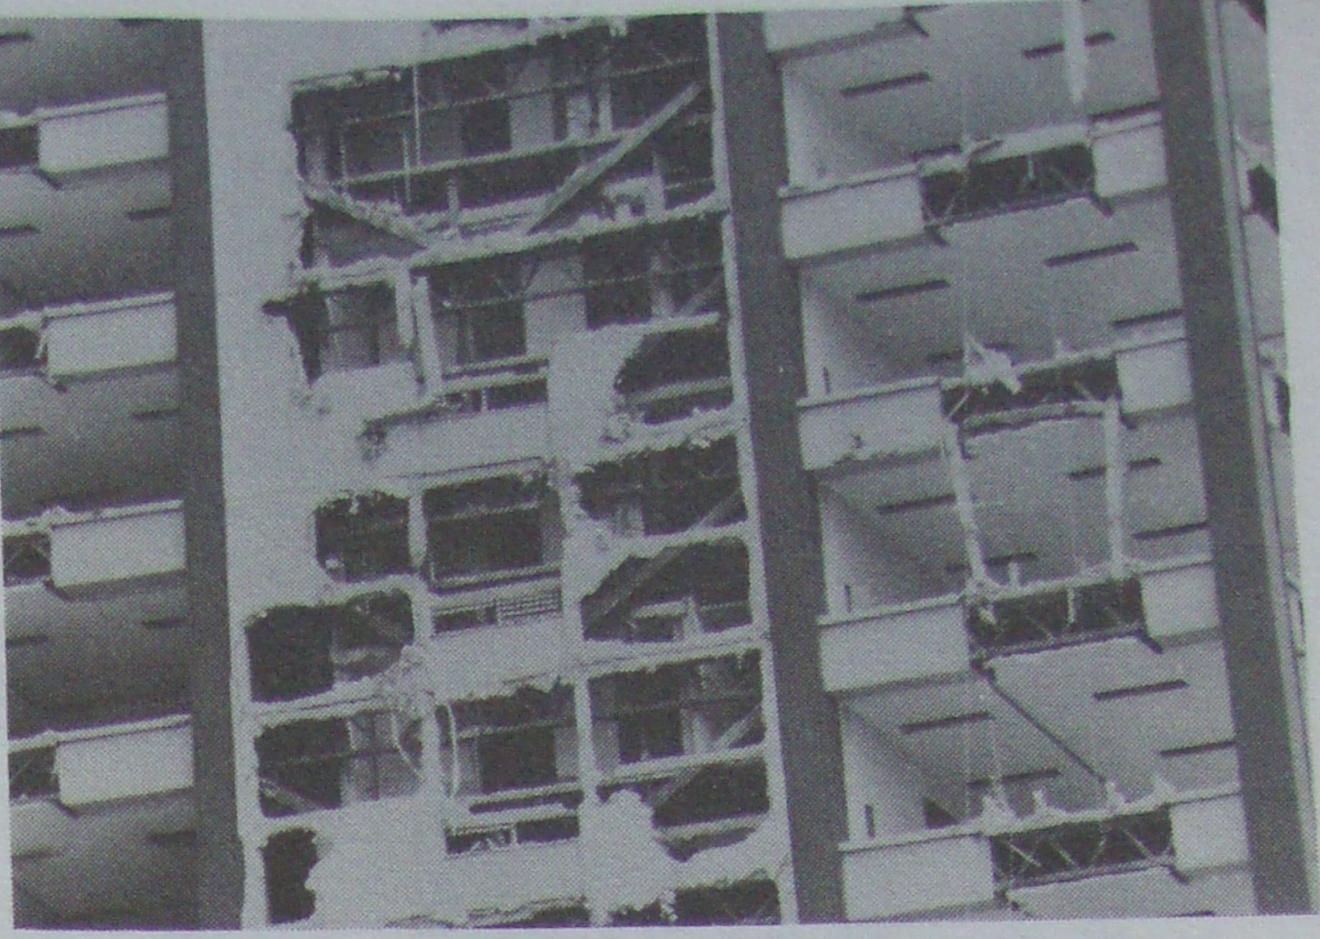
adjacent 14 storey structure causing it to collapse as shown in Fig. 50. The framing of these structures consists of built-up tubular steel columns, tubular steel trusses and K-bracing as shown in Fig. 51. Figure 52 shows a buckled corner column of one of the 21 storey structures that is still standing. The tubular columns were fabricated from 4-20 mm thick steel plates which had fillet welds at the corners to form a 400 mm x 600 mm box section. A close-up view of one of the buckled corner columns (see Fig. 53) reveals the local buckling of the plates and the failure of the welds. This structure was severely damaged with a permanent displacement at the top, in one direction, of 1200 mm. In addition permanent torsional deformations of the structure were evident.

Fig. 51. Structural framing of the Pino-Suarez office towers.

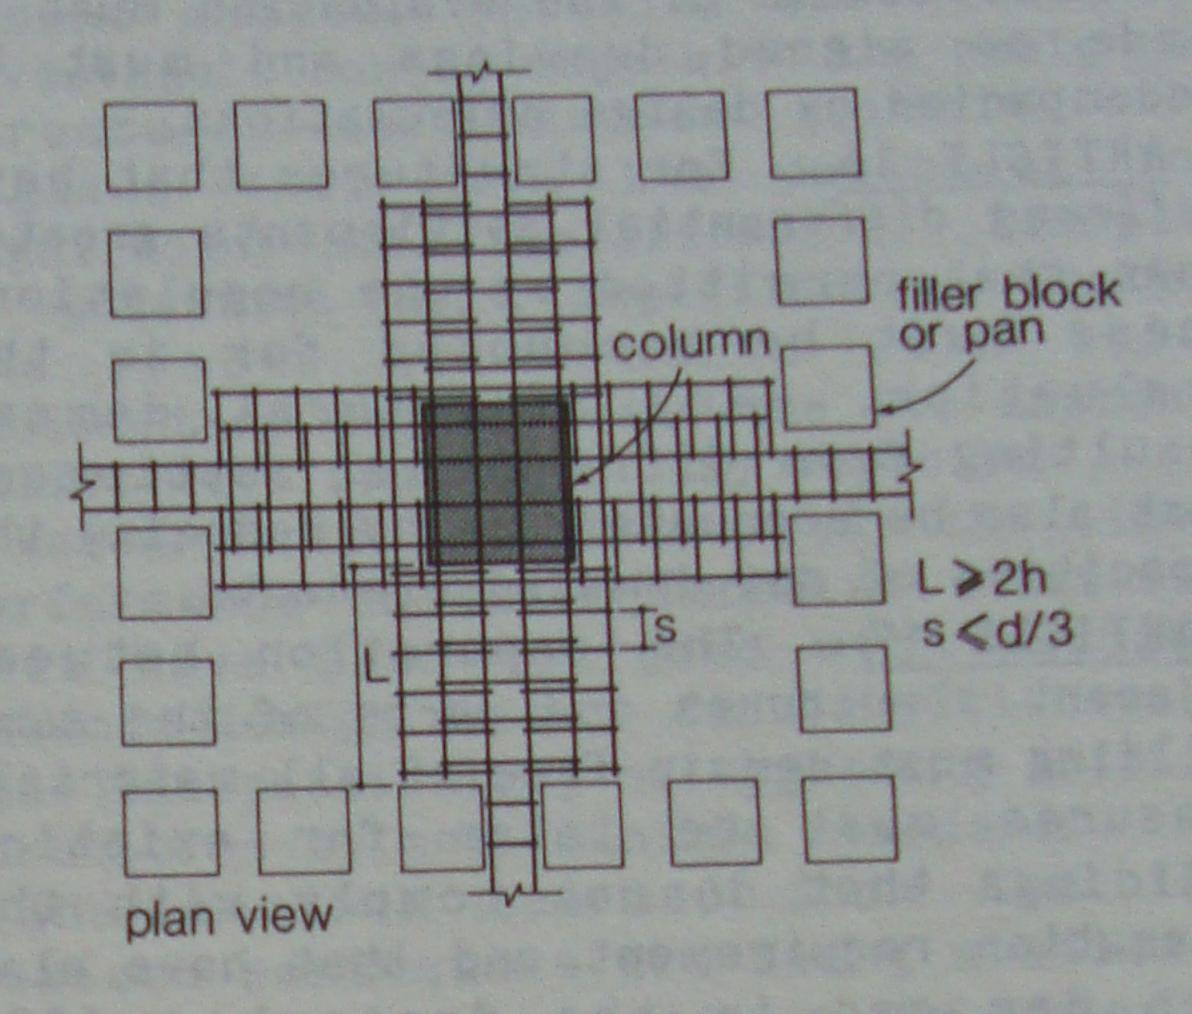
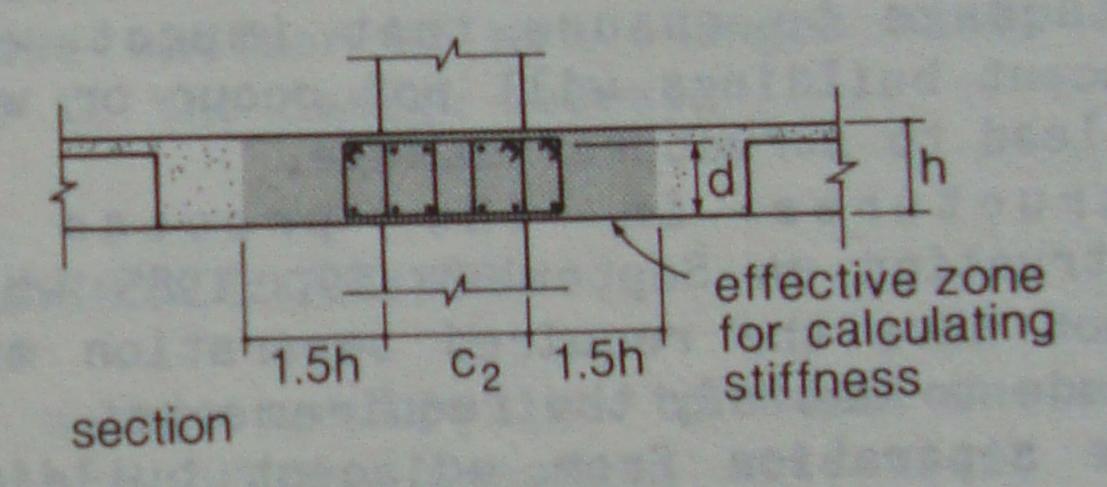
Fig. 54. Waffle slab details required by emergency code changes (Mitchell et al. 1986a&b).

ARTICLE 12 In using the equivalent frame analysis for regular slab structures Subjected to vertical loads the column stiffnesses should be reduced by one-half. for lateral load analysis an equivalent slab beam width equal to c2 + 3h is used (where c2 = column dimension perpendicular to the direction in which moments are being determined and h = slab thickness). At least 75 percent of the longitudinal Slab reinforcement necessary to resist seismic loads must pass through the column and the rest of the reinforcement must be face a distance of 1.5 h from the column face. The waffle slabs must contain a

solid slab region around the column over a distance of at least 2h from each column face. In the analysis of slabs it is necessary to account for the variation of the moment of inertia of the equivalent beam. The reinforcement of the equivalent beam in the solid portion of the slab around the column must have stirrups having a spacing not exceeding 1/3 of the effective slab depth. (The resulting details of a waffle slab are illustrated in Fig. 54).
