The Effect of Lateral Spreading on the Landing Road Bridge in the 1987 Edgecumbe, New Zealand Earthquake

J.B. Berrill¹ and S.A. Christensen²

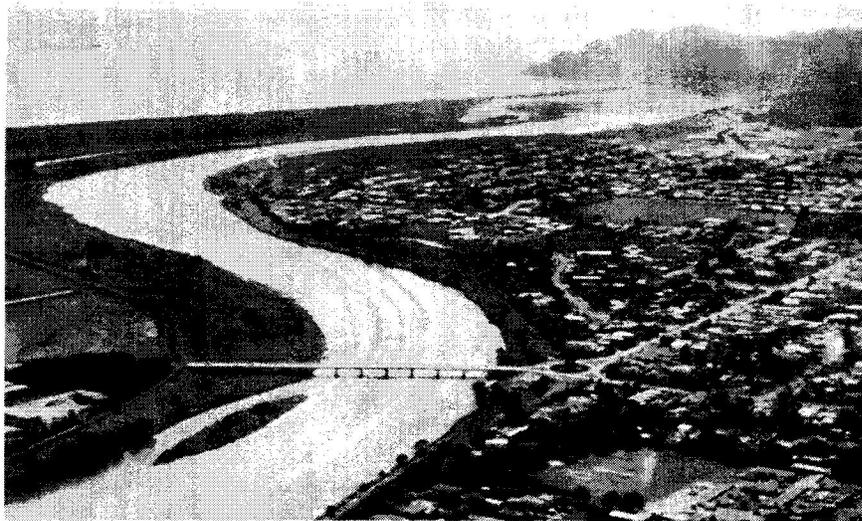
Figure 2. The Landing Road Bridge, looking north east to the mouth of the Whakatane River.

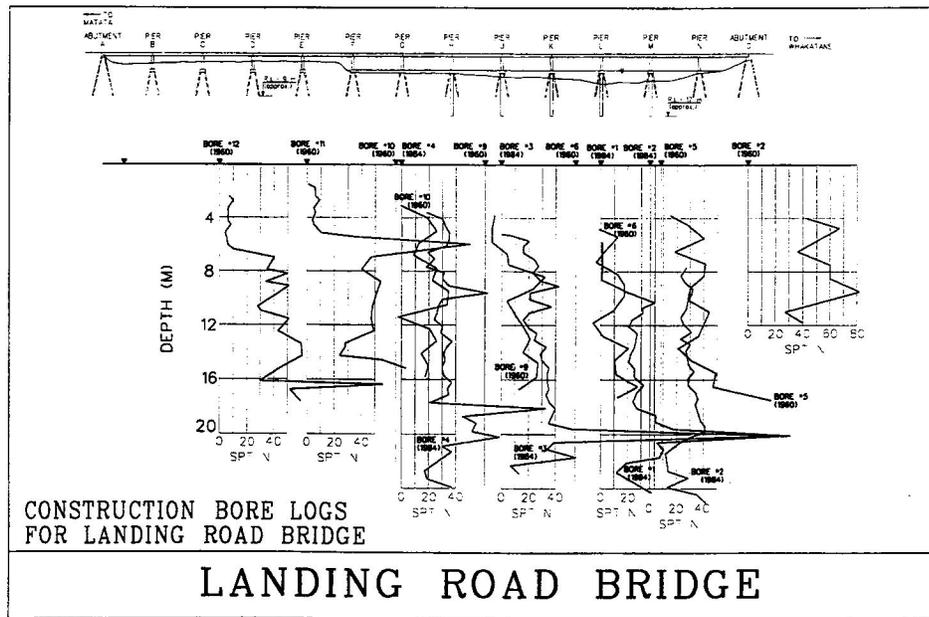
Figure 3. Section along the centre-line of the Landing Road Bridge showing the SPT logs which were used for the bridge design and redesign. Abutment A is at the north end of the bridge.

During the past 100 years the river has prograded about 100 m towards the south, leaving behind loose sands and silts, in a classical point-bar structure, to a depth of about 6 m; it is these soils which liquefied. The bridge piles were driven into denser sands below that depth. These older and denser sands are also found extending to the ground surface at the south abutment. Gross features of the soil profile are seen in the SPT logs reproduced in Figure 3.
