Seismic Upgrade Techniques For Concrete Reservoirs

John Sherstobitoff¹ and Svetlana Nikolic-Brzev²

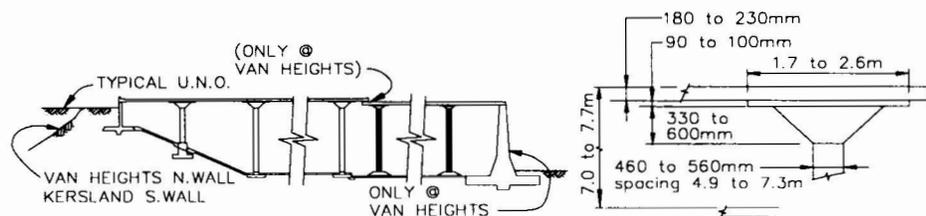
Figure 1. Typical reservoir cross section and details.

The seismic evaluation of the 1928 portion indicated a number of critical structural deficiencies, such as: i) no bottom reinforcing in the roof slab at column locations, ii) roof slab connected only to the east wall, thus creating high torsional eccentricity, iii) columns of a limited flexural capacity and nominal ductility performance, iv) a deteriorated roof slab with limited shear capacity, v) a water retaining east wall grossly under reinforced, with potential for catastrophic failure at MCE loading, and vi) north wall with poor foundation conditions and inadequate flexural reinforcing. The 1968 portion was significantly better, with deficiencies similar to iii) above, and with short perimeter columns (high relative stiffness compared to the interior columns), attracting a significant load without adequate capacity or ductility.

In the 1928 portion the roof was made structurally independent from the east wall by removing a 70 m strip of roof slab 150 mm wide. The roof slab, independent from the east wall, was torsionally symmetric, however its strength and ductility still remained inadequate. Options to retrofit the roof structure included new shear walls, slab-to-roof concrete or steel trusses, and fibre wrapping of the columns. The square pattern of shear walls was selected as the most effective and economical. The steel and concrete trusses were effective, but estimated to be 10% and 25% more costly. Fibre wrapping would increase ductility but could not offset the extremely low level of column flexural reinforcing and inadequate splice lengths.

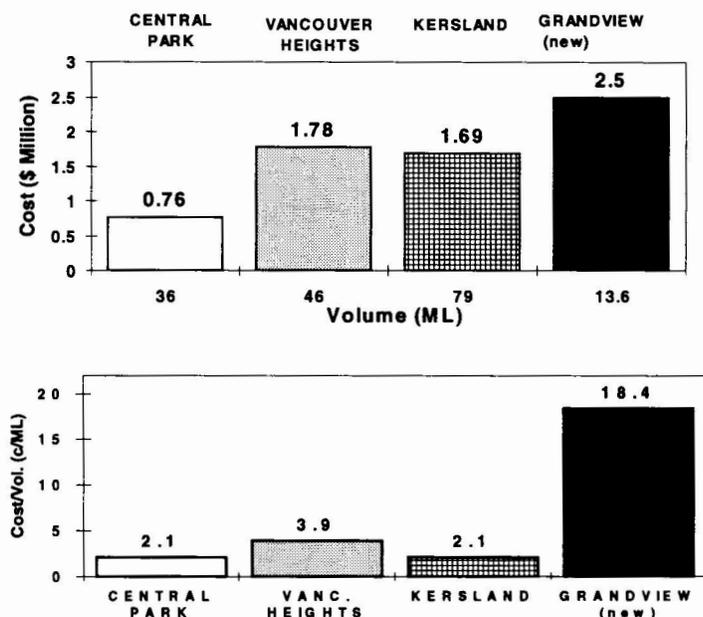
A cost summary is presented in Figure 5 for the three reservoirs discussed, using costs based on the completed construction projects. The retrofit costs are presented in comparison to the estimated "all-in" costs (including site prep, piping, etc.) of the new Grandview reservoir, designed to the same criteria and constructed in 1998.

Figure 5. Cost estimate vs. total volume and cost per unit volume for the reservoirs studied.
