Seismic Response Analysis of Water Supply Pipe Network During the 1995 Hyogoken Nambu Earthquake

Miyajima, Masakatsu¹ and Kitaura, Masaru²

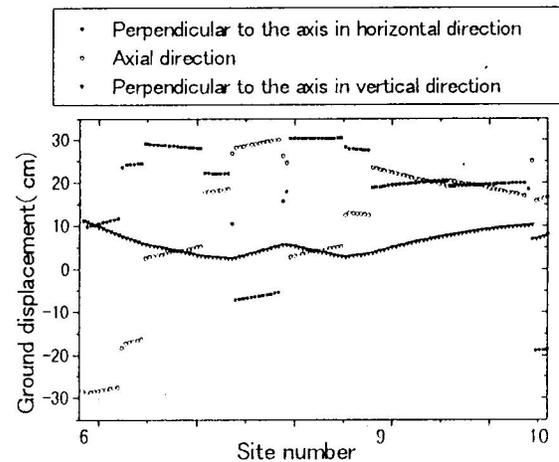
Fig. 6 Ground displacement along pipeline in Egeyama area.

A part of the water supply pipelines constructed in Egeyama area was analyzed employing the method presented above. A rough sketch of pipelines analyzed here is displayed in Fig. 5. The sites of pipe failure are also shown in this figure. The type of pipes was ductile cast iron and their diameters were 100 mm and 150 mm. The response of the pipelines corresponded to point 6 to point 10 shown in Fig. 5 was investigated in this chapter. The length of pipelines was about 234 m. Fig. 6 illustrates ground displacements along the pipelines. These were interpolated from the measured

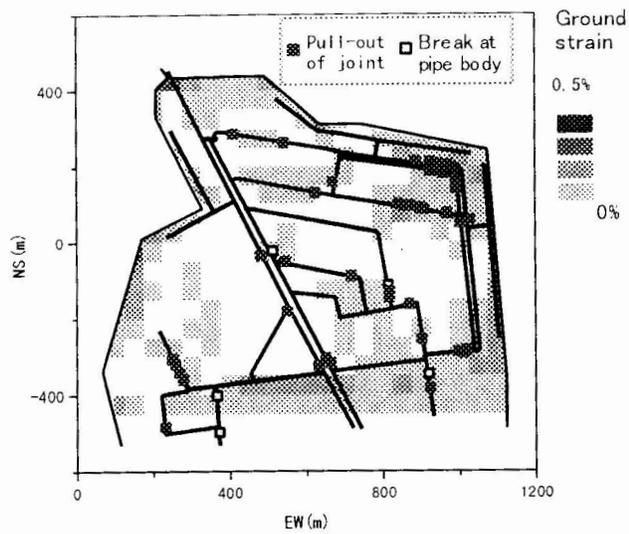
Fig. 10 Distribution of principal ground strain in Fukaehama.

The permanent ground displacement induced by liquefied ground flow were measured from aerial photographs before and after the earthquake in Kobe city by Hamada et al. (1995). Fig. 9 displayed the horizontal permanent ground displacement (Hamada et al. 1995) and damage to water supply pipelines (Japan Water Works Association 1996) plotted on the pipeline network in Fukaeahama. The length of arrows in this figure means the magnitude of permanent ground displacement and they were transformed from the actual measured data to cell data of 50 m x 50 m. Great permanent ground displacement occurred near the coastlines. The quay wall line moved toward the sea with a maximum magnitude of about 4 m, and also largely subsided. The principal ground strains were evaluated by using the permanent ground displacements in each 50m mesh. Fig. 10 shows the principal ground strains and sites of pipe failures. According to this figure, pipe failures were occurred at sites where the large ground strains appeared. The ground strains in Fukaeahama were less than those in Egeyama presented shown in Fig. 4.

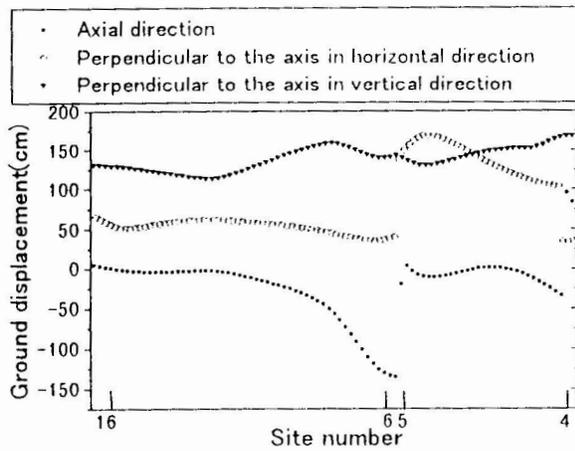
Fig. 12 Ground displacement along pipeline in Fukaehama.

were 100 mm and 200 mm. The response of the pipelines corresponded with point 4 to point 16 shown in Fig. 11 was investigated in this chapter. The length of pipelines was about 680 m. Fig. 12 indicates the distribution of permanent ground displacement along pipelines. The maximum magnitude of displacement was about 2 m in this area, much larger than that in Egeyama area.
