## September 19, 2017 Puebla-Morelos Earthquake in Mexico Reconnaissance Report

The Canadian  
Association  
for Earthquake  
Engineering

## **INTRODUCTION**

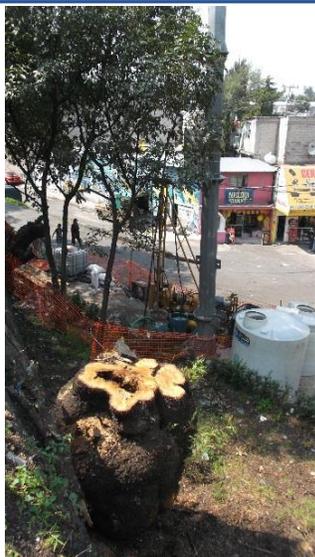
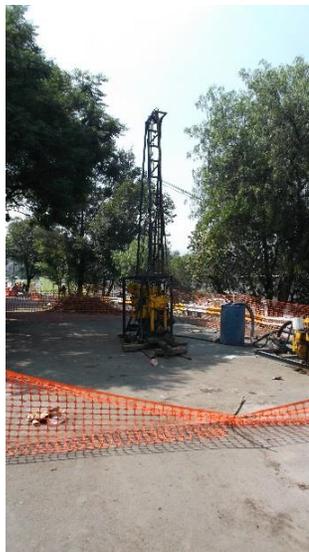
Slope instability was observed at Xochimilco in a residential area located on a hill slope. Anecdotal evidence indicated that the slope had deformed prior to the earthquake probably due to groundwater withdrawal by pumping, and the deformation became more substantial after the quake. Aerial view of the slope instability with marked cracks is shown in Fig. 17 (GEER 2018). The deformed hill slope consists of roads at three levels: the base, 1<sup>st</sup> and 2<sup>nd</sup> level; one drill rig was set at each of the two lower levels as shown in Figs. 18(a) and 18(b). The main crack was along the 1<sup>st</sup> level road, while a shorter crack was on the 2<sup>nd</sup> level road as can be seen in Figs. 19(a) and 20(a). The damaged masonry wall on the 1<sup>st</sup> level road was being repaired at the time of our visit, with new masonry materials transported in and stockpiled on the road, and a short distant end-segment of the deformed wall was shored up by timber struts. Houses on the hill slope above the 2<sup>nd</sup> level road appeared to be in good condition, with minor masonry debris on the road side.

Fig. 18 Drill rig sets on road side - (a) road at hill base, (b) the 1<sup>st</sup>-level road

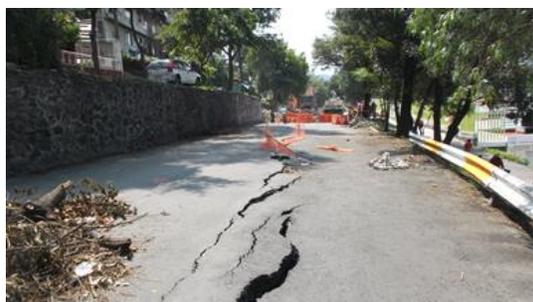
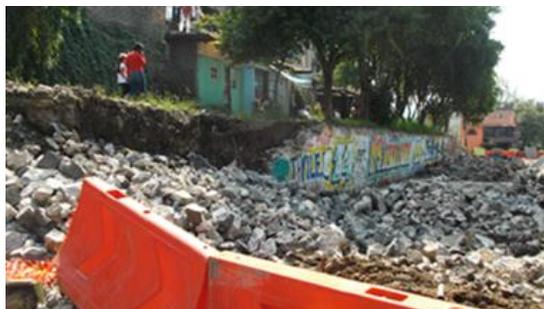
Fig. 19 (a) Longitudinal crack on the 1<sup>st</sup>-level road (b) damaged masonry wall on the 1<sup>st</sup>-level road

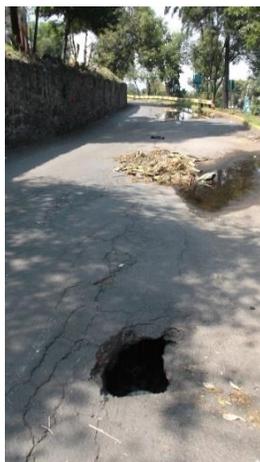
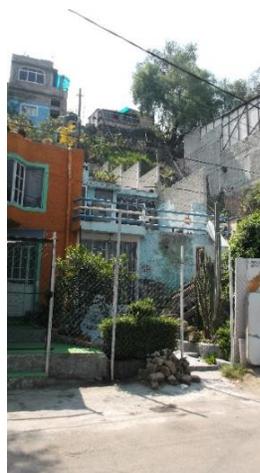
Fig. 20 (a) Road condition on the 2<sup>nd</sup>-level road, (b) condition of houses above the 2<sup>nd</sup>-level road

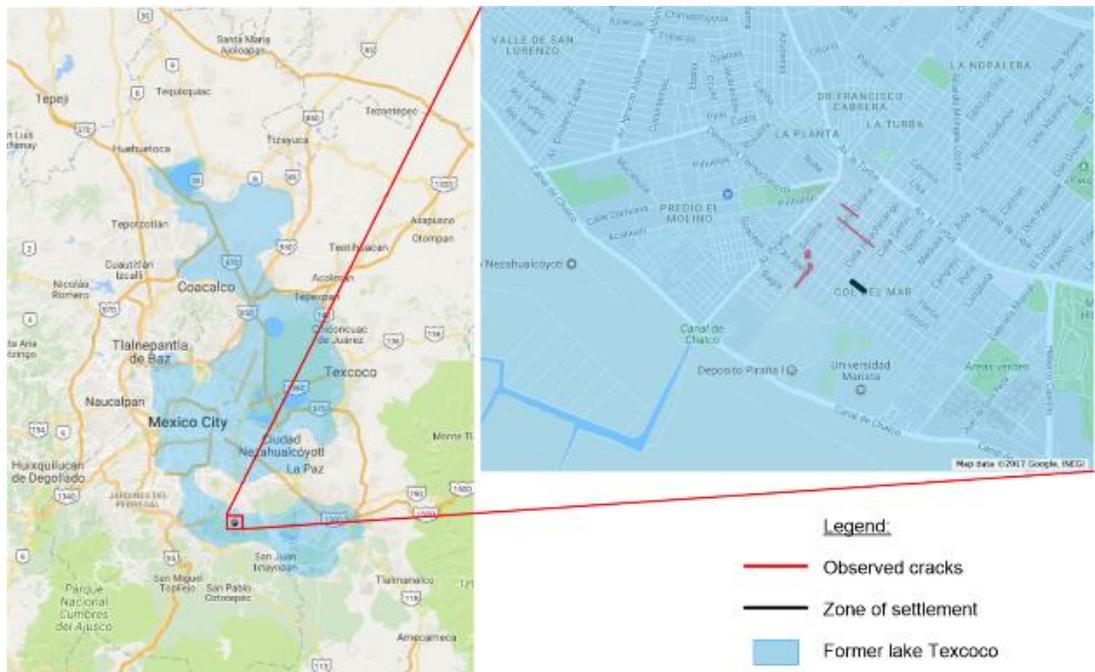
Figure 24 shows a Google Earth map of the area of Colonia Del Mar, Tlahuac within La turba and Canal de Chalco (north-south main roads) and Langosta and Pirana (east-west main roads) the team visited on Oct. 17 (east of Camaron) and Oct. 18 (west of Camaron), where wide-spread ground cracking and settlement occurred. Figure 25 shows the location of the borough of Tlahuac in south Mexico City and some of the team’s observed ground cracks and settlements superimposed on the local street map. Also

Fig. 25 Map of Tlahuac and location of the cracks observed by the CAEE team

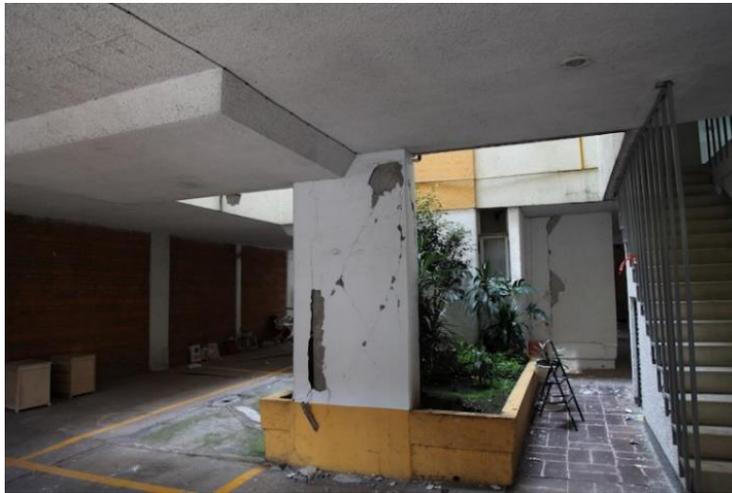
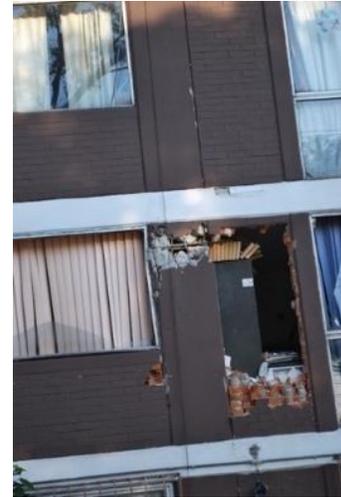
Fig. 41 (a) Shear cracks in a rectangular column of a soft-storey; the use of rectangular columns in the form of narrow shear walls saved the building, while the adjacent building suffered from complete collapse, (d) lack of concrete confinement and column hinging in an apartment building.

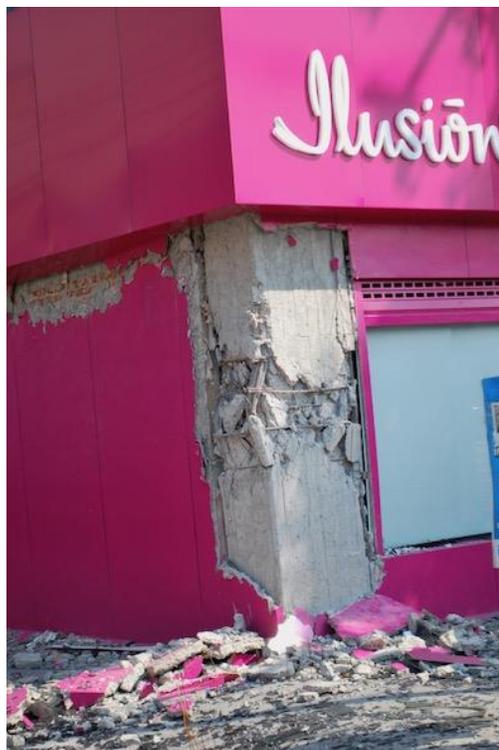
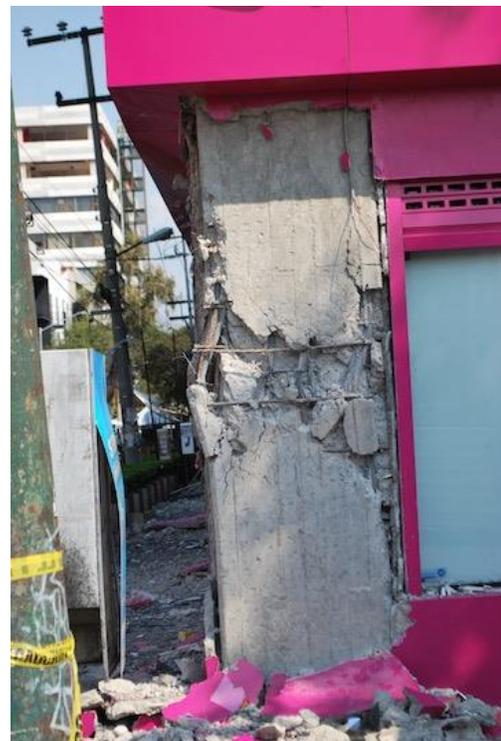
Fig. 42 Insufficient buckling restraining ties in a column and bar buckling

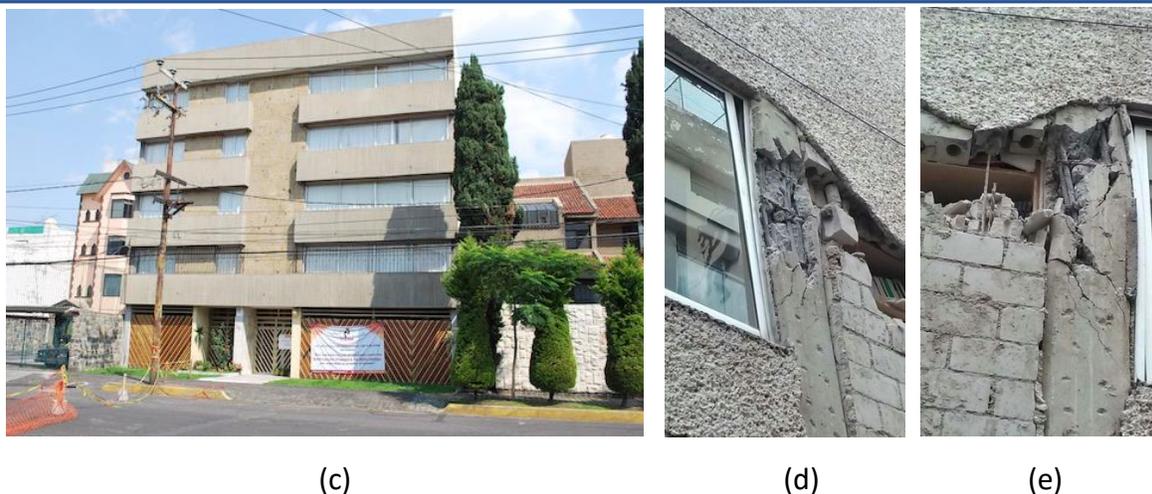
Lack of column transverse reinforcement was evident in older pre-1985 buildings. Figure 39 illustrates diagonal tension failure of one of the first storey columns of a multi-storey reinforced concrete frame building with masonry infill walls located in the Piedad Narvarte district of Mexico City. The figure also illustrates buckling of column longitudinal reinforcement near the previously opened wide diagonal cracks. Similar diagonal tension cracks were observed in other older residential construction. Figures 40(a) and (b) illustrate diagonal cracks in the first storey columns of a frame building with a soft storey. Figure 41(a) illustrates a rectangular column with diagonal shear cracks and Fig. 41(b) shows lack of concrete confinement due to insufficient transverse reinforcement in a residential building, hence resulting in the formation of a plastic hinge at the top. Lack of sufficient transverse column reinforcement could be seen in a number of different buildings as further illustrated in Fig. 42, which shows columns of an office building with insufficient buckling restraining ties and buckling of longitudinal bars in compression. All of these buildings were designed and built prior to the revisions of the seismic detailing requirements after the 1985 Mexico City Earthquake. However, one of the newer 5-storey reinforced concrete residential buildings, designed after 1985, also suffered column damage though the building in general performed well. One of the factors contributing to the column damage in this case was widely spaced column ties, as illustrated in Fig. 43, while the short column effect has also contributed to the increased seismic demand.

Fig. 43 Post-1985 reinforced concrete frame building with masonry infill walls and insufficient column transverse reinforcement

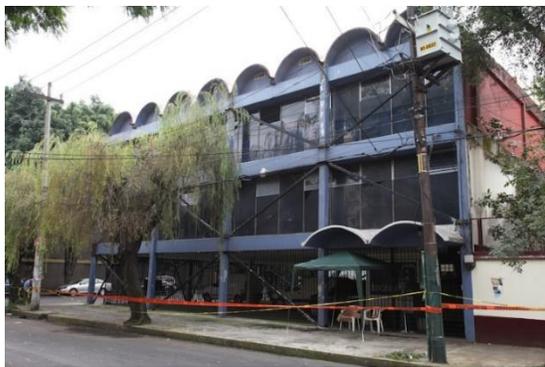
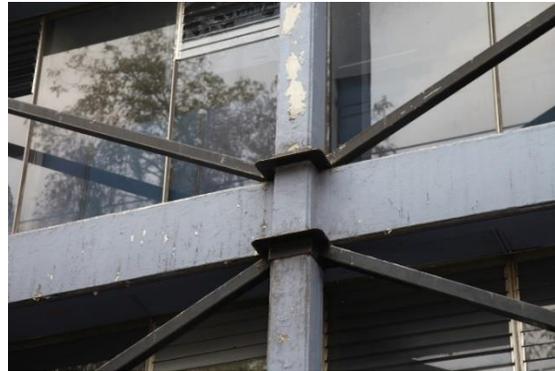
Another seismic retrofit method used in Mexico City was bracing of frame buildings with structural steel. Two of the buildings, one commercial and the other industrial, had been retrofitted with cross bracings prior to the earthquake and survived the ground shakings without any indication of damage. These buildings are shown in Figs. 47 and 48. Steel bracing of another reinforced concrete frame building that was under construction during the visit is illustrated in Fig. 49. It appears that, when seismic force and deformation demands are high, as in the case of soft stories or places of discontinuity, global interference such as the use of lateral bracing is a better choice than the retrofit of individual columns.

Fig. 47 Steel bracing of reinforced concrete commercial building

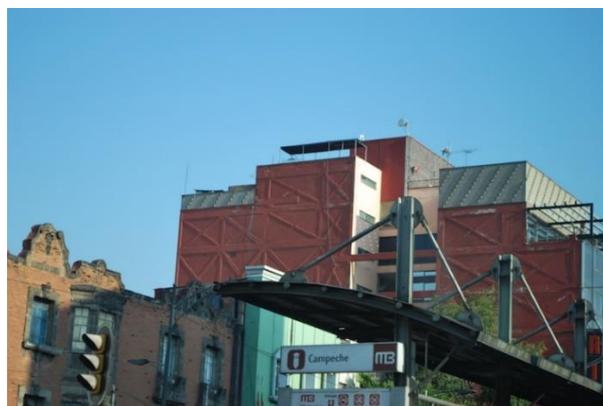
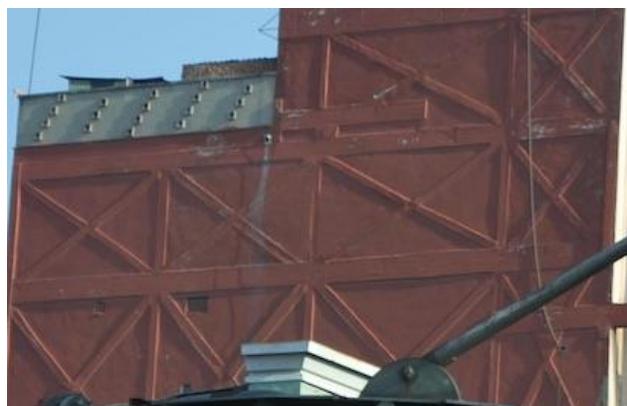
Fig. 48 Cross bracing of an industrial building

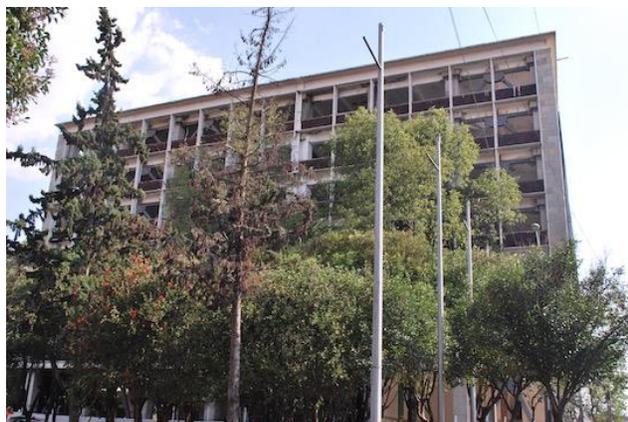
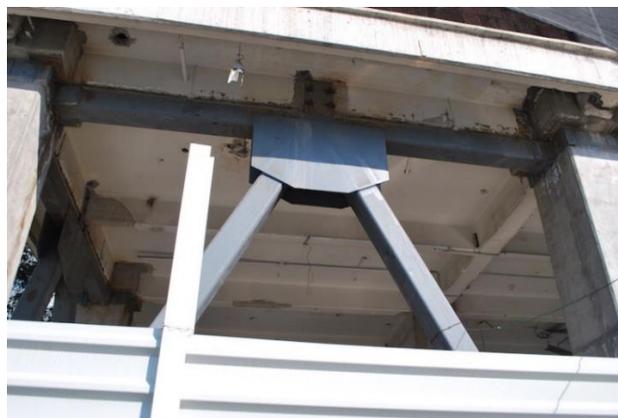
Fig. 49 Reinforced concrete office building being retrofitted after the earthquake with structural steel braces

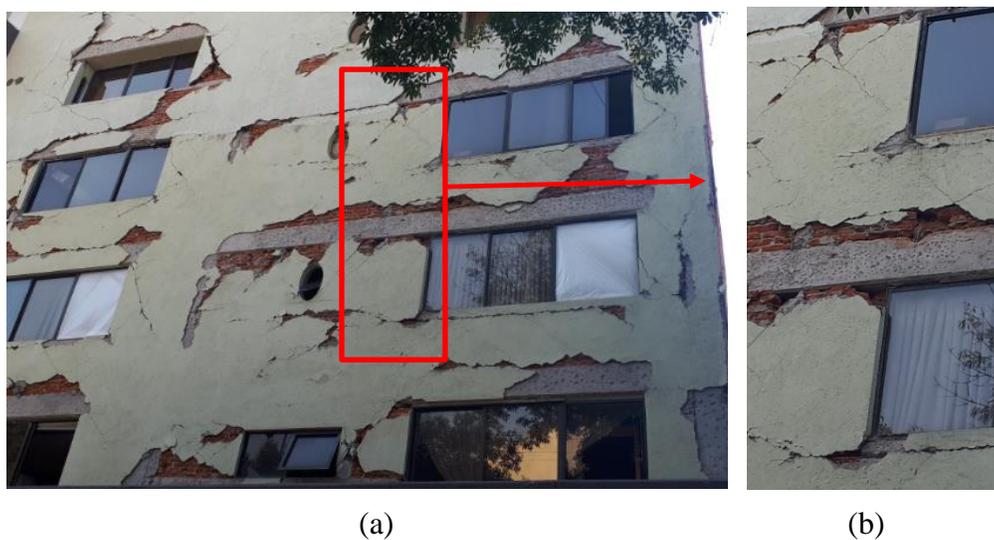
Another example of poorly built confined masonry residential building is shown in Fig. 54. This building also belongs to the pre-1985 building inventory, and did not have tie columns around the openings. The use of longer spans between the tie columns, contrary to the requirement of the masonry code NTC-M, 2004, was also observed.

Fig. 54 Confined masonry building (Condesa, Cuautemoc, Mexico City).

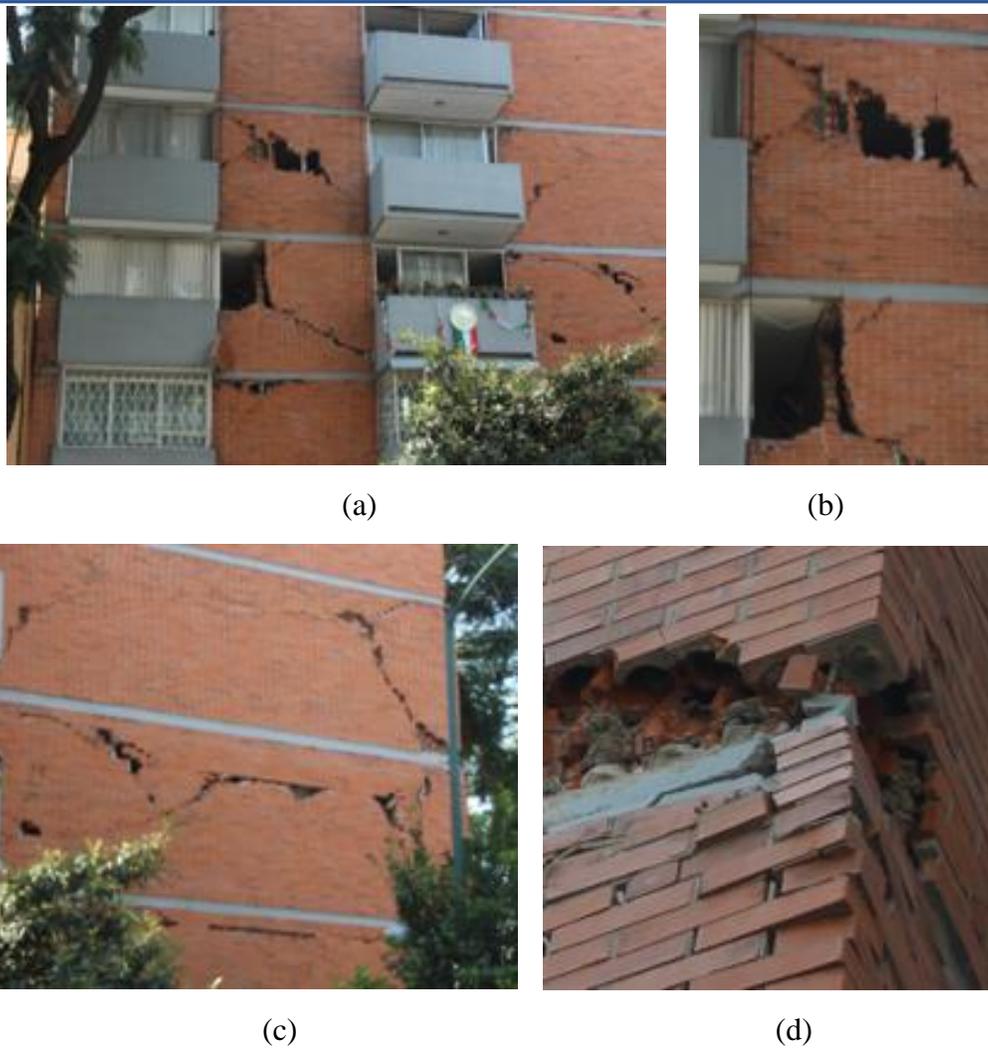
The majority of load bearing masonry buildings consisted of unreinforced masonry (URM) construction. Very few partially reinforced and partially grouted masonry buildings were used in Mexico. Figure 57 illustrates a partially reinforced and partially grouted masonry building in Cuauhtemoc, Mexico City. The figure shows typical damage observed in the form of wide diagonal and horizontal cracks. Figures 57(b) and (d) show lack of tie-columns over a large span (approximately 8.0 m). Furthermore, the code for masonry (NTC-M, 2004) specifies that at least two consecutive reinforced cells should be used in wall intersections and at wall ends in addition to those required by structural analysis. This requirement was not complied with in this building. Also, no horizontal reinforcement was observed in the infill walls, contrary to the code recommendation of placing horizontal reinforcement at least every 6 courses or every 600 mm, whichever is less.

Fig. 57 Partially reinforced and partially grouted masonry building (Cuauhtemoc, Mexico City)

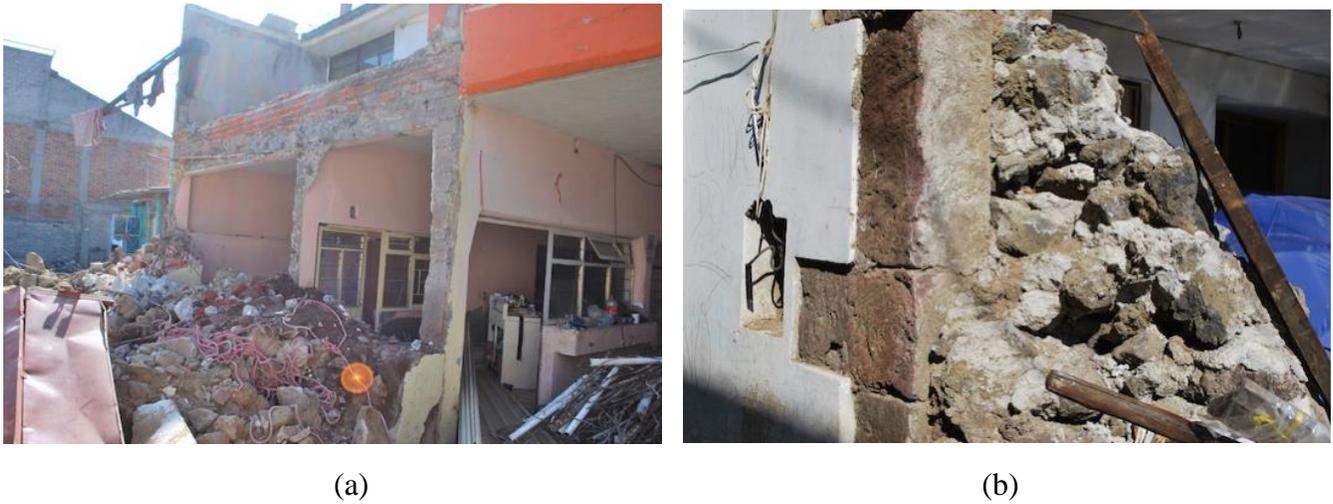
Traditional non-engineered masonry and adobe construction is very common in rural area of Mexico. Simple form of confined masonry, built by local tradesmen or homeowners, without adhering to any code or standard resulted in massive destruction of buildings. Figure 60 illustrates examples of such destruction in the state of Morelos. The figure also demonstrates the type of construction practices employed, mostly consisting of brick load masonry walls, with or without small size concrete tie columns of low quality concrete, and sometimes locally found stones replacing bricks. These buildings are often limited to two stories, with wood roofs sometimes carrying heavy roofing tiles.

Fig. 60 Collapse of non-engineered buildings in the State of Morelos

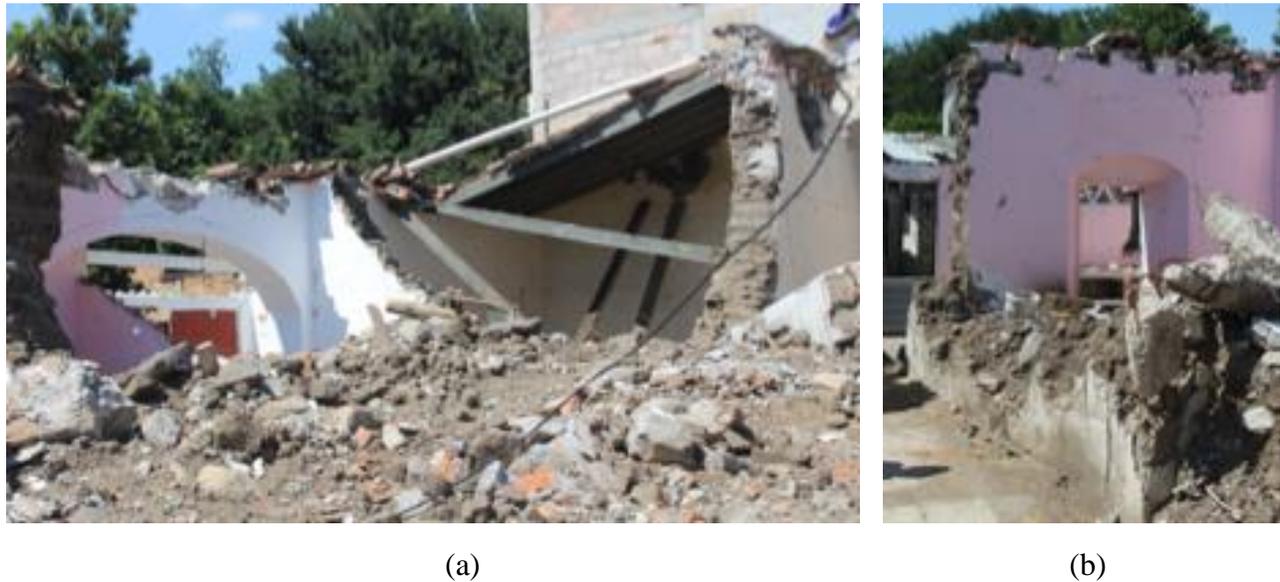
Adobe houses are built using thick, handmade units. This type of construction is extremely brittle and often suffers from complete collapse when subjected to strong ground excitations. Figures 61 shows examples of destruction of adobe houses in the state of Morelos. Figures 61 and 62 show similar destruction in rural Xochimilco, just south of Mexico City. Adobe houses are built with lighter wood roof. However, sometimes owners interfere with the construction and make alterations that have structural implications. The original wood roof of the adobe house shown in Figs. 62(c) and (d) was replaced by a thick concrete roof, which attracted high seismic forces, resulting in the total destruction of the house.

Fig. 61 Adobe construction in the State of Morelos

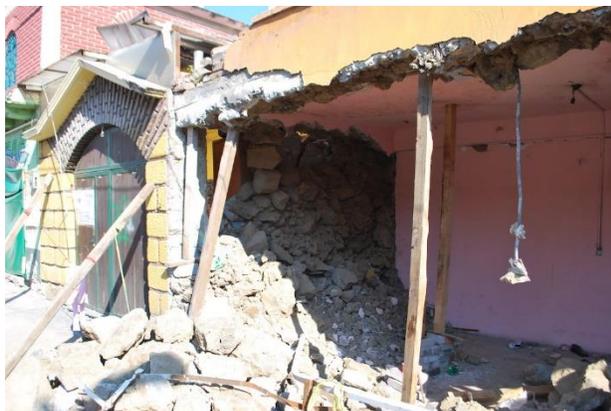
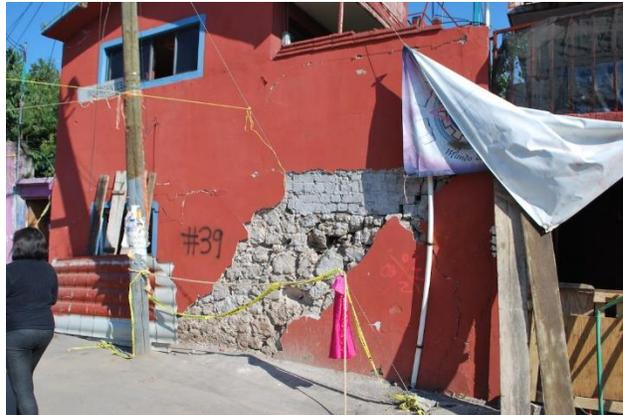
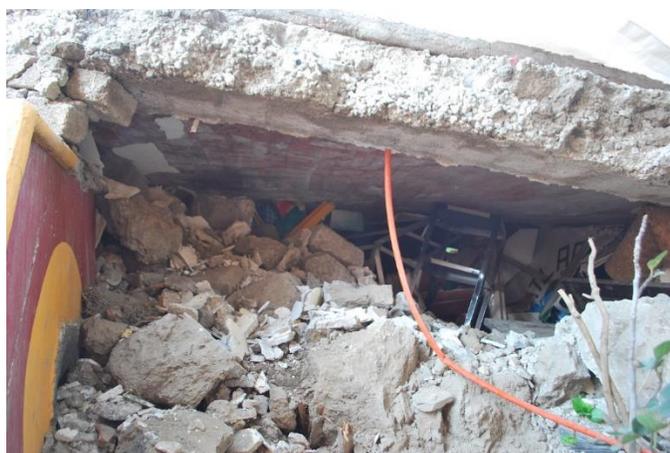
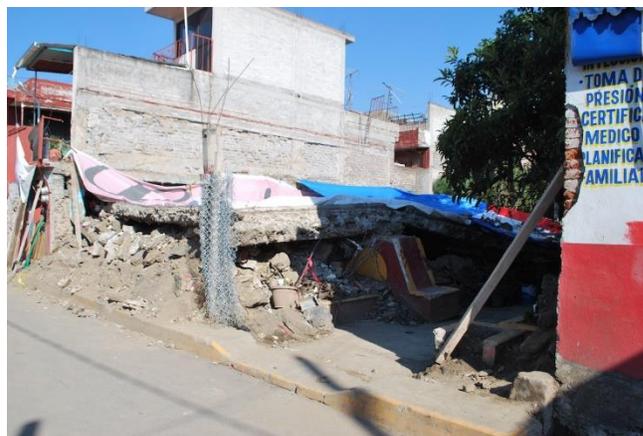
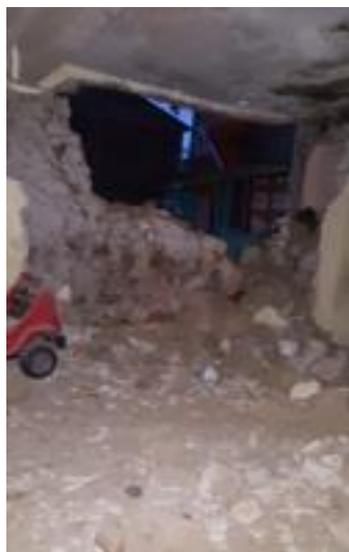
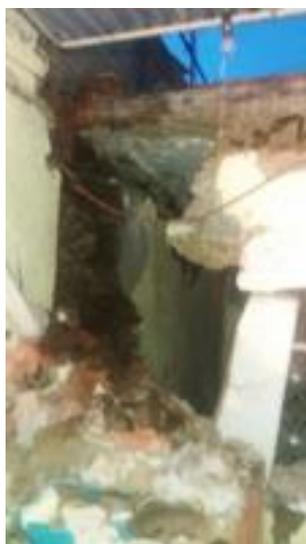
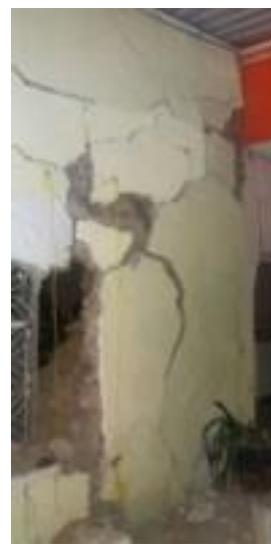
Fig. 62 Failures of adobe buildings in Xochimilco, Mexico City

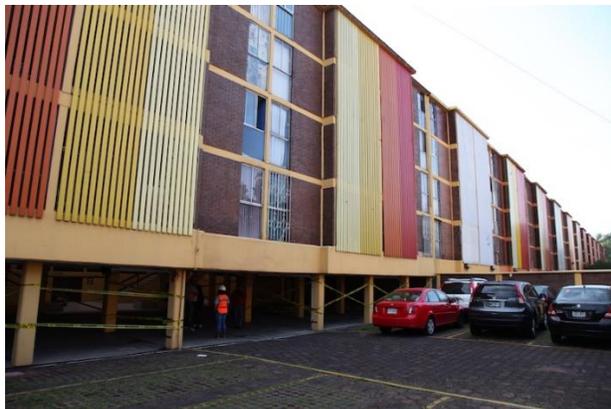
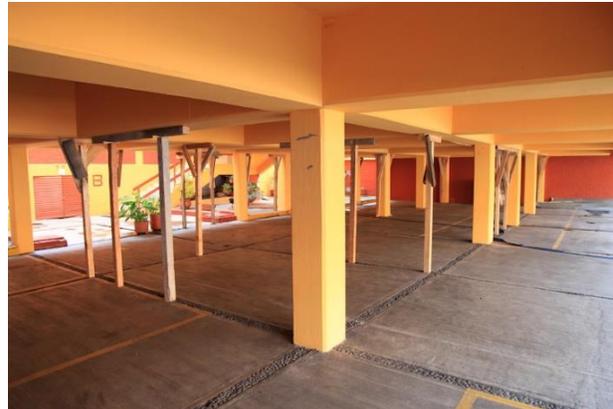
Figure 63 shows a reinforced concrete frame with a soft storey and masonry infill walls above the first floor. The columns of the building suffered shear damage and developed extensive diagonal tension cracking as illustrated earlier in Figs. 63(a) and (b). Another example of a soft-storey reinforced concrete building damage is illustrated in Fig. 64 where two residential buildings were located side by side, one with reasonably sized rectangular columns that survived the earthquake with diagonal tension cracking in the columns, but the nearby building collapsed, losing the first storey parking area. Other examples of soft storey performance, often resulting in the failure of reinforced concrete columns with insufficient strength and deformability leading to the collapse of the entire first-floor, are illustrated in Figs. 65 and 66.

Fig. 63 Reinforced concrete frame building with a soft storey in Mexico City.

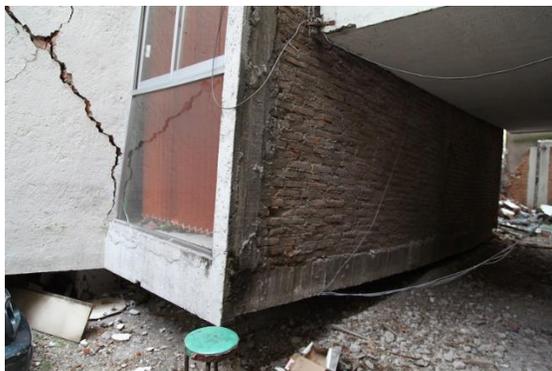
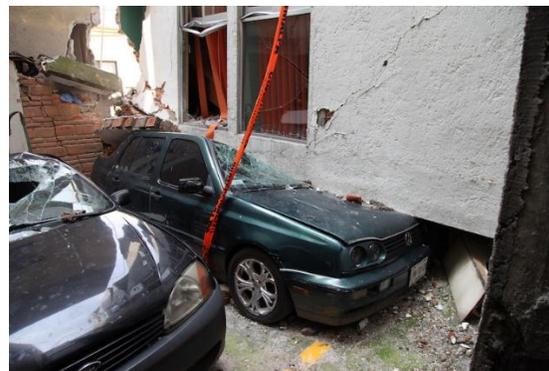
Fig. 64 Failure of a soft storey in a reinforced concrete frame residential building.

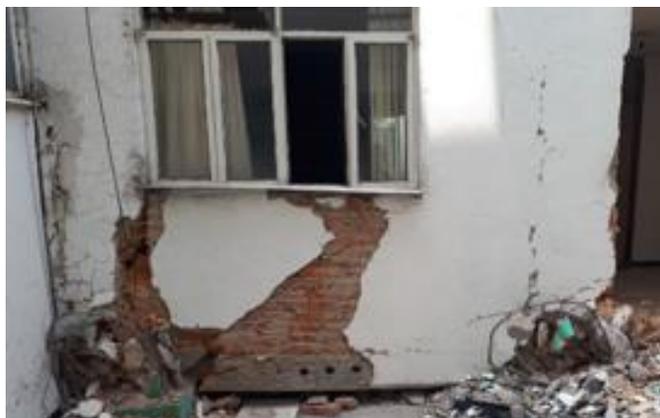
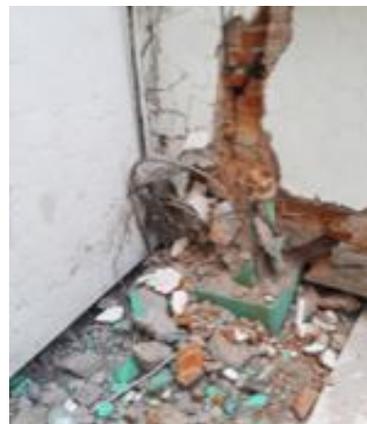
Fig. 65 (a) Collapse of a soft storey over reinforced concrete columns, (b) crushing of a first-storey column

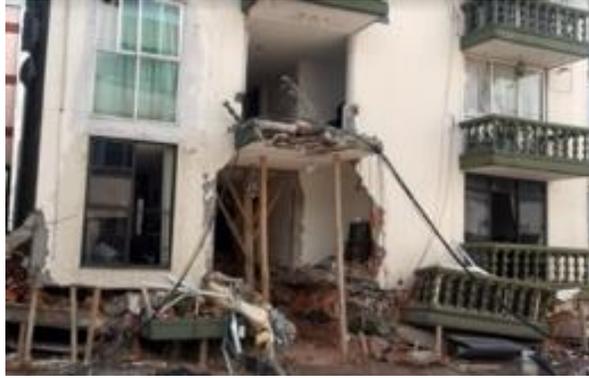
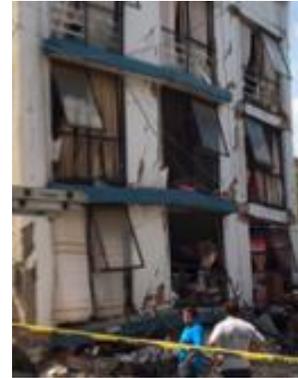
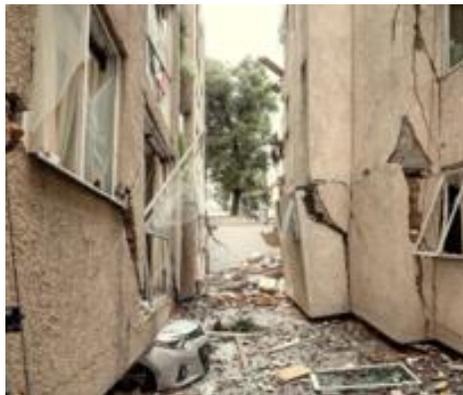
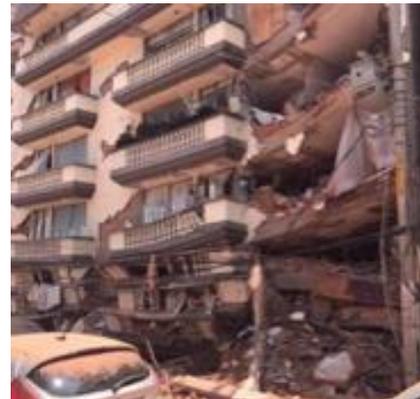
Fig. 66 Soft storey failures (a) Balsas St, Benito Juarez, Mexico City, (b) Saratoga St, Benito Juarez, Mexico City, (c) Tokio St, Benito Juarez, Mexico City, (d) Coquimbo St, Gustavo A. Madero, Mexico City

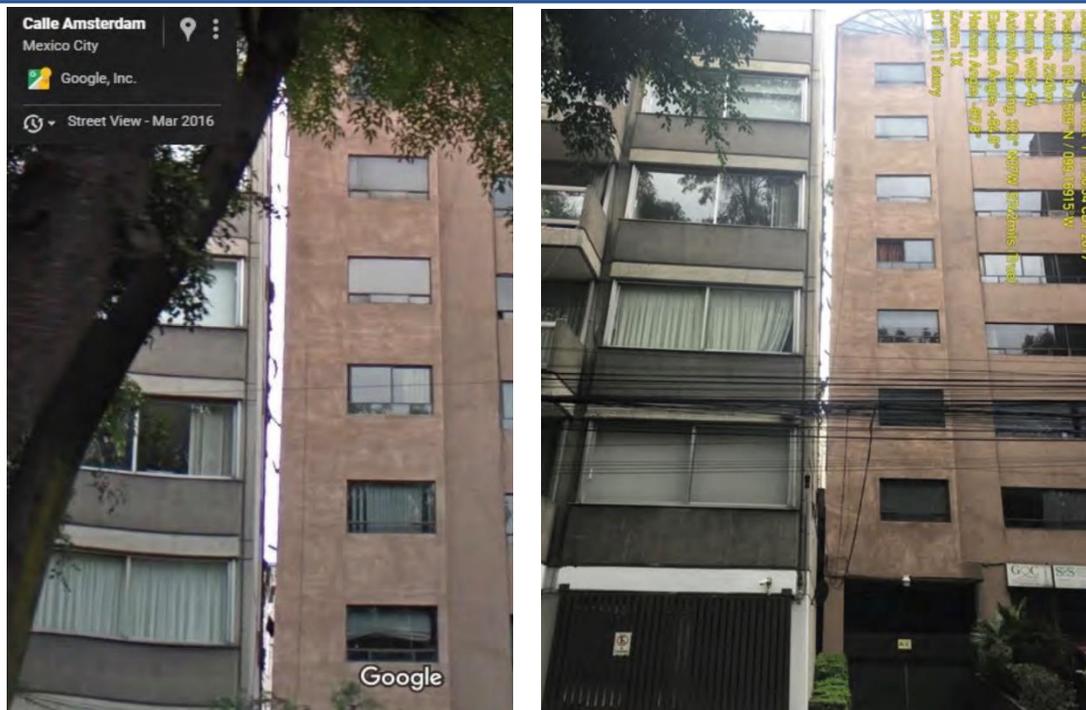
The presence of lacustrine deposits in the Valley of Mexico basin resulted in foundation related structural problems. These include ground subsidence and settlement prior to the earthquake. A number of apartment buildings in the Cuauhtemoc Borough of Mexico City was observed to have pre-existing settlement and tilting of multistorey residential buildings. The reconnaissance team had difficulty judging whether the observed settlement and/or tilting of multi-storey buildings could be attributed to the earthquake or it existed prior to the seismic event. UNAM report (2017) provides a comprehensive background of this unique issue of soil subsidence and its effects on buildings over the years, covering its development over a period of six decades between 1959 and 2016. Figure 71 illustrates the uneven separation of two multistorey buildings in La Condesa, Mexico City. The building on the left was estimated to have rotated about 1 degree prior to the earthquake (GEER Report 2017).

Fig. 71 11-Storey La Condesa building (on the left) that had tilted and rotated about 1 degree prior to the earthquake, (a) Google Street View photo of 2016, (b) building after the earthquake

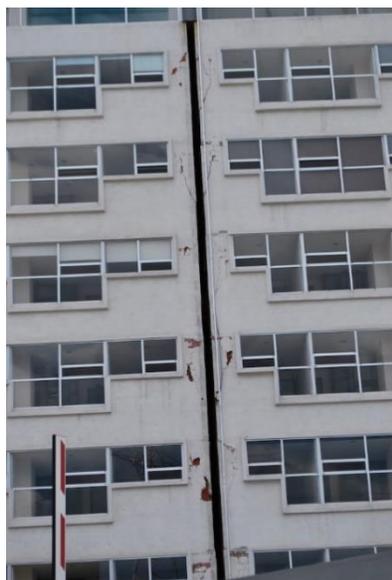
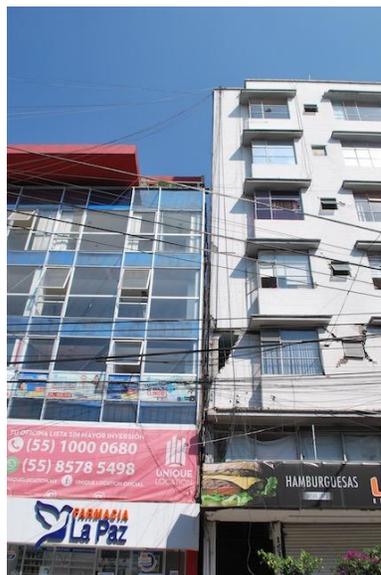
According to the Mexican seismic guidelines (NTC-DS, 2004), the space between buildings should be greater than 50 mm plus the minimum lateral drift ratio defined for each zone. The minimum lateral drift ratios are defined as 0.1%, 0.3% and 0.5% of the building height for seismic Zones I, II and III, respectively. The minimum separation is to be calculated for each building on either side of the separation relative to the land boundary. This implies that the separation between two 8-storey buildings should be more than approximately 250 mm in Zone III. The observed buildings by the reconnaissance team did not have this level of separation and violated the current building code. Figure 72 shows typical building separation observed.

Fig. 72 Typical separation between buildings, less than that recommended by the Mexico City Seismic Code, (a) post 1985 building in Puebla, (b) pre-1985 buildings in Mexico City.

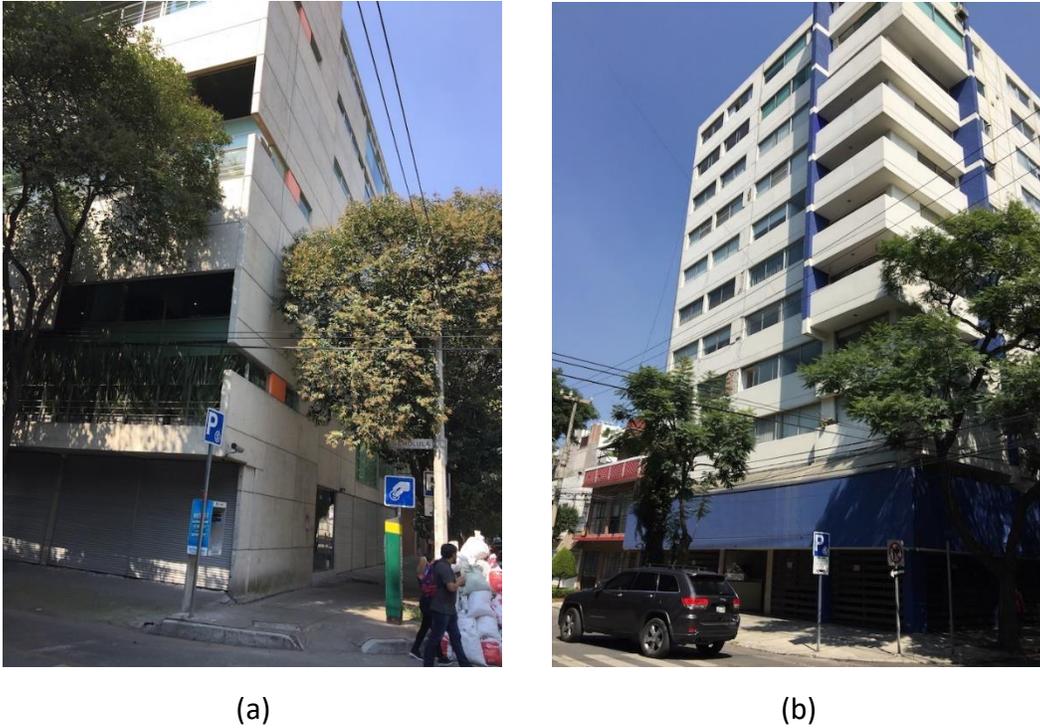
The building design practices in Mexico City improved significantly after the 1985 Mexico City Earthquake as indicated earlier. The most recent edition of the seismic code is dated 2008 and reflects the improvements introduced after the 1985 event. Revised and improved edition of the code was expected to be printed in 2018. Buildings designed after the 1985 improvements performed well, except for some minor damage, essentially resulting from lack of proper implementation of seismic detailing practices. In newer buildings, the majority of damage was limited to damage to masonry infill walls, which often developed diagonal shear cracking. However, the lateral load resisting systems performed well in the post-1985 engineered buildings. Figure 76 illustrates two buildings in the Esquina Parque district, where older buildings suffered damage. These building performed well, with damage limited to the cracking of non-structural infill walls.

Fig. 76 Post-1985 buildings in Mexico City, showing superior performance

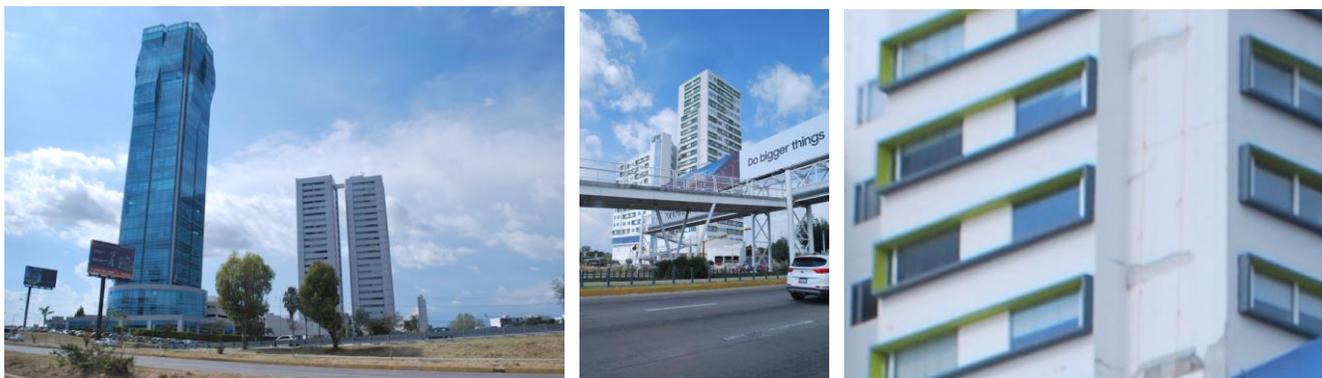
In the city of Puebla, in spite of the widespread damage observed in older reinforced concrete, confined masonry and more conventional masonry/adobe buildings, newly designed buildings after 2000 survived the earthquake with little damage, mostly to non-structural elements and exterior cladding. Figure 77 shows modern high-rise buildings at the north entrance to the city with no apparent structural damage. It is noteworthy that these buildings were taller than the older buildings, thus having longer periods.

Fig. 77 Modern construction of post-2000 era in Puebla, (a) high-rise building with curtain wall cladding, (b) Holiday Inn buildings, reinforced concrete with masonry infill walls, (c) damage to the exterior cladding of the Holiday Inn building.

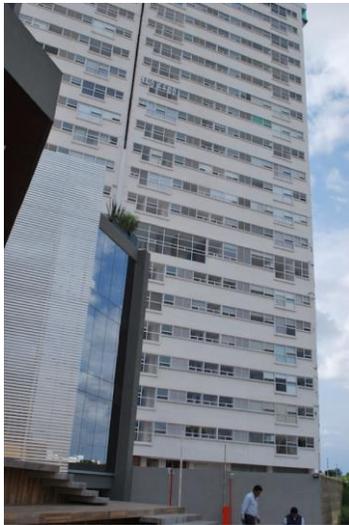
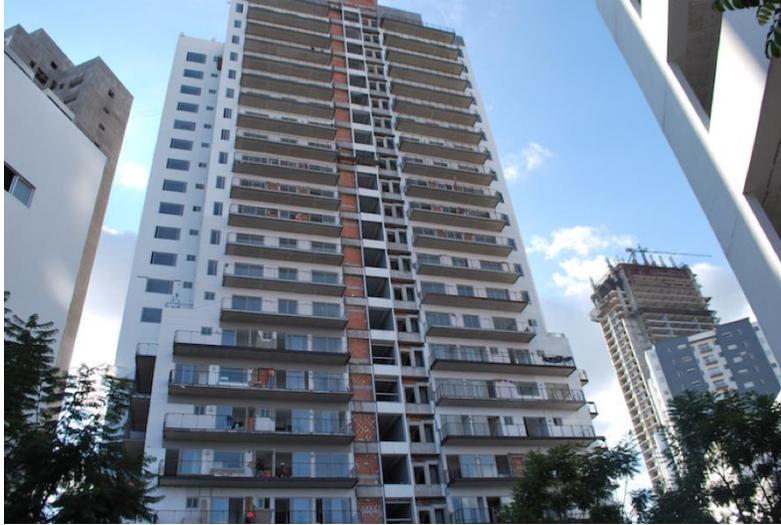
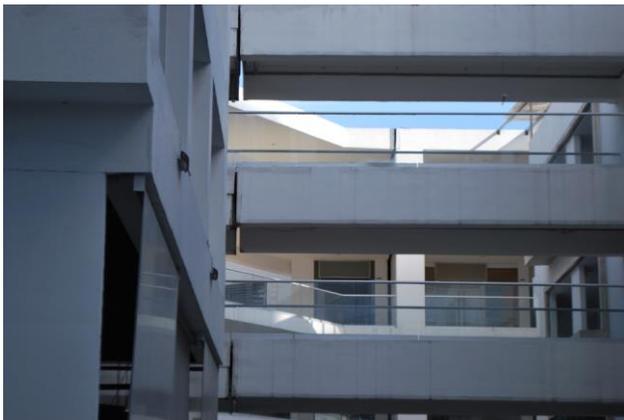
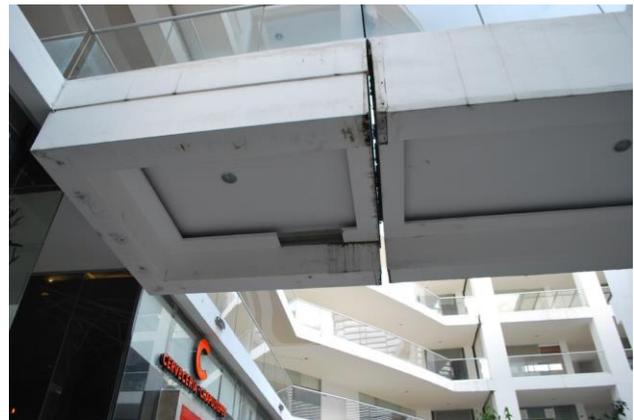
Additional new buildings were inspected in the city of Puebla, mostly reinforced concrete, having lateral load resisting systems consisting of either shear walls or frames with infill walls. Figure 78 shows buildings with damage limited to masonry cracking, which was being repaired during the visit.

Fig. 78 Post 2000 buildings in Puebla, (a) and (b) residential multistory buildings, (c) and (d) separation of the bridge connecting parking structure to the nearby shopping centre.

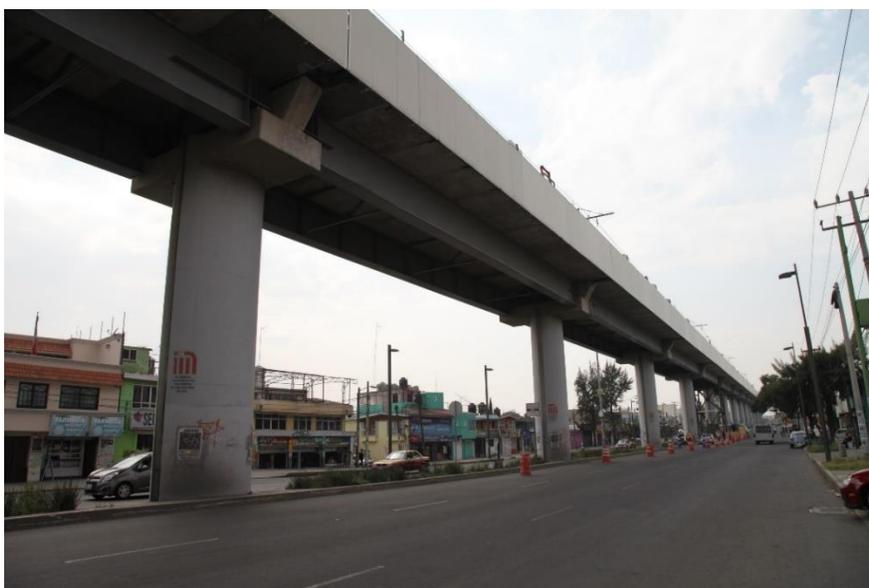
Fig. 79 Mexico Metro Line viaduct

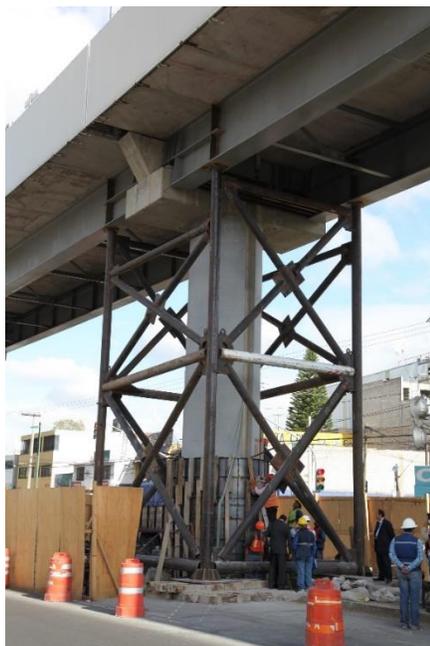
Fig. 83 (a) Emergency support of damaged column (b) Repair of damaged column by jacketing

After the earthquake, an emergency frame was erected around the damaged column to provide shoring support to the steel girders of the two adjacent viaduct spans, as illustrated in Fig. 83(a). The repair measure was concrete jacketing with steel forms, as shown in Fig. 83(b). The repaired column is also shown in Fig. 80(b). According to the Metro engineering personnel at the site, the column foundation was also repaired with new concrete, which can also be seen in Fig. 83(b). No further details could be obtained by the reconnaissance team.

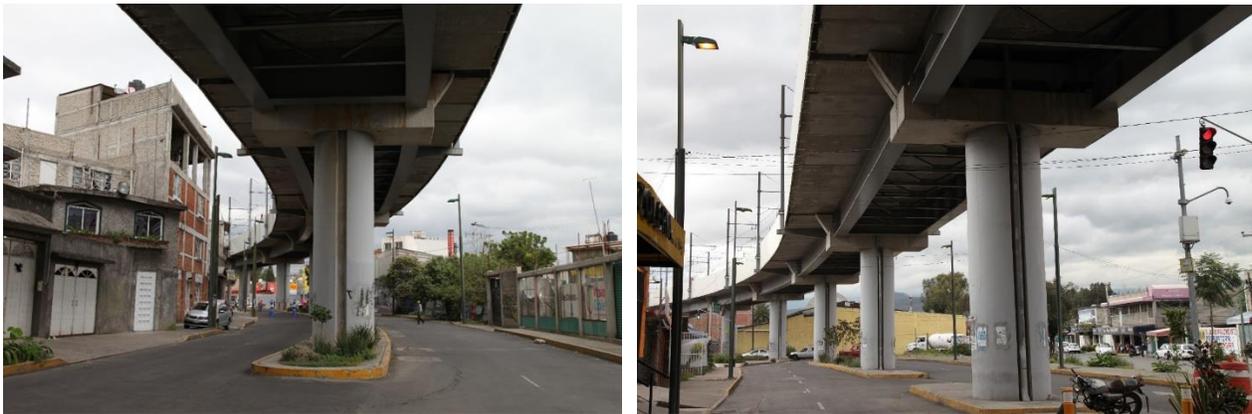
At a distance 1.2 km south-east of Site 1, at the intersection of Av. Tlahuac and Av. Guillermo Prieto, the Metro Line 12 viaduct has the alignment layout of an S-shaped double curve, as shown in Fig. 84. At this location, damage was observed at the shear keys of a span with three steel girders. This was attributed to excessive movement of the girders in the longitudinal direction, resulting in complete spalling of the concrete restraint at the shear keys. This is illustrated in Fig. 85. Significant rocking of the column piers, possibly exacerbated by torsional response of the curved viaduct, was observed. Figure 86 shows cracks on the roadway next to a column pier at this location as evidence of the significant rocking response of the column pier during the earthquake. Torsional response of the curved viaduct could have further exacerbated the rocking of the piers. Figure 87 shows significant shift of the girders along the longitudinal direction of the viaduct. It was fortunate that the cap beam provided sufficient seat support length for the girders and prevented the collapse of the entire span of the viaduct. Figures 88 and 89 show significant shear deformation of bridge elastomeric bearings supporting the steel girders of the viaduct.

Fig. 84 Double curved Metro Line viaduct, (a) towards NW direction, (b) towards SE direction

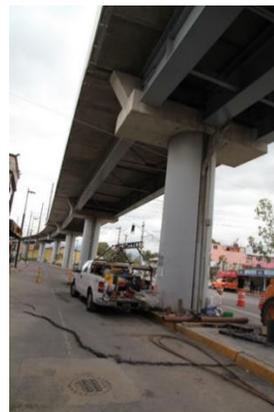
Fig. 86 Cracks on roadway due to rocking of viaduct pier

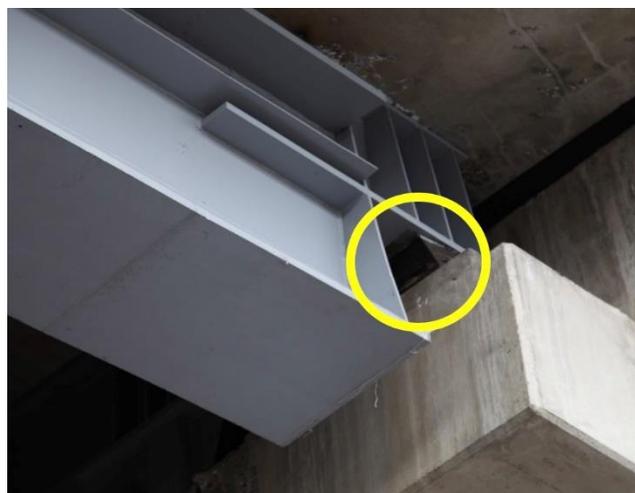
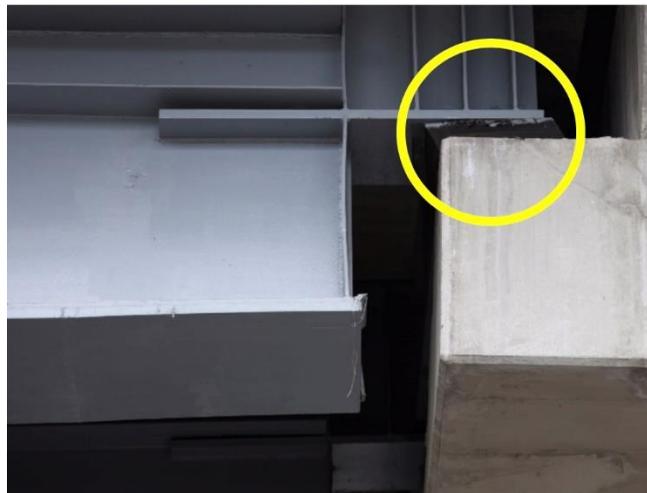
Fig. 88 Shear deformation of girder bearings

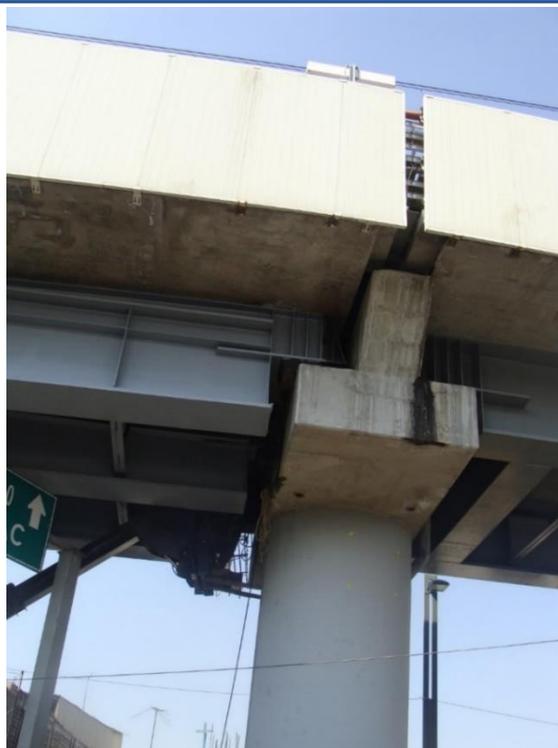
Fig. 89 Longitudinal displacement at deck level and lateral displacement

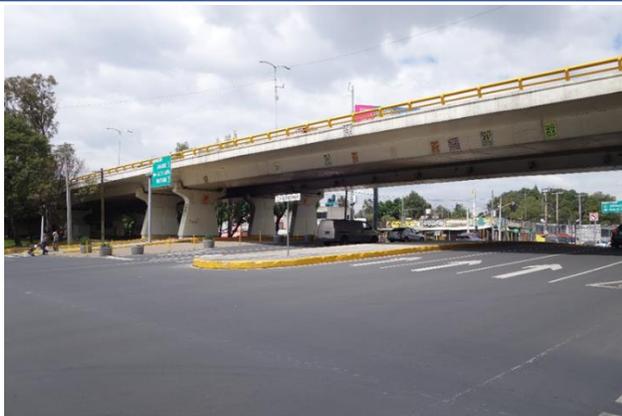
Fig. 90 Parallel 5-span underpasses

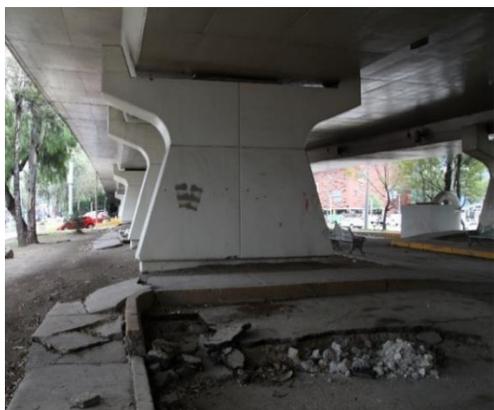
Fig. 92 (a) Rocking of wall pier, (b) crack and settlement of surrounding ground adjacent to wall pier
