## September 19, 2017 Puebla-Morelos Earthquake in Mexico Reconnaissance Report

The Canadian  
Association  
for Earthquake  
Engineering

## **INTRODUCTION**

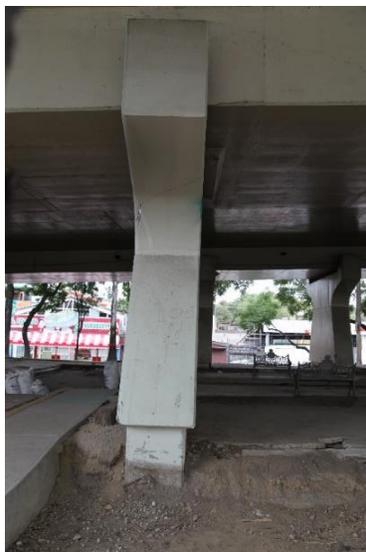
The third bridge damage site visited by the reconnaissance team was a highway bridge located at Circuito Interior Avenida Rio Churubuscophotos in Mexico City. The bridge structure is shown in Fig. 90. It consists of two parallel underpass bridges. The 5-span bridge has wall piers and unreinforced masonry (URM) abutments. The URM abutments were damaged during the earthquake as shown in Fig. 91. Some reinforcement was observed at the exposed upper part of the abutment; but the lower main part of the masonry abutment was unreinforced. Figure 92 shows cracks and settlement in the surrounding ground due to significant rocking of the wall piers. Permanent tilting of some of the wall piers was clearly evident after the earthquake. This is shown in Fig. 93.

Fig. 93 Tilting of wall pier after earthquake

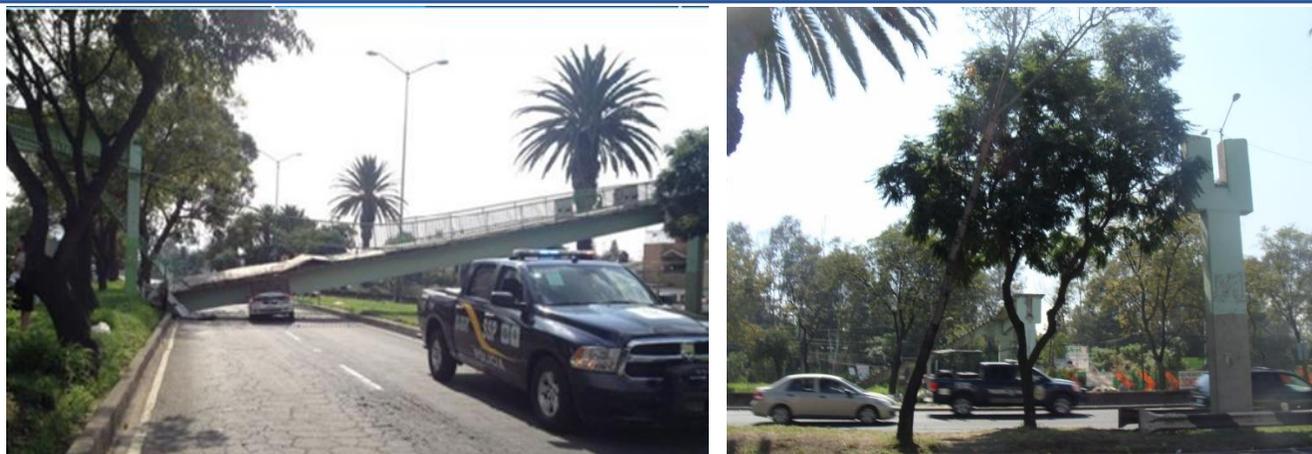
When pedestrian overpasses are damaged, they can be closed to traffic with little impact on the transportation system. Similarly, if they collapse over a major route they are relatively easy to be removed, generally having high priority. This creates challenges for reconnaissance team members to identify the cause of the collapse if the visit is conducted afterwards. The fourth bridge, Periferico Pedestrian overpass near the intersection with Muyuguarda Street is an example. This overpass crossed a 4-lane divided highway, Periferico Ave (Adolfo Ruiz Cortines Blvd), with frontage roads. While the piers fared well, the south span of the superstructure appears to have displaced off the centre pier in the boulevard as illustrated in Fig. 94. In doing so, it collapsed on a taxi whose driver was fortunately able to escape through a window. No information on other injuries has been noted. The remaining spans were removed, as well as the collapsed portion of the bridge, prior to reconstruction.

Fig. 94 Collapsed Pedestrian Overpass on Periferico Blvd
