**Reconnaissance Report on
The December 26, 2004 Sumatra Earthquake
and Tsunami**

June 2005

Murat Saatcioglu¹, Ahmed Ghobarah² and Ioan Nistor³

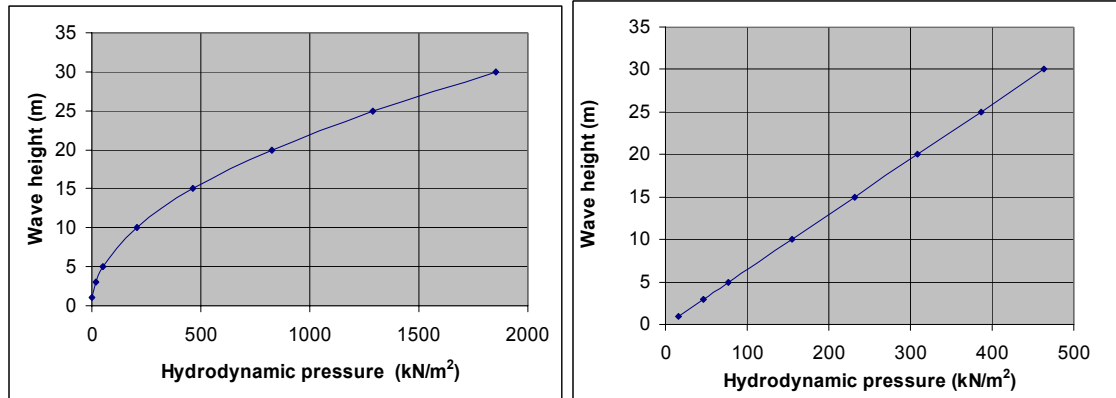
Equation 1 gives an empirical expression for the estimation of impulsive water pressure of breaking waves, developed by Goda (1995). Accordingly, wave impulse pressure is a function of specific gravity of water, water celerity, wave height and impact duration. The variation of wave pressure obtained from Eq. 1 is plotted in Fig. 13(a) as a function of water height.

A simpler expression that is more applicable to the mechanism of tsunami wave impact was suggested by Hiroi (1919) for the estimation of uniform dynamic pressure as a function of sea-water specific gravity and wave height. The expression is given in Eq. 2. The variation of uniform lateral pressure, as computed from Eq. 2 is plotted in Fig. 13(b).

(a) Wave pressure as per Eq. 1 (Goda 1995) (b) Wave pressure as per Eq. 2 (Hiroi 1919)

Fig. 13 Estimates of breaking wave impact pressure on a structure at the coast

The hydrodynamic wave pressure was compared with wind design pressures at the coastal city of Vancouver, Canada and was found to be up to approximately 26 times higher, explaining the widespread damage to masonry walls observed within the first stories of most buildings. Design lateral forces due to wind and seismic effects were compared with estimates of lateral forces due to a tsunami of similar characteristics as the December 26, 2004 event. A sample 6-story, 3-bay reinforced concrete frame structure, located in Vancouver, Canada was used for this purpose. It was found that the total base shear due to tsunami was about twice the base shear caused by wind and 60% of that caused by elastic seismic forces. While this comparison is presented to provide a feel for the magnitude of tsunami forces on buildings, it is important to recognize that the same comparison could give different results for buildings with different heights and different characteristics, especially for different tsunami water heights.

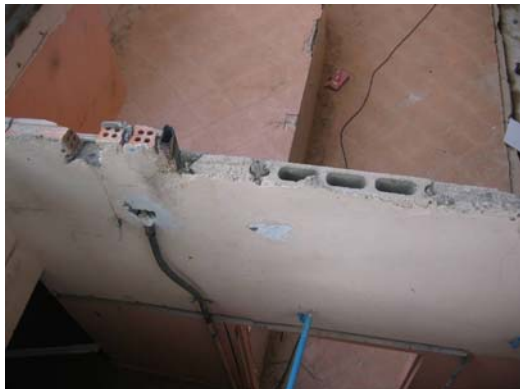
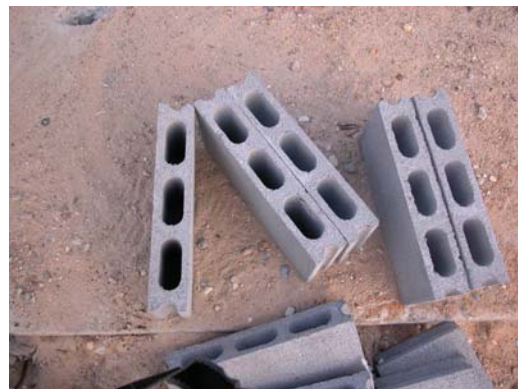
The majority of buildings in Thailand and Indonesia had frames infilled with unreinforced masonry walls. The masonry units used were consistently of the same type, with 50 mm thickness. Both hollow clay bricks and concrete masonry blocks of the same thickness were used, as illustrated in Fig. 15. These walls suffered punching shear failures due to the tsunami wave pressure, applied perpendicular to the wall plane. These resulted in large holes in walls, sometimes removing the masonry almost entirely. The remaining walls around the frames did not show any sign of diagonal tension cracks, contrary to expectations, unless the failure was caused by seismic excitations, which was limited to Banda Aceh only. Figure 16 shows the type of punching failures observed in masonry infill walls.

Fig. 15 Clay brick and concrete masonry block units with 50 mm thickness
