The August 17, 1999, Kocaeli (Turkey) earthquake — damage to structures

Murat Saatcioglu, Denis Mitchell, René Tinawi, N. John Gardner, Anthony G. Gillies, Ahmed Ghojarah, Donald L. Anderson, and David Lau

Abstract: The 1975 Turkish code provisions are first reviewed to provide the background for design and detailing of structures prior to the earthquake. The performance of reinforced concrete and masonry structures is described indicating many of the deficiencies in design, detailing, and construction execution. The behaviour of precast concrete structures, steel structures, and industrial facilities is also presented. The provisions of the 1997 Turkish building code are summarized and a description of new construction provides evidence of both excellent and poor construction practice. Some examples of retrofitting of damaged structures soon after the earthquake are also presented.

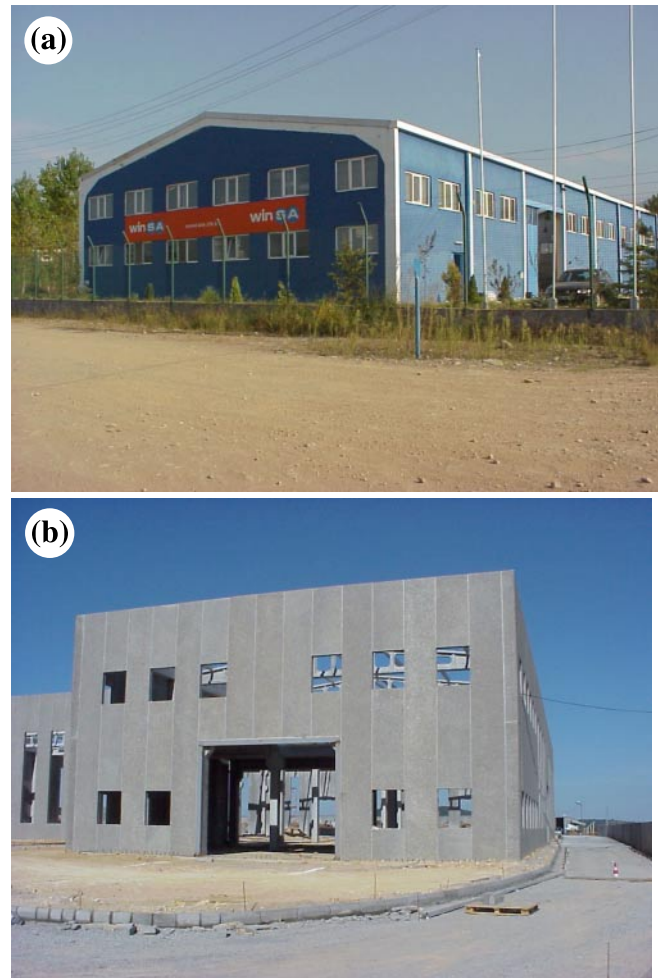
Although there were many examples of precast buildings with poor design, detailing, and construction, there were also large numbers of precast industrial buildings in the epicentral area that performed extremely well, as shown in Figs. 20a and 20b.

Fig. 20. Examples of precast structures that performed well.

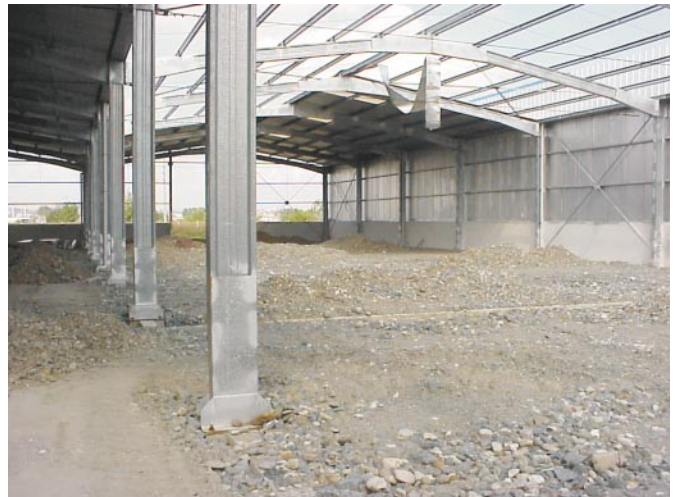
Apart from the special facilities such as oil refineries, there were very few steel industrial structures. Figure 21 shows a one-storey steel structure in an industrial park in the epicentral region. The I-shaped beams and columns were formed with galvanized light-gauge, cold-formed steel. The steel structure had tension-only bracing in the roof and tension-only bracing every fourth bay along the side walls. This structure with its partially completed roof diaphragm did not suffer any damage.

Fig. 21. Cold-formed steel structure.

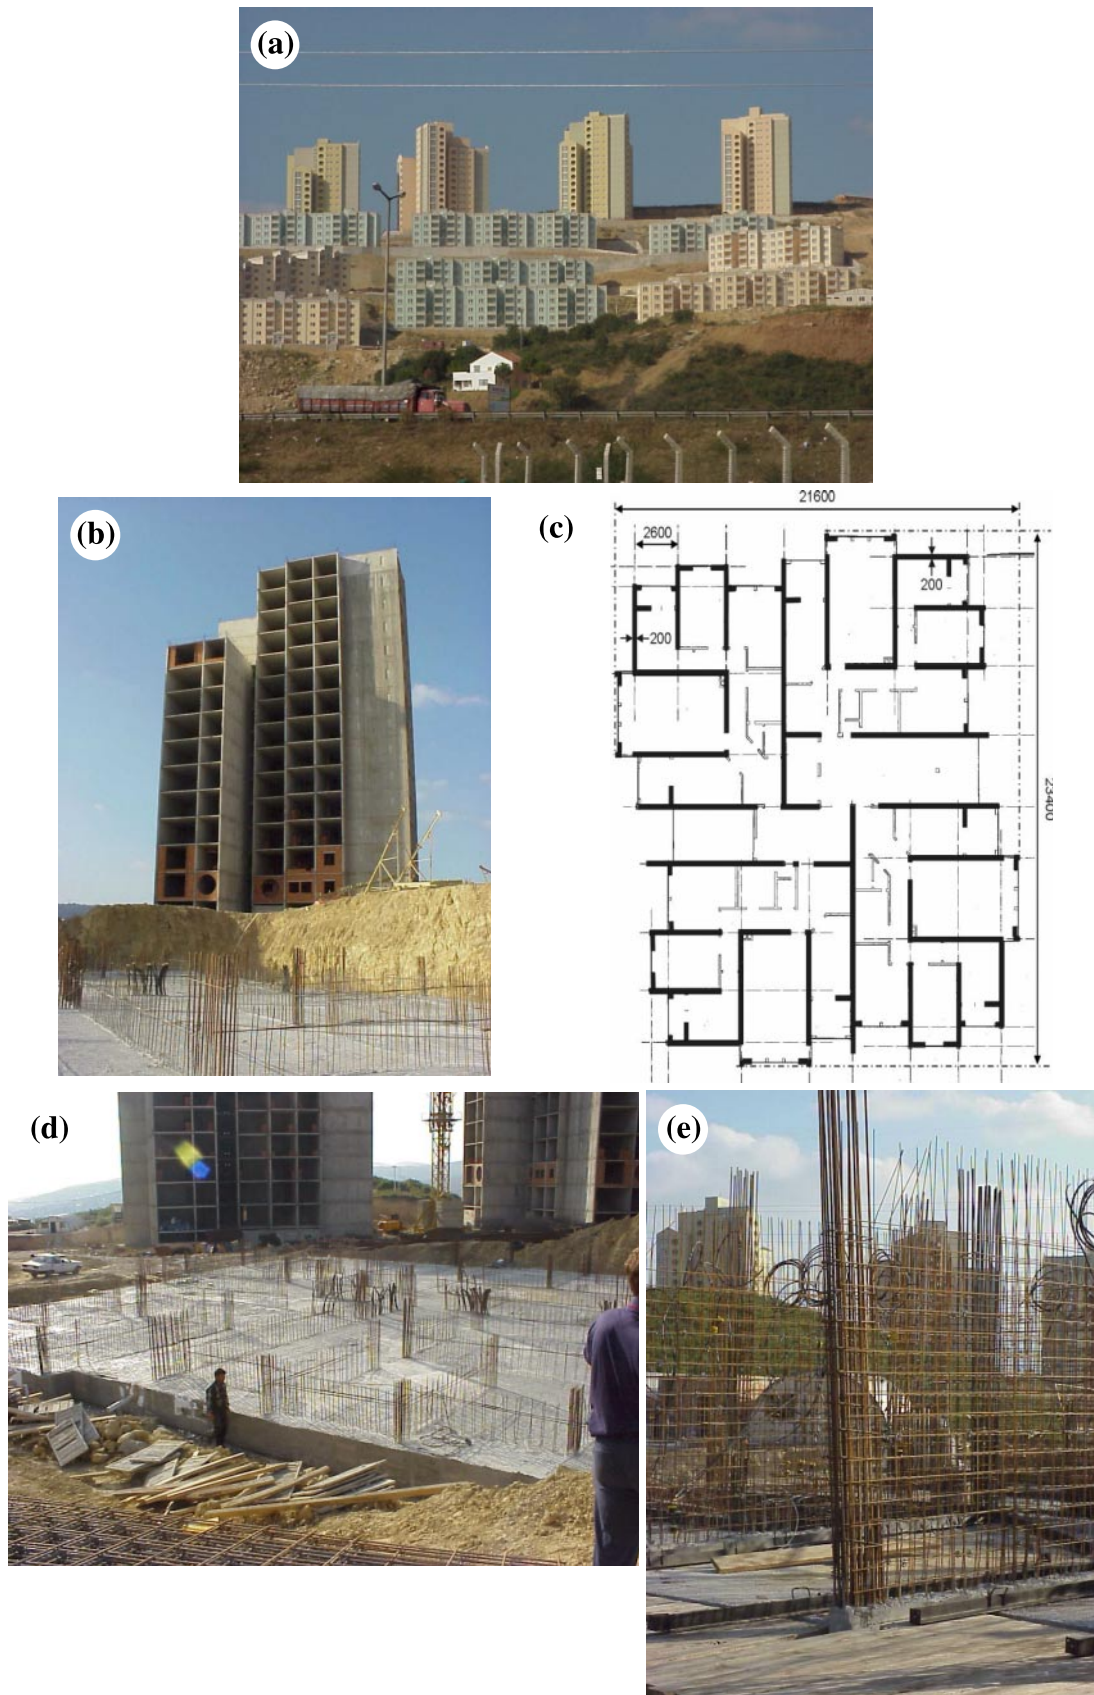
One very large complex of apartment buildings in Izmit having 10–20 storeys and located about 5 km from the fault sustained no visible damage. Figure 32a shows the overall view of the apartment complex and Fig. 32b shows a 15-storey structure under construction. Figure 32c shows the plan view of the structural walls and Fig. 32d shows the foundation mat. The reinforcement detailing in a typical wall at the second-storey level is shown in Fig. 32e. The aspects that contributed to the excellent performance include the following:

- (i) The 700 mm thick, heavily reinforced foundation mat was founded on firm ground (see Fig. 32d).
- (ii) The multiplicity of the symmetrically located shear walls (see Fig. 32c) in both principal directions provided excellent drift control, limited torsional effects, and provided redundancy in resisting lateral loads.
- (iii) The 200 mm thick walls were reinforced with concentrated reinforcement (14–20 mm diameter bars at the

Fig. 32. Shear wall structures under construction: (a) overall view of apartment buildings; (b) 15-storey structure; (c) plan view of structural walls; (d) foundation mat; (e) typical wall reinforcement details.

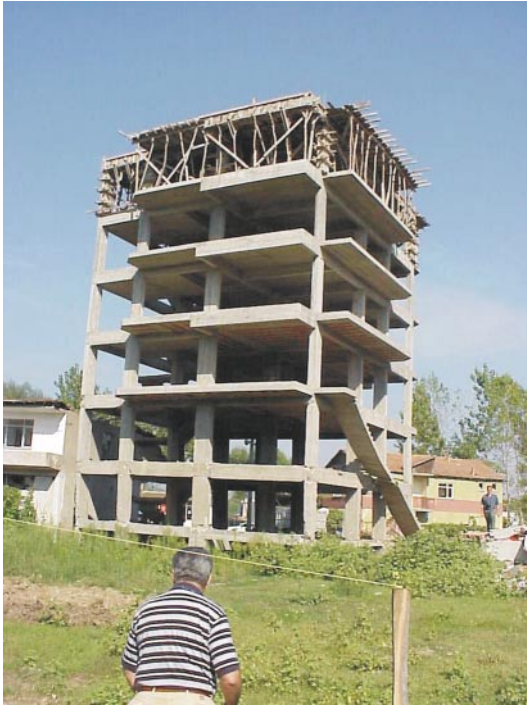
A six-storey reinforced concrete cast-in-place frame structure under construction in Yuvacik is shown in Fig. 34a. This 3 bay by 4 bay structure has the very common “asmolen” floor slab system. This structure, which is south of Izmit and about 5 km from the fault, suffered structural damage to the columns and joints. The traditional masonry infill had not been placed before the earthquake. The 250 by 600 mm corner column contained 10–15 mm diameter smooth vertical bars. These vertical bars were hooked at the ground floor slab level and the dowel bars coming up from the basement overlapped the vertical column bars. Hinging took place just below the hooks. The column ties consisted of 8 mm diameter smooth bars with 90° bend anchorages and 60 mm free end extensions. The spacing of the ties was 200 mm. Shear distress occurred in the joints of a corner and an edge column. There was no joint shear reinforcement in any of the joints. In addition, insufficient concrete cover had been provided. These details in this structure provide strong evidence that there was insufficient inspection and enforcement of building regulations, despite the well-established seismic code requirements of 1975 and the more stringent requirements of 1997.

Fig. 34. Concrete frame structure under construction.

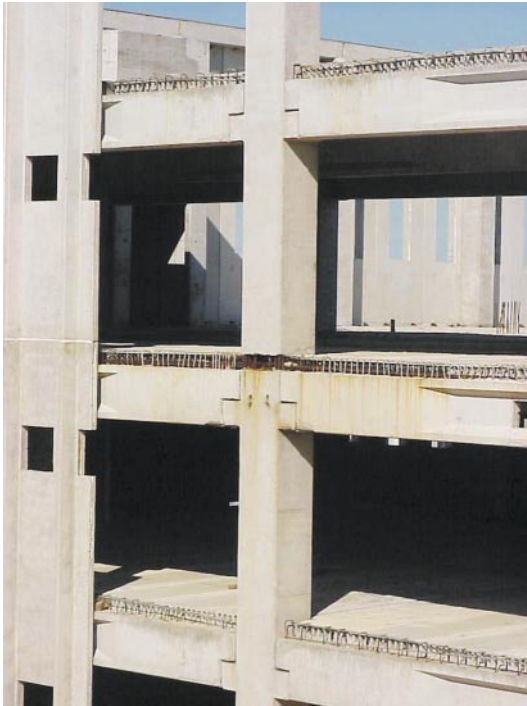
Although there were many examples of precast concrete structures with poor lateral load resisting systems and details under construction in 1999, there were many examples of excellent systems under construction. Figure 35 shows the beam–column connections in a three-storey precast building under construction near the epicentral region. The hollow

**Fig. 35.** Precast concrete structure under construction.

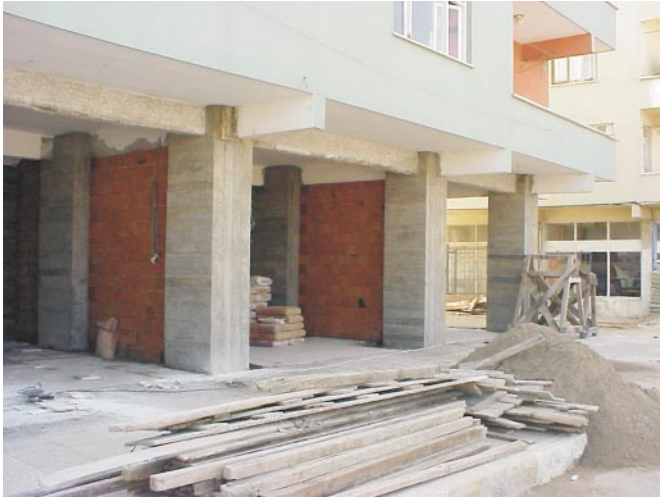
Figure 37 shows severe damage to the ground-storey column of a five-storey reinforced concrete frame structure on Darica Road in Gebze, between Istanbul and Izmit. Shear failure occurred at the base of the column just above the lap splice in the vertical reinforcing bars. The 400 by 520 mm column contained 16–25 mm diameter bars with 8 mm diameter ties at 200 mm spacing. The ties had 90° bend anchorages. A similar five-storey structure immediately across the street had similar damage to the ground-storey columns. Figure 38 shows the retrofitted ground-storey columns. The columns were retrofitted by encasing the existing columns with at least 200 mm of reinforced concrete on all sides. The resulting dimensions were 650 by 850 mm for the edge col-

Fig. 38. Concrete columns after retrofit.

umns and 650 by 1080 mm for the corner columns. The added vertical bars were 14 mm in diameter, while 8 mm diameter ties were added around the perimeter. The added ties were spaced at 100 mm near the top and bottom of the column, and at 150 mm in the central region. Although this retrofit strengthened and stiffened the ground-storey columns, there was no attempt to provide continuity with the structure above and below the ground storey.
