# February 6, 2023 Kahramanmaraş Earthquakes in Türkiye

## Reconnaissance Report

Canadian  
Association  
for Earthquake  
Engineering  
and Seismology

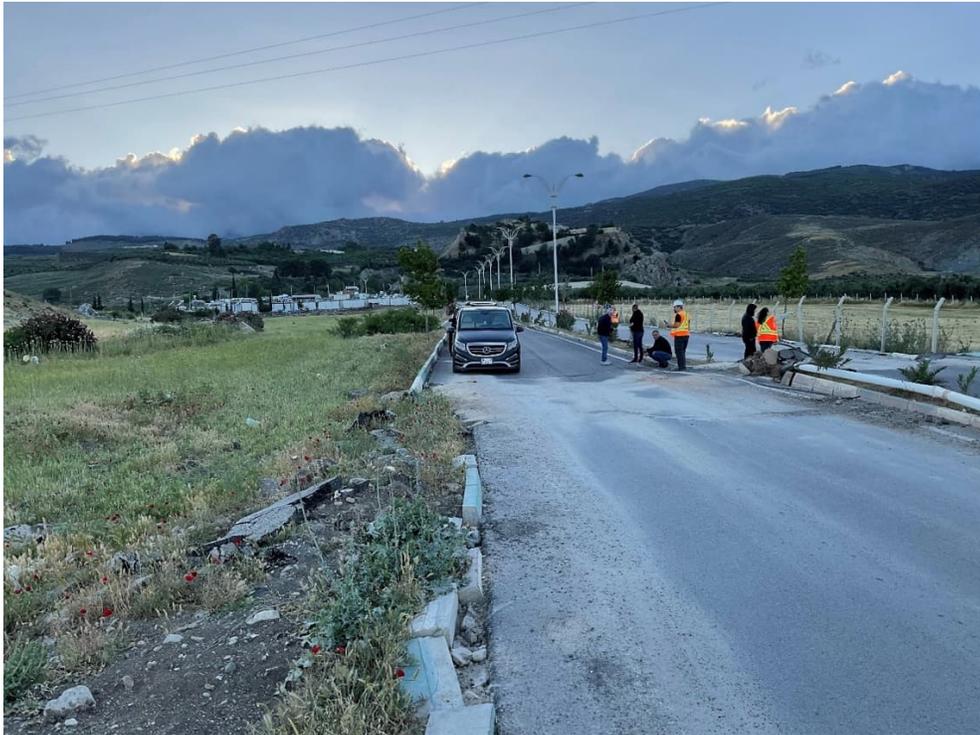
The fault was observed as a 2.07 m left-lateral offset of a road ascending an alluvial fan Figure 3.1). Offset was distributed along two sharp strands 46 km apart. The road offset was in line with right-stepping en-echelon tension gashes and mole-track scarps extending north and south of the road crossing (Figure 3.2).

**Figure 3.1:** Facing west across fault offset of paved road, near Kırıkhan, Hatay Province (36.5284 N, 36.3711 E). Photo: M. Zaleski.

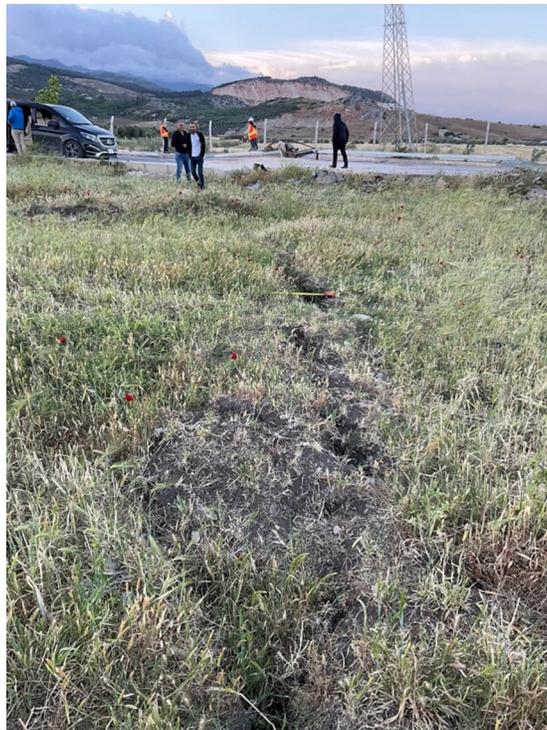
**Figure 3.2:** Facing north along right-stepping, en-echelon cracks that define surface fault rupture, near Kırıkhan, Hatay (36.5283 N, 36.3709 E). Photo: M. Zaleski.

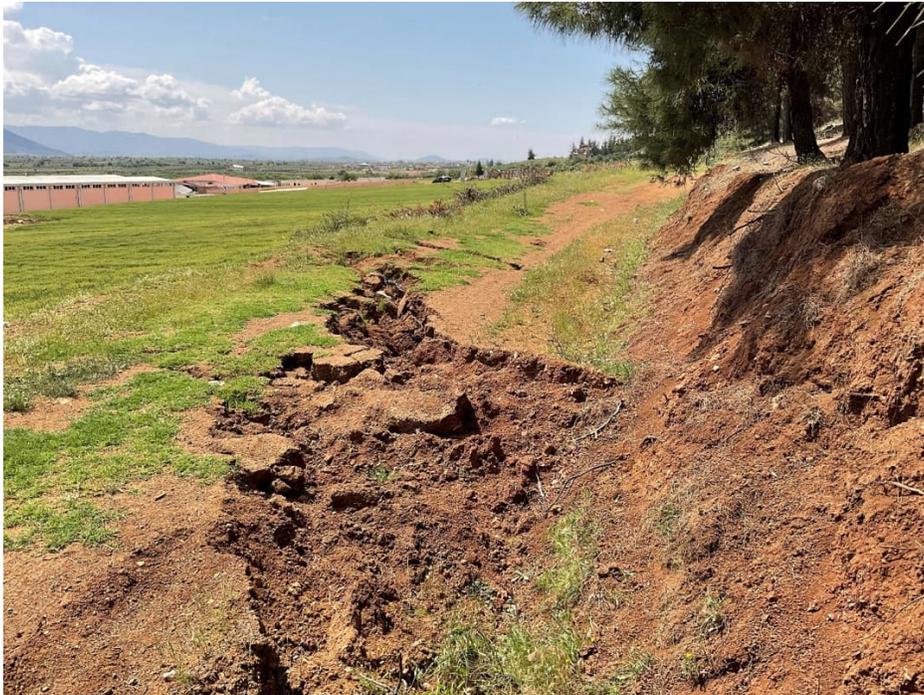
At Altınüzüm, a cast-in-place concrete pad and attached concrete-block wall were damaged and offset by surface faulting directly through them. Up to 1.65 m left-lateral and 0.35 m west-side-up displacement occurred (Figure 3.3). To the immediate north, the scarp changes from west-side-up through alluvial fan deposits to east-side-up where it crosses a west-facing, bedrock-cored slope (Figure 3.4 and Figure 3.5).

**Figure 3.4:** Facing south along fault strike, near Altınüzüm, showing right-stepping en-echelon surface rupture pattern (36.9576 N, 36.5840 E). Photo: M. Zaleski.

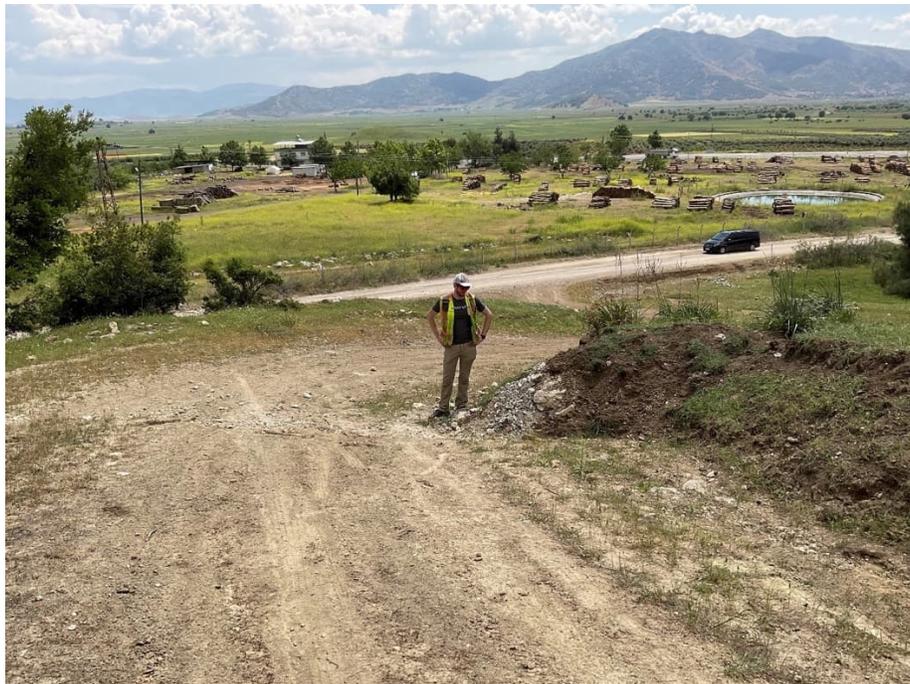
**Figure 3.5:** Facing east across left-lateral fault offset of an unpaved road near Altınüzüm (36.95856 N, 36.5843 E). Photo: M. Zaleski.

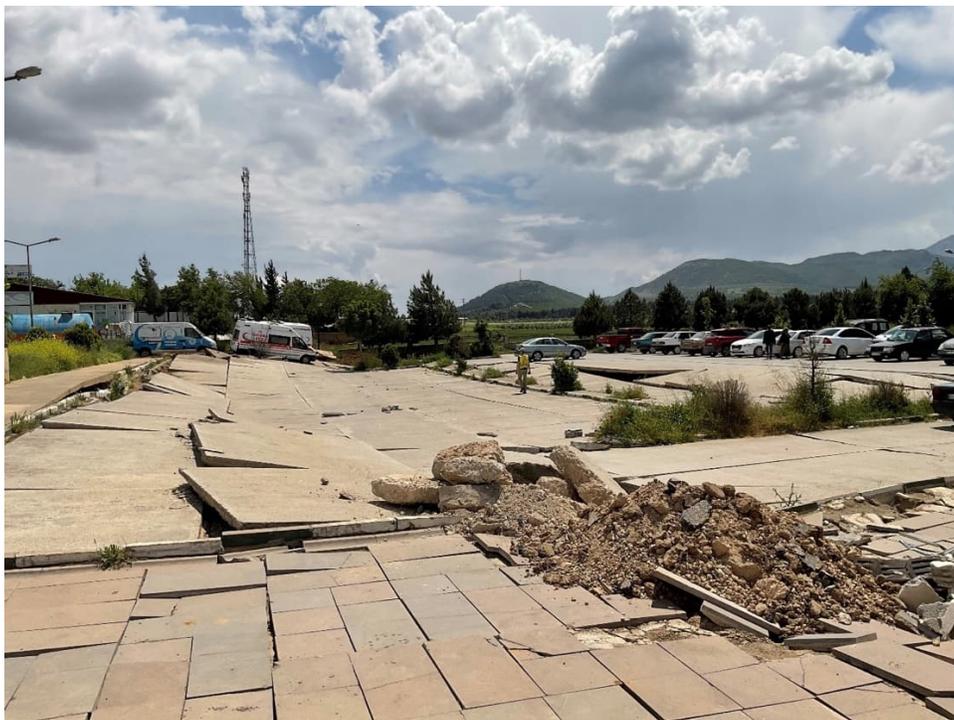
The main fault trace passes through the parking lot of the Islahiye hospital, north of the city (Figure 3.7). The fault is expressed as a 14 m wide graben, bounded by near-vertical scarps in agricultural fields south of the paved parking lot (Figure 3.8). 2.4 m left-lateral offset was measured at a concrete-block wall bounding the south side of the parking lot. The graben bottom was observed up to 1.6 m below the adjacent terrain. The overall vertical offset was observed up to 0.8 m, east side up.

**Figure 3.7: Facing south along fault trace, forming a graben at the Islahiye hospital parking lot (37.0450 N, 36.6295 E). Photo: M. Zaleski.**

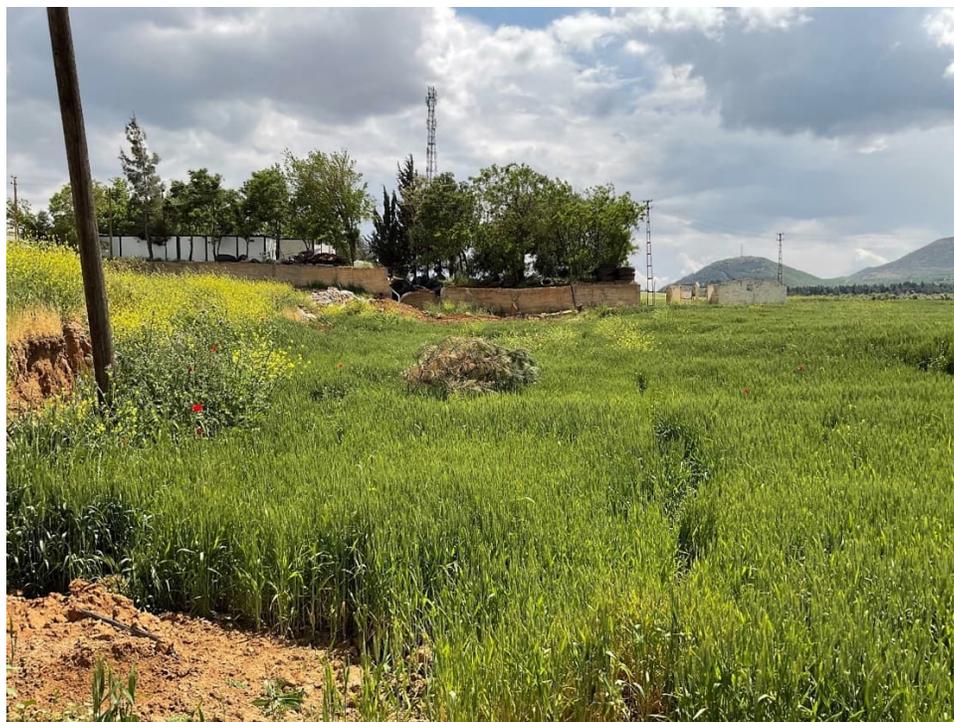
**Figure 3.8: Facing south along fault graben, from Islahiye hospital parking lot (37.0443 N, 36.6294 E). Photo: M. Zaleski.**

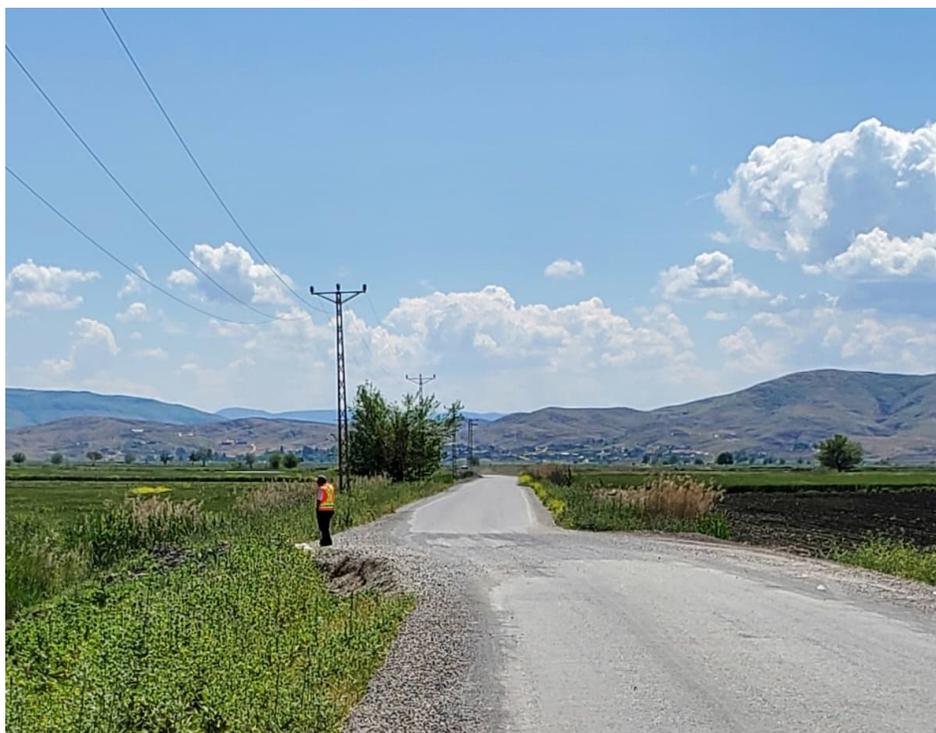
Near Türkoğlu 3.6 m of left-lateral separation was measured at a road crossing of the fault (Figure 3.10) as well as in offsets of drainage ditches and furrows in adjacent farm fields. Surface rupture continues to the northeast and southwest of the road crossing, manifesting as a continuous array of moletracks, right-stepping en-echelon fractures oriented 20° counterclockwise from the main trace, and push-up ridges oriented 20° to 50° clockwise from the main trace (Figure 3.11 and Figure 3.12).

**Figure 3.10: Facing southeast across fault offset of a road near Türkoğlu (37.3706 N, 36.8693 E). Photo: M. Zaleski.**

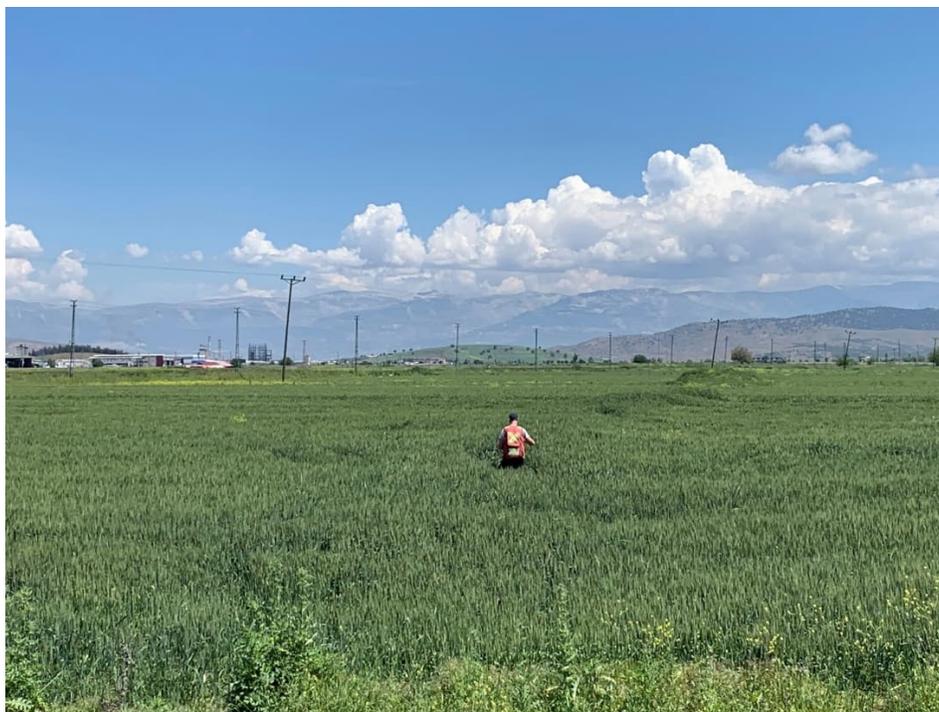
**Figure 3.11: Facing northeast along fault strike near Türkoğlu, showing aligned moletracks and push-up ridges (37.3716 N, 36.8701 E). Photo: T. Southam.**

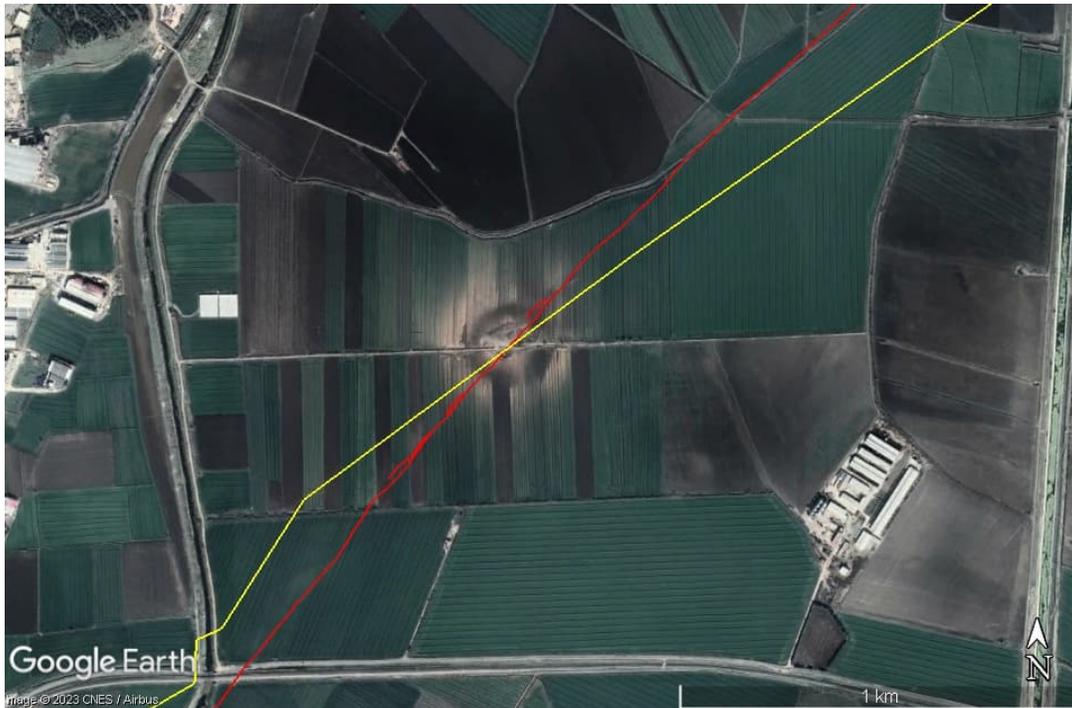
Two known natural gas transmission pipeline crossings occur near Türkoğlu, both within about 3 km of the site at which the CAEES/ACGPS team measured 3.6 m left-lateral surface offset. Post-event orthophoto imagery available through Google Earth (dated March 1, 2023) depict charred craters and recent excavations, consistent with gas pipeline ruptures and exposures (Figure 3.13 and Figure 3.14). The crossings occur in floodplain deposits.

**Figure 3.13:** Google Earth imagery dated March 1, 2023, depicting a charred blast crater at a natural gas pipeline (yellow line) crossing of the surface fault trace mapped by USGS (red line). Site is located 3.4 km east of Türkoğlu, at 37.3880 N, 36.8852 E.

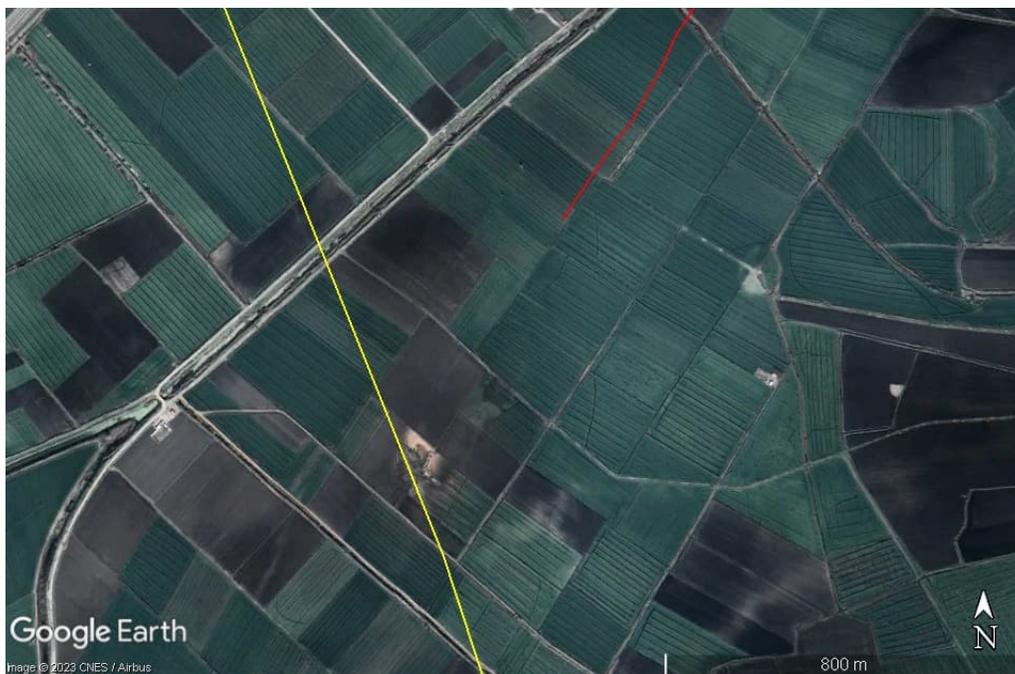
**Figure 3.14:** Google Earth imagery dated March 1, 2023, depicting a charred blast crater at a natural gas pipeline (yellow line), along strike of the surface fault trace mapped by USGS (red line). Site is located 3.8 km south of Türkoğlu, at 37.3880 N, 36.8852 E.

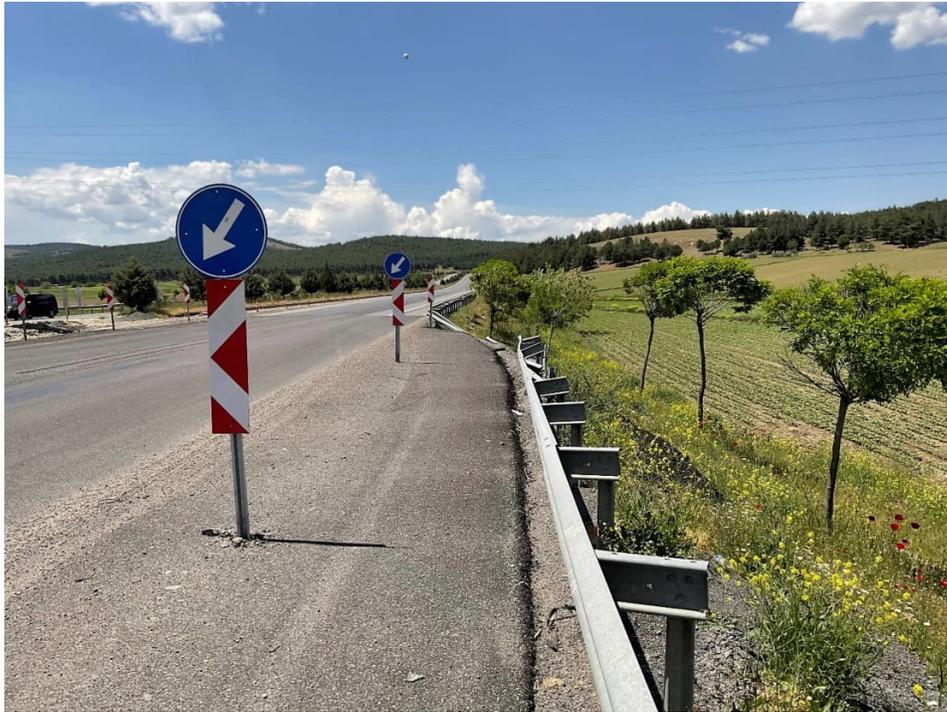
The largest ground-surface offsets observed by the CAEES/ACGPS team along the East Anatolian fault were near the town of Çiğli. The main fault trace crosses the D835 highway about 3 km southwest of the town and a concrete-lined canal about 2 km southwest of the town. At both locations, the fault is confined to a width less than about 3 m, producing distinct offsets of these features. The CAEES/ACGPS team measured 3.5 m left-lateral offset at the highway crossing (Figure 3.15) and 4.8 m at the canal (Figure 3.16). At both sites, the infrastructure had been temporarily repaired before the CAEES/ACGPS reconnaissance: the highway pavement had been re-patched with new asphalt, and the canal had been re-lined with shotcrete.

**Figure 3.15: Facing southeast at K835 highway crossing of the East Anatolian fault (37.4799 N, 37.0422 E), with 2.8 m left-lateral offset. Photo: M. Zaleski.**

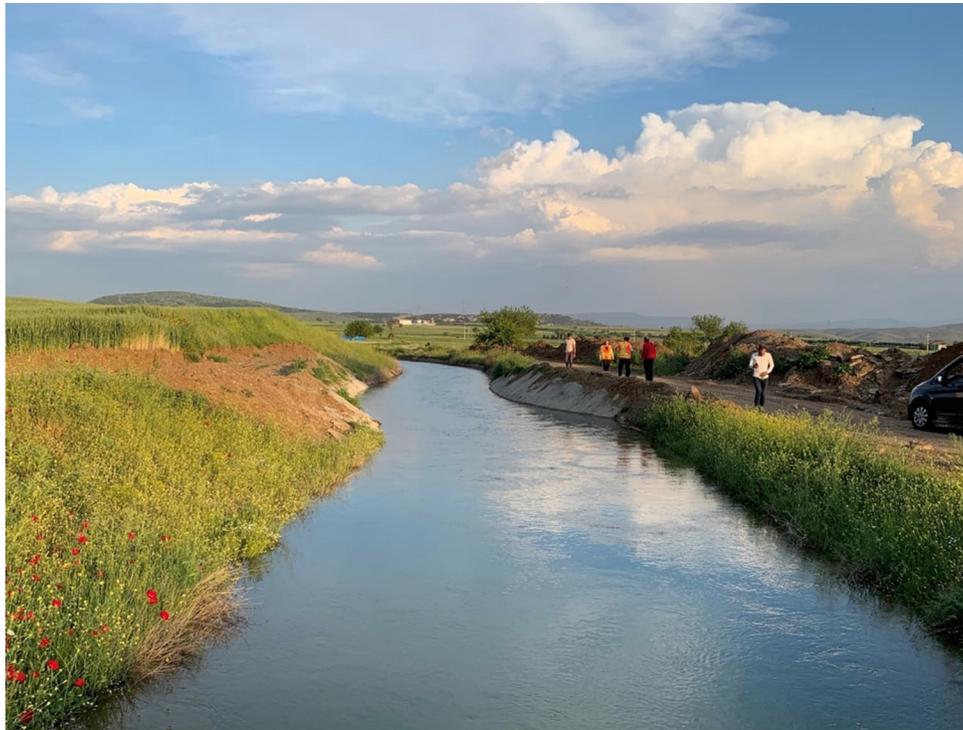
**Figure 3.16: Facing southeast along canal offset by the East Anatolian fault (37.4850 N, 37.0540 E). Photo: T. Southam.**

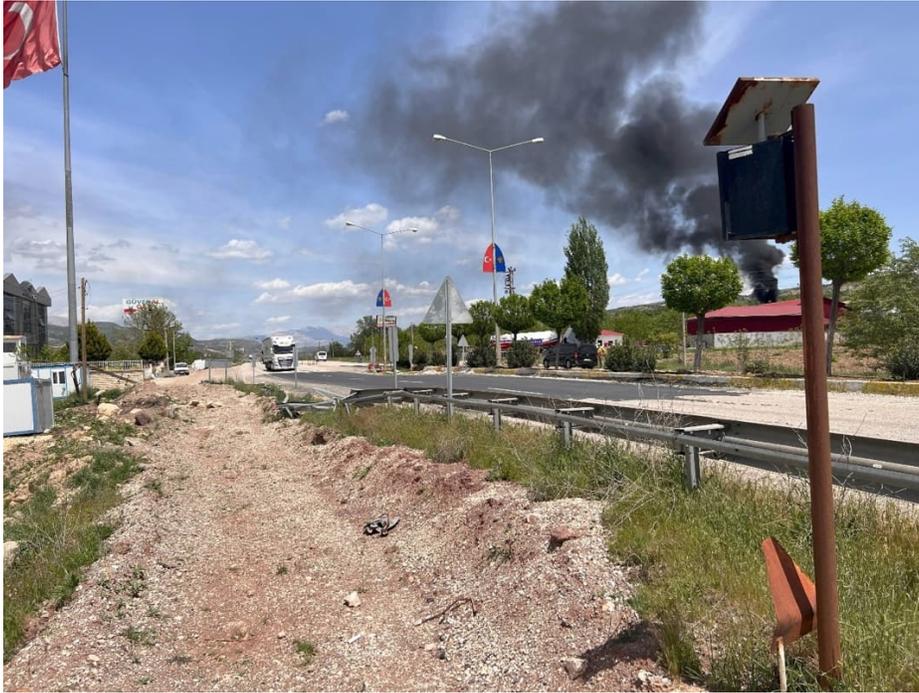
The CAEES/ACGPS team measured 4.5 m horizontal separation and 0.4 m vertical separation on a northwest-facing, continuous scarp crossing the D-360 highway (Figure 3.19). Uncertainty introduced by the acute angle between the highway and fault is estimated at +/- 1.2 m.

**Figure 3.19:** Facing northeast along fault strike at the D-360 highway crossing in Balkar (37.7346 N, 37.5659 E). Photo: M. Zaleski.

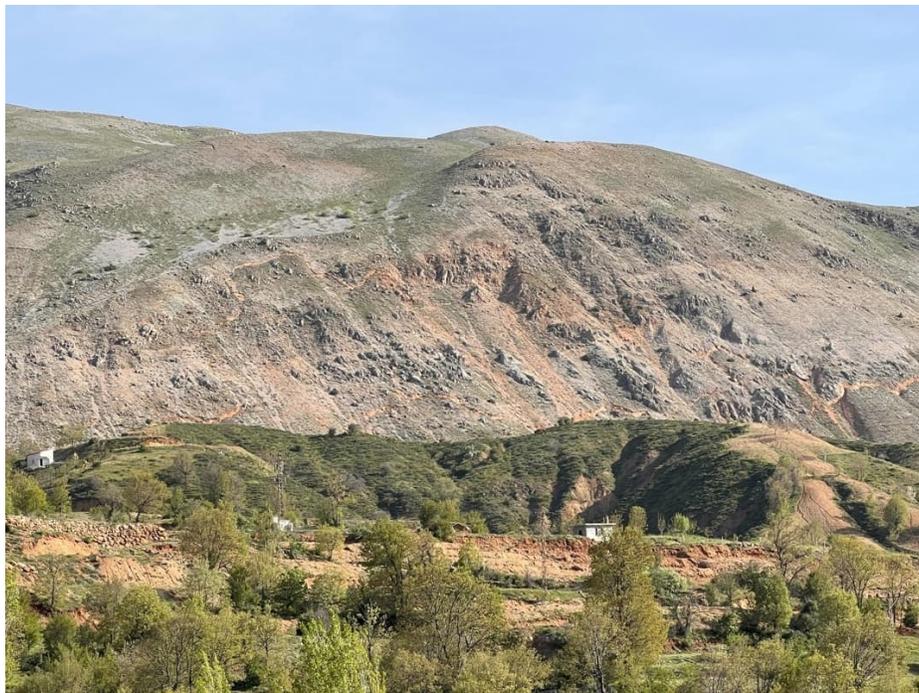
**Figure 3.20:** Facing southeast across the trace of the East Anatolian fault, near Çelikhan (38.0368 N, 38.2621 E). Slope-scale coseismic landslides occur on the range front, collocated with the fault trace. Photo: M. Zaleski.

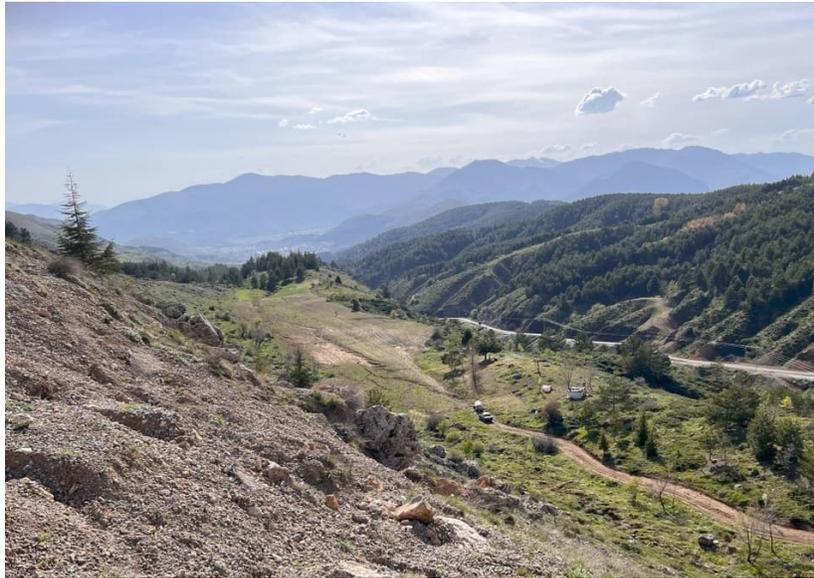
A clear, unequivocal surface rupture of the East Anatolian fault was observed on an elevated terrace, about 6 km east of Çelikhan (Figure 3.21). Here, the fault was expressed as a series of right-stepping en-echelon fractures. The features' location, set back from the terrace riser, and their linear form were inconsistent with coseismic landsliding.

**Figure 3.21:** Facing southwest along East Anatolian fault trace, east of Çelikhan (38.0413 N, 38.3073 E). Right-stepping en-echelon crack array crosses the middle of an elevated terrace surface. Photo: M. Zaleski.

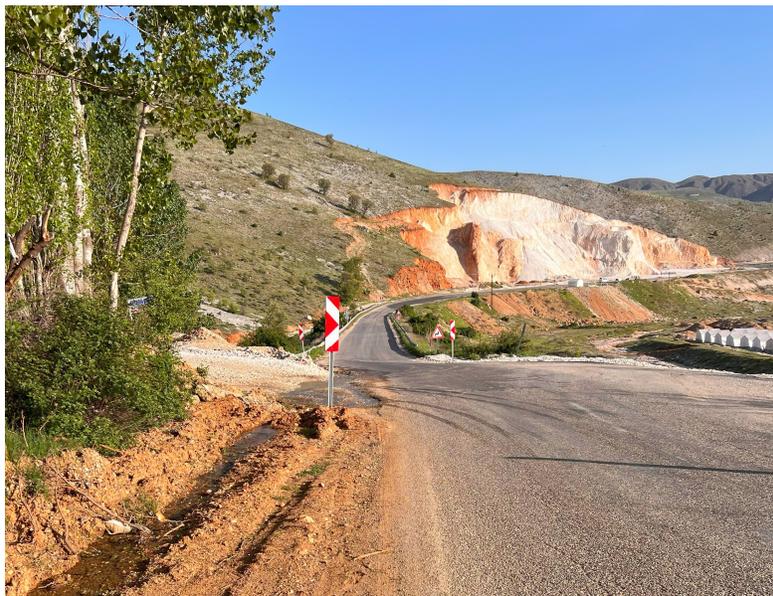
Horizontal separation of 4.9 m and vertical separation of 0.3 m (north side up) were measured at a highway crossing west of Çelikhan; however, the measurement assumes the road was straight before the earthquake and is therefore subject to an estimated +/- 1.5 m uncertainty (Figure 3.22). The scarp is confined to 1 to 2 m width across the hills on either side of the road crossing.

**Figure 3.22:** Facing north across East Anatolian fault crossing of a highway southwest of Çelikhan (38.0104 N, 38.2246 E). Photo: M. Zaleski.

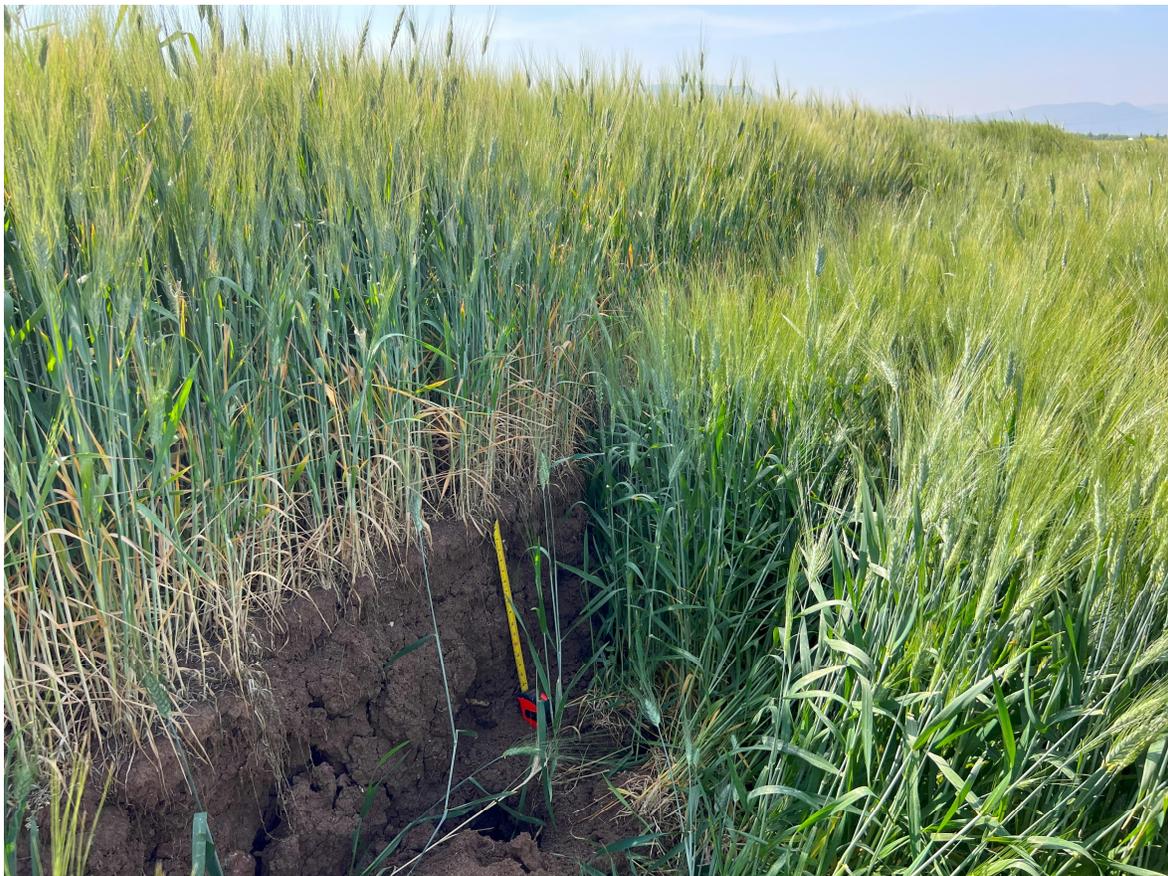
The Narlı fault passes through agricultural land along the east side of the town of Bahçelievler. Distributed faulting bounds an approximately 200 m wide graben, downdropped about 0.3 to 0.5 m with respect to the surrounding terrain (Figure 3.23). Soil within the downdropped block is anomalously wet. The fields are planted with garlic, which fares better in well-drained soil; accordingly, the downdropping is interpreted as tectonic and having occurred after the fields were seeded. Slip displacement could not be reliably measured using available piercing points.

**Figure 3.23: Facing south along a 0.4 m high fault bounding a downdropped graben along the Narlı fault near Bahçelievler (37.3908 N, 37.1511 E). Photo: M. Zaleski.**

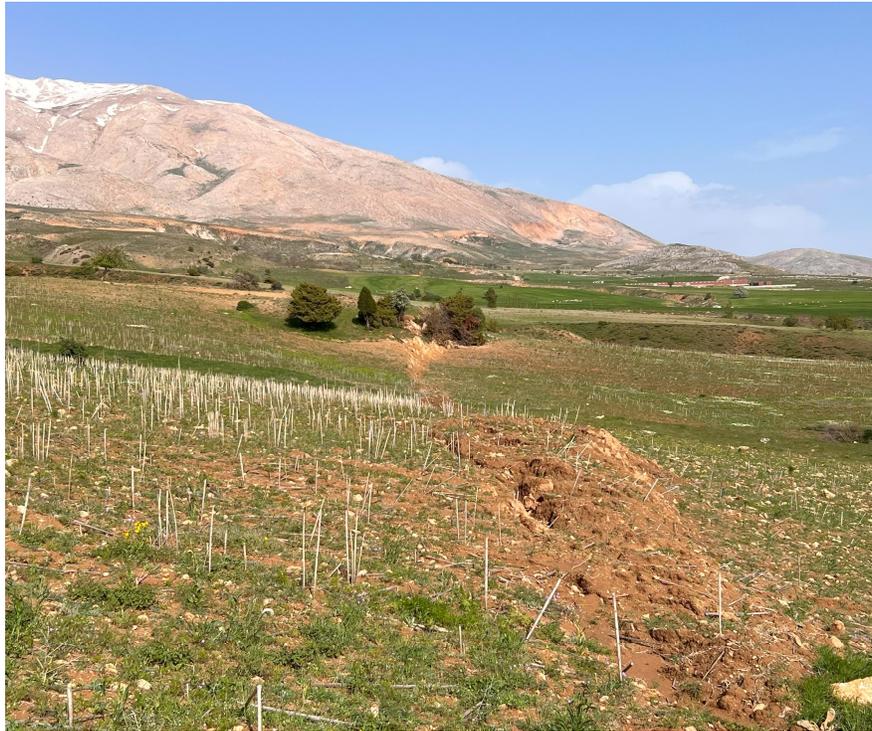
The Sürgü-Çardak fault is near linear for about 8 km from Around Barış to the east; accordingly, fault deformation is confined to a sharp scarp, with little evidence for distributed deformation and en-echelon cracking (Figure 3.26 and Figure 3.27: ). The largest left-lateral displacement

**Figure 3.26:** Facing east along Sürgü-Çardak surface rupture near Barış (38.0017 N, 37.3460 E). Continuous surface rupture is visible across the range front in the photo background.  
**Photo:** M. Zaleski.

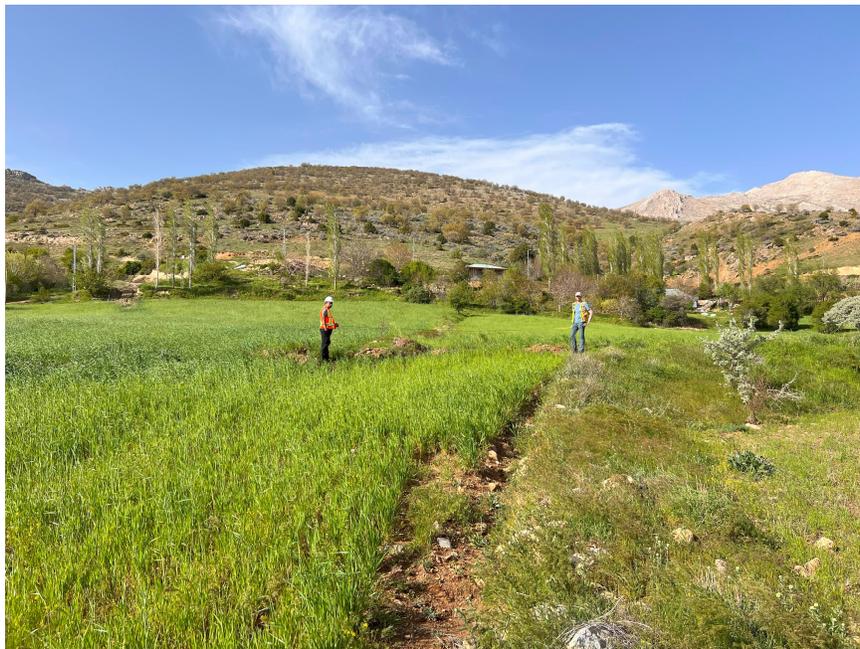
**Figure 3.27:** Facing north at 6.9 m left-lateral offset of a field drain near Barış (38.0018 N, 37.3452 E). Photo: M. Zaleski.

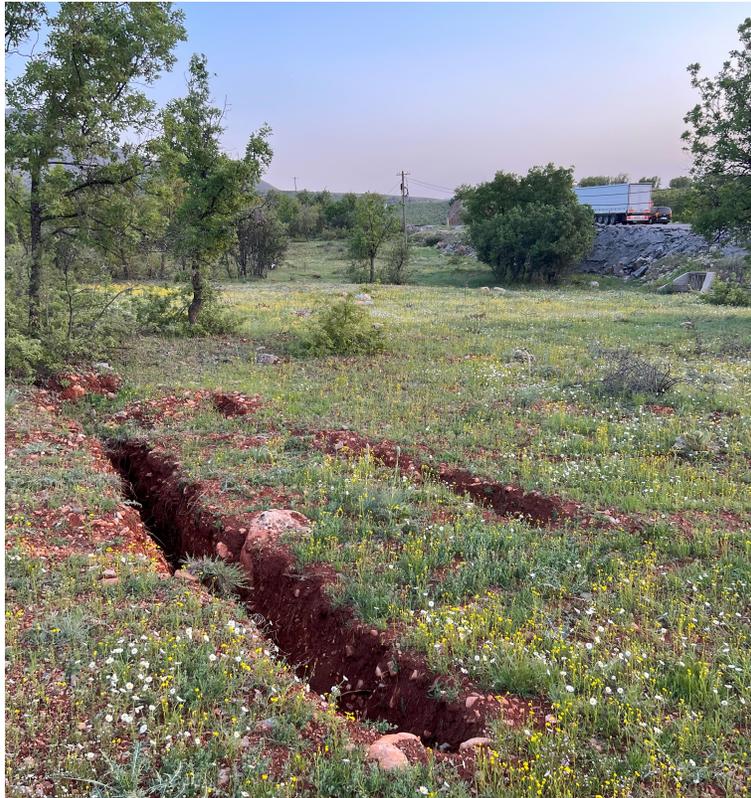
Polatdere is near the easternmost limit of observed surface rupture along the Sürgü-Çardak fault. A releasing bend occurs at the fault's crossing of the D-850 (Gölbaşı to Malatya) highway, producing discontinuous, open tension gashes up to 0.5 m wide and 2.3 m deep, distributed over a zone up to 20 m wide (Figure 3.28). Left-lateral displacement of up to 1.4 m was measured across one of the fault segments, though this is interpreted as an underestimate, given the distributed nature of the faulting (Figure 3.29).

**Figure 3.28: Open tension gashes in a releasing bend near Polatdere (38.1456 N, 37.9625 E). Photo: M. Zaleski.**

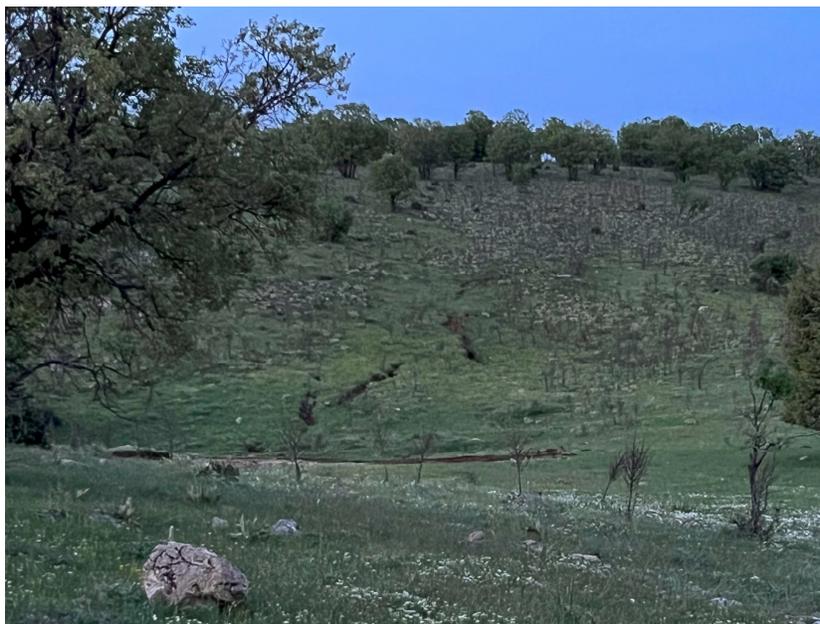
**Figure 3.29: Facing northeast along distributed surface rupture near Polatdere (38.1433 N, 37.9610 E). Zone of surface faulting is about 8 m wide. Photo: M. Zaleski.**

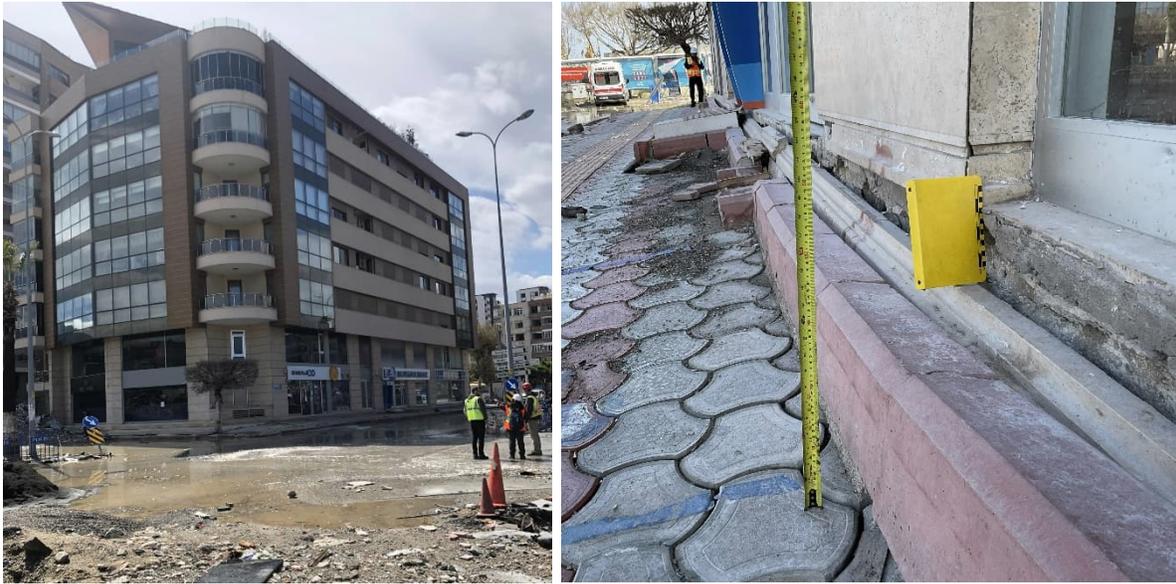
A notable building in the area was the 7-storey Çivisöken Apartment building which did not display structural damage congruent with the surrounding areas which experienced a high level of damage and structural collapse. The report published by the Türkiye Earthquake Reconnaissance and Research Alliance notes that the foundation of the building included diaphragm walls and ground improvement [6]. The sidewalks adjacent to the building displayed approximately 15 to 20 cm of settlement, the observations of the building are shown in Figure 5.4.

**Figure 5.4: Çivisöken Apartment (36.5905,36.1757)**

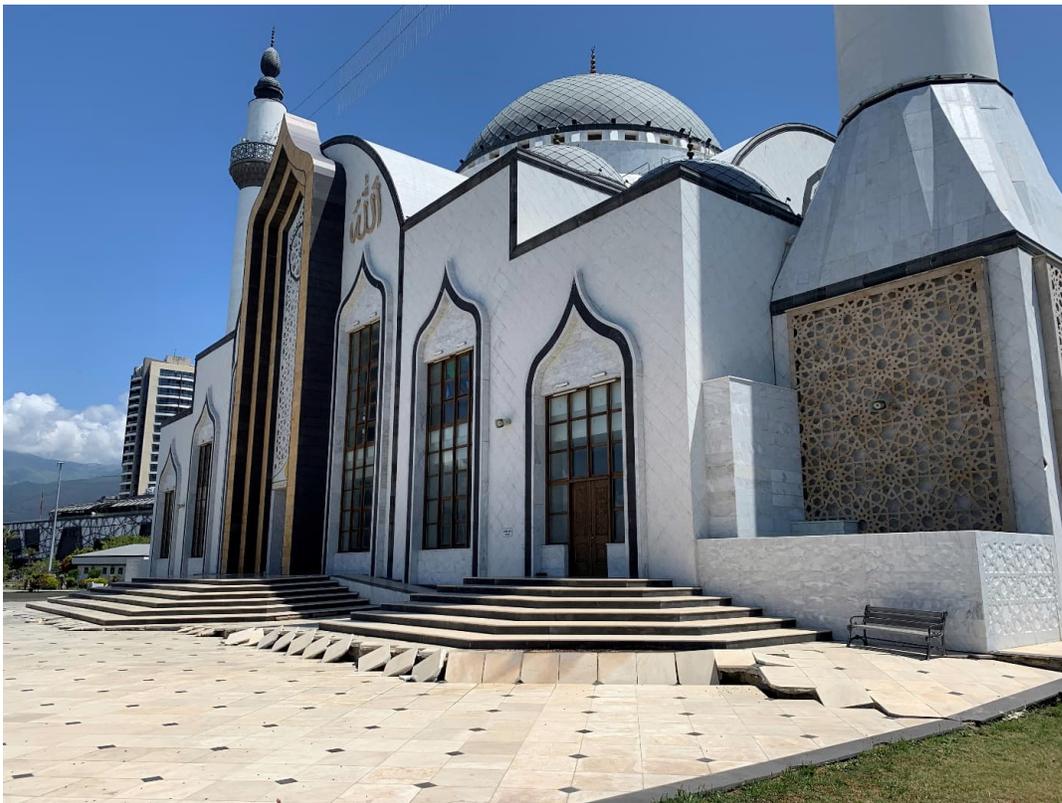
To the west, the İskenderun Nihal Atakaş Mosque which is adjacent to the waterfront displays evidence of liquefaction induced settlements around the structure. The structure which appears to have been constructed on piles was observed to be approximately 30 to 50 cm above the surrounding ground as shown in Figure 5.5. At the time of the reconnaissance the area around the mosque was closed for repairs which limited detailed measurements from being obtained, surface ejecta was also observed within tiled area surrounding the mosque and is discussed further in Section 5.1.1.3.

**Figure 5.5: İskenderun Nihal Atakaş Mosque (36.5927, 36.1572)**

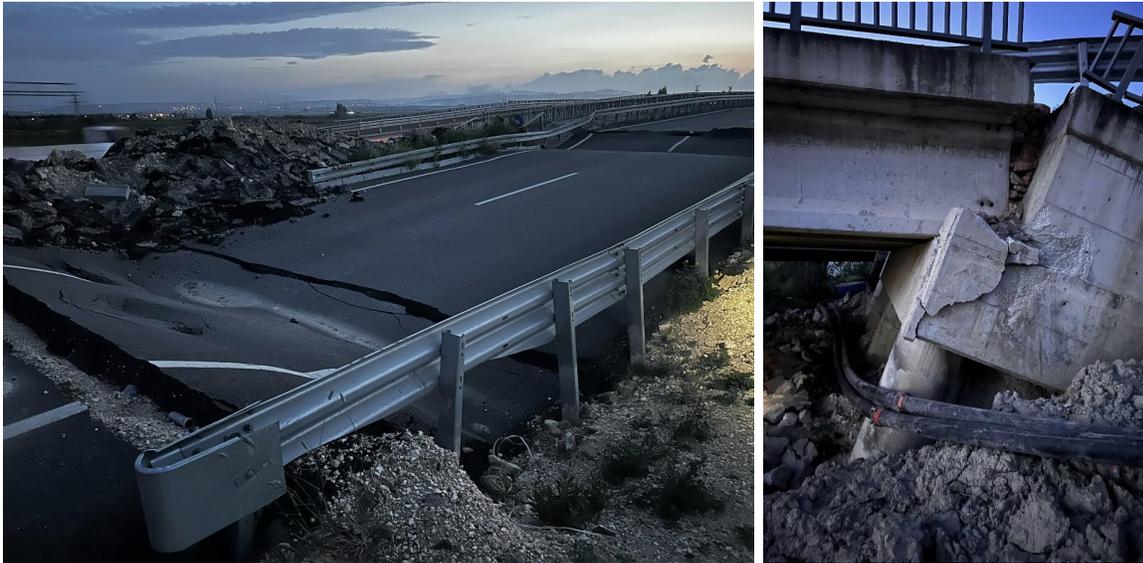
In Demirköprü, Hatay on the Antakya Cilvegözü road there was failure of a pair of bridges that resulted from liquefaction induced lateral spreading. The bridges are three span structures with two piers within the river and abutments located about 10 m back from the riverbank. The abutments formed by four piles and a pile cap. As a result of the liquefaction induced lateral spreading the approaches to both bridges on both sides failed as shown for the northeast approach in Figure 5.9. At each of the four abutments, the abutments were observed to have rotated inwards approximately 23 degrees towards the free face of the Orontes River, as shown in Figure 5.9. In addition, the west pier on the north bridge appeared to have rotated in counter-clockwise when viewed from above as shown in Figure 8.10. At the time of the reconnaissance the south bridge approaches had been filled and repaved and was open to traffic. The bridges are further described within Section 8.2.3.

**Figure 5.9: Condition of Orontes River Bridges in Demirköprü (36.2456, 36.3573). Left - North East Approach Slab Failure Right - South East Abutment Rotation.**

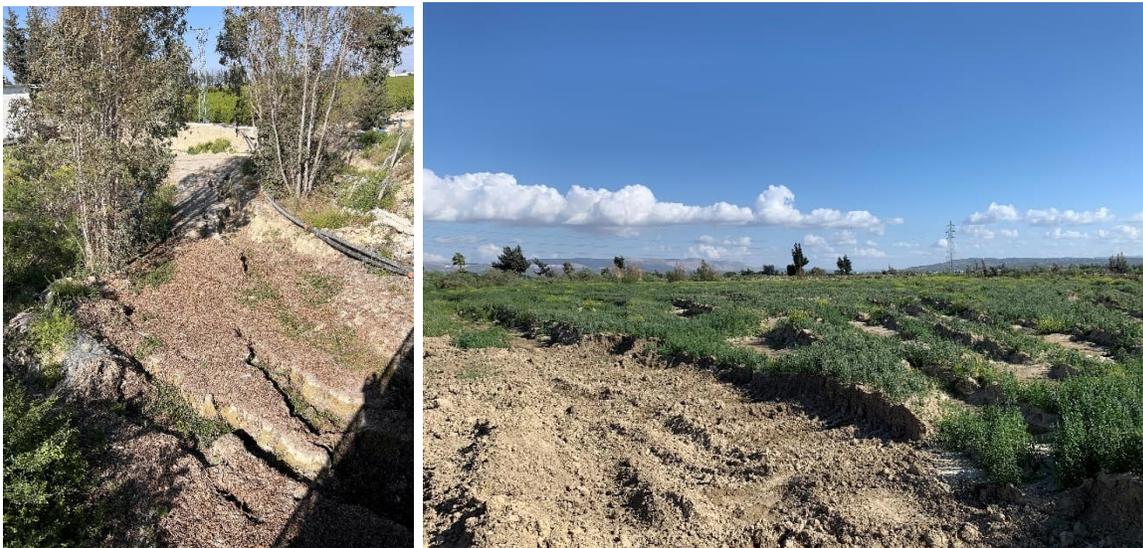
Lateral spreading was evident both to the northeast and southwest of the bridges, with parallel tension cracks and back scarps present at both locations, as shown in Figure 5.10. An area of widespread sand boils and ejecta was present to the southwest. The sand boils were concentrated at the back scarps of the lateral spread features and were up to about 1.5 m in diameter. The ejecta was a light brown fine sand with trace (<10%) fines; subsequent laboratory testing will be required to substantiate field characterization. The sand boils and their ejecta are shown Figure 5.11.

**Figure 5.10: Lateral Spreading of the Orontes River Bridges in Demirköprü (36.2456, 36.3573) Left-Northeast, Right Southwest.**

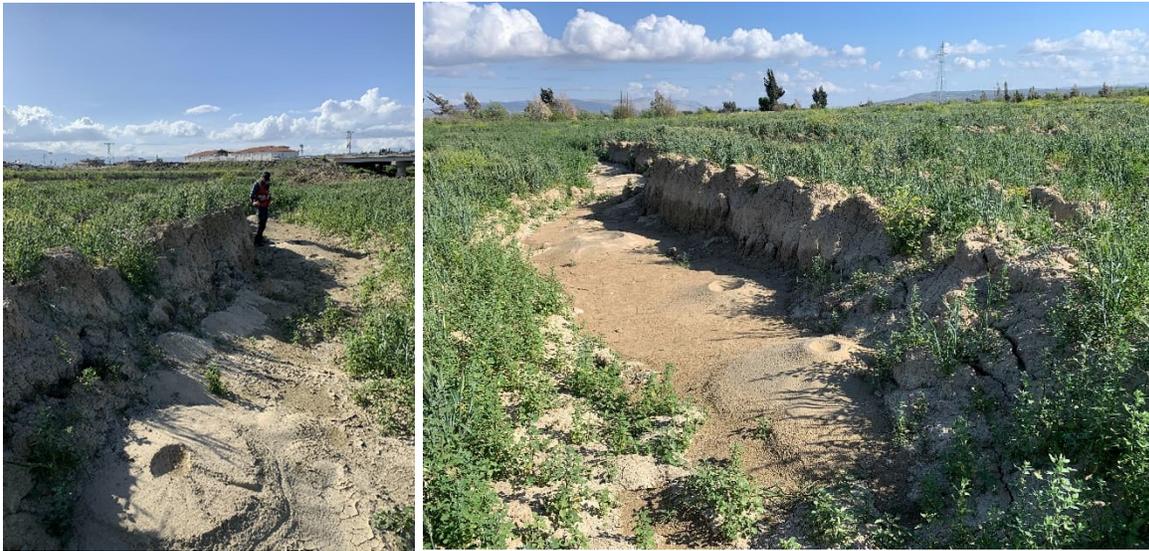
**Figure 5.11: Sand boils adjacent to the Orontes River Bridges in Demirköprü (36.2456, 36.3573).**

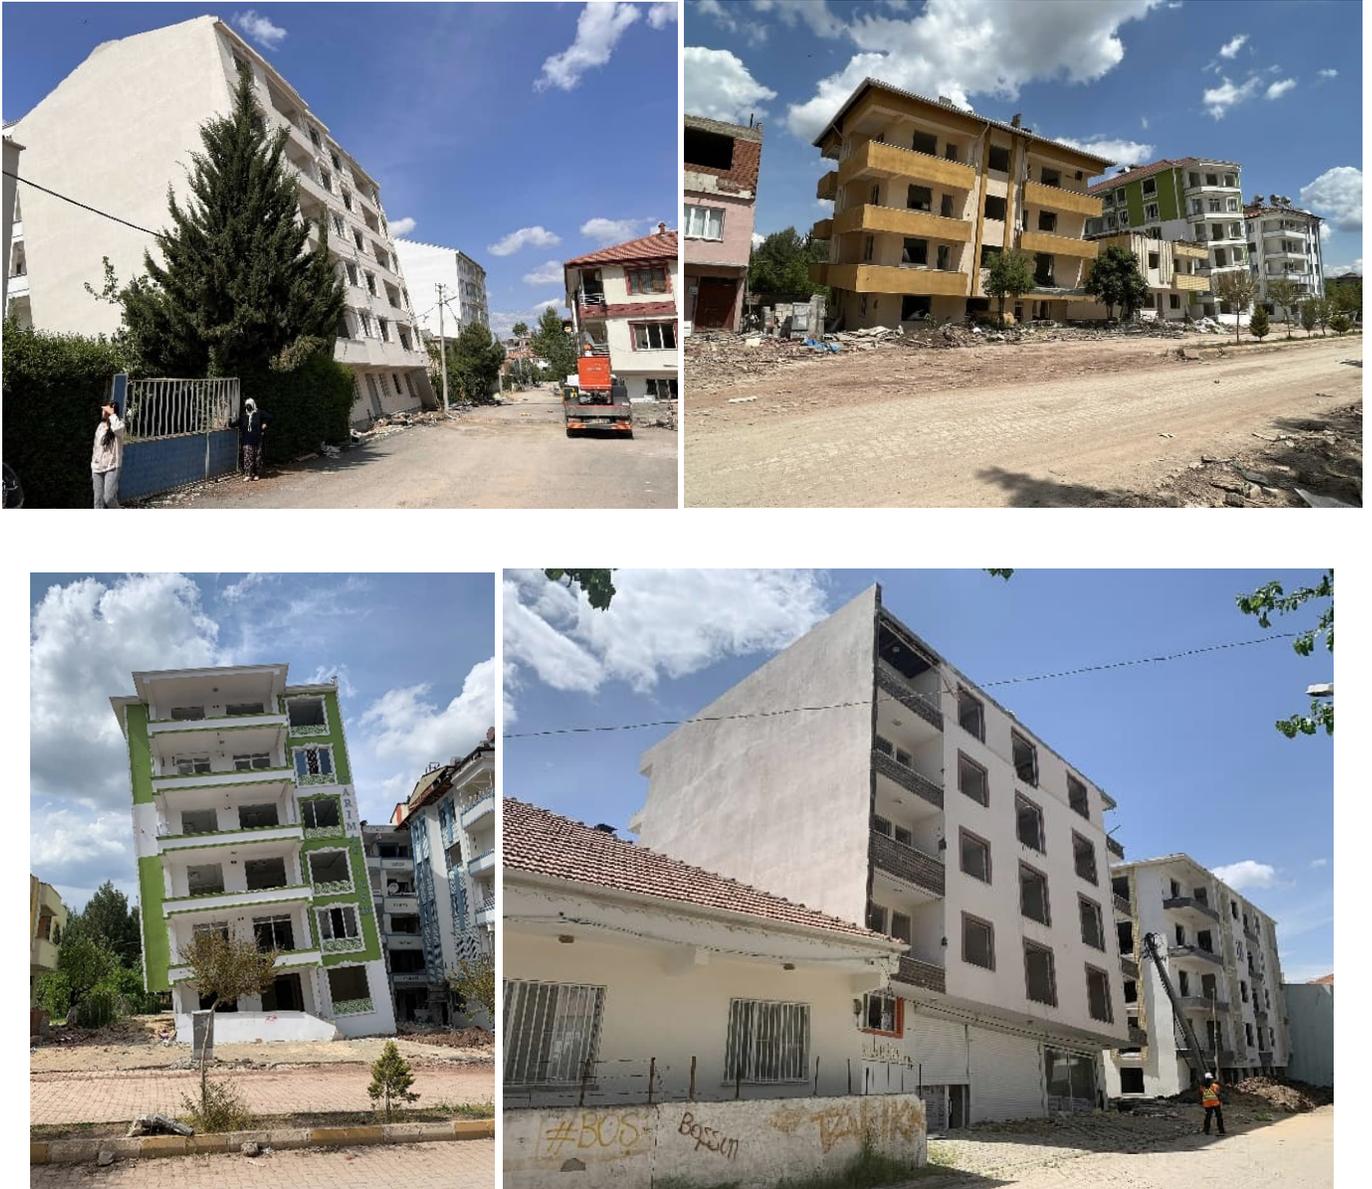
The downtown lakeside area of Gölbaşı experienced widespread settlement of buildings which was inferred to be a result of liquefaction induced bearing capacity loss. Buildings above 3-4 stories typically experienced settlement, whereas buildings under this height generally showed less signs of settlement. Of the buildings that experienced settlements the settlements were generally relatively uniform; however, there were instances differential settlement caused buildings to develop excessive tilt and in extreme cases overturning of the buildings. Examples of relatively uniform settlements are shown in Figure 5.12, examples of differential settlements are shown in Figure 5.13.

**Figure 5.13: Examples of differential settlement. Top left - 37.7876, 37.6432, Top right - 37.7886, 37.6449, Bottom left 37.7888, 37.6454, Bottom right 37.7872, 37.6431.**
