# February 6, 2023 Kahramanmaraş Earthquakes in Türkiye

## Reconnaissance Report

Canadian  
Association  
for Earthquake  
Engineering  
and Seismology

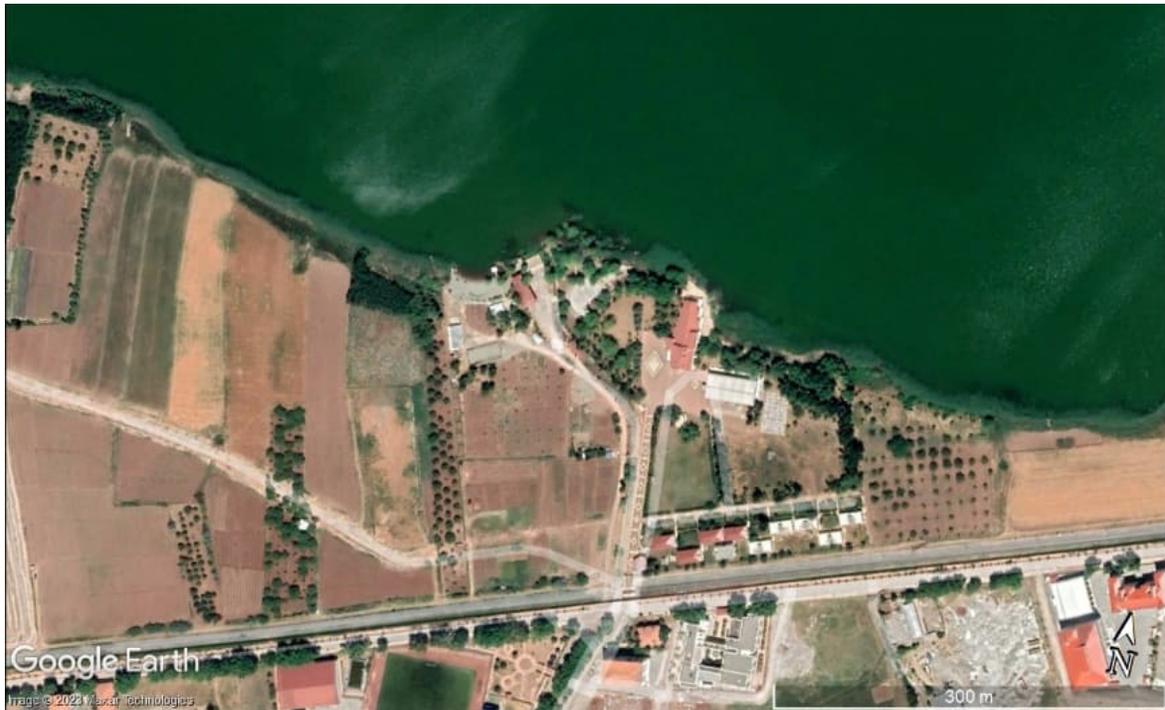
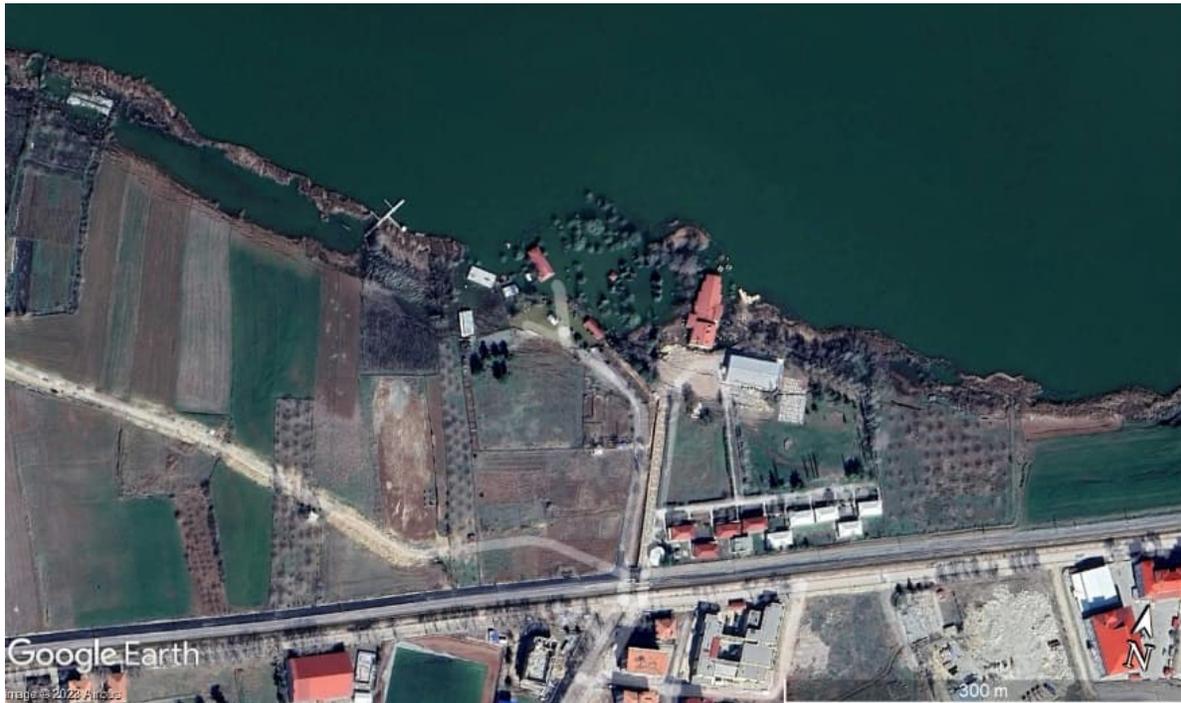
Examples of lateral spreading were observed on both the north and south side of lake Gölbaşı. In both instances the slope of the ground was shallow, and material moved towards the free face of the lake. Examples of the lateral spreading around lake Gölbaşı are shown in Figure 5.14 through Figure 5.16.

**Figure 5.14: Lateral Spreading on south bank of Lake Gölbaşı (37.7947, 37.6486). Top Google Earth Aerial Imagery Dated Jun. 10, 2021, Bottom Google Earth Aerial Imagery Dated Mar. 6, 2023. [9]**

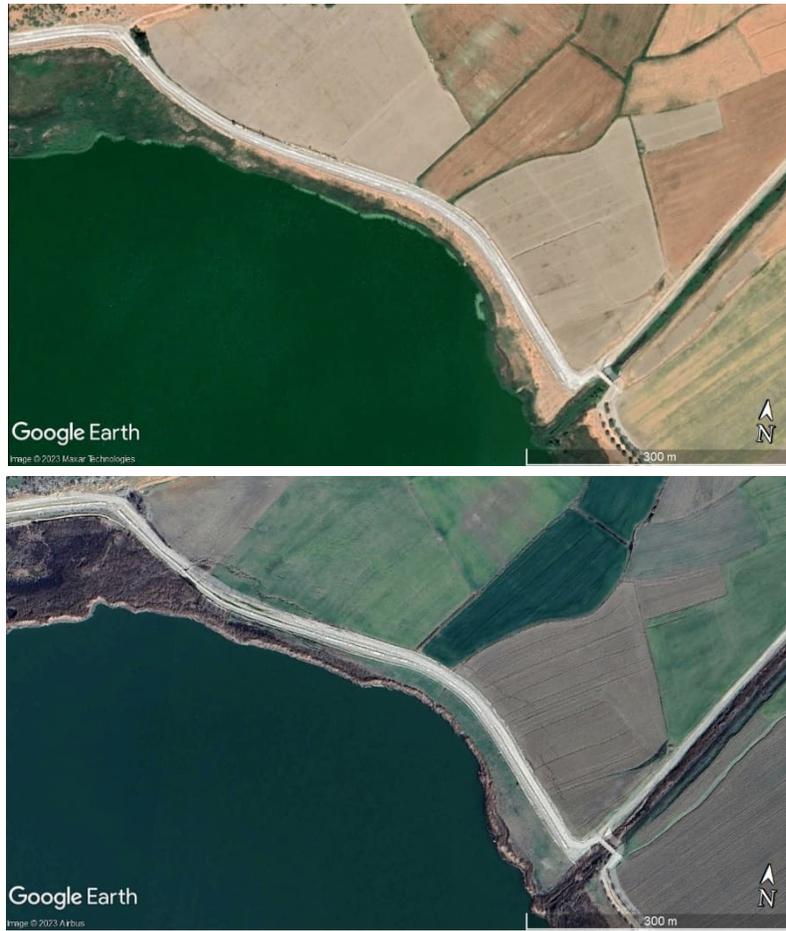
**Figure 5.15: Lateral Spreading on north bank of Lake Gölbaşı (37.8059, 37.6550). Top Google Earth Aerial Imagery Dated Jun. 10, 2021, Bottom Google Earth Aerial Imagery Dated Mar. 6, 2023. [9]**

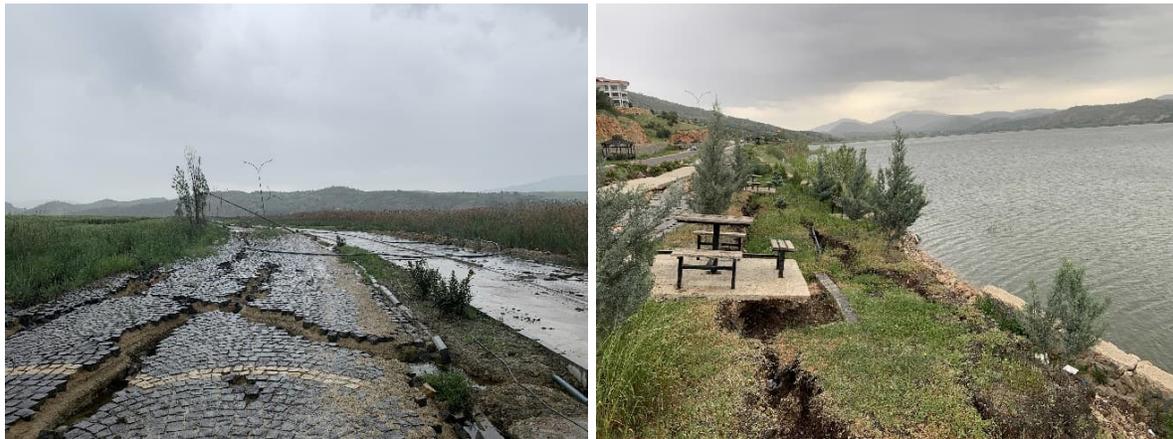
**Figure 5.16: Lateral Spreading on north bank of Lake Gölbaşı. Left – 37.8062, 37.6525 Right - 37.8001, 37.6363.**

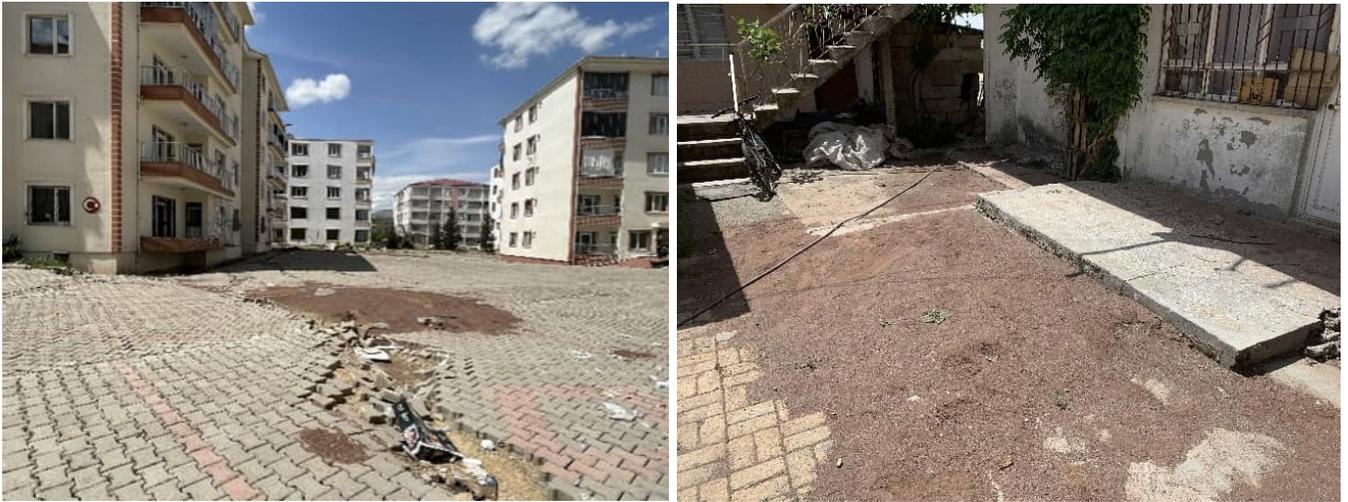
Liquefaction ejecta was observed in isolated locations throughout Gölbaşı as shown in Figure 5.17. The ejecta generally appeared to be composed of red-brown fine sand with some low plastic fines (10%-20%), however subsequent laboratory testing will be required to substantiate field observations.

**Figure 5.17: Liquefaction Ejecta observed within Gölbaşı. Left – 37.7886, 37.6418 Right - 37.7863, 37.6449.**

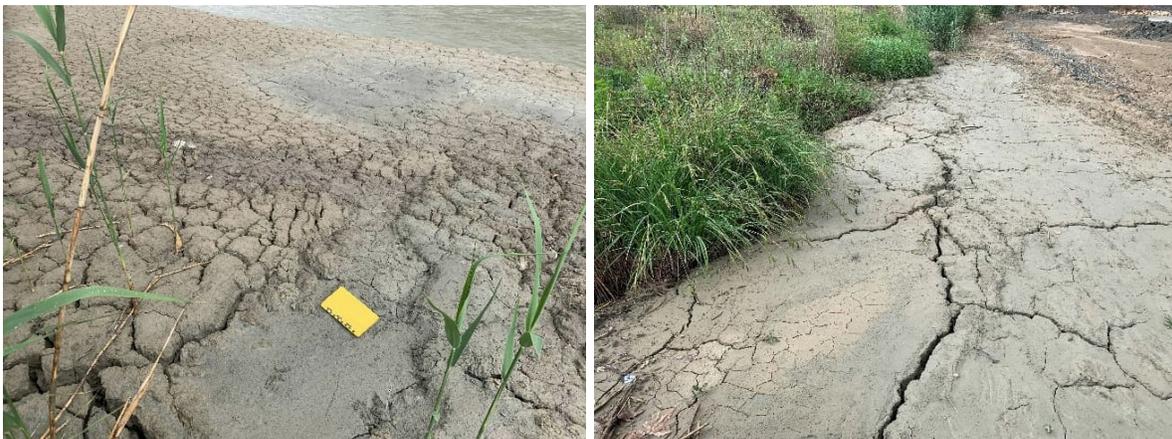
**Figure 5.19: Liquefaction Ejecta along banks of Göksu Stream - 37.8643, 37.7703.**

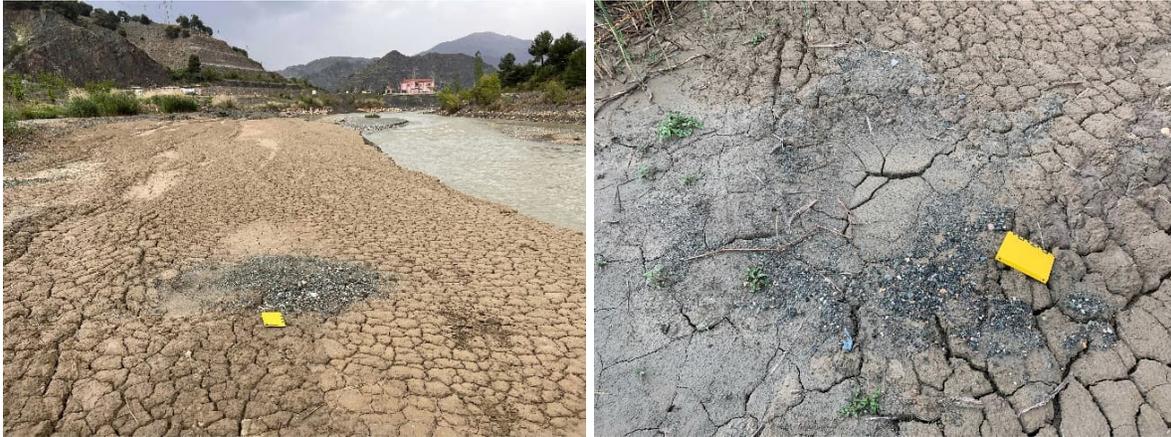
On the banks of the Göksu Stream on the southside of the roadway and in the flat area to the north of the embankment there was remnants of liquefaction ejecta. The ejecta was typically light grey fine sand with trace fines (<10%). Some of liquefaction ejecta appeared to contain some gravel to gravelly (10-35% gravel), it was unclear if the composition of this ejecta had been significantly altered since the event due to exposure to weather washing the sand fraction away or if the ejecta entrained or contained larger clasts. Photographs of the ejecta observed along the banks of Göksu Stream are shown in Figure 5.20 below.

**Figure 5.20 (Cont'd): Liquefaction Ejecta along banks of Göksu Stream - 37.8643, 37.7703.**

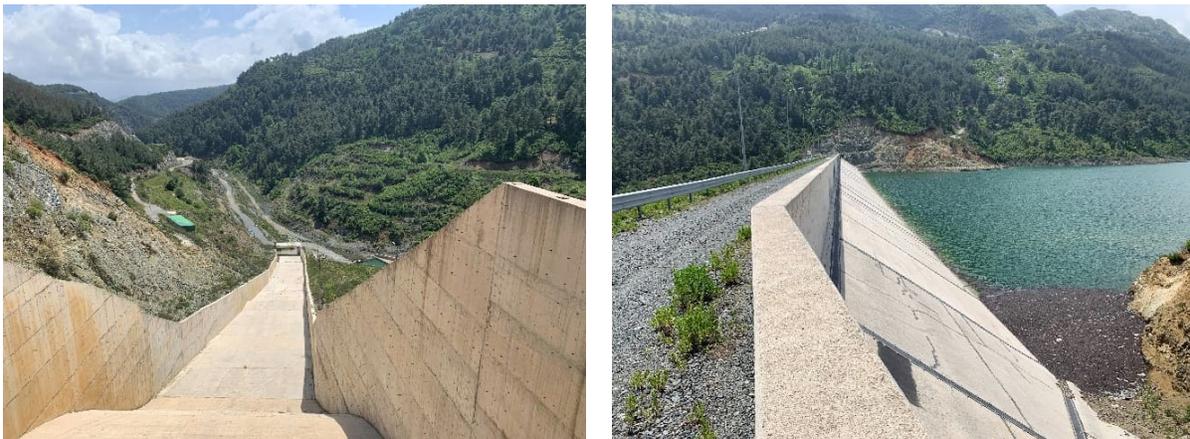
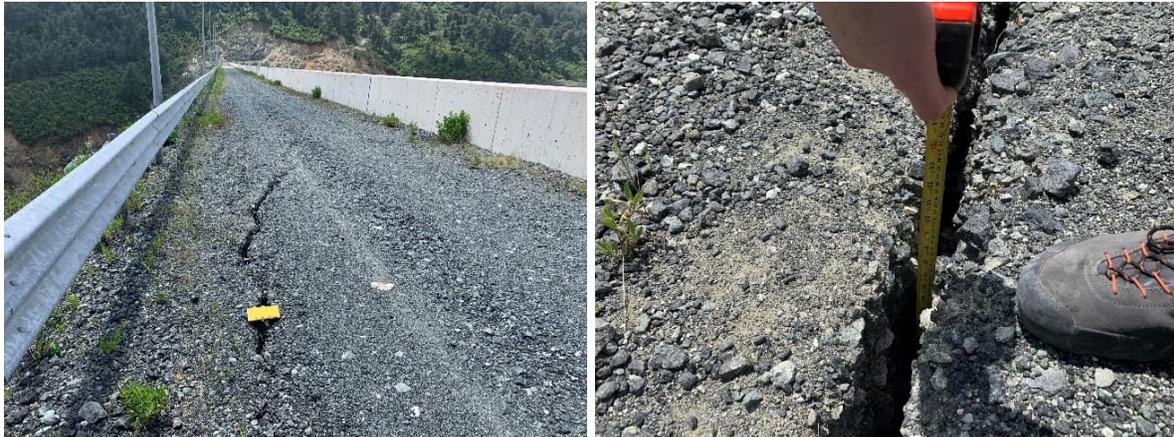
At the time of the review, the water level of the dam appeared to be at a typical operating water level and no damage was observed to the spillway or dam faces. Along the crest of the dam a 66 m tension crack was observed with maximum widths of 12 cm with up to 50 cm depth. This is illustrated in Figure 5.21.

**Figure 5.21: Condition photographs of Büyük Karacay Dam - 36.1877, 35.987**

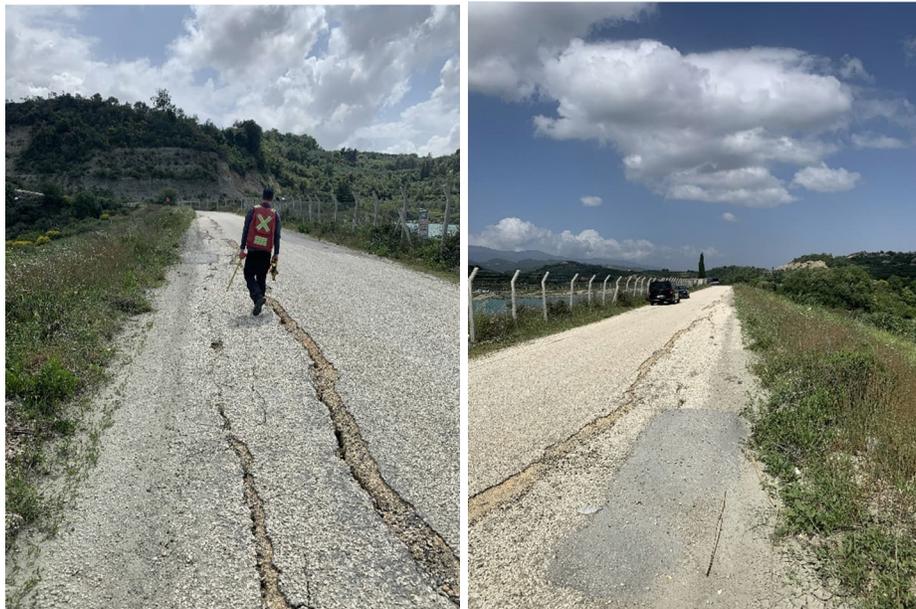
**Figure 5.22: Condition photographs of Karamanli Göleti Dam - 36.1693, 36.0329.**

At the time of the review, the water level of the dam appeared to be at a typical operating water level and no damage was observed to dam faces. Along the crest of the dam a 130 m tension crack with a maximum width of about 20 cm (Figure 5.21). The tension crack had been partially infilled with granular material to reinstate the driving surface.

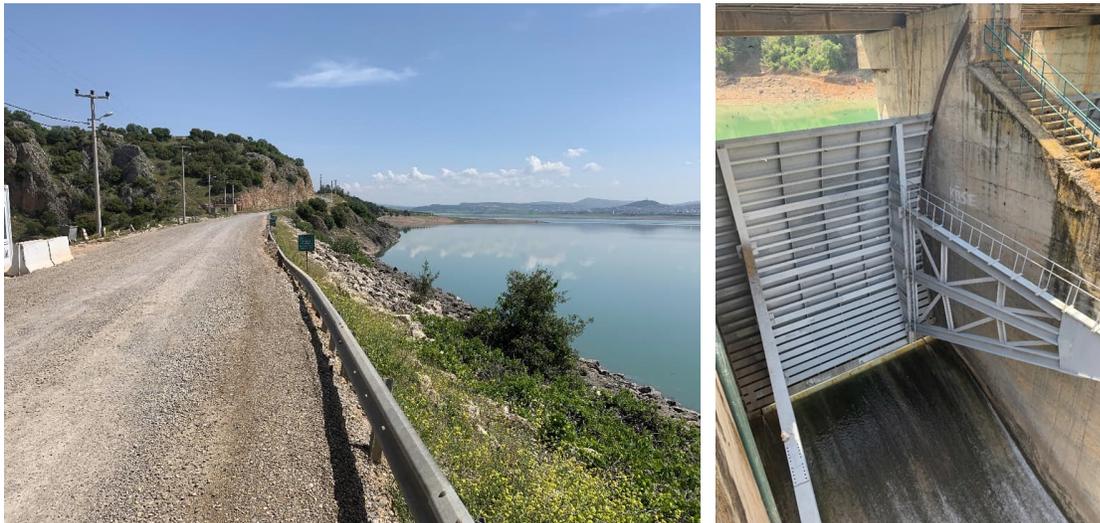
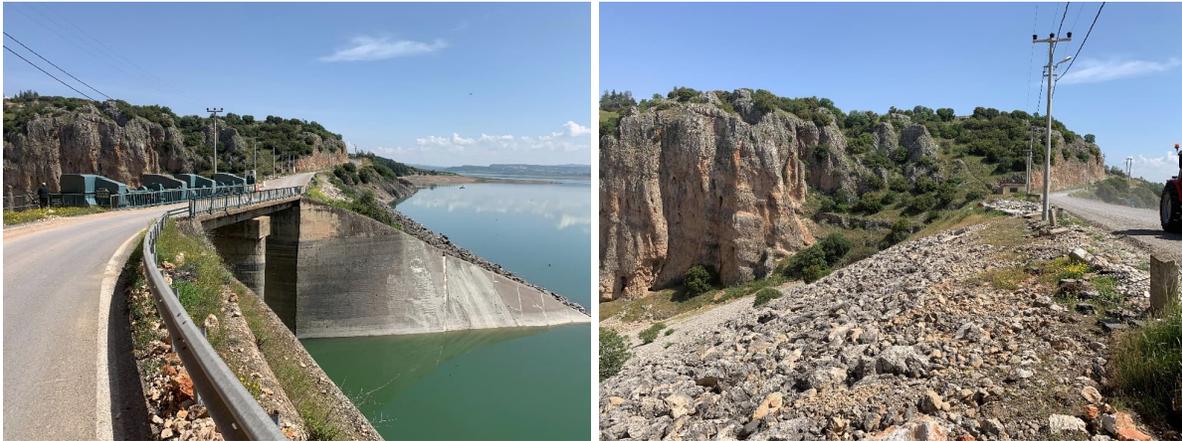
The dam had a paved running surface but due to extensive cracking at the crest the running surface on the crest of the dam has been covered in granular material to reinstate the roadway. It appears the crest of the dam slumped at the center about 0.5 m and granular material has been placed to level the running surface nearly covering the steel road barriers on the upstream side. The spillway is a concrete lined open channel on the left side of the dam. The spillway has two radial gates which appeared to be operational and allowing water down the spillway at the time of the review. The dam appeared to be operating at a lowered water level at the time of the review. The left wingwall of the inlet gate appeared to have undergone repair at the concrete joint compared to earlier observations made by the Türkiye Earthquake Reconnaissance and Research Alliance (TERRA) [6].

**Figure 5.23: Condition photographs of Kartalkaya Dam - 37.4684, 37.2390.**

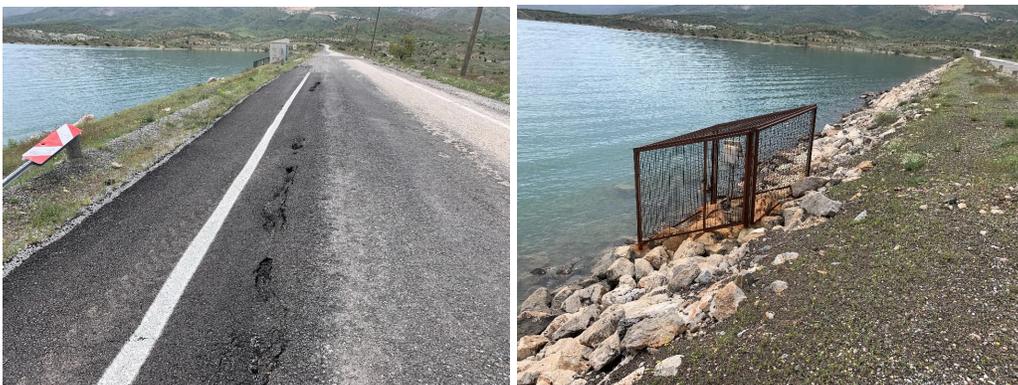
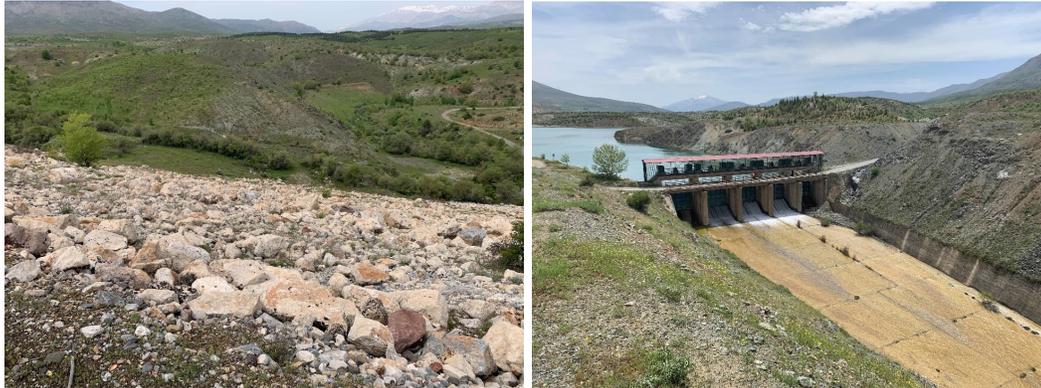
The Sürgü Dam, shown in Figure 5.23, is an earth core rock fill dam in Malatya that was commissioned in 1969 [6]. The dam is 57 m high with a crest length of 736 m. The crest is paved with asphalt and forms part of the Hudutköy Köyü road. As a result of the earthquake sequence surface cracking was reported on the crest of the dam with surficial tension cracks 14-20 cm wide [5, 6]. The cracks have been paved over with asphalt since the event, however distress was observed within the asphalt. Minor bulging was observed in the upstream face. Additionally, the rockfill on the downstream face appeared to have undergone surficial movements with some of the rockfill having rolled beyond the downstream toe of the dam. The estimated PGA values for the M7.8 and M7.5 earthquakes was 0.19 and 0.50 g, respectively, with PGV values of 44 cm/s and 125 cm/s, respectively [5].

The dam has a concrete lined open channel spillway which has five sluice gates. The spillway is not attached to the dam and is separated from the dam about 500 m to the south on the left side of the dam. At the time of the review the central three gates were partially open. The south spillway wingwall had partially failed with debris still present within the spillway channel near the southmost gate. The reservoir appeared to at a normal operating level at the time of the review.

**Figure 5.24: Condition photographs of Sürgü Dam - 38.0350, 37.8795.**

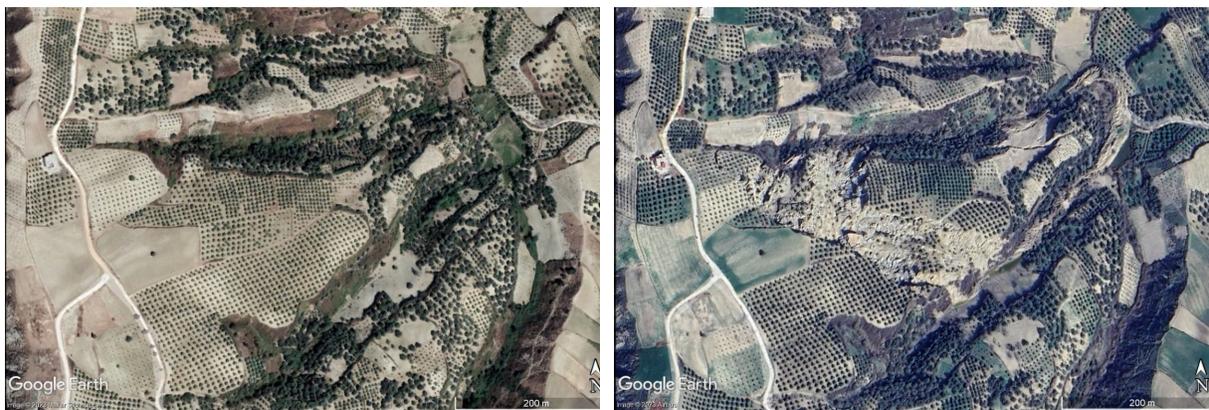
The geology appeared to be comprised primarily of a weathered diatomaceous claystone with marl or shale interbeds. The geology consists of the Tepehan formation which comprises of sandstone, clayey limestone, claystone, and marl [5]. The bedding planes were dipping coplanar to the slope at about 7-10 degrees, with the slope angle varying between about 10 to 20 degrees. Locals noted the slide occurred following a period of wet weather. A small pond

had formed due to the accumulation of material at the toe of the landslide. Ground motions as a result of the M7.8 earthquake estimated the PGA as 0.40 g and the PGV as 48 cm/s [5]. Aerial imagery and observed conditions are shown in Figure 5.28 and Figure 5.29.

**Figure 5.28: Aerial Imagery of the Olive Grove Block Slide, Tepehan, Hatay - 36.1618, 36.2195. Left - Google Earth Aerial Imagery Dated Sept. 26 2021, Right - Google Earth Aerial Imagery Dated Feb. 11, 2023.**

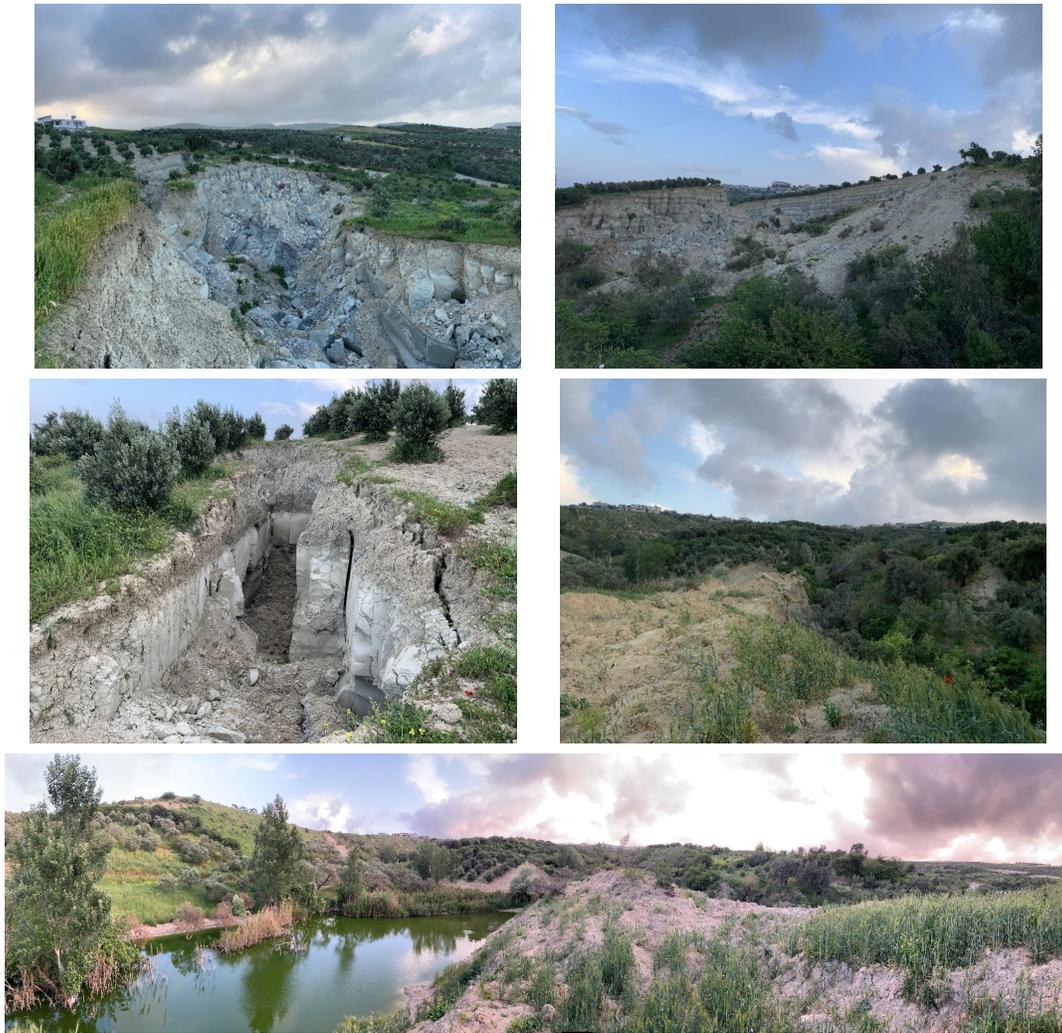
**Figure 5.29: Olive Grove Block Slide, Tepehan, Hatay - 36.1618, 36.2195.**

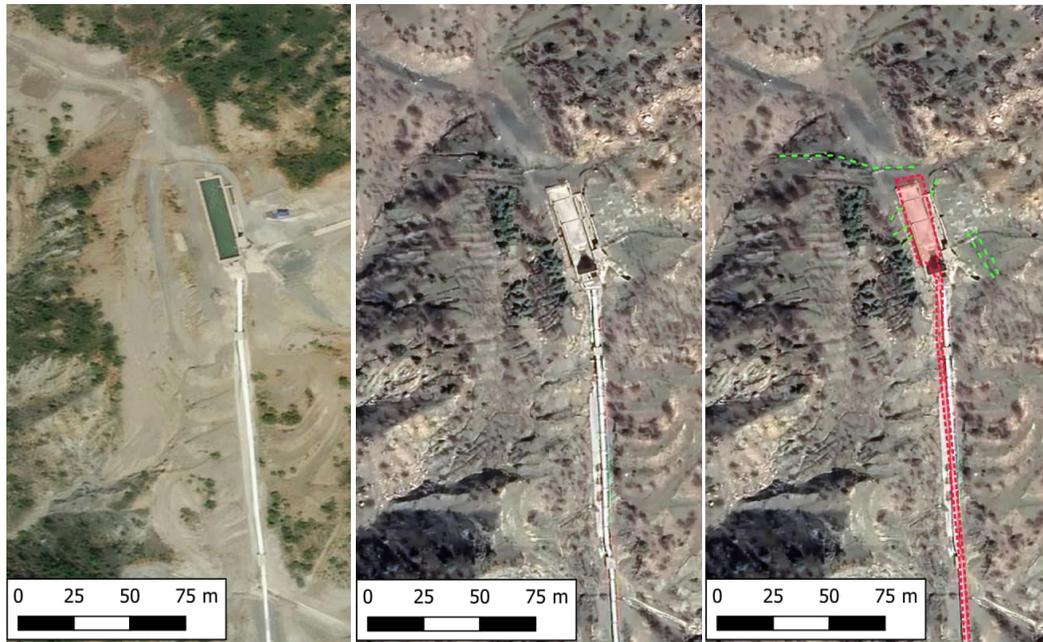
The forebay to the penstocks, which was comprised of three open channel concrete segments, underwent significant displacements at the joints and was no longer functional. Curvilinear

tension cracks and scarps were present around the forebay suggesting seismic slope stability as a probable cause of the observed displacements to the forebay. Additionally, significant damage was observed to the penstock foundation elements which had typically failed with the footings being observed downslope of the adjoining pipe connections. Furthermore, the penstock had buckled at one of the thrust blocks which appeared to be coinciding with the general trend of observed movement downslope. No damage was observed to the thrust blocks at the joints of the penstocks. The intake tunnel was not reviewed.

**Figure 5.30:** Comparison of Pre- and Post-event Satellite Imagery of Tektuğ Erkenek Hydroelectric Facility - 37.8694, 37.8201. Left - Bing Aerial Imagery Undated, Centre - Google Earth Aerial Imagery Dated Mar. 20, 2023, Right - Google Earth Aerial Imagery Dated Mar. 20, 2023 with overlay of original location (red) and surficial cracking (green).

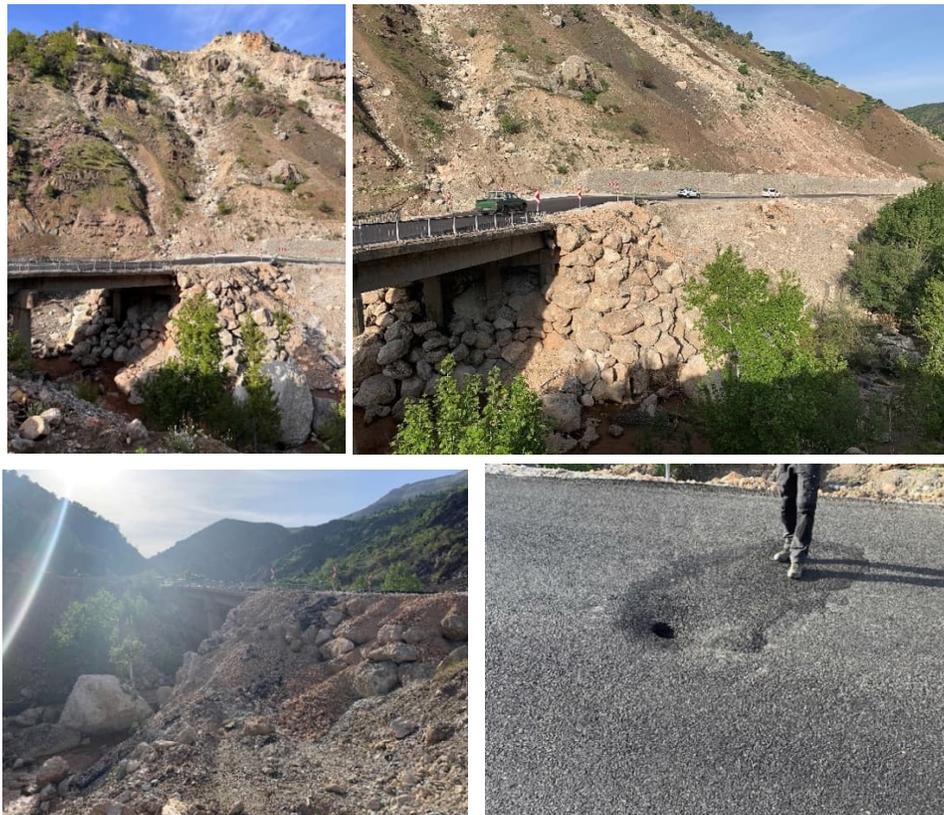
The Bulam 2 bridge on the Adiyaman-Çelikhan road outside of Mestan village in Adiyaman failed due to rockfall during the earthquake sequence. The bridge was a three-span bridge with two piers within a creek channel. The bridge had an initial total span length of about 45 m between the two abutments. As a result of the rockfall the eastern most span was destroyed.

The rockfall appears to have originated about 100 m above the roadway and travelled down the 50 to 60-degree slope to where it struck the bridge. The rockfall material included limestone boulders up to approximately 80 m<sup>3</sup>, which were observed in the creek channel at the time of the review. Following the rockfall, the bridge was reinstated to allow for traffic to pass by infilling the failed first span with large rockfill to the eastern pier. The surface of the rockfill was paved to allow for traffic to pass. At the time of the review, holes were observed in the asphalt pavement which was attributed to material redistributing into the voids of the rockfill which appeared to be placed uncompacted and with an open gradation. Additional damage was observed to the stone retaining structures that appeared to be due to strikes from rockfall at the crests of the wall. Figure 5.34 below shows the condition of the Bulam 2 Bridge at the time of the review.

**Figure 5.34: Bulam 2 Bridge, Adiyman-Çelikhan Road- 37.9835, 38.2821.**

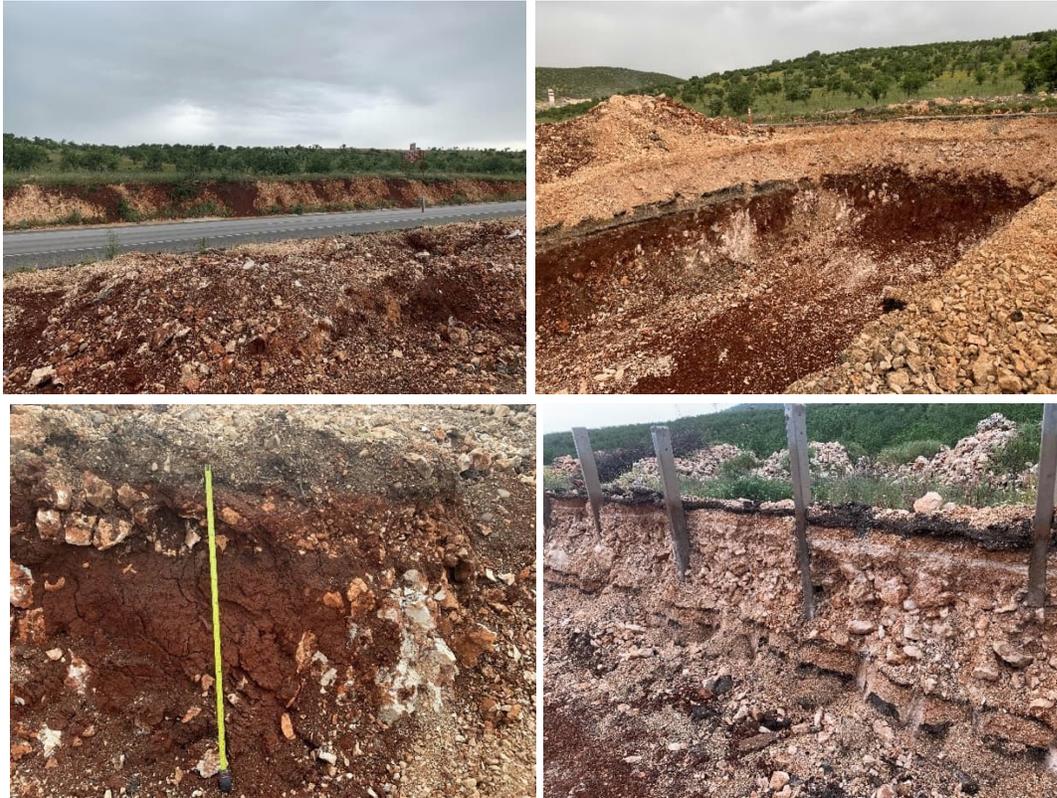
**Figure 5.35: 37.5104, 37.3876.**

In addition to the landslides, rockfall and slope stability there were two failures identified related to karst geology. The first was on the D360 Gaziantep-Malatya Highway where the road appeared to have experienced differential settlement due to infilled limestone dolines. At the time of the review, the north two lanes, the previous westbound lanes, of the four laned roadway were open allowing for a single traffic lane in each direction. The north lanes had been repaved and lowered relative to southern two lanes, the previous eastbound lanes. Review of the temporary soil cuts showed multiple layers of asphalt and road base suggesting this site had experienced problems with differential settlement in the past. The infilled dolines were

visible within the existing rock cuts and temporary excavations. It is uncertain if as a result of the earthquake sequence additional settlement occurred which resulted in the extensive repairs observed during the reconnaissance or if the repairs predated the earthquake sequence. Figure 5.35 shows the infilled dolines in the rock cuts and temporary excavations, and the multiple asphalt surfaces within one of the temporary soil cuts.

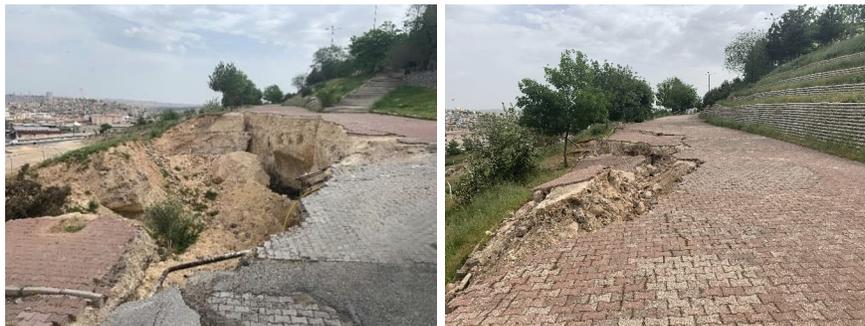
A second area where karst geology resulted in a failure was within Gaziantep on a pedestrian path located at the end of Derin Çukur road. A large sinkhole developed on the path that was about 40 m long, 25 m wide and 10 to 20 m deep. Smaller sinkholes were observed further north along the pathway.

**Figure 5.36: Gaziantep Derin Çukur Road Sinkhole 37.0543, 37.3854.**

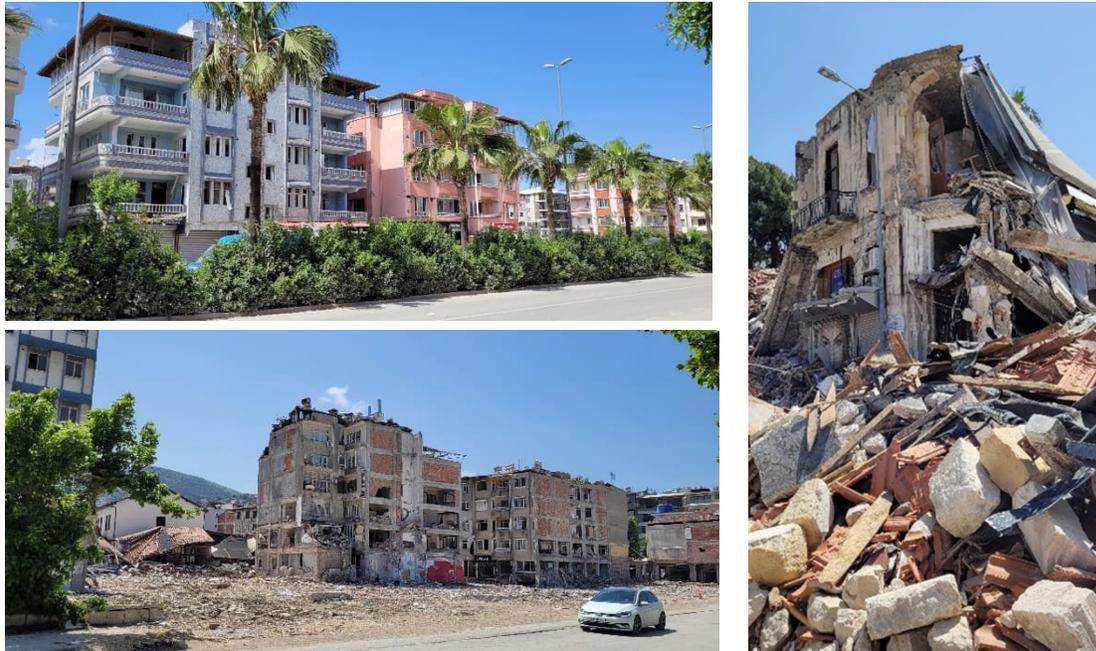
*Antakya*, the capital of the province of Hatay, is the southernmost province of Türkiye. Located in close vicinity to the Syrian border, this city was identified as that most damaged during the earthquakes. The main reason for the extensive damage is due to the fact that Antakya is founded on deep alluvial deposits. During the reconnaissance, the extent of damage was confirmed, in particular in the city center along the Orontes River. Entire neighborhoods appear to have been abandoned due to the catastrophic and extensive damage. The team focused on the severely affected historic center with many masonry and stone structures and a nearby neighborhood characterized by older concrete buildings. Typical damage observed in Antakya is illustrated in Figure 6.12. Better performance was observed for newer buildings founded at higher elevations which are inferred to have been constructed on more competent soil conditions.

**Figure 6.12: Typical observed damage in Antakya.**

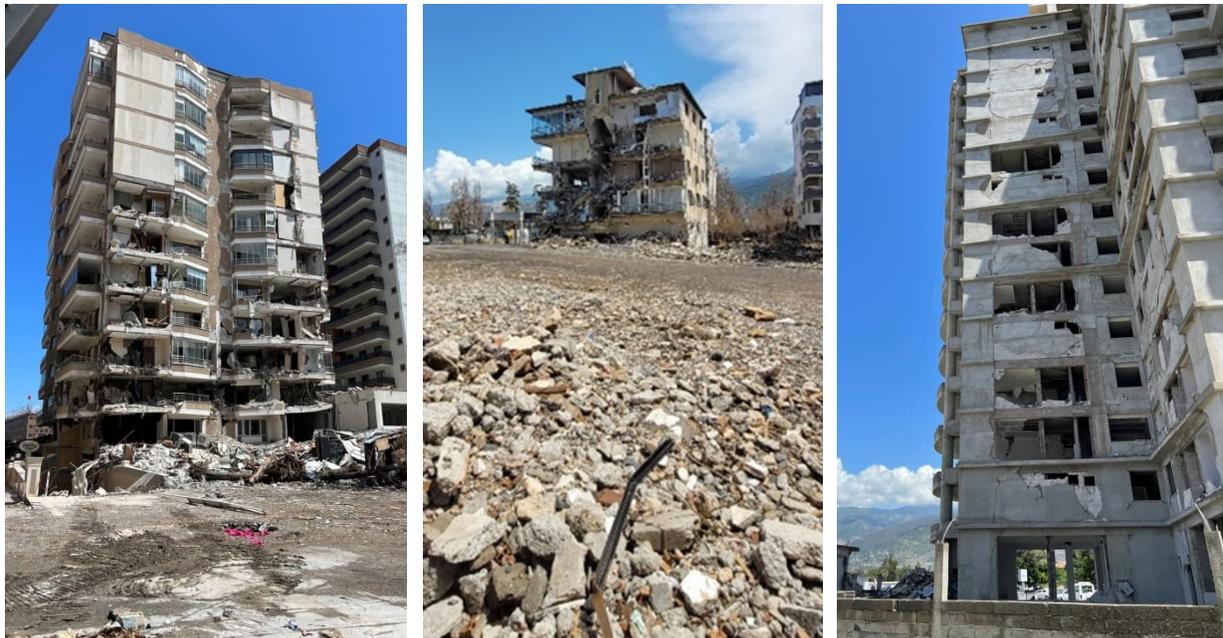
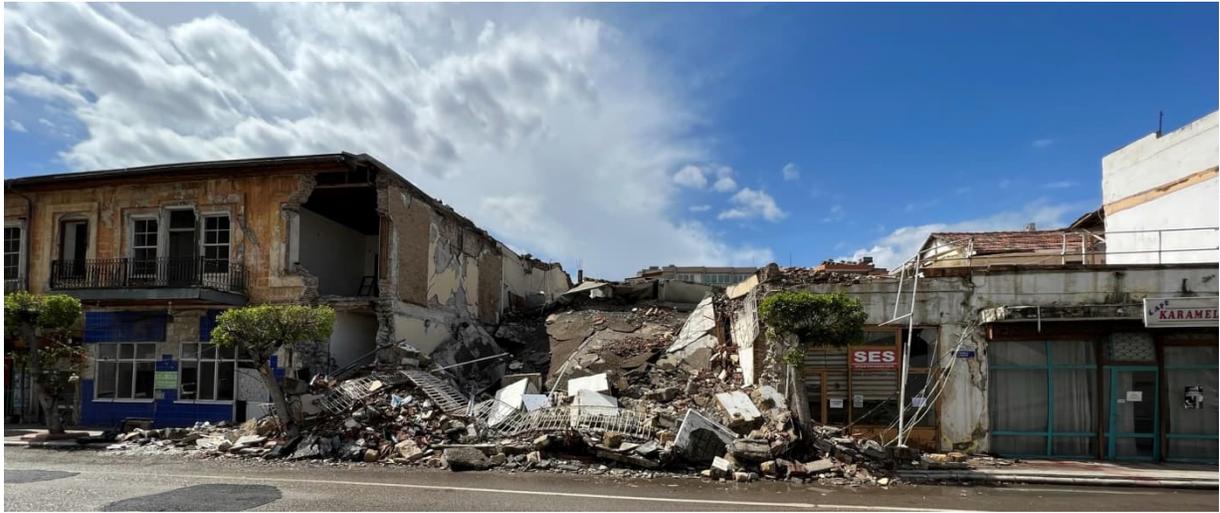
*İskenderun*, a port city located in the province of Hatay, was also heavily affected by the events. The reconnaissance was focused on neighborhoods close to the waterfront. The team observed widespread damage associated with poor soil conditions and liquefaction in a well-defined area. See Section 5.1.1 for further details on the liquefaction observed. Buildings in other areas of the city also presented damage to historic buildings and non-structural damage to modern construction observed, although in a smaller proportion than the waterfront regions. Figure 6.13 shows typical damage observed in İskenderun.

**Figure 6.13: Typical damage observed in İskenderun**

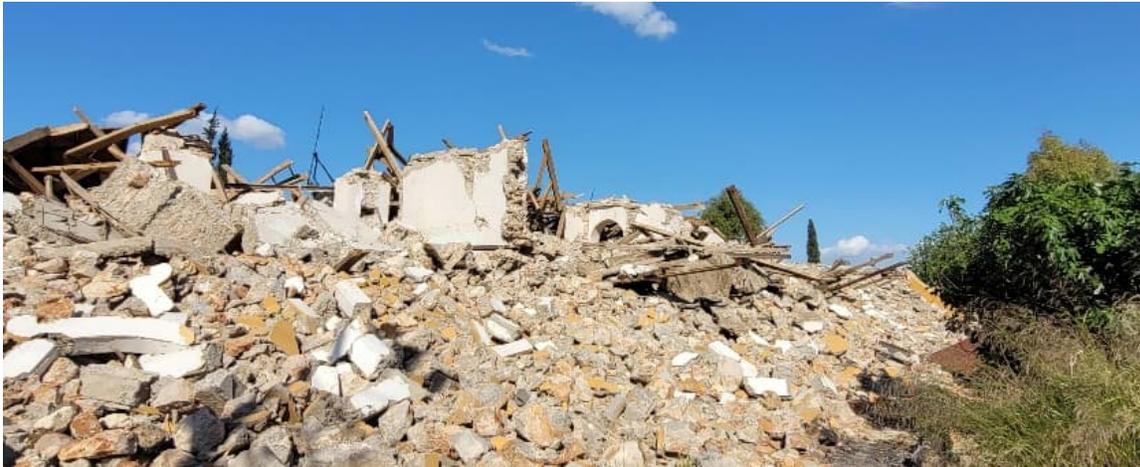
**Kırıkhan** is a smaller town in Northern Hatay. Widespread damage was again observed throughout the town. Detailed observations were focused on historic structures. A monument of high religious and cultural significance, Türbe, in the vicinity was also visited. Figure 6.14 shows some of the damage observed in Kırıkhan.

**Figure 6.14 Cont.: Typical damage observed in Kırıkhan**

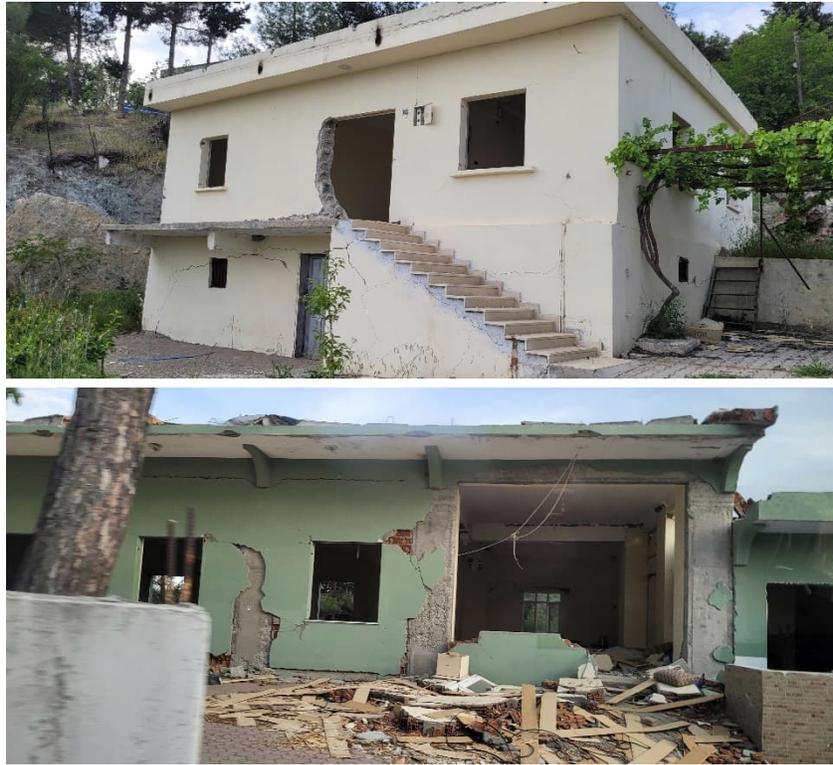
Other than the main urban centers described above, small villages in rural areas were also visited. Damage varied from one to another, but overall, the damage was significant when a building site was closer to a fault line. Typically, construction was made from reinforced concrete and/or masonry, with buildings one or two storeys in height. Examples of these buildings are shown in Figure 6.25: Typical observed damage in small villages.

**Figure 6.25: Typical observed damage in small villages**

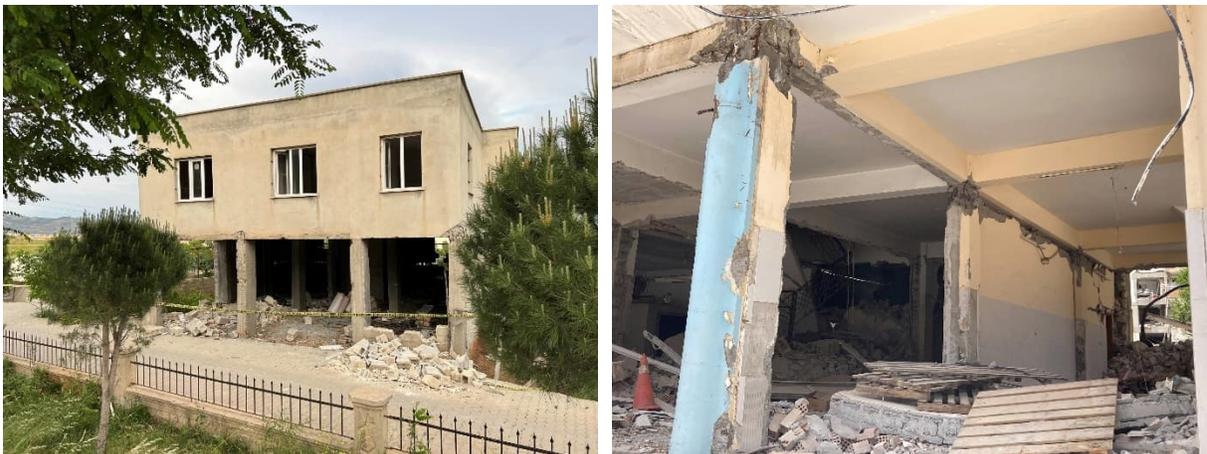
**Figure 6.26: Damage in moment frame buildings due to soft storey effects**

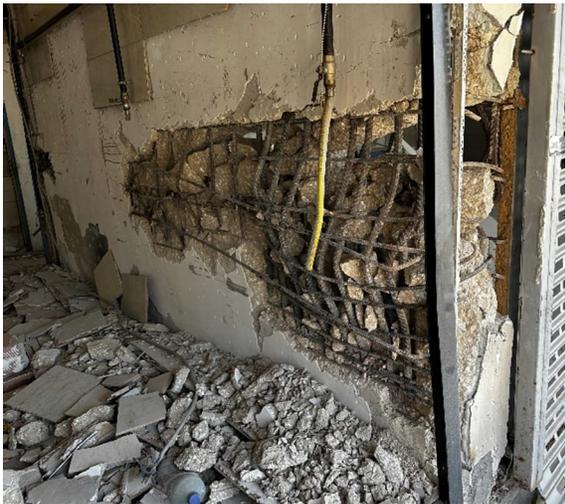
(a) vertical bars buckling

**Figure 6.27: Damage to shear walls and coupling beams, Antakya**

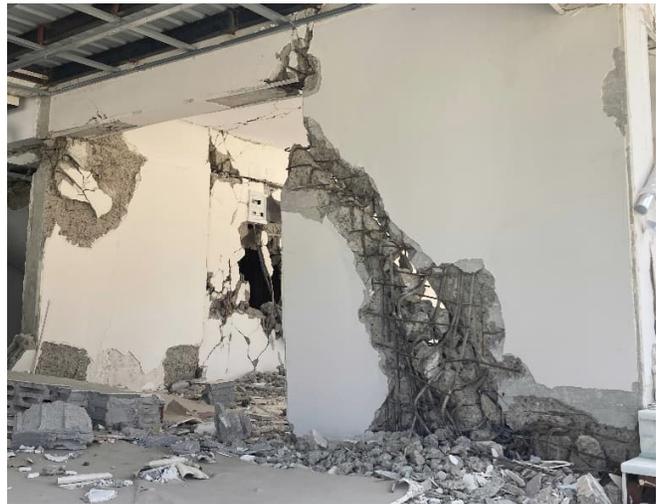
(b) diagonal tension failure

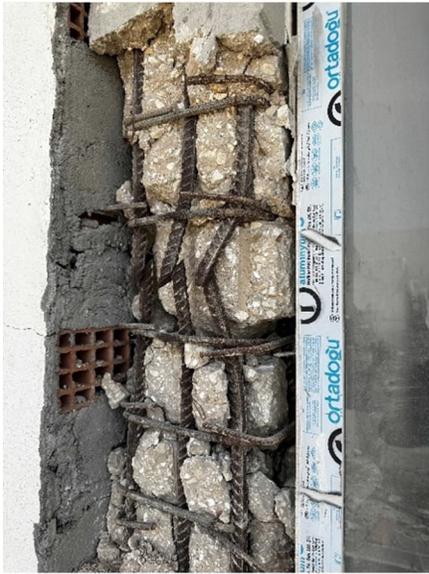
(c) vertical bars buckling failure, concrete crushing

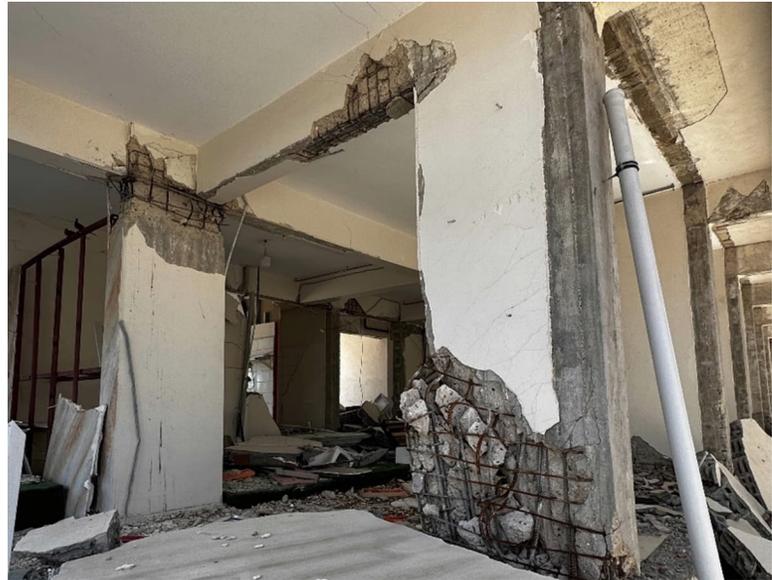
Buildings with shear walls showed improved performance over older RC moment frame structures but many were still heavily damaged in areas that experienced very high ground motions. Some examples of severe damage observed in shear walls are shown in Figure 6.27 in Antakya. This building was located a couple of blocks from the Orontes River. Despite that this building was constructed only 5 years ago, the team observed issues of inadequate reinforcing detailing and questionable concrete material quality. It should be noted that the earthquake ground motions in this area exceeded the design level forces and despite the high level of damage, the building could be deemed as meeting its performance objectives since it did not collapse. A significant number of new buildings, presumably of similar construction and with shear wall SFRS, collapsed in this area.

(d) hinge in coupling beam and top of SW (left); shear or bond failure causing bar buckling and concrete crushing in SW (right)

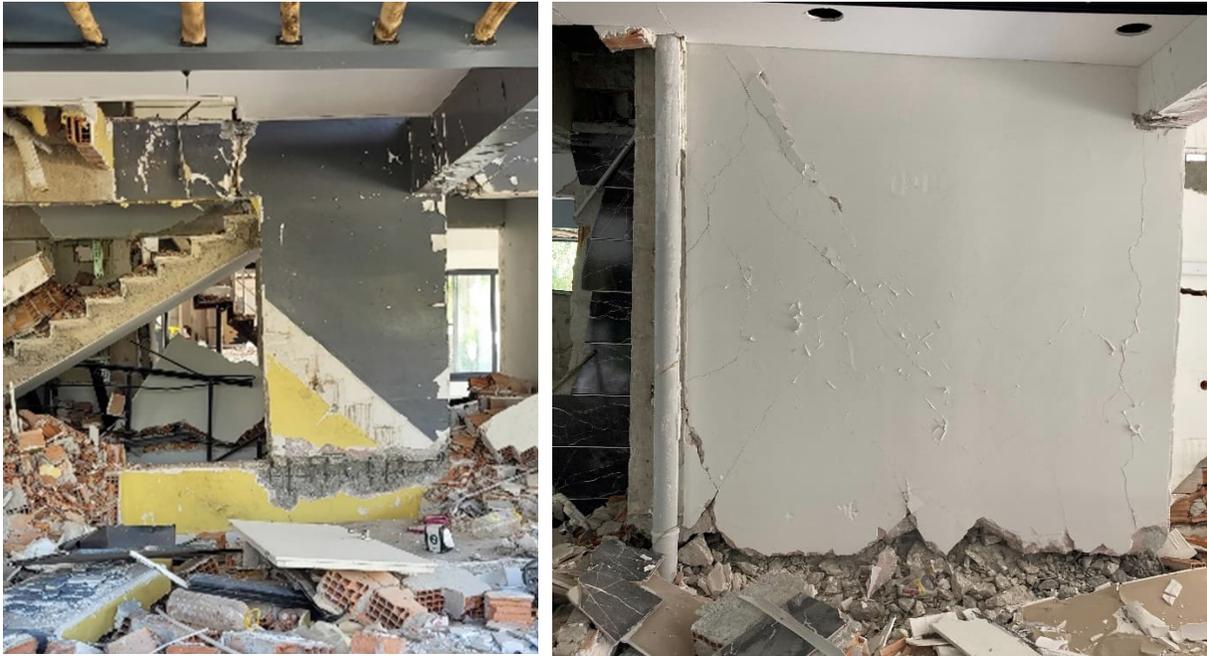
Sliding shear failure was also documented in newer buildings a bit further distanced from the Orontes River in Antakya, see Figure 6.28. The team also observed examples of shear wall buildings in this same area which performed very well with only minor cracking evident in the shear wall elements. It was the opinion of neighboring building owners that the buildings which did not perform well had poor oversight during construction and were not constructed in conformance with the seismic code. Those documented had only minimal shear walls in relation to the height of the building. They also advised that, at the time of construction of their buildings, it was often difficult to get ready mixed batched concrete in Antakya since the nearest concrete plant was some distance away. There are currently ready-mix concrete suppliers in Antakya.

**Figure 6.28: Examples of shear wall sliding shear failure, Antakya**

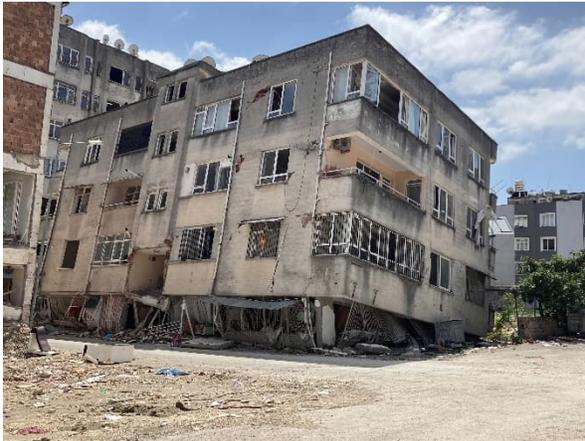
(a) short column hinging & partial collapse of ground floor level, frame structure

**Figure 6.29: Short column failures in buildings in Antakya**
