# February 6, 2023 Kahramanmaraş Earthquakes in Türkiye

## Reconnaissance Report

Canadian  
Association  
for Earthquake  
Engineering  
and Seismology

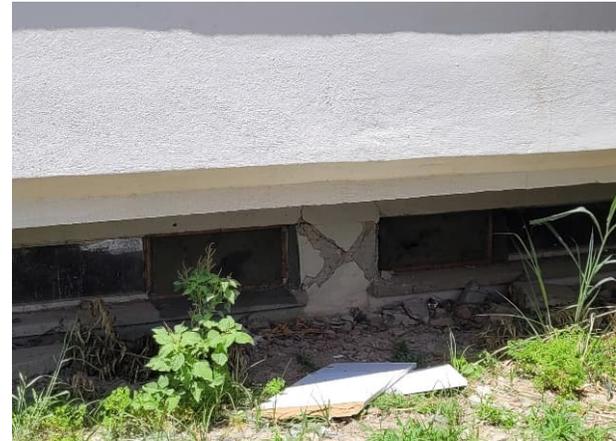
(b) classic diagonal shear cracking

**Figure 6.29: Short column failures in buildings in Antakya**

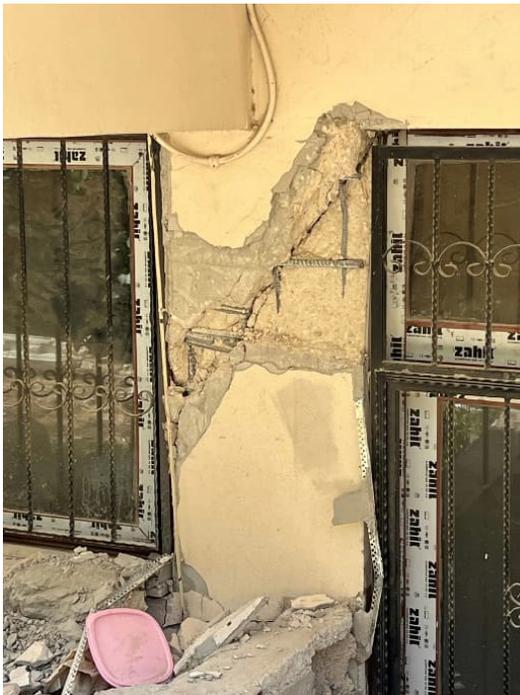
(c) short column shear failure, shear wall SFRS

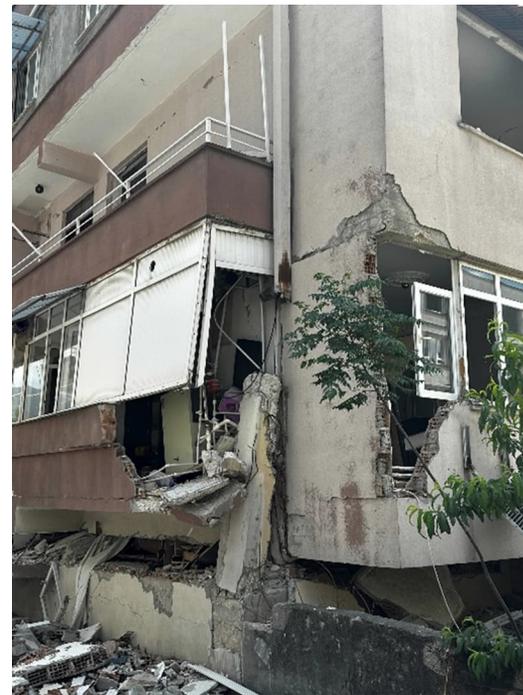
(d) ground floor collapse – column snapped off due to large drifts, frame structure

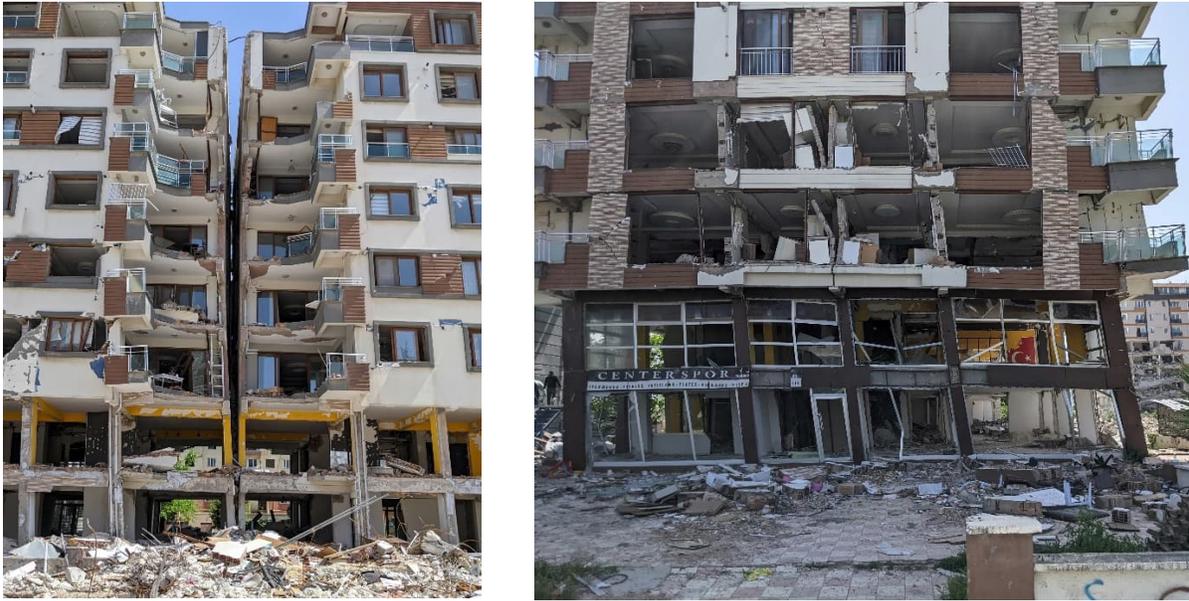
Another observed scenario was a strong beam-weak column condition. In this case, a soft storey will occur and cause hinges to form on the columns. This was observed in buildings with URM infills at the top levels only. The stiffness imparted by the URM infill was so much greater than the inherent stiffness in the SFRS of the storey below without URM infill, that it resulted in a strong beam-weak column mechanism. The maximum displacement demand was concentrated in the first storey below the residential floors and resulted in complete building collapse, collapse of the first storey, or significant residual drift and concentrated damage in the lower storey lateral resisting elements (Figure 6.30 and Figure 6.31).

**Figure 6.31: Observed residual drift, Antakya.**

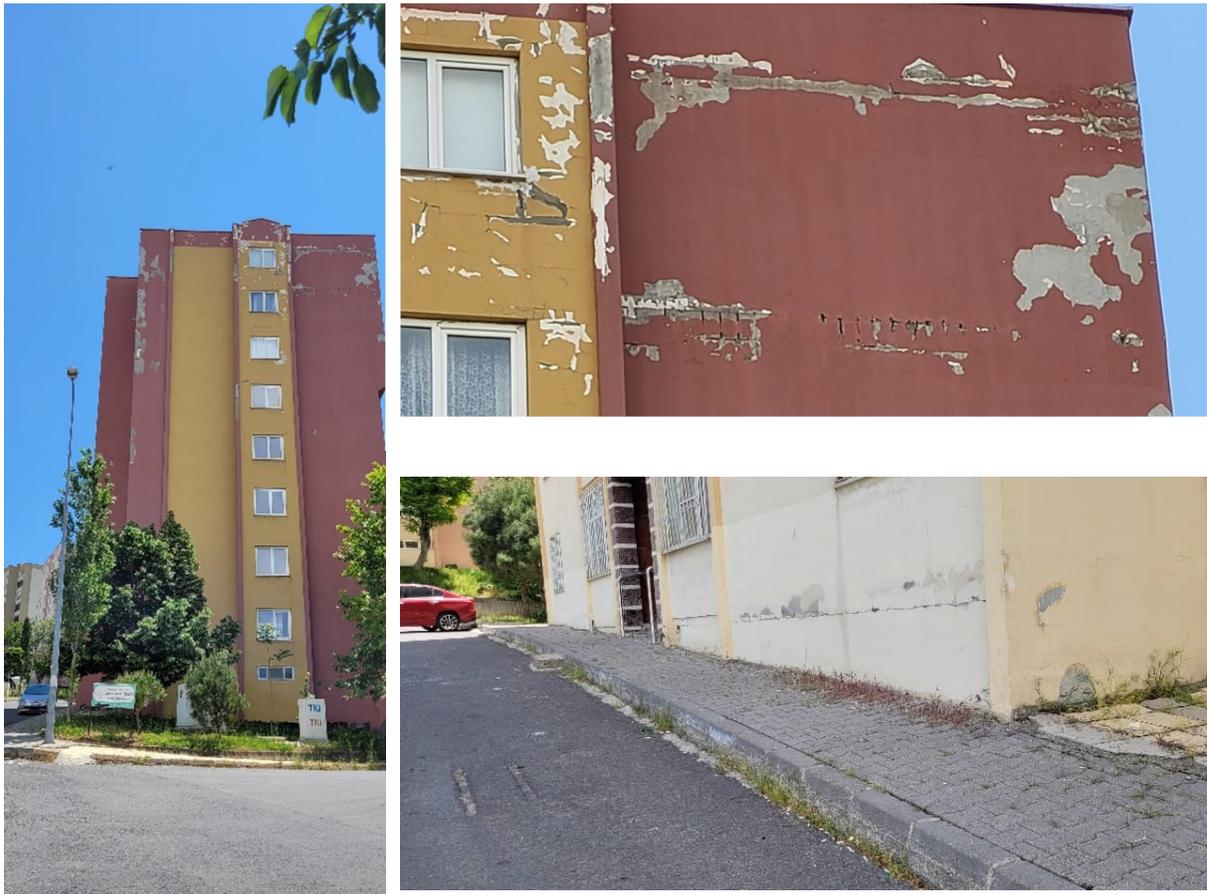
The team was able to observe several tunnel form buildings at two locations. In Kahramanmaraş, around 30 buildings of this type were observed on the same site, with little to no damage, as shown in Figure 6.34. Damage observed could likely have been caused by degradation and may not be a result of the earthquakes. For example the exposed, corroded bars may be due to lack of concrete cover, or cracks in cold joints as shown in the figure. While the buildings performed well, it is important to note that they were located in an area that overall suffered limited damage. Figure 6.35 shows a photo of the neighboring buildings for comparison.

**Figure 6.34: Tunnel form buildings in Kahramanmaraş [37.57628, 36.857665].**

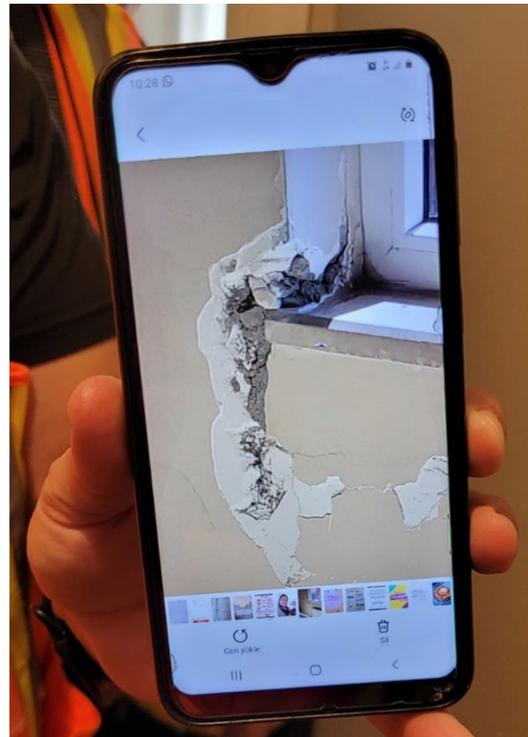
(c) Reported damage

Another complex of tunnel form buildings (10 individual buildings) was visited in Osmaniye, where the team was granted access to one of the units (Figure 6.36) **Error! Reference source not found.** While no damage was observed, some small damages were reported by the inhabitants, but these had already been repaired (Figure 6.36 (c)).

**Figure 6.36: (a), (b), & (d) Tunnel form buildings in Osmaniye [37.07506627, 36.2285699], (c) Only reported damage to tunnel form buildings.**

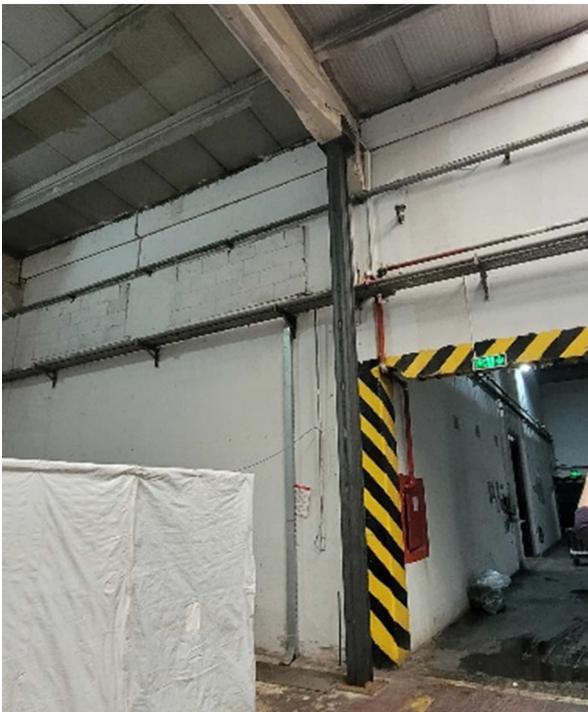
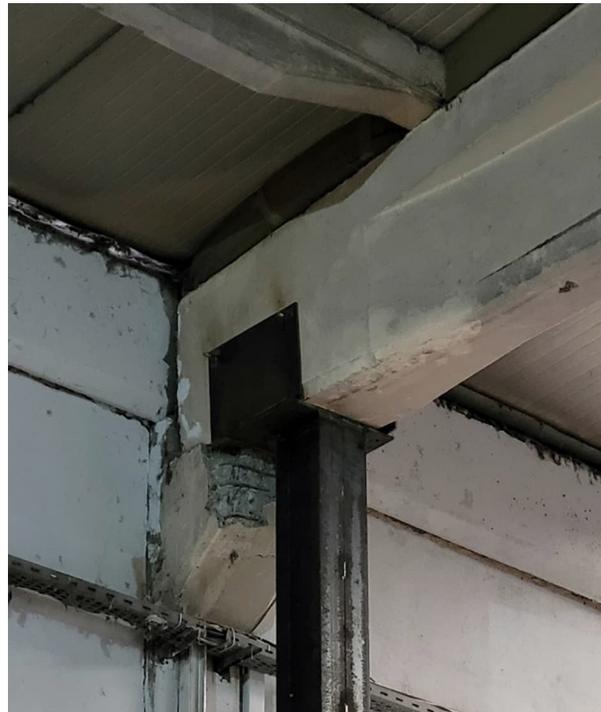
Figure 6.39 shows a close-up of the typical column-to-beam connections. **Error! Reference source not found.** shows the only damage observed at this location consisting of spalling of the concrete cover on the column corbel. The structure had already been retrofitted by the addition of a new steel column and shoe bracket to support the beam at the damaged corbel. The factory owners reported very little disruption due to the earthquake. The perceived shaking intensity was so low that work continued uninterrupted through the night shift.

**Figure 6.40: Observed damage and repair at connection, precast frames [37.16311557, 37.29198872].**

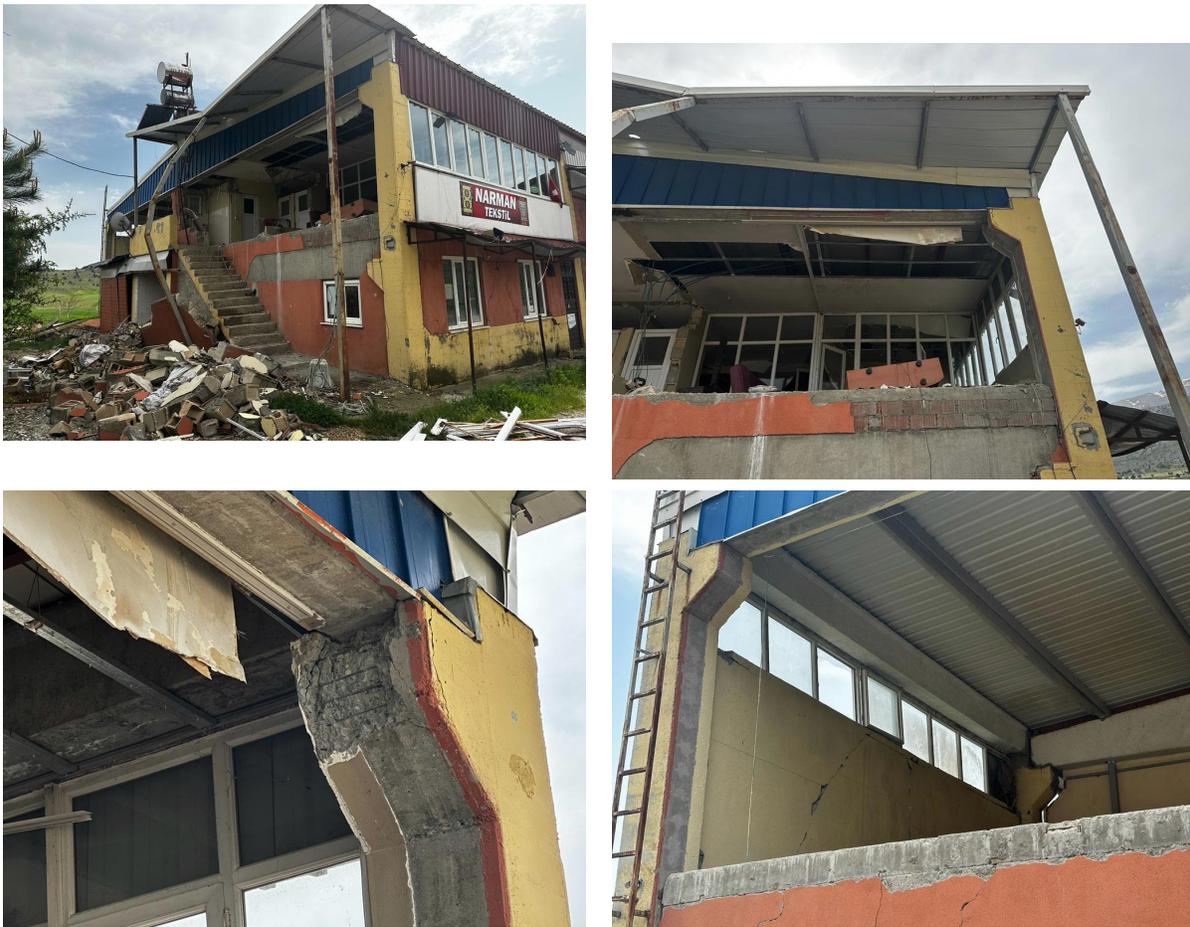
The second site visited was a much smaller rural industrial facility in Nurhak, 50km south-east of Elbistan). As can be seen in Figure 6.42, infill walls collapsed and some damage was observed

to the column corbels, although it appeared that the damage was limited to spalling of the concrete cover over the ties and did not penetrate into the corbel core.

**Figure 6.42: Precast concrete frame rural industrial facility [37.968578, 37.487122].**

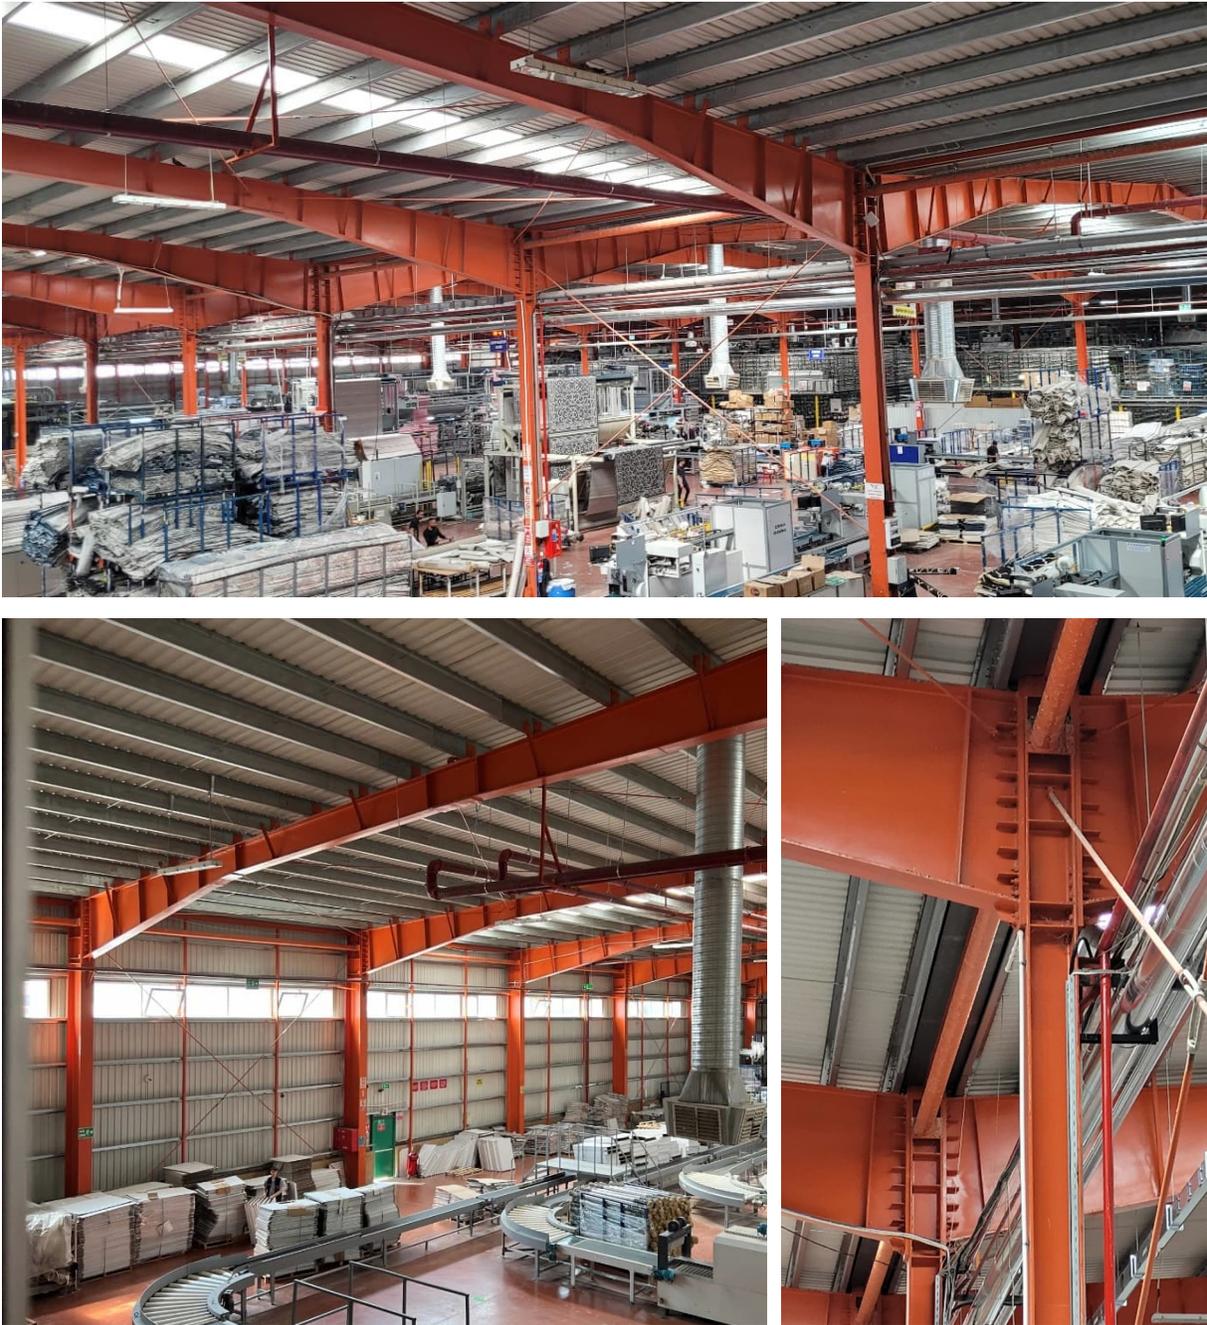
**Figure 6.44: Structural steel industrial carpet factory in Gaziantep.**

Structural steel construction is not very common in Türkiye. The structural team documented only two completely structural steel industrial buildings. The first building shown in Figure 6.44 is a structural steel industrial carpet factory which performed very well despite that the connections are not detailed following capacity design principles. This structure consists of a system of welded W-shaped girder moment frames spanning 35 m. Columns are also W-sections anchored at the base. The lateral system in the direction perpendicular to the moment frames consists of steel rod bracing tensioned with turn buckles. The bracing terminates about 2.5 m – 3 m above the floor to minimize interference with factory operations. Similar in-plane roof bracing runs the width of the building between vertical bracing lines. Vertical bracing is located every second or third bay.

The only visible damage was buckling of some of the in-plane rod roof bracing, although the damage is not evident in the photos. The factory owner was fully aware of the damaged elements and intended to replace the yielded bracing.

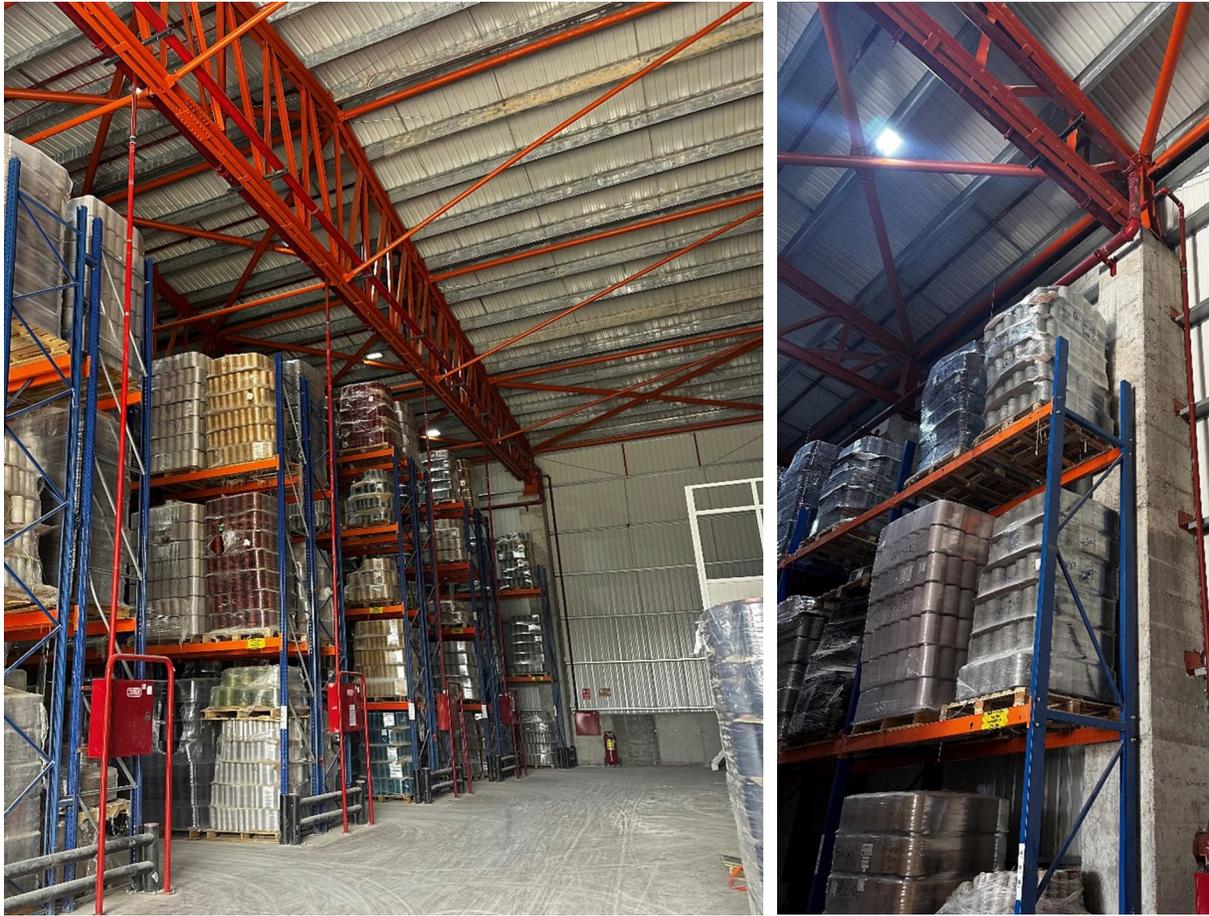
**Figure 6.45: Hybrid Structural Steel and RC warehouse support structure for carpet factory, Gaziantep.**

A second warehouse storage building on the same site was a hybrid structural steel and RC structure, see Figure 6.45. Long span truss girders span 32 m across the width of the warehouse and are supported onto precast concrete columns. Evenly spaced steel channel purlins span between the truss girders and support an insulated metal panel roof deck. Steel channel girts with sag rods span between the columns and support insulated metal panel exterior cladding. A system of round HSS in-plane roof bracing forms the lateral resisting system for the roof. Given their size they are assumed to be tension/compression bracing. The roof bracing is anchored to upstand posts on top of the concrete columns.

The concrete columns are precast and are fixed at the base into socketed footings similar the precast concrete columns described in Section 6.5. A continuous cast-in-place upstand RC wall approximately 1.2 m high runs between the RC precast columns.

This building performed very well in the earthquake and showed no visible signs of damage to the structure. The factory was fully operational. The factory owner informed the team that both buildings were founded on a rock substrate.

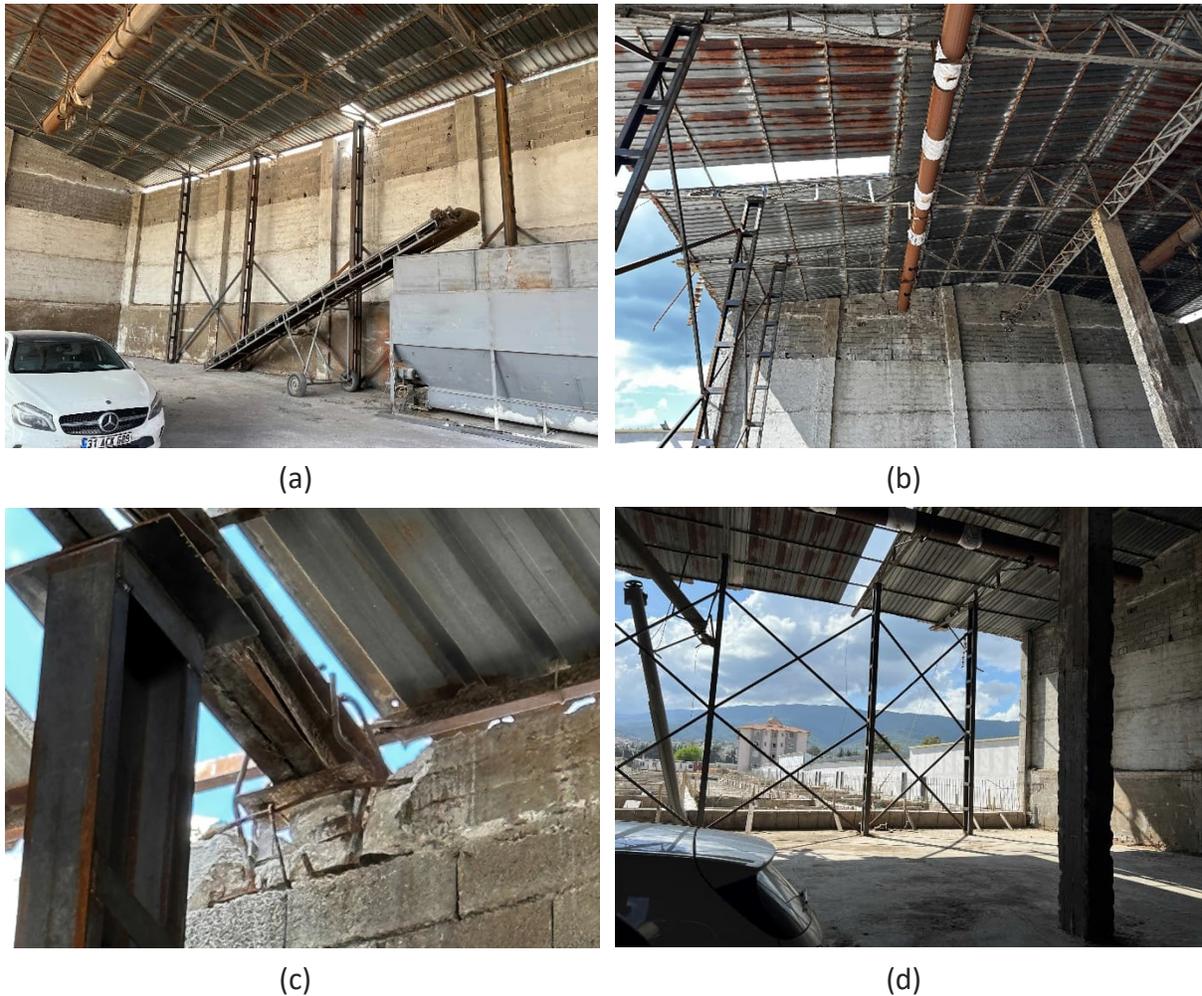
**Figure 6.46: Industrial steel roof structure outside Antakya.**

Another industrial structure was investigated on the outskirts of Antakya which was constructed with a light steel framed roof consisting of a form of open web steel joists supporting very light purlins and corrugated metal decking (Figure 6.46). This structure was a support building for a cotton oil factory. The centre beam strut, providing lateral support for the center concrete columns, consisted of a triangular steel space frame. The roof girder layout was not well coordinated with the exterior masonry wall pilaster spacing and beam to wall connection locations were not located at pilasters. Significant damage was observed at the joist to wall connections. The bracing visible in the photos was not present prior to the earthquakes and was being added at the time of the reconnaissance. The structure adjacent to the open wall had collapsed and was being reconstructed at the time of the reconnaissance.

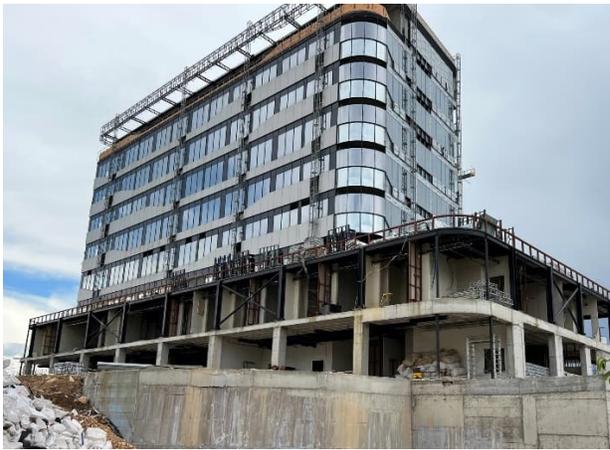
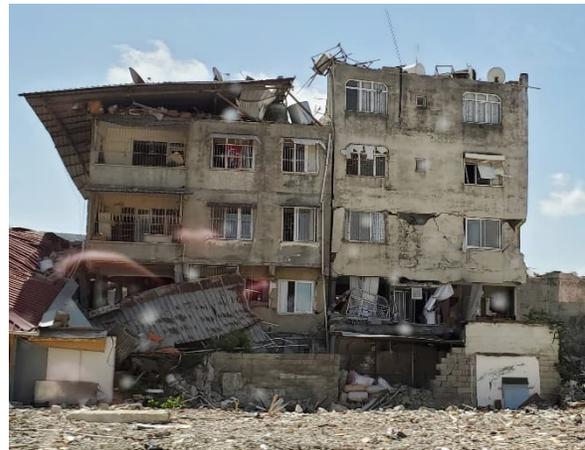
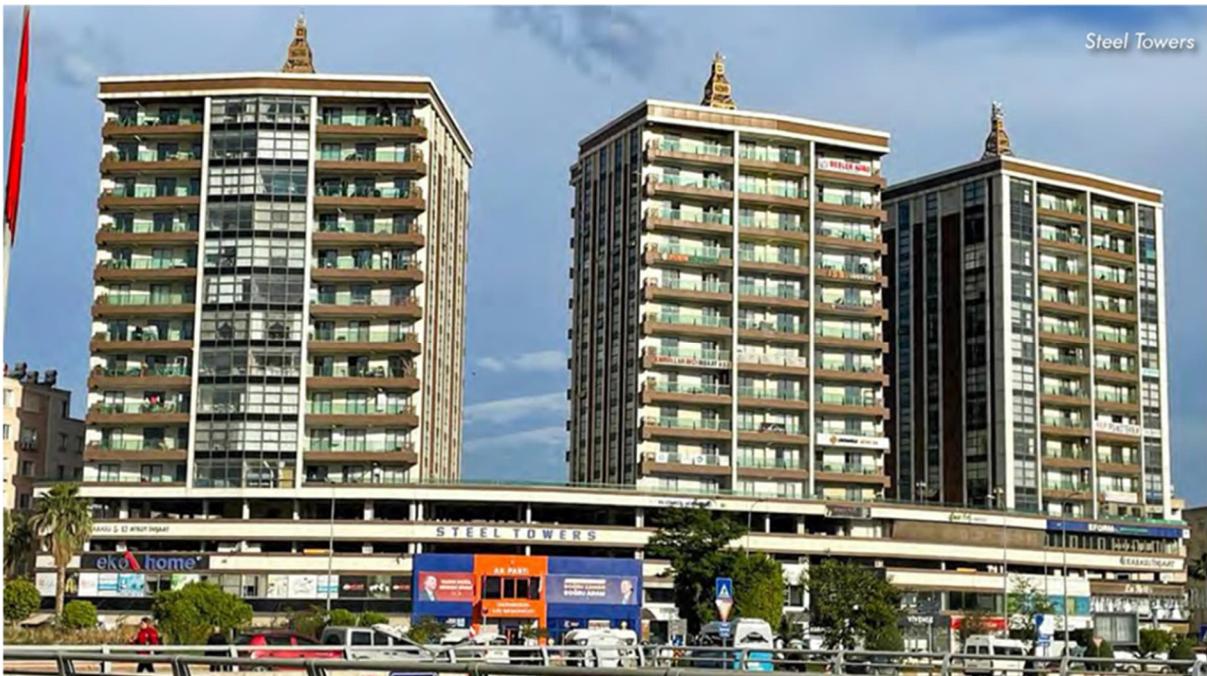
**Figure 6.47: Examples of structural steel in residential buildings (image courtesy of Celik Yapilar).**

Steel is more commonly incorporated as components in residential and commercial buildings such as sandwich panel roof decking on precast concrete buildings or to frame penthouse or podium roof structures. Figure 6.47 shows observed examples of structural steel structure framing for a new podium roof under construction and a collapsed penthouse roof on a four-storey building. Many light framed roof structures observed had collapsed, presumably due to inadequate bracing or anchorage to the main structure.

Although the CAEES/ACGPS structures team did not investigate any residential buildings with structural steel as the main gravity and seismic force resisting system, the good performance of a multistorey three building residential complex in İskenderun was reported in a local publication named “Çelik Yapılar” published by the Turkish Structural Steel Association (TUCSA). This three-building complex named “Steel Towers” did not experience notable damage and continued to be occupied by residents without any interruption. The photograph of this complex is the courtesy of TUCSA (Figure 6.47 b)).

Structural steel podium (left) and roof (right)

Residential buildings with structural steel framing.

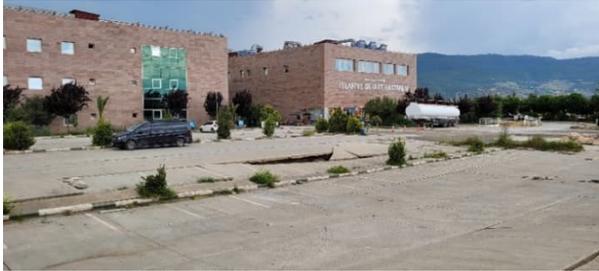
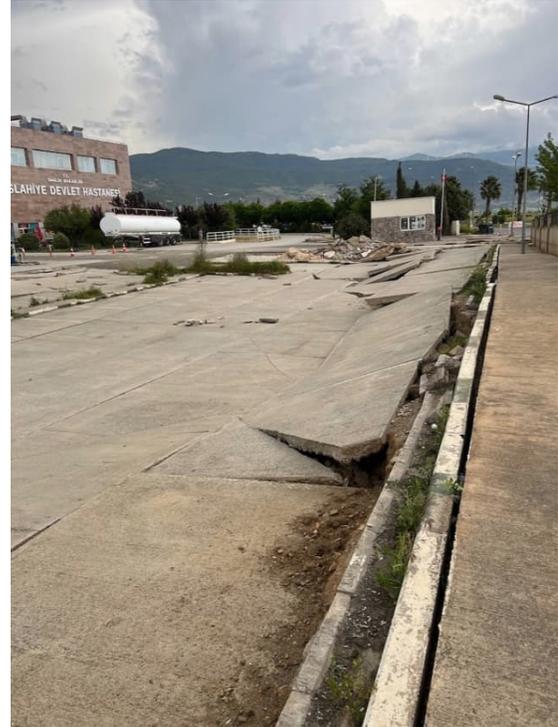
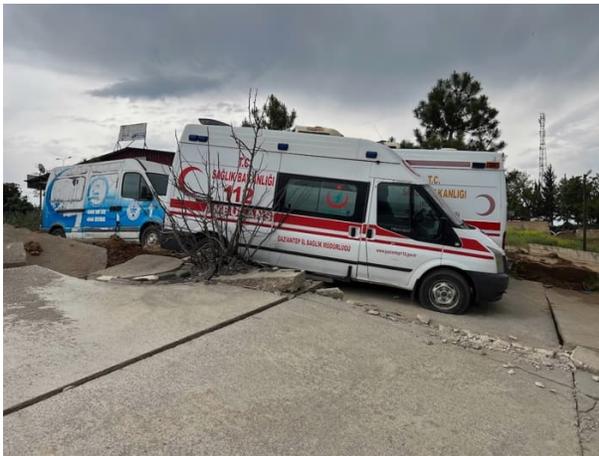
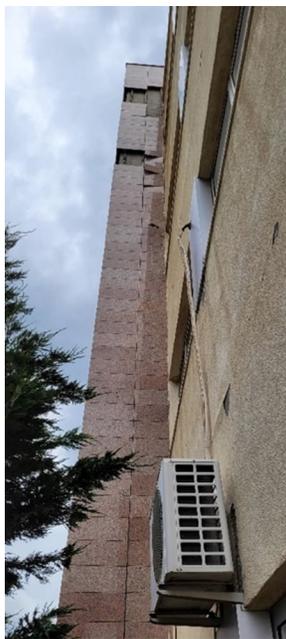
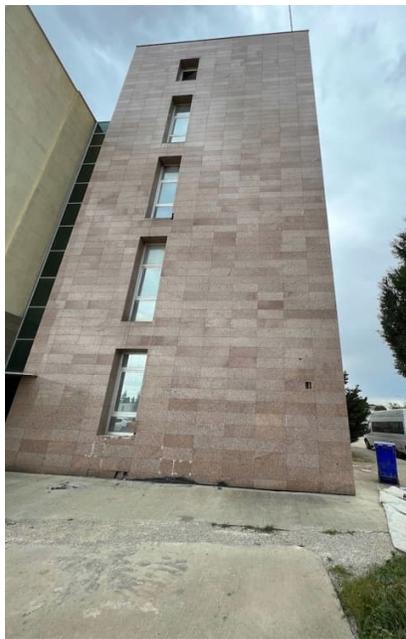
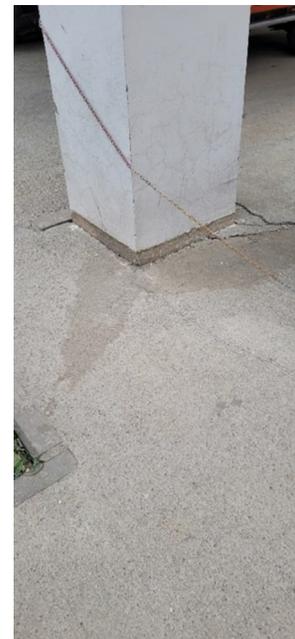
**Figure 6.48: Islahiye hospital [37.04449522, 36.62957175].**

The Islahiye hospital, a shear wall concrete structure with three storey above ground with one basement remarkable because of the little damage it presented to the building, while an important surface rupture was observed in the parking lot, as illustrated in Figure 6.50 and further discussed in Section 3.1.4. Exterior damage was limited to failure of limited portions of the façade cladding. Vertical displacement of exterior slabs on grade was also observed due to

the surface rupture. Hospital officials and staff indicated that the construction of this hospital dates from 2014, and that it was constructed on a mat foundation due to an underground waterway found on site. They reported no to limited structural damage, but damage to medical equipment. Service was continuously provided after the earthquake. To achieve this, power was supplied by a generator, and water and sewage, cut off due to the earthquake, was replaced by portable systems.

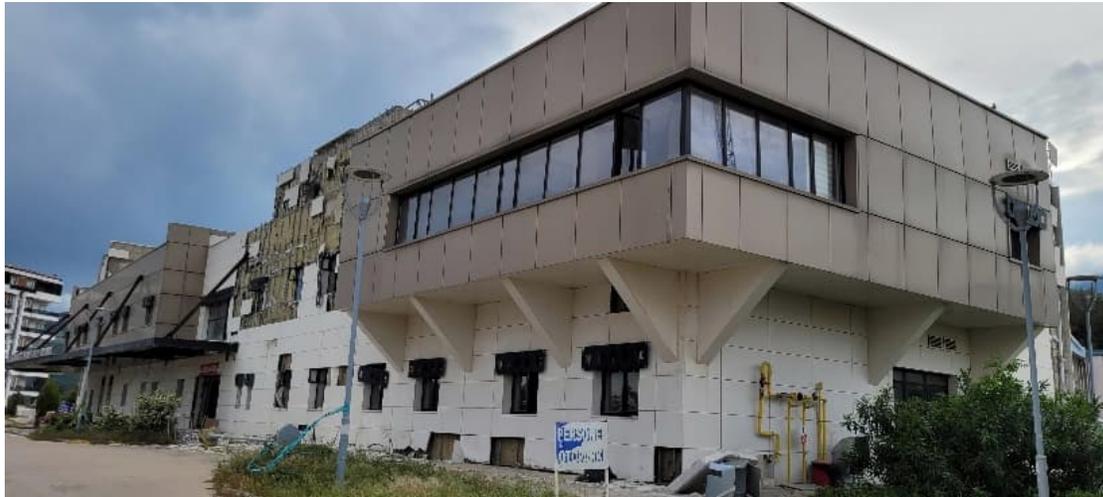
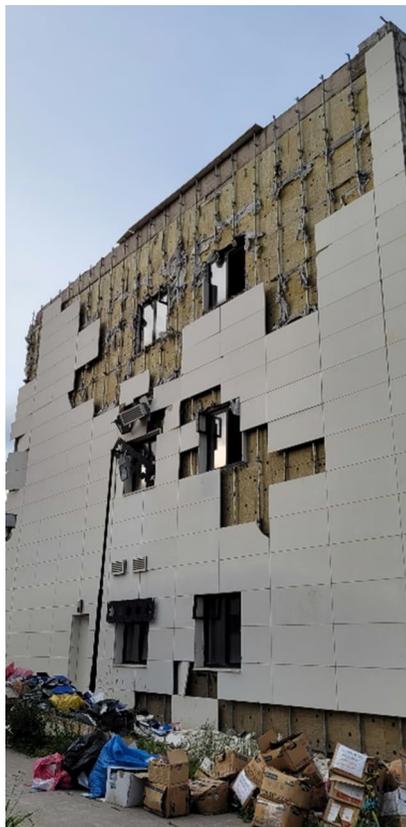
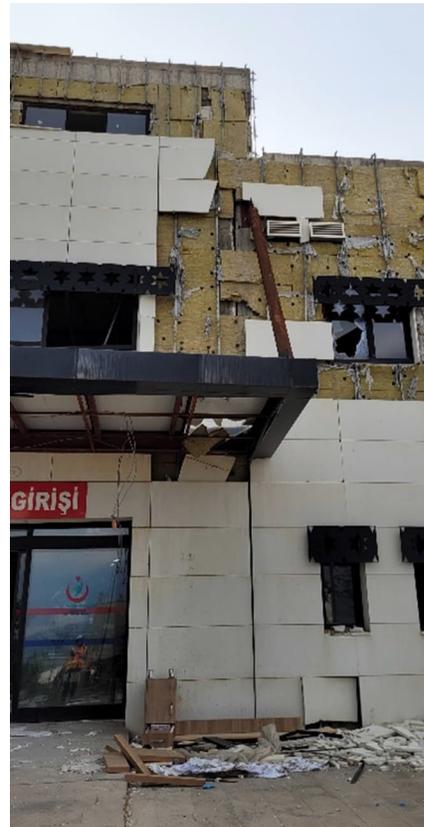
**Figure 6.49: Nurdagi hospital, exterior [37.18729225, 36.73195308].**

The Nurdagi hospital, nonfunctional at the time of our reconnaissance, is a two storey and a basement concrete structure relying primary on frames as the lateral load resisting system. While no structural damage was observed, the building stood out for its extensive non-structural damage. Figure 6.49 shows the exterior damage to the building's cladding. It appears that the attachments to the supporting structure were not adequate. Figure 6.50 illustrates the interior damage, including failure of suspended ceilings and mechanical fixtures, as well as cracking of infill unreinforced concrete walls.

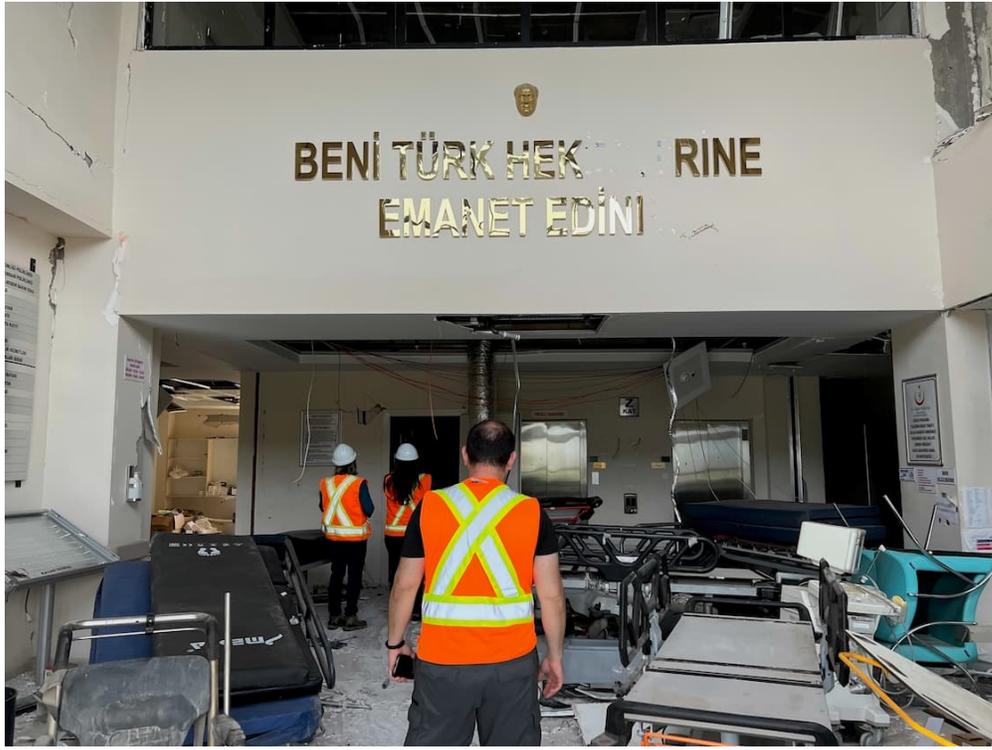
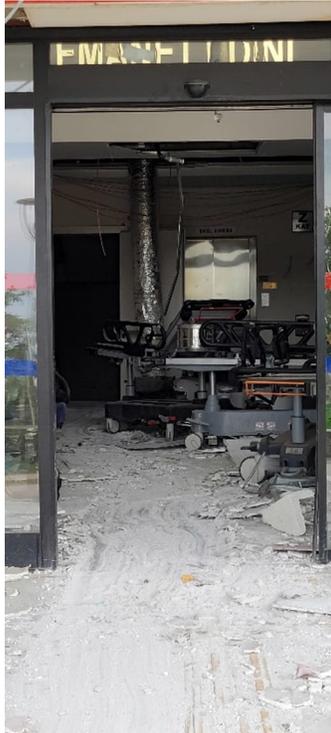
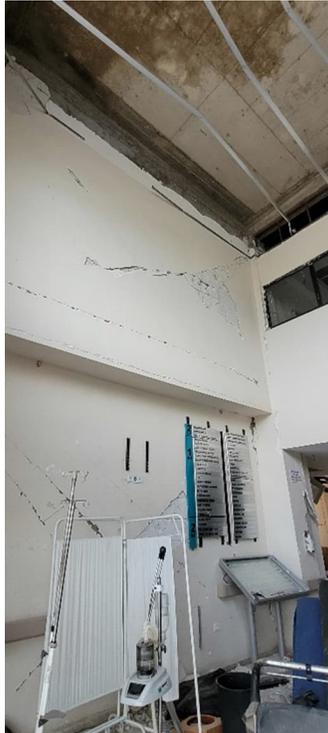
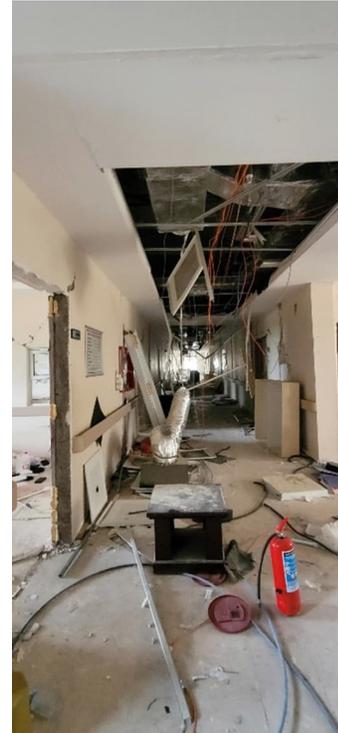
**Figure 6.50: Nurdağı hospital, interior damage [37.18729225, 36.73195308]**

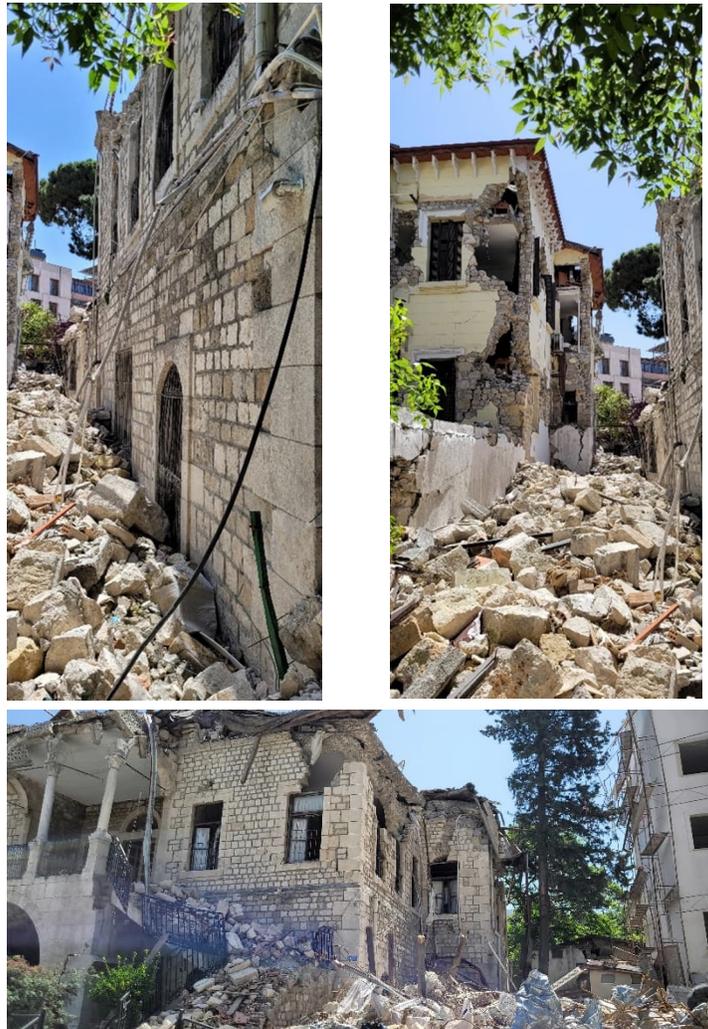
In Antakya, the first visited school was housed in two buildings of different structural characteristics. One building was a two-level historic stone masonry structure, the second was a three-level concrete frame building with masonry infill. Located in the historic neighborhood ravaged by the earthquake, the school buildings also presented severe damage and partial collapse for the historic building, Figure 6.51. The more modern concrete construction fared better, although several of the infill walls collapsed rendering the use of the school impossible as shown in Figure 6.54.

**Figure 6.51: Damage to the historic masonry building, school No.1 in Antakya [36.19927577, 36.15955117].**

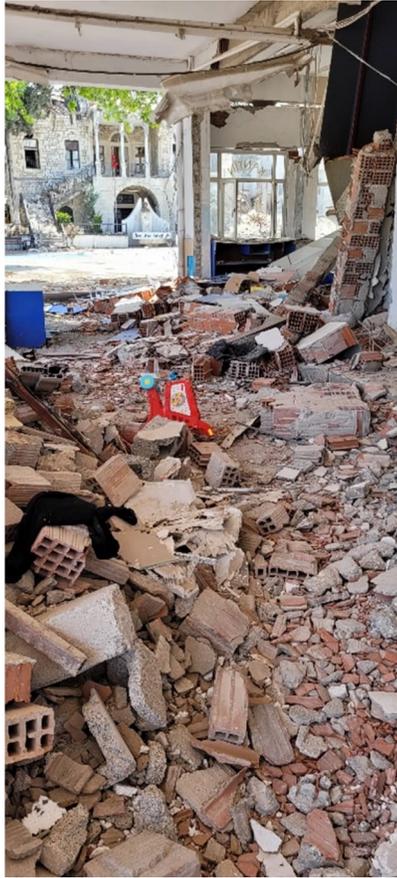
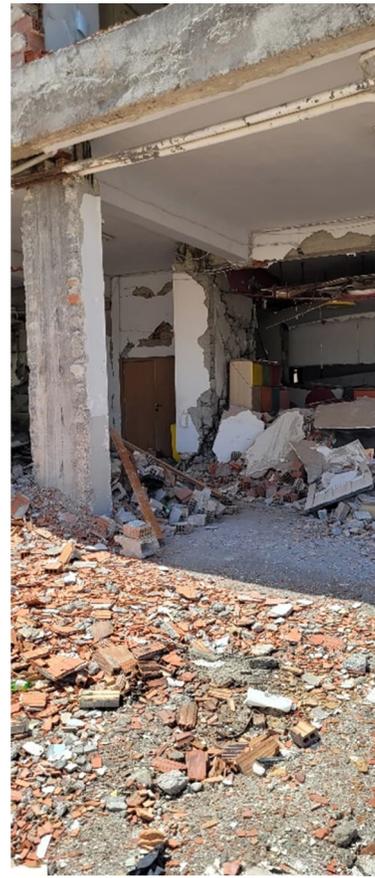
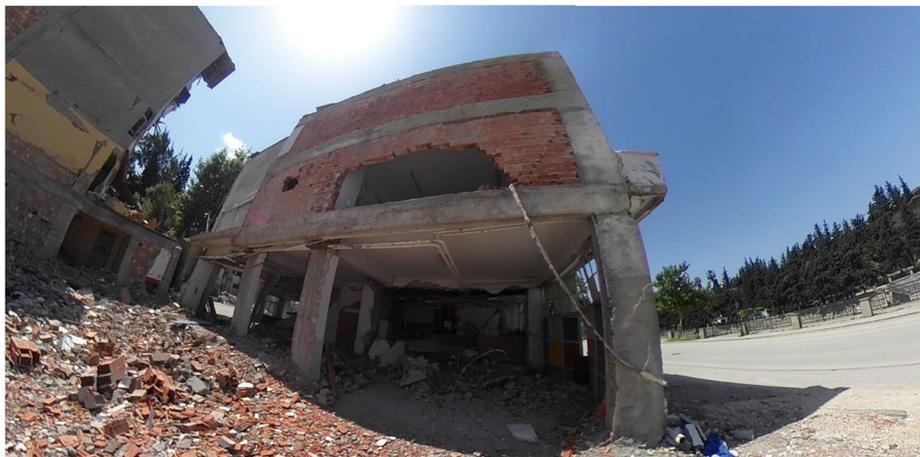
**Figure 6.52: Damage to the concrete frame building, school number 1 in Antakya [36.19927577, 36.15955117].**

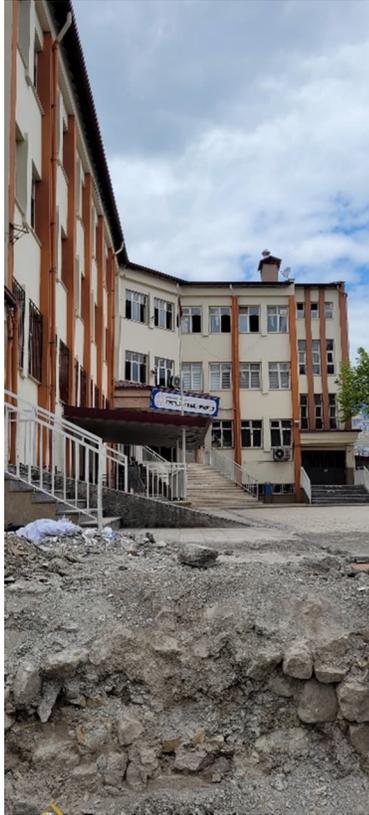
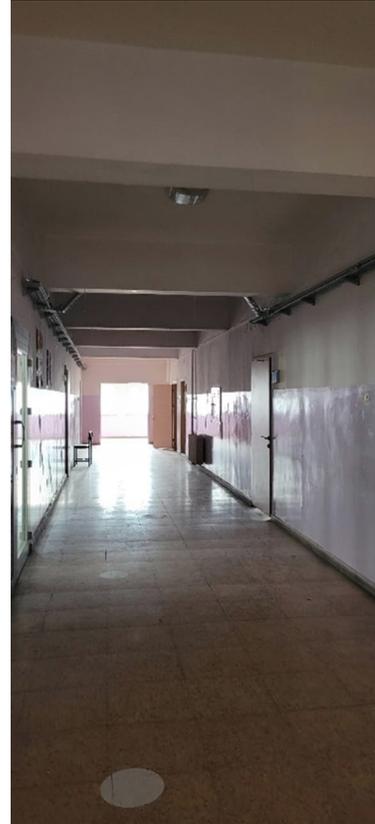
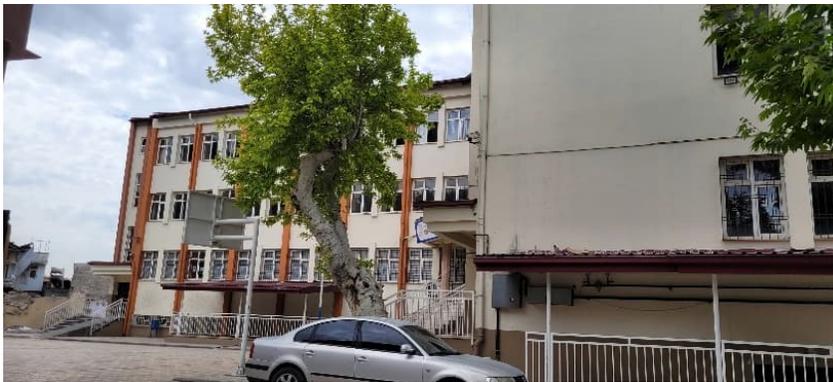
**Figure 6.55: Condition of school in Kahramanmaraş [37.5843718, 36.92947084].**

This building, according to school staff, was constructed in 2005, and is a shear wall building with large columns and deep beams. According to staff, some clay roofing fell off, and the roof was scheduled to be replaced with corrugated steel sheets. Other than this, only some wall painting was needed.

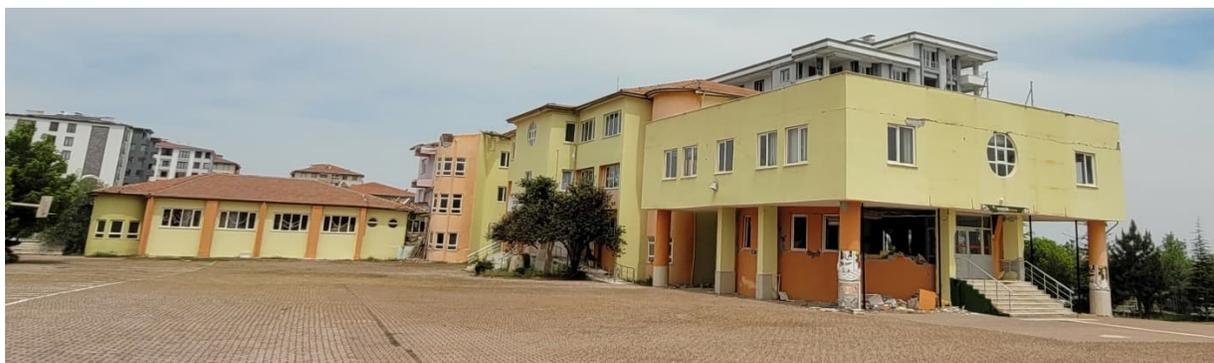
**Figure 6.57: General overview, school in Malatya [38.3268974, 38.22168567]**

The final school visited during the reconnaissance was a private institution located in Malatya. The school was composed of four individual buildings with different levels of damage (Figure 6.57). The school owner, who was present on site during the review, confirmed these buildings as being constructed in 2006, with concrete mixed on site.

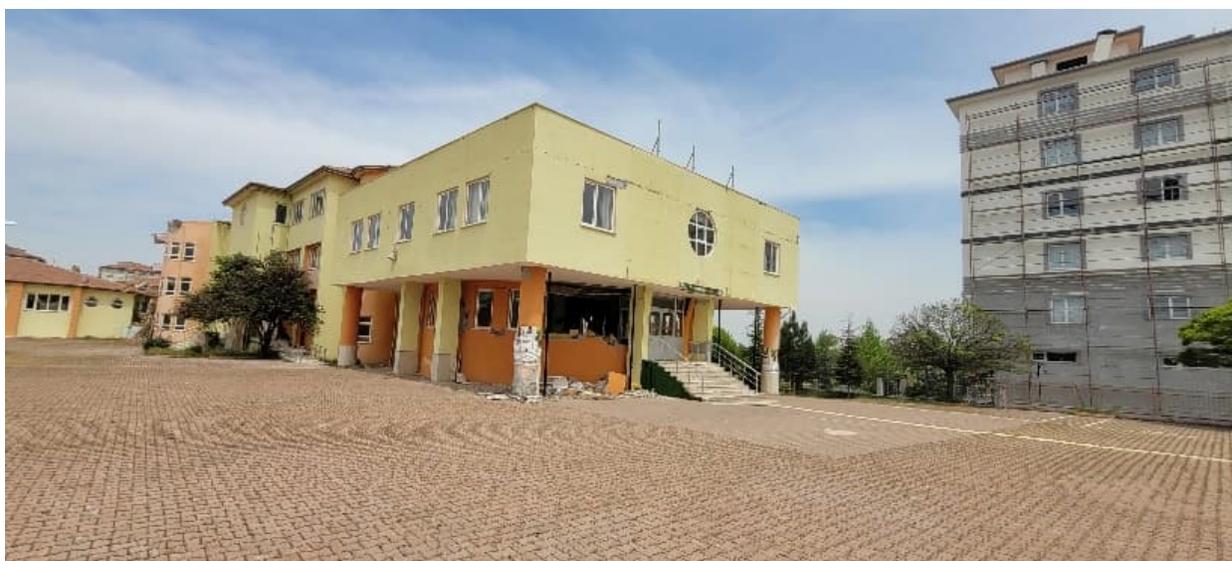
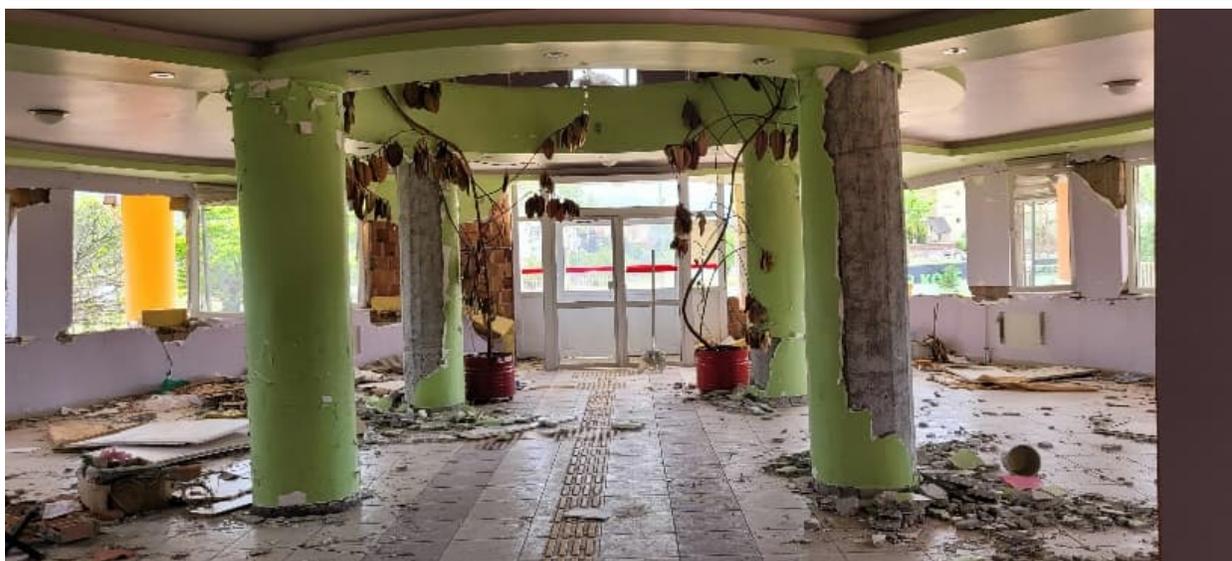
Building 1, a 2-storey concrete frame building, showed the most damage of the four, as well as being an irregular building (see Figure 6.). Other than extensive damage to the unreinforced masonry infill walls, damage to columns was observed, where no or very highly spaced ties were observed. Additionally, pounding damage with the adjacent building was also apparent. This building was classified as heavily damaged by building inspectors.

**Figure 6.58: Damage to building 1, school in Malatya.**
