# February 6, 2023 Kahramanmaraş Earthquakes in Türkiye

## Reconnaissance Report

Canadian  
Association  
for Earthquake  
Engineering  
and Seismology

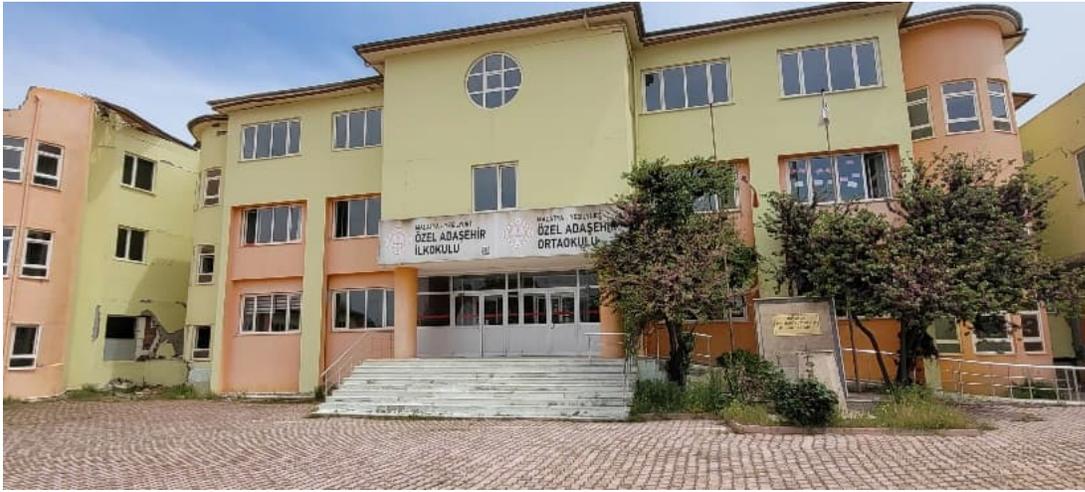
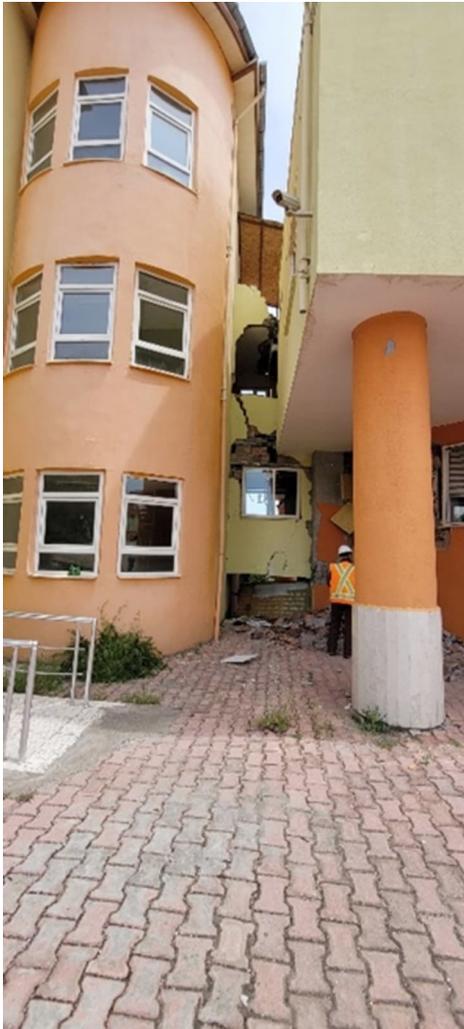
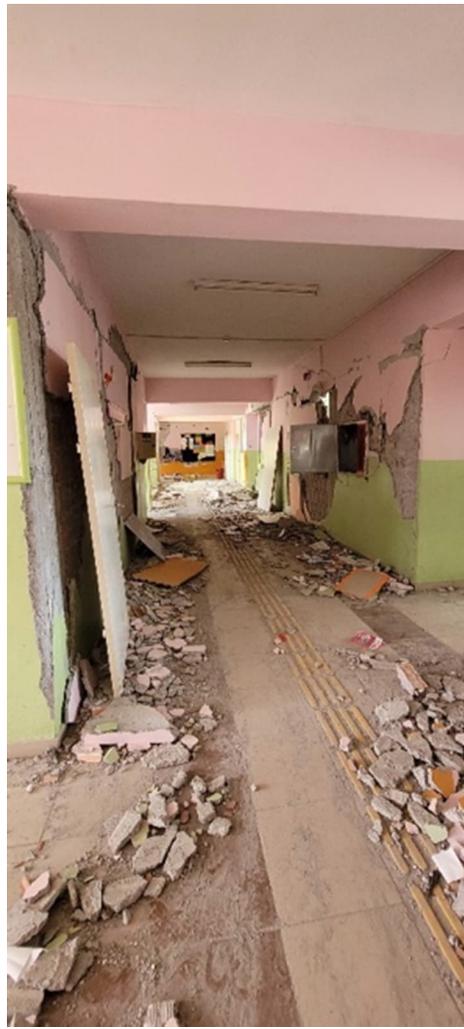
Building 2, a 3-storey above ground structure with a single storey basement, with concrete shear wall as the lateral load resisting system, showed much less damage, indicating that the use of shear walls was beneficial (see Figure 6.59). Here, some damage to the infill walls was observed, but little damage was visible from the outside other than at the joint to building 1. Inside, as for the other buildings, extensive damage to the operational and functional components was observed. This building was classified as low damage by building inspectors.

**Figure 6.59: Damage to Building 2, school in Malatya.**

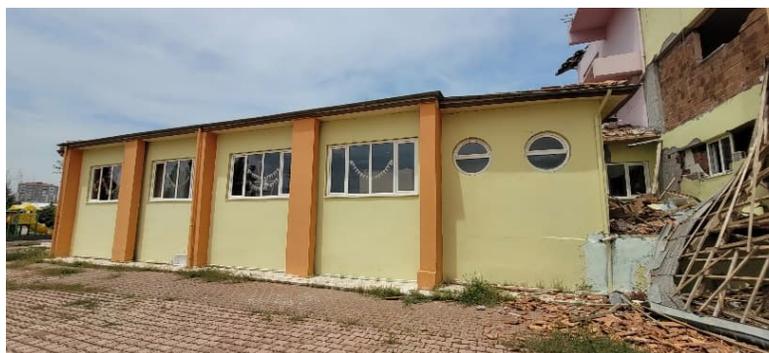
**Figure 6.61: Damage to Building 4, school in Malatya.**

Finally, Building 4, a one level concrete frame building, did not exhibit any visible damages (see Figure 6.61).

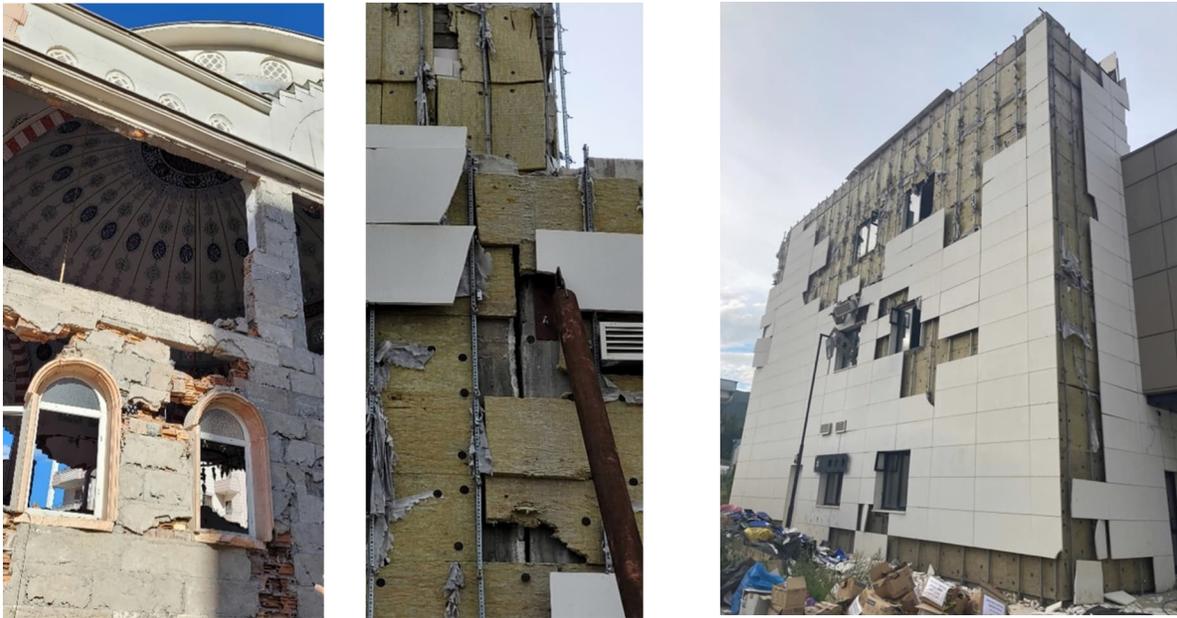
As can be seen throughout this section, other building components were severely affected by the earthquake. Some observed damage typologies are collapse of heavy façades due to inadequate attachment to the supporting structure (Figure 6.66), failure of suspended ceilings and related MEP equipment (Figure 6.67) and damage to ancillary light-weight steel structures (Figure 6.68).

**Figure 6.66: Inadequate attachment of façade cladding.**

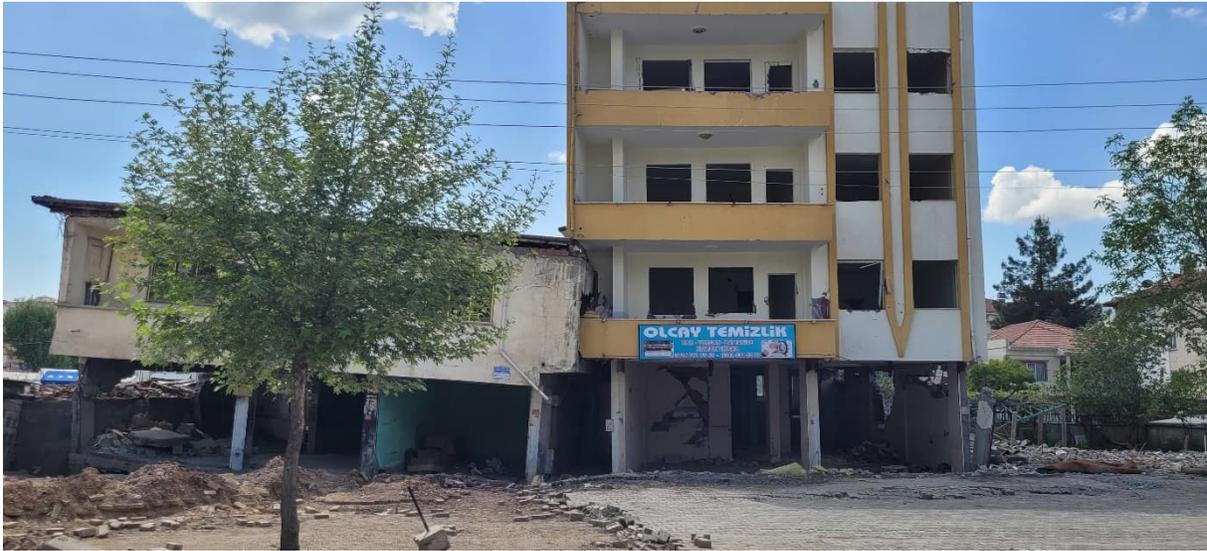
In Gölbaşı, pounding was observed between a 4-storey and a 2-storey building with misaligned floor diaphragms, see Figure 6.69. The slab of the taller building impacted an infill wall causing its failure. Note that the lower building also presented significant structural damage that could not be attributed to pounding.

**Figure 6.69: Pounding damage in Gölbaşı [37.78972311, 37.65123458].**

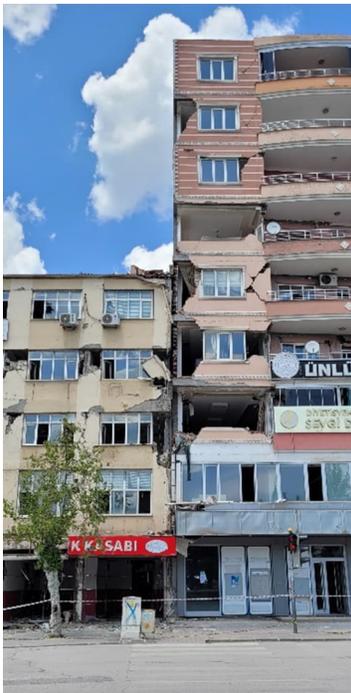
(a) Adiyaman

Another example of pounding was observed in Adiyaman, where a 5-storey and 9-storey building, with misaligned floor diaphragms, exhibited damage produced by pounding, see left images (a) in Figure 6.70. In Kahramanmaraş, the façade of a shopping mall appeared to have been constructed without respecting the minimum spacing of the building's seismic joint, producing local failure of the cladding, see right image (b) in Figure 6.70.

**Figure 6.70: (a) Pounding damage in Adiyaman [37.76320913, 38.27261233] and (b) Kahramanmaraş [37.56952171, 36.92154011].**

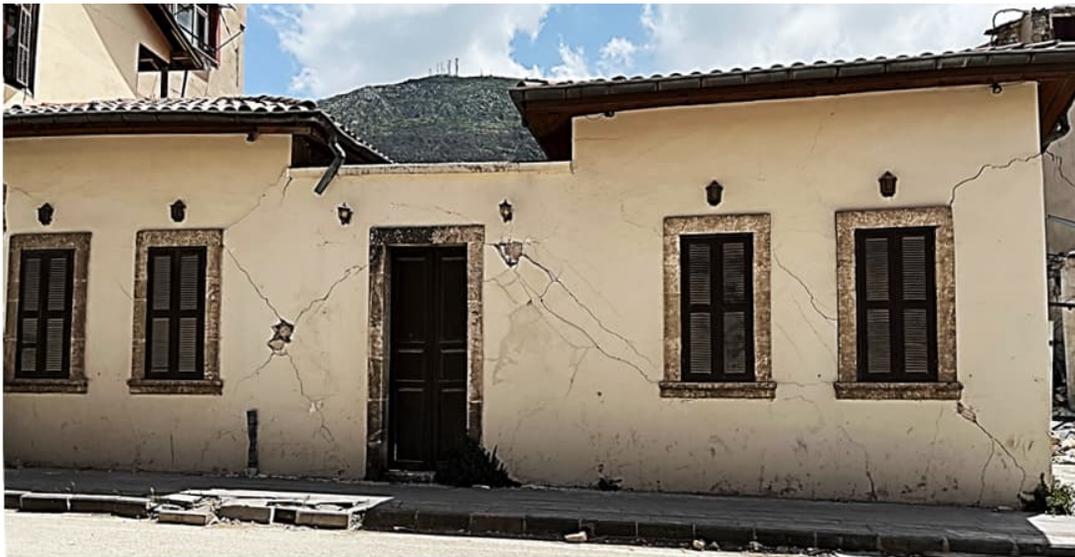
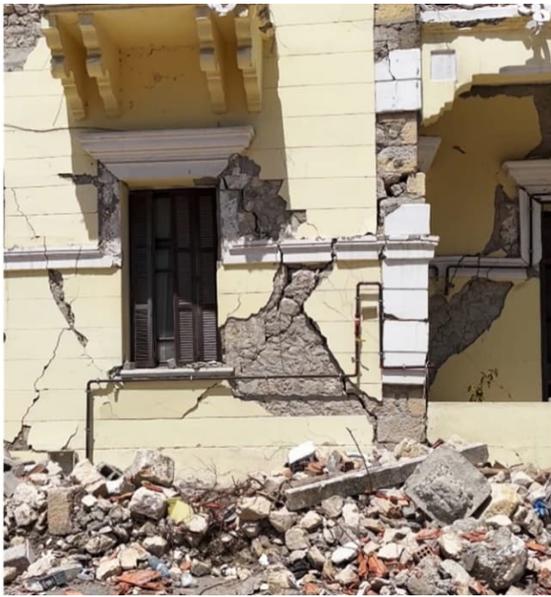
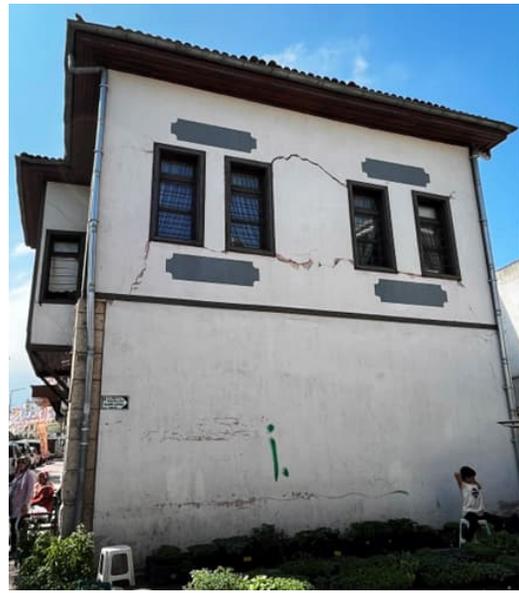
The most observed in-plane (IP) structural failure modes for regular and irregular URM walls were diagonal shear cracking and flexural/rocking failure, among other mechanisms, including bed-joint sliding and toe crushing. The different failure mechanisms often occur subsequently or almost simultaneously in URM walls under seismic actions since the interaction between failure modes can happen under increasing lateral displacement. Figure 7.1 shows diagonal shear and flexural/rocking failures noted at the single and multi-storey residential unreinforced stone masonry buildings. Different failure mechanisms can be seen at the URM walls in the same structural system, as shown in Figure 7.1a, in which the inner URM panels show diagonal shear cracks, whereas a flexural/rocking mechanism was observed at the right (slender) pier (Figure 7.1a). Specifically, diagonal shear failures develop when the principle tensile stresses violate the tensile strength of the masonry material and are mainly depicted by diagonal or “X” shape cracks in URM panels (see Figure 7.1b). The size and position of the openings have a decisive role in the IP crack pattern (see Figure 7.1a) and the seismic capacity of URM walls, as discussed in [28].

**Figure 7.1: In-plane failure mechanisms of unreinforced masonry buildings: (a) diagonal shear failure and flexural/rocking behaviour at the right pier (Antakya), (b) diagonal shear failure of rubble (irregular) stone masonry wall (Antakya), (c) flexural/rocking failure at the URM panel between two openings (Osmaniye).**

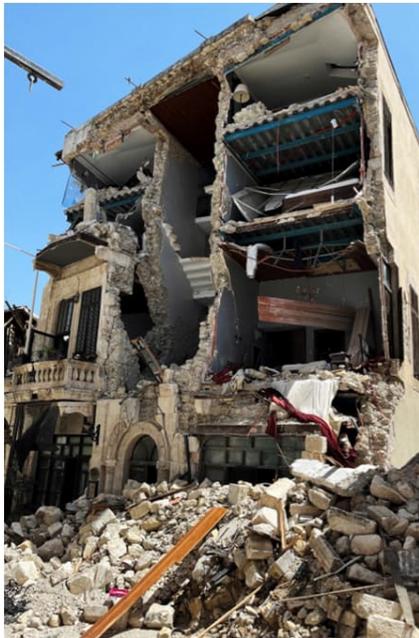
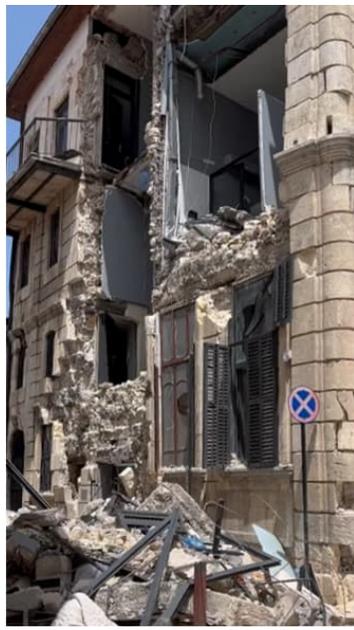
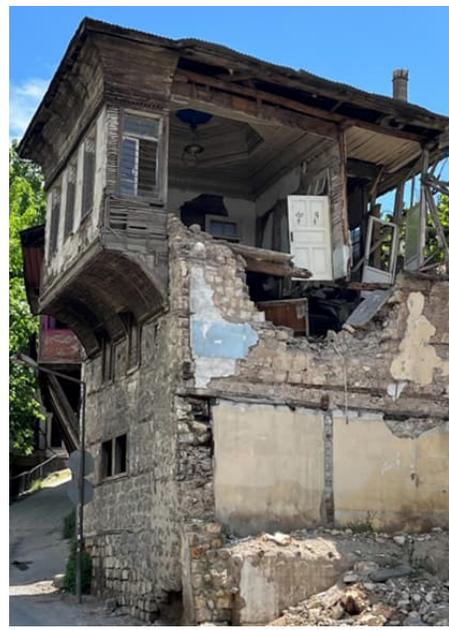
**Figure 7.2: Out-of-plane failure of front façade:(a-b) stone masonry building (Antakya), (c) mixed timber-stone masonry house (Kahramanmaras)**

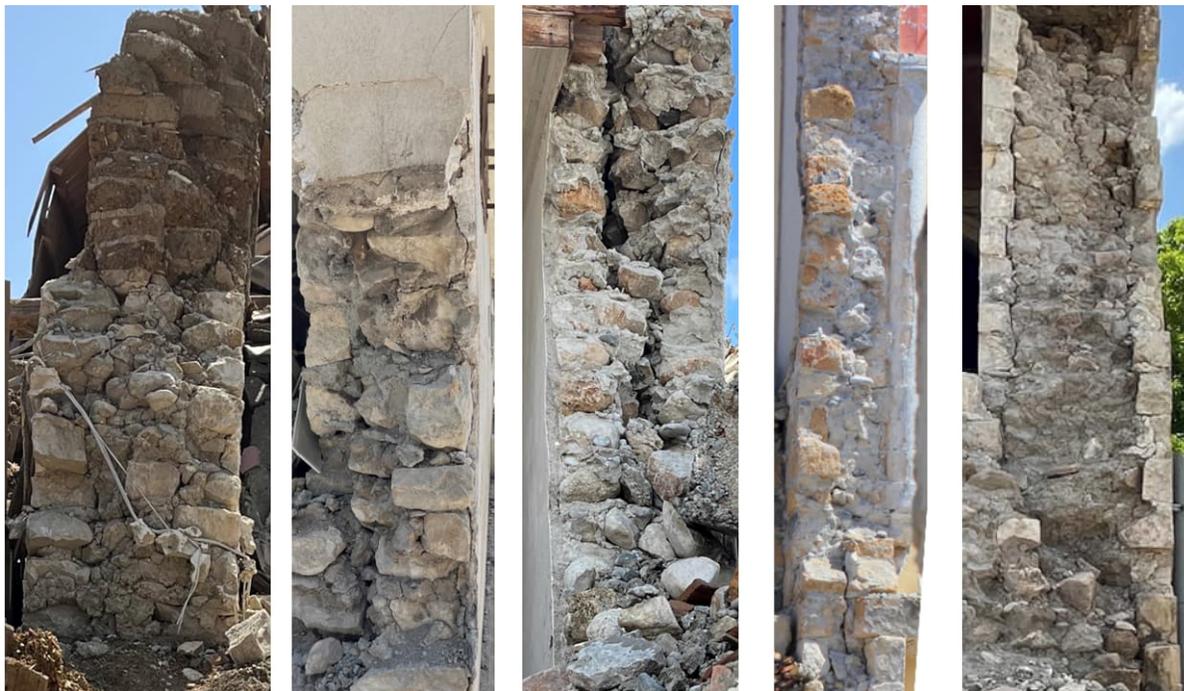
**Figure 7.4: Typical multi-leave URM wall cross-sections taken from partial or total collapsed buildings**

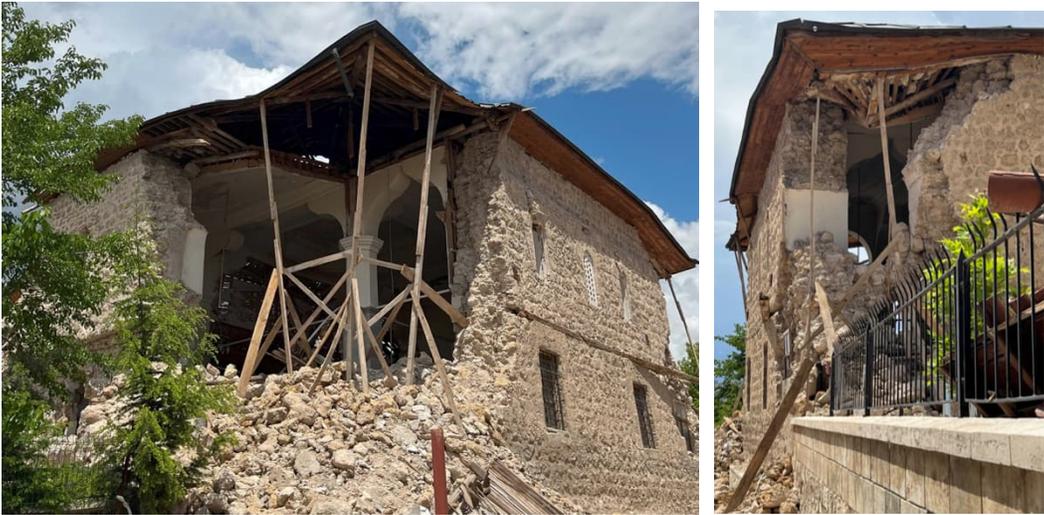
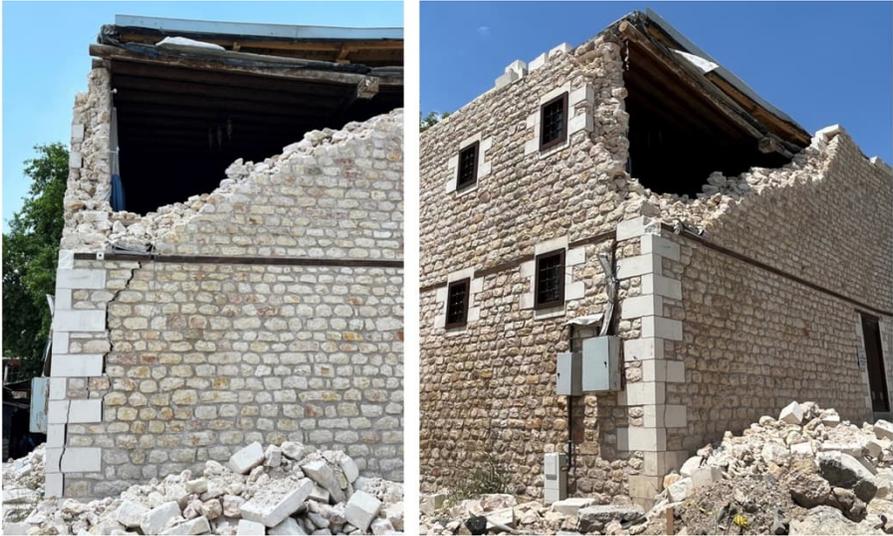
Corner and combined IP-OOP failures were another local mechanism noted during the reconnaissance visit, shown in Figure 7.5a and Figure 7.5b, respectively. The former failure

mode generally happens when one corner of the building is free to displace (no adjacent structure), and the orthogonal URM walls are well-connected so that wedge shape cracks can develop (see Figure 7.5a). The openings closely positioned to the corner and the thrust force imposed by the roofs inclined in perpendicular directions are the primary factors initiating this mechanism. The latter, the combined IP-OOP mechanism, corresponds to failures stemming from the combined action of IP and OOP damages. As presented in Figure 7.5b, a URM wall initially suffered from IP damage that was later exposed to the OOP component of the ground motion leading to failure. It is worth noting that this kind of bidirectional interaction becomes very important considering the aftershocks for already damaged buildings. *Both* corner and combined IP-OOP failure modes are open for research and need further experimental and computational investigations.

**Figure 7.5: (a) Corner and (b) combined IP-OOP failure mechanisms**

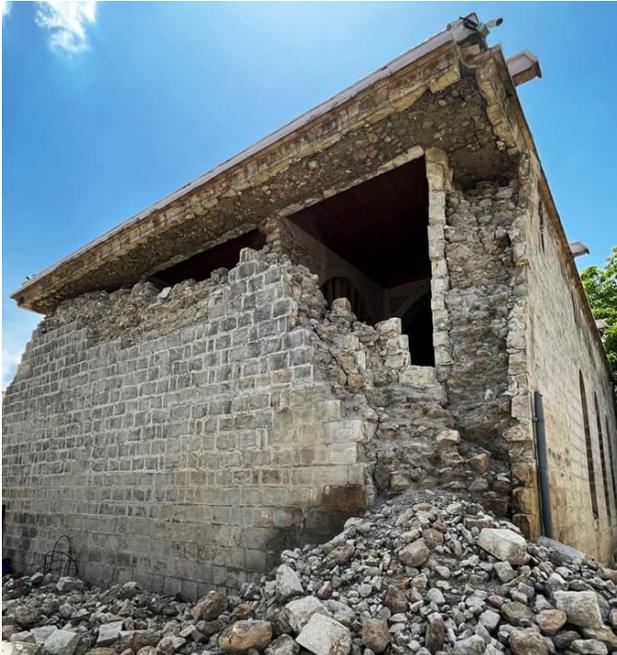
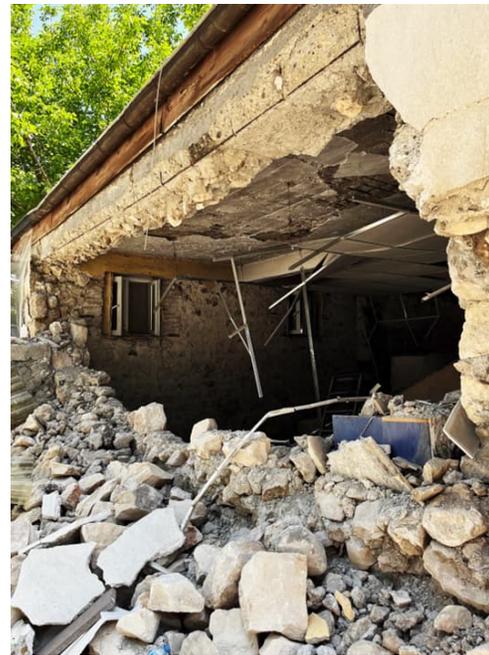
Figure 7.8 shows several OOP failure mechanisms of multi-layer unreinforced stone masonry walls strengthened via RC elements. In Figure 7.8a, the RC ring beam became visible upon the

partial collapse of the stone masonry wall. As mentioned earlier, the adopted intervention did not provide sufficient structural integrity and became disconnected from the load-bearing system due to the strong ground shaking. A similar situation is presented in Figure 7.8b, where the adopted RC roof did not prevent the OOP failure of the rubble stone masonry wall, which was detached from the RC beam. Note that the poorly constructed multi-layer URM walls may not resist the new strength demands. Hence, it is necessary to better understand the effectiveness of the implemented intervention plan beforehand.

**Figure 7.8: Out-of-plane failure of irregular multi-layer unreinforced masonry walls strengthened with RC beam: (a) St. Petrus and St. Pavlus Church (Adiyaman), (b) a stone masonry building (Antakya)**

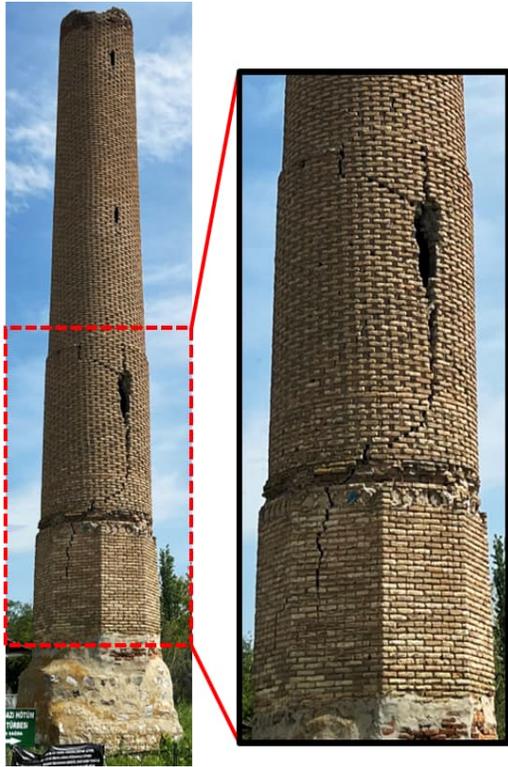
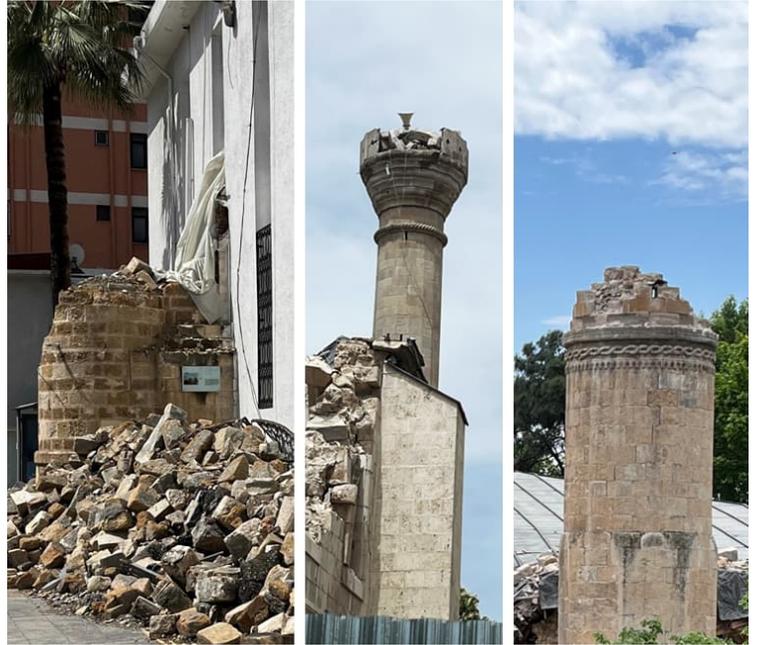
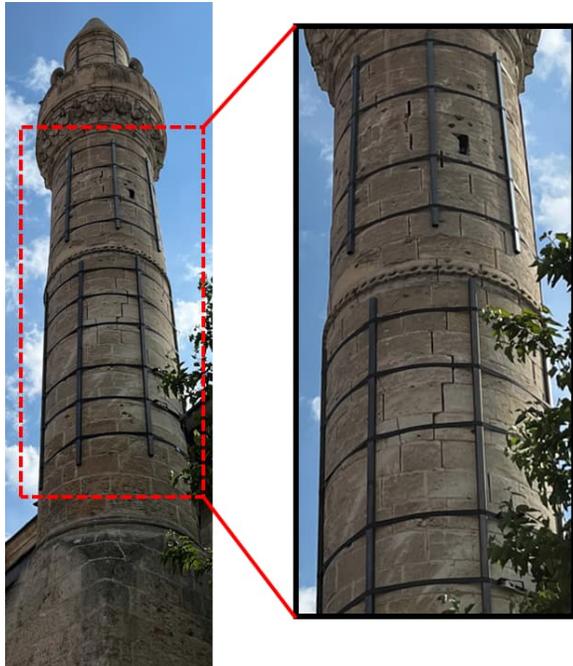
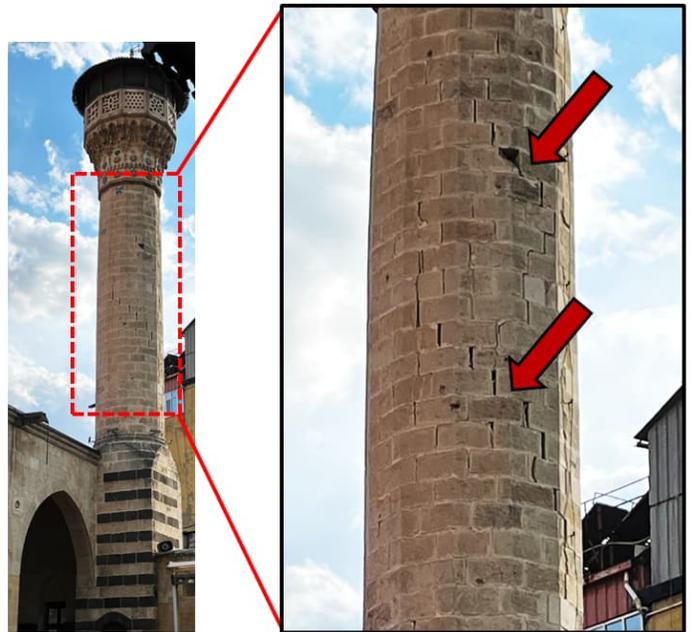
The seismic behavior of slender URM masonry structures, including masonry towers, minarets and chimneys, was examined during the reconnaissance visit. A wide range of architectural styles, geometrical properties (*e.g.*, slenderness ratio: height over the base diameter, wall thickness, etc.), and material characteristics used in the construction of slender masonry structures (*e.g.* brick, stone, or combination of both) were noticed (see Figure 7.9). Different partial and total failure mechanisms are presented in Figure 7.9. The diagonal cracks initiated from the opening and propagating along the mortar joints were noted at the lower section of the masonry tower (Hötüm Dede Türbesi, located in Adiyaman), shown in Figure 7.9a. It is important to highlight that the seismic behavior of slender URM structures is highly dependent on the dominant frequency of the base excitation, which can trigger a global over-turning mechanism or partial collapse of the spire (or upper part of the minaret), as can be seen in Figure 7.9b. Furthermore, joint sliding and cracking developed diagonally through the height of the masonry tower (Handanbey Mosque, Gaziantep) that can be observed in Figure 7.9d. The

current (damaged) state the minaret may pose a threat to the adjacent structure in the case of an aftershock unless it is stabilized via reversible interventions as performed in another nearby minaret (Alaüddevle Mosque, Gaziantep), shown in Figure 7.9c.

**Figure 7.9: Different failure mechanisms observed in slender masonry structures**

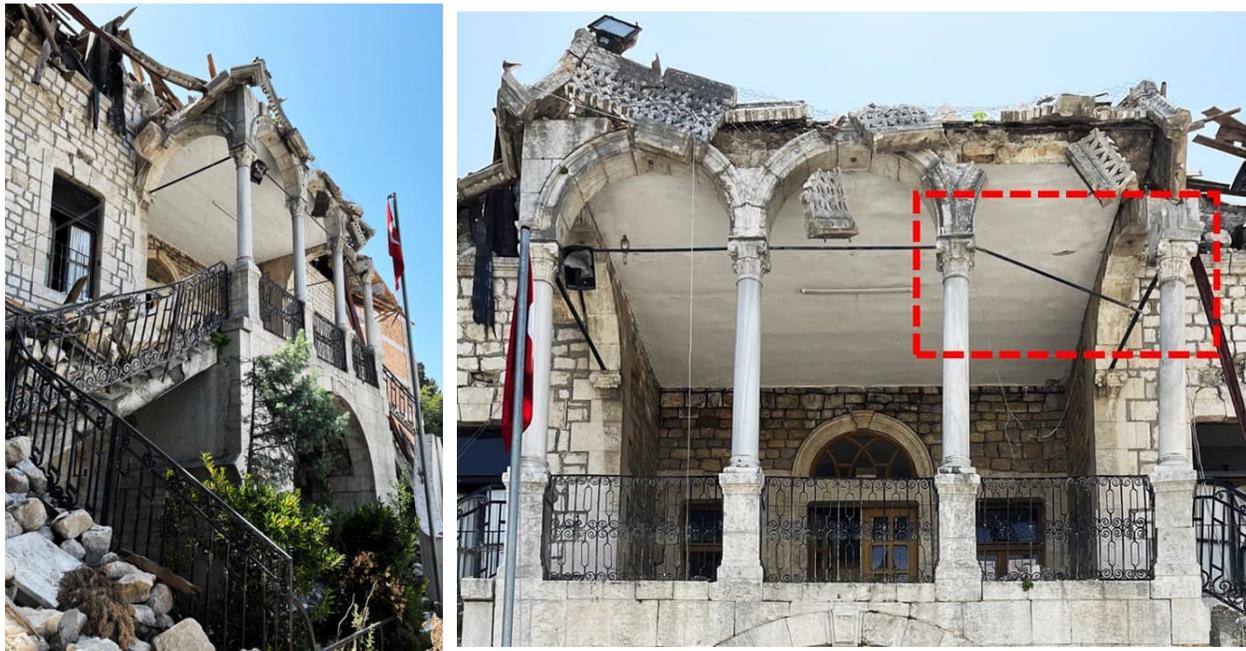
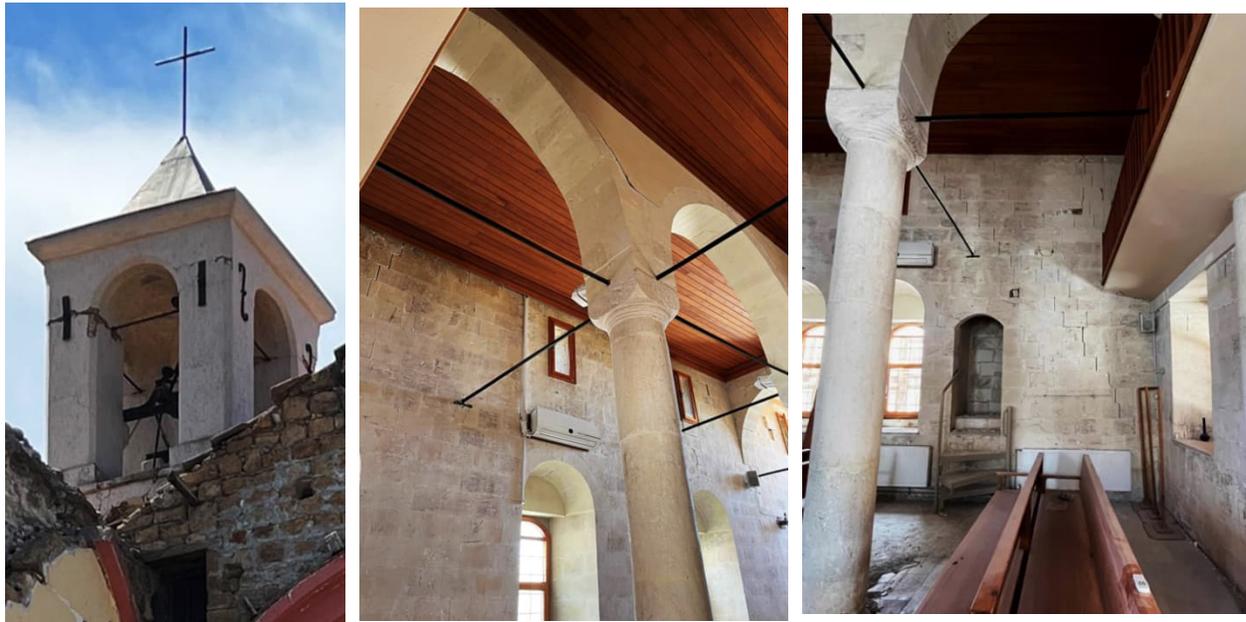
The beneficial effect of metal ties was noted on many occasions, as shown in Figure 7.10, where the strengthened masonry arch-pier systems resisted the strong ground motion. If properly connected, the adopted steel ties improve structural integrity and prevent local failures. Typically, the failures were noted either at the tie-rod connection (Figure 7.10a) or the mortar joints nearby to the tie-rod connection, which can be observed in Figure 7.10b. Overall, the implementation of steel ties was found very effective once the load carrying capacity of tie-rod connections was ensured to resist expected seismic loads (see Figure 7.10c).

**Figure 7.10: The use of metal ties in different structures (a) failure of the tie-rod connection, (Ata Koleji – Antakya); (b) Damage at masonry where the connections (Roman Catholic Church – Iskenderun), and (c) Steel ties connecting inner pier-arch systems to peripheral walls (St. Petrus and St. Pavlus Church - Adiyaman).**

- Seismic retrofitting via steel tie rods was found to be very effective, often noted at the arch-pier systems. However, monitoring of their condition needs to be done, especially for historical buildings, since the failure at the steel-tie connections was noted on several occasions.

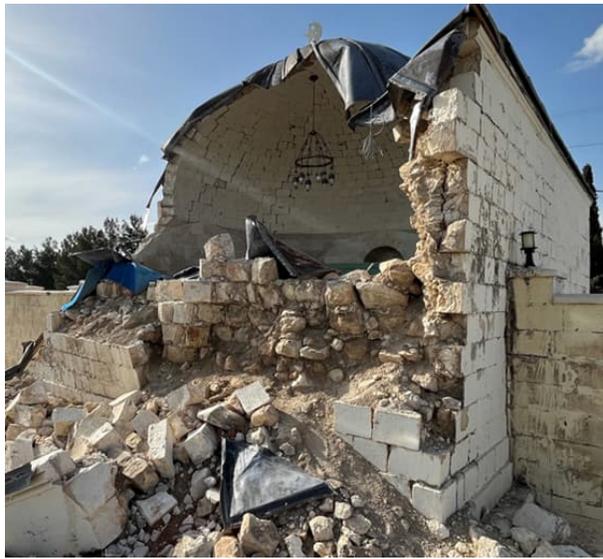
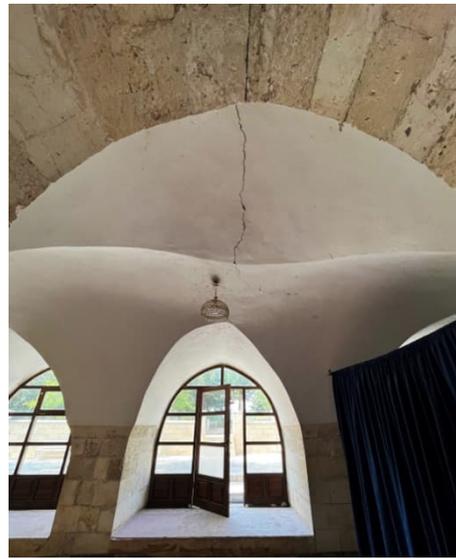
Various damage conditions were observed in URM domes and vaults, shown in Figure 7.11. The damage and structural stability of URM domes are directly influenced by the boundary conditions (i.e., displacement and rotation of the supporting walls and buttresses). In Figure 7.11a, the collapse of a masonry dome is presented, which suffered from excessive deflection of the supporting wall in the outward direction. Moreover, the crack at the intrados of the vaults was noted due to the rocking behavior of the structural systems that induce flexural tensile stresses both at the intrados and extrados, given in Figure 7.11b.

**Figure 7.11: (a) The collapse of a masonry dome due to tilting at the support masonry wall (the tomb of Mahmut El-Ensari, Adiyaman) and (b) cracks at the intrados of an unreinforced masonry vault (Tomb of Abuzer Gaffari, Adiyaman).**

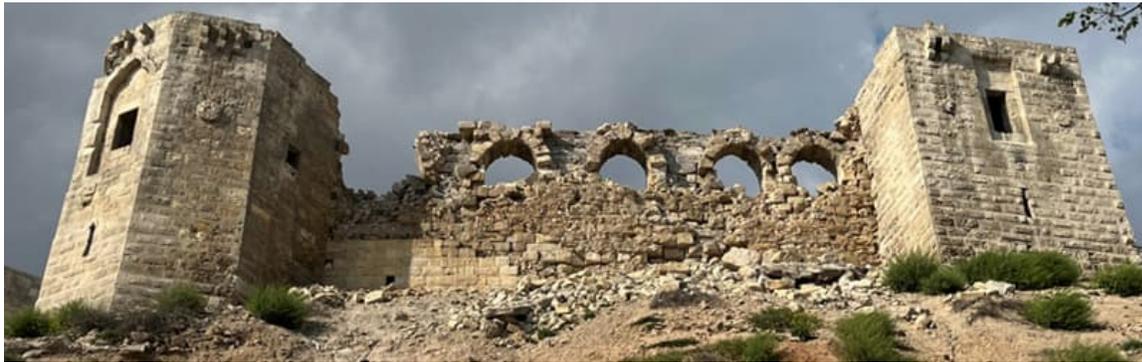
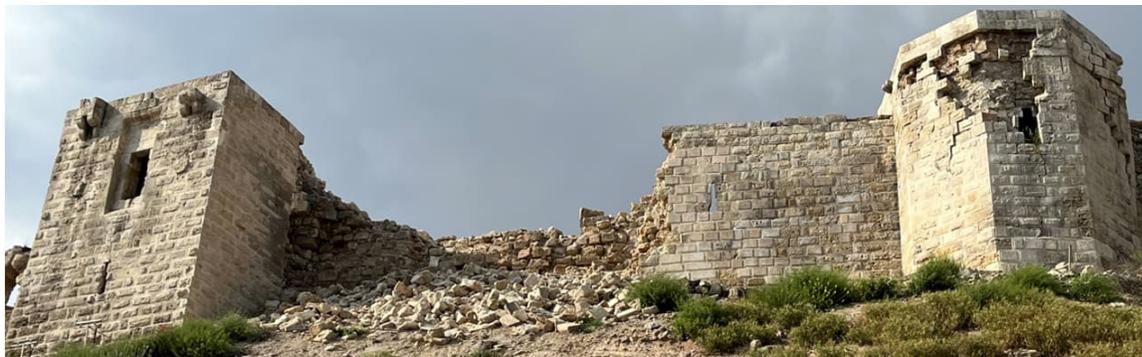
The walls and towers of Gaziantep Castle were severely damaged, where most URM walls failed due to local disintegration and stone unit separation, as seen from Figure 7.12a-c. The majority of the standing parts of the castle were noticed to be the original construction.

**Figure 7.12: Out-of-plane, in-plane, combined OOP-IP, and local wall disintegration failures observed at the Gaziantep Castle (Gaziantep)**

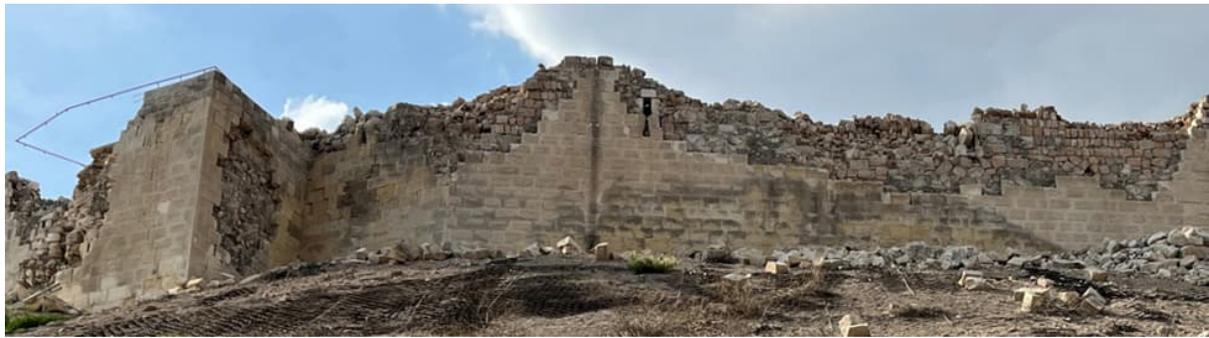
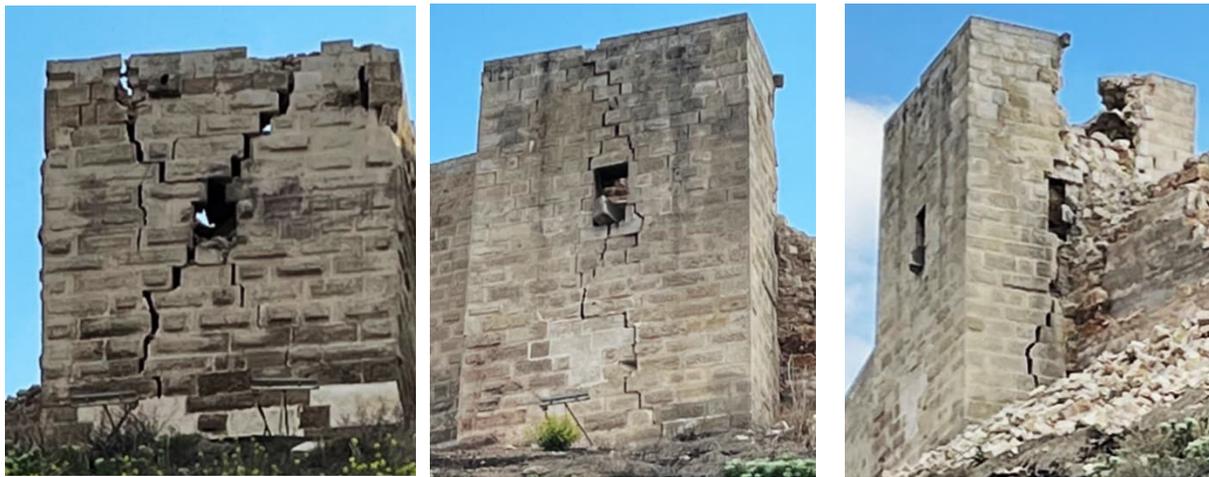
Different failure mechanisms can be noticed from the “as-is” condition of the towers, shown in Figure 7.12d, where IP and OOP and combined IP-OOP failure modes were observed.

**Figure 7.13 (Cont'd): Out-of-plane, in-plane, combined OOP-IP, and local wall disintegration failures observed at the Gaziantep Castle (Gaziantep)**

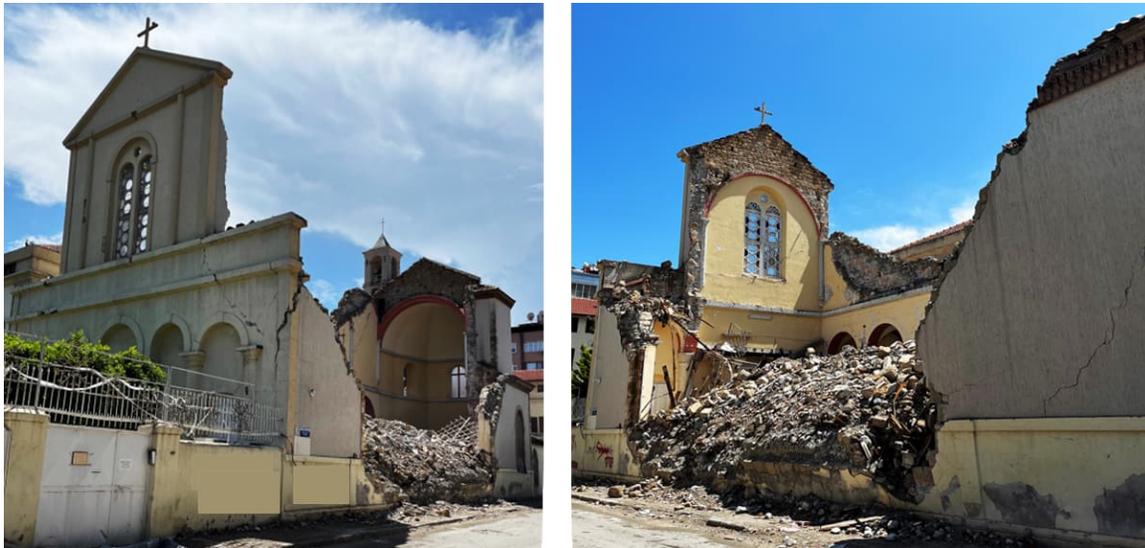
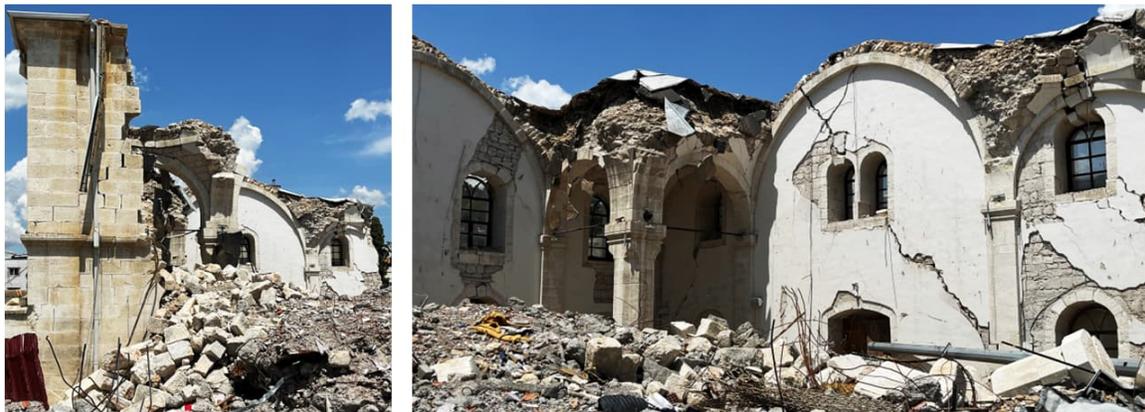
While this chapter mainly discusses partial collapse, many historic buildings and cultural heritage presented total collapse or were severely damaged. In Figure 7.14, two examples are provided where the main body of the structures turned to rubble. Only two façades of the Roman Catholic church were standing in a vulnerable condition needing stabilization (Figure 7.14a). Another example is the severely damaged and collapsed Ulu Mosque, as shown in Figure 7.14b. Although several retrofitting details were noticed in both structures (see Figure 7.14b – tie-rods were implemented), it was clearly insufficient to prevent total collapse, suggesting further investigations regarding the cause of inadequate strengthening solutions.

**Figure 7.14: Total destruction of a masonry church (Roman Catholic Church – Iskenderun) and mosque (Ulu Mosque, Adiyaman).**

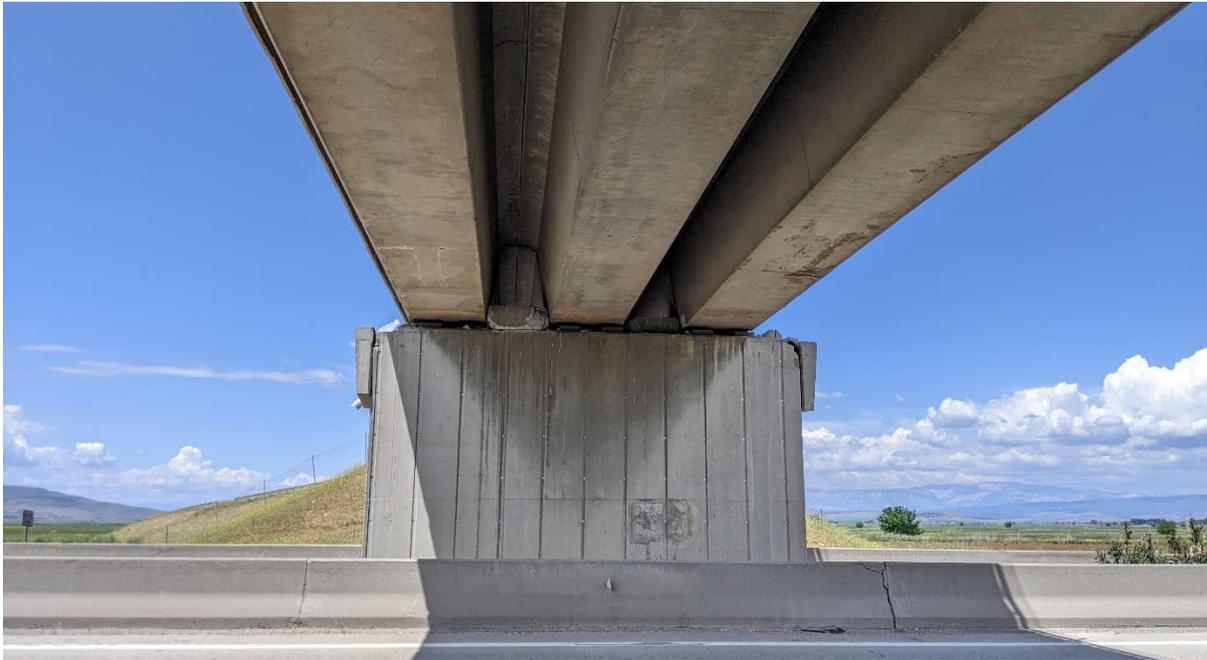
The clear majority of the many observed typical highway underpasses performed extremely well during the earthquakes, with no observed damage. Where damage was seen, it was typically spalled/cracked shear keys, indicating that the spans had displaced temporarily or permanently during the shaking. At two bridges we observed complete shear key failure. One of these cases is shown in Figure 8.2, where the two exterior shear keys of the central wall pier can be seen to have failed, rotated outwards and are hanging 180° out of alignment with their original orientation. The interior shear keys are badly damaged, but sufficient reinforcing remained in place to prevent the girders from unseating during the shaking.

**Figure 8.2: Damaged shear keys at a Typical Highway Underpass.**

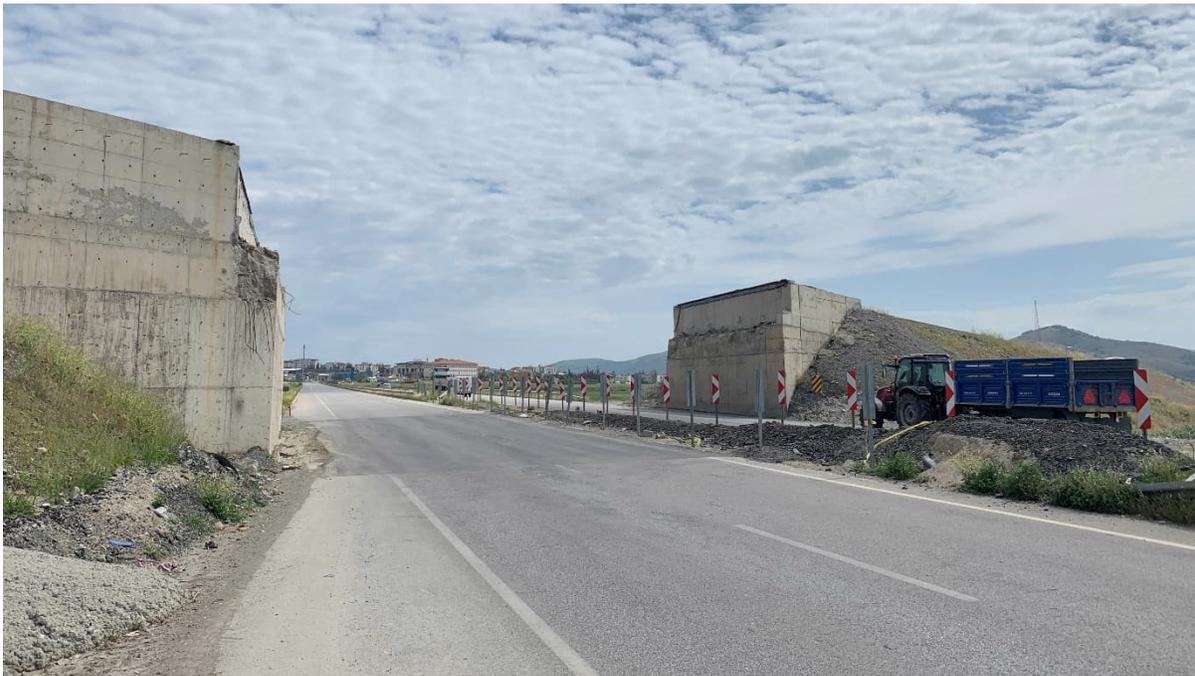
The second highway underpass where shear key failure was observed, was a structure under construction at the time of the earthquakes. The superstructure unseated and collapsed onto the highway below. The collapse was cleared away quickly, and only the partially complete abutment and failed shear keys remained visible at the time of our visit as shown in Figure 8.3.

**Figure 8.3: Shear key damage at abutments of bridge under construction.**

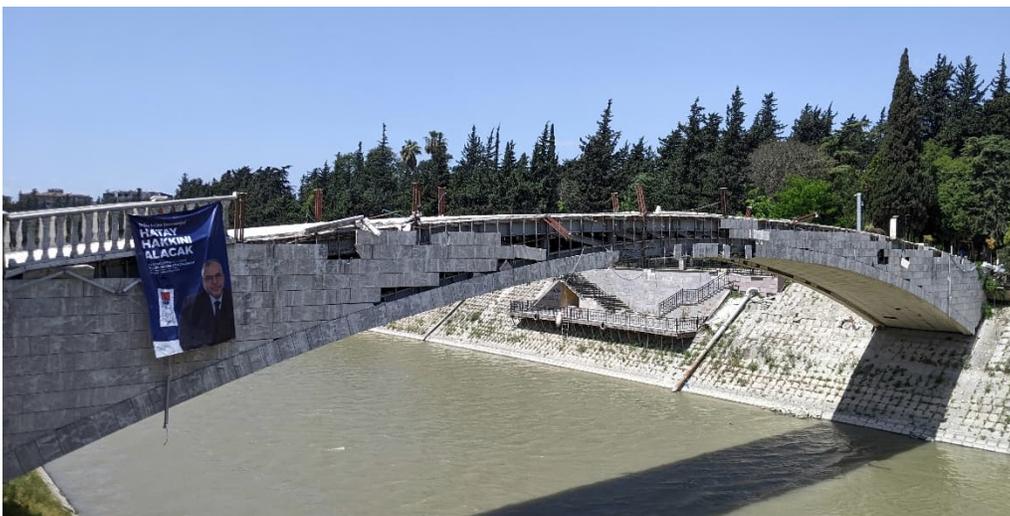
There are very few instances of damage observed to pedestrian bridges, and in all cases was related to approach settlement, or non-structural, such as railing, façade panel or escalator damage. Figure 8.6 shows a steel pedestrian bridge in Antakya that had damaged/collapsed railings and façade panels.

**Figure 8.6: Damaged Pedestrian Bridge in Antakya**

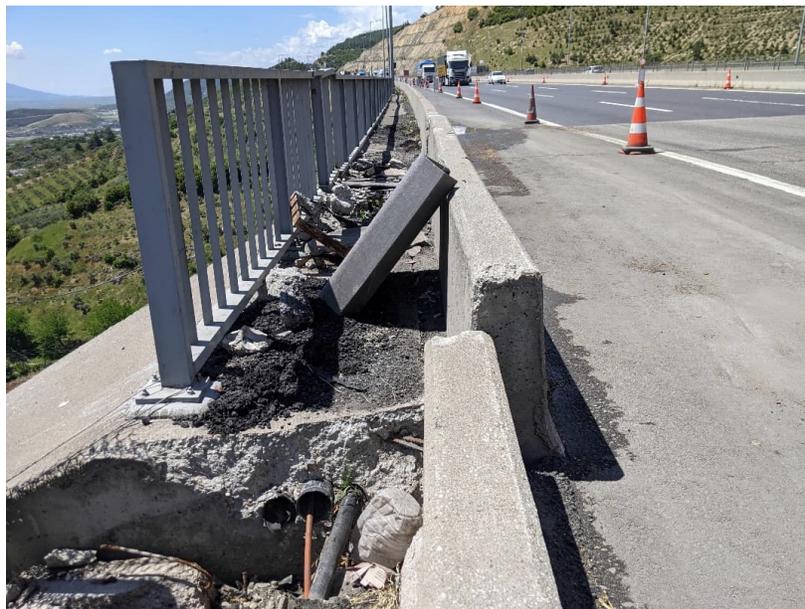
There were many instances of damage at modular joints, most often involving larger than anticipated joint movements and/or settlement at approaches. Many of the joints that were damaged on the larger highways had been temporarily repaired to reinstate traffic quickly after the earthquakes, and in one case the joint replacement was under construction. An example of the frequently observed damage scenario is shown in Figure 8.8, which shows the temporary repair asphalt, evidence of approach settlement at barriers and damage to the utilities and ducting. Other damaged joints frequently featured spalled concrete and deformed railings due to pounding.

**Figure 8.8: Damage at a viaduct abutment modular joint (not visible under temporary repair asphalt) and barrier**

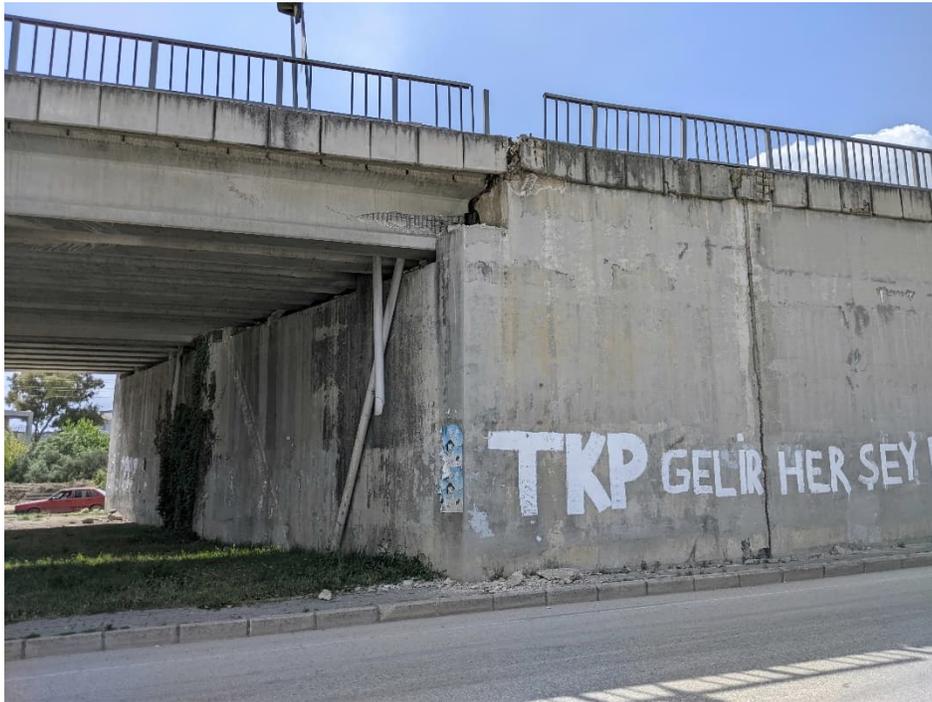
The earthquake loading damaged at least five girders on a pair of 5-span concrete bridges in Antakya. The spans were all simple, with seven prestressed concrete girders and each pier/abutment had four shear keys. One of the damaged girders is shown in Figure 8.9, which shows a destroyed web near the support, due to overloading the girder in weak axis bending when the girder pounded into the shear key.

**Figure 8.9: Damage to precast girder, abutment and drainage pipe, Antakya**

Many of the shear keys were also damaged on these bridges, and many spans had permanent displaced offsets. Observations suggest that the web of one of the girders had been damaged when it was subject to weak-axis bending due to the large vertical accelerations and its constructed condition with a misaligned bearing – there was a 50mm or so misalignment between the girder and bearing centerlines, and constructed geometry was such that it could have not impacted a shear key, hence the horizontal force that is thought to have caused the damage came from the horizontal component of the vertical accelerations that resulted from the unintended eccentric loading.
