# February 6, 2023 Kahramanmaraş Earthquakes in Türkiye

## Reconnaissance Report

Canadian  
Association  
for Earthquake  
Engineering  
and Seismology

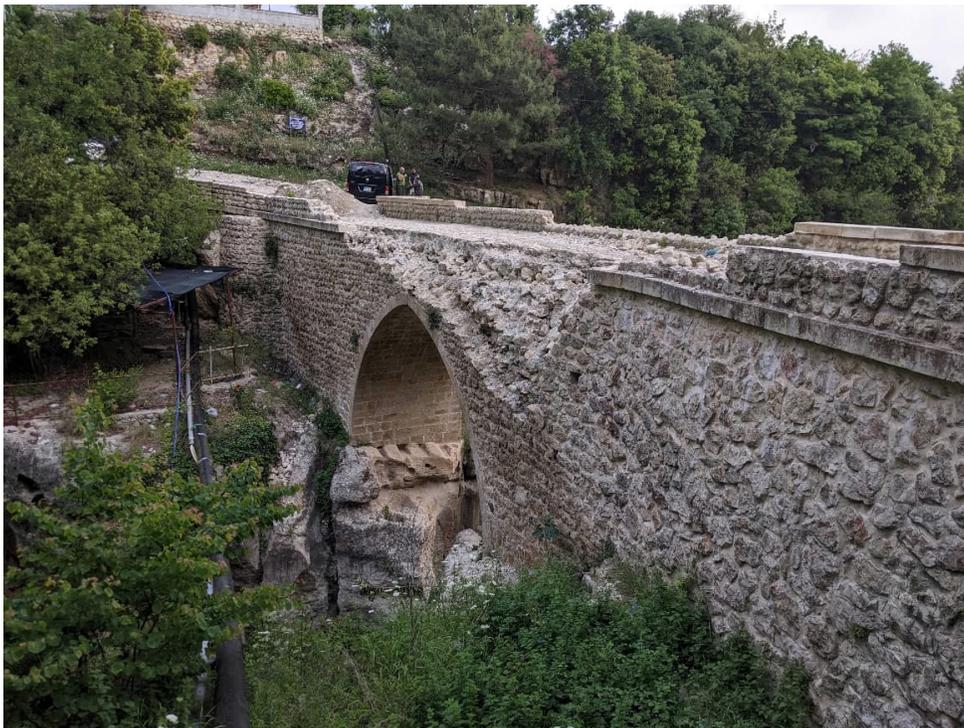
An example of an historic masonry bridge (that had been refurbished in 2019) is shown in Figure 8.11. The spandrel wall had partially collapsed in one location during the earthquake. This is the only example of structural damage observed among inspected masonry structures.

**Figure 8.11: Masonry Bridge (Tarihi Batiayaz Köprü)**

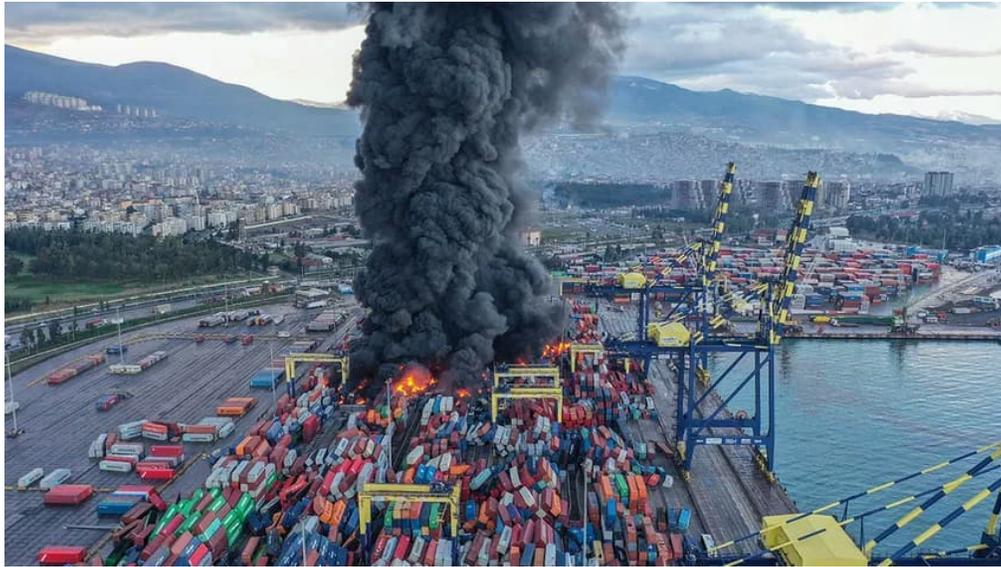
Iskenderun port experienced a significant fire during the immediate aftermath of the earthquakes. Local media reported that the fires were caused by the ignition of toppled containers. Combined with damage to structures, the port was out of commission for approximately two months. At the time of the team's visit the port was operational, however access to the port was restricted. Remnants of charred debris was still visible through the fenced areas of the port at the time of the reconnaissance.

**Figure 8.12: Earthquake and fire damage at the Iskenderun Port (image from *Dunya Gazetesi*)**

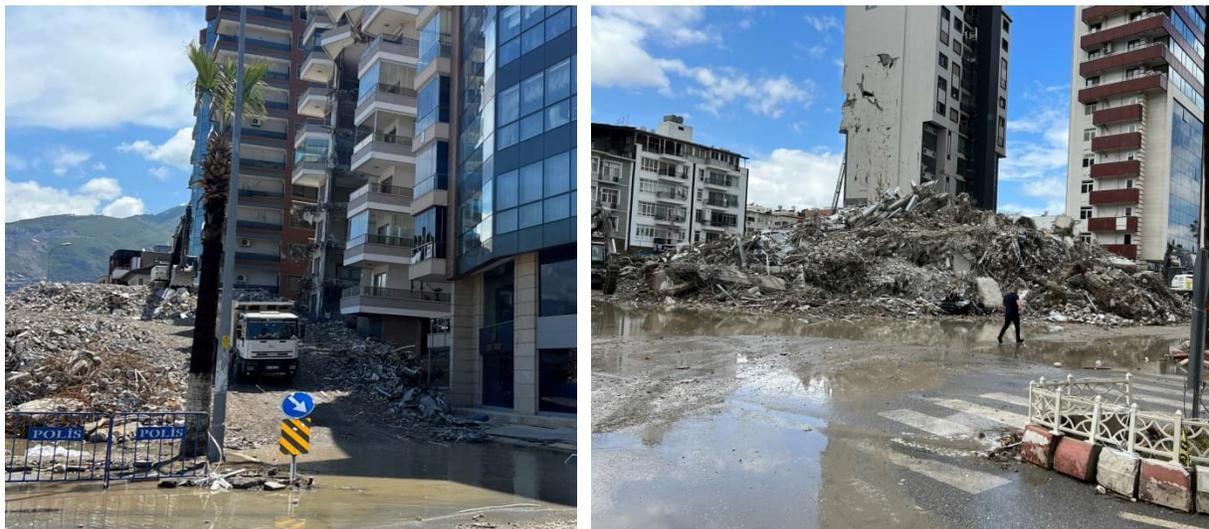
In many urban centres a large extent of the collapsed buildings had been removed. Huge volumes of debris and rubble, resulting from the collapse and demolition of buildings, need to be managed. The team observed the ongoing effort to stockpile debris on sites where buildings had previously stood. From these stockpiles the debris was being loaded into dump trucks and hauled away. It will be a major challenge to remove and manage the excessive volume of debris.

**Figure 9.1: Debris stockpiles on sites where buildings previously stood in Iskenderun.**

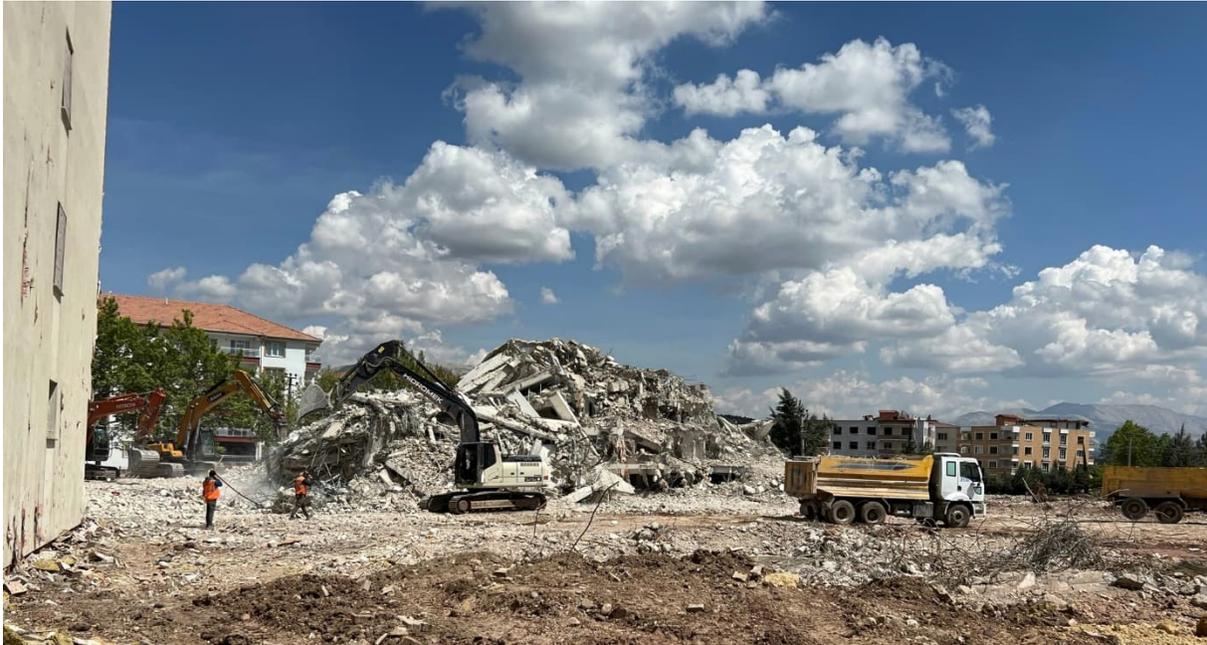
**Figure 9.2: Building demolition and debris removal, Gölbaşı**

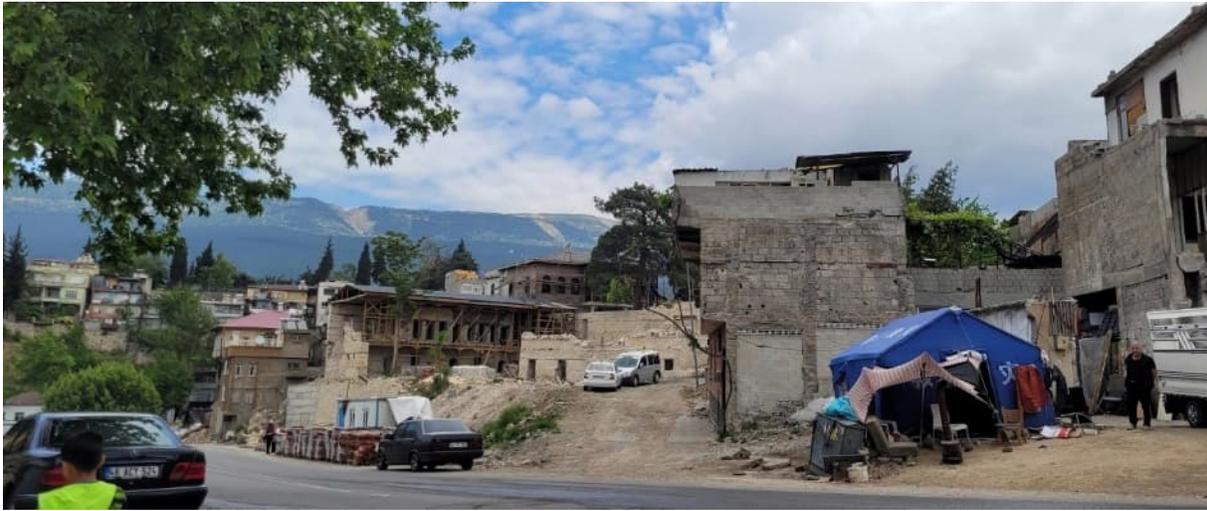
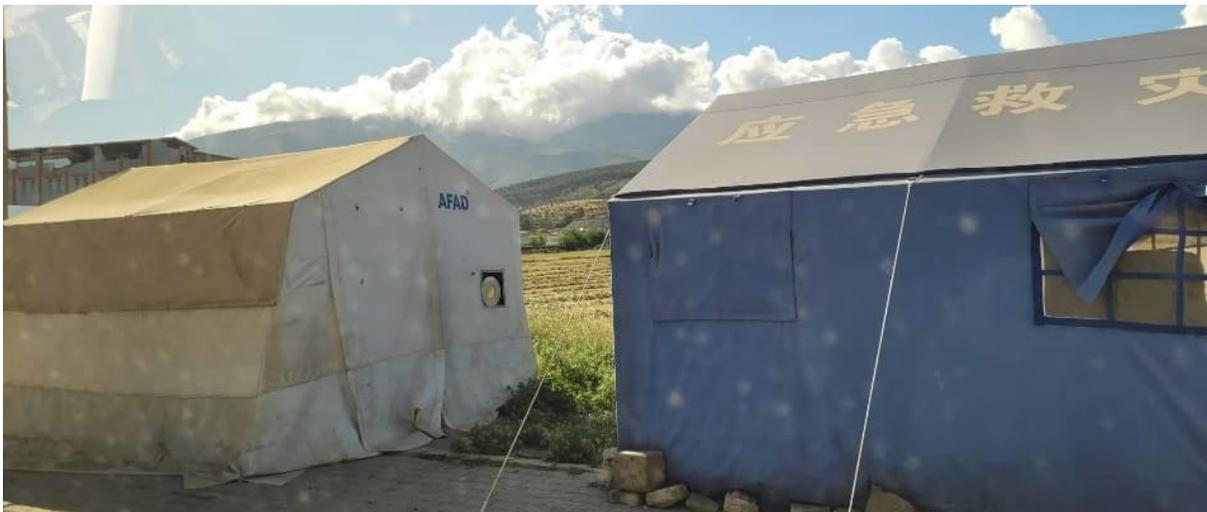
The acute lack of housing seemed to have been relieved by the distribution of tents, identified with logos of national and international relief agencies. The team observed these both in rural and urban settings, in gardens, public spaces, lining the road, and in greater numbers in newly established tent cities on the outskirts of population centers. Some examples are presented in Figure 9.3.

**Figure 9.3: Tents in urban and rural settings serving as temporary housing**

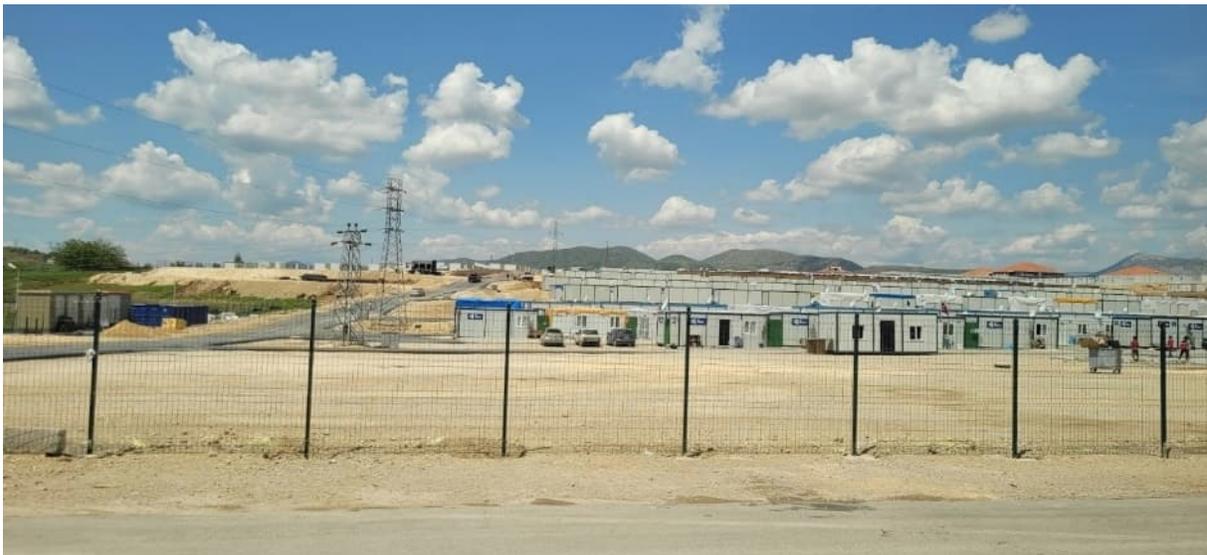
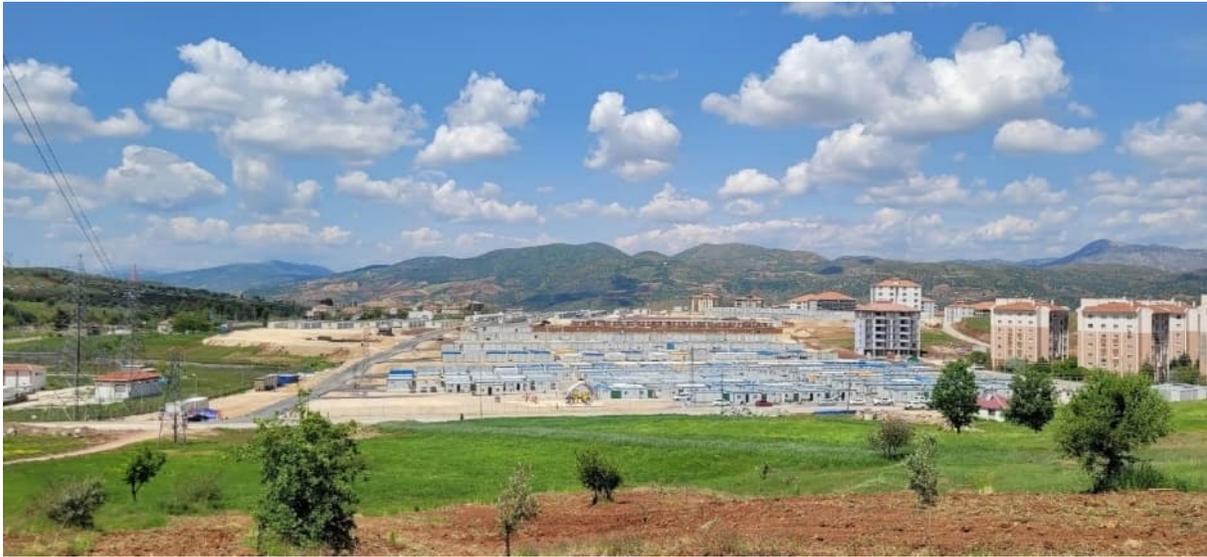
As a more robust solution, the use of modified containers seemed to be more widespread, see Figure 9.4. New fenced communities were being constructed in several of the visited locations.

***Figure 9.4: More semi-permanent housing constructed out of containers***
