## Full-scale impact tests of columns for rocking steel braced frames

Paul Mottier<sup>1</sup>, Robert Tremblay<sup>2</sup>, Colin Rogers<sup>3</sup>.

### ABSTRACT

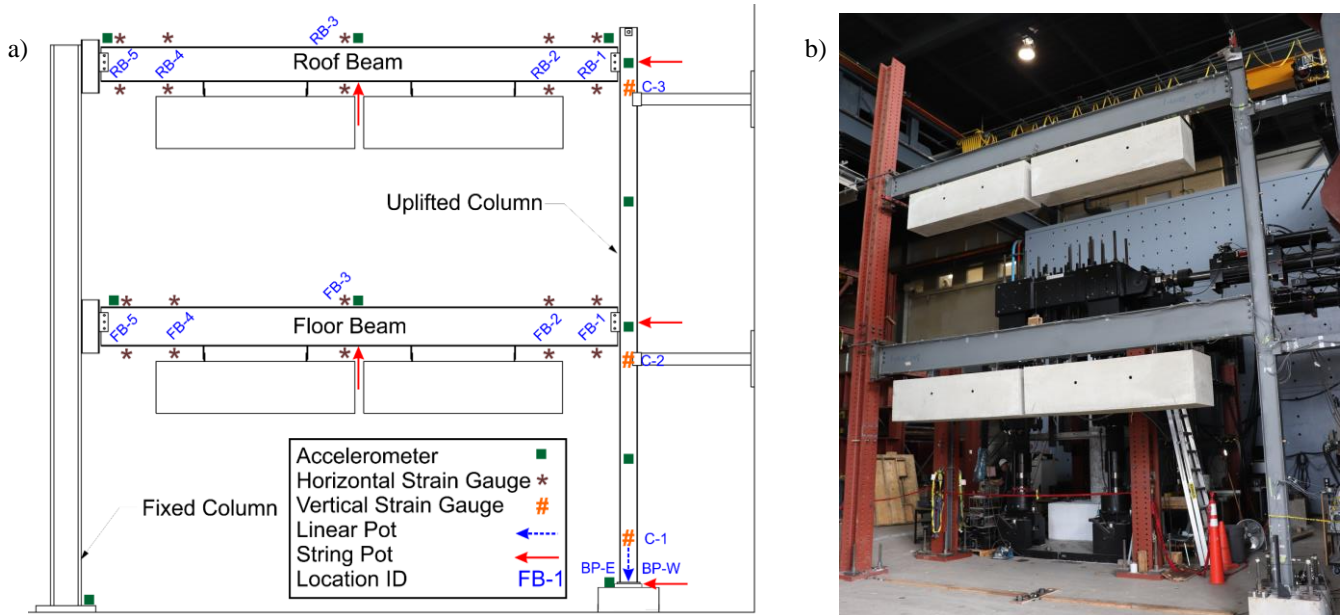
Figure 4— Test setup: a) Instrumentation of the specimen; b) Overall view of the test setup.

Figure 4a shows details and locations of the sensors that were used in the test program. Accelerometers were used to measure vertical accelerations at different elevations along the GCRBF column: two 50g accelerometers on the column base plate, ten vertically 10g accelerometers placed at regular spacing along the column flanges and web. In addition, 20g accelerometers were used to measure the vertical accelerations of the foundation block. Three accelerometers were installed at both ends and at the mid-span of each beam to measure vertical accelerations. 3g and 5g accelerometers were used at the roof level and floor levels, respectively. Linear pots were used to measure the vertical displacement of the GCRBF column base. Strain gauges were placed horizontally on beams and vertically on columns to obtain member forces. Axial compression in the GCRBF column was obtained at three elevations from the mean value of the strain gauge readings at these positions. Bending moments were obtained at 5 positions along the beams from curvatures determined with strain gauges placed on the beam flanges. End shears in beams were calculated from gradients in bending moment measured near the beam ends. All data was recorded using an HBM synchronized data acquisition system and processed with Catman DAQ software. Two different acquisition rates were used during the tests: 300 Hz during the dynamic characterization tests and 2400 Hz during the column impact tests.

The response history results from the column impact test performed for an uplift of 125 mm are presented in Figure 6. The locations where response parameters were measured or calculated correspond to the location IDs shown in Figure 4a. Static values are included in all plots; the vertical displacements shown in Figure 6a include displacements from initial uplift. The time values when the first and second column impacts occurred are indicated by the vertical light grey lines. To improve the clarity of the results, all signals have been low-pass filtered with a cut-in frequency of 150 Hz.

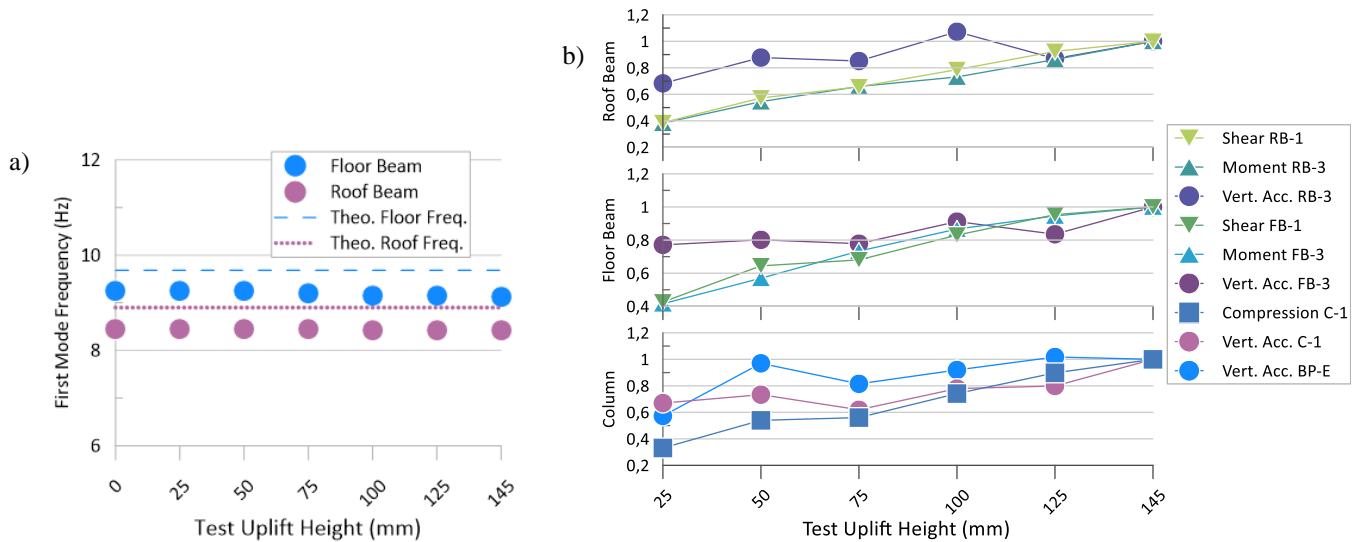
Figure 5—*a) First mode beam frequencies from characterization tests; b) Peak response parameters from column impact tests (normalized w.r.t. 145 mm uplift test values)*

The first mode frequencies of the beams from the characterization tests are presented in Figure 5a. The frequencies from modal analysis of the specimen are also given for comparison purposes. As shown, the measured first mode frequencies of the two beams correspond well to the theoretical values (residuals of 4.5% and 5% for the roof and floor beams, respectively). For both beams, they remained nearly constant over the test program, although the values slightly decreased as the number of tests performed and the uplift amplitudes increased. This variation can be explained by a progressive reduction of the flexural stiffness of the beam-to-column connections during the test program. As noted earlier, bolt retightening was not carried out.

Table 1 presents the maximum values of the response parameters for the column and the two beams during the six tests that were performed. These parameters are also plotted in Figure 5b. In the figure, the values are normalized to the value obtained during the test with the largest uplift value (145 mm). In the column, the peak axial compression generally increases with the height of the drop; the regression coefficient of the best-linear fit (not plotted for clarity) is  $R^2=0.98$ . The evolution of the vertical accelerations is however not as regular, as the regression coefficient are 0.75 and 0.80 for the vertical acceleration in the base plate and in the column, respectively. In the beams, vertical accelerations also generally increase along with the height of the uplift, though the increase rate varies between tests. However, shears and bending moments in beams increase almost linearly with the height of the drop. For instance, the regression coefficients of the best-linear fits are  $R^2=0.98$  and 0.99 for the moments at the floor and roof levels, respectively.
