SHAKE-TABLE TESTS OF A THREE-STORY MASONRY-INFILLED RC FRAME

ABSTRACT

This paper presents the shake table tests of a three-story, two-bay, 2/3-scale, masonry-infilled RC frame. The specimen was representative of the construction practice in California in the 1920s. It had a non-ductile frame design and was infilled with unreinforced masonry panels including a wall with a window opening in one bay and solid wall in the other bay in each story. The structure was subjected to a series of 14 ground motions of increasing intensity before it practically collapsed. The design of the specimen, the testing sequence, and the major findings are discussed here.

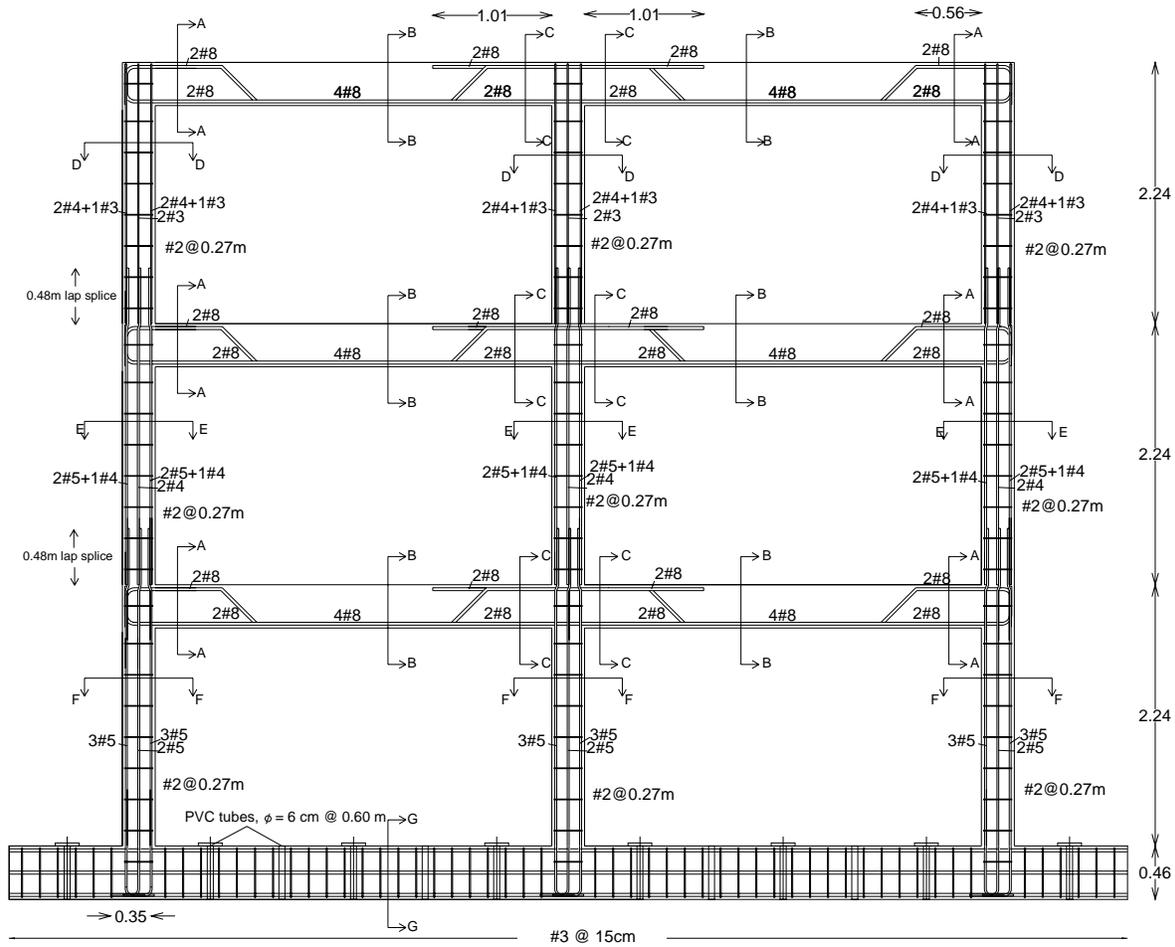
Figure 1. Design of three-story specimen tested at UCSD (dimensions in m).

The three-story specimen corresponds to the exterior frame of a prototype structure designed to represent existing structures built in California in the 1920s. The employed design approach was similar to the allowable stress method and considered only gravity loads. Details on the design of the prototype are provided by Stavridis (2009). The specimen was scaled with a length scaling factor of $2/3$ compared to the prototype structure. The dimensions of the frame and the layout of the steel reinforcement are presented in Fig. 1, while the cross sectional details of the RC members are shown in Fig. 2. The design of the columns was modified in view of a second specimen which would be tested to investigate the effectiveness of retrofit schemes consisting of overlays of Engineered Cementitious Composite (ECC) and Fiber Reinforced Polymeric (FRP) materials (Shing et al. 2009). The longitudinal reinforcement of the RC columns was increased from 1% that the exact scaling of the prototype would require to 2% at the first and 1.5% in the second story to provide sufficient capacity to resist the overturning moment, considering the strengthened panels of the retrofitted specimen. Such values of the longitudinal reinforcement ratio are not uncommon for existing structures as they are within the 1% and 4% limits used in the 1920s era. Moreover, lap splices were not included at the base of the bottom-story columns to prevent premature failure in the lap-splice region since this is not an expected failure for the prototype structure. Finally, to facilitate the construction, the roof beam was modified to be identical to the beams at the first two stories. The infill walls had two wythes of brick units built with Type N mortar consisting of 1 part Portland cement, 1 part lime and 5 parts sand. At each story, the specimen had a solid infill in one bay and an infill wall with a window opening in the other bay, as shown in Fig. 3(b).

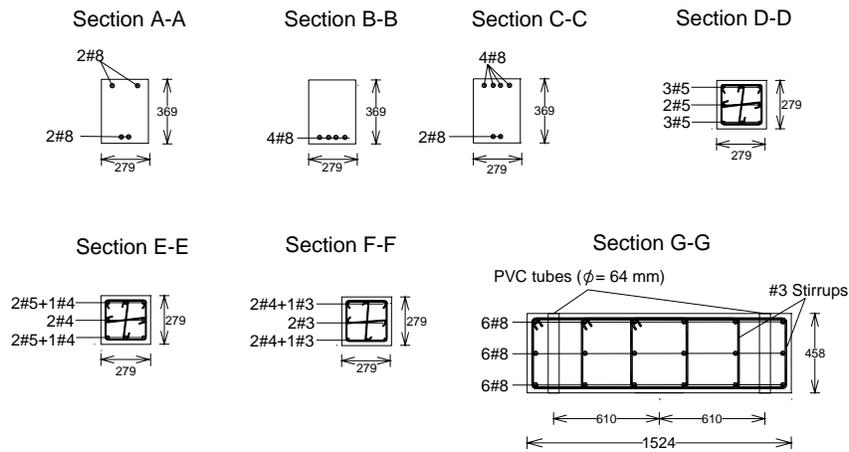
Figure 2. Cross sections of RC members (dimensions in mm).

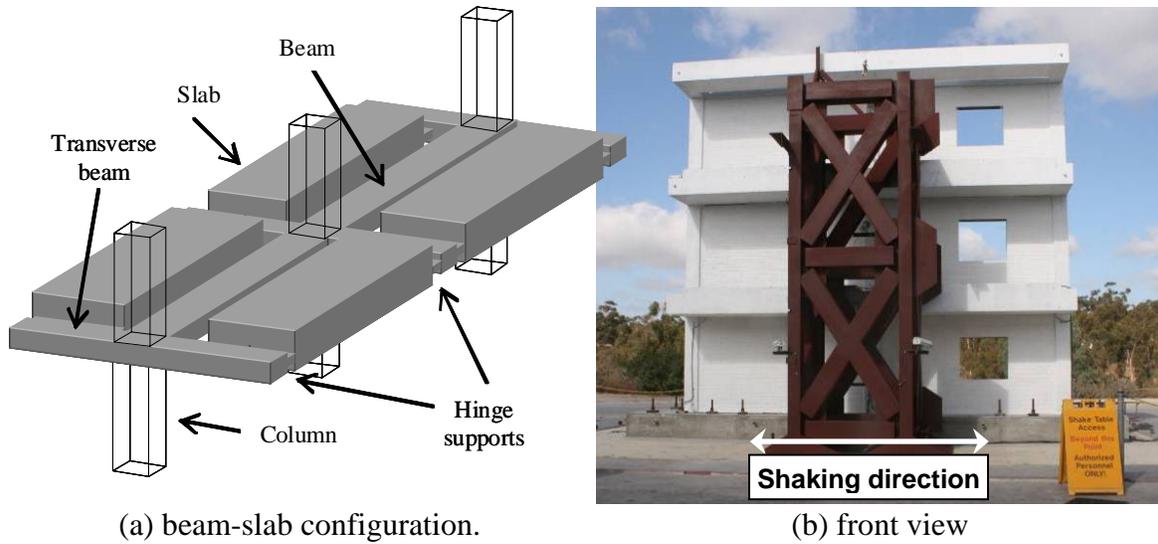
Figure 3. Shake-table specimen.

The mass required to simulate the gravity loads was attached to the frame, through the construction of thick slabs at levels 1, 2, and 3, as shown in Fig 3(a). Although the specimen simulated an external frame of the prototype, the slabs extended to both sides of the frame to provide symmetry to the test structure and prevent the undesired behavior that an eccentric center of mass would cause under seismic excitation. This adjustment was necessary to represent the behavior of the three-dimensional prototype structure. In the latter, the centers of rigidity and mass would coincide and prevent the out-of-plane motion of the prototype under uniaxial excitation within the plane of the frame.

The slabs simulating the gravity mass were designed to be relatively short but rather thick, having an out-of-plane length of 0.97 m (38 in.) and a height of 0.48 m (19 in.), to prevent issues related to the structural stability introduced by long cantilever slabs. The roof slabs had smaller dimensions due to the reduced amount of gravity load applied at the roof of the prototype. If directly connected to the beams of the frame, the thick slabs would act as a single, unrealistically rigid, beam which would prevent any deformation of the beams and joints of the frame. To avoid this undesired constraint, a gap of 51 mm (2 in.) was introduced between the slabs and the beams and the slabs were only connected to the frame through three transverse beams at each floor. Moreover, slots were introduced at the connection of the slabs with the transverse beams. The slots were 51 mm (2 in.) wide and were arranged in such a way to form a concrete joint of 102 mm (4 in.) height which would connect the slabs to the transverse beam. The reinforcement connecting the slabs to the transverse beams was bended to form an 'X' inside the joint. This configuration resulted in the creation of four slabs per floor. The slabs were connected with the frame through pin supports which enabled the transfer of gravity and inertia forces generated by the mass of the slabs. The minimal moment capacity of the joints would minimize the rotational constraints imposed to the longitudinal beams of the frame, as they would crack to allow the relative rotation between the transverse beams and the slabs.

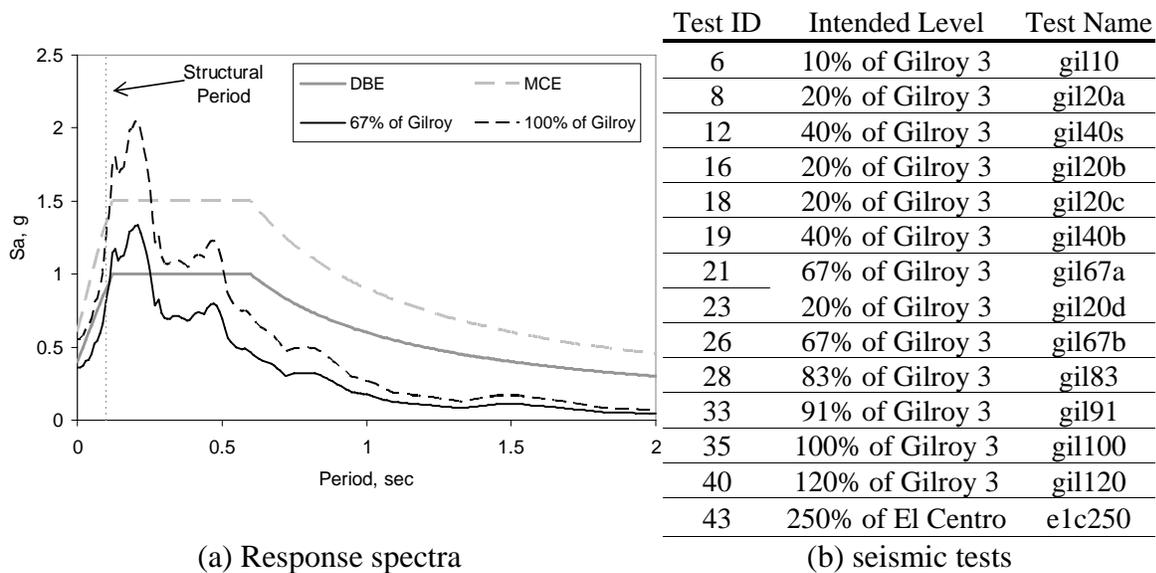
Figure 4. Acceleration response spectra and conducted seismic tests.

which is the estimated frequency of the prototype infilled frame considered here, 67% of the Gilroy 3 motion corresponds to a design basis earthquake (DBE) for Seismic Design Category (SDC) D (FEMA P695, ASCE 41-06). Moreover, for this structure, the 100% level of the Gilroy 3 motion corresponds to a maximum considered earthquake (MCE). The acceleration response spectra for these levels of the Gilroy 3 motion are presented in Fig. 4. Based on this correspondence and the goal to gradually inducing damage to the structure, the loading protocol presented in Fig. 4(b) was assembled.

When the seismic excitations were applied to the structure, differences were noted between the intended and the recorded motions at the base of the structure. These differences introduced the need re-evaluate the scaling coefficients for the recorded motions as percentages of the historical records of Gilroy 3 and El Centro. For an elastic structure this could be achieved by considering the elastic acceleration response spectra with respect to its fundamental period. However, the damage induced to the specimen by the test sequence changed the modal periods. Consequently, the estimated from the white-noise tests period of the structure (Moaveni et al. 2010) before and after each seismic test were used to define the range of values of the fundamental period during each test. Then, the scaling coefficient minimizing the difference between the obtained record and the desired time history over that period range was calculated. As shown in Table 5, the re-evaluation of the scaling coefficients indicates that for ground motions up to 91% of Gilroy the table provided in most cases spectral accelerations for the period of interest for each test slightly lower than the desired ones. For gil100 and gil120 though, the input motions were amplified reaching 113% and 133% of the original motion.

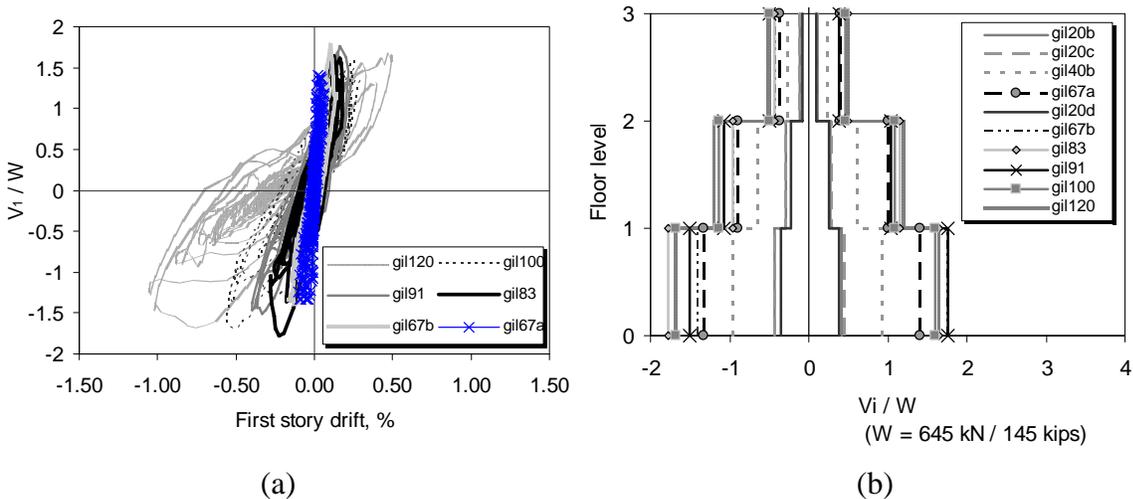
Figure 5. (a) First story shear- vs.-drift relation and (b) shear force distribution.

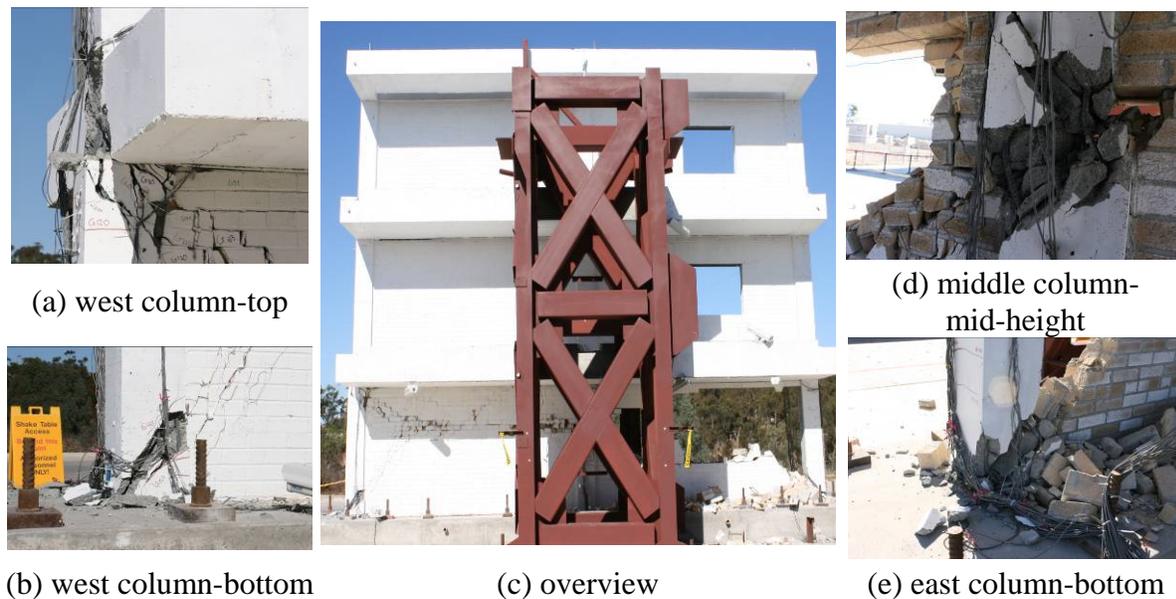
Figure 6. Overview of damaged specimen and details of column failure in the first story after ec250.

During the ec250, a significant portion of the east bay masonry panel collapsed on the

shake table and the three first-story columns failed in shear, at different heights, as shown in Fig. 6. Although the specimen failed out-of-plane at the very early stages of the ground motion, the steel towers prevented the collapse by continuously supporting the structure during its lateral motion. At the end of the test, the structure could not carry its own weight and was leaning against the support towers. In a real structure the RC members in planes transverse to the tested frame would have prevented the out-of-plane collapse mechanism. Therefore, this is a possible mechanism for real structures and it is interesting to observe it. The most impressive failure was the shear crack that developed near the bottom of the east column. This failure occurred early in the test and was followed by the gradual collapse of the infill wall in the east bay of the specimen. This was the wall that included a window which played an important role not only in the development of the cracks which initiated at its corners, but also in reducing the out-of-plane stability of the infill panel, when two triangular pieces of the masonry wall on the sides of the window detached from the rest of the wall. As a result, the unsupported lintel beam collapsed in subsequent cycles of motion. It is important, though, to point out that the structure collapsed after being subjected to a series of strong motions that a real structure is not likely to experience.
