IN-PLANE BEHAVIOR OF FULL SCALE DHAJJI WALLS (WOODEN BRACED FRAME WITH STONE INFILL) UNDER QUASI-STATIC LOADING

Qaisar Ali¹, Tom Schacher², Mohammad Ashraf¹, Akhtar Naeem¹, Bashir Alam¹

ABSTRACT

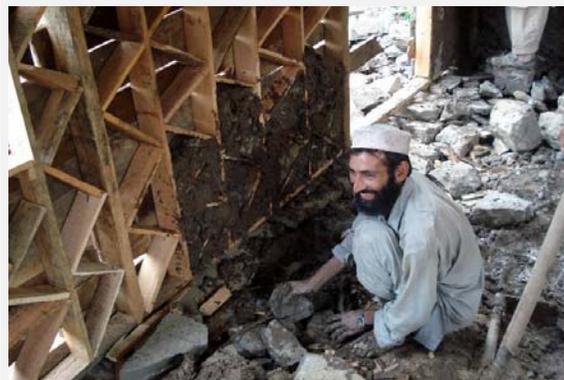
Figure 1. Typical Dhajji Construction in Northern areas of Pakistan

Dhajji means interconnected in local Kashmiri language or patch quilt wall in Persian. It is a type of traditional construction, used in parts of northern regions of Pakistan, India and Kashmir. In this type of construction, a wooden frame is first erected which is then filled with suitable materials, generally rubble stones with mud mortar, figure 1.

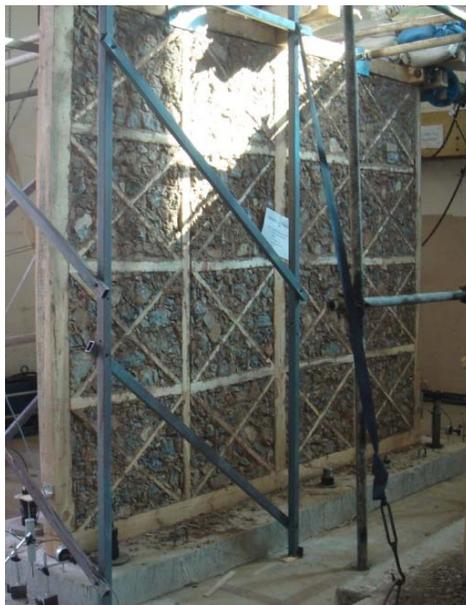
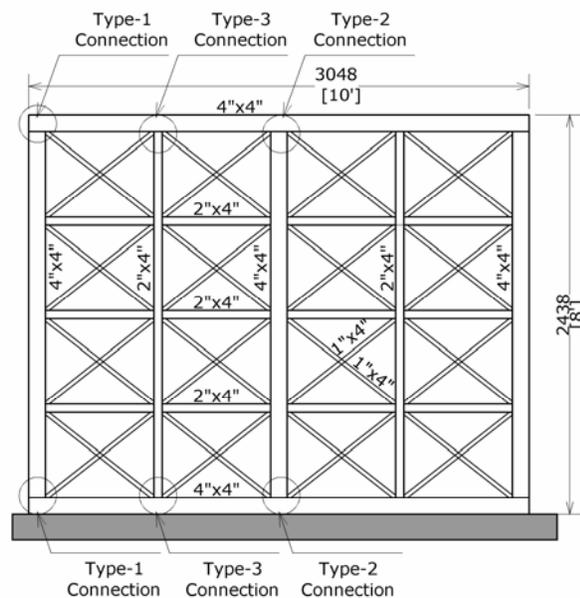
Figure 1. Dhajji wall test specimen, wall and member sizes, and configuration

Three full scale walls (DW-1, DW-2 and DW-3) were constructed in the EEC of NWFP UET Pakistan. The wall size, member sizes and configuration were chosen to be representative

of ERRA specification given in their manual and common construction practice being followed in the area, figure 1. Length of the test specimens was kept equal to 10 ft. Height was kept equal to the storey height. Main and secondary vertical posts were connected to the top and bottom horizontal members through tennon and mortise connection detailed in figure 2. Wooden nails 3" long made of mild steel were used to fix the connections. The intermediate horizontal members were connected through type-3 connection to the main vertical posts and through two wooden nails 3" long with secondary posts. Similarly each brace was connected to the vertical post with two wooden nails 2" long.

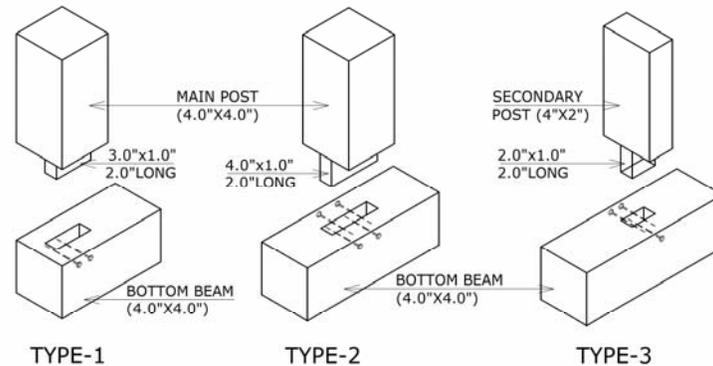
Figure 2. Tennon and mortise connections details

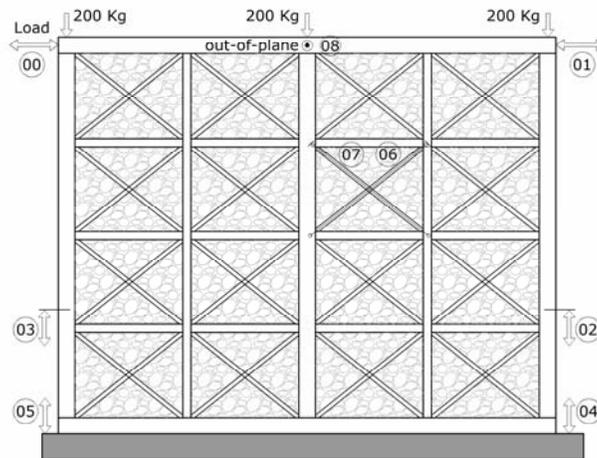
Figure 3. Test setup for Dhajji Wall specimens

The experimental test setup is shown in figure-3. The reinforced concrete footing was fixed with the strong floor of the laboratory. Horizontal load was applied through a hydraulic jack attached to the top horizontal wooden member of the wall. Horizontal load was measured through a load cell of 50 tons capacity. Hinges were provided at both the ends of hydraulic jack to release the horizontal and vertical rotations. 200 kg vertical dead load was applied through sand bags placed on top of each main vertical post to simulate load from roof truss. Eight displacement transducers numbered from 1 to 8 were used to measure displacement. All the gauges were connected to a data acquisition system. Restraints were provided to restrict the out-of-plane movement of the wall but allowing free in-plane movement. In-plane displacement measured with gauge-01 was used as the control displacement.

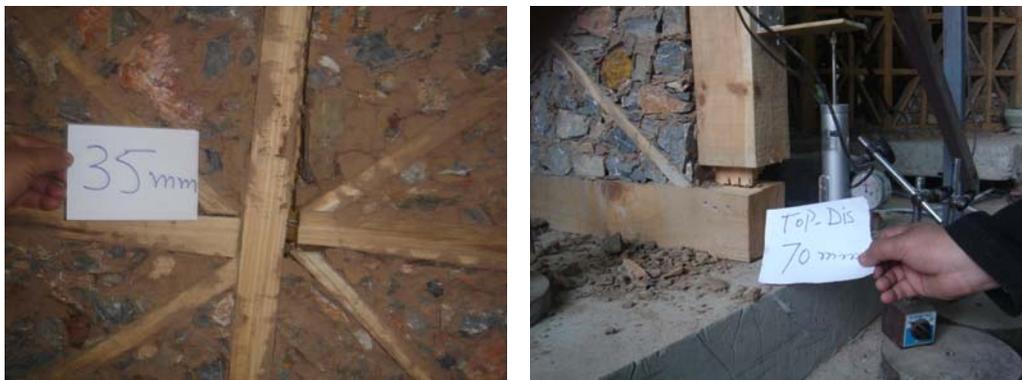
Figure 4. Separation of infill from wooden frame and opening of connections

The behavior of both Dhajji wall specimens DW-1 and DW-2 were almost similar. The pushing and pulling forces caused the opening of various joints and finally the complete separation of the joint members. The walls showed rocking behavior in form of opening and closing of bottom connections from the very beginning of the test, figure 4. Connections of intermediate beams and bracers with secondary post kept on opening and closing with positive and negative displacement. The behavior of walls with infill was more or less similar with the main difference being that in DW-1 the failure initiated from the front bottom connection while in DW-2 the rear bottom connection failed first. The behavior of both walls having been subjected to complete loading cycles is given as follows:

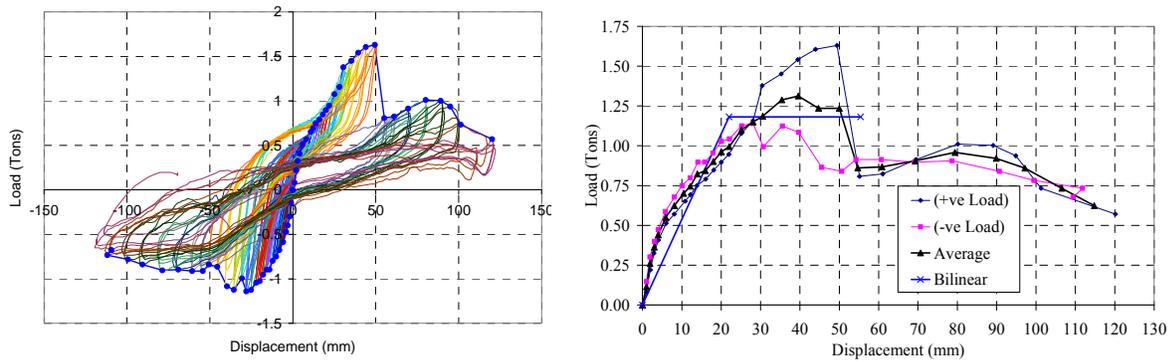
Figure 5. DW-1: Force-deformation hysteresis loops (left) and envelope curves (right)

The force-deformation hysteresis loops, positive, negative and average envelope curves and the bilinear approximate curves are shown in figure 5. The hysteresis loops showed a stiffening trend with increasing displacement. Both the positive and negative curves followed

same trend up to 25.0 mm displacement. After 25 mm cycle, strength degradation started in the negative loading direction while the load was still increasing in positive load direction. It happened because of the failure of the front bottom connection well before the rear bottom connection. The load in positive direction kept on increasing until the 50 mm cycle during which the rear bottom connection failed and the strength dropped to a value which was almost equal to the strength in the negative direction. Afterward, the behavior was almost similar in positive and negative directions.

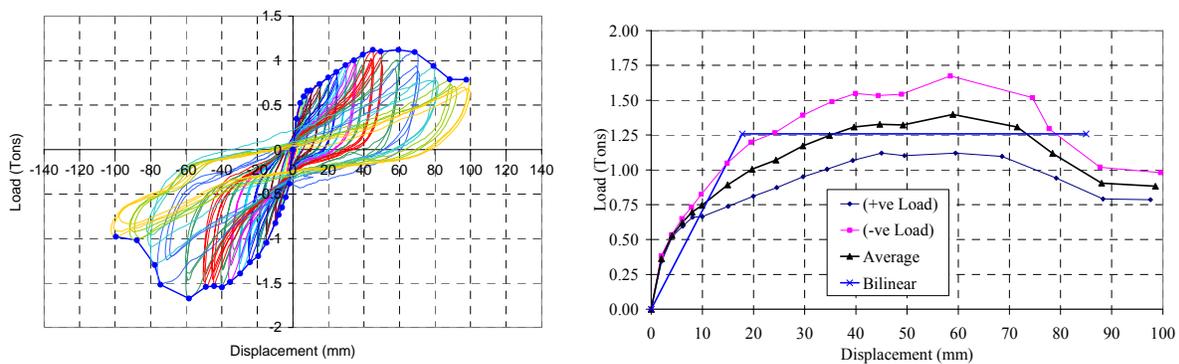
Figure 6. DW-2: Force-deformation hysteresis loops (left) and envelope curves (right)

The behavior of wall DW-2 in the positive and negative loading directions was almost same up to the 4.0 mm displacement. But after that, significant decrease in the stiffness was observed in the positive load direction, figure 6. However the stiffness in the negative load direction was changing at a slower rate. The wall reached to its peak resistance both in positive and negative direction at almost same displacement level but the resistance in negative load direction was greater than that in the positive direction. Despite the difference in peak resistance of the positive and negative load cycles, the shape of force-deformation envelope was found to be similar.

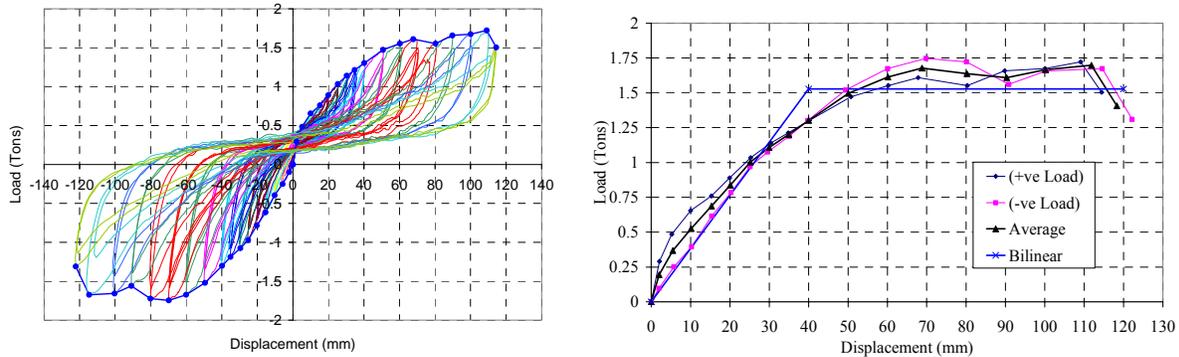
Figure 7. DW-3: Force-deformation hysteresis loops (left) and envelope curves (right)

Compared to previous two walls, the behavior of wall DW-3 in positive and negative direction was almost similar, figure 7. Since there was no interaction of frame with the infill, the overall behavior of wall DW-3 was more explicit and symmetric than that of DW-1 and DW-2,

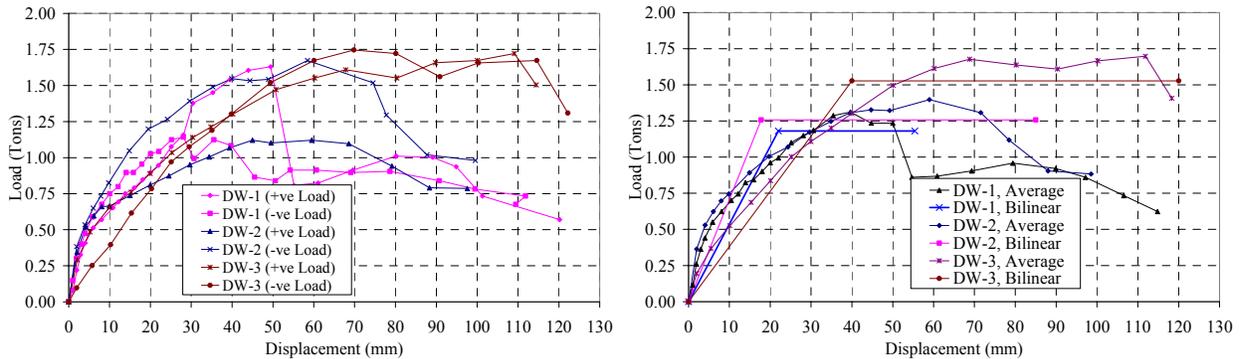
Figure 8. Force-deformation curves of all walls (left), average and bilinear curves (right)

figure 8. Moreover it can also be observed from figure 8 that effective stiffness of DW-3 is less than that of DW-1 and DW-2. On the other hand the ultimate displacement capacity of DW-3 is more than that of DW-1 and DW-2. However the ultimate strength of all walls is found to be approximately the same.

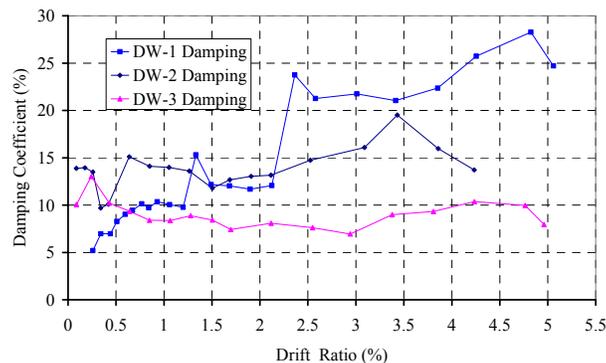
Figure 9 Equivalent viscous damping

Equivalent viscous damping calculated from the hysteresis loops was found to be increasing with increasing drift (figure 9) for walls with infill material. The damping remained constant for specimen DW-3.
