## The seismic vulnerability assessment of Québec churches: considerations on territorial specificities

Gessica Sferrazza Papa<sup>1</sup>, Marie-José Nollet<sup>2</sup>, Maria Adelaide Parisi<sup>3</sup>, Suze Youance<sup>4</sup>

Keywords: architectural heritage, historic churches, unreinforced masonry, timber, seismic assessment

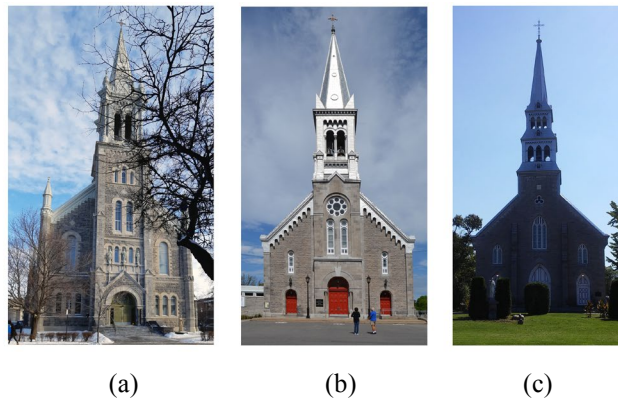
Figure 6. Examples of néo-Roman churches in Montreal: (a) Immaculée Conception, (b) Presentation de la Sainte Vierge, (c) Saint Joseph.

In the case of the néo-roman typology, the bell tower stands in the middle of the façade interrupting the continuity of the façade macro-element. Figure 6 shows three examples of néo-roman churches on the Island of Montreal.

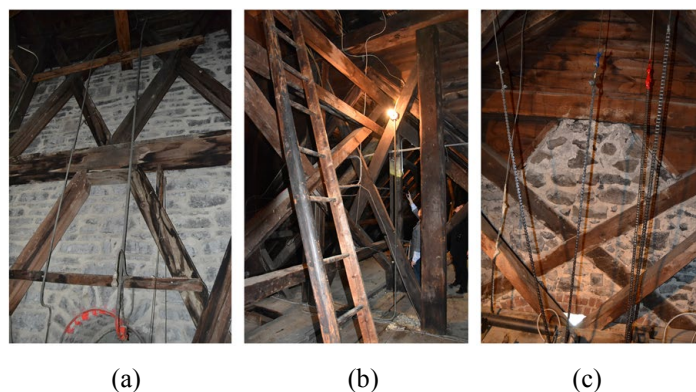
Figure 8. Examples of the structure of the bell tower at the level of connection with the façade: (a) the timber structure of the bell tower is attached to the façade masonry wall, (b) the structure of the roof intersects with that of the bell tower, (c) the timber structure of the bell tower starts inside the masonry of the façade.

It is clear that it is necessary to go beyond the rapid 28-kinematic mechanisms procedure. The consideration of other aspects of these macro-elements, such as how they are constructed and what is the connection between the bell tower and the façade, becomes crucial. Visual inspections of the above church examples show that the structure of the bell tower is strictly tied to the façade, the “jubé” (church balcony or roof screen) and the lateral walls. Analysis of the construction materials visibly shows that the structure of the bell tower is made of wood while the supporting walls and façade are in stone masonry. Figure 8 shows the timber structure of the bell tower observed from the interior of some churches at the level of connection between the masonry of the façade and the timber of the bell tower.

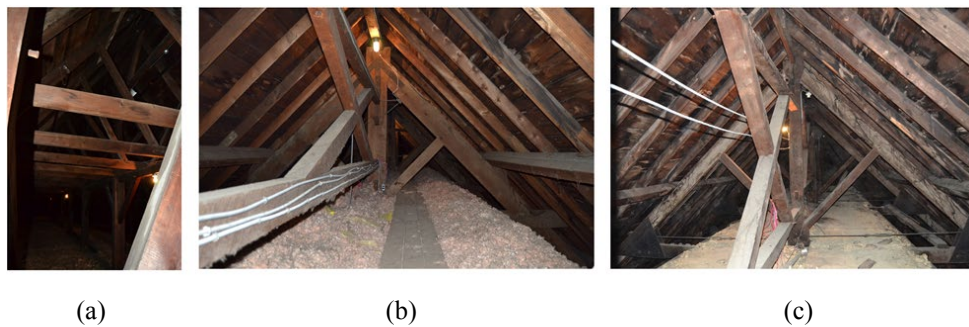
Figure 9. Examples of roof structures of visited churches in Montreal Island: (a) Sainte-Famille, (b) Présentation de la Sainte Vierge, (c) Saint-Joseph.

Another significant aspect related to the construction tradition of this territory is represented by the structures of the roof of these churches, as shown in figure 9. Often difficult to be inspected, this part of the building plays an important role in the box-like behaviour of the structure, a key element for a good seismic performance [30, 31].
